2.1.1 A. Foundations

FOUNDATION - ENGINEER REVIEW

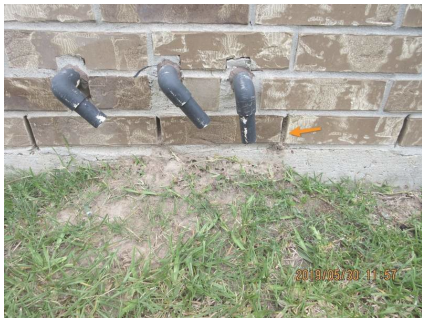
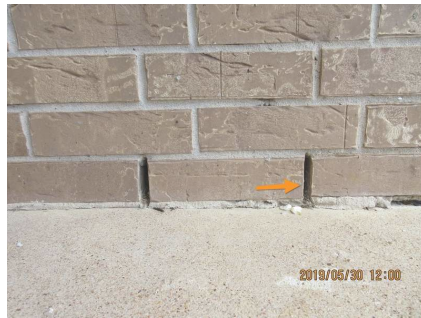
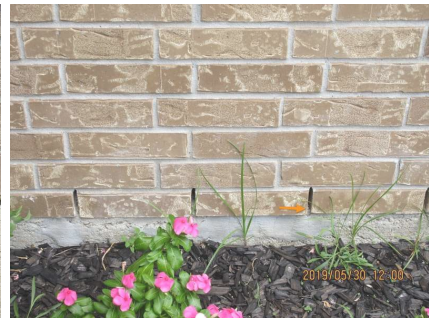
WEEP HOLES

Weep Holes are blocked or clogged. Weep holes are essential for proper ventilation and moisture control behind brick. Recommend unclogging.

Contact a qualified professional.

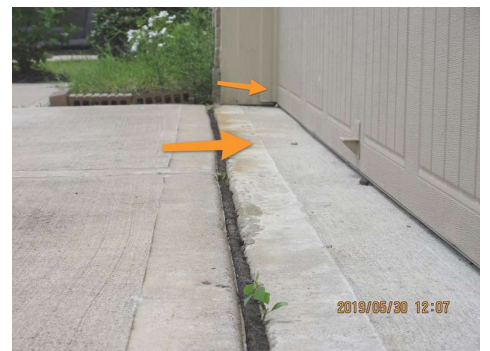
NEGATIVE APPROACH

Negative approach at garage entrance. Should slope away from garage..

Contact a qualified professional.

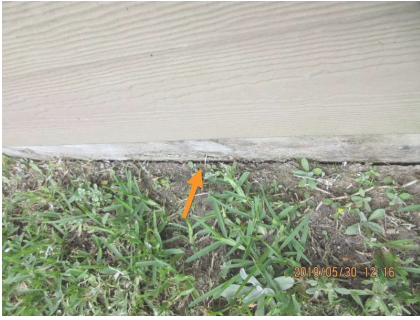
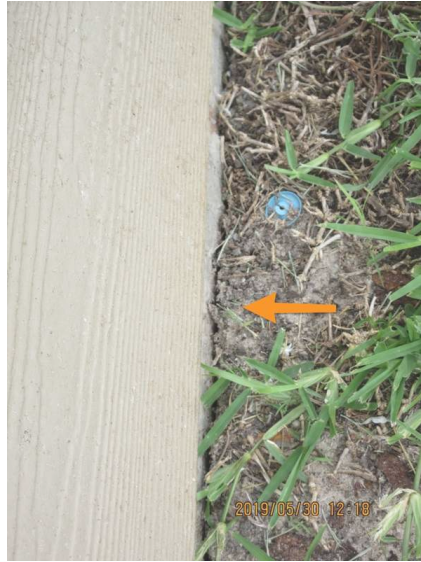
GROUND SEPARATION

Ground separation from foundation. Recommend maintaining proper hydration around foundation and yard.

Recommendation
Contact a qualified professional.

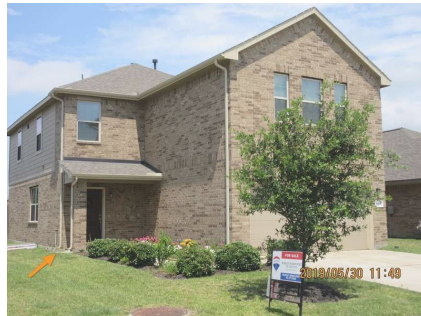
Down spouts must drain 5 away from the house or into underground drains for proper drainage of the lot.

Recommendation
Contact a qualified professional.

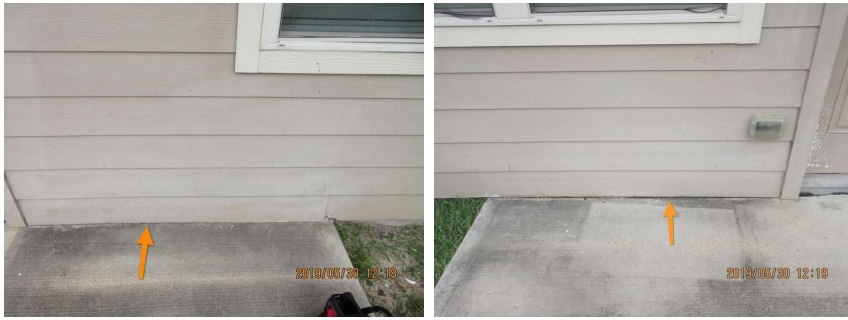
2.2.2 B. Grading and Drainage
GRADE 4-6

Proper grade is to have a 6" drop sloping away from foundation in 10 feet. Also with brick a exposed slab of 4" minimum and with siding 6" (8" for sole plates) of exposed slab from bottom of material to finished grade. Brick/Siding should be 2" above or more from flat-work (concrete)

Should have 2" of clearance between concrete and siding.

Recommendation
Contact a qualified grading contractor.

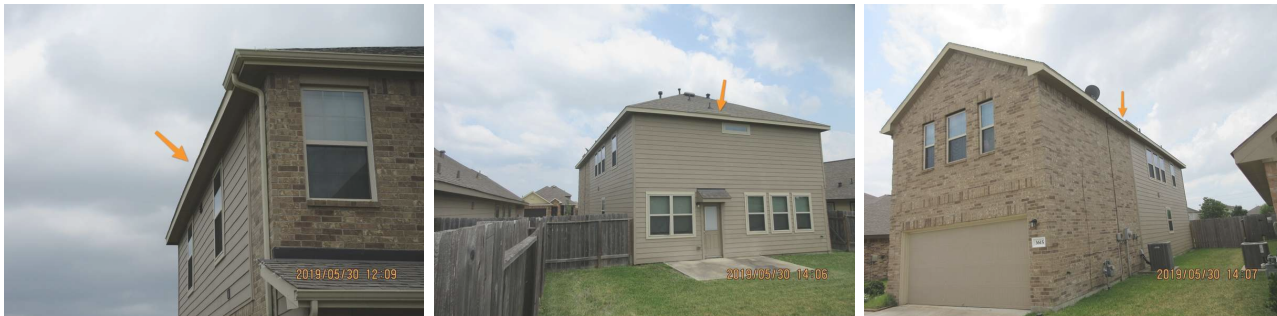
MISSING GUTTERS

Recommend gutters and drain lines to prevent possible water intrusion and or erosion of soil around building causing possible foundation issues.

Contact a qualified professional.

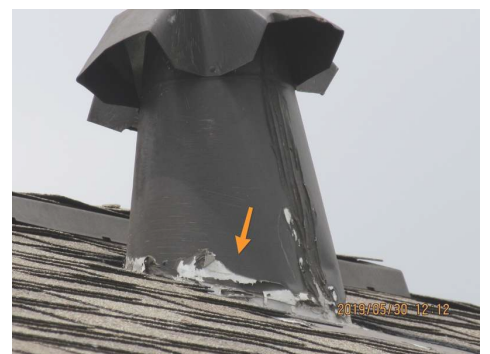
BOOTS

Vent boots are deteriorating/damaged. Recommend repair

Contact a qualified roofing professional.

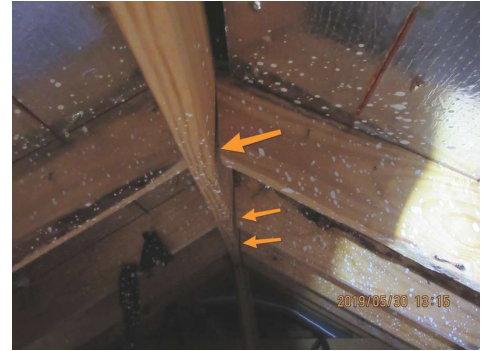
RAFTERS SEPARATING

Multiple rafters are separating from the ridge. Could happen from natural settling of the house, improper installation or foundation issues. Recommend having a structural engineer evaluate.

Contact a qualified structural engineer.

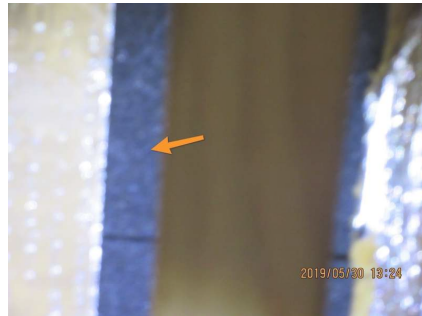
Ridge-vent was improperly cut or damaged.

Ridge vent was either supposed to extend to this area or sheathing was improperly installed. Recommend roofing professional calculate net free ventilation and determine the proper size of the ridge vent.

Contact a qualified professional.

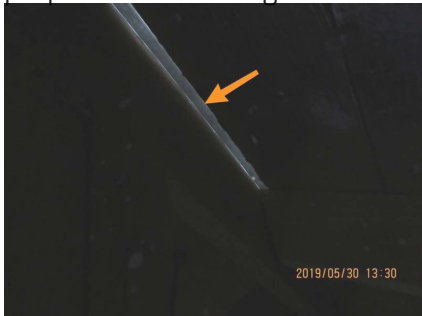
Extent of ridge vent.

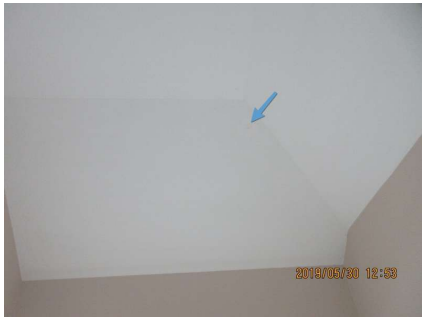
Previous repairs. Recommend asking what this was from.

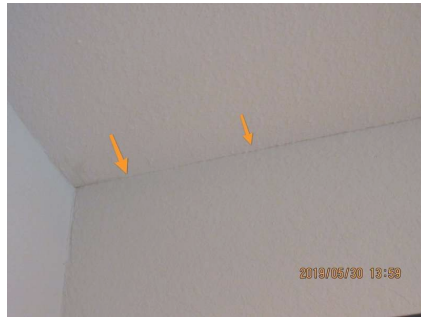
Crack starting to form on ceiling/wall joint. Recommend monitoring for future expansion of crack. This along with comments made in foundations section, recommend evaluation by structural engineer.

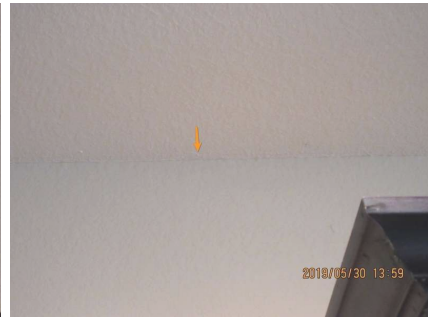
Crack starting to form on ceiling/wall joint. Recommend monitoring for future expansion of crack. This along with comments made in foundations section, recommend evaluation by structural engineer

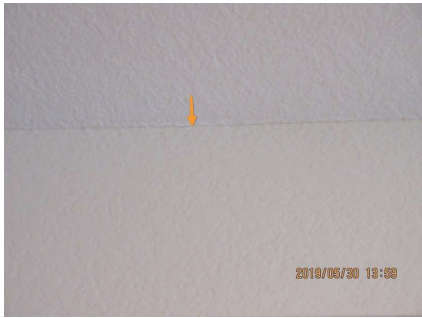
Crack starting to form on ceiling/wall joint. Recommend monitoring for future expansion of crack. This along with comments made in foundations section, recommend evaluation by structural engineer

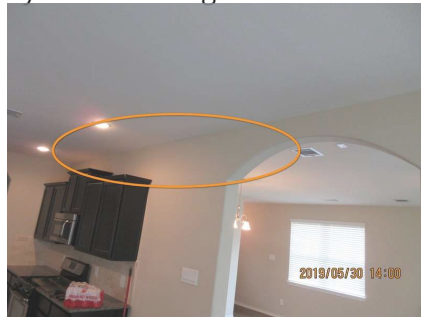
Crack starting to form on ceiling/wall joint. Recommend monitoring for future expansion of crack. This along with comments made in foundations section, recommend evaluation by structural engineer

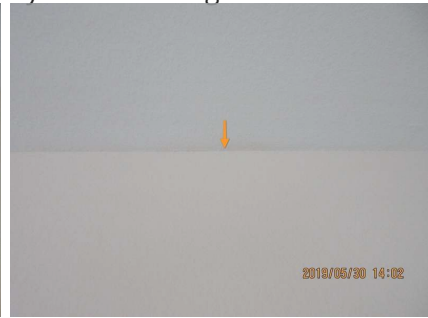
Crack starting to form on ceiling/wall joint. Recommend monitoring for future expansion of crack. This along with comments made in foundations section, recommend evaluation by structural engineer

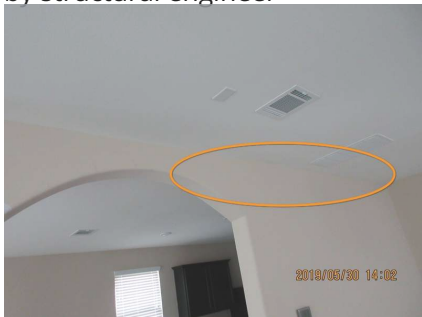
Crack starting to form on ceiling/wall joint. Recommend monitoring for future expansion of crack. This along with comments made in foundations section, recommend evaluation by structural engineer

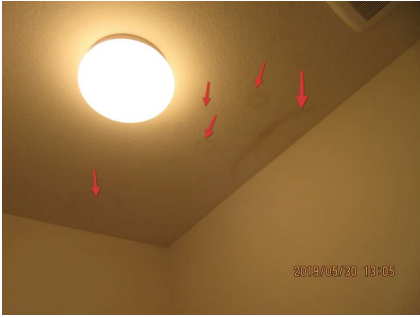
Ceiling structure showed signs of water intrusion, which could lead to more serious structural damage. Recommend a qualified contractor identify source or moisture and remedy.

I believe this to be from the ductwork above the laundry room.

Recommendation
Contact a qualified structural engineer.

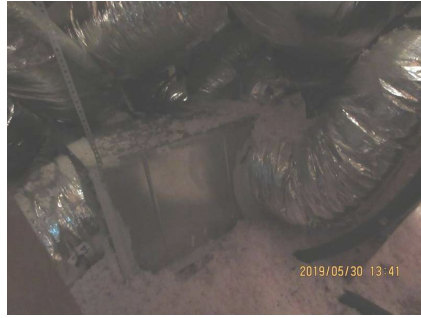
This plenum is resting in insulation. Which could be causing condensation to drip down to the laundry room below. Recommend having a licensed HVAC professional evaluate the entire ductwork and HVAC system for efficiency and proper installation of ductwork.

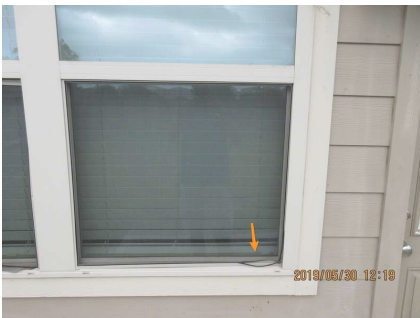
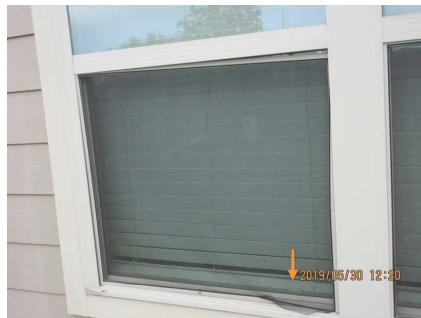
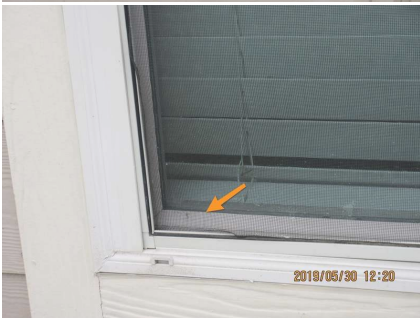
One or more windows are missing a screen or have damaged screens. Recommend replacement.

Contact a qualified window repair/installation contractor.

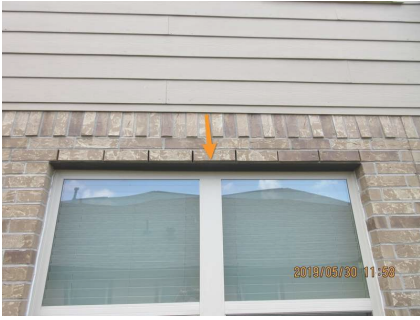
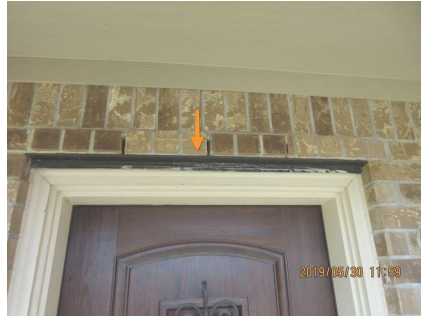
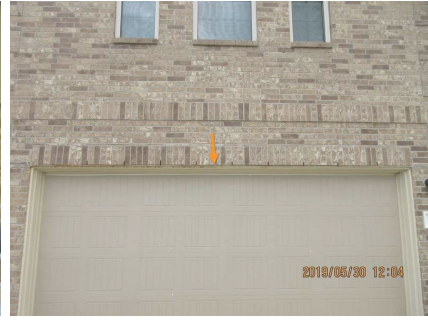
PAINT LINTELS

Recommend painting lintels to prevent rusting and cracking of mortar.

Garage lintel is rusted and there is separation between lintel and brick. This could be the cause of the cracked brick above. Recommend having a structural engineer evaluate.

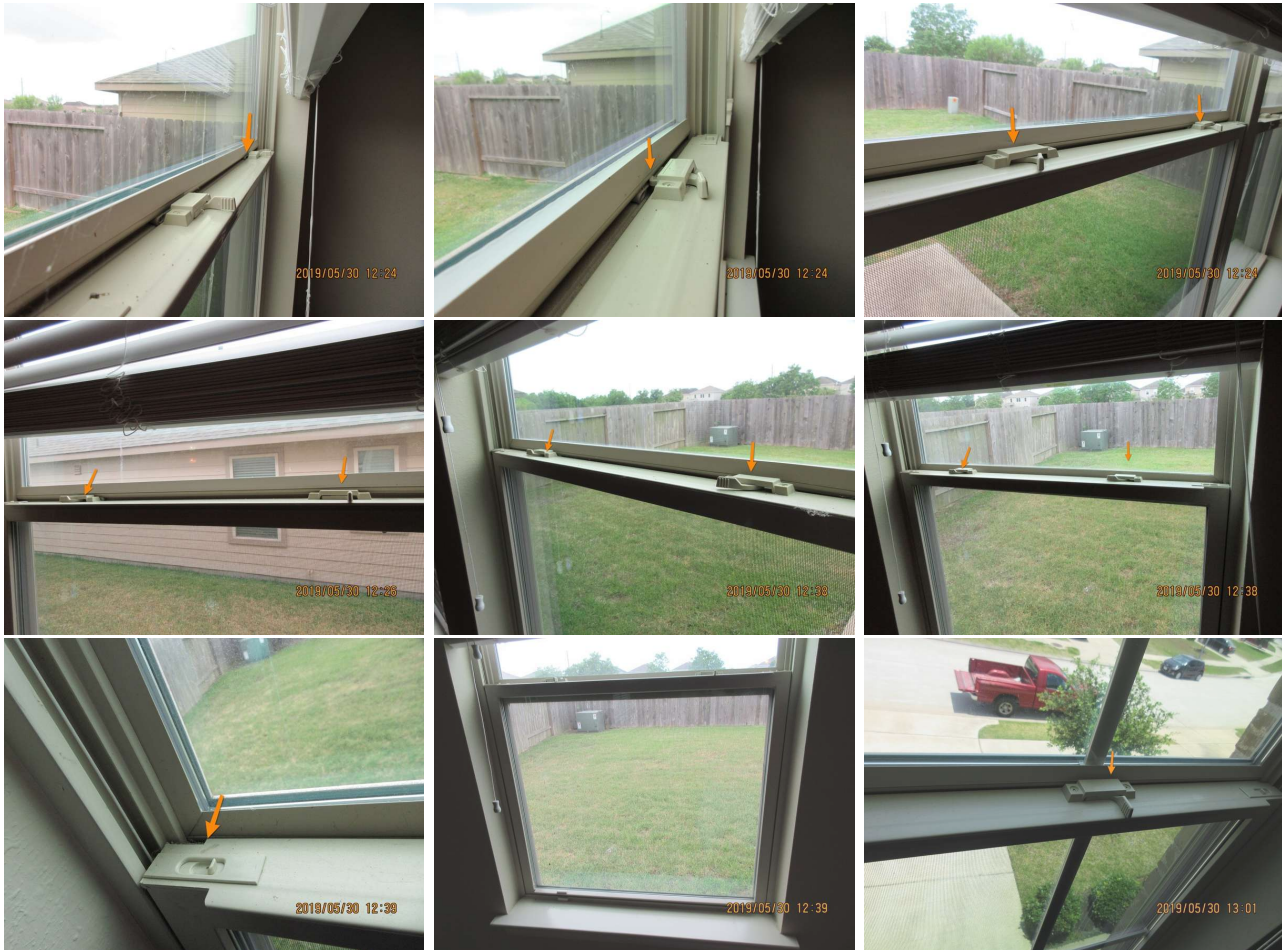
Window does not close completely. This could be from improper installation, settling or foundation issues. Recommend repair. If problem persists contact a structural engineer for further evaluation.

This window is off the railing.

Recommendation
Contact a qualified window repair/installation contractor.

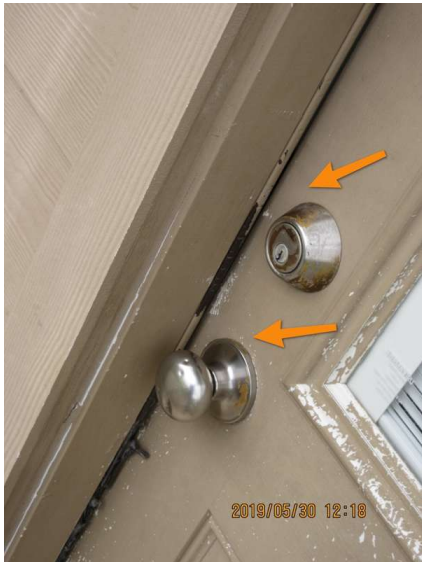
Back door does not close properly. You have to pull up on the door for it too close. Recommend having door repaired.

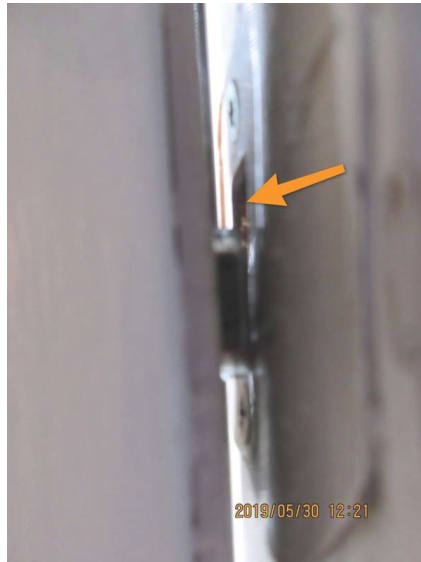
This shows distance that door is off.

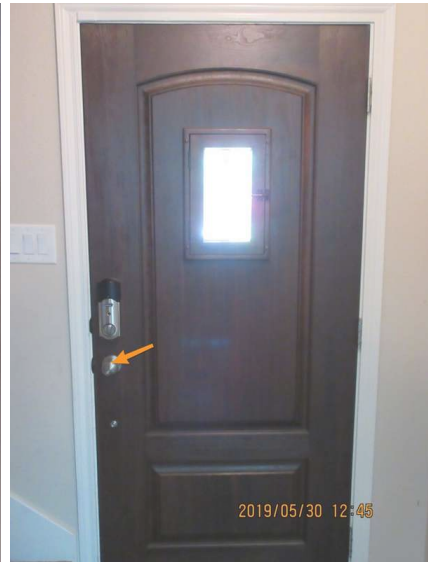
Door knob sticks.

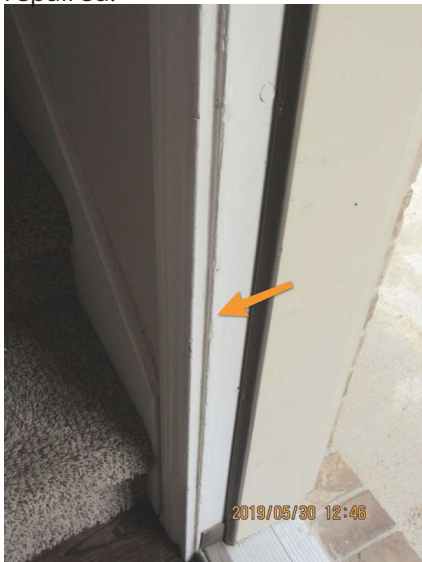
Poor workmanship. Cosmetic only.

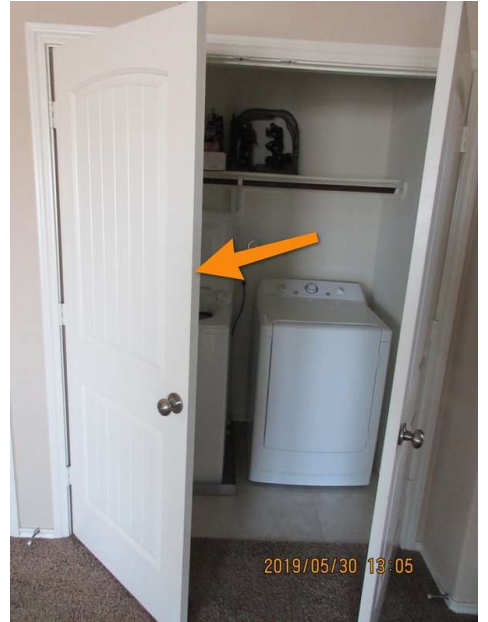
Doors move without pushing. This could be due to out of level doors, frames or issue with foundation. Recommend further evaluation and repair.

This door closes with out pushing it.

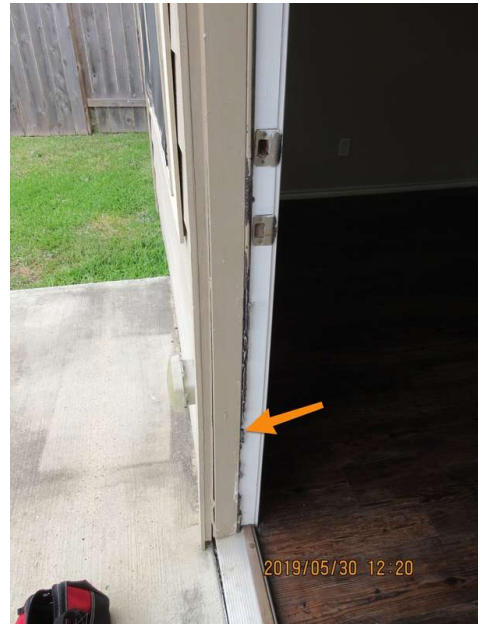
Weather stripping is damaged. Recommend replacing for proper sealing of house.

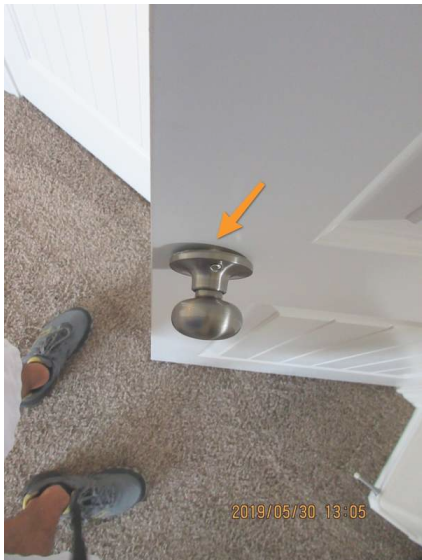
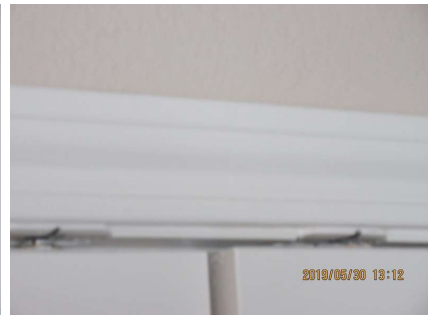
Door Hardware is loose or damaged. Recommend repairing/replacing.

Top of laundry door. missing latch. Recommend replacing.

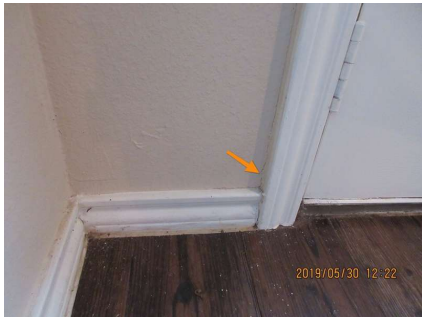
Recommend caulking.

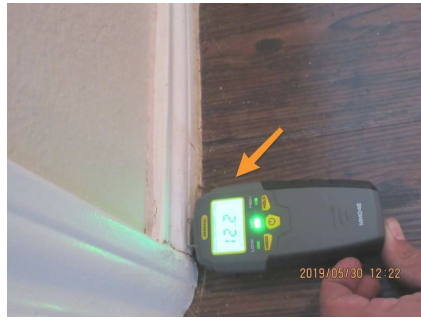
Right side (looking out) of back door. Visible moisture present. This is most likely due to the wood rot around the door not the exterior along with the siding not being 2" above concrete. Recommend removing and seeing what is behind the wood for any further moisture damage.

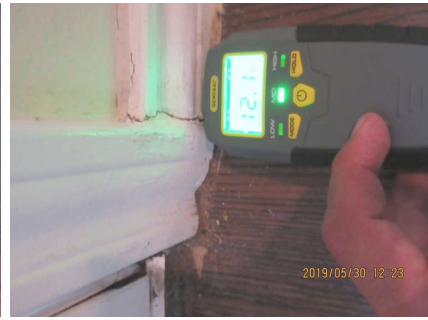
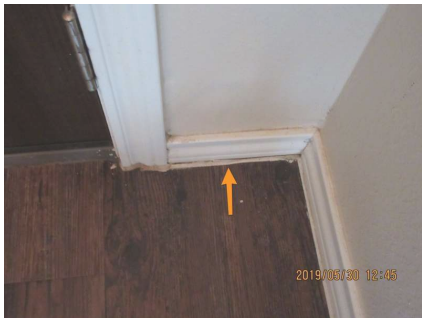
Recommend recaulking.

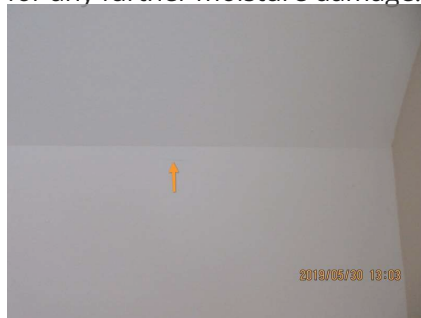
Joint tape starting to come undone. Recommend repairing.

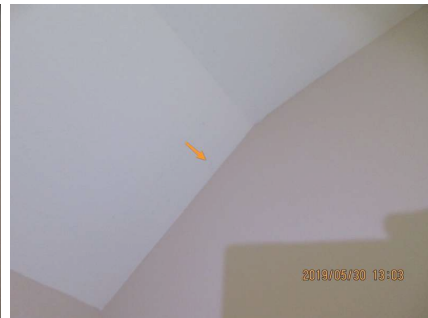
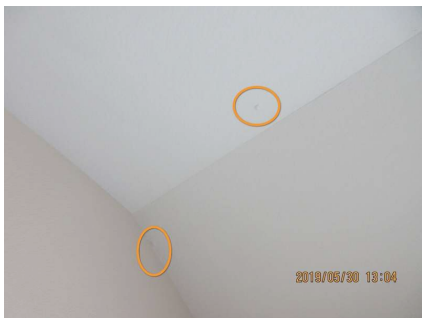
Nail pops.

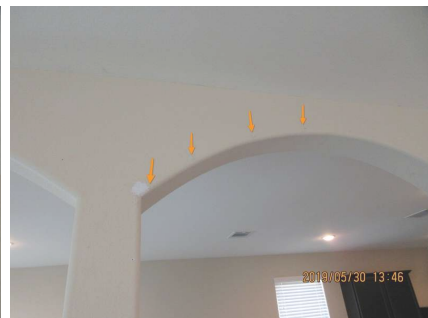
Repairs above arches. Recommend finishing repairs.

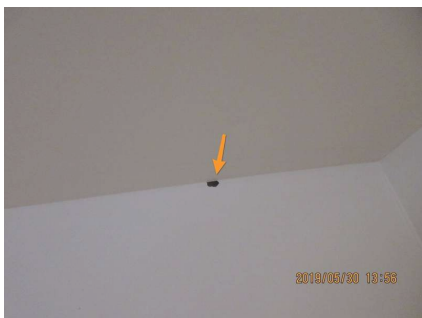
Hole in wall in alcove in garage. Recommend repairing

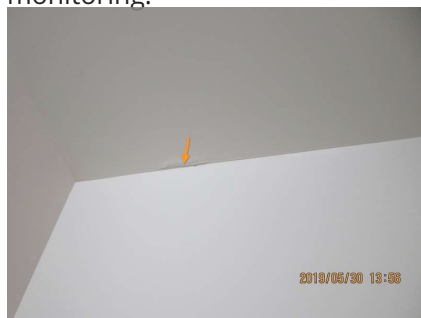
Joint tape starting to come undone. Recommend repairing.

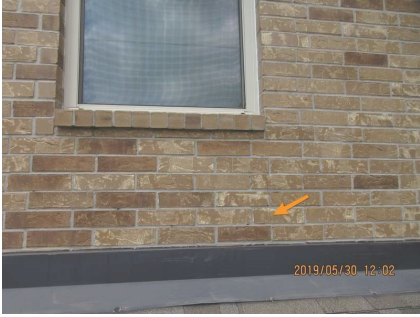
Major cracking observed in wall structure. This could be from moisture intrusion at the structure and/or soil movement. Recommend a qualified structural engineer evaluate and advise on course of action.

Cracked brick. See comments in "Foundations"

Contact a qualified structural engineer.

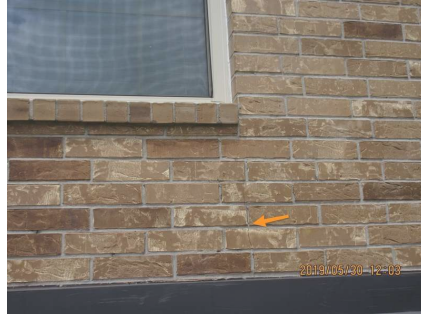
Cracked brick. See comments in "Foundations"

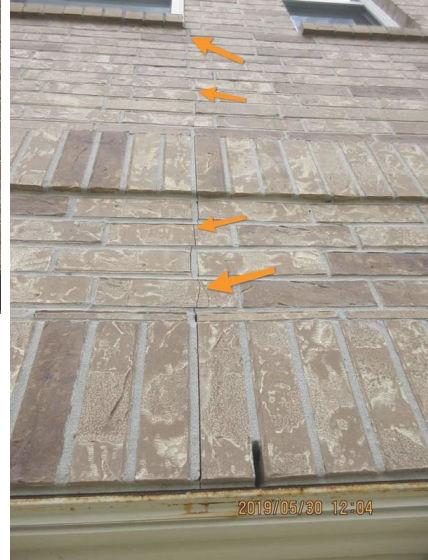
Cracked brick. See comments in "Foundations"

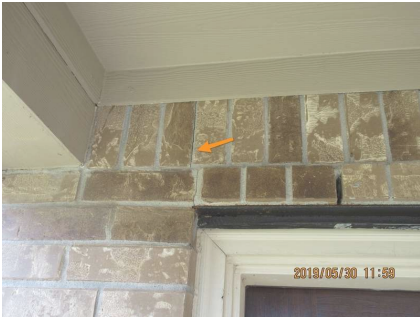
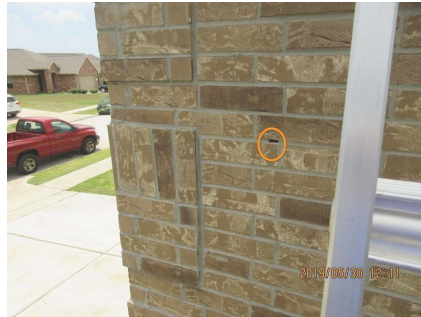
Minor cracking was observed in wall structure. Could be from rusted lintels, settling or foundation issues. Recommend sealing and monitoring.

Recommend sealing this to prevent moisture and pest intrusion.

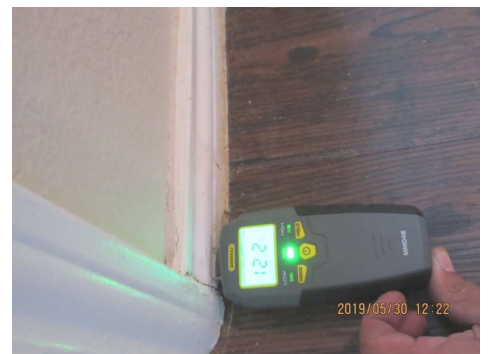
Right side (looking out) of back door. Visible moisture present. This is most likely due to the wood rot around the door not the exterior along with the siding not being 2" above concrete. Recommend removing and seeing what is behind the wood for any further moisture damage.

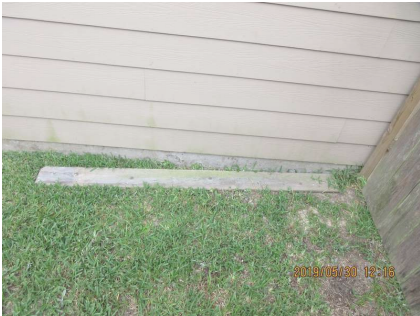
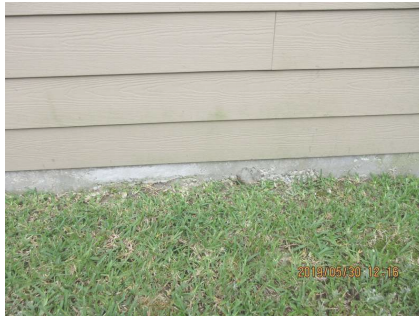
Algae/Organic growth on wall. Recommend cleaning to prevent damage to wall.

Contact a qualified professional.

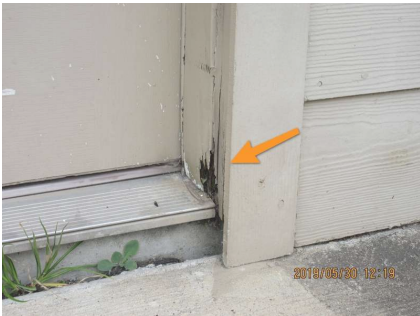
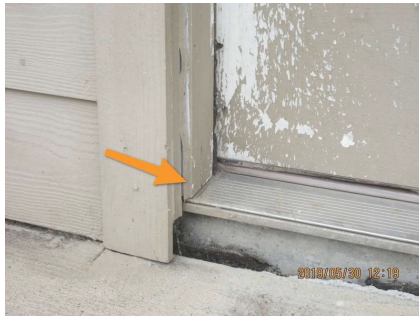
Rotten wood at trim work. Recommend having a a qualified competent carpenter repair.

Contact a handyman or DIY project

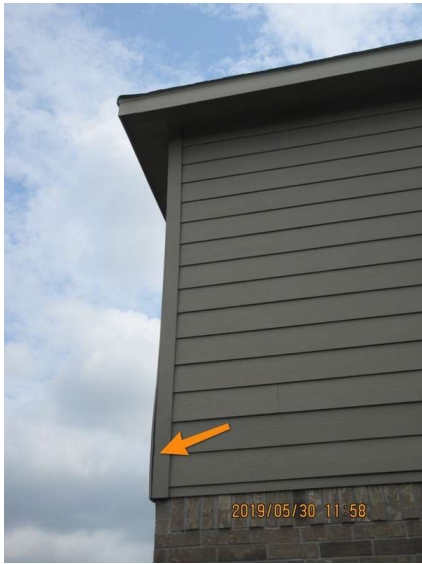
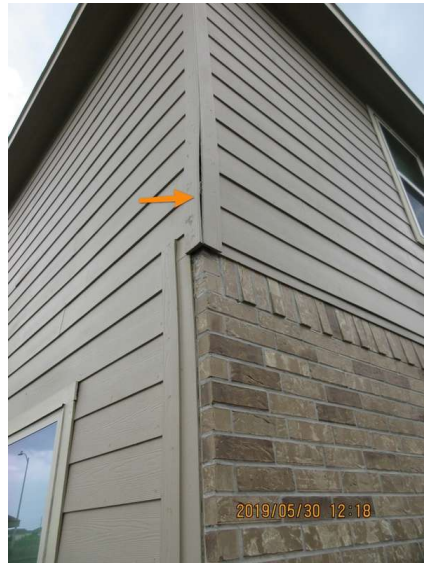
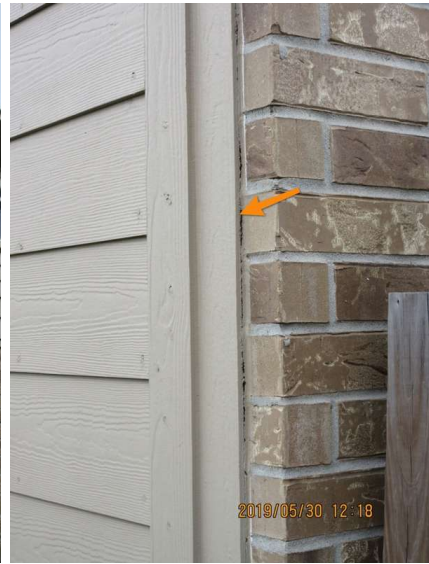
TRIM/SIDING - CAULKING/SEALING

Caulking/Sealing needed at trim and or siding. Recommend caulking to prevent water/moisture intrusion.

Contact a qualified professional.

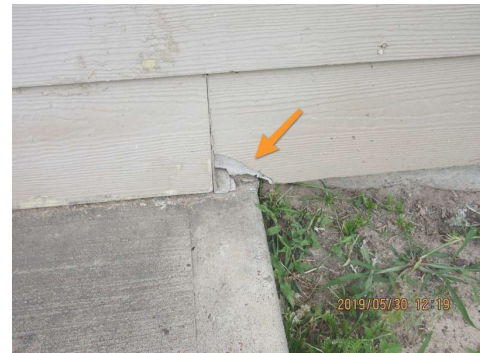
WALL DAMAGE

Damage to wall. Recommend patching/repairing.

Contact a qualified professional.

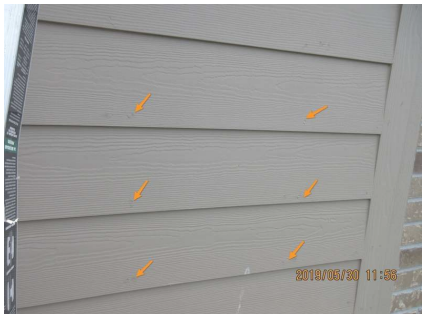
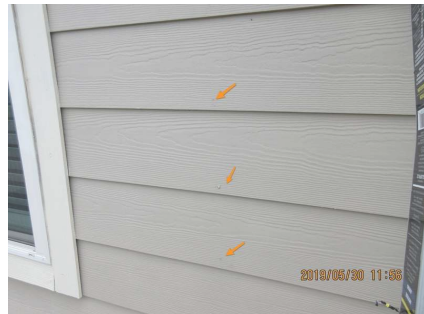
Siding was improperly fastened. Nail heads should be hidden by the layer above it. Nail heads should not be exposed. Exposed nail heads are potential entrances for moisture. Recommend having a qualified professional repair all siding

Contact a qualified professional.

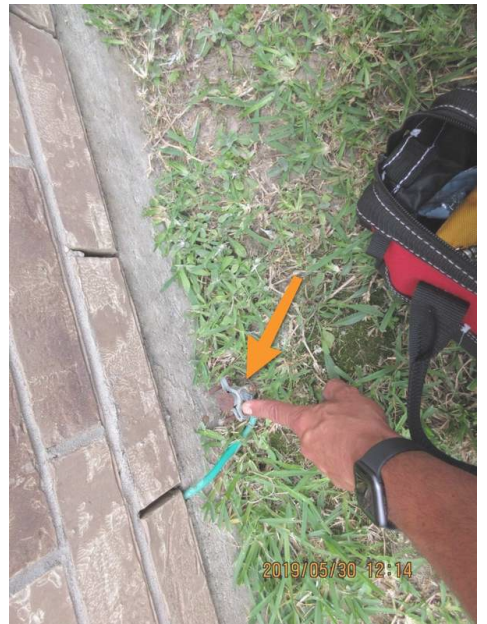
Grounding Rod/Clamp/Wire loose. Needs to be securely fastened to provide proper grounding.

Ground wire clamp loose.

Contact a qualified electrical contractor.

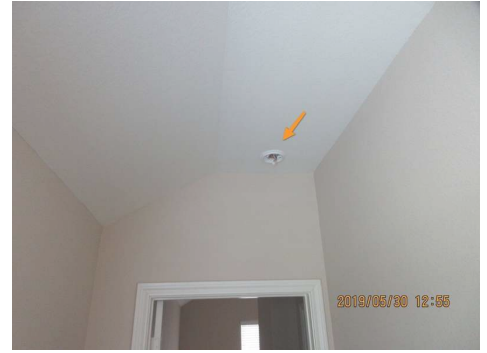
CARBON MONOXIDE DETECTOR MISSING

Carbon monoxide detector is not present at time of inspection. Recommend installation before closing.

Recommendation
Contact a qualified professional.

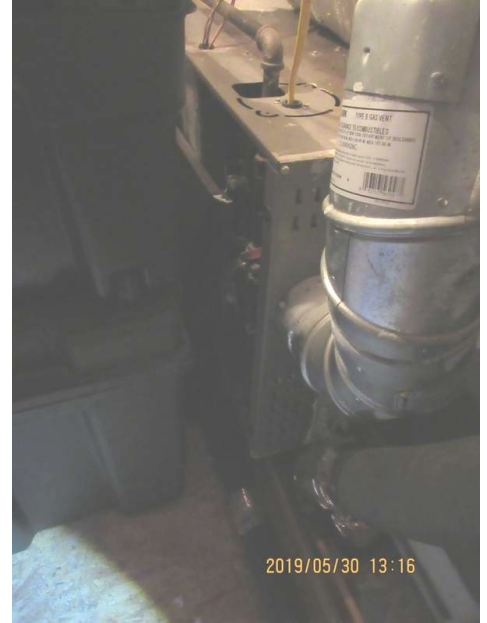
FURNACE ACCESS PANEL OFF

Furnace access panel is off. Recommend installing panel for safety reasons.

Recommendation
Contact a handyman or DIY project

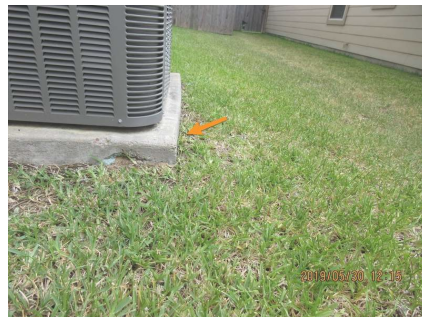
Recommend maintaining 3" exposed slab for unit.

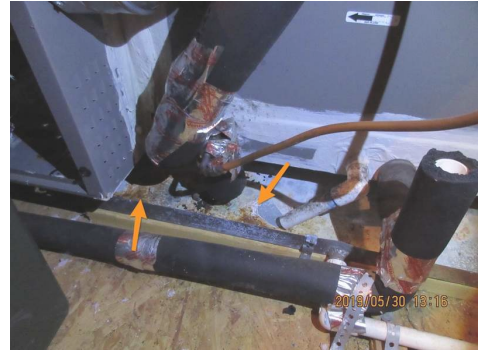
RUSTY DRAIN PAN

Rust/Rusty drain pan. Recommend replacing.

Contact a qualified HVAC professional.

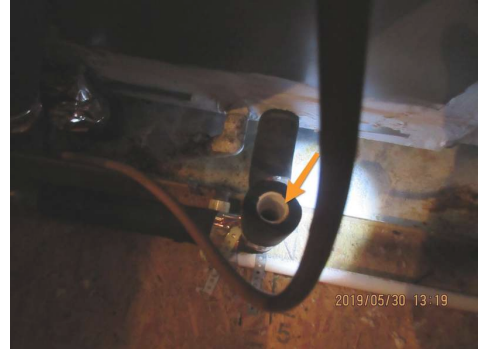
Cold air was coming out of drain pipe. Recommend capping and having a licensed HVAC professional evaluate system as cold air should not be coming out of here.

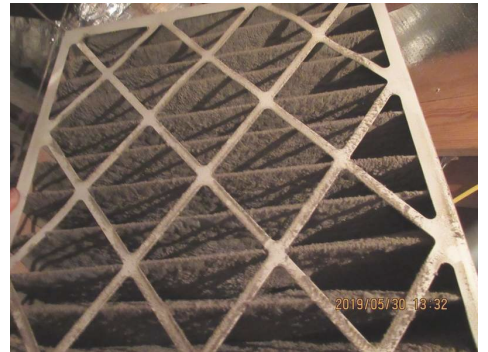
Filter needs replacement ASAP.

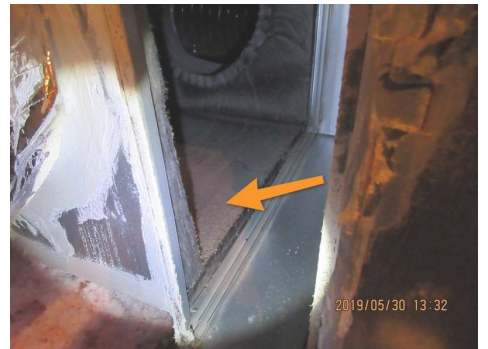
DIRTY RETURN DUCTS

Return Duct needs to be cleaned

Contact a qualified professional.

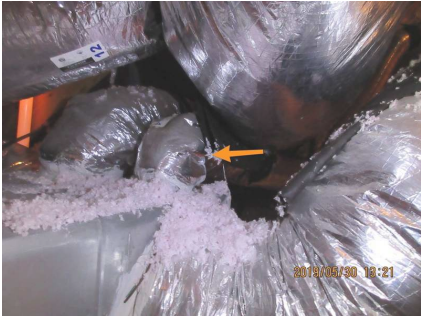
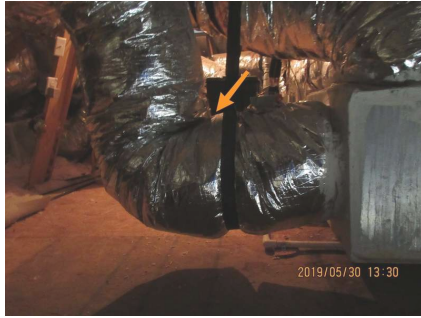
Duct is crimped or sagging. Crimped ducts can cause restrictions in air flow. Recommend correction to provide proper airflow.

Recommendation

Contact a qualified professional.

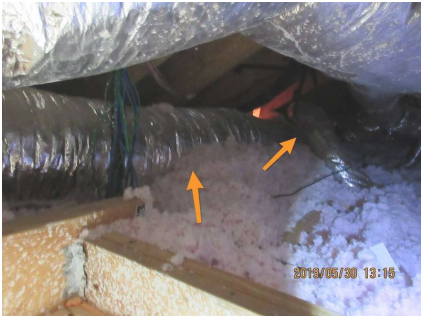
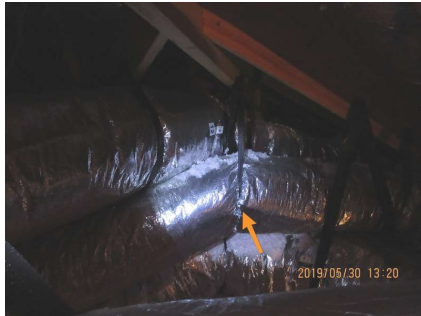
4.3.5 C. Duct System, Chases, and Vents

Insulation is laying on top and sides of much of ductwork in attic. Ductwork should not be touching insulation.

Recommendation

Contact a qualified HVAC professional.

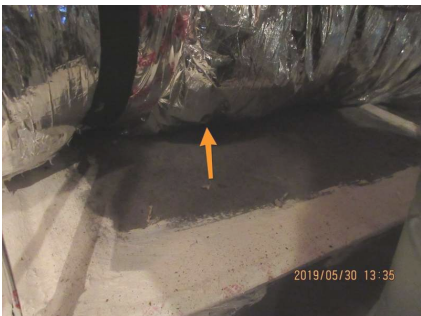
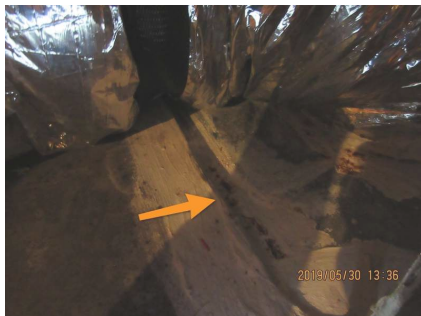
Moisture present on top of AC unit in attic with organic growth. Ductwork should not be laying on anything because it causes condensation which leads to moisture build up.

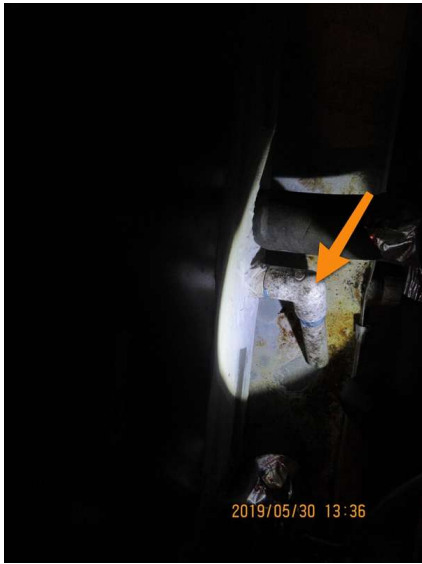
Organic growth detected on secondary drain. Improper installation of secondary drain.

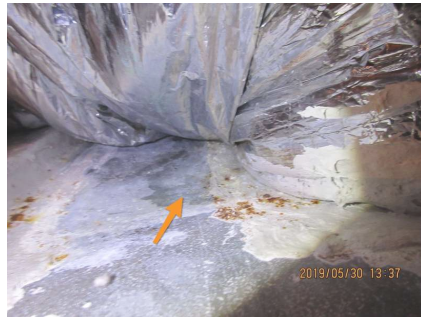
Moisture present on top of AC unit in attic with organic growth. Ductwork should not be laying on anything because it causes condensation which leads to moisture build up.

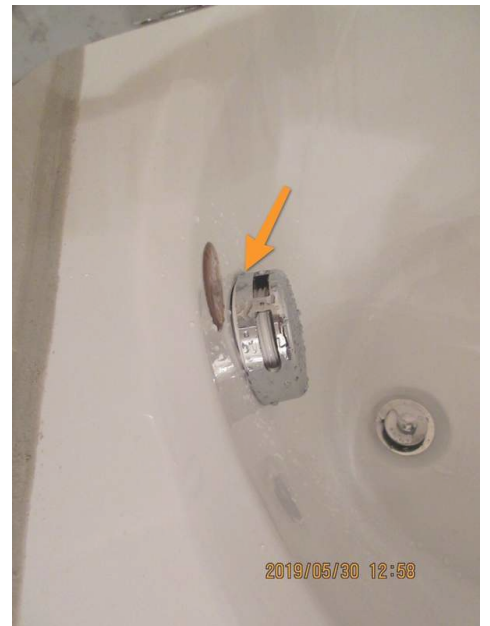
Recommend sealing around this as moisture can get behind and cause issues.

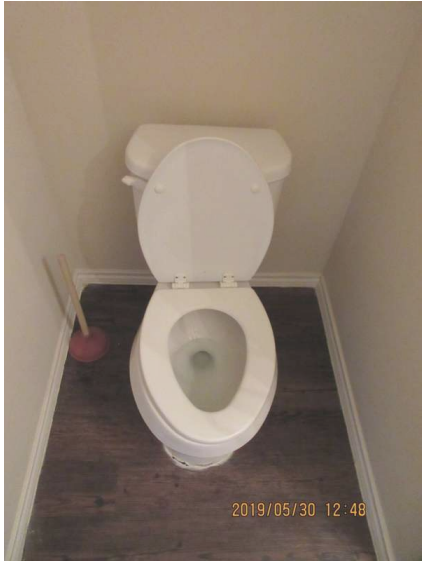
Toilet did not flush when handle was pressed all the way.

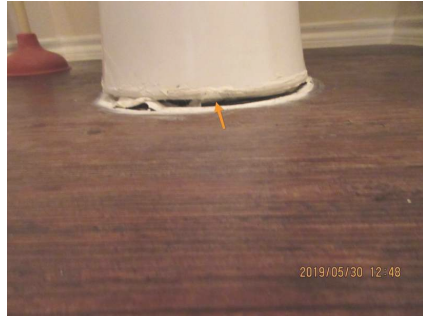
Recommend caulking around toilet. Toilet also appears to be lifted. This could be from using an incorrect toilet ring size. Recommend having a licensed plumber come out and evaluate.

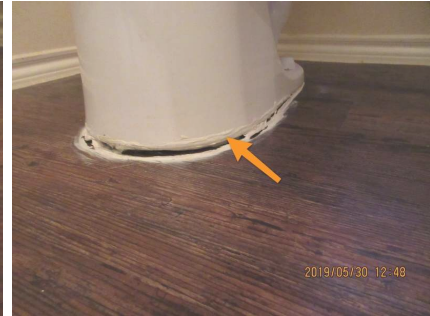
Recommend caulking around toilet. Toilet also appears to be lifted. This could be from using an incorrect toilet ring size. Recommend having a licensed plumber come out and evaluate.

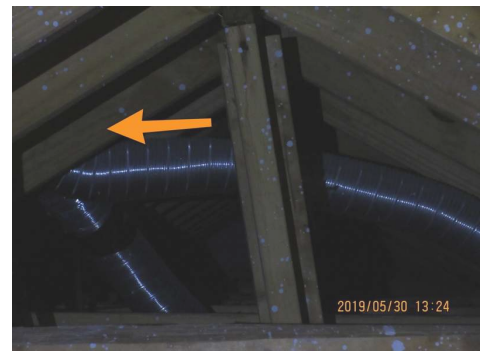
EXHAUST VENT NOT A PROPER ANGLE

Exhaust vent is not installed with a continuous upward slope. Recommend repairing so that the vent has a continuous upward slope from exhaust vent through roof. Can not have any dips or crimps.

Contact a qualified professional.

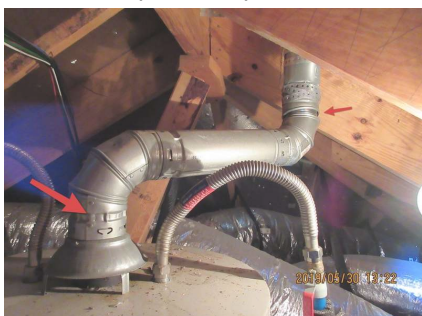
Water heater flue is damaged. This needs to be repaired/replaced as toxic gasses may not evacuate and could enter the home.

Exhaust should have a 12" minimum straight rise out of the water heater before a turn. broken exhaust flue.

Contact a qualified professional.

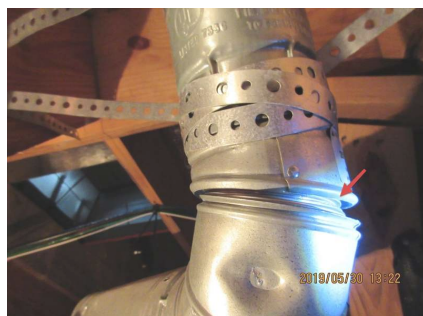
Broken flue.

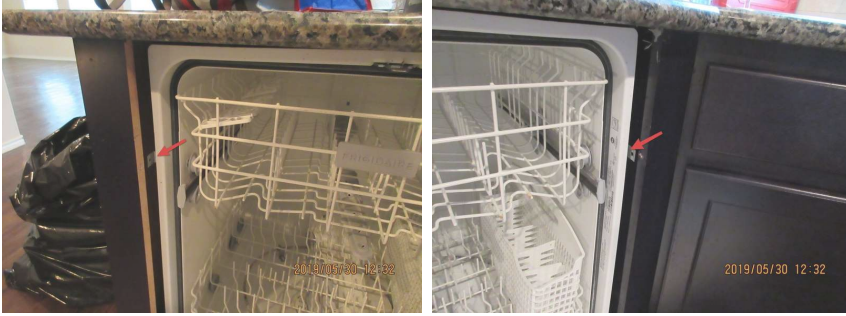
DISHWASHER NOT SECURED

Dishwasher is not properly secured. Recommend securing for safety reasons.

Contact a qualified professional.

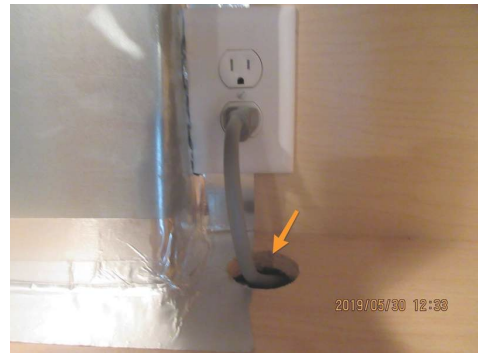
Exhaust should not be coming out of electrical hole.

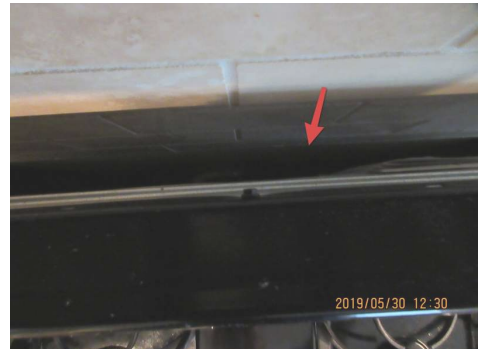
ANTI-TIPPING

Oven/Stove is missing anti-tipping bracket to secure it to the wall. Recommend installing for safety reasons.

Contact a qualified professional.

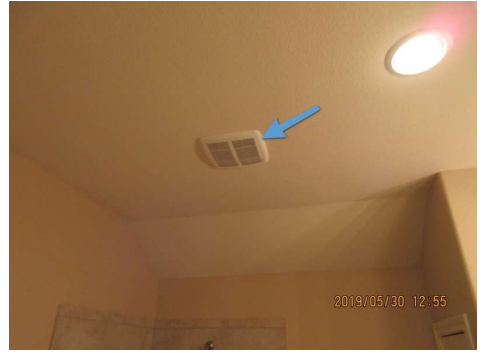
Noisy fan.

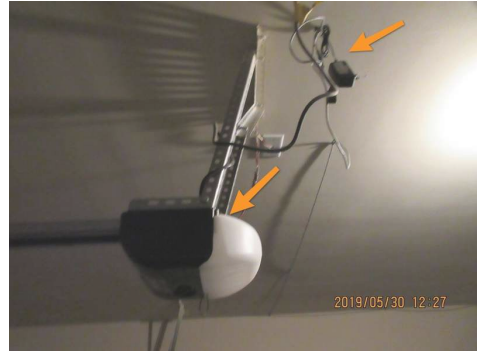
Opener had loud buzzing noise. Recommend removing electrical wiring.
