SUMMARY

1234 Main St. New Britain CT 06053

Buyer Name
05/16/2018 9:00AM

Lukasz Zagrobelny
CT Home Inspector #856
Renovee Inspection Services, LLC
(860)874-7848
inspect@renovee.com

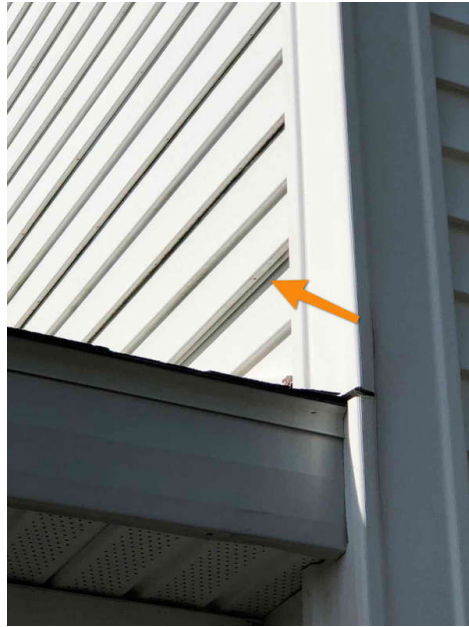
2.2.1 Exterior Wall Covering, Flashing & Trim

LOOSE BOARDS

One or more siding boards were loose, which could result in moisture intrusion. Recommend a qualified siding contractor secure and fasten.

Contact a qualified professional.

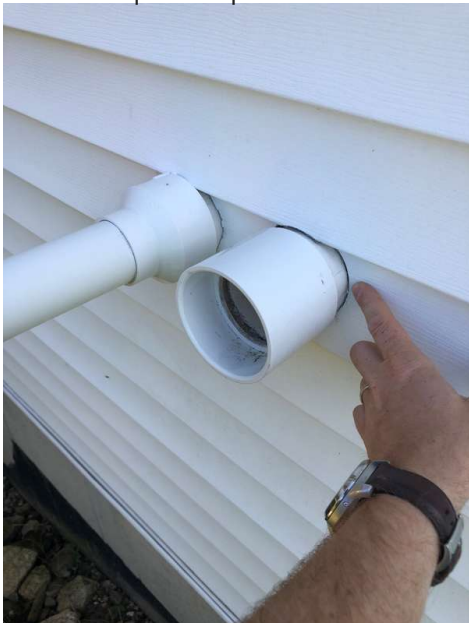
2.2.2 Exterior Wall Covering, Flashing & Trim

PENETRATIONS

Wall covering penetrations should be sealed to help keep water out.

Contact a qualified professional.

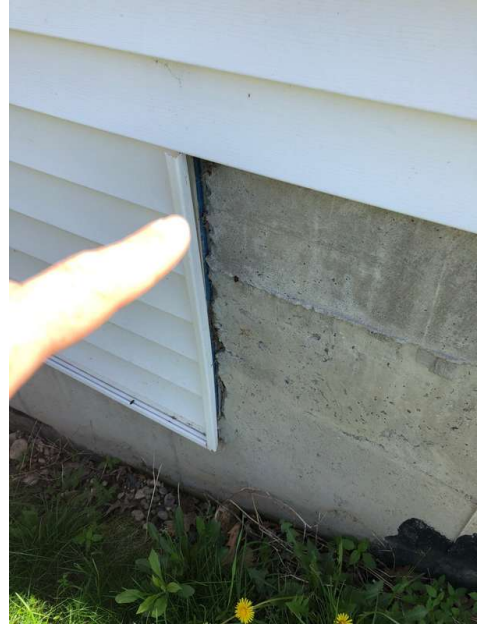
2.2.3 Exterior Wall Covering, Flashing & Trim

EXPOSED SHEATHING

Exposed sheathing should be properly sealed off to prevent water intrusion and damage. Siding should be properly installed.

Contact a qualified professional.

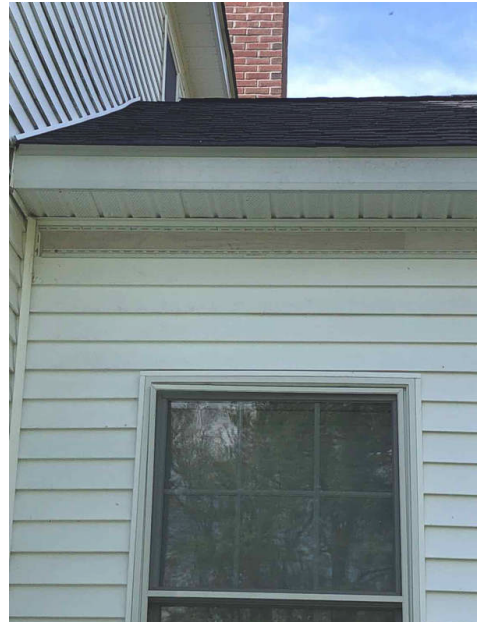
2.2.4 Exterior Wall Covering, Flashing & Trim

MISSING SIDING

Missing siding should be replaced to prevent water damage.

Contact a qualified professional.

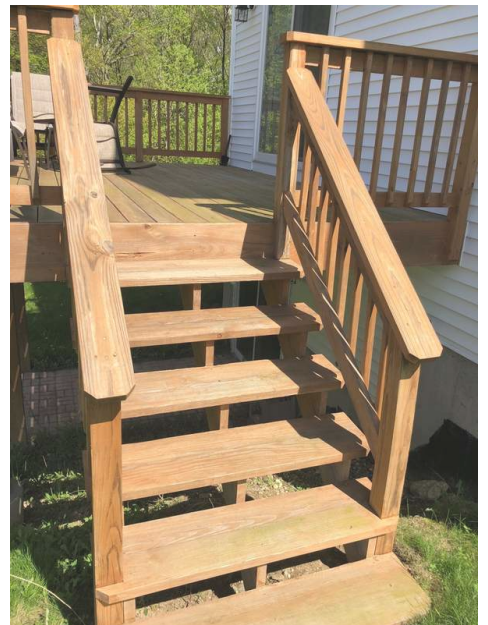
2.5.1 Decks, Balconies, Porches & Steps

GRASPABLE HANDRAIL

I suggest adding a graspable handrail to the exterior railing.

Contact a qualified professional.

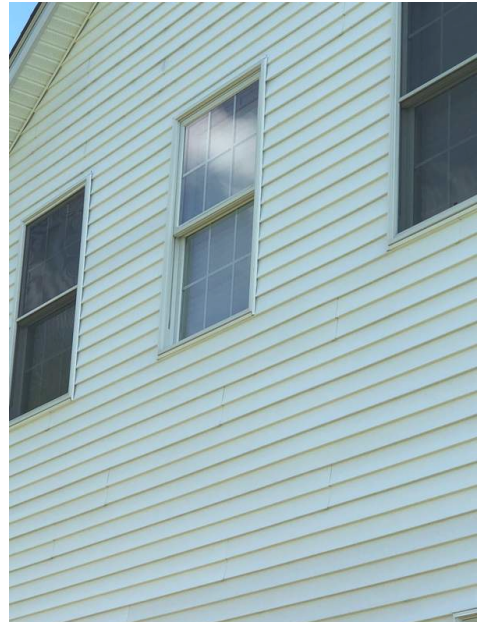
4.2.1 Windows

MISSING SCREEN

Window missing screen. Recommend replacement.

Contact a qualified window repair/installation contractor.

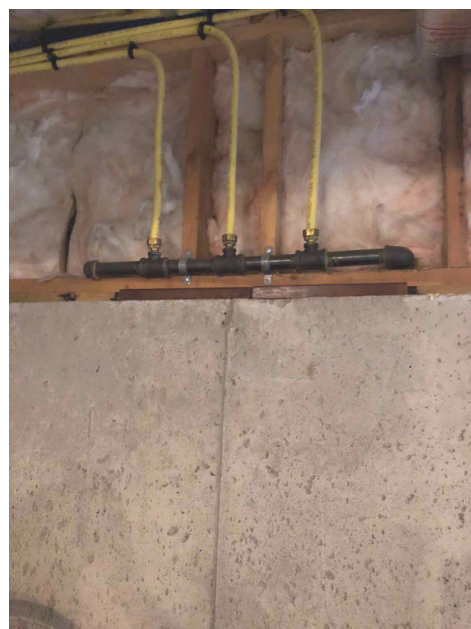
10.2.1 Main & Subpanels, Service & Grounding, Main Overcurrent Device

NO GROUND WIRE

The gas lines were not grounded. Recommend qualified electrician evaluate and install.

Contact a qualified electrical contractor.

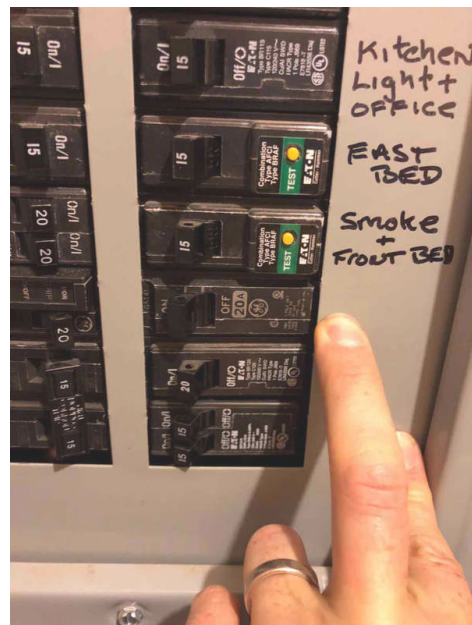
10.3.1 Branch Wiring Circuits, Breakers & Fuses

IMPROPER BREAKERS

General Electric breakers were used in this Cutler Hammer panel. The GE breakers are not meant for this panel and should be replaced with proper ones by a licensed electrician.

Contact a qualified professional.

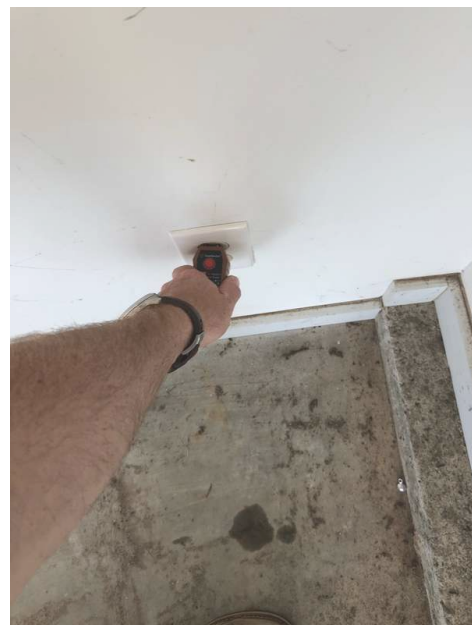
10.4.1 Lighting Fixtures, Switches & Receptacles

RECEPTACLES LOOSE

an outlet in the garage was loose and will need to be properly attached by a licensed electrician.

Contact a qualified professional.

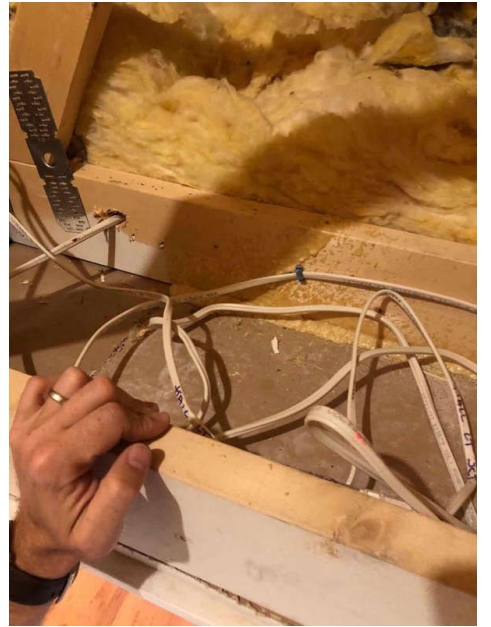
10.5.1 Visible wiring

ATTACHMENT

Electrical wires in the attic should be properly attached to framing members.

Contact a qualified professional.
