## RECOMMENDATIONS SUMMARY

1234 Main St. Naches WA 98937

Integrity Inspection Services LLC

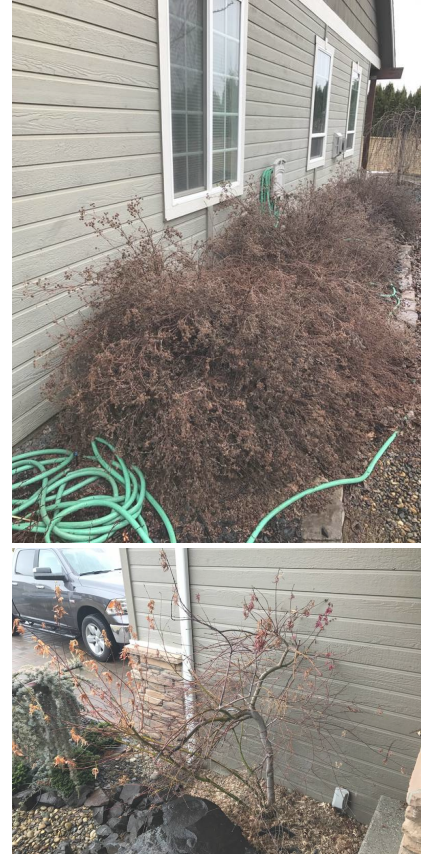
### 2.1.1 Vegetation, Grading & Drainage

## VEGETATION AGAINST HOME

Trees, shrubs or vegetation in contact with exterior siding or trim will cause excessive wear and may lead to eventual deterioration. Recommend all vegetation be cleared and maintained with a minimum of 8" clearance from home and all other structures.

Contact a qualified landscaper or gardener.

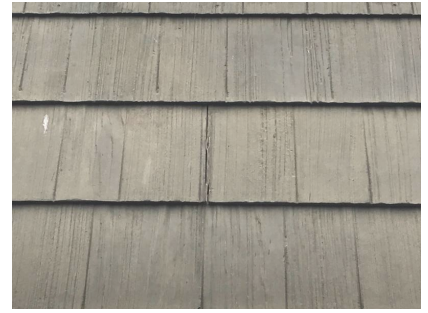
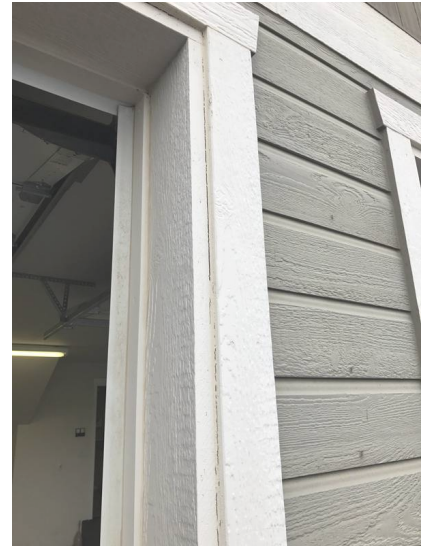
### 3.1.1 Siding, Flashing & Trim

## CAULKING - MAINTENANCE

Exterior caulking shrinks with time and exposure. Siding butt joints, windows, doors and trim all require regular maintenance to prevent possible moisture intrusion. Recommend maintaining a proper seal at all exterior caulked joints.

Contact a qualified siding specialist.

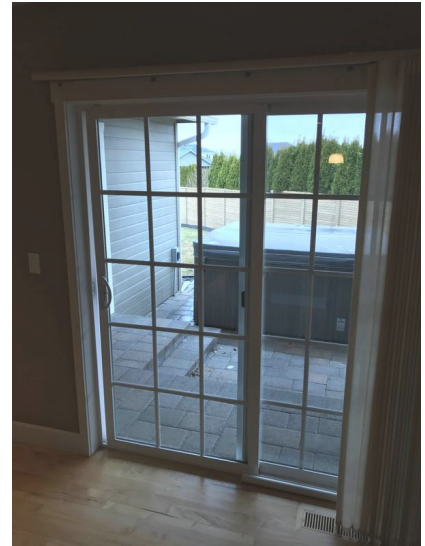
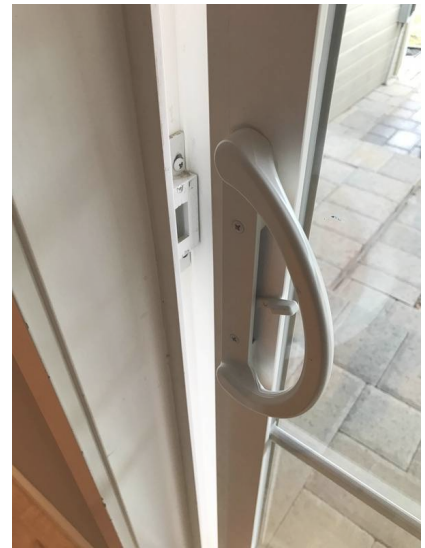
3.2.1 Exterior Doors & Windows

# HARDWARE ADJUSTMENT NEEDED

DINING ROOM

Some entry door hardware was not operating properly and may be in need of adjustment or repair.

Contact a qualified door repair/installation contractor.

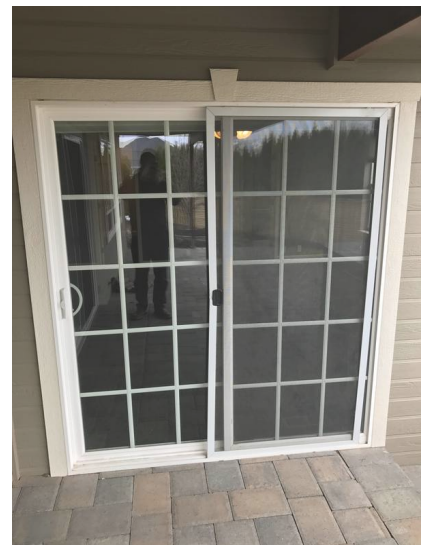
3.2.2 Exterior Doors & Windows

# SCREEN DOOR

MASTER BEDROOM

Screen door damaged or not operating properly. Recommend repair.

Contact a qualified door repair/installation contractor.

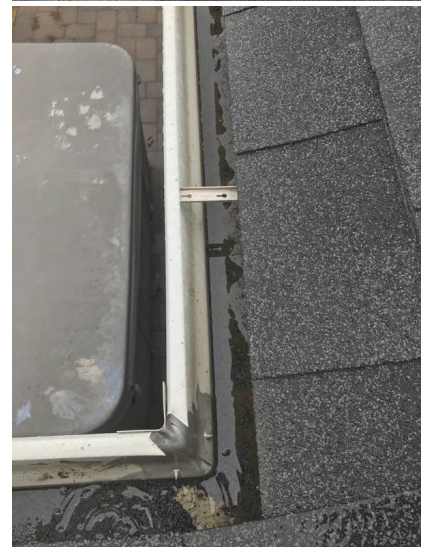
#### 4.2.1 Gutter & Drainage Systems

## DEBRIS

Debris has accumulated in the gutters. Recommend cleaning to facilitate water flow.

Contact a qualified roofing professional.

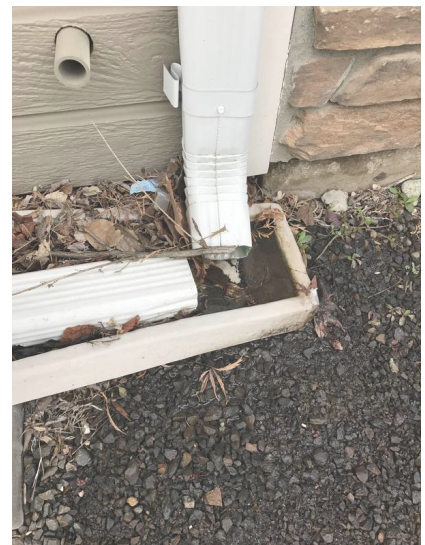
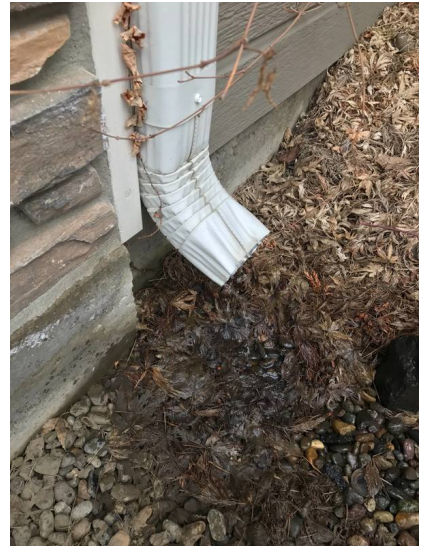
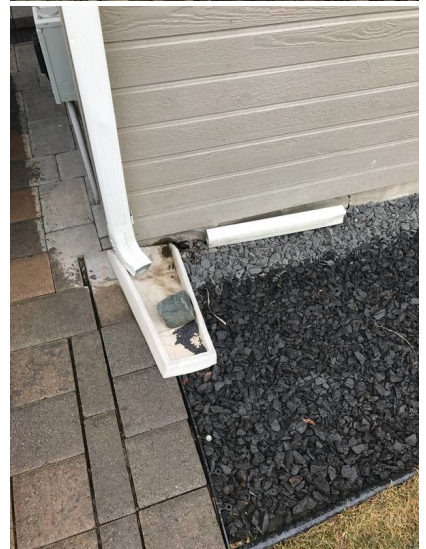
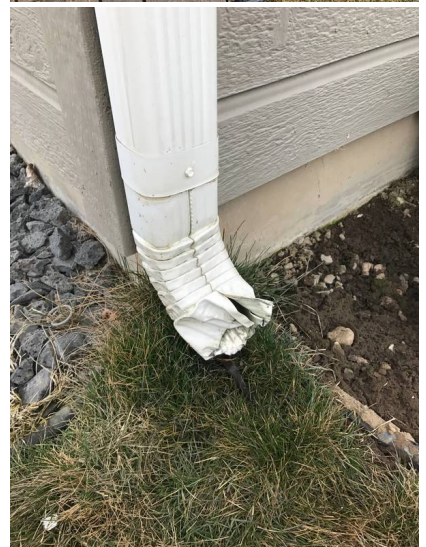
#### 4.2.2 Gutter & Drainage Systems

## DOWNSPOUTS DRAIN NEAR HOUSE

One or more downspouts drain too close to the home's foundation. This can result in excessive moisture in the soil at the foundation, which could lead to eventual structural compromise. Recommend a qualified contractor adjust downspout extensions to drain at least 6 feet from the foundation.

Contact a qualified roofing professional.

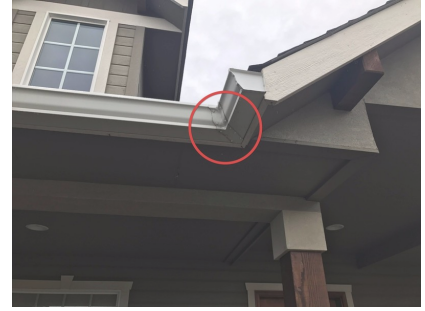
#### 4.2.3 Gutter & Drainage Systems

## GUTTER LEAKAGE

Gutters were observed to be leaking in one or more areas. This can result in excessive moisture in the soil at the foundation, which can lead to structural compromise. Recommend a qualified professional further evaluate and repair.

Contact a qualified roofing professional.

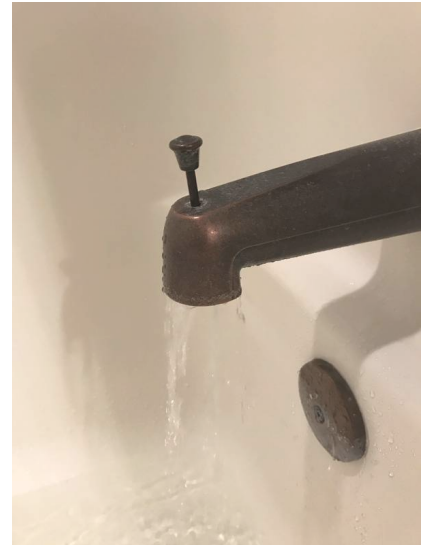
#### 5.1.1 Fixtures / Faucets

## SHOWER DIVERTER NOT OPERATING

#### HALL BATHROOM

Shower diverter valve was not diverting water flow to shower head properly or completely. Recommend repair.

This may be a symptom of not being used and may self repair with time.

Contact a qualified plumber.

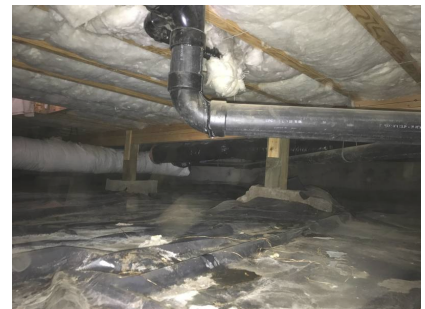
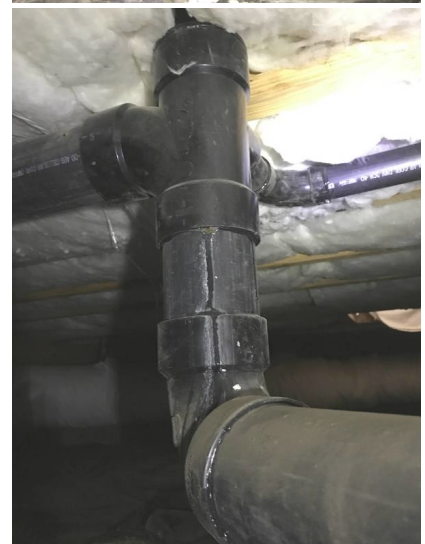
#### 5.2.1 Drain / Waste, & Vent Systems

## LEAK OBSERVED

#### CRAWLSPACE (HALL BATHROOM)

Leak observed at waste drain plumbing. Condition conducive to moisture damage. Recommend a qualified professional further evaluate and repair.

Contact a qualified plumber.

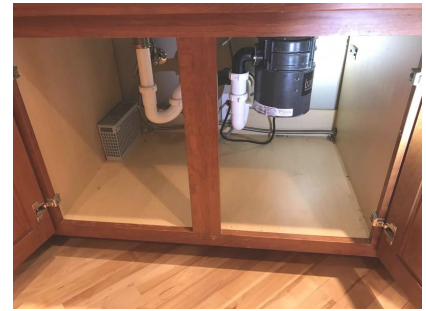
5.4.1 Appliances

# GARBAGE DISPOSAL LEAKING

## KITCHEN

Leak noted at garbage disposal. Condition conducive to moisture damage. Recommend a qualified professional further evaluate and repair.

Recommendation  
Contact a qualified plumber.

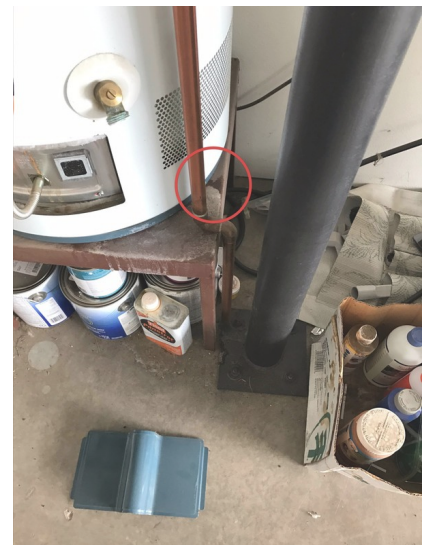
6.1.2 Condition

# LEAK - MINOR

Possible (minor) leak noted at base of Hot Water Tank. Recommend a qualified professional further evaluate and repair as needed.

Recommendation  
Contact a qualified plumber.

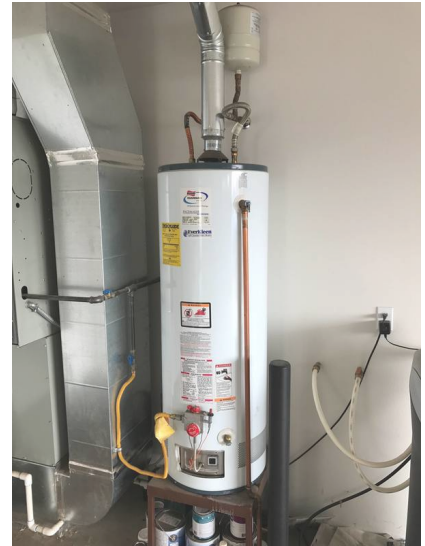
6.4.1 Seismic Strapping

# SEISMIC STRAPPING NOT INSTALLED

**⚠ Safety Hazard and/or Requires Immediate Attention**

Modern code requires Hot Water Tank seismic strapping at top and bottom thirds of tank using an approved strapping and anchored to framing. Recommend qualified professional further evaluate and repair.

Contact a qualified appliance repair professional.

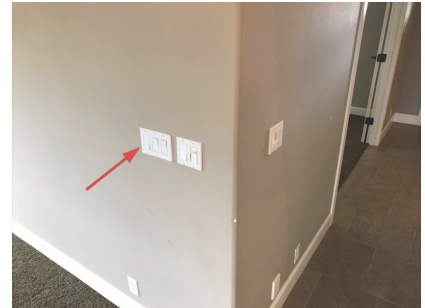
7.4.1 Connected Devices and Fixtures

# UNKNOWN SWITCH / DEVICE

LIVING ROOM

Unknown switch/device noted. Recommend qualified electrician further evaluate.

Contact a qualified electrician.

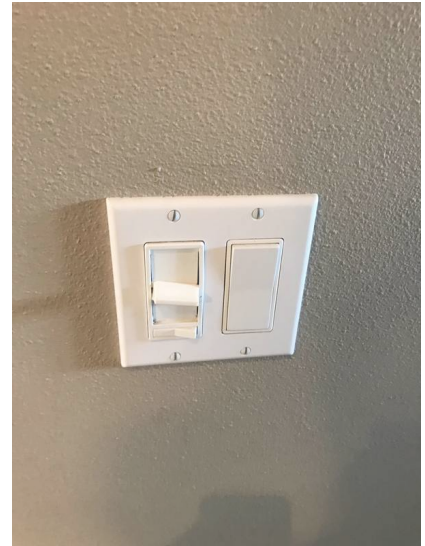
7.4.3 Connected Devices and Fixtures

## DEVICE INTERMITTENT

LIVING ROOM

A switch or outlet was intermittent at time of inspection. Recommend a qualified professional further evaluate and repair.

Contact a qualified electrician.

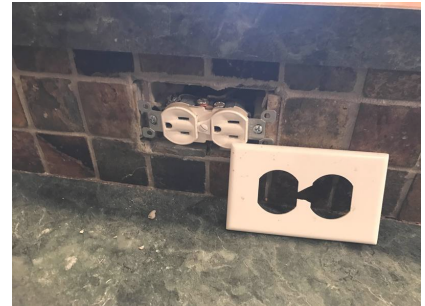
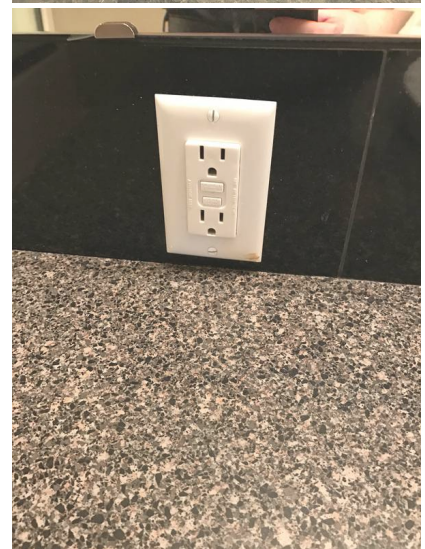
7.4.4 Connected Devices and Fixtures

## LOOSE / UNSECURED OUTLETS

KITCHEN, HALL BATHROOM

**⚠ Safety Hazard and/or Requires Immediate Attention**

Loose or unsecured outlets may risk short or possible electrical shock. Recommend a qualified electrician further evaluate and repair.

Contact a qualified electrician.

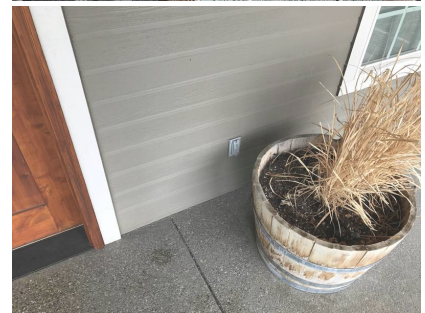
7.6.1 GFCI & AFCI

# OUTLET(S) WON'T TRIP

EXTERIOR, GARAGE

**⚠ Safety Hazard and/or Requires Immediate Attention**

One or more outlets won't "trip" when tested. Recommend a qualified electrician further evaluate all required GFCI locations and repair as needed.

Contact a qualified electrician.

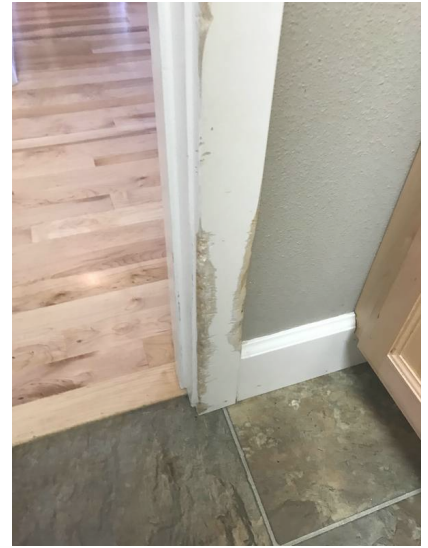
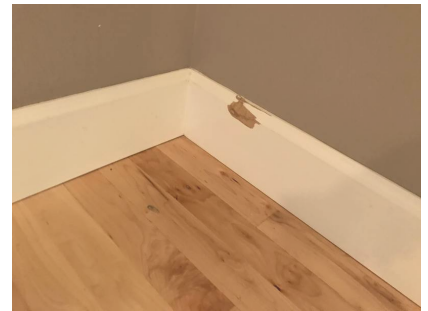
10.1.1 Walls

# COSMETIC DAMAGE

Some interior cosmetic damage was noted at walls and/or ceilings.

Contact a qualified general contractor.

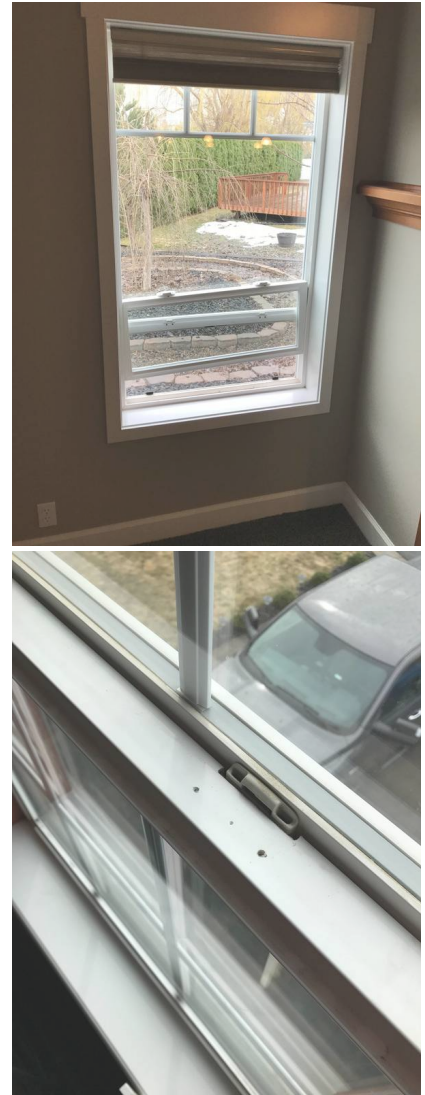
10.4.1 Windows

# SINGLE-HUNG WINDOWS

LIVING ROOM, BONUS ROOM

Some single hung windows not operating smoothly/properly and may be in need of adjustment or repair. Recommend qualified professional further evaluate and repair.

Contact a qualified professional.

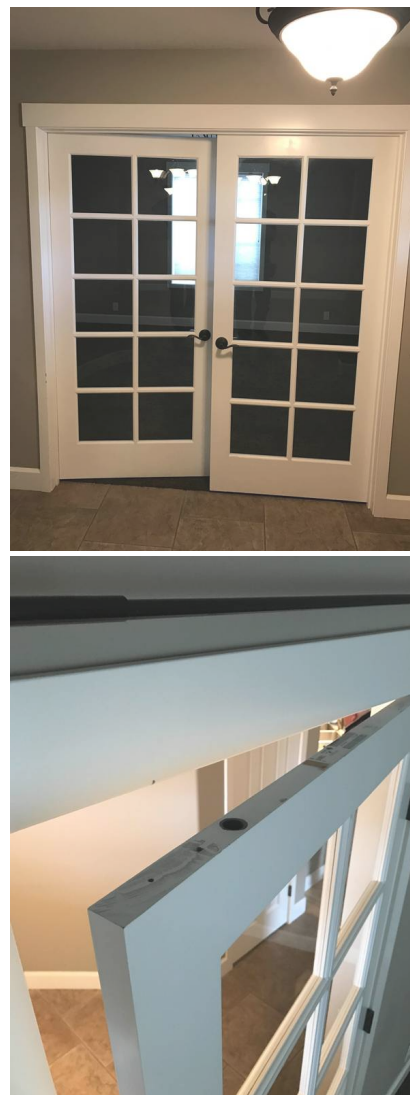
10.5.1 Doors

## DOOR DOESN'T LATCH

Door/s doesn't latch properly and may be in need of adjustment or repair.

Contact a quality handyman.

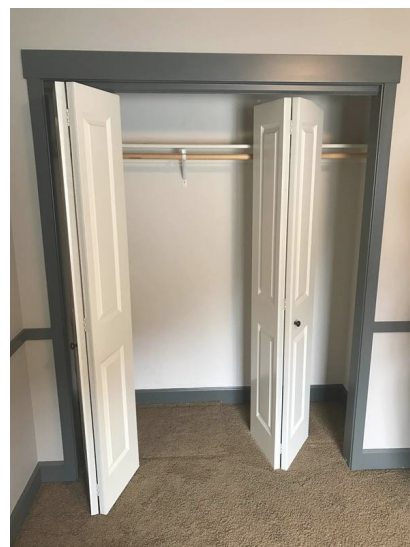
10.5.2 Doors

## DOORS MISSING OR NOT INSTALLED

BEDROOM

Some interior doors and/or closet doors were missing or not installed at time of inspection. Recommend repair.

Contact a qualified door repair/installation contractor.

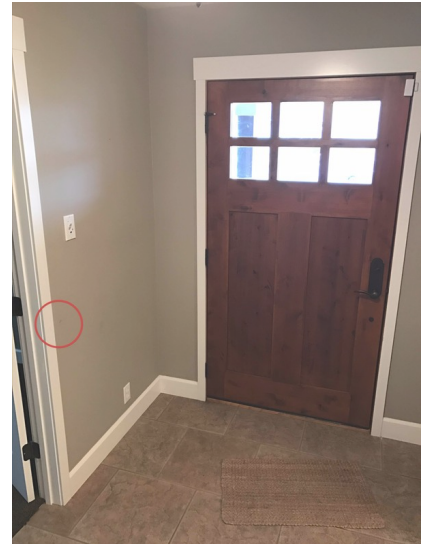
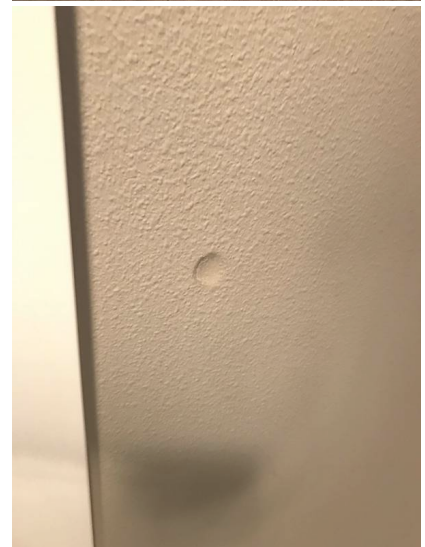
### 10.5.3 Doors

## DOOR STOPS MISSING

Some interior or entry door Door Stops were missing or not installed. This may result in damage to walls and/or door hardware.

Recommended DIY Project

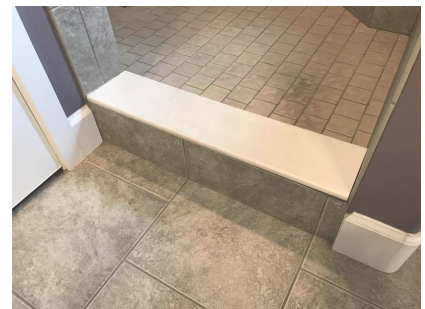
### 10.9.1 Bathroom

## DAMAGED SHOWER CURB

#### MASTER BATHROOM

Shower curb was loose or damaged. Condition conducive to moisture damage. Recommend repair.

Contact a qualified general contractor.

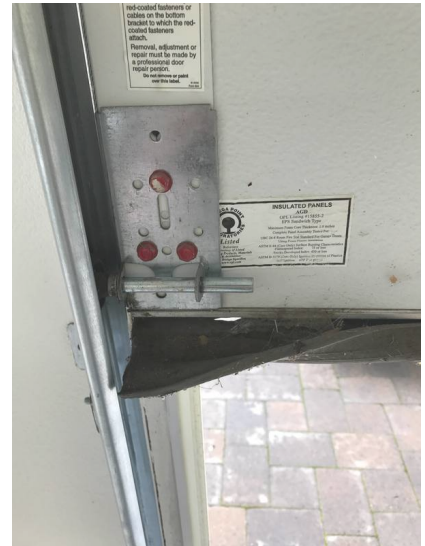
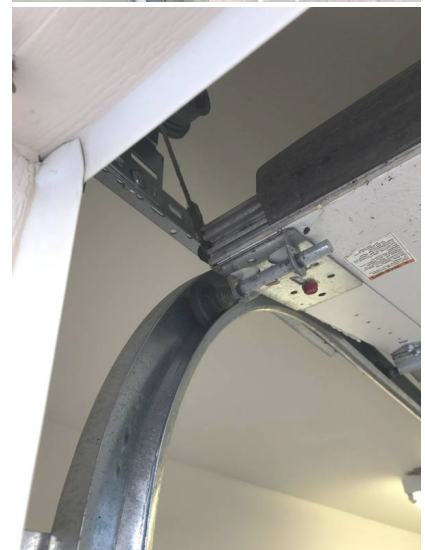
14.1.1 Garage Door

# THRESHOLD SEAL

Garage door threshold seal was worn or damaged. Recommend repair.

Contact a qualified garage door contractor.
