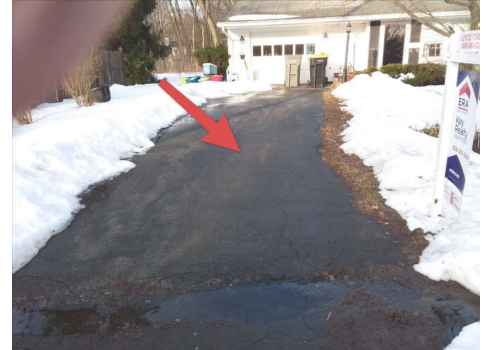
2.2.1 Driveways

DRIVEWAY CRACKING

Cracks observed. Fill in the cracks in seal to extend the life expectancy. Recommend concrete contractor evaluate and repair.

Contact a qualified driveway contractor.

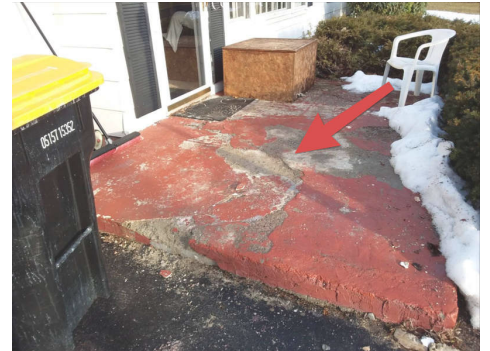
2.3.1 Walkway

IRREGULAR SURFACE

Cracking and trip hazards are present.

Contact a qualified professional.

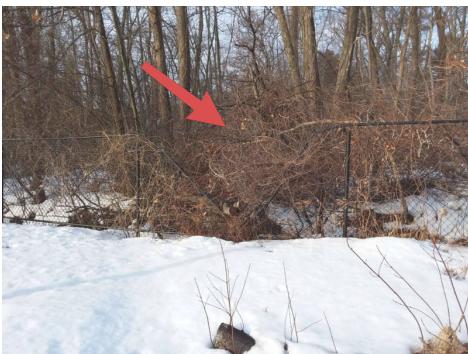
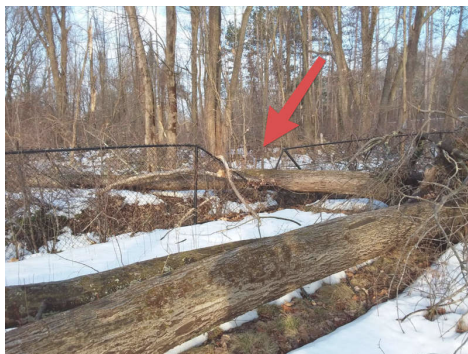
2.7.1 Fences

DAMAGED NOTED

Contact a qualified fencing contractor

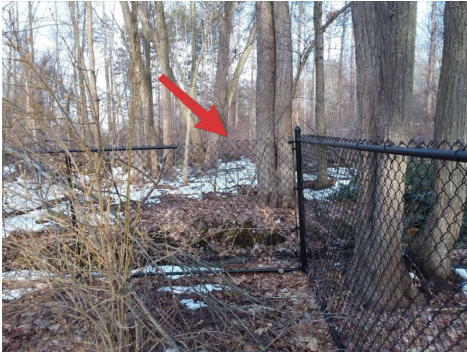
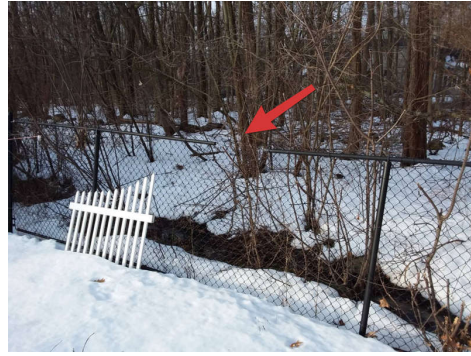
2.7.2 Fences

FENCE PANEL IMPROPERLY SECURED

Contact a qualified professional.

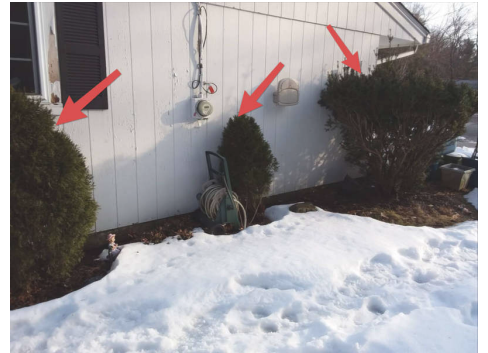
2.8.1 Landscaping

SHRUBS

Shrubs are in close contact with structure, older roots may be in contact with foundation. Shrubs should be trimmed or removed

Contact a qualified landscaping contractor

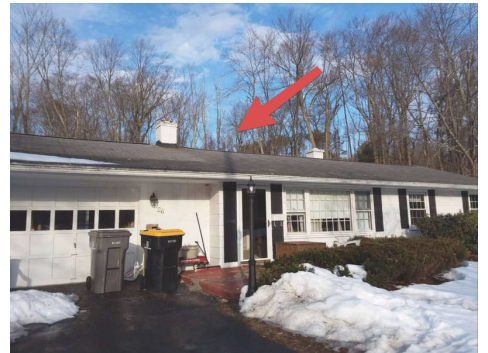
3.1.1 Roof

NORMAL AGING

Signs of aging are present. Regular maintenance and inspections are advised. The roof is approaching the end of its anticipated serviceable life.

Contact a qualified roofing professional.

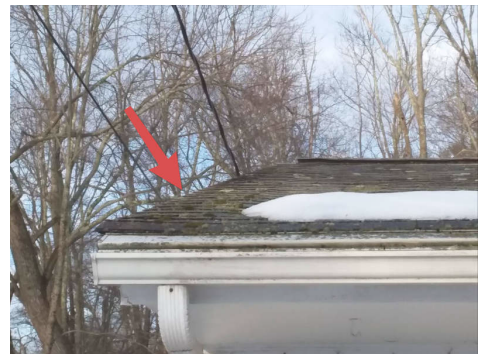
3.1.2 Roof

MOSS

Moss algae and lichen are noted growing on the roof surface. The moss and lichen can grow into the roof and damage the shingles. Improper removal of the moss and lichen growth may also remove the granular surface of the shingle. A zinc strip may eliminate moss, algae and lichen.

Contact a qualified roofing professional.

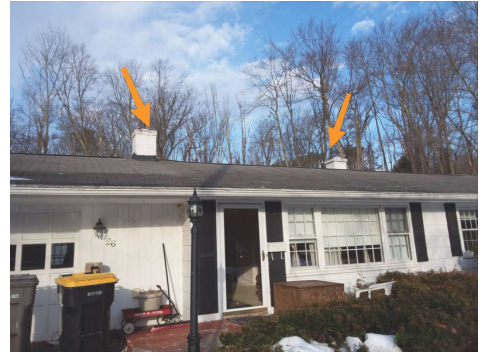
3.2.1 Chimneys

NO RAIN HAT

The chimney does not have a rain hat or spark arrester. Installation of a spark arrester and rain hat is recommended.

Contact a qualified chimney contractor.

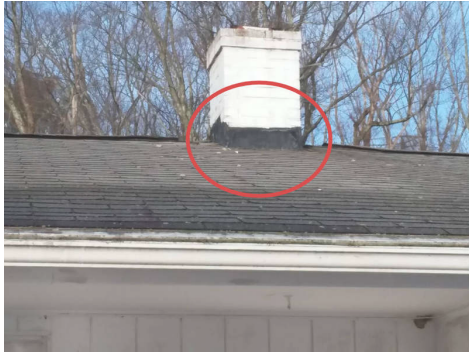
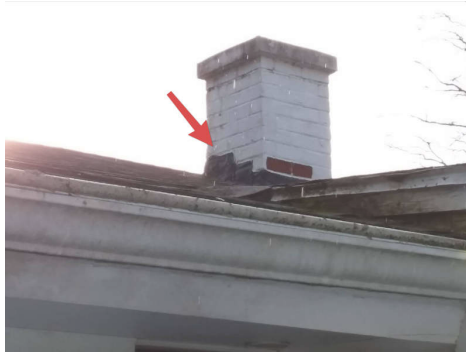
3.3.1 Flashings

SEALED FLASHING

Flashing Covered with asphalt or outer sealant

Contact a qualified roofing professional.

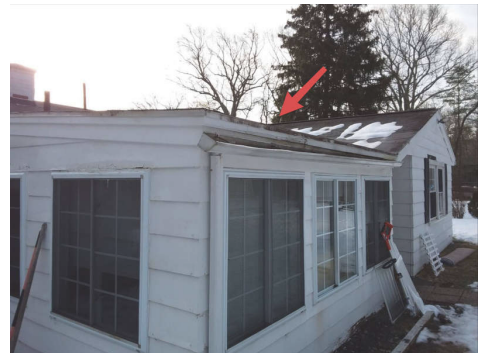
3.7.1 Roof Drainage Systems

SPILL OVER NOTED

Staining indicates the gutters have been spilling over. Keep the gutters free of debris to prevent spill over.

Contact a qualified gutter contractor

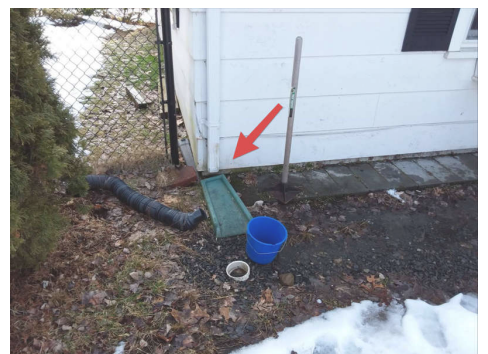
3.7.2 Roof Drainage Systems

DOWNSPOUTS MISSING EXTENTION

One or more downspouts drain too close to the home's foundation. This can result in excessive moisture in the soil at the foundation, which can lead to foundation/structural movement. Extensions should be added. Recommend a qualified contractor adjust downspout extensions to drain at least 6 feet from the foundation.

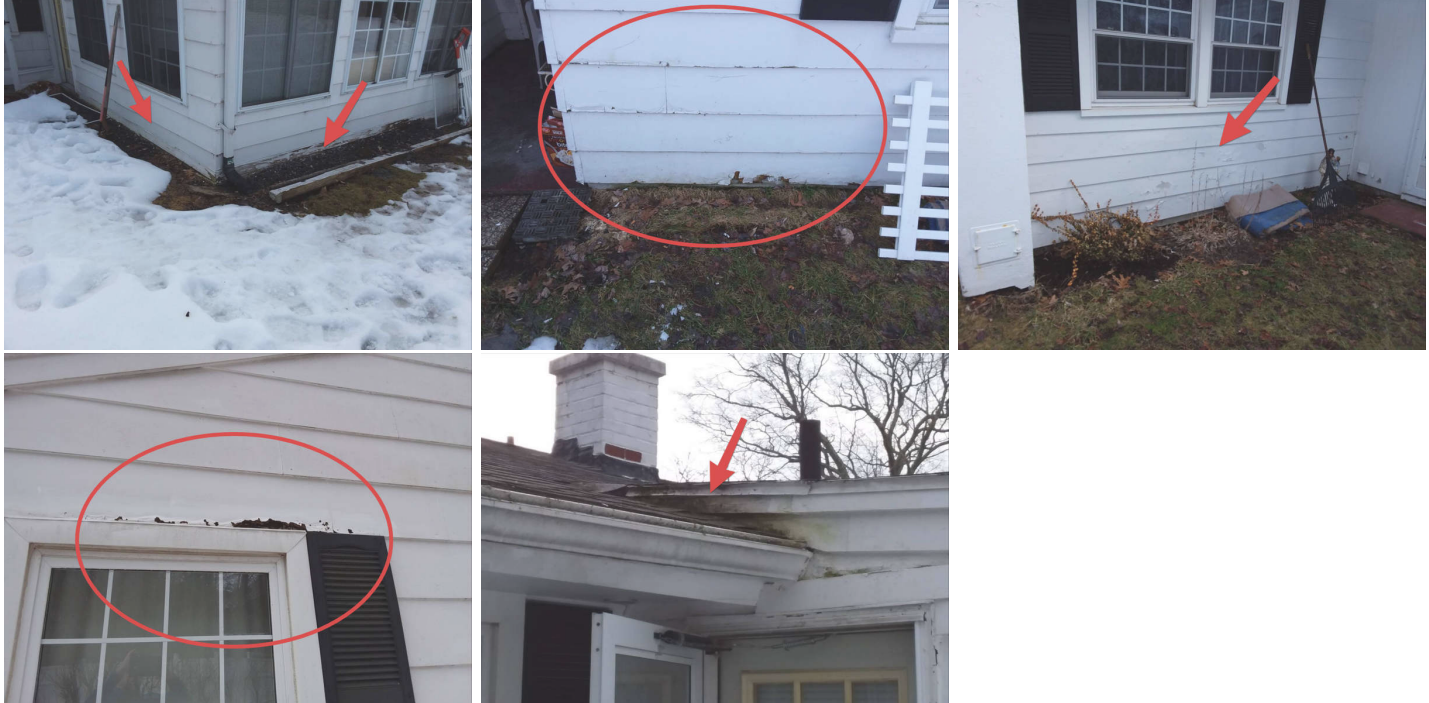
4.1.1 Exterior Wall Cladding

DETERIORATED

The siding is in contact with the ground and roof, moisture damage is present, peeling paint present and there are voids that are in properly sealed.

Recommendation
Contact a qualified siding specialist.

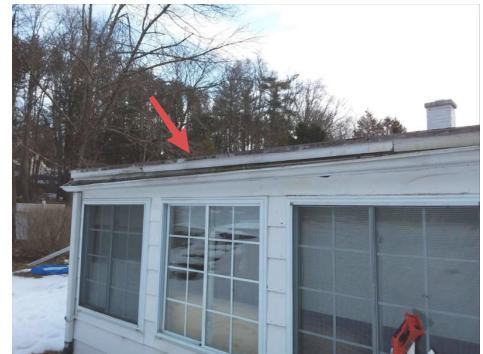
4.2.1 Trim

DETERIORATED

The trim has peeling paint, moisture damage and signs of deterioration are present.

Recommendation
Contact a qualified siding specialist.

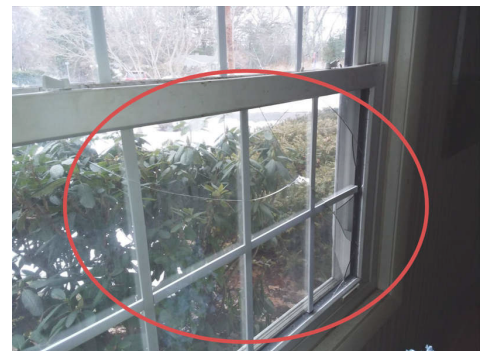
4.5.1 Windows

BROKEN GLASS

Window broken or cracked

Recommendation
Contact a qualified window repair/installation contractor.

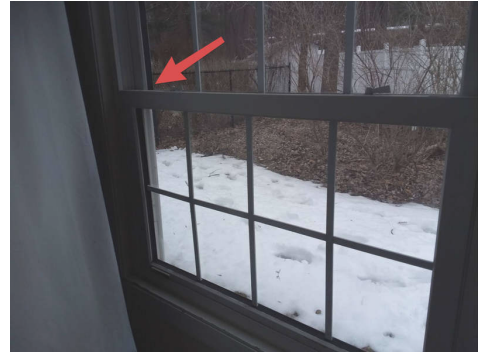
4.5.2 Windows

SLIDE SPRING

The spring or slide that holds the window in the up position is nonfunctional. It needs to be replaced.

Contact a qualified window repair/installation contractor.

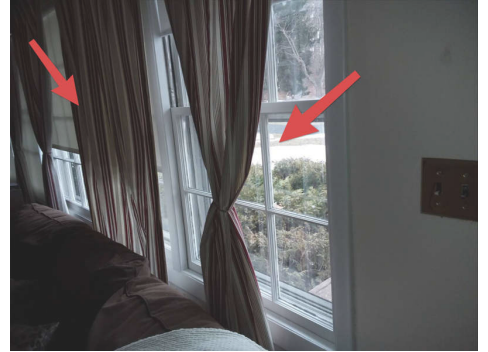
4.5.3 Windows

ENERGY

The windows do not conform to current standards of energy efficiency. Replace older windows with an energy efficient window.

Contact a qualified window repair/installation contractor.

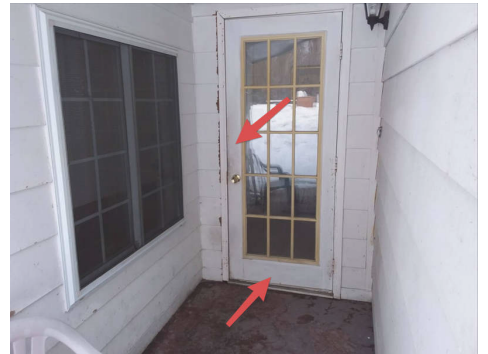
4.6.1 Exterior Doors

RUBS AND STICKS

Trim is improperly secured or loose. Improper weather stripping and daylight is seeing under the door.

Contact a qualified door repair/installation contractor.

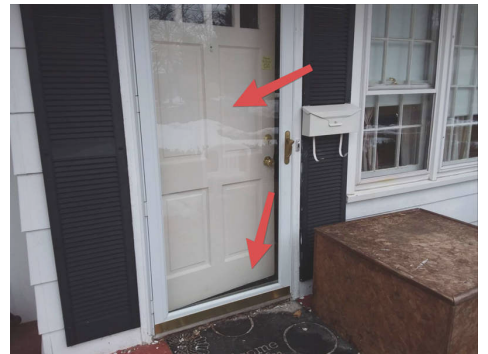
4.6.2 Exterior Doors

ENERGY

Door does not conform to current standards of energy efficiency.

Contact a qualified professional.

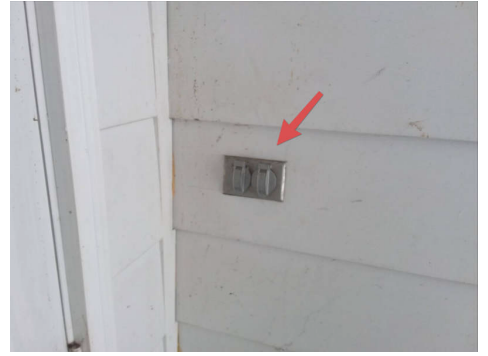
4.9.1 Exterior Outlets

GFI MISSING

Exterior outlets have improper weatherproof covers. They were not functioning at the time of the inspection, and are not GFCI protected. Consult and electrician for further review and estimate of repairs.

Contact a qualified electrical contractor.

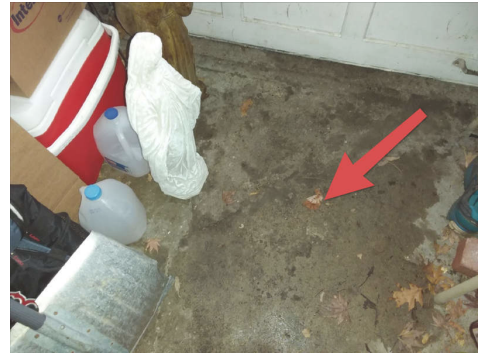
5.6.1 Floor **CRACKING**

Cracking visible in the garage floor. I recommend a structural engineer evaluate.

Contact a qualified professional.

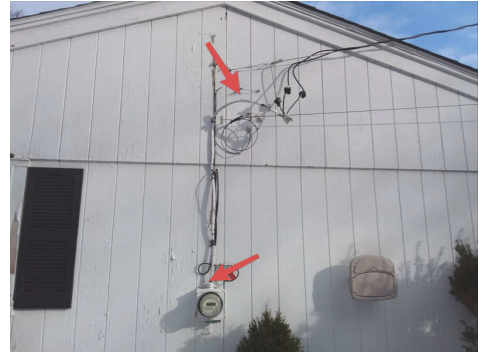
7.1.1 Service Entrance Conductors **IMPROPERLY SECURED CABLE**

Improperly secured to the building. The sheathing is frayed and worn. It is improperly sealed at the meter.

Contact a qualified electrical contractor.

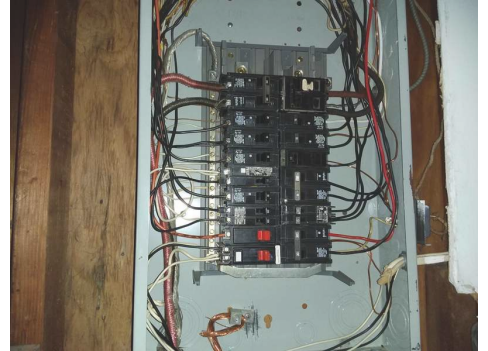
7.4.1 Main Service Panel

AFCI NOT FULLY INSTALLED

Combination type AFCI protection is not present for all the recommended locations.

Contact a qualified electrical contractor.

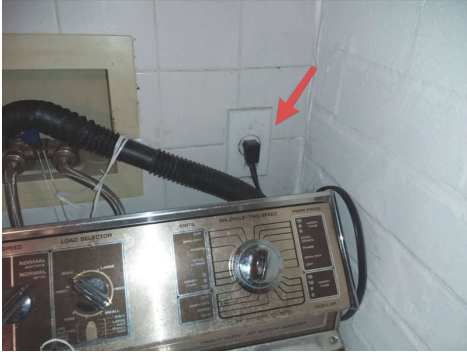
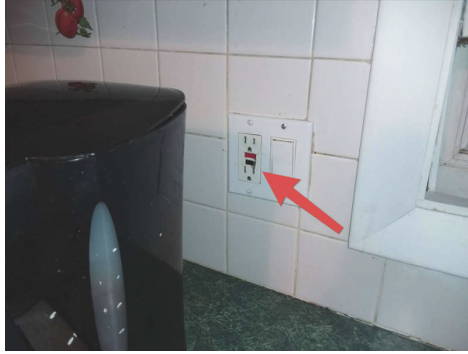
7.9.1 Electrical Outlets
GFI NOT PRESENT

Cracked and broken outlets present. Outlets are missing covers.

Recommendation
Contact a qualified electrical contractor.

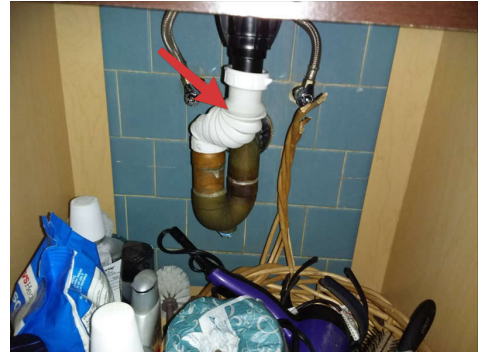
8.11.1 Bathroom Sink
FLEX DRAIN

Improper Flex tube noted at the drain.

Recommendation
Contact a qualified plumbing contractor.

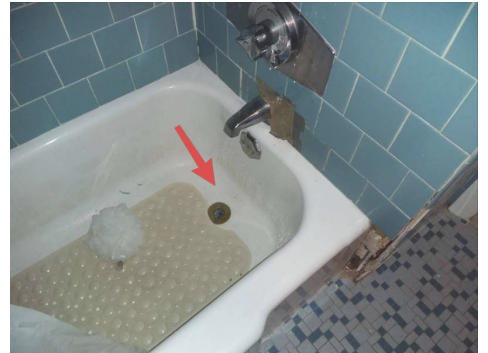
8.13.1 Tub/Shower Fixtures

MECHANICAL STOPPER DEFECTIVE

The mechanical stopper does not functional intended.

Contact a qualified plumbing contractor.

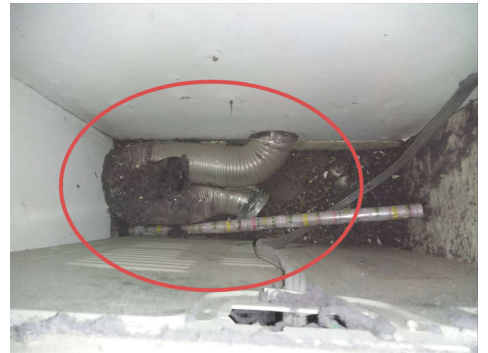
8.19.1 Dryer Vent

IMPROPER MATERIAL

This type of vent may trap lint and may be a fire hazard. It is improperly connected.

Contact a qualified professional.

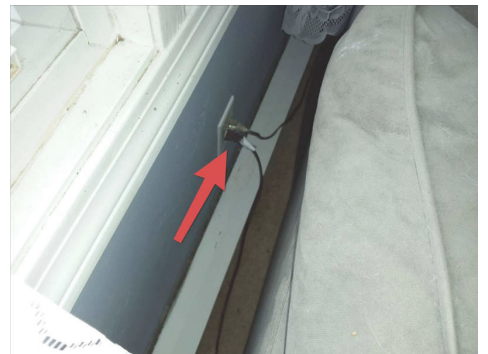
9.4.1 Electric baseboard Heating

ELECTRICAL OUTLET ABOVE

At least one of the electrical baseboard heating strips has an electrical outlet installed above it. This is considered a serious fire hazard and needs to be corrected immediately.

Contact a qualified electrical contractor.

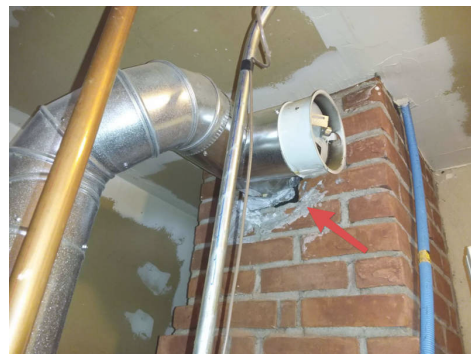
9.15.1 Exposed Flue Pipe

FLUE CONDITION

The flu is in properly sealed where meets the chimney. Flu gasses may back up into the house.

Contact a qualified heating and cooling contractor

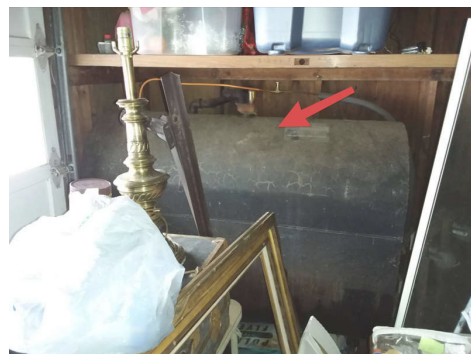
9.19.1 Fuel System

VENT/FILL PIPE LEAKS

vent and fill pipe shows signs of leakage, possible due to over fill. The system is fully depreciated, it has outlived its manufacturers serviceable life.

Contact a qualified heating and cooling contractor

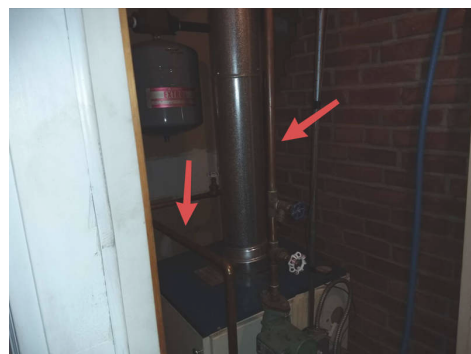
9.21.1 Pipes/Valves/Fittings

NOT INSULATED

Pipes are not insulated. Insulate the pipes.

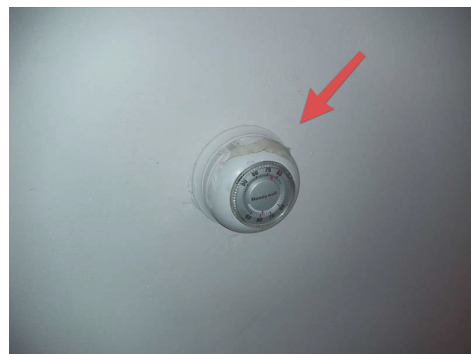
9.25.1 Normal Operating Controls

NOT PROGRAMMABLE

A programmable thermostat can result in energy savings. The client should consider upgrading to a programmable thermostat.

Contact a qualified heating and cooling contractor

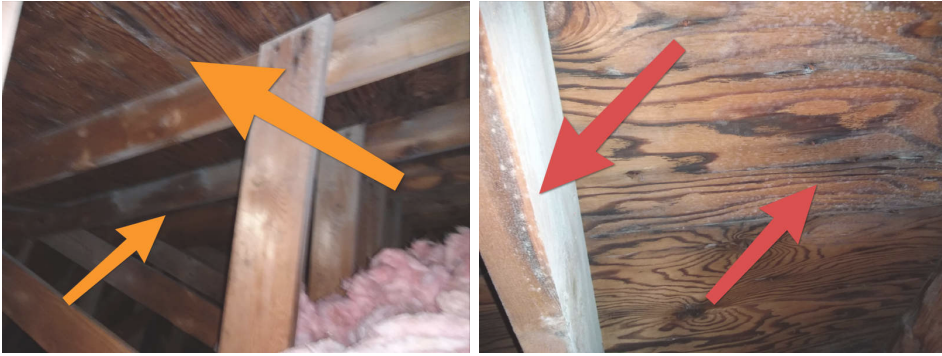
11.2.1 Structure

STAINING

Visible staining indicate moisture problems. Further review is recommended.

Recommendation
Contact a qualified mold inspection professional.

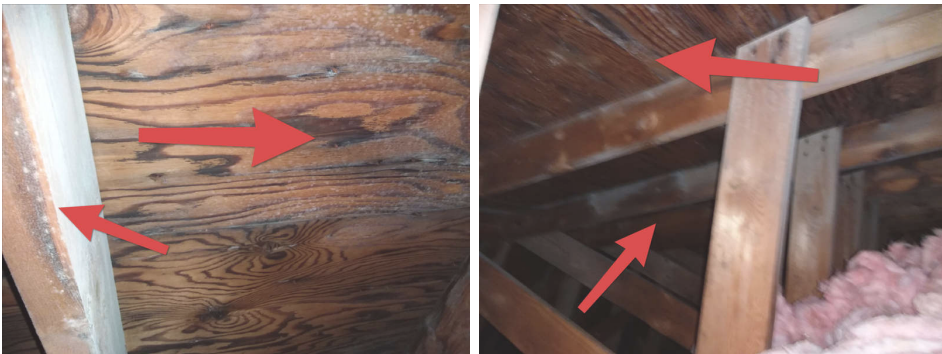
11.3.1 Ventilation

DISCOLORATION - POSSIBLE MOLD

Attic showed areas of discoloration and possible mold growth. Recommend a mold lab analysis to prevent spread of potential mold and damage to home or health risk. I also recommend finding source of moisture or lack of ventilation in attic space.

Recommendation
Contact a qualified mold inspection professional.

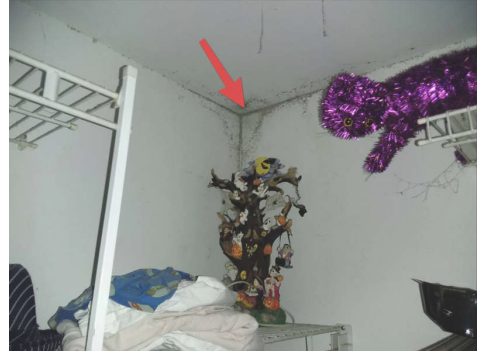
12.3.2 Walls

VISIBLE STAINING

Visible staining indicates moisture problem.

Contact a qualified mold inspection professional.

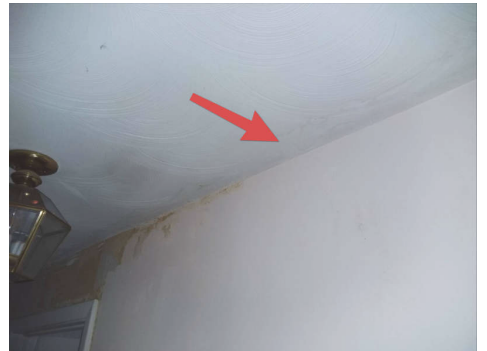
12.4.1 Ceilings

PRIOR LEAK

Evidence of prior water penetration.

Contact a qualified professional.

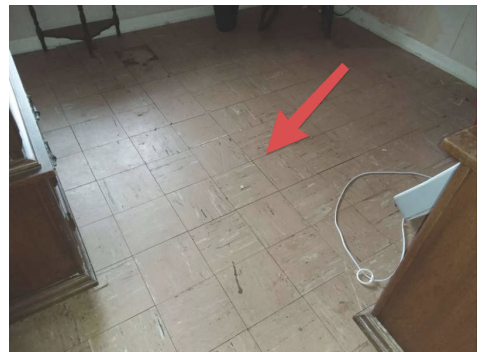
12.5.2 Floors

9X9 ASBESTOS TILES

9x9 composition tiles may or may not contain asbestos.

Contact a qualified professional.

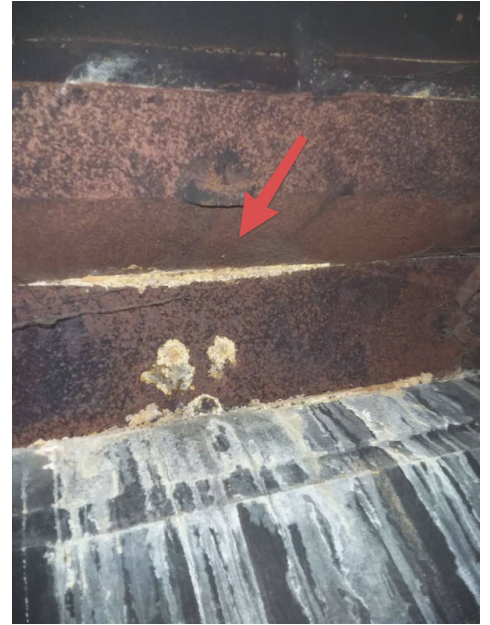
12.8.1 Fireplace/Wood Stove

DAMPER FTO

Damper is not operational.

Recommendation
Contact a qualified fireplace contractor.

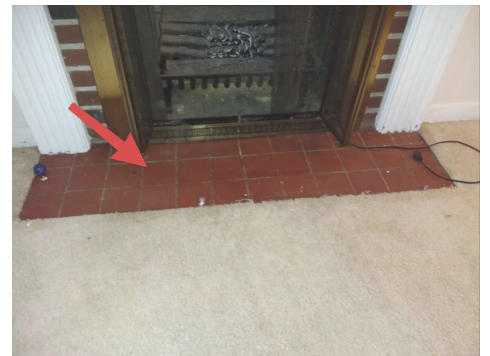
12.8.2 Fireplace/Wood Stove
INADEQUATE HEARTH

The hearth does not extend 16 inches to the front and 8 inches to the side of the firebox.

Recommendation
Contact a qualified fireplace contractor.

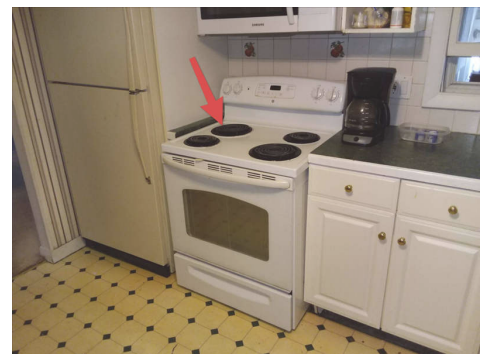
13.1.1 Range/Cooktop/Oven
FULLY DEPRECIATED

This appliance is approaching the end of its economic life. Older appliances typically use more energy than modern energy star rated appliances.

Recommendation
Contact a qualified appliance repair professional.

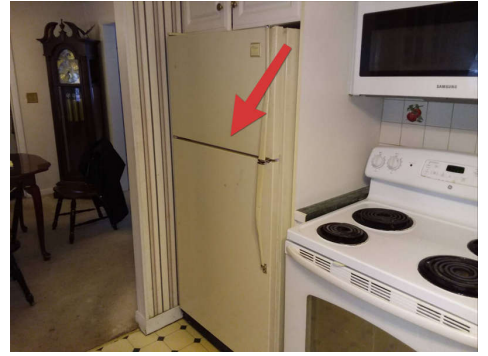
13.3.1 Refrigerator
FULLY DEPRECIATED

This appliance is approaching the end of its economic life. Older appliances typically use more energy than modern energy star rated appliances.

Recommendation
Contact a qualified professional.

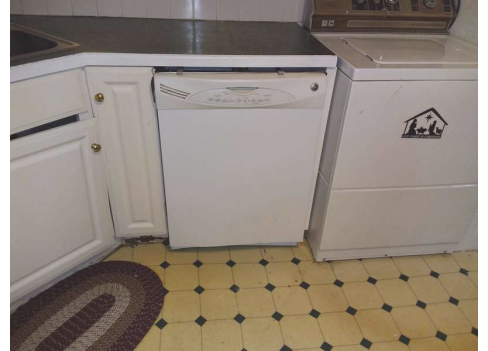
13.4.2 Dishwasher
FULLY DEPRECIATED

This appliance is approaching the end of its economic life and was not functioning at the time of the inspection. Older appliances typically use more energy than modern energy star rated appliances.

Recommendation
Contact a qualified appliance repair professional.

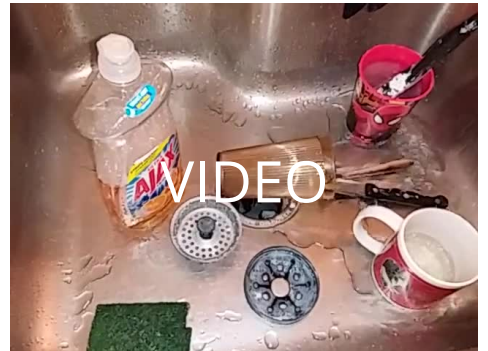
13.5.1 Garbage Disposal
GARBAGE DISPOSAL FTO

Garbage disposal is functioning however it is out of balance and vibrates the whole counter.

Recommendation
Contact a qualified appliance repair professional.

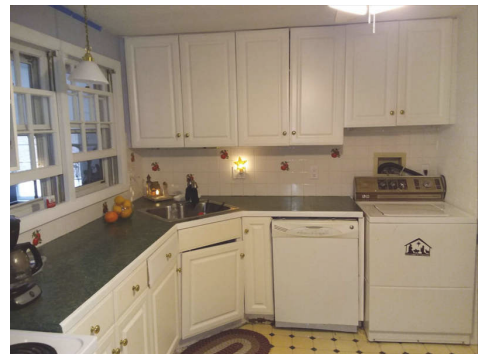
13.7.1 Kitchen Cabinets And Counters
FULLY DEPRECIATED

This appliance is approaching the end of its economic life. Older appliances typically use more energy than modern energy star rated appliances.

Recommendation
Contact a qualified cabinet contractor.
