Below is a summary of all deficiencies found at the property. Estimated costs are added as a courtesy and must be verified by a licensed contractor in their respectable trade.

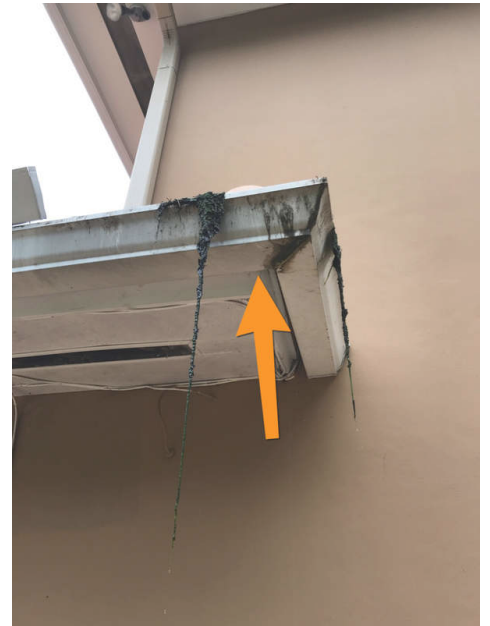
2.2.1 Roof Drainage Systems

DEBRIS

Debris has accumulated in the gutters. Recommend cleaning to facilitate water flow.

Contact a qualified gutter contractor

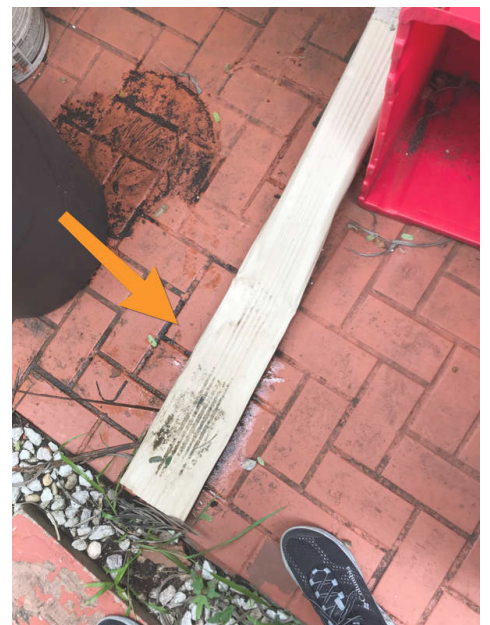
2.2.2 Roof Drainage Systems

GUTTER DAMAGED

Gutters were damaged. This can result in excessive moisture in the soil at the foundation, which can lead to foundation/structural movement. Recommend a qualified contractor evaluate and repair.

Contact a qualified gutter contractor

\$100 - \$200

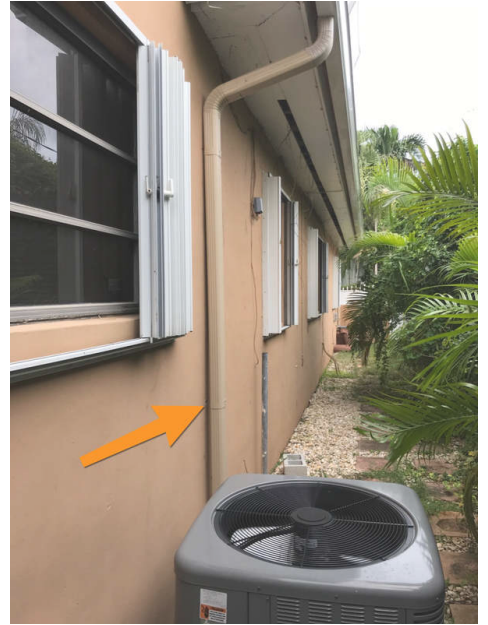
2.2.3 Roof Drainage Systems

GUTTER LOOSE

The gutter(s) is loose and needs to be re-fastened to fascia and pitched properly.

Contact a qualified gutter contractor

\$100

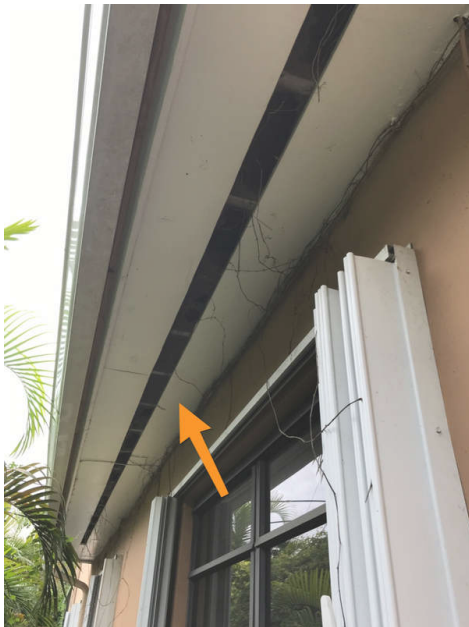
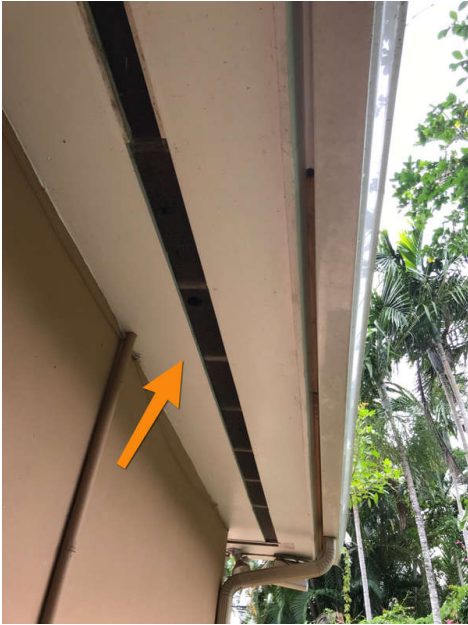
2.3.1 Ventilation

DAMAGED VENTS

Damaged roof vents observed. A licensed roofer is recommended for repairs.

Contact a qualified roofing professional.

\$2,000 - \$2,500

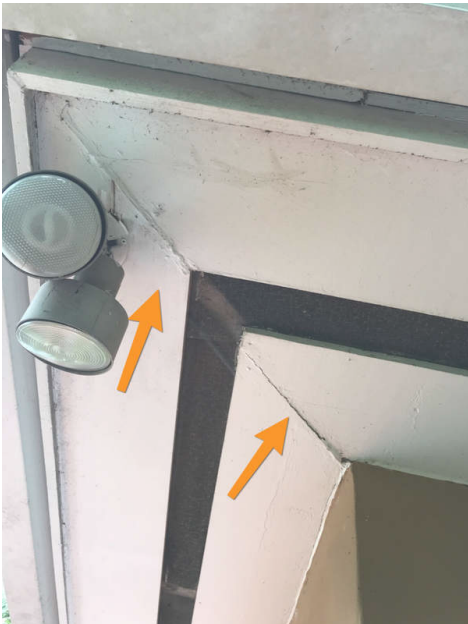
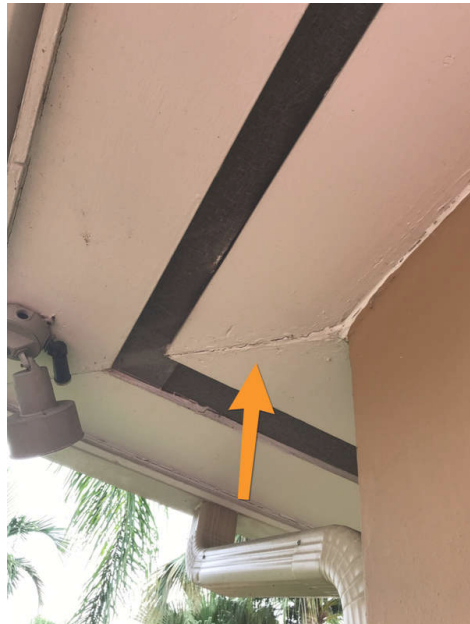
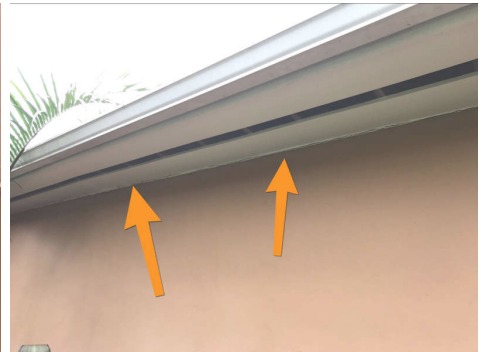
EAVES - DAMAGED

One or more sections of the eaves are damaged. Recommend qualified roofer evaluate & repair.

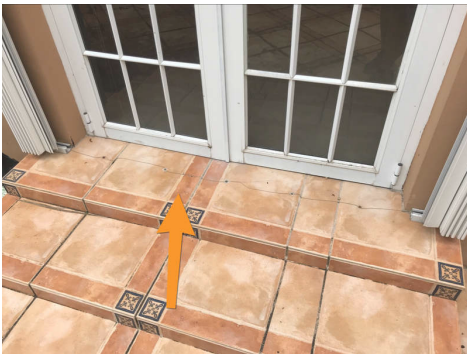
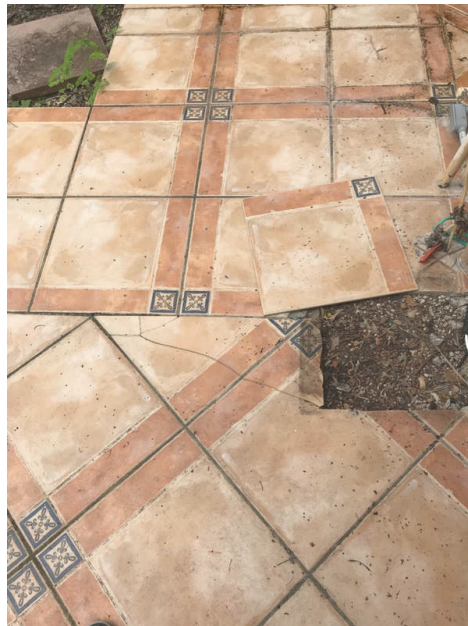
3.3.1 Walkways, Patios & Driveways

DAMAGED TILES

Patio tiles are cracked and damaged; replacement recommended.

Recommendation
Contact a qualified tile contractor

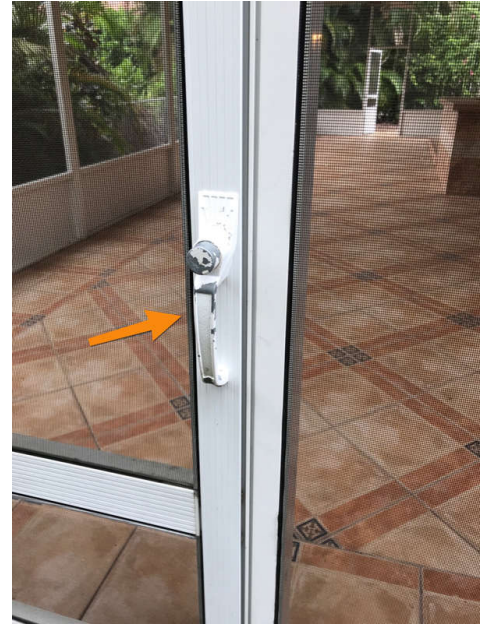
3.4.1 Decks, Balconies, Porches & Steps

SCREEN ENCLOSURE LOCK

Screen enclosure lock is damaged; repairs/replacement recommended.

Recommendation
Contact a qualified professional.

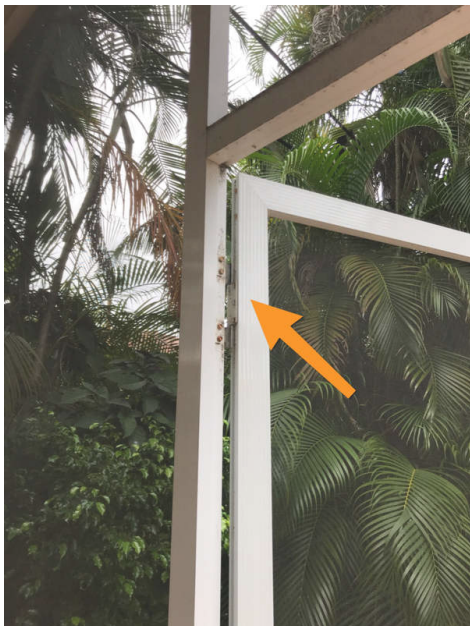
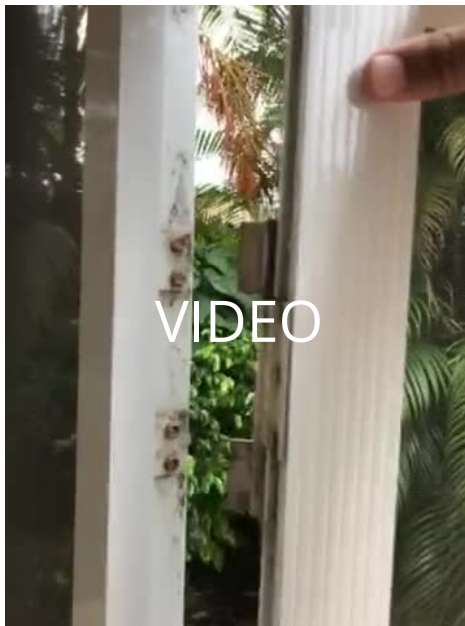
DAMAGED DOOR

Screen enclosure door is damaged and needs repair.

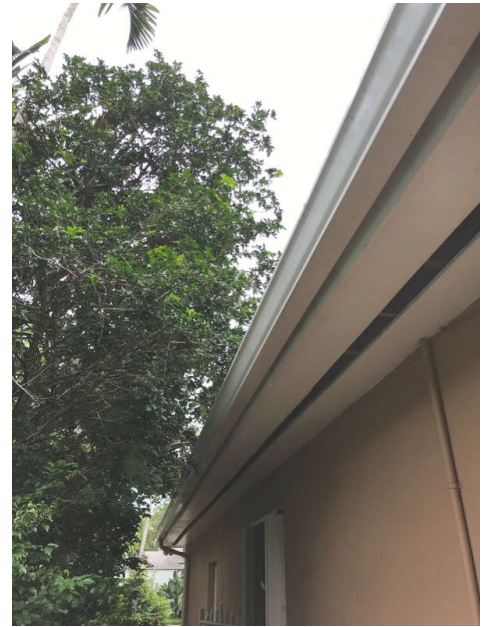
3.5.1 Vegetation, Grading, Drainage & Retaining Walls

TREE OVERHANG

Trees observed overhanging the roof. This can cause damage to the roof and prevent proper drainage. Recommend a qualified tree service trim to allow for proper drainage.

Recommendation
Contact a qualified tree service company.
Estimated Cost
\$200

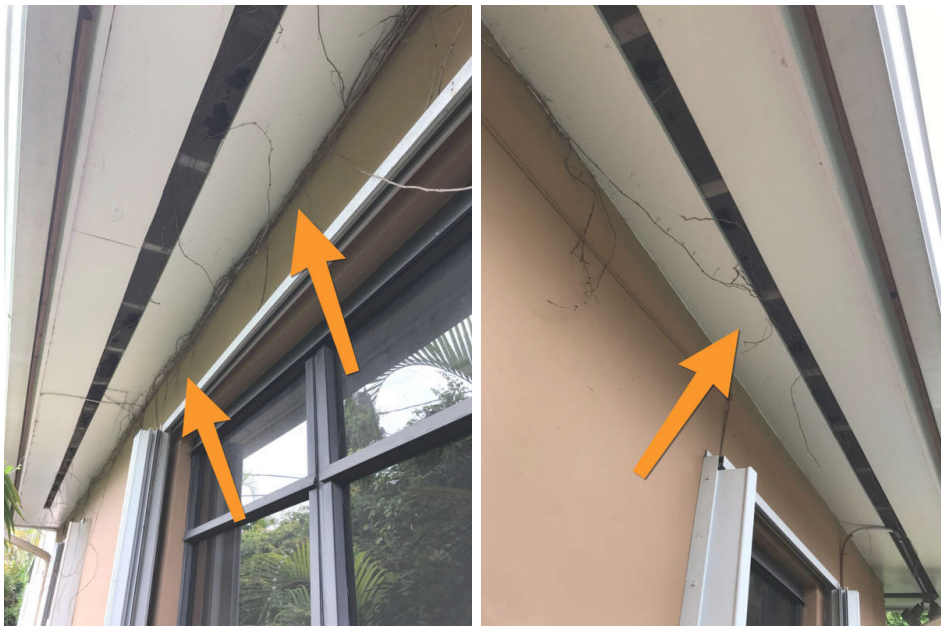
3.5.2 Vegetation, Grading, Drainage & Retaining Walls
TREES/BRUSH

Trees coming in contact with property structure must be trimmed.

Recommendation
Contact a handyman or DIY project
Estimated Cost
\$200

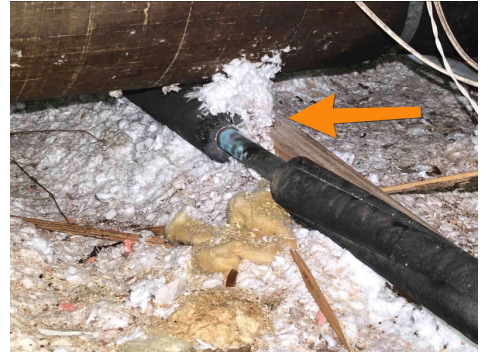
4.5.1 Wood Destroying Organisms
VISIBLE EVIDENCE

Wood destroying organisms evidence observed at the property.
Treatment is recommended.

Recommendation
Contact a qualified pest control specialist.

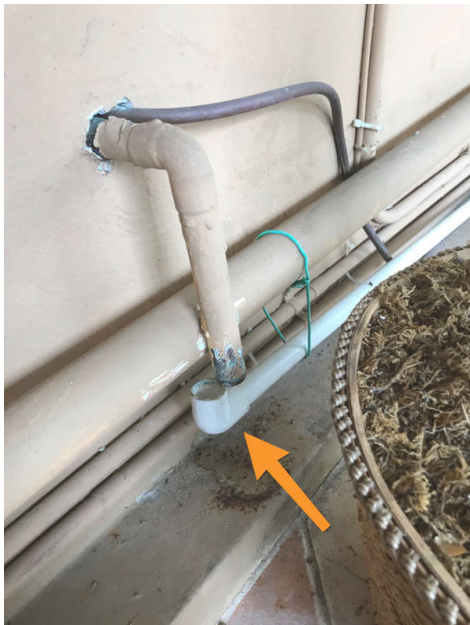
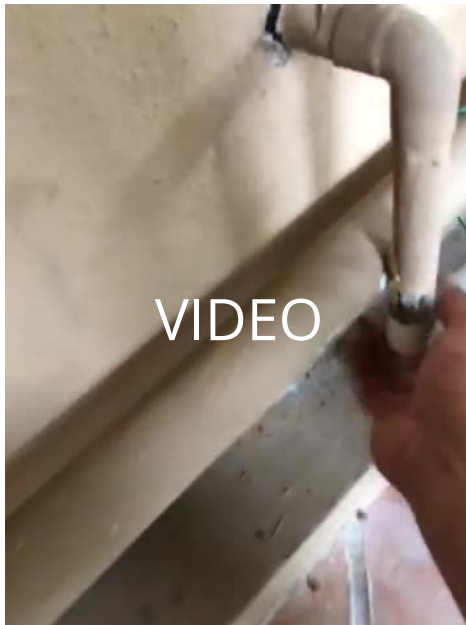
6.1.1 Cooling Equipment

CONDENSATE TUBE DAMAGED

Condensate tube was damaged, which limits safe discharge of condensation produced by evaporator coils. Recommend a qualified HVAC technician repair.

Contact a qualified heating and cooling contractor

\$100

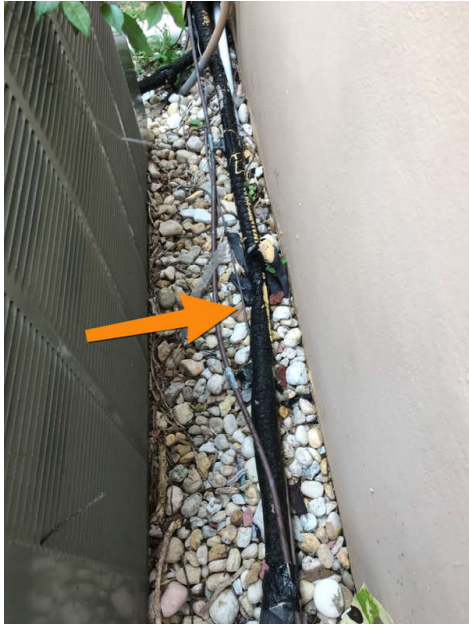
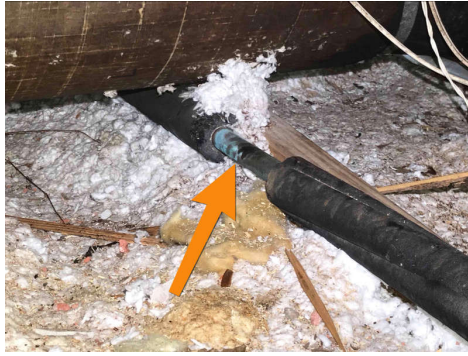
INSULATION MISSING OR DAMAGED

Missing or damaged insulation on refrigerant line can cause energy loss and condensation.

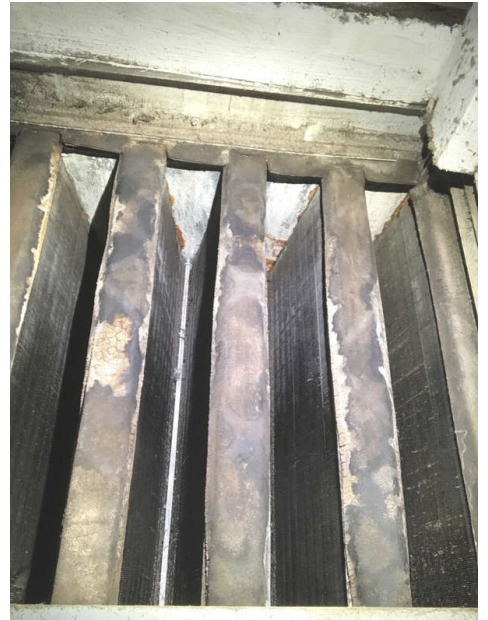
6.1.3 Cooling Equipment

MOLD OBSERVED ON COILS

Visible mold observed on air handler coils. It is recommended that a mold test be performed. The apparent mold is located on the return air section and could be blowing mold spores in the air of the home through the ducts. The only way to check is to collect air samples inside the home along with a physical swab. These samples will be sent to a laboratory and a determination will be made whether you have a mold problem inside the house.

Contact a qualified mold inspection professional.

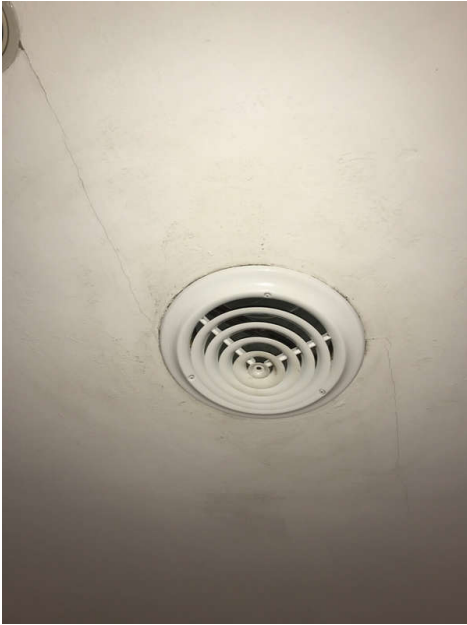
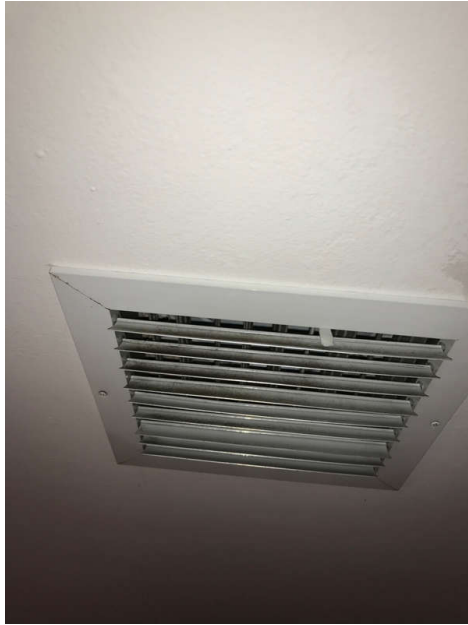
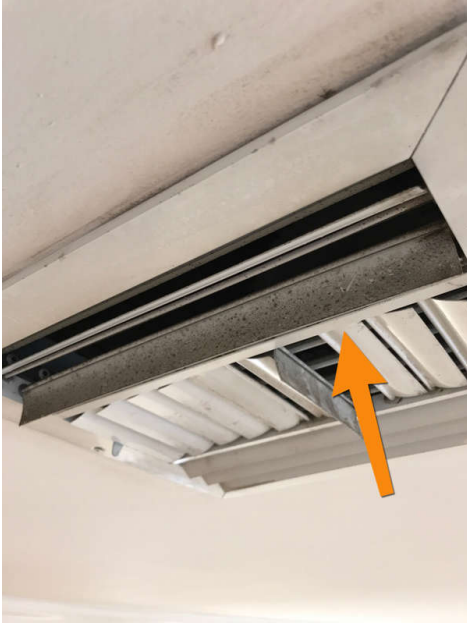
6.3.1 Distribution System

COLD AIR RETURN LEAKING

The cold air return is leaking at the unit. Recommend licensed HVAC contractor seal or patch ductwork. Visible mold and condensation observed.

Contact a qualified heating and cooling contractor

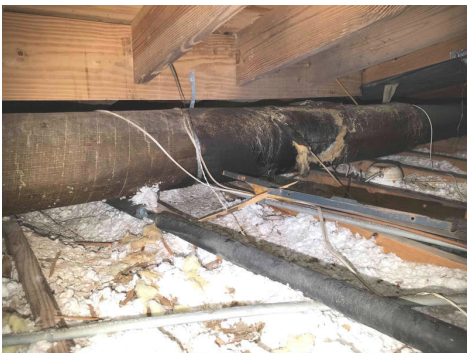
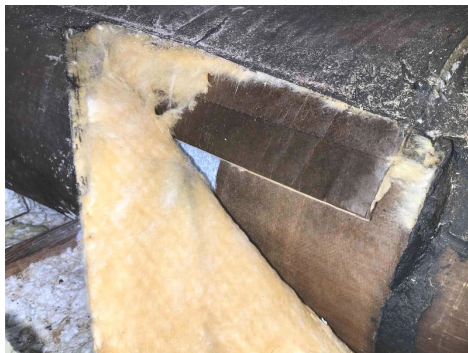
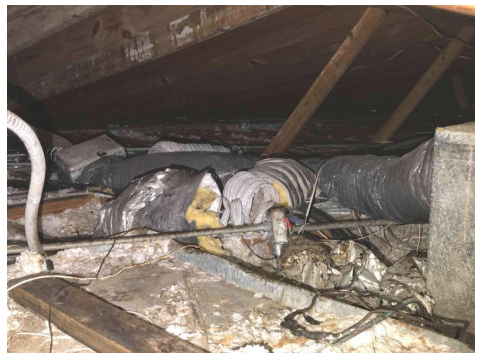
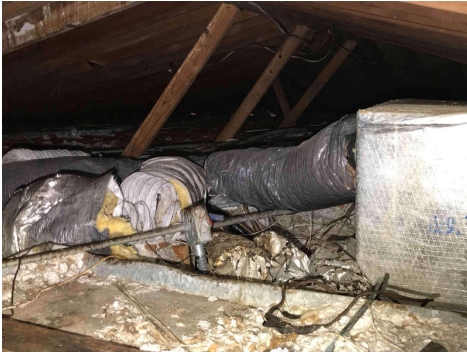
6.3.2 Distribution System **DUCTS DETERIORATED**

Deteriorated ducts were observed. Recommend licensed HVAC contractor repair or replace.

Contact a qualified heating and cooling contractor

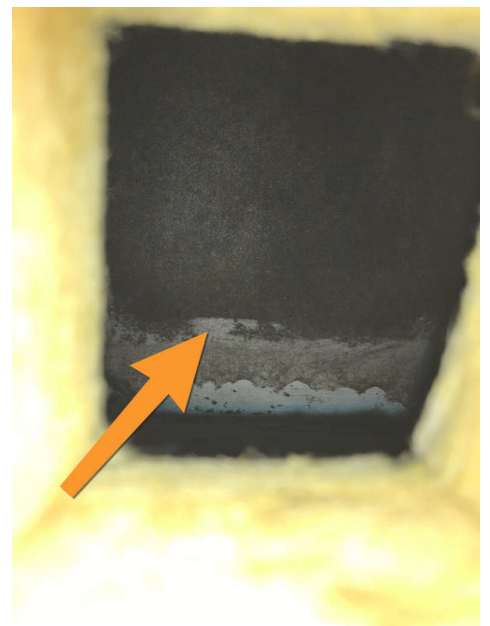
6.3.4 Distribution System

MOLD OBSERVED SUPPLY PLENUM

Observed mold on/inside supply plenum. A Mold Assessment is recommended for further evaluation and remediation protocol.

Recommendation
Contact a qualified mold inspection professional.

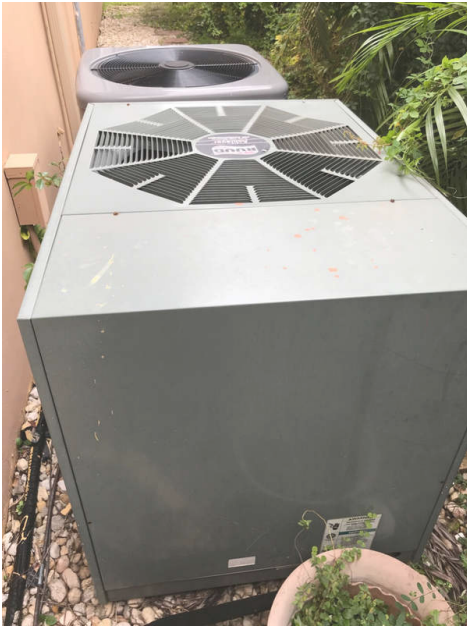
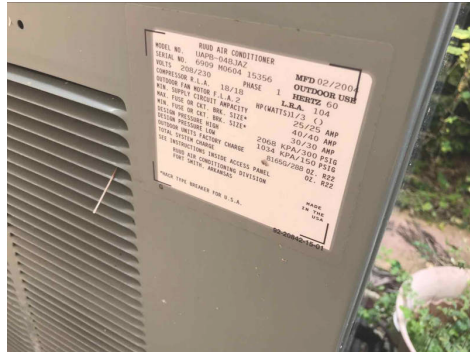
7.1.2 Cooling Equipment

UNIT PAST LIFE EXPECTANCY; REPLACEMENT ANTICIPATED

Unit has exceeded it's life expectancy and replacement should be anticipated.

Contact a qualified heating and cooling contractor

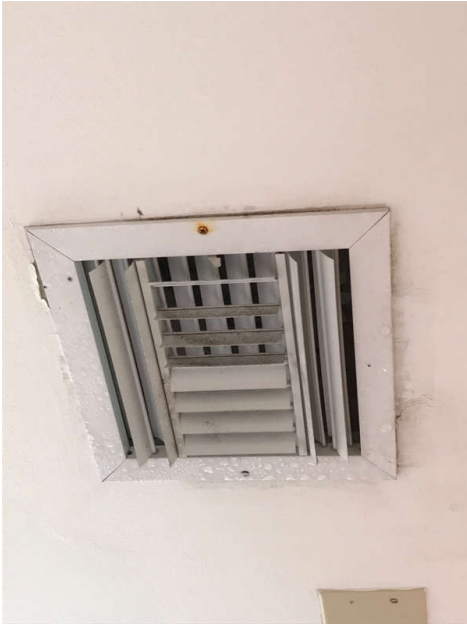
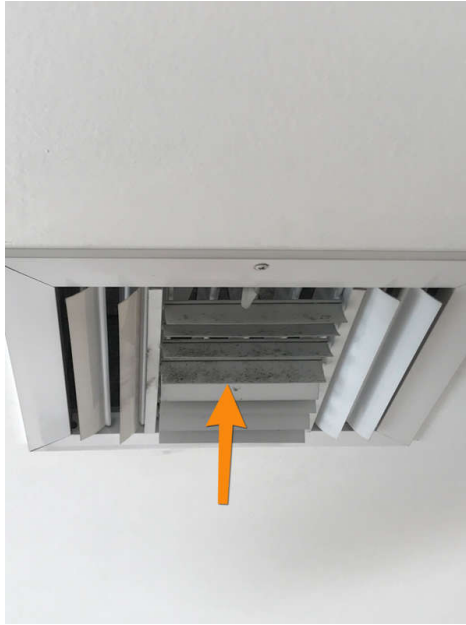
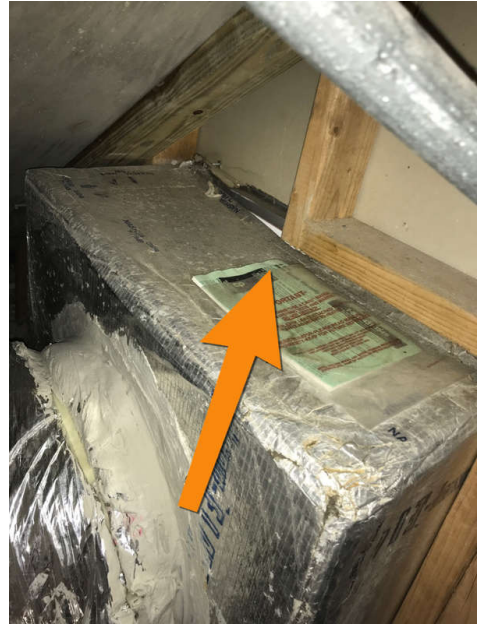
7.3.1 Distribution System

COLD AIR RETURN LEAKING

The cold air return is leaking at the unit. Recommend licensed HVAC contractor seal or patch ductwork. There is visible mold and condensation observed on vent railings.

Contact a qualified heating and cooling contractor

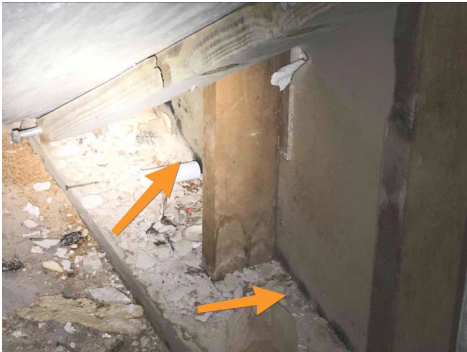
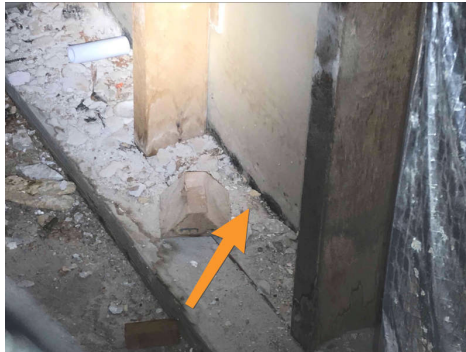
7.3.2 Distribution System

MOLD

Visible mold observed inside air handler closet. A mold inspection is recommended.

Contact a qualified mold inspection professional.

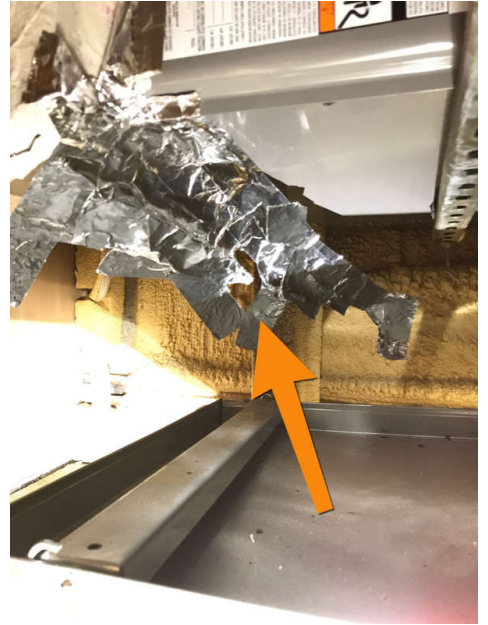
7.3.3 Distribution System

SUPPLY PLENUM NOT SEALED CORRECTLY

Air handler supply plenum is not sealed correctly and is leaking cold air. Cold air leaking can cause condensation which in turn causes mold growth.

Contact a qualified HVAC professional.

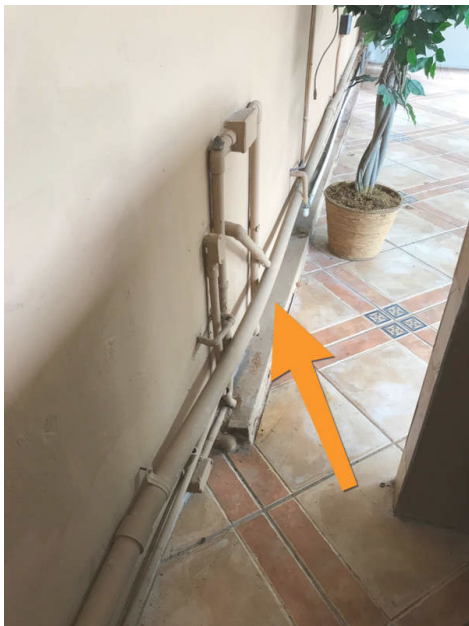
8.2.1 Drain, Waste, & Vent Systems
DRAIN LINE NOT UP TO CODE

Drain line is not up to code and repairs need to be made.

Recommendation
Contact a qualified plumbing contractor.
Estimated Cost
\$1,000 - \$1,600

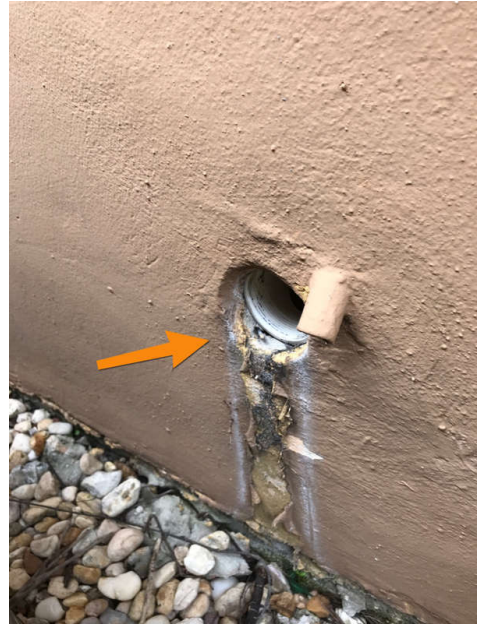
8.2.2 Drain, Waste, & Vent Systems
DAMAGED CLEANOUT

Clean out pipe is damaged and needs repair.

Recommendation
Contact a qualified plumbing contractor.
Estimated Cost
\$10 - \$100

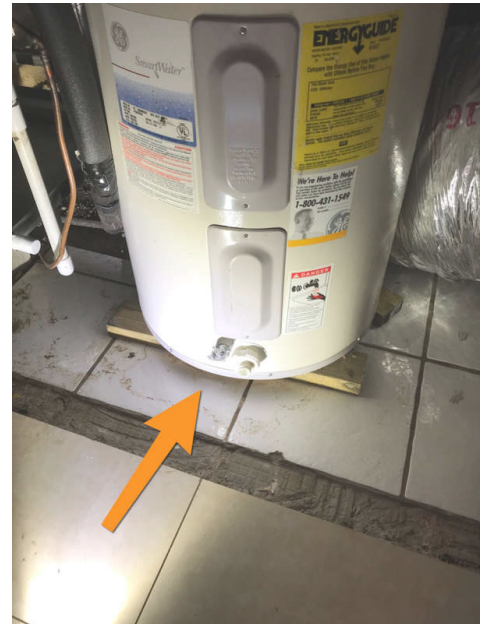
8.5.1 Hot Water Systems, Controls, Flues & Vents 2

NO DRIP PAN

No drip pan was present. Recommend installation by a qualified plumber.

Recommendation
Contact a qualified plumbing contractor.
Estimated Cost
\$300 - \$400

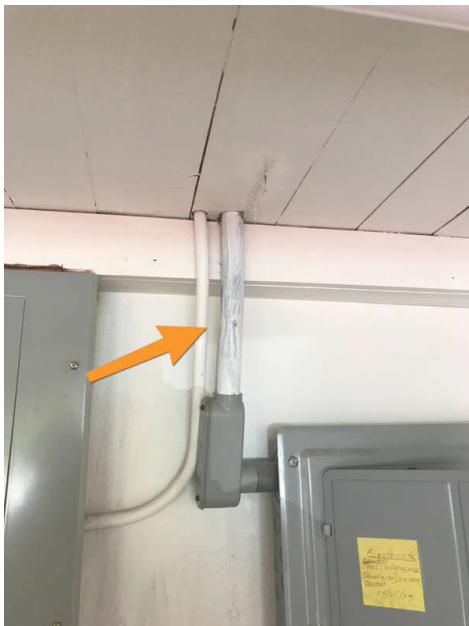
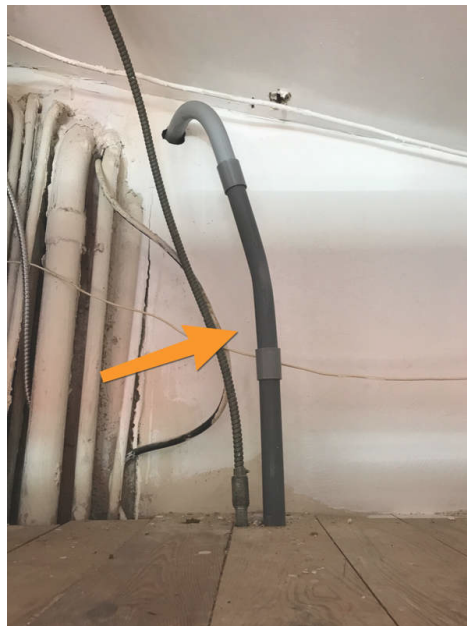
9.3.1 Branch Wiring Circuits, Breakers & Fuses

IMPROPER WIRING

Wires not installed up to code. A licensed electrician needs to be hired in order to make proper repairs.

Recommendation
Contact a qualified electrical contractor.
Estimated Cost
\$500

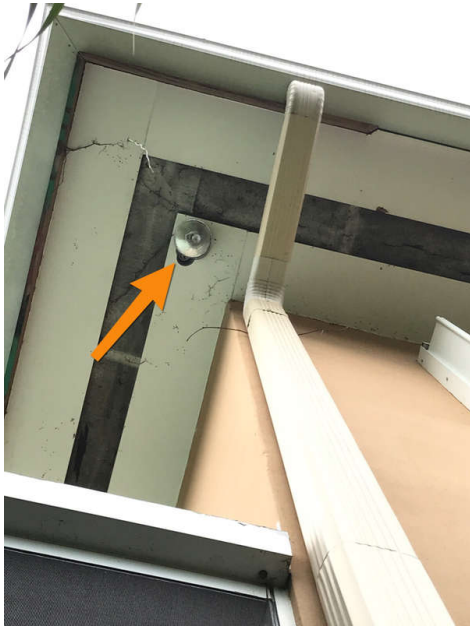
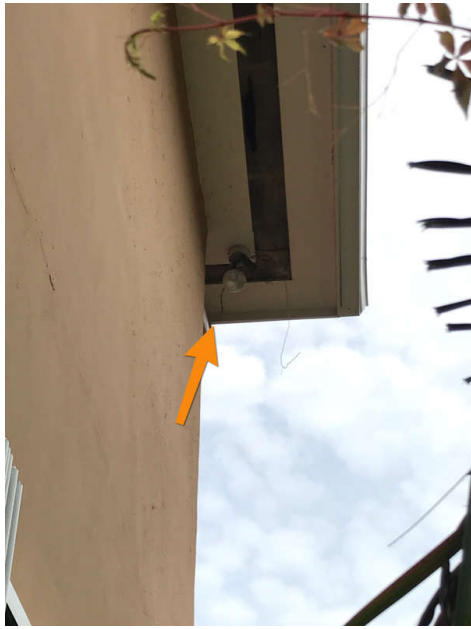
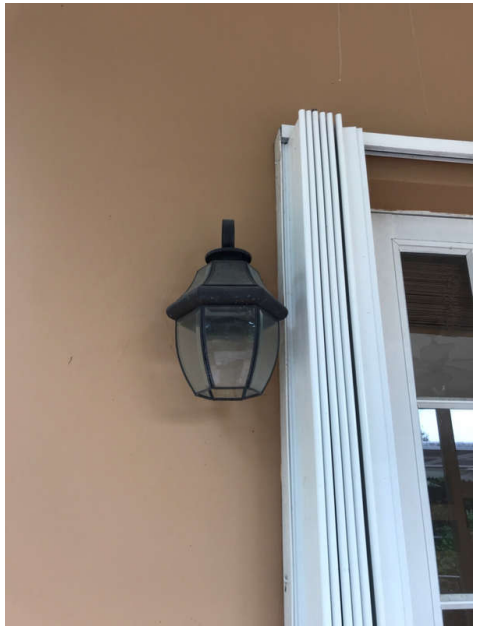
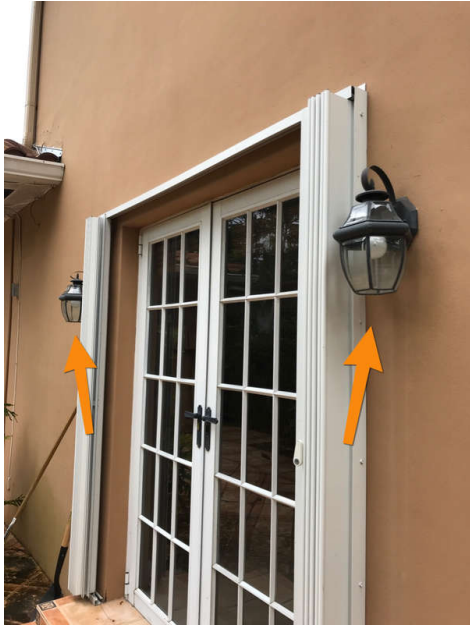
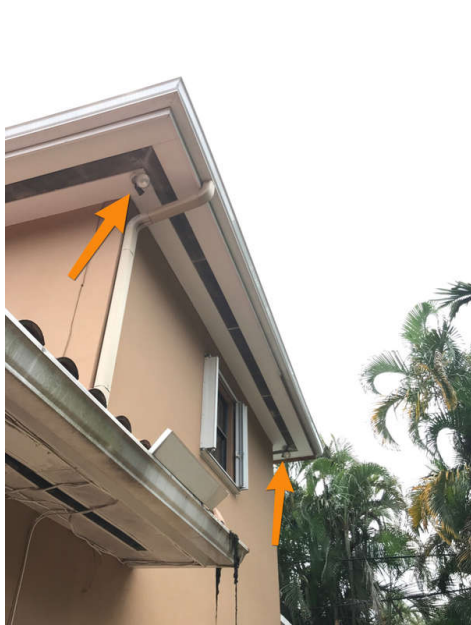
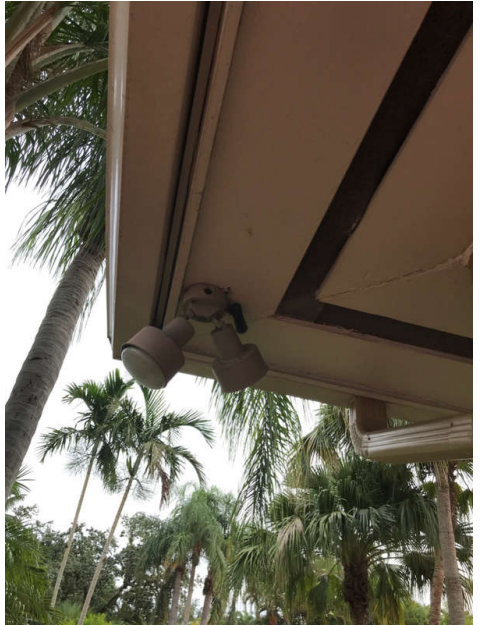
9.4.1 Lighting Fixtures, Switches & Receptacles

EXTERIOR LIGHT INOPERABLE

One or more lights are not operating. New light bulb possibly needed.

Contact a qualified electrical contractor.

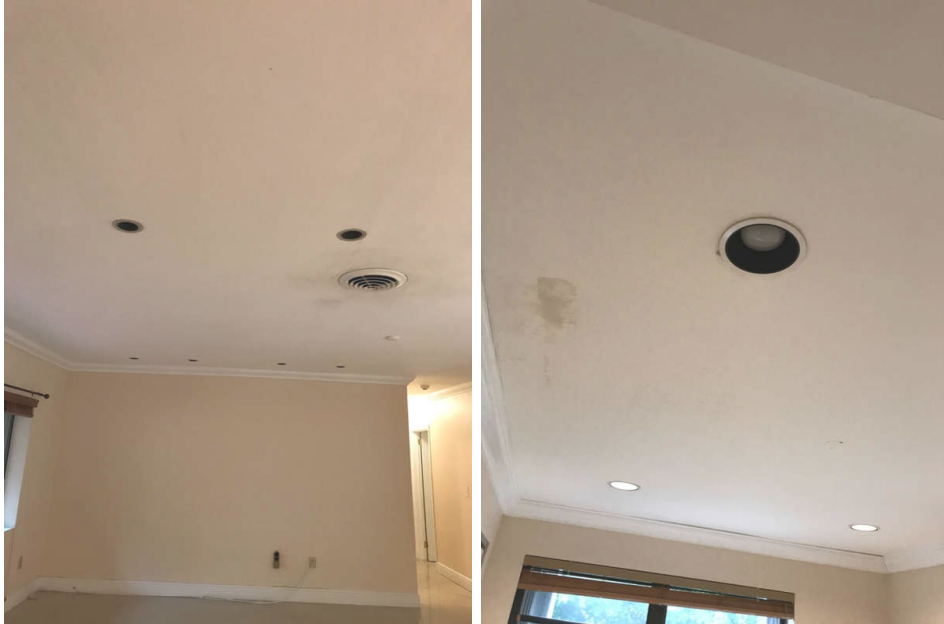
9.4.2 Lighting Fixtures, Switches & Receptacles

INTERIOR LIGHT INOPERABLE

One or more lights are inoperable. New light bulbs possibly needed.

Contact a qualified electrical contractor.

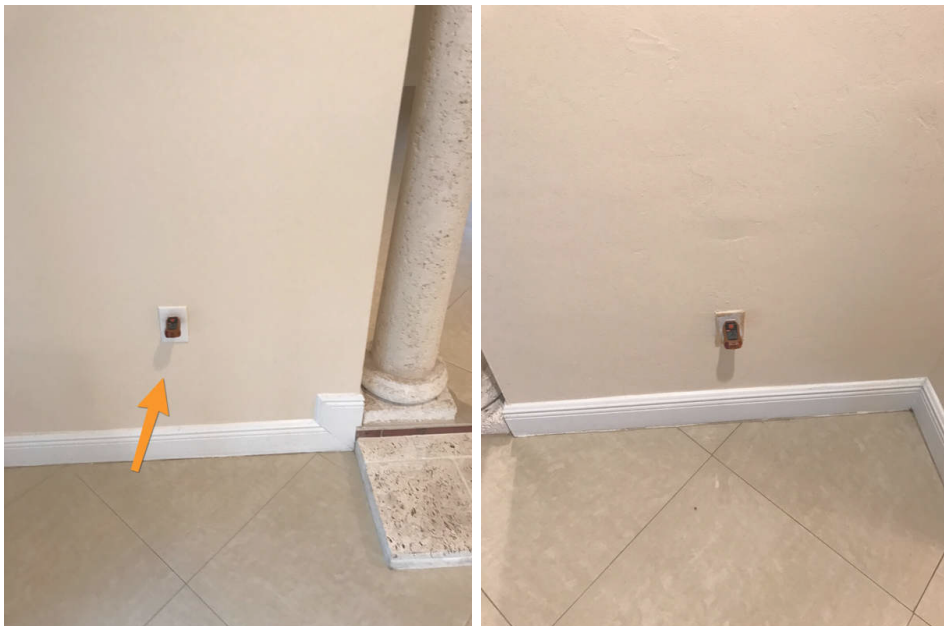
9.4.3 Lighting Fixtures, Switches & Receptacles

NO POWER

One or more outlets do not have power. A licensed electrician should be hired to make proper repairs.

Contact a qualified electrical contractor.

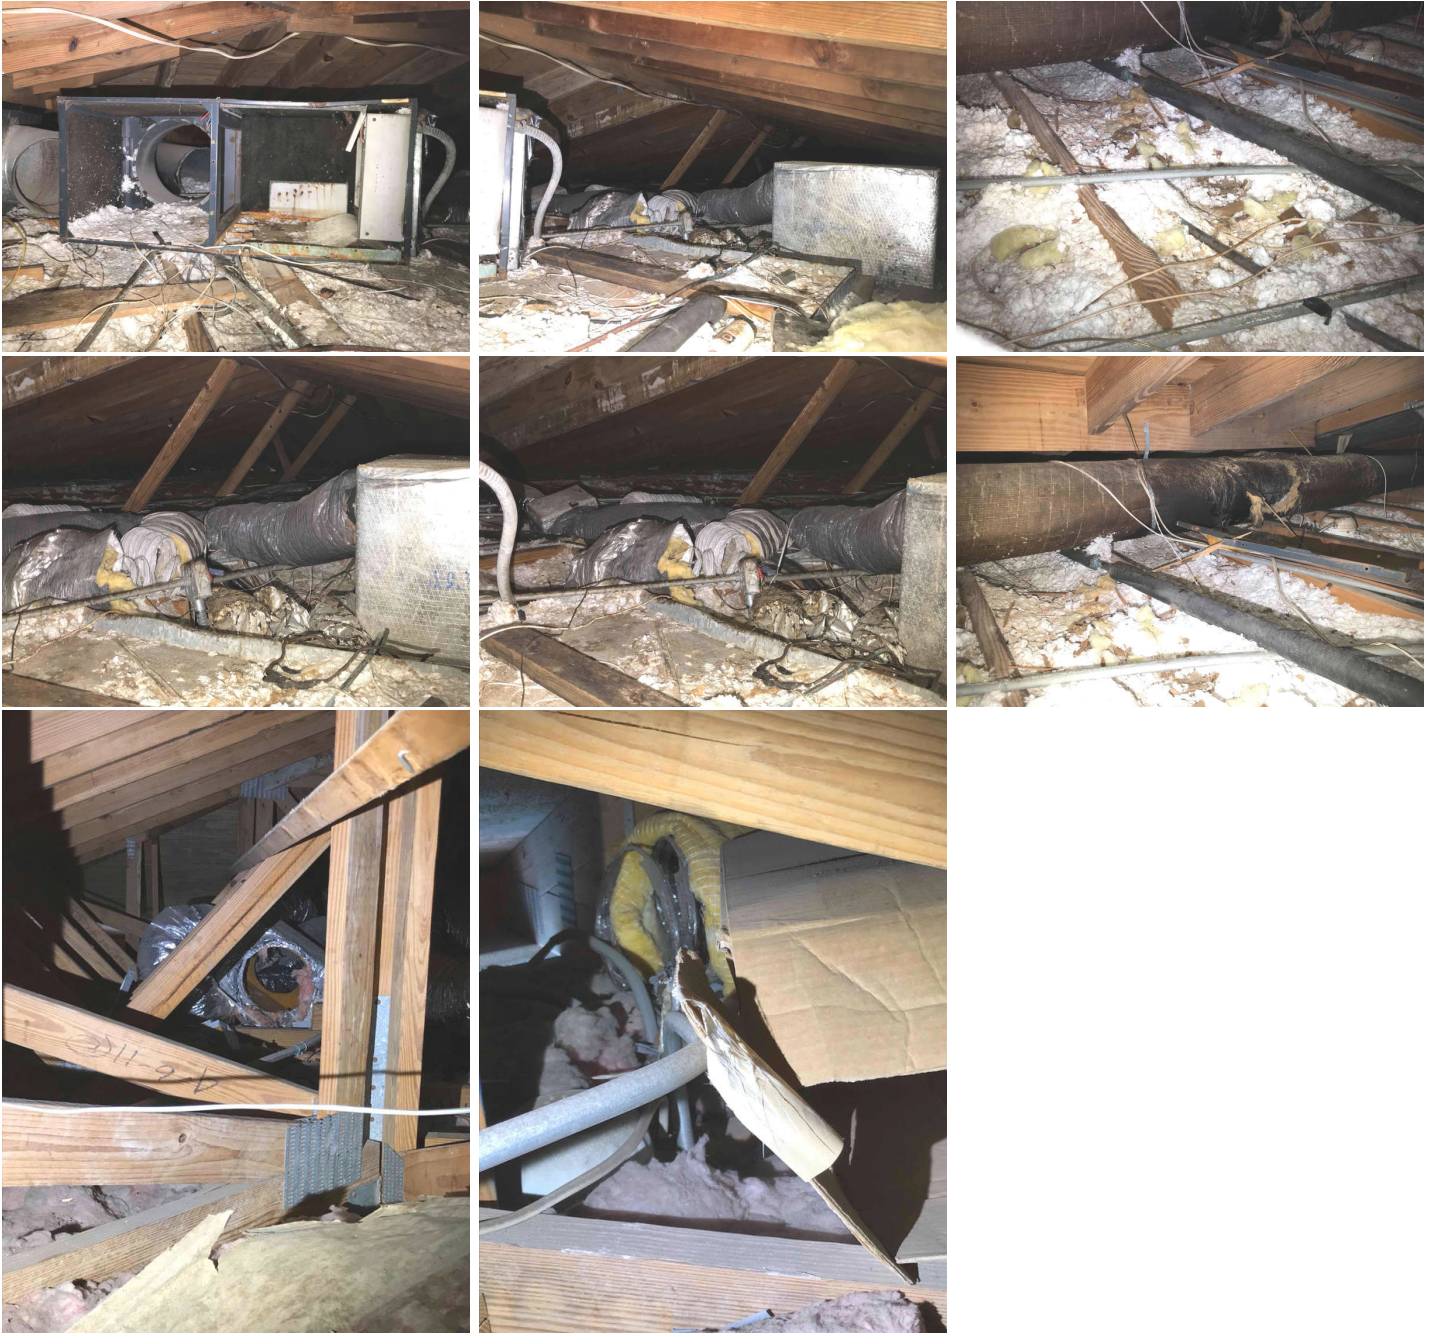
10.1.1 Attic Insulation

DEBRIS

Debris inside attic should be removed.

Recommendation
Contact a qualified professional.

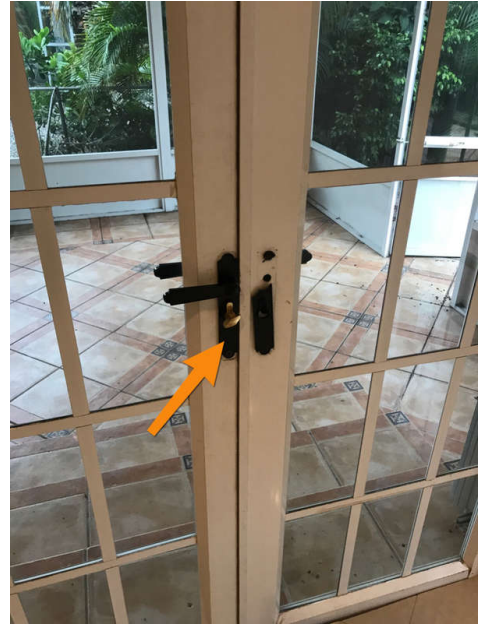
11.1.1 Doors

LOCK NEEDS REPAIR

Door locks need repair.

Recommendation
Contact a qualified handyman.

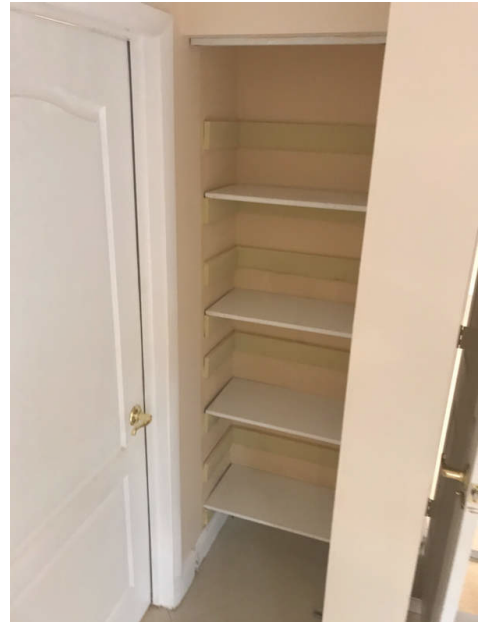
11.1.2 Doors

CLOSET DOORS MISSING

Observed one or more closet doors that are missing.

Contact a qualified door repair/installation contractor.

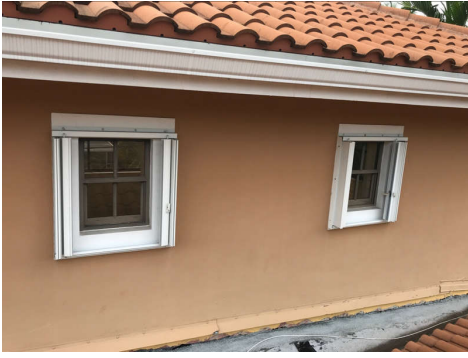
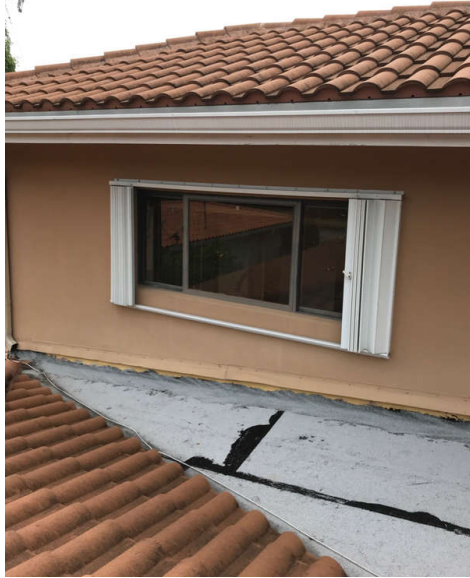
11.2.1 Windows

MISSING/DAMAGED SCREEN

Observed one or more windows with missing/damaged screens. Recommend replacement.

Contact a qualified window repair/installation contractor.

\$200 - \$300

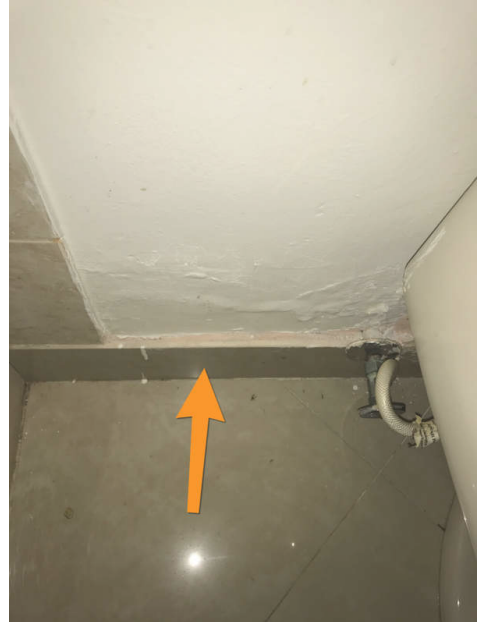
11.4.1 Walls

MOISTURE DAMAGE

Stains on the walls visible at the time of the inspection appeared to be the result of moisture intrusion. Recommend further examination by a Mold Inspector to provide further testing.

Contact a qualified mold inspection professional.

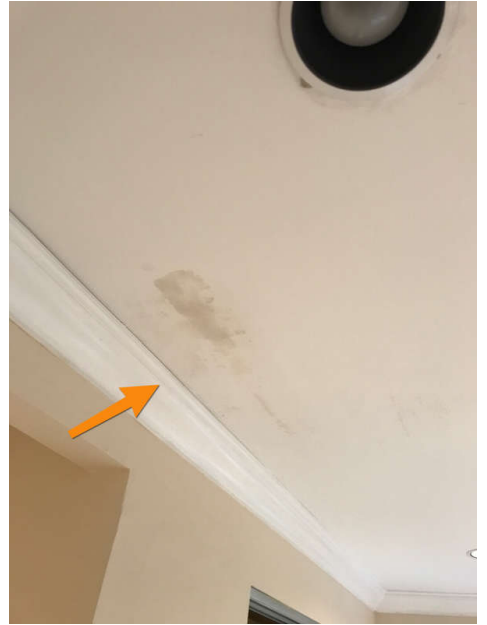
11.5.1 Ceilings

STAIN(S) ON CEILING

There is a stain on ceiling/wall that requires repair and paint. Source of staining should be determined.

Contact a qualified roofing professional.

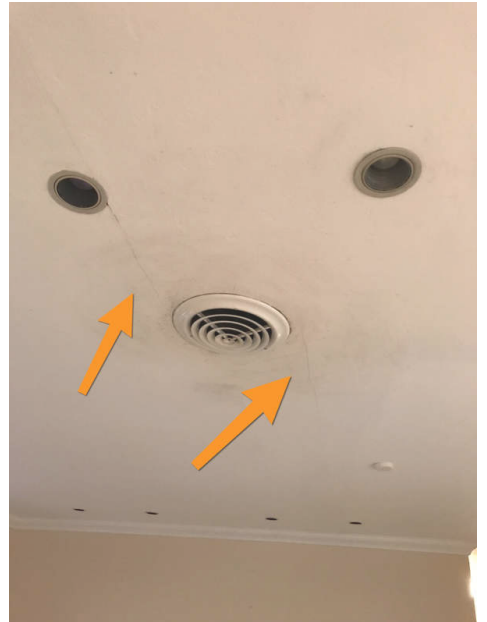
11.5.2 Ceilings

CRACKS

Cracks observed on interior ceilings.

Contact a qualified professional.

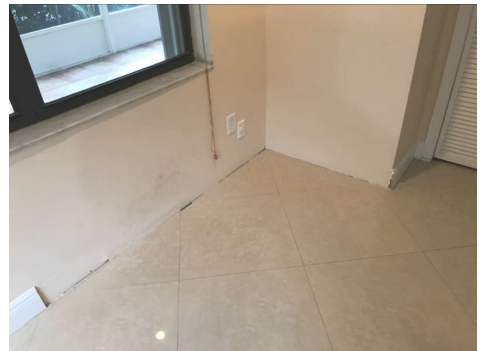
11.7.1 Baseboards

MISSING BASEBOARDS

Missing baseboards observed at the property.

Contact a qualified handyman.

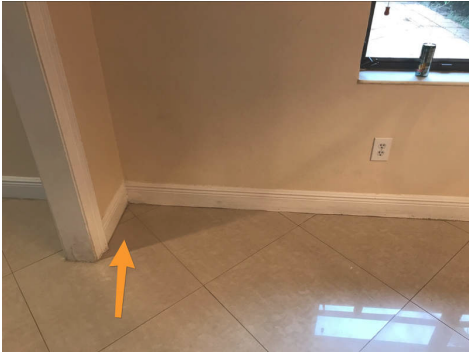
11.7.2 Baseboards

WATER DAMAGE

Water damage observed on baseboards is an indication of an active leak somewhere in the home. It is recommended that the source of the leak be located and repaired.

Contact a qualified mold inspection professional.

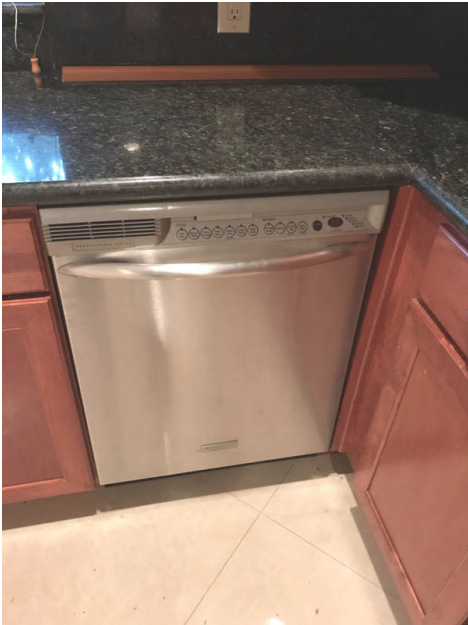
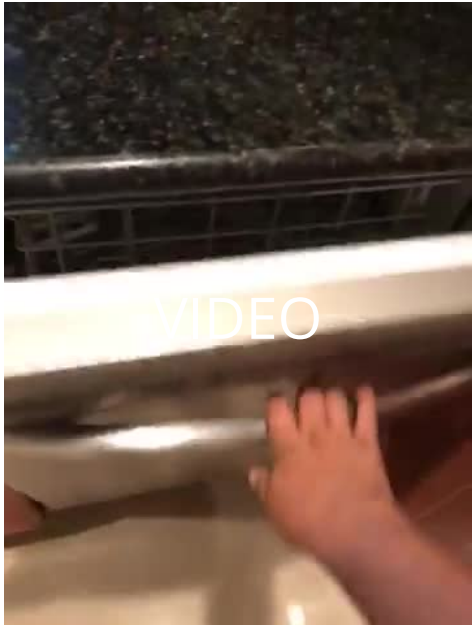
13.1.1 Dishwasher

INOPERABLE

Dishwasher was inoperable using standard controls. Recommend a qualified plumber or contractor evaluate.

Contact a qualified appliance repair professional.

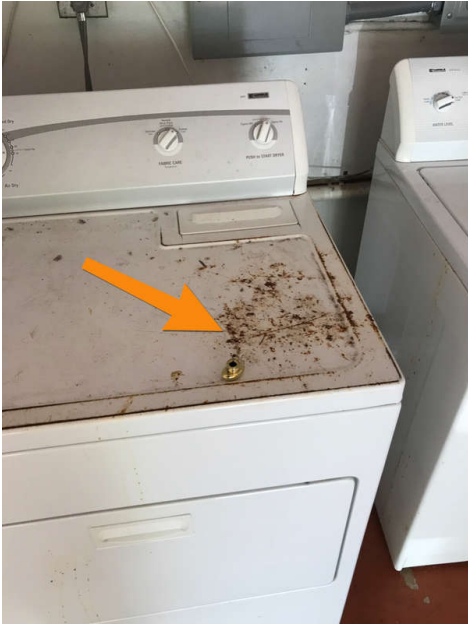
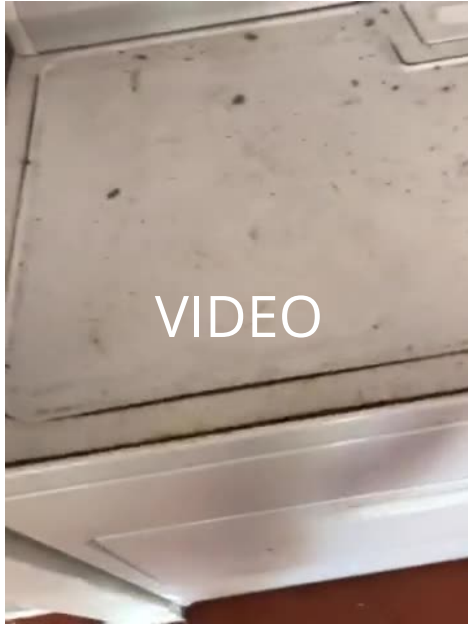
13.6.1 Dryer

DAMAGE

Damaged observed to drying machine.

Contact a qualified appliance repair professional.

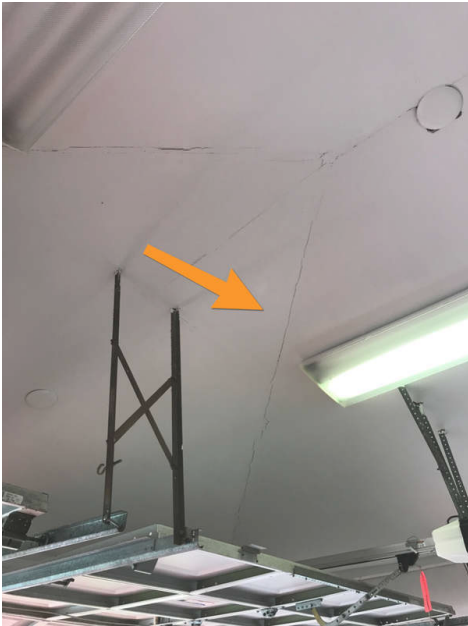
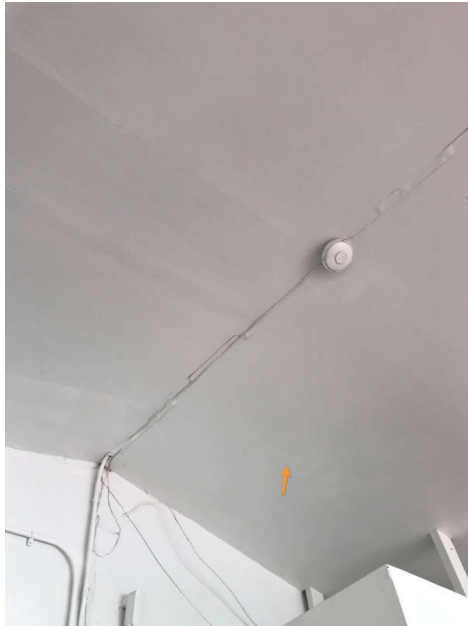
14.1.1 Ceiling
CRACKS

Observed ceiling cracks in garage area.

Recommendation
Contact a qualified professional.

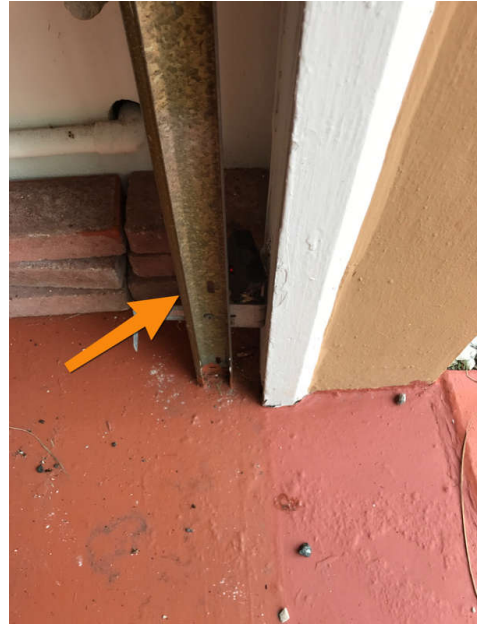
14.5.1 Garage Door Opener
DAMAGED SENSOR

Garage force sensitive sensor is damaged and needs repair/replacement.

Recommendation
Contact a qualified garage door contractor.

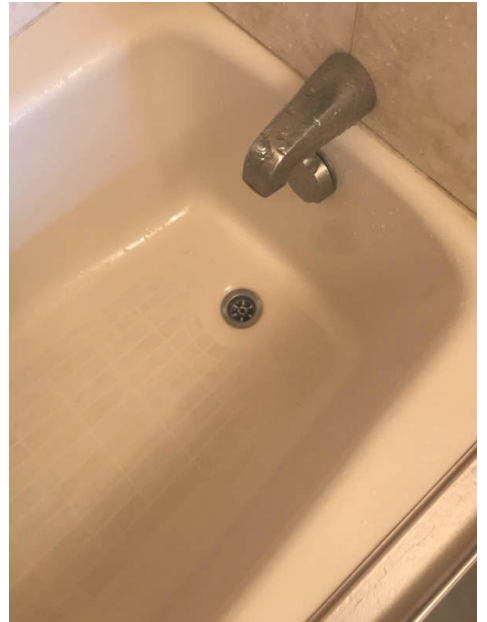
15.3.1 Bathtub

DRAIN CAP

Bathtub drain cap is missing or damaged.

Contact a qualified plumbing contractor.
