Below is a summary of all deficiencies found at the property. Estimated costs are added as a courtesy and must be verified by a licensed contractor in their respectable trade.

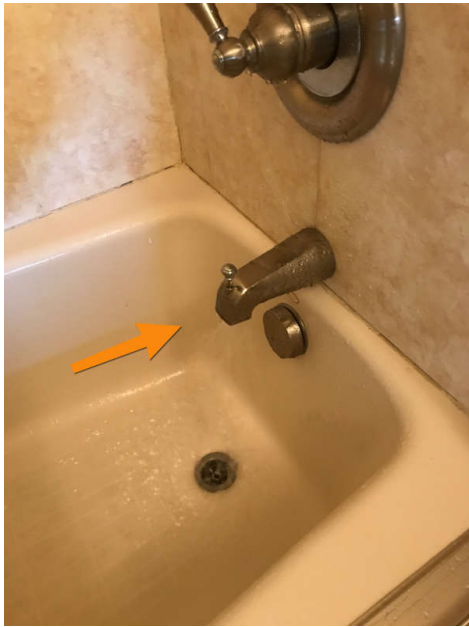
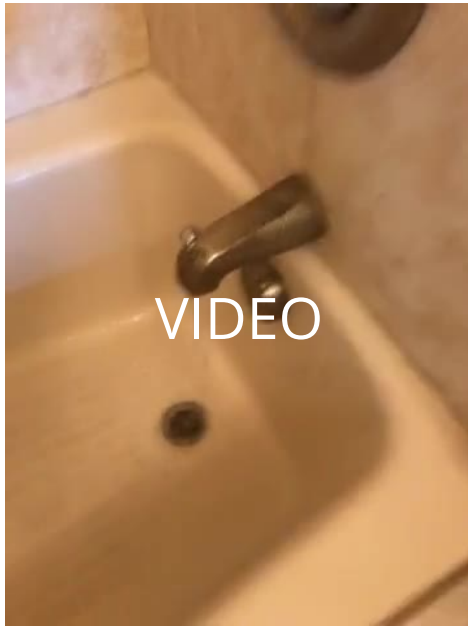
15.3.2 Bathtub

INOPERABLE FIXTURES

Bathtub fixtures were inoperable at the time of inspection. Recommend a qualified plumber or handyman evaluate.

Contact a qualified plumbing contractor.

\$400 - \$500

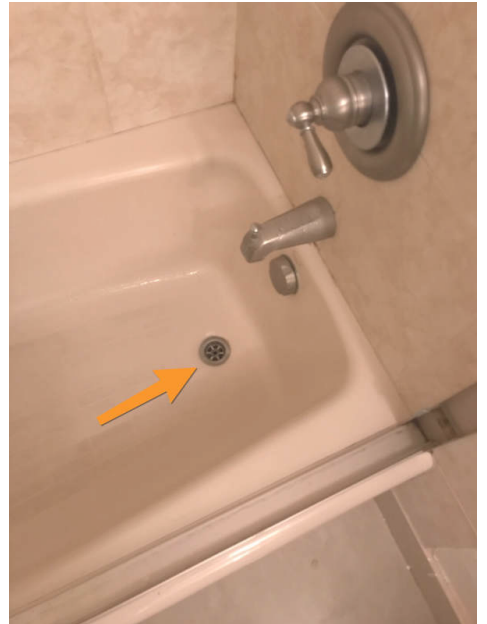
16.3.1 Bathtub

DRAIN CAP

Bathtub drain cap is missing or damaged.

Contact a qualified plumbing contractor.
