SUMMARY

1234 Main St.Seymour TN 37865

Buyer Name
04/23/2019 9:00AM

Joel Bruce
Certified Professional...
Bruce Inspections, LLC
865.712.1592
joel@bruceinspections.com

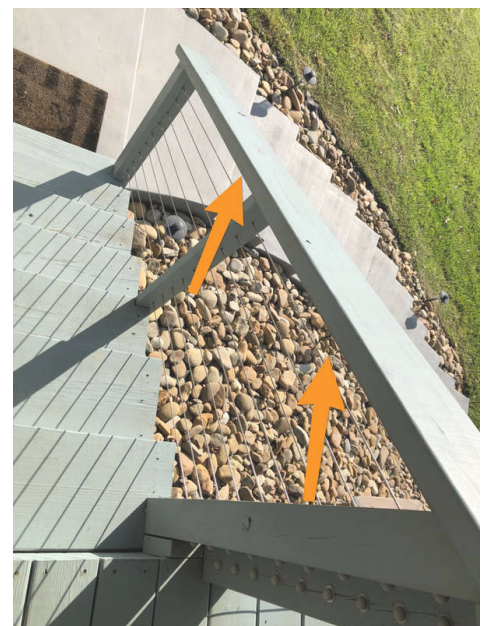
3.5.1 Decks, Balconies, Porches & Steps

HANDRAILS NOT INSTALLED - STEPS

Safety No handrails installed on in places with three or more steps. Recommend correction by installing a graspable handrail system. Similar to what you would see on interior stairs.

Recommendation
Contact a qualified carpenter.

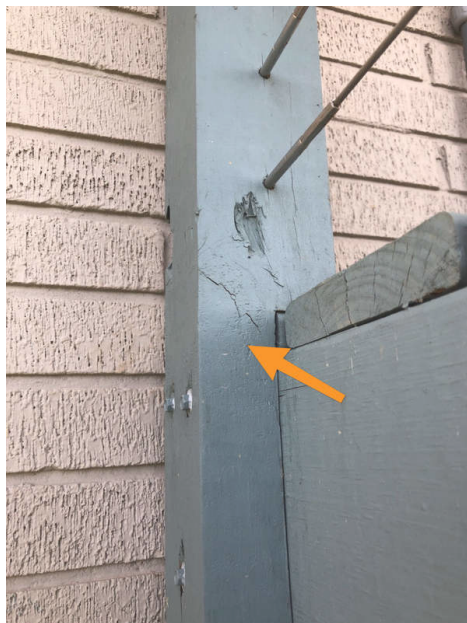
3.5.2 Decks, Balconies, Porches & Steps

BASE DEGRADED

Railing post degraded at the base. Appears to be a crack due to a knot in the wood. The railing post may snap when force is applied. Recommend further evaluation.

Recommendation

Contact a handyman or DIY project

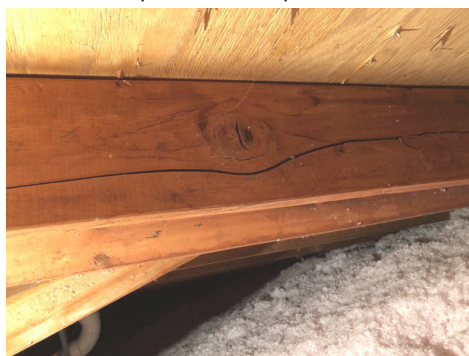
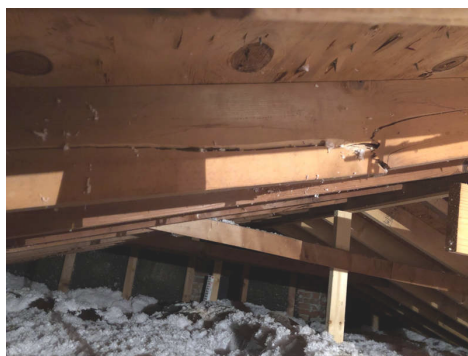
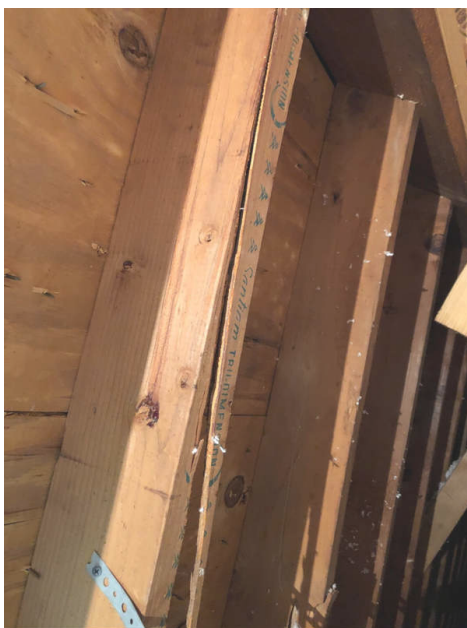
4.6.1 Attic Structure & Sheathing

RAFTER WOOD SPLIT

Rafter wood has split in multiple locations due to high heat and drying. The inspector walked the roof. There did not appear to be any "soft spots". Recommend sistering effected rafters.

Recommendation

Contact a qualified carpenter.

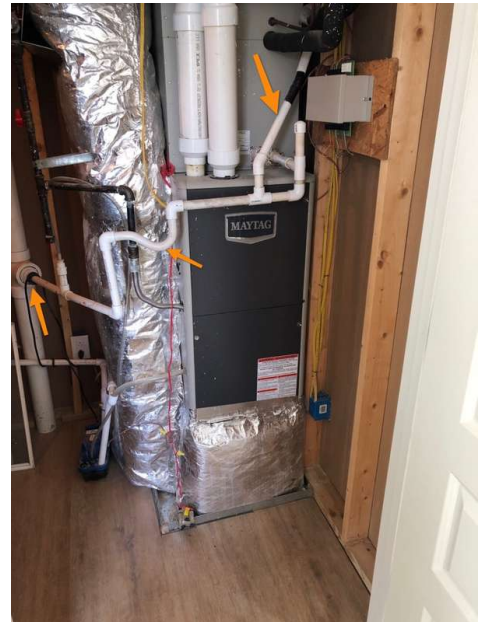
5.2.1 HVAC Heat Pump Equipment

CONDENSATE DRAIN LINE

Condensate drain line ties directly into the waste line. There is a trap on the condensate line. However, a direct connection could allow sewage water to back up into the furnace. Recommend an air gap (post p-trap) between these two lines.

Recommendation

Contact a qualified HVAC professional.

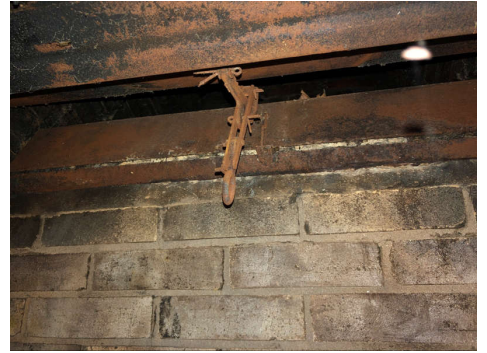
6.4.1 Damper Doors

DAMPER INOPERABLE

Damper was inoperable. Recommend a qualified fireplace contractor repair.

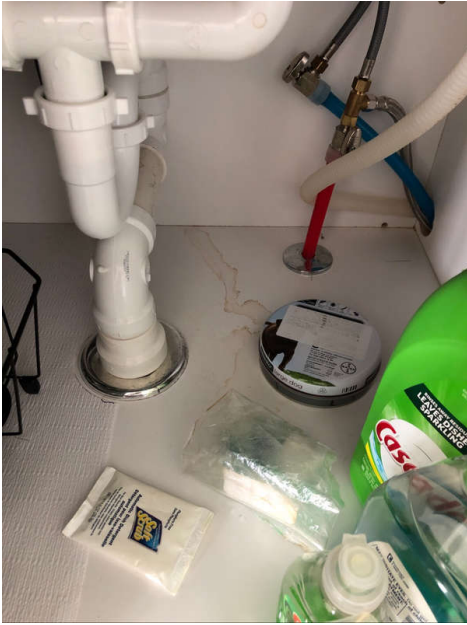
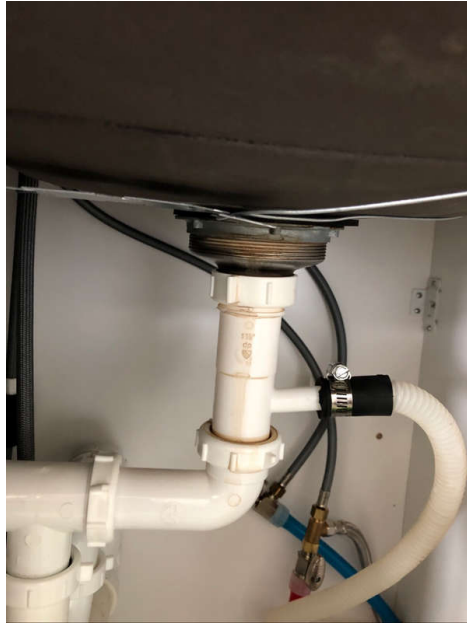
9.5.1 Countertops & Cabinets

BELOW WATER DAMAGE

Water damage was found in shelving or cabinets below the sink. Recommend source of water damage is stopped (if active) and damaged area is corrected as necessary. Could not determine condition of underlying material.

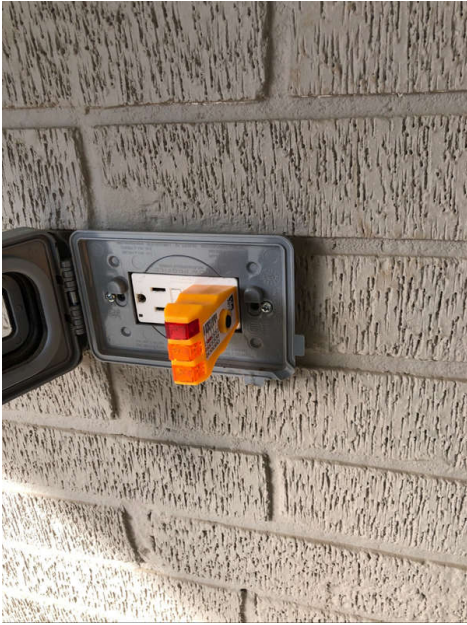
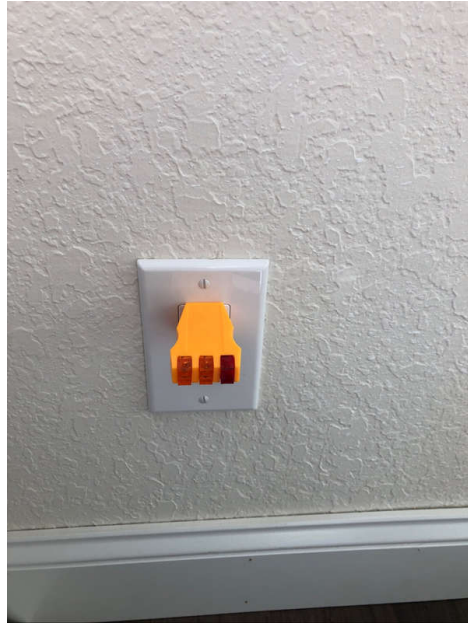
11.5.1 Receptacles (All Accessible)

RECEPTACLE NOT OPERABLE

Receptacles in noted locations did not operate when tested. Recommend qualified electrician evaluate and repair.

Recommendation

Contact a qualified electrical contractor.

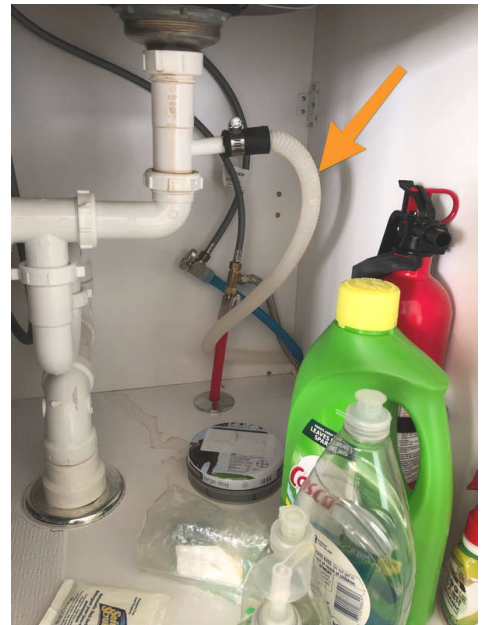
19.2.1 Dishwasher

IMPROPERLY INSTALLED DRAIN PIPE

Dishwasher drain pipe was installed improperly. manufactures recommend a high loop to promote proper drainage.

Recommendation

Contact a qualified plumbing contractor.
