SUMMARY

1234 Main St. Naches WA 98937

Ryan Franke
Lic. No. 809

Integrity Inspection Services LLC
509-961-2863
ryan@inspectwithintegrity.com

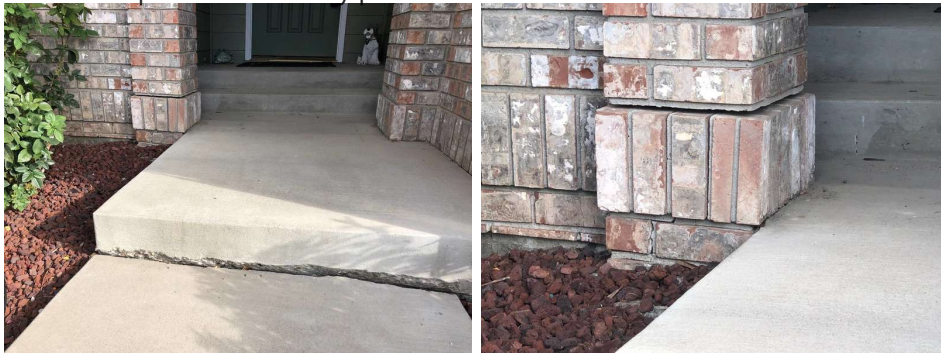
2.2.1 Driveways, Walkways & Patios

WALKWAY SETTLING

FRONT ENTRY

Settling noted at concrete walkway near entry stoop. Settling at walkway appears to be a cosmetic in nature only.

Some loose or damaged bricks noted at entry veneer near walkway. If not repaired/remedied further deterioration may occur.

Contact a qualified masonry professional.

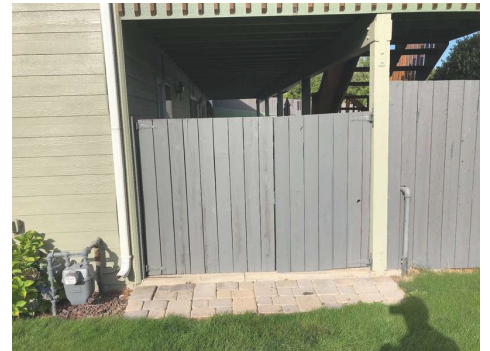
2.3.1 Fencing & Retaining Walls

GATE STICKS/RUBS

Fence Gate sticks/rubs and does not operate smoothly/properly and may be in need of adjustment or repair.

Contact a qualified handyman.

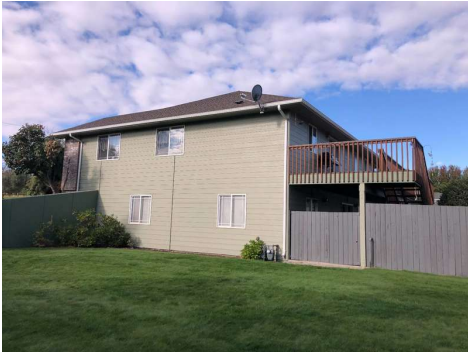
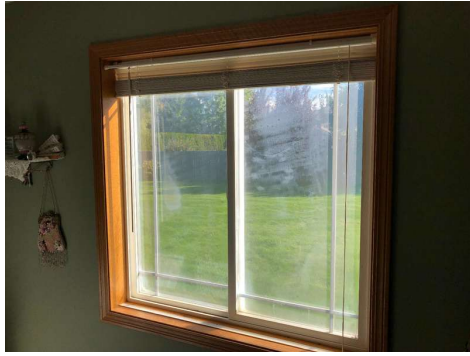
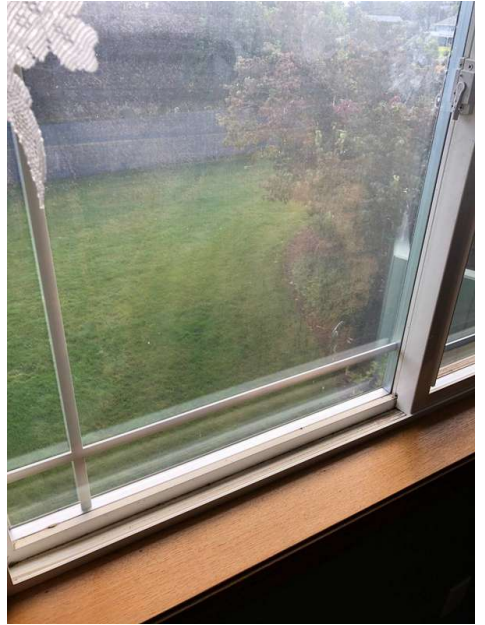
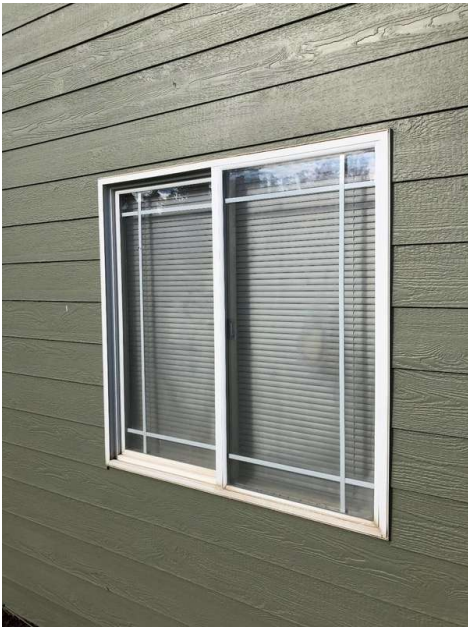
3.2.1 Exterior Doors & Windows

FAILED SEALS

EAST WINDOWS

Condensation or moisture staining noted between window panes may indicate a failed seal reducing visibility and thermal efficiency. Recommend qualified professional further evaluate and repair or replace as needed.

Contact a qualified window repair/installation contractor.

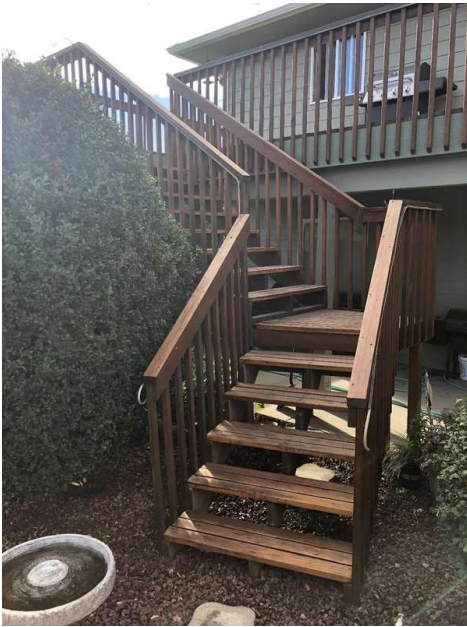
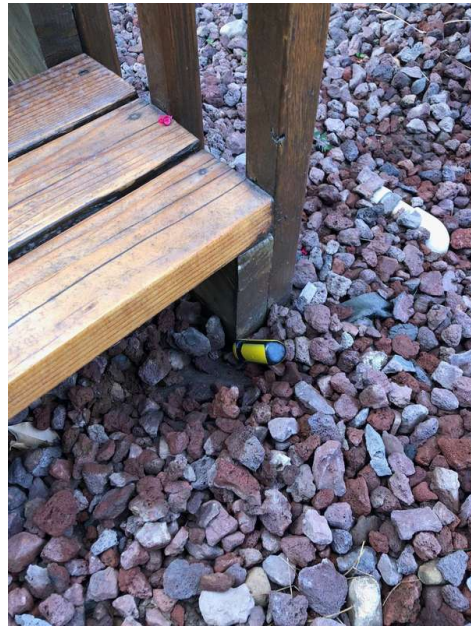
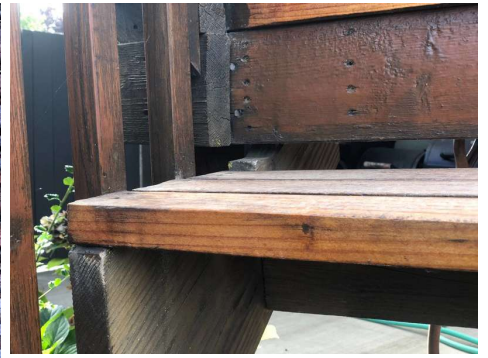
3.3.1 Decks, Porches & Steps

QUESTIONABLE CONSTRUCTION PRACTICES

DECK STAIRS

Lower section of deck stairs were not resting on a permanent footing and structural wood supports were in contact with soil. Deterioration and setting observed. Stairs were pitched and may be unsafe to walk on. Recommend further evaluation by a qualified professional and repair/remedy as needed.

Contact a qualified deck contractor.

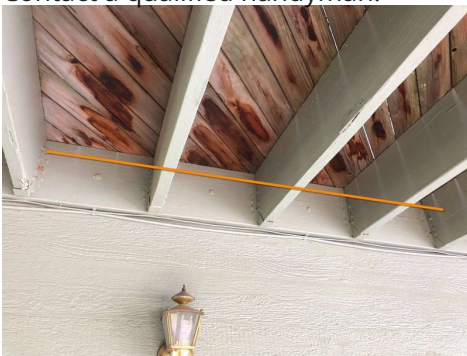
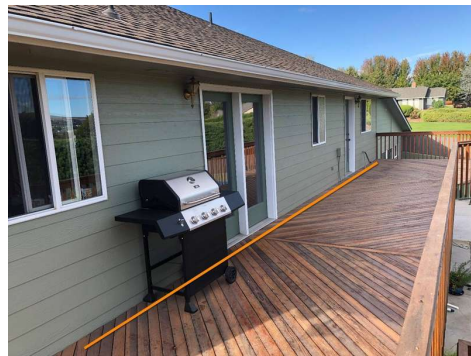
3.3.2 Decks, Porches & Steps

IMPROPER FLASHING

BACK DECK

Z-metal or ledger flashing not installed. Without a proper ledger flashing moisture may become trapped between ledger and home structure allowing for moisture damage and possible compromise. It is recommended that proper flashing be installed.

*No evidence of compromise was observed at time of inspection.

Contact a qualified handyman.

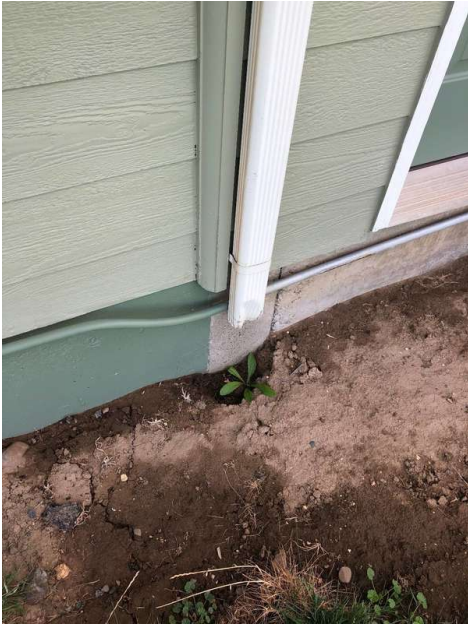
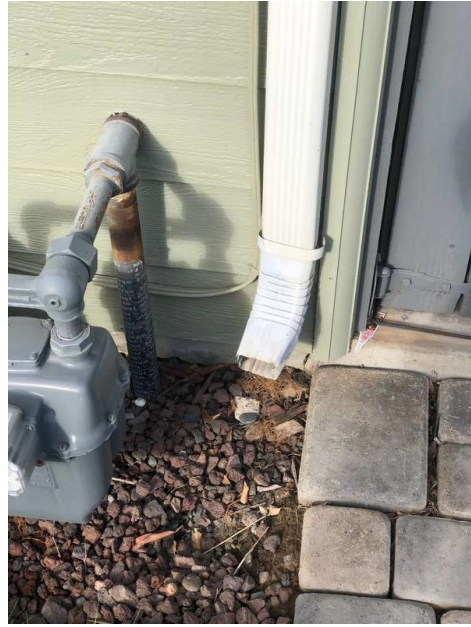
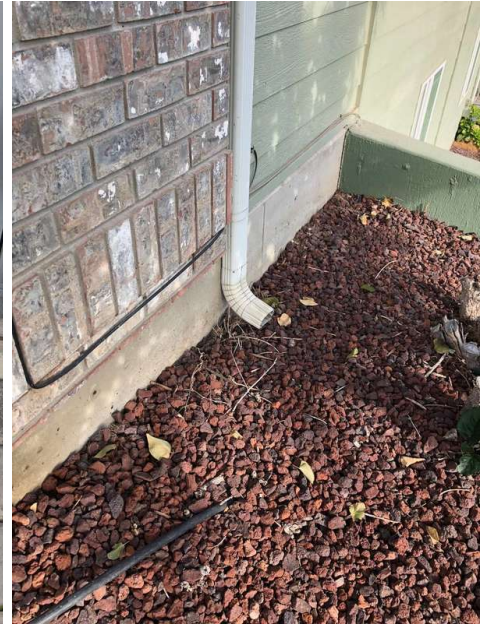
4.2.1 Gutter Systems

DOWNSPOUTS DRAIN NEAR HOUSE

THROUGHOUT EXTERIOR

One or more downspouts drain in close proximity to foundation. Recommend proper downspout extensions to drain a minimum of 4-6 feet from the foundation.

Contact a handyman or DIY project

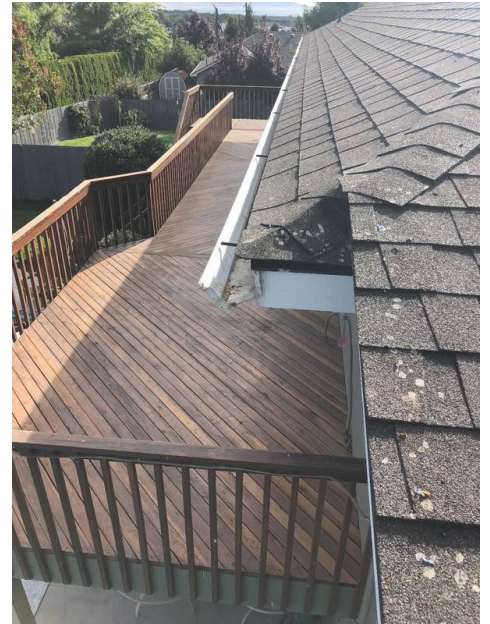
4.2.2 Gutter Systems

MISSING END CAP

BACK

Missing gutter end-cap. Recommend repair or replace as needed.

Contact a qualified handyman.

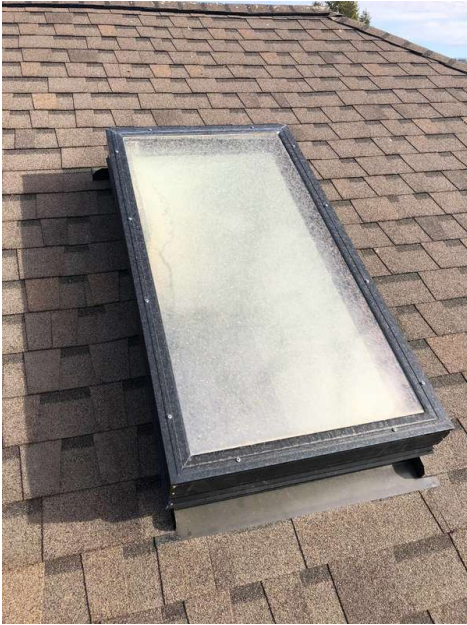
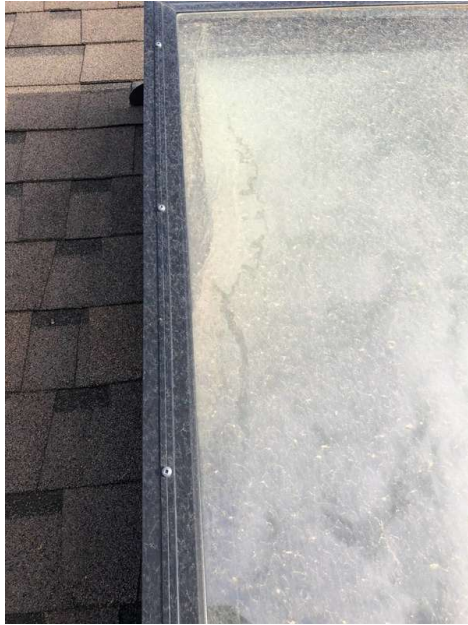
4.6.1 Skylights

FAILED SEAL

Condensation or moisture staining between window panes may indicate a failed seal. Recommend qualified professional further evaluate and repair or replace as needed.

Contact a qualified window repair/installation contractor.

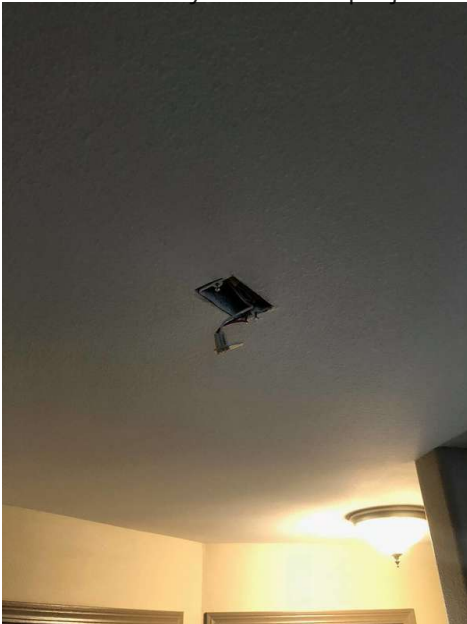
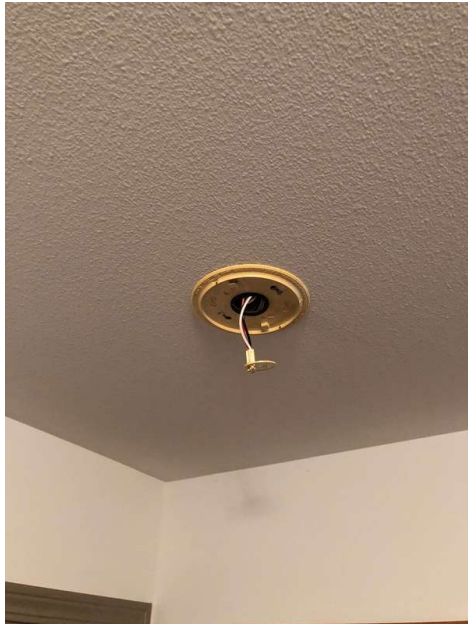
5.1.1 Safety Equipment

SMOKE AND CARBON MONOXIDE DETECTORS

THROUGHOUT INTERIOR

Smoke and Carbon monoxide detectors are required at minimum on each floor and outside all sleeping areas. Installed safety devices should be checked/tested regularly for proper operation. Inspector recommends confirming local safety codes and installing/maintaining any required safety devices as needed. Smoke detectors throughout were missing or not installed.

Contact a handyman or DIY project

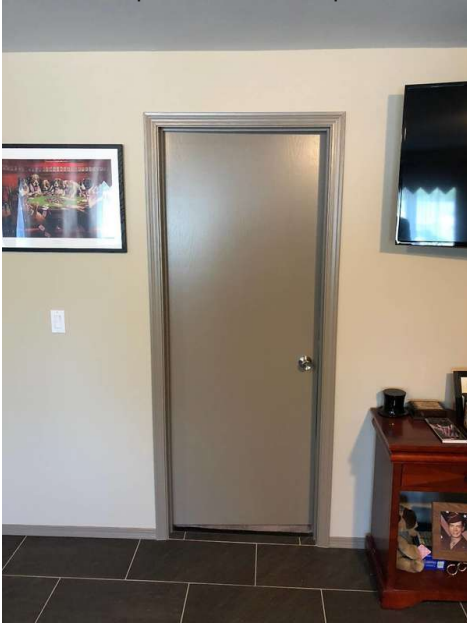
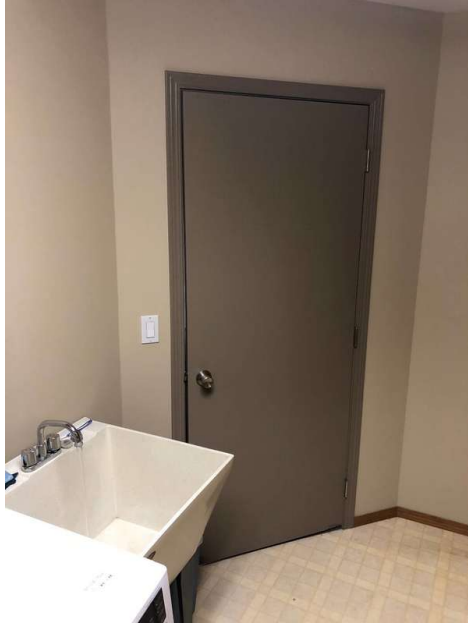
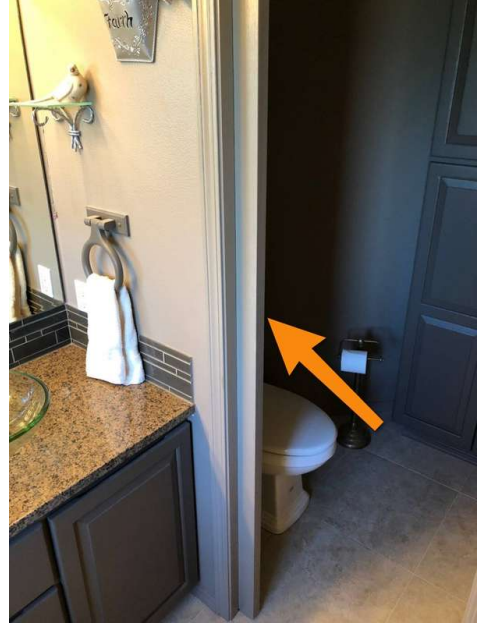
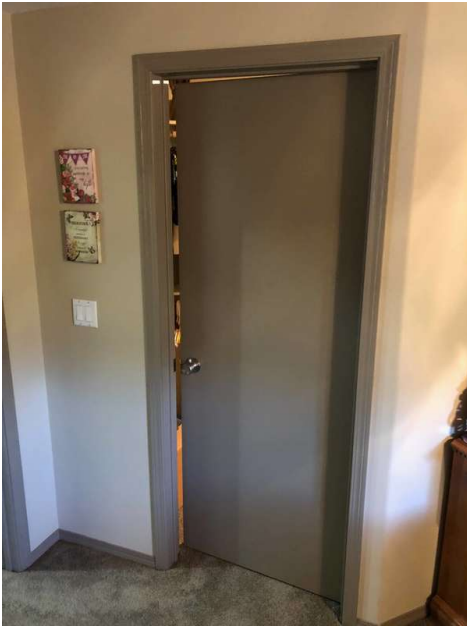
5.6.1 Doors

DOOR IN NEED OF ADJUSTMENT

THROUGHOUT INTERIOR

One or more interior doors and/or closet doors sticks/rub or do not latch smoothly/properly and may be in need of adjustment or repair.

*Master bathroom door was missing some hardware and may be difficult to operate.

Contact a qualified door repair/installation contractor.

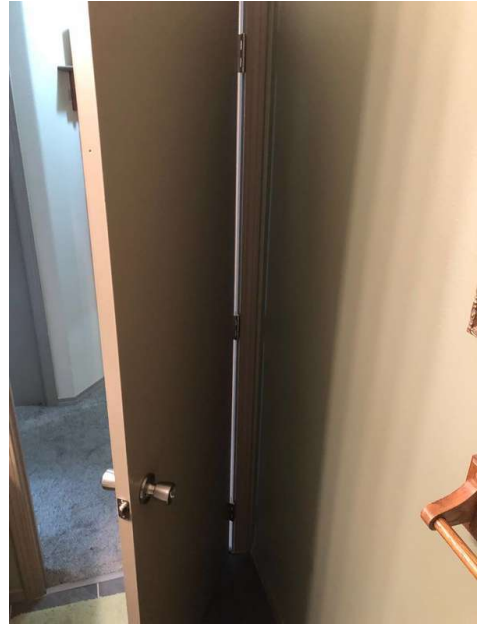
5.6.2 Doors

DOOR STOPS MISSING

THROUGHOUT INTERIOR

One or more interior door stops were missing or not installed at time of inspection. Door stops protect interior walls and door hardware from potential damage.

Contact a handyman or DIY project

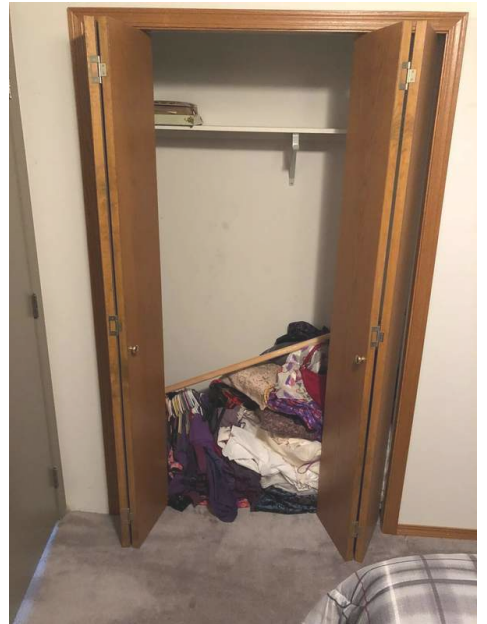
5.12.1 Bedrooms

DAMAGED CLOSET ROD

BASEMENT BEDROOM

Closet rod was fallen/compromised and in need of repair.

Contact a qualified handyman.

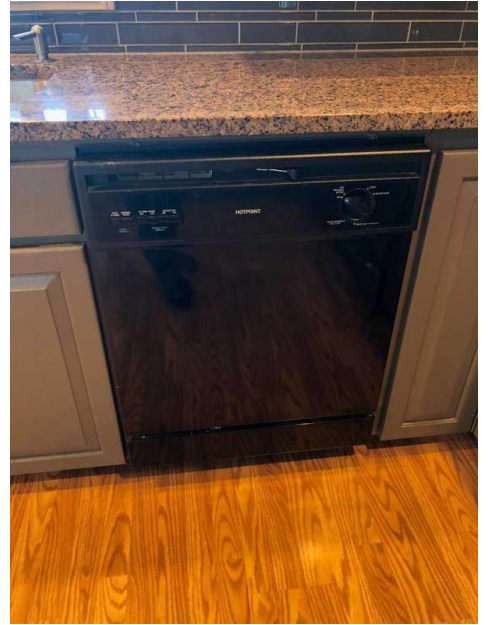
6.3.1 Dishwasher

NOISY

Dishwasher was noisy when operating and may be in need of service or repair. Recommend a qualified professional further evaluate and repair as needed.

Contact a qualified appliance repair professional.

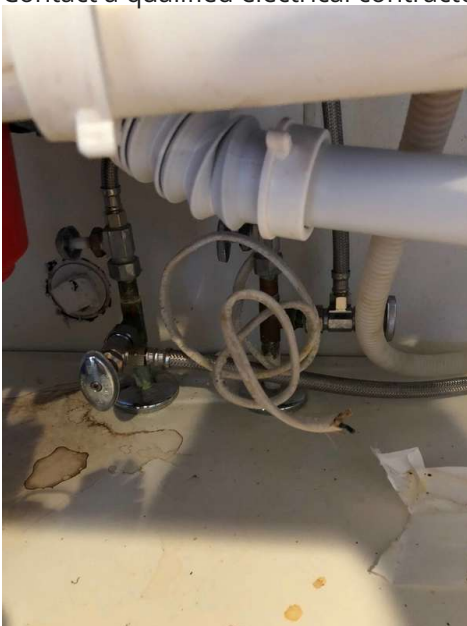
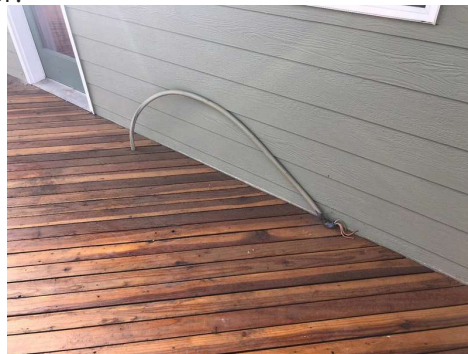
8.3.1 Branch Circuit Conductors
EXPOSED ENDS & SPLICES
KITCHEN, BACK DECK

Wire splices/connections and terminations must be secured/protected in an approved junction box. Potential safety hazard. Recommend a qualified professional repair as needed.

Recommendation
Contact a qualified electrical contractor.

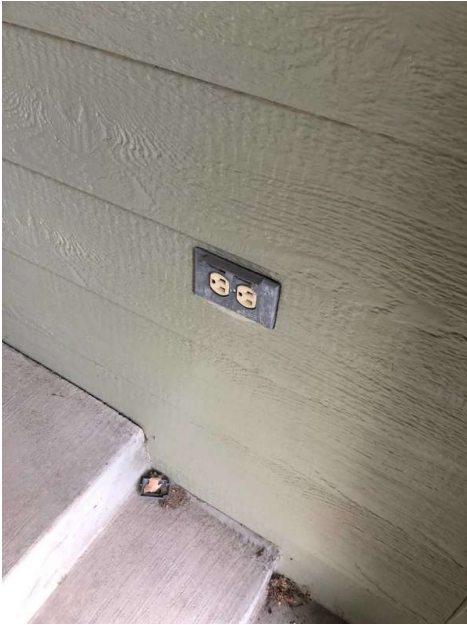
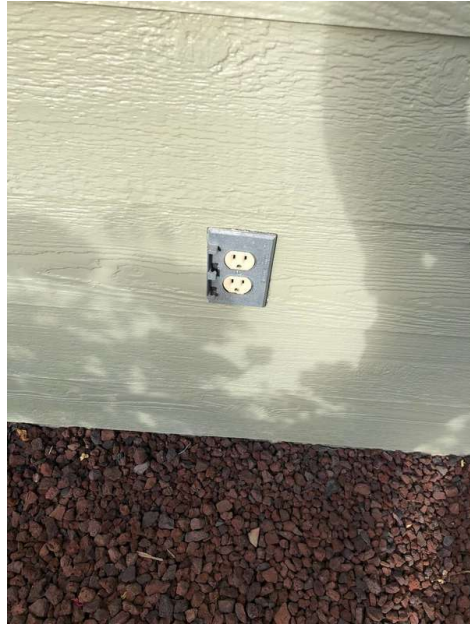
8.4.1 Connected Devices & Fixtures
EXTERIOR WEATHER COVERS DAMAGED OR MISSING
THROUGHOUT EXTERIOR

Some exterior switches or outlets did not have proper exterior weather covers. Recommend repair or replace as needed.

Recommendation
Contact a qualified handyman.

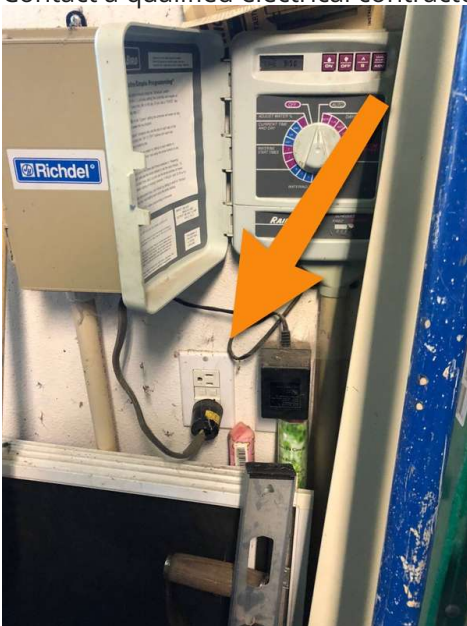
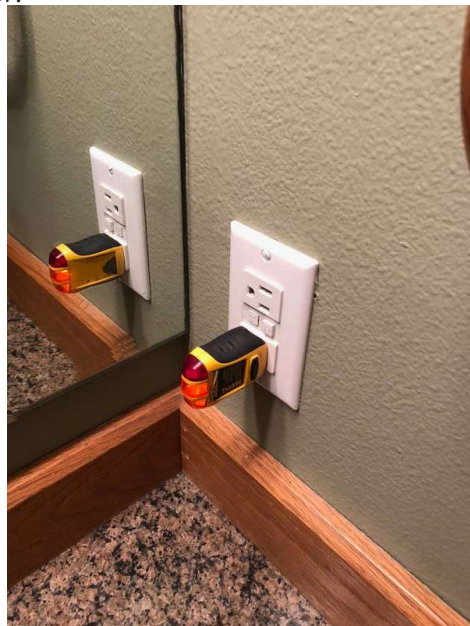
8.6.1 GFCI & AFCI
NOT OPERATING

GARAGE, HALL BATHROOM

Some GFCI outlets were not operating properly at time of inspection and may be in need of replacement. Recommend further evaluation by a qualified professional and repair or replace as needed.

Recommendation
Contact a qualified electrical contractor.

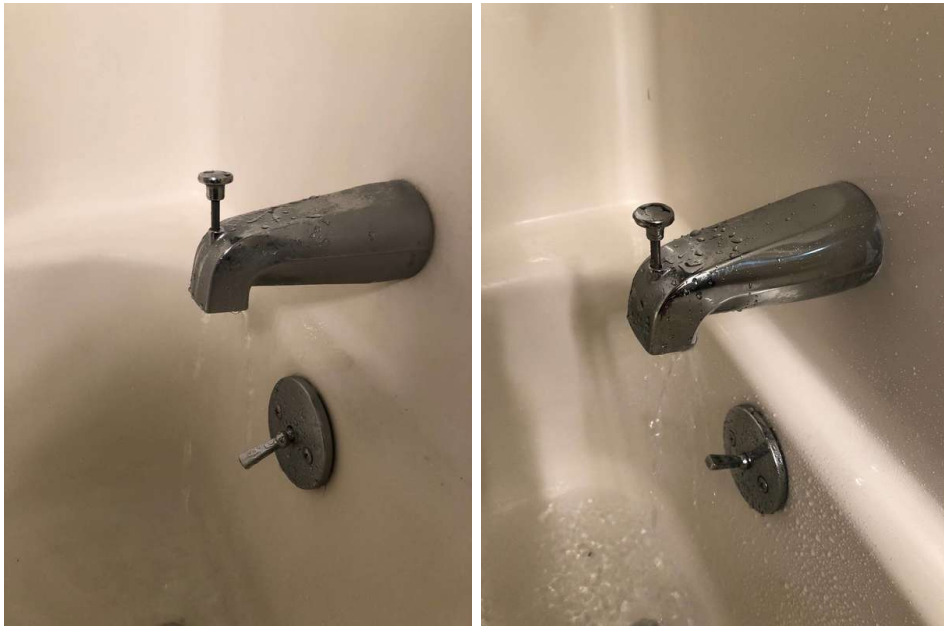
9.2.1 Fixtures & Faucets
SHOWER DIVERTER NOT OPERATING PROPERLY

BASEMENT BATHROOM, HALL BATHROOM

Shower diverter valve was not diverting water flow to shower head properly or completely. Recommend repair.

Recommendation
Contact a qualified plumbing contractor.

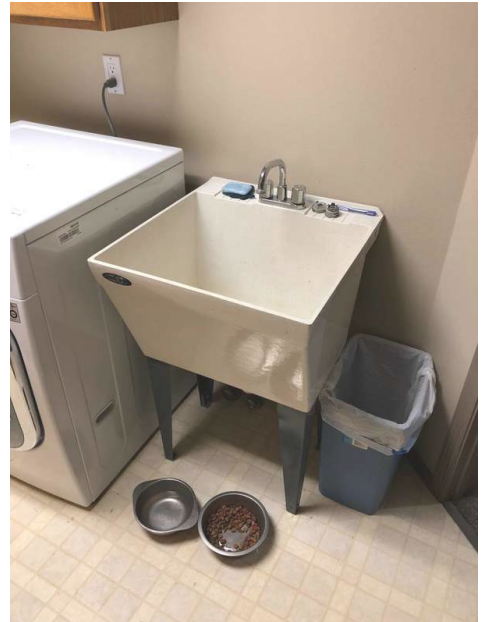
9.2.2 Fixtures & Faucets

SINK NOT SECURE

LAUNDRY ROOM

Sink not secured. Condition conducive to stress at plumbing fittings and possible leaks. Recommend securing/fastening sink to wall.

Contact a qualified handyman.

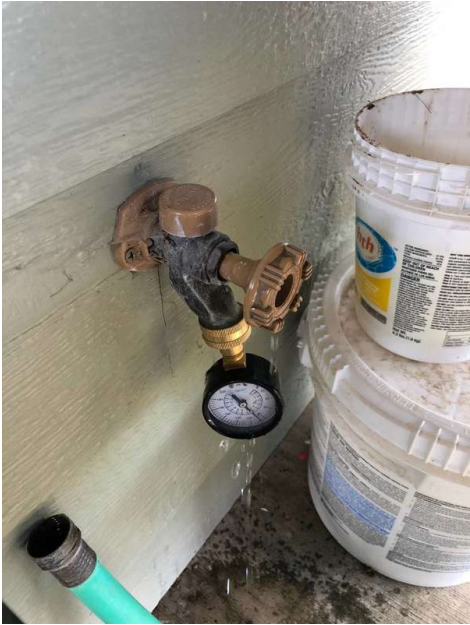
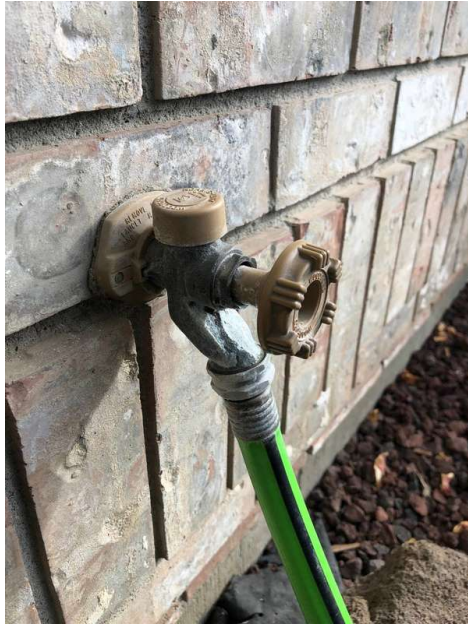
9.2.3 Fixtures & Faucets

SPIGOT LEAKING

FRONT, BACK EXTERIOR

Leak noted at exterior garden spigot/s. Recommend repair or replace as needed.

Contact a qualified handyman.

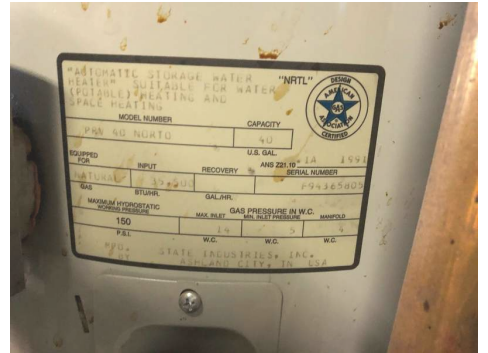
10.1.1 Equipment

DEFERRED COST ITEM

Hot Water Tank appears to be 12 years old or more and may be within 5 years of its estimated useful life. This comment is based off an estimated useful life of 12-15 years. Recommend Monitor. Anticipate maintenance and/or future replacement.

Recommendation
Recommend monitoring.

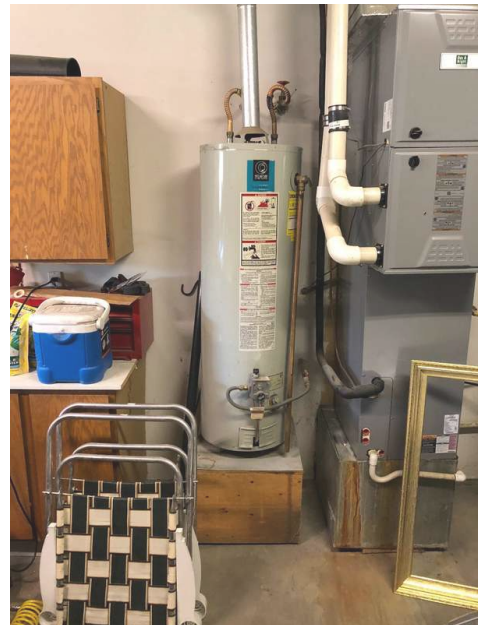
10.3.1 Safety Features

SEISMIC STRAPPING NOT INSTALLED OR IMPROPER

Modern safety standards requires seismic strapping at top and bottom thirds of installed Hot Water Tanks. See this helpful [link](#) for approved strapping and anchoring techniques. Recommend repair.

Recommendation
Contact a qualified appliance repair professional.

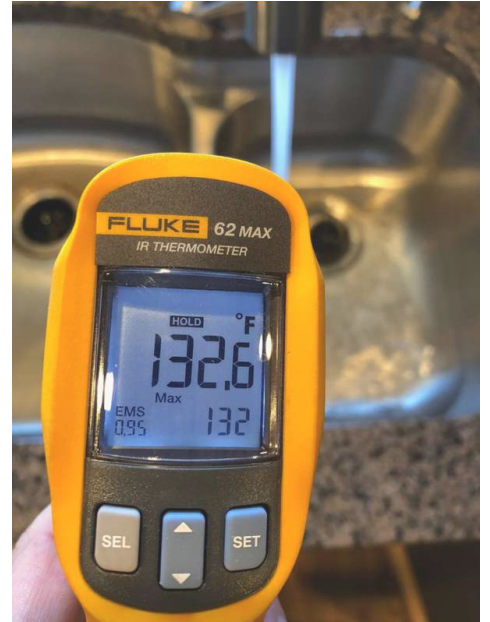
10.3.2 Safety Features

WATER TEMPERATURE HIGH

Water temperature was measured above maximum recommended safe water temperature (120F) and may have the potential for scalding. Recommend adjusting water temperature to no more than 120F to prevent potential scaling.

Contact a qualified appliance repair professional.

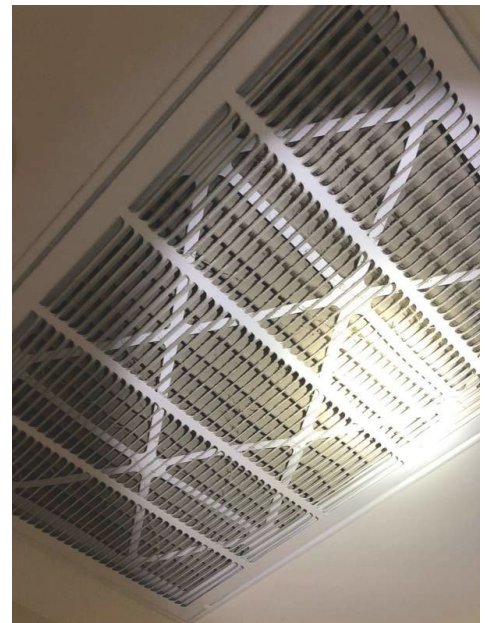
11.1.1 Heating Equipment

FILTER REQUIRES REPLACEMENT

HALL

The furnace filter appears to be beyond its expected lifespan. A dirty Furnace Filter may cause excessive wear and undue maintenance to HVAC system. Recommend replacement.

Contact a handyman or DIY project

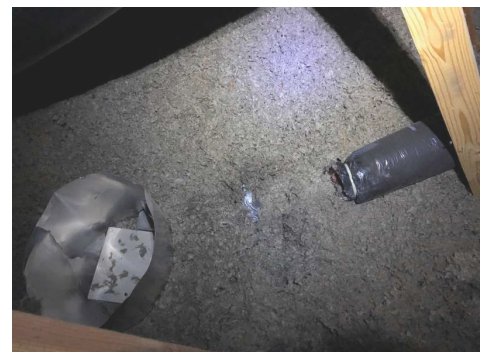
14.2.1 Exhaust Systems

EXHAUST VENT DISCONNECTED

Exhaust vent connection/s is disconnected and/or compromised and not properly terminating to exterior. Recommend reattaching with a more permanent method.

Contact a qualified HVAC professional.

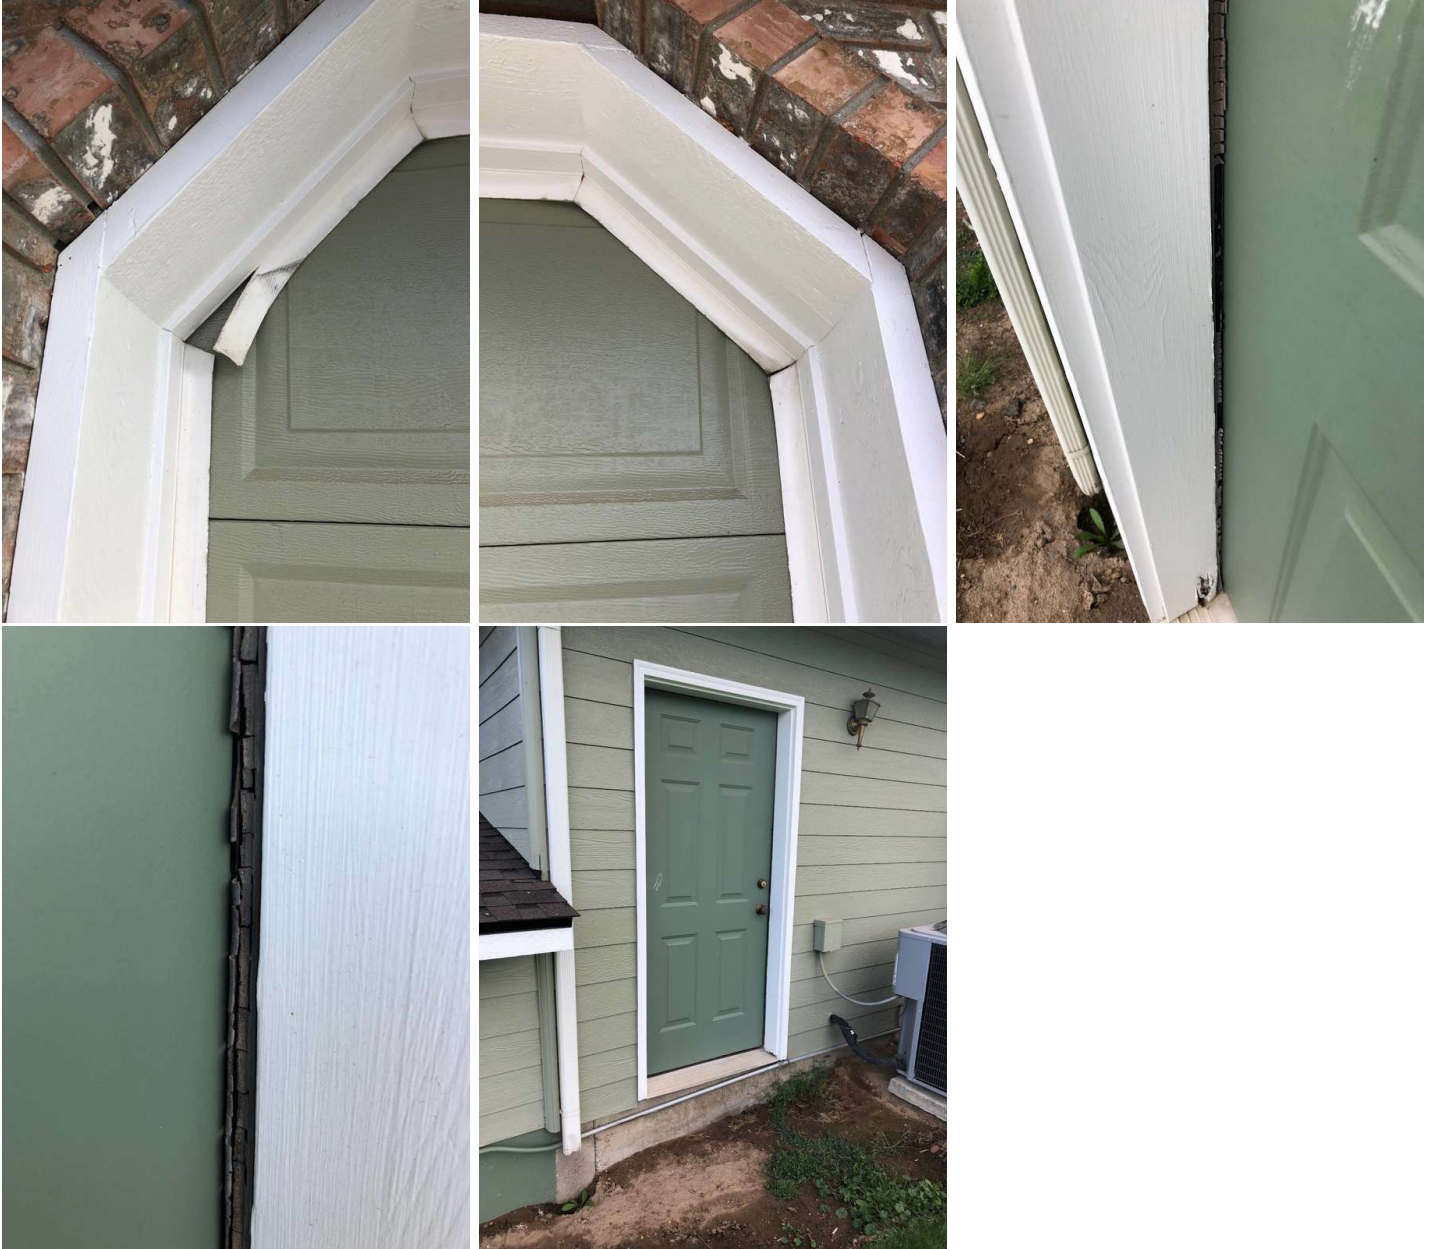
15.3.1 Garage Door

WEATHER SEAL DAMAGED

Damaged or deteriorated exterior seal may not provide adequate protection from weather.

*Also, garage entry door.

**No step/stoop installed at garage entry door. Possible fall/trip hazard. recommend installing a proper step or stoop.

Recommendation
Contact a qualified handyman.

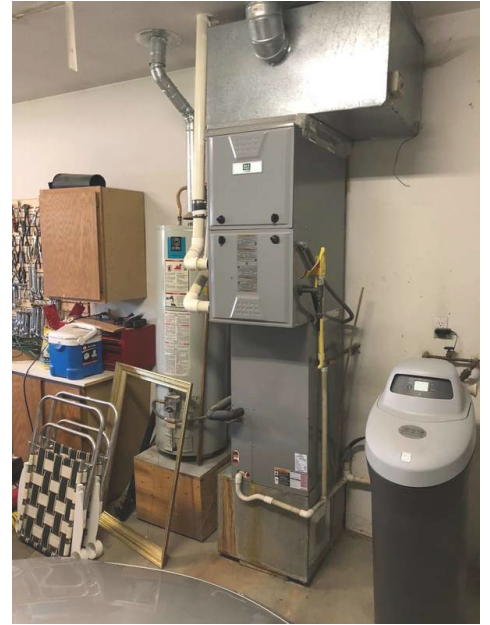
15.5.1 Safety Features

BULKHEAD

GARAGE

A bulkhead/barrier should be present/installed when gas appliances are located inline with the drive-path (back wall) of garage. In case of emergency the bulkhead is designed to protect gas appliances from impact and a potential safety hazard. Recommend qualified professional further evaluate and repair or replace as needed.

Recommendation
Contact a qualified general contractor.

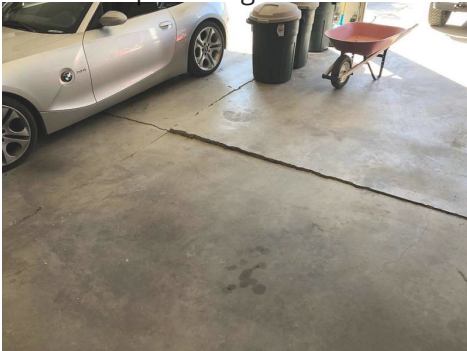
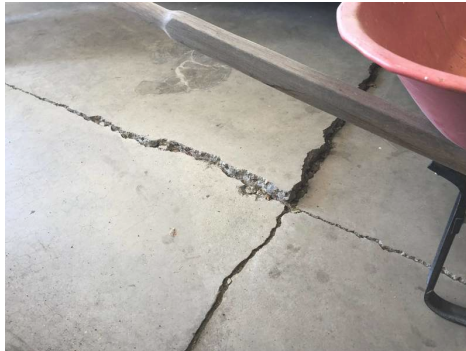
15.6.1 Interior

SIGNIFICANT CRACKING

Significant cracking observed at garage floor. Settling and heaving may simply be indication or poor initial compaction or evidence of significant ongoing compromise. Inspector recommends further inquiry as to recent activity and further evaluation by a qualified professional. Monitoring cracks over time is recommended.

Recommendation
Contact a qualified general contractor.
