## SUMMARY

1234 Main St. Groveport OH 43125

Todd Kirk  
TKO Home Inspections  
614-569-1110  
todd@tkohomeinspections.com

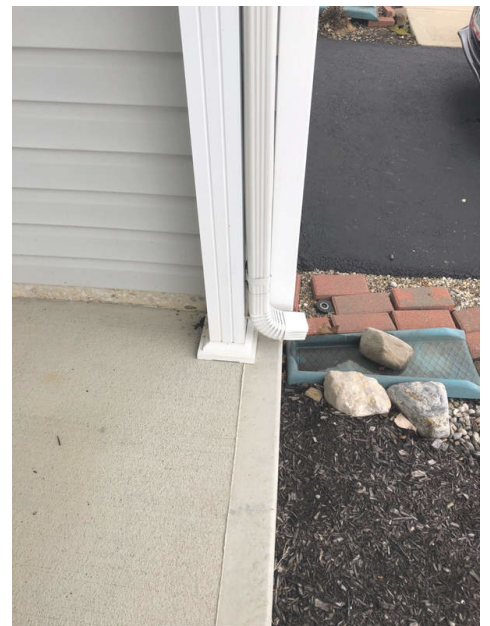
### 2.2.1 Roof Drainage Systems

#### **DOWNSPOUTS DRAIN NEAR HOUSE**

FRONT OF HOME

One or more downspouts drain too close to the home's foundation. This can result in excessive moisture in the soil at the foundation, which can lead to foundation/structural movement. Recommend a qualified contractor adjust downspout extensions to drain at least 4-6 feet from the foundation.

Recommendation  
Contact a handyman or DIY project

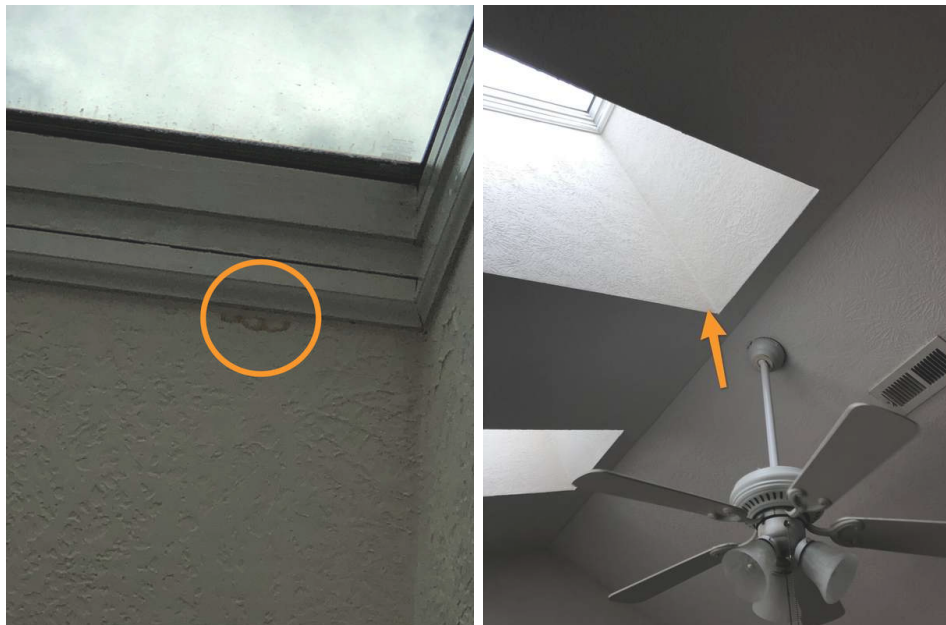
### 2.4.1 Skylights, Chimneys & Other Roof Penetrations

#### **SKYLIGHT WATER PENETRATION**

MASTER BEDROOM

There are signs of possible water penetration at or near the skylight. Skylights, if not properly installed, are prone to leaking. Monitor the condition and if there are signs of leaking then have the skylight repaired or replaced. Please ask seller for full disclosure regarding this issue.

Proper flashing around the skylight is critical.

Recommendation  
Contact a qualified roofing professional.

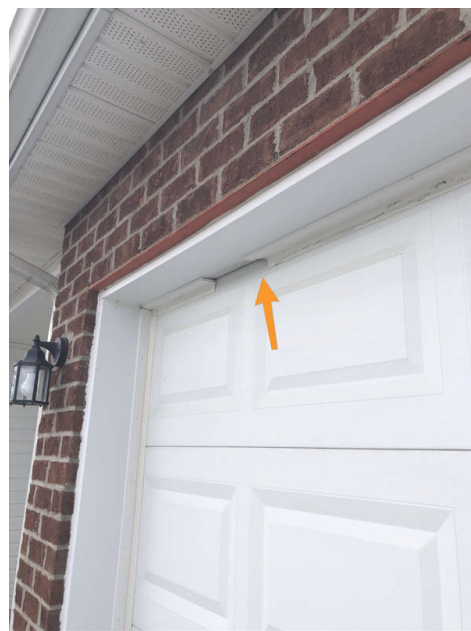
3.1.1 Siding, Flashing & Trim  
**TRIM - MINOR DAMAGE**

GARAGE

Trim is broken and needs repaired or replaced.

Recommendation  
Contact a qualified handyman.

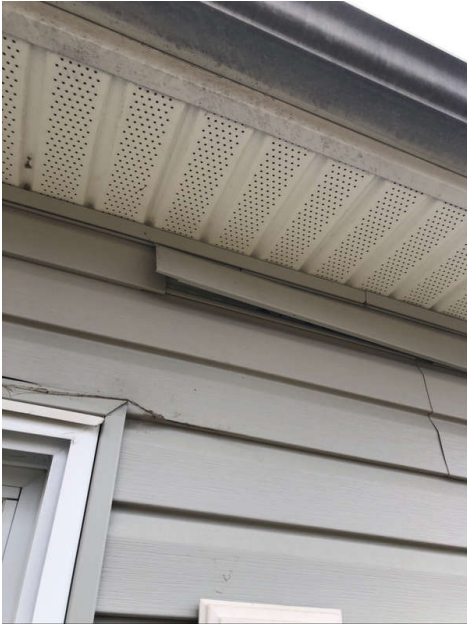
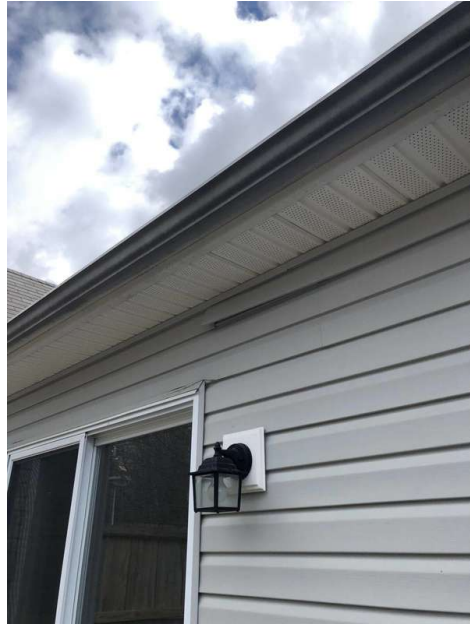
3.1.2 Siding, Flashing & Trim  
**SIDING -LOOSE**

REAR OF HOME

Recommendation  
Contact a qualified siding specialist.

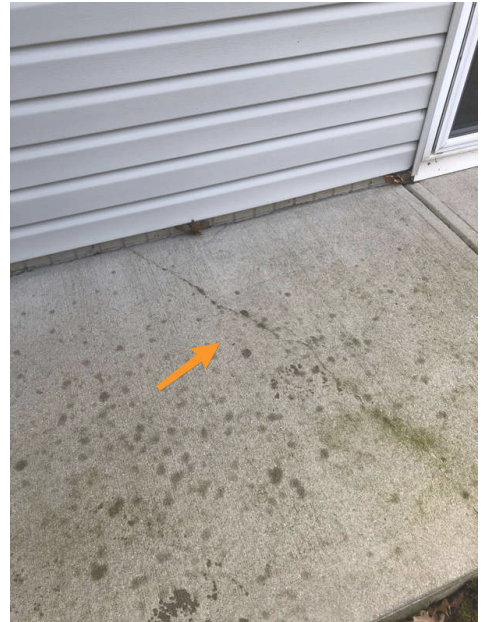
### 3.5.1 Patios

#### **PATIO CRACKING - MINOR**

REAR OF HOME

Normal settling & cracking observed. Recommend monitor and/or patch/seal.

Recommended DIY Project

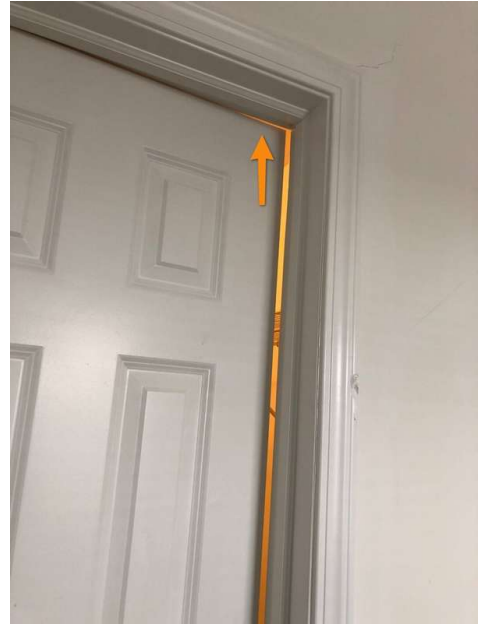
### 4.3.1 Doors

#### **DOORWAY OUT OF SQUARE**

SOUTHWEST BEDROOM CLOSET

Doorway was visibly out of square and door did not close. This condition indicates settling. To determine the cause and the likelihood that settling will continue, the Inspector recommends that before the expiration of your Inspection Objection Deadline you consult with a structural engineer.

Contact a qualified structural engineer.

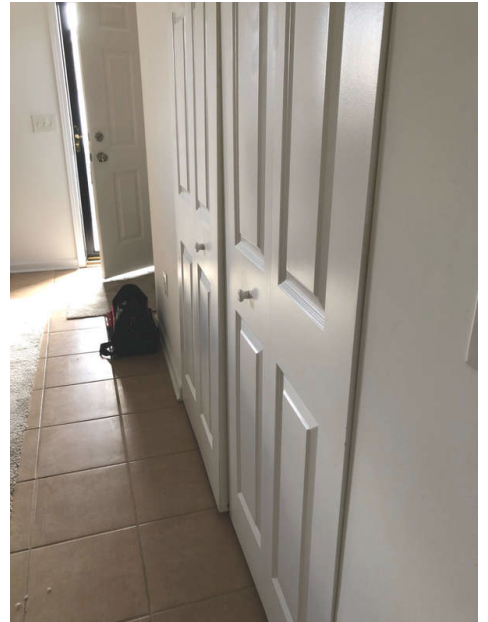
#### 4.3.2 Doors

### **LAUNDRY DOOR - DOOR DOES NOT CLOSE PROPERLY**

KITCHEN

Hardware needs an adjustment. This is a handyman/DIY repair.

Contact a handyman or DIY project

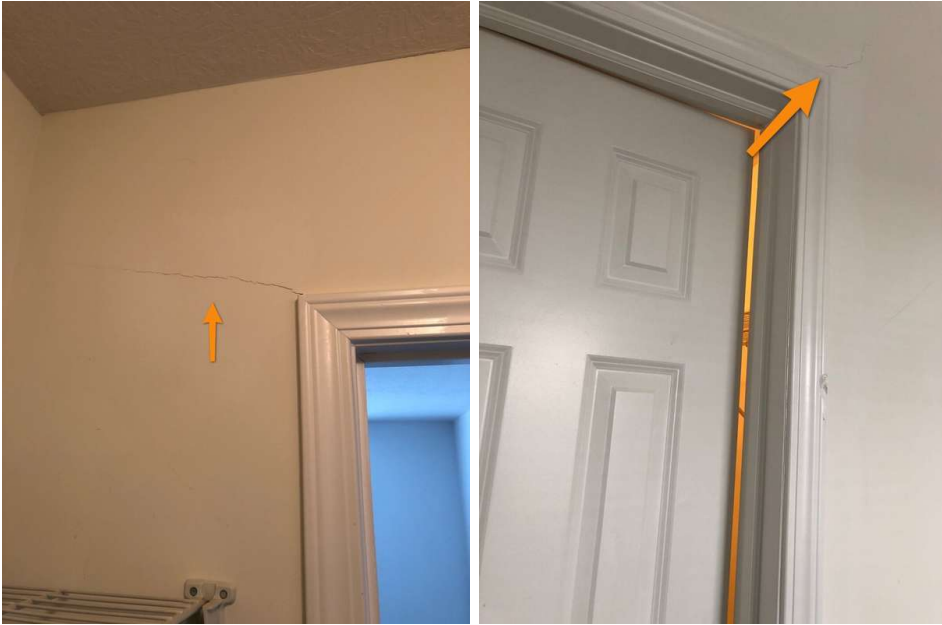
#### 4.6.1 Walls

### **DIAGONAL CORNER CRACKS**

SOUTHWEST BEDROOM

Diagonal cracks that extend out from the corner of a window or doorway may be a sign of periodic movement or even a structural issue. Headers over doors and windows carry considerable loads and when they aren't supported adequately, one side of the header drops and surfaces crack.

Contact a qualified structural engineer.

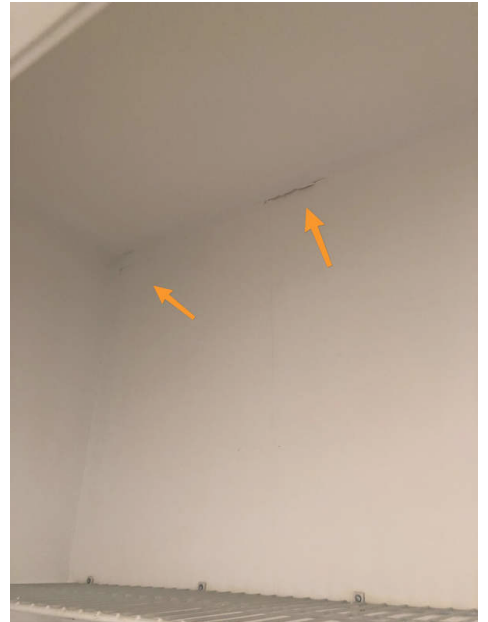
#### 4.6.2 Walls

### **MINOR DAMAGE AND DETERIORATION- GENERAL**

#### MASTER BEDROOM CLOSET

Interior walls in the home exhibited general minor damage or deterioration at the time of the inspection.

Contact a qualified drywall contractor.

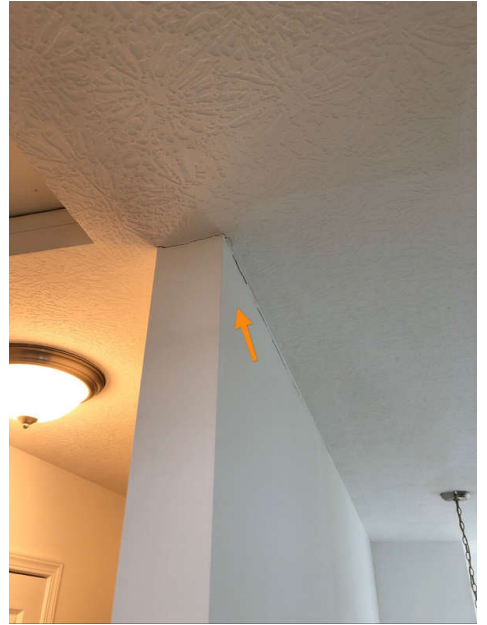
#### 4.7.1 Ceilings

### **MINOR DAMAGE**

#### UPSTAIRS HALLWAY

Minor general damage to the ceilings was visible at the time of the inspection.

Contact a qualified drywall contractor.

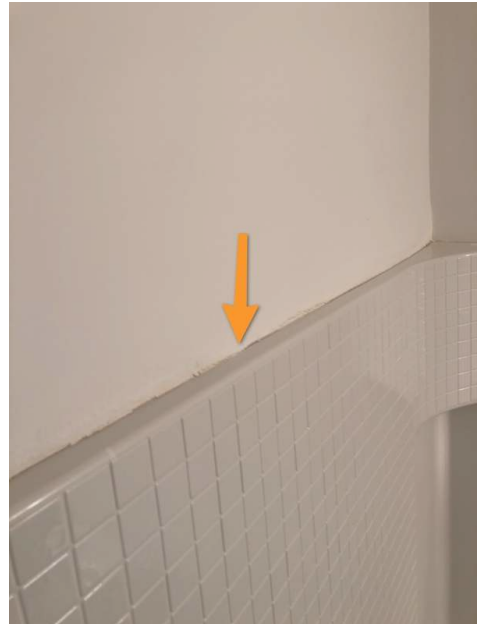
#### 4.11.1 Tiled Areas- Kitchen, Bath & Laundry

### **SHOWER WALL - NEEDS CAULK**

#### BATHROOM

Maintaining this seal is critical to keeping the framing and the subfloor beneath dry.

Contact a handyman or DIY project

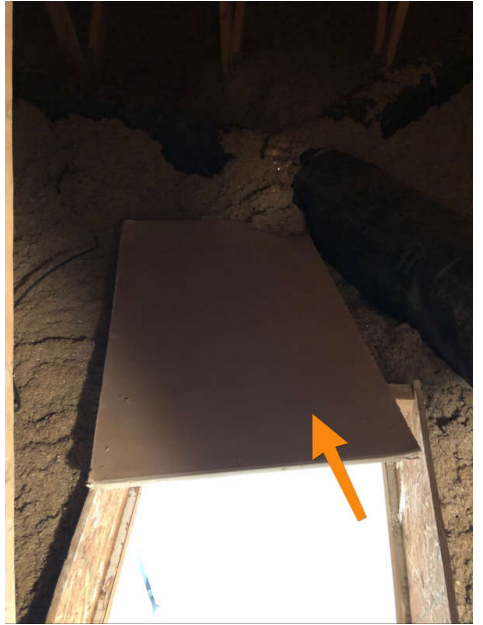
#### 6.1.1 Attic Insulation

### **ATTIC ACCESS HATCH NOT INSULATED**

The attic access hatch cover was not insulated. The Inspector recommends insulating the attic access hatch cover to reduce unwanted heat loss/gain.

Contact a handyman or DIY project

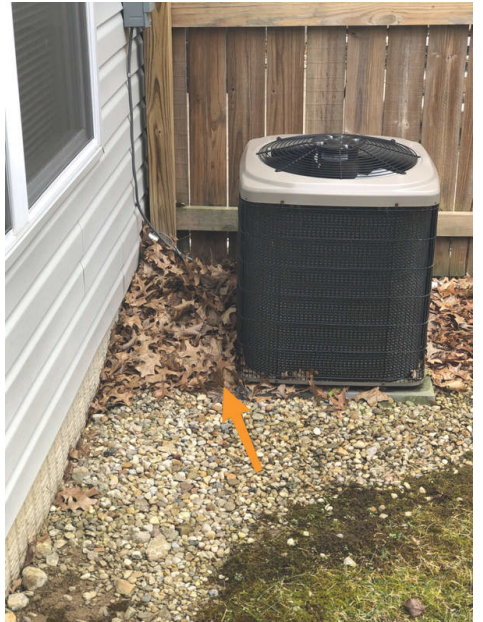
8.1.1 Cooling Equipment  
**AIR FLOW RESTRICTED**

REAR OF HOME

Air flow to the air conditioner condenser was restricted. This may result in inefficient operation. Recommend cleaning dirt and/or debris from unit.

Contact a qualified HVAC professional.

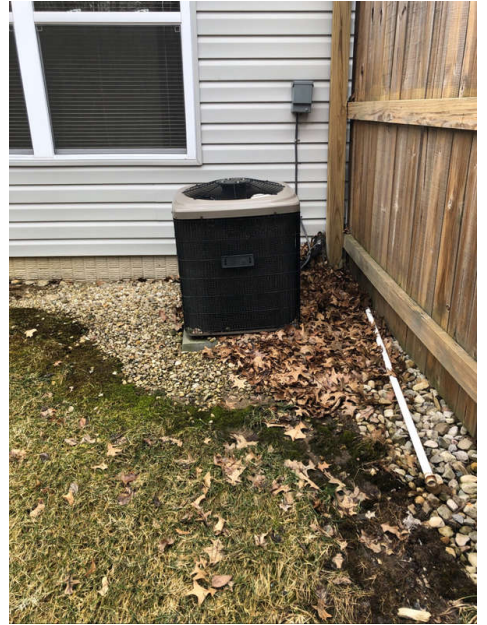
8.1.2 Cooling Equipment  
**UNIT NOT LEVEL**

REAR OF HOME

Pad supporting the outdoor condensing unit is not level. This can cause accelerated deterioration of components. Recommend licensed HVAC contractor level the unit.

Contact a qualified HVAC professional.

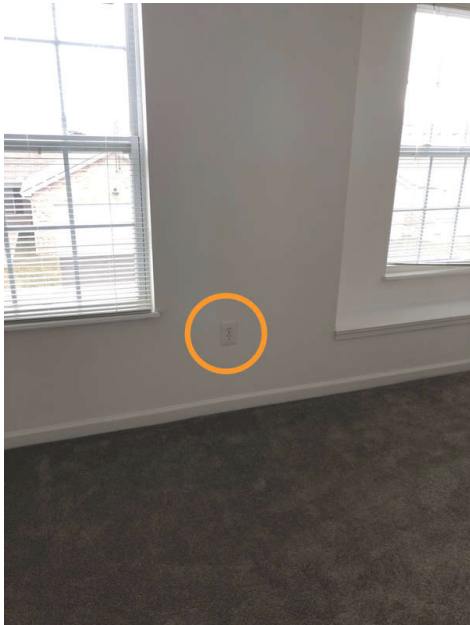
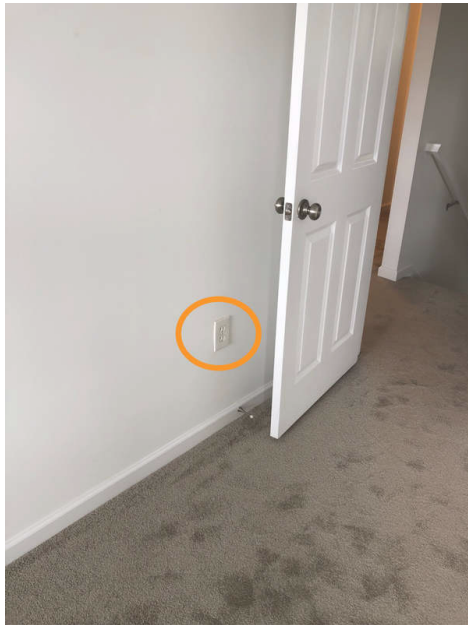
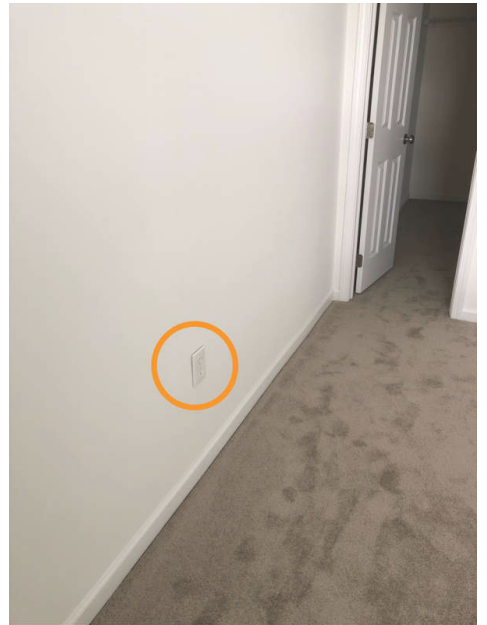
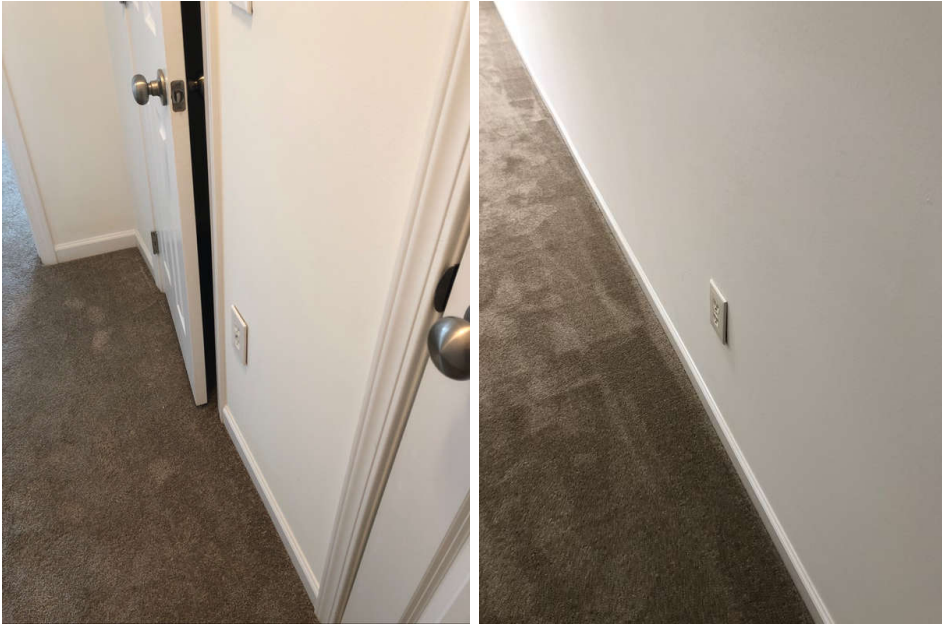
#### 9.4.1 Lighting Fixtures, Switches & Receptacles

### LOOSE RECEPTACLE

SOUTHEAST BEDROOM, SOUTHWEST BEDROOM, UPSTAIRS HALLWAY, DINING ROOM

An electrical receptacle(s) was improperly secured and moved when a plug was inserted. Receptacles should be securely installed to prevent fire, shock and/or electrocution hazard. The Inspector recommends correction by a qualified electrical contractor.

Contact a qualified electrical contractor.

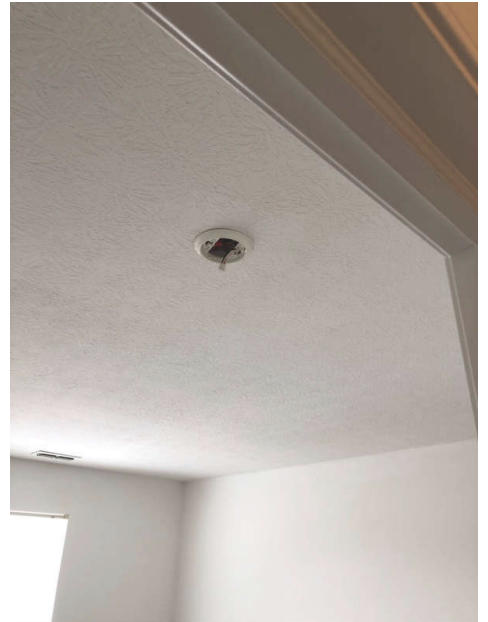
#### 9.6.1 Smoke Detectors

### **SMOKE DETECTOR - MISSING**

SOUTHWEST BEDROOM

Contact a handyman or DIY project

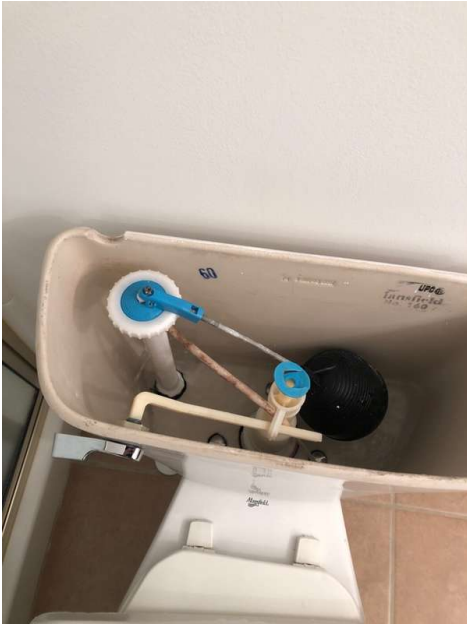
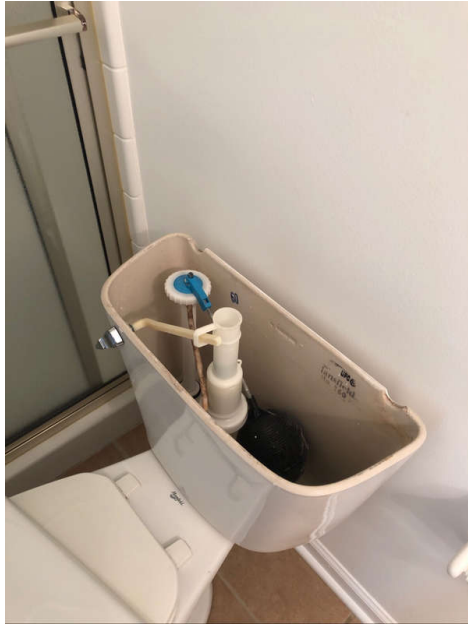
#### 10.2.1 Water Supply, Distribution Systems & Fixtures

### **TOILET - FLUSH VALVE**

MASTER BATHROOM

Flush valve does not function properly. Recommend repair by a qualified plumber.

Also, the water was turned off at this toilet. This might be something to ask the seller about before the contract deadline.

Contact a qualified plumbing contractor.

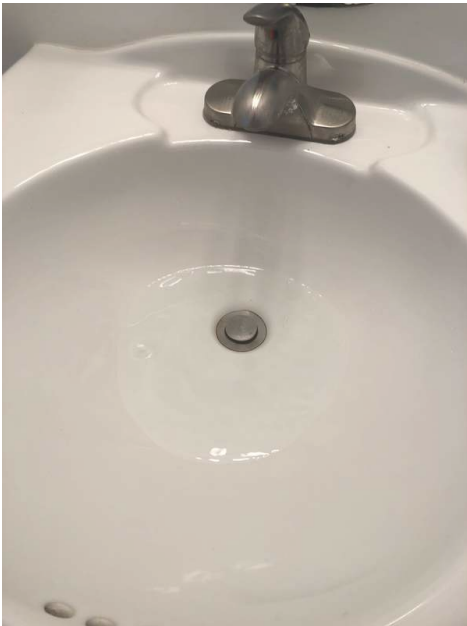
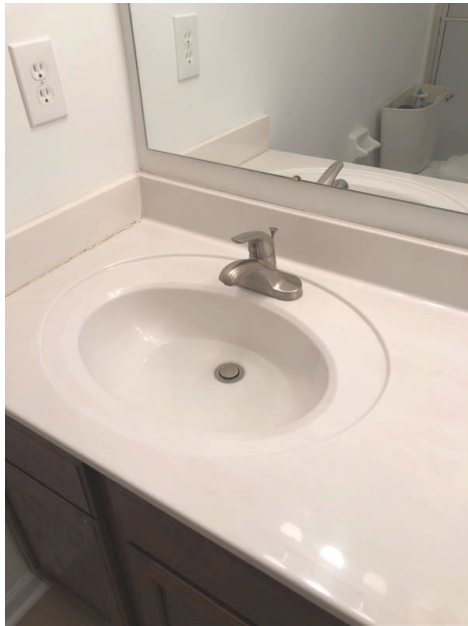
10.3.1 Sewage & Drain, Waste, & Vent (DWV) Systems

**SINK - POOR DRAINAGE**

MASTER BATHROOM

Sink had slow/poor drainage. Potentially a Handyman repair.

Contact a qualified handyman.

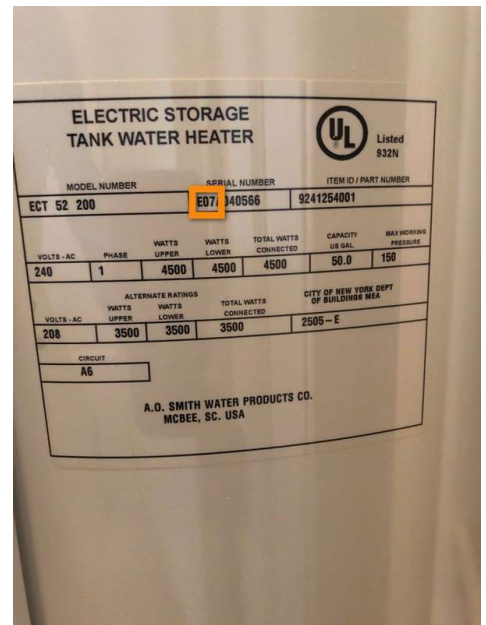
10.4.1 Hot Water Systems, Controls, Flues & Vents

**HOT WATER HEATER - AGED**

Hot water heater is 12 years old. Manufacture year is 2007. The life expectancy of a water heater is about 8 to 12 years.

Recommend monitoring.

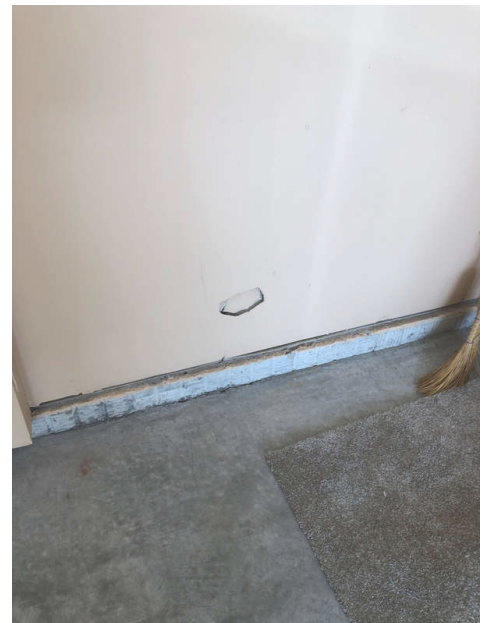
### 12.3.1 Walls & Firewalls

## DAMAGED DRYWALL

### GARAGE

Garage wall had damaged drywall. Recommend drywall contractor repair.

Contact a qualified drywall contractor.
