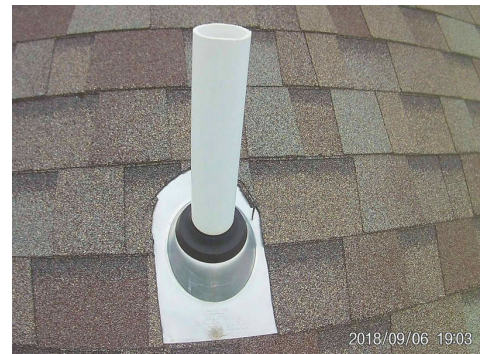
2.3.1 Flashing/Vents

PLUMBING VENT SCREENS

One or more plumbing vents on the roof do not have screens installed. This is a common practice. It is recommended to have screens installed at the top of plumbing vent stacks to reduce the chance of access to the plumbing system by small animals/rodents.

Recommendation
Contact a qualified roofing professional.

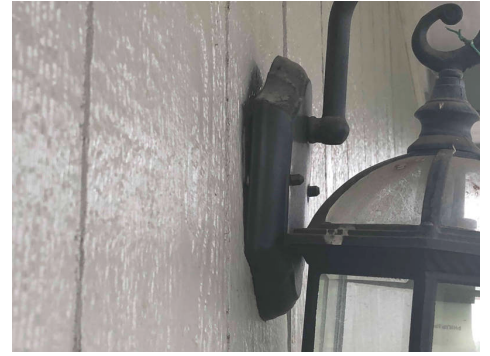
3.4.1 Electrical

NO CAULK LIGHT

One or more wall-mounted exterior light fixtures had no caulk or deteriorated sealant at the back plate. Water can enter the space behind the back plate and contact wiring. Recommend that a qualified person apply caulk above and around the back plate per standard building practices. A gap should be left at the bottom of the plate so that condensation can drain out.

Contact a handyman or DIY project

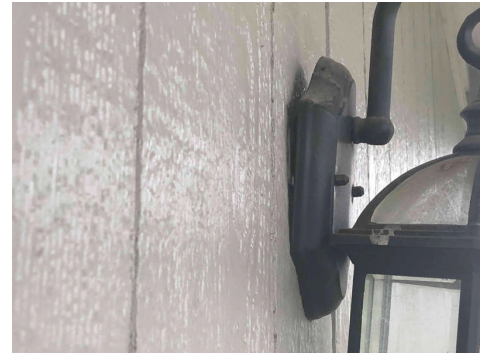
3.4.2 Electrical

LIGHT LOOSE/SUBSTANDARD

One or more light fixtures are loose or installed in a substandard way. A qualified contractor or electrician should evaluate and make repairs as necessary so light fixtures are securely mounted and installed in accordance with the manufacturer's installation instructions.

Contact a qualified electrical contractor.

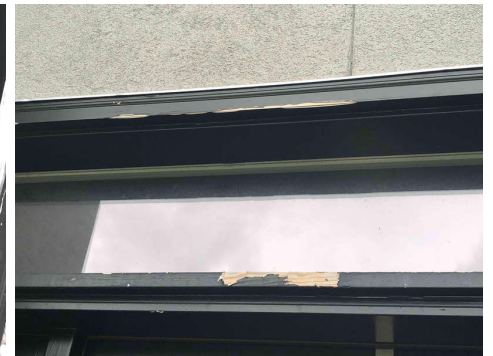
3.5.1 Windows and Door

DOOR DAMAGE/DETERIORATION

One or more exterior doors had minor damage and/or deterioration. Although serviceable, the client may wish to repair or replace such doors for appearances' sake and to help prevent future deterioration.

Contact a qualified professional.

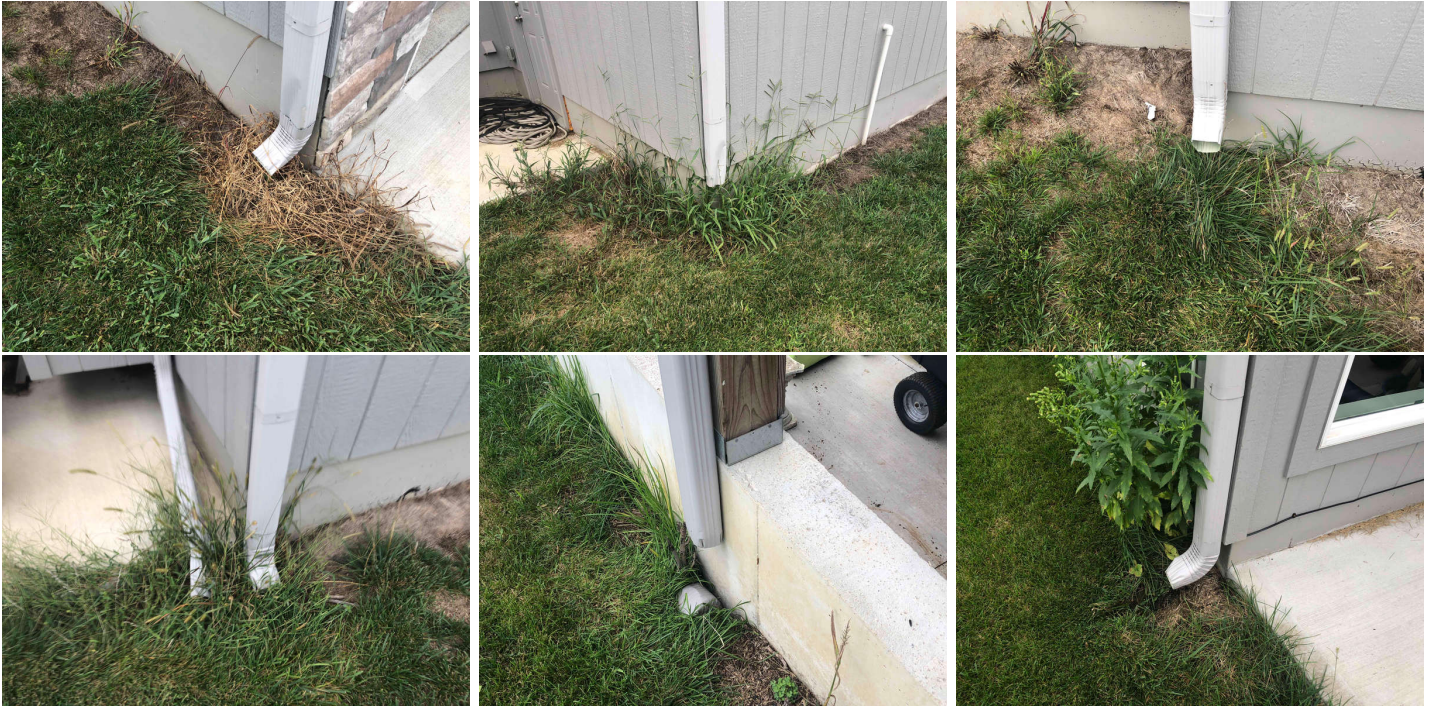
3.7.1 Gutters and Flashing

DOWNSPOUT EXTENSIONS

Extensions such as splash blocks or drain pipes for one or more downspouts were *missing / poorly sloped / misaligned / clogged / substandard / damaged*. Water can accumulate around the building foundation or inside crawl spaces or basements as a result. Recommend that a qualified person install, replace or repair extensions as necessary so rainwater drains away from the structure.

Contact a qualified professional.

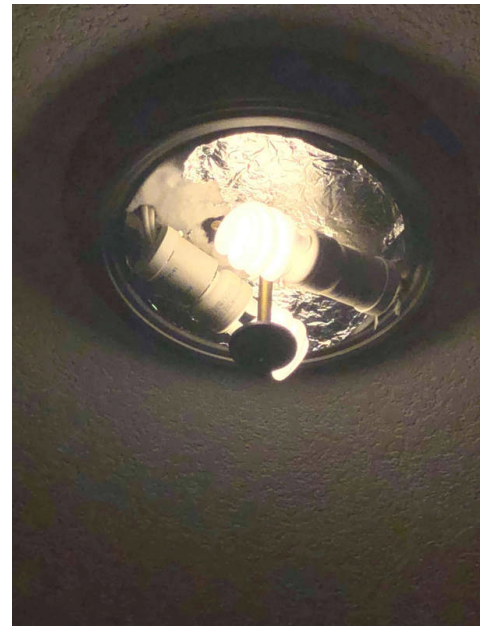
4.1.1 Electrical

LIGHT FIXTURE-OPEN LAMP

PANTRY

Lamp holders or light fixtures with fully or partially exposed bulbs are installed in one or more closets. This is a safety hazard due to the risk of fire. Flammable stored items may come into contact with hot bulbs, and hot fragments from broken bulbs may fall on combustible materials. Standard building practices require closet lighting to use fluorescent light fixtures, or to use fully enclosed incandescent fixtures. Installing a compact fluorescent lamp in a lamp holder is not an acceptable practice. A qualified electrician should replace closet lights as necessary and as per standard building practices.

Contact a qualified electrical contractor.

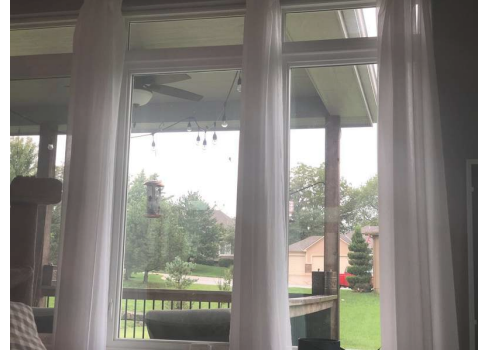
4.4.1 Windows and Door

WINDOW-SCREENS MISSING

LIVING ROOM

Screen(s) in one or more windows are missing. The client(s) should ask the property owner(s) about this. Screens are often removed for window cleaning and they may be stored somewhere. If not, then recommend installing screens where missing.

Contact a qualified window repair/installation contractor.

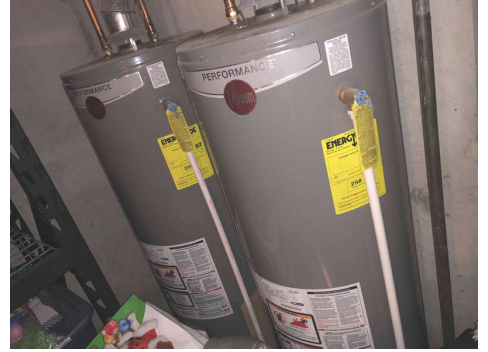
6.1.1 Water Heater

TPR IMPROPER MATERIAL

The TPR drain line was made of an improper material. These drains lines are to be made of either CPVC, Copper, or Galvanized piping to prevent melting when hot water or gases escape. Recommend qualified plumber repair.

Contact a qualified plumbing contractor.

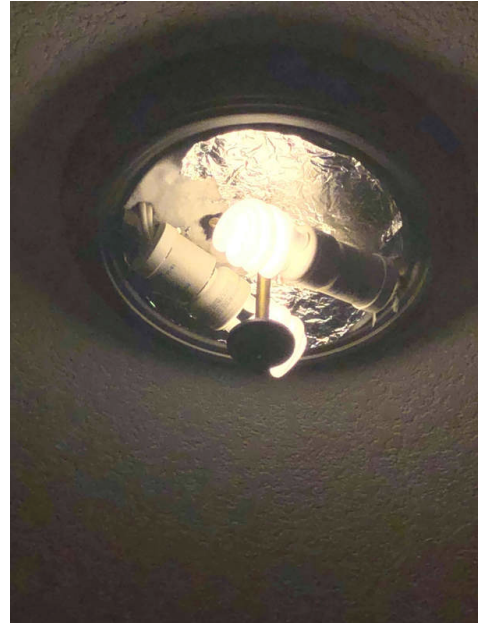
9.3.1 Electrical

OPEN PANTRY LIGHT

Lamp holders or light fixtures with fully or partially exposed bulbs are installed in one or more closets. This is a safety hazard due to the risk of fire. Flammable stored items may come into contact with hot bulbs, and hot fragments from broken bulbs may fall on combustible materials. Standard building practices require closet lighting to use fluorescent light fixtures, or to use fully enclosed incandescent fixtures. Installing a compact fluorescent lamp in a lamp holder is not an acceptable practice. A qualified electrician should replace closet lights as necessary and as per standard building practices.

Contact a qualified electrical contractor.

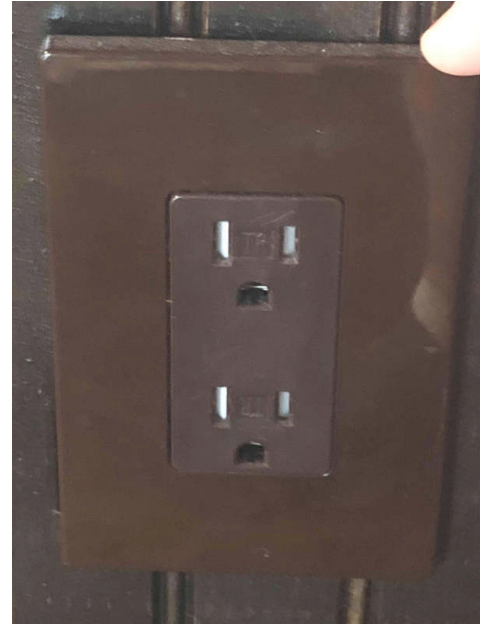
9.3.2 Electrical

RECEPTACLE LOOSE

One or more electric receptacles and/or the boxes they are installed in are loose and/or not securely anchored. Wire conductors may be damaged due to repeated movement and/or tension on wires, or insulation may be damaged. This is a safety hazard due to the risk of shock and fire. A qualified electrician should evaluate and repair as necessary.

Recommendation
Contact a qualified electrical contractor.

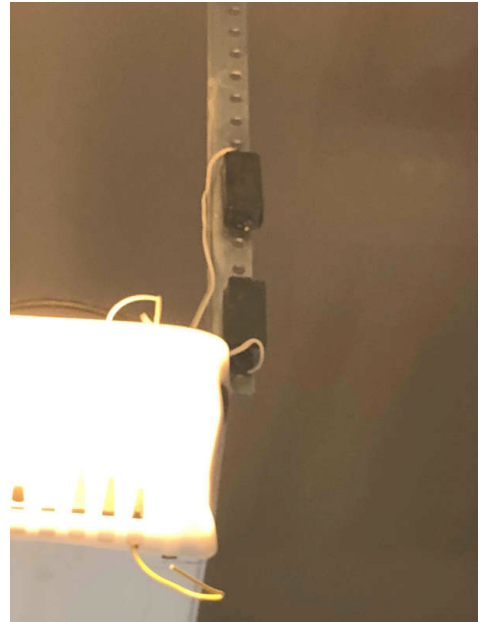
11.4.2 Vehicle door

PHOTO-EYES TOO HIGH

The infrared "photo eye" devices that trigger the vehicle door opener's auto-reverse feature are located higher than 4 to 6 inches from the floor. This is a potential safety hazard. A qualified contractor should relocate these devices so they're 4 to 6 inches from the floor.

Contact a qualified garage door contractor.
