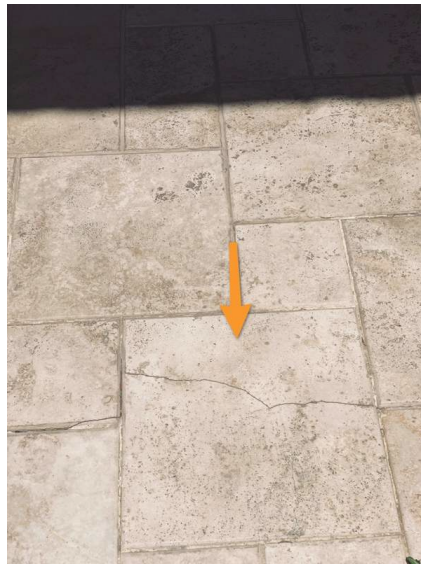
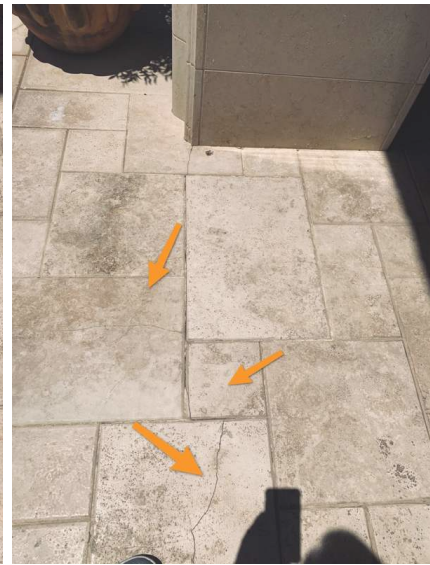
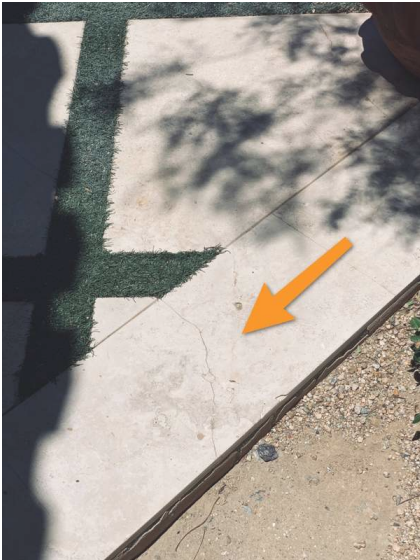
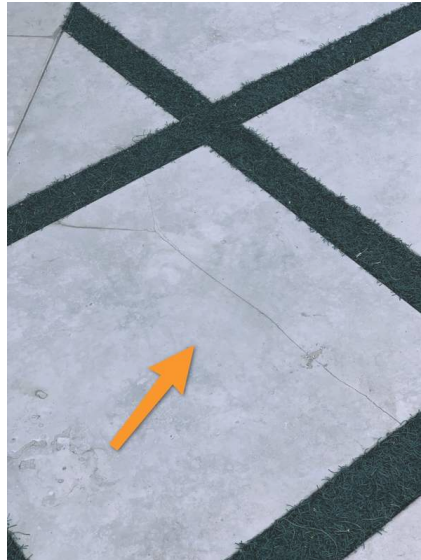
**PATIO WALKWAY CRACKING - MINOR**

We observed several cracked tiles at the front exterior entry, posterior patios, and walkways. This condition does not pose a trip or safety hazard at this time. However, we recommend monitoring.

Attached are some sample photos.

Contact a qualified tile contractor

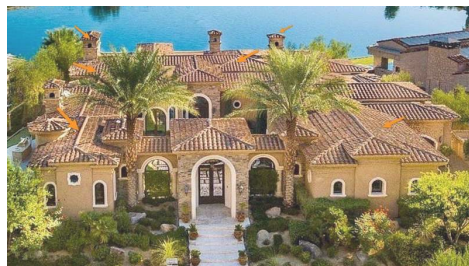
**LOOSE & DISPLACED TILES**

We noticed several loose and displaced tiles, This is a common condition and roofs with this type of system need periodic adjustments/repairs. There was no evidence of interior water intrusion or visible interior damage at this time

Attached is a sample photo highlighting areas where we observed this condition.

Contact a qualified roofing professional.

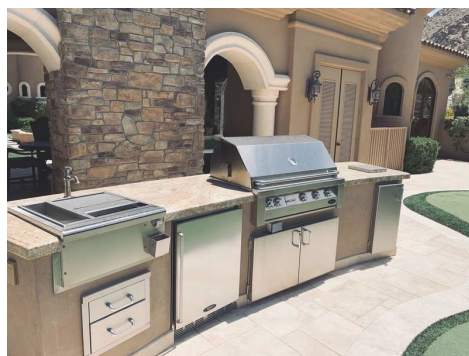
### INOPERABLE

We could not light or inspect this unit.

We recommend verification before the close of your escrow if this unit is of concern to you.

Contact a qualified appliance repair professional.

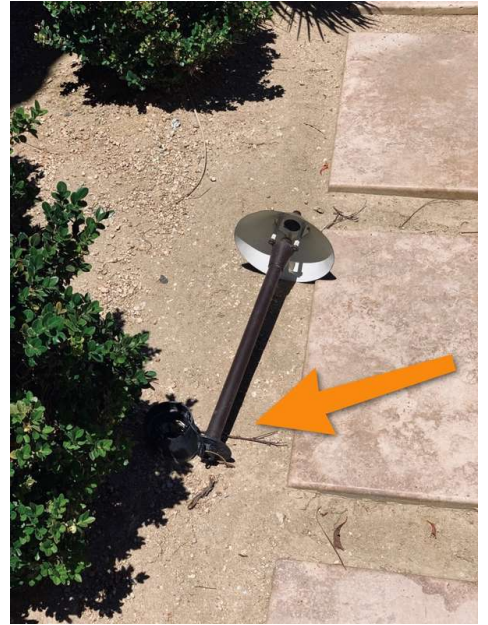
### SEVERAL LIGHTS ARE INOPERABLE.

Several of the landscape lights are inoperable.

This could be as simple as replacing bulbs, we recommend verification.

Also, we observed broken fixtures at the side yard and posterior.

Contact a qualified electrical contractor.

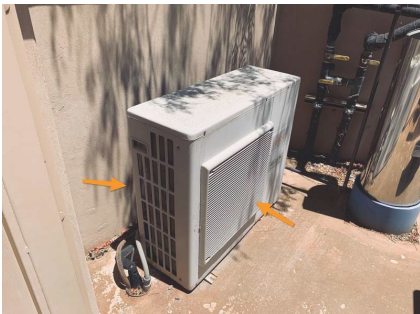
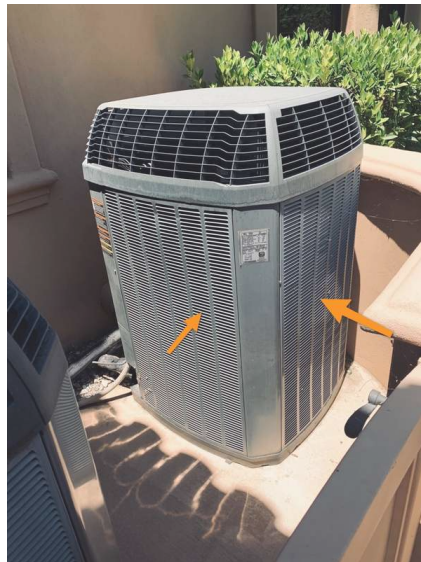
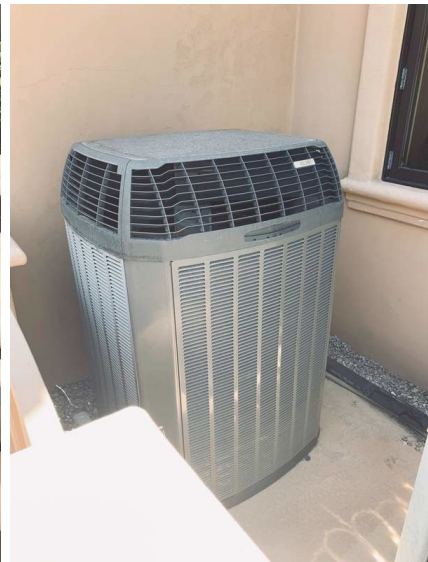
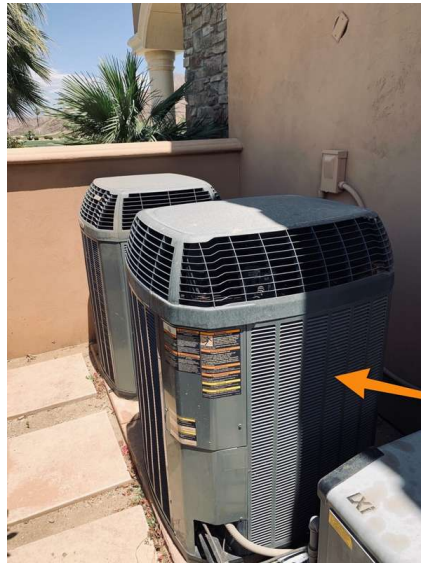
#### **SERVICE NEEDED**

5 Units (Exterior) 1 Fujitsu Minisplit Unit.

\*HVAC units are operational at time of inspection. However, due to age, variable conditions & use of these units, we recommend service and verification by an HVAC specialist. We observed Dirty exterior coils and dirty interior filters.

Contact a qualified HVAC professional.

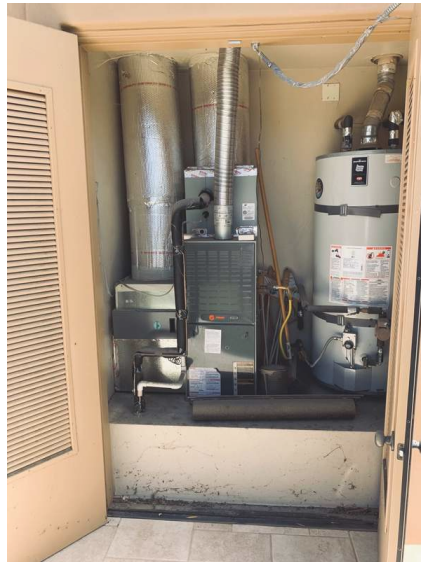
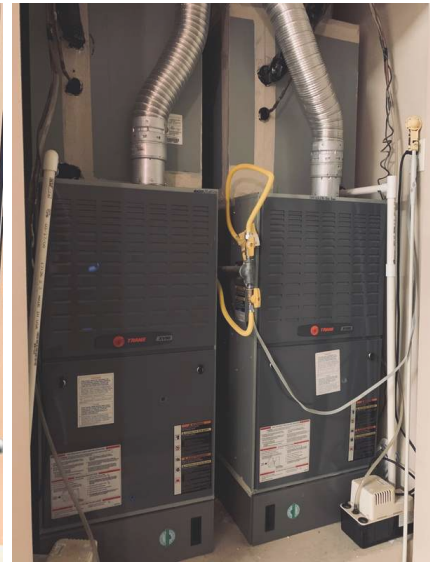
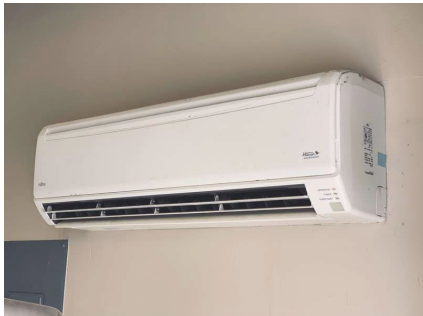
### 7.4.1 Forced Air Heating Equipment **NEEDS SERVICING/CLEANING**

5 Units (Interior) 1 Fujitsu Mini-split Garage Unit.

The furnaces should be cleaned and serviced semi-annually.

We recommend a qualified HVAC contractor clean, service and certify furnace.

Contact a qualified HVAC professional.

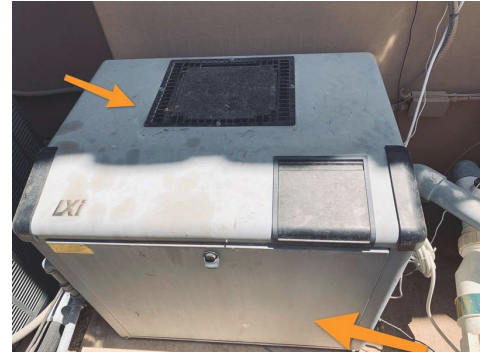
#### **SERVICE NEEDED**

Unit is operational, However we detected dirt and debris on the burner tray assembly as well as the heat exchanger.

We recommend further evaluation by a licensed swimming contractor.

Recommendation  
Contact a qualified Swimming Pool Contractor

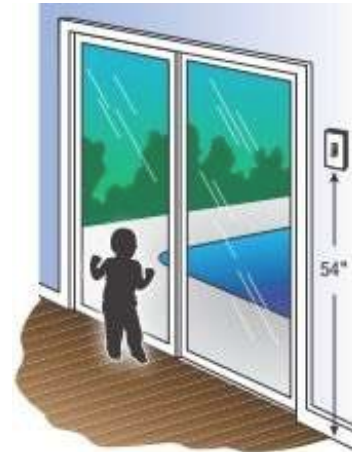
#### **SAFETY EQUIPMENT**

California Pool Owners As of January 1, 2018, pool owners will need to install at least 2 of 7 specified drowning prevention safety features to reduce the serious risk of drowning. We strongly recommend consulting a licensed pool contractor for details and corrections to this new building and safety code.

Below is one example of pool access door alarms.

Recommendation  
Contact a qualified professional.
