## SUMMARY

1234 Main St. Salt Lake City Utah 84106

Rich Lavine  
InterNACHI CPI #NACHI15122905  
Blue Sky Home Inspections  
4358172255  
support@slcbluesky.com

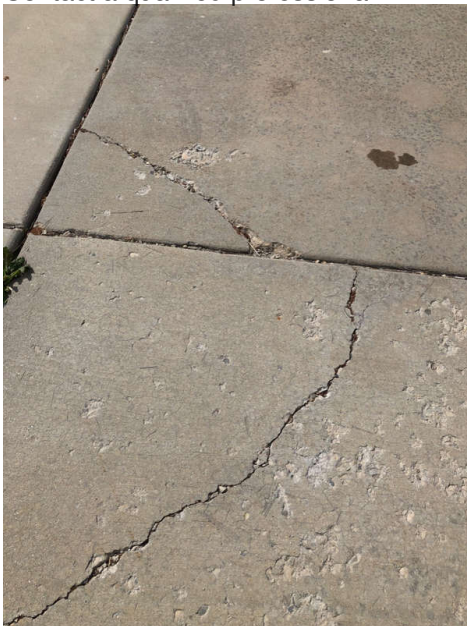
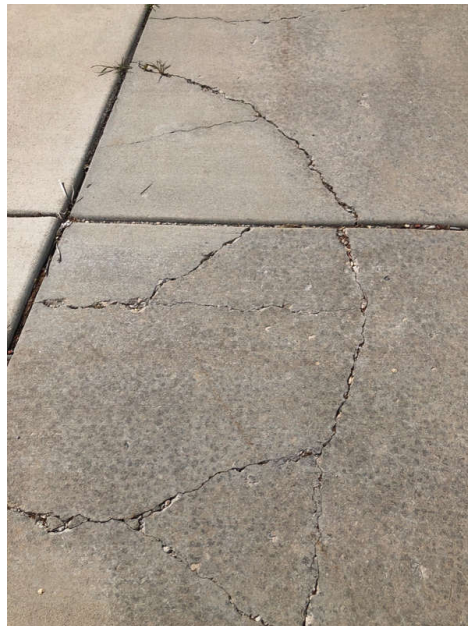
### 2.2.1 Driveway

#### DRIVEWAYS - MINOR

Minor deterioration (e.g. cracks, holes, settlement, heaving) was found in the driveway, but no trip hazards were found. The client may wish to have repairs made for cosmetic reasons.

Contact a qualified professional.

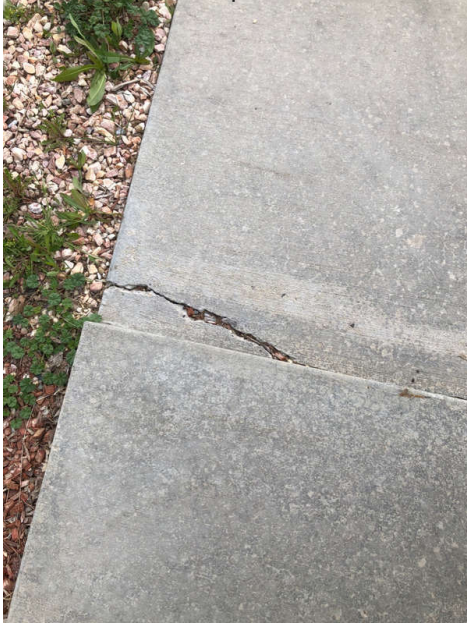
2.3.1 Sidewalks / Patios

**MINOR**

Minor deterioration (e.g. cracks, holes, settlement, heaving) was found in sidewalks or patios, but no trip hazards were found. The client may wish to have repairs made for cosmetic reasons.

Contact a qualified professional.

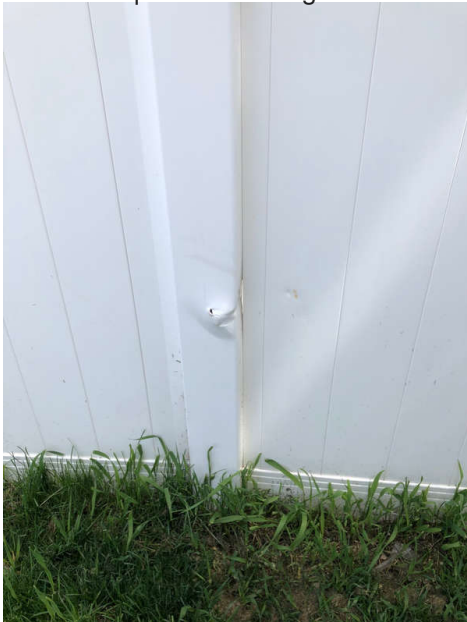
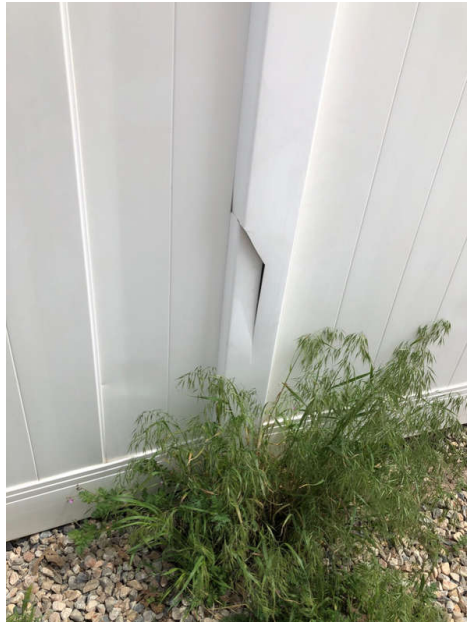
2.6.1 Fence

**DAMAGE**

Fence is damaged.

Contact a qualified fencing contractor

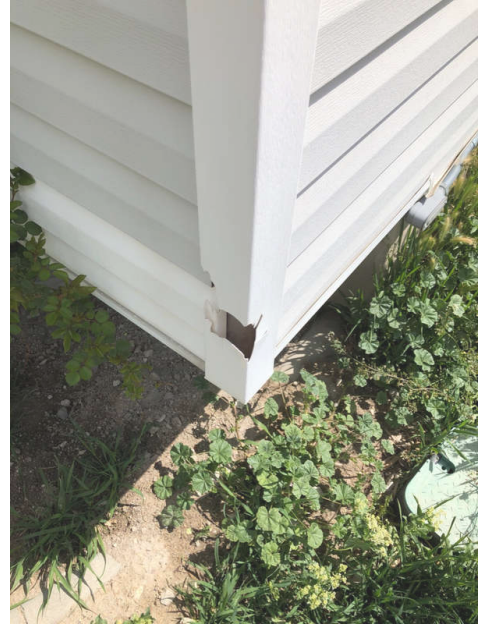
3.1.1 Exterior Walls / Trim

**SIDING/TRIM DAMAGE**

SOUTH WEST

Some / Many sections of siding and/or trim were *deteriorated / loose / split / warped / missing / damaged / substandard*. Recommend that a qualified person repair, replace or install siding or trim as necessary.

Contact a qualified professional.

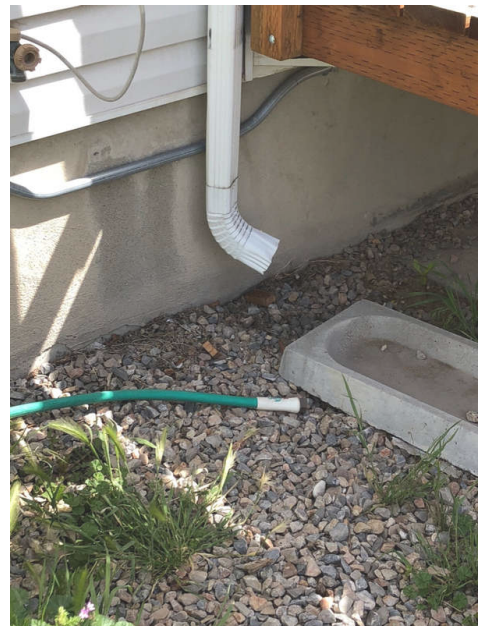
#### 5.4.1 Gutters / Downspouts / Extensions

### DOWNSPOUT EXTENSIONS

Extensions such as splash blocks or drain pipes for one or more downspouts were *missing / poorly sloped / misaligned / clogged / substandard / damaged*. Water can accumulate around the building foundation or inside crawl spaces or basements as a result. Recommend that a qualified person install, replace or repair extensions as necessary so rainwater drains away from the structure.

Contact a qualified professional.

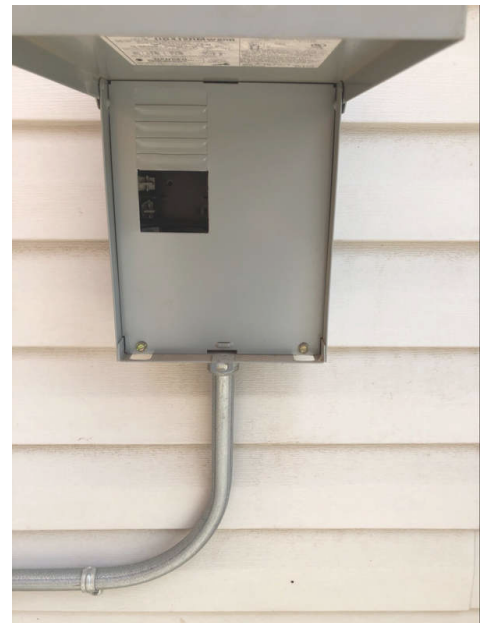
#### 8.2.1 Panels

### MISSING KNOCKOUT

One or more knockouts were missing from panel(s) #A / B / C / D / E. Holes in panels are a potential fire hazard if a malfunction ever occurs inside the panel. Rodents can also enter panels through holes. Recommend that a qualified person install knockout covers where missing and per standard building practices.

Contact a qualified electrical contractor.

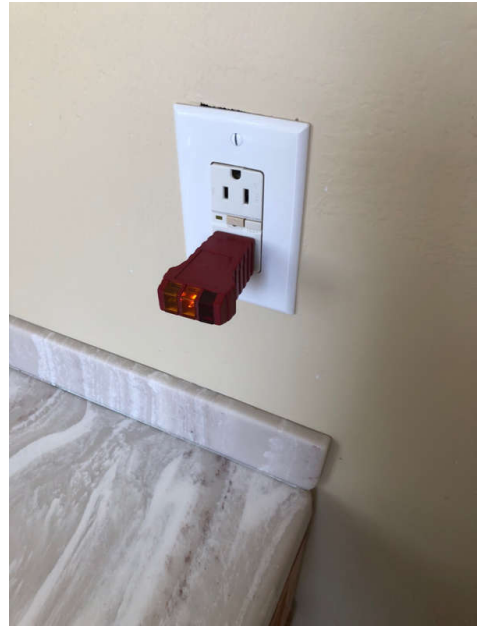
#### 8.4.1 Receptacles

### OPEN GROUND - REWIRE

#### 1ST FLOOR BATHROOM

One or more modern, 3-slot electric receptacles were found with an open ground. This is a shock hazard when appliances that require a ground are used with these receptacles. Examples of such appliances include computers and related hardware, refrigerators, freezers, portable air conditioners, clothes washers, aquarium pumps, and electrically operated gardening tools. Recommend that a qualified electrician repair as necessary so all receptacles are grounded per standard building practices.

Contact a qualified electrical contractor.

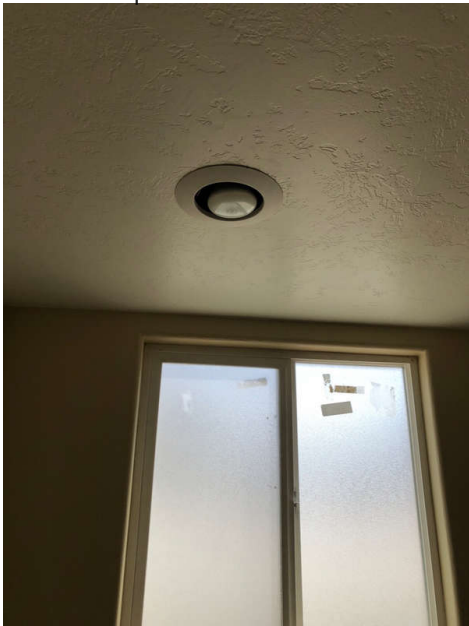
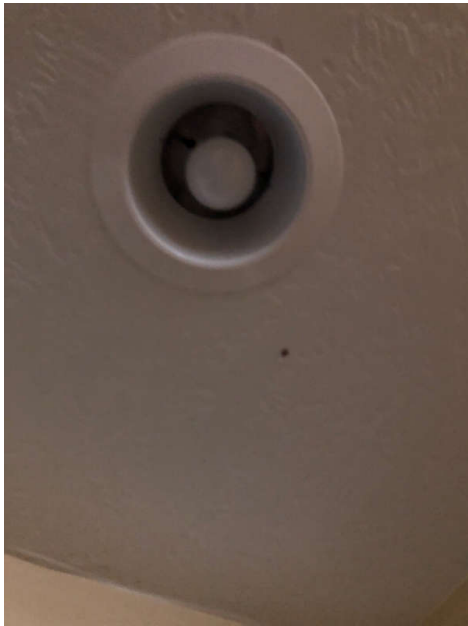
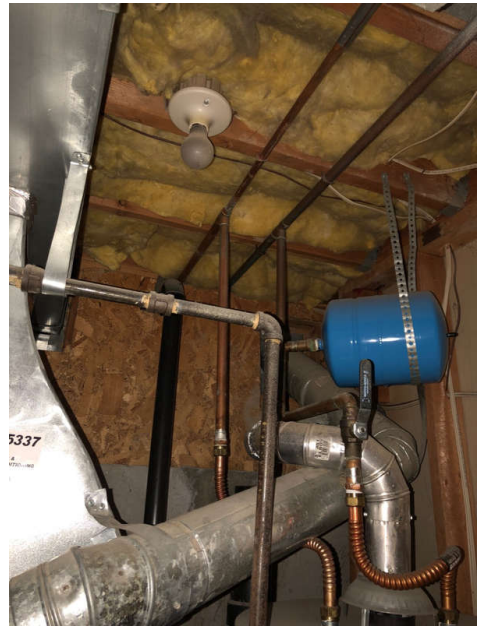
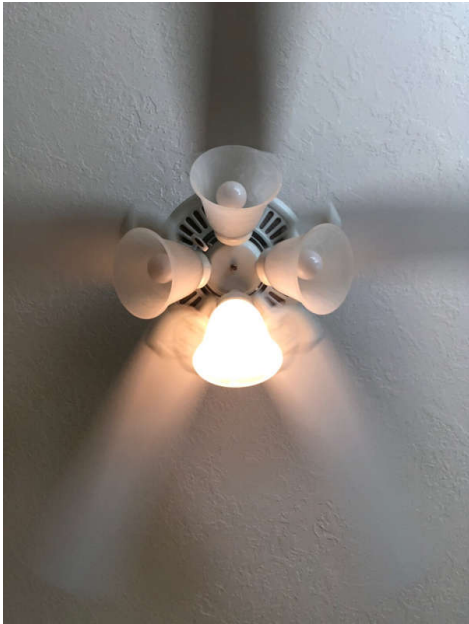
### 8.6.1 Lighting

## **BULBS MISSING OR BROKEN**

Bulbs in one or more light fixtures were missing or broken. These light fixtures couldn't be fully evaluated. If replacement bulbs are inoperable, then recommend that a qualified electrician evaluate and repair or replace light fixtures as necessary.

Contact a qualified electrical contractor.

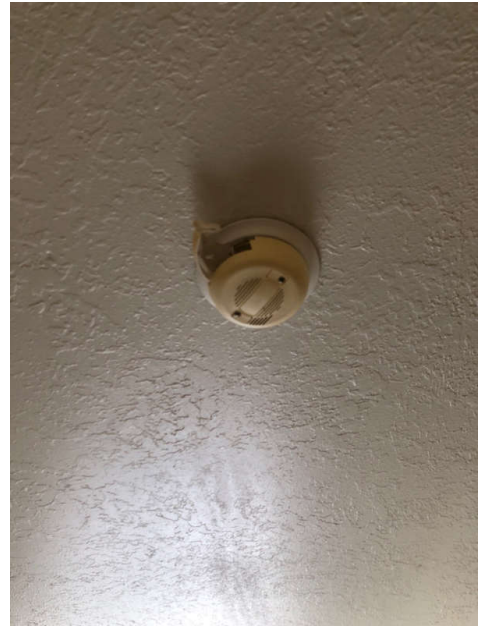
### 8.8.2 Smoke and CO alarms

#### MISSING OR LOW BATTERIES

For home buyers, batteries in all the smoke alarms should be replaced after taking occupancy. Batteries should be replaced annually in the future. "Chirping" noises emitted from smoke alarms typically indicate that batteries need replacing. For more information, visit:

Recommended DIY Project

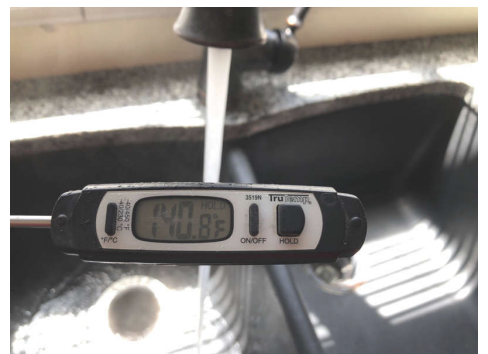
### 10.3.1 Temp

#### **> 120**

The hot water temperature was greater than 120 degrees Fahrenheit. This is a safety hazard due to the risk of scalding. The thermostat should be adjusted so the water temperature doesn't exceed 120 degrees. If the water heater is powered by electricity, a qualified person should perform the adjustment, since covers that expose energized equipment normally need to be removed. For more information on scalding dangers, visit:

Recommendation  
Recommended DIY Project

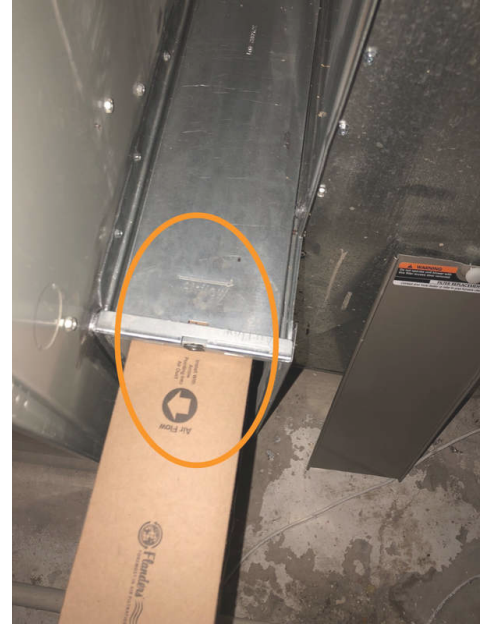
#### 11.4.2 Filters

### HARDWARE IS BACKWARDS

The aero directing the airflow is incorrect.

Contact a qualified professional.

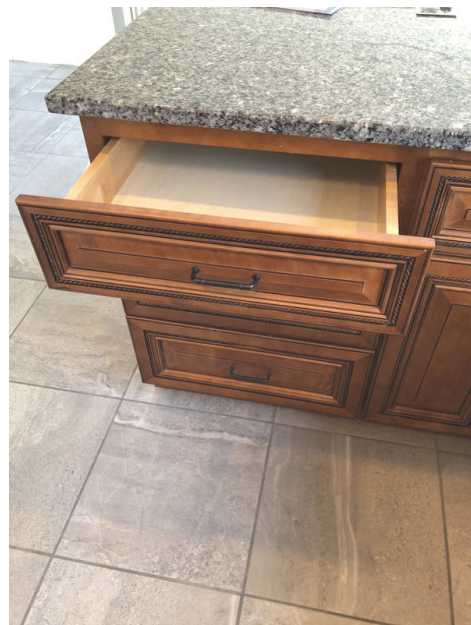
#### 12.2.1 Cabinets

### DRAWERS

Inspector had difficulty getting this drawer closed. Recommend that a qualified person repair as necessary.

Contact a qualified handyman.

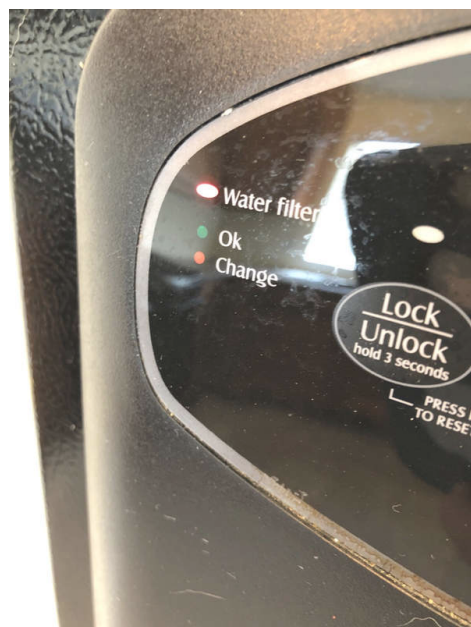
12.9.1 Refrigerator

### **FILTER**

Filter needs changed

Contact a qualified professional.

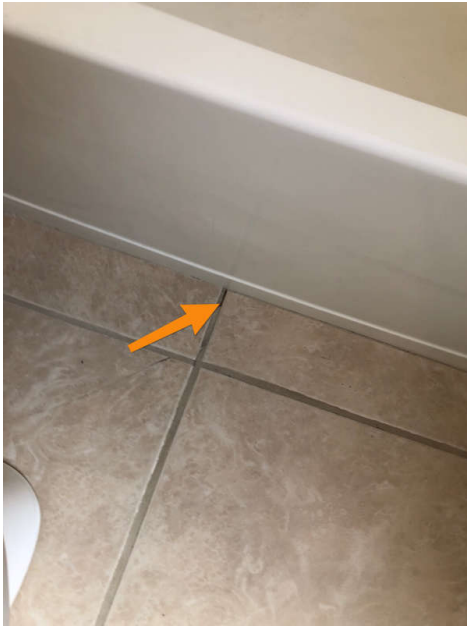
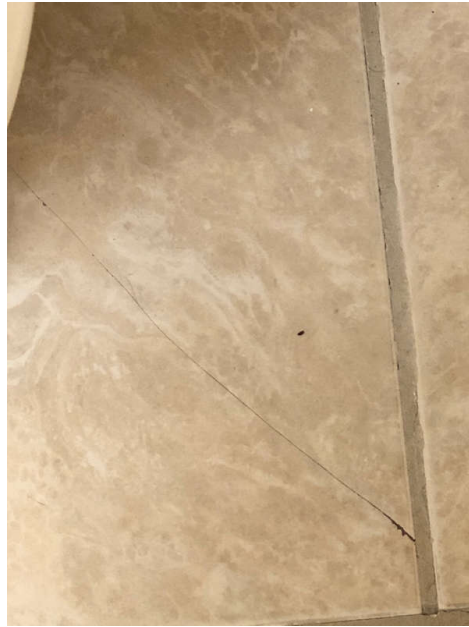
13.3.1 Floors

### **TILE, STONE, GROUT DETERIORATED, SUBSTANDARD**

Tile, stone and/or grout in the flooring was deteriorated (e.g. loose or cracked tiles, missing grout) or substandard. Water can damage the sub-floor as a result. Recommend that a qualified contractor repair as necessary.

Contact a qualified professional.

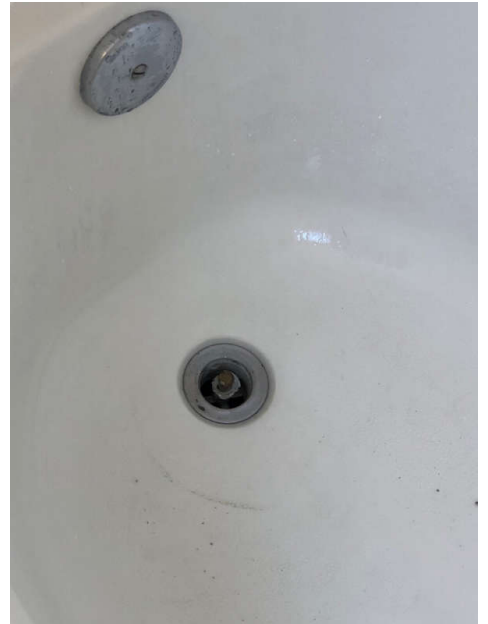
13.6.1 Bathtubs

**DRAIN STOPPER**

MASTER BATHROOM

The bathtub drain stopper mechanism was damaged. Recommend that a qualified person repair or replace as necessary.

Contact a qualified professional.

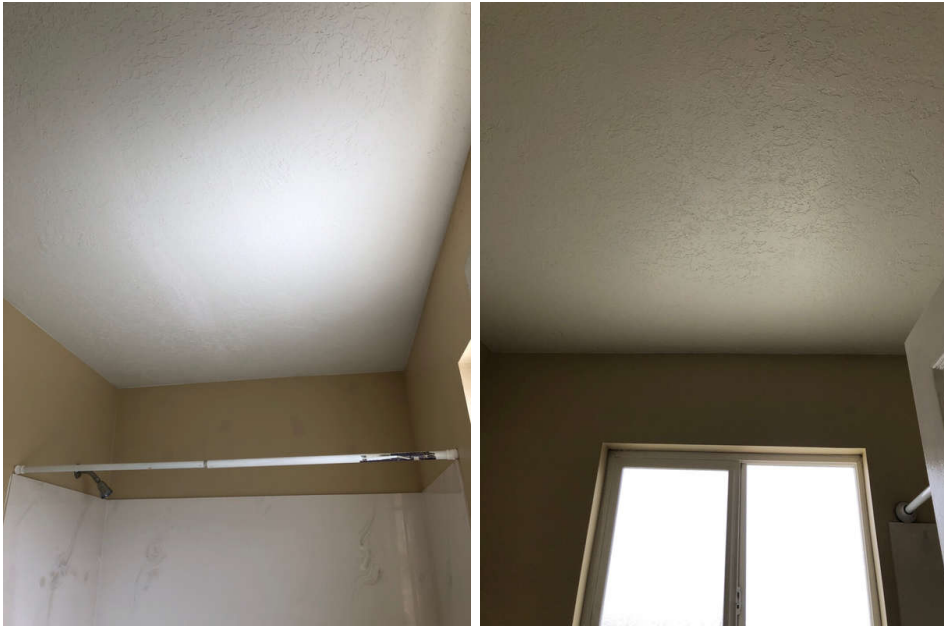
### 13.8.1 Ventilation

## **NO EXHAUST FAN WITH SHOWER, TUB**

MASTER BATHROOM & 2ND FLOOR BATHROOM

The bathroom with a shower or bathtub at location(s) #A didn't have an exhaust fan installed. Moisture can accumulate and result in mold, bacteria or fungal growth. Even if the bathroom has a window that opens, it may not provide adequate ventilation, especially during cold weather when windows are closed or when wind blows air into the bathroom. Recommend that a qualified contractor install exhaust fans per standard building practices where missing in bathrooms with showers or bathtubs.

Contact a qualified professional.

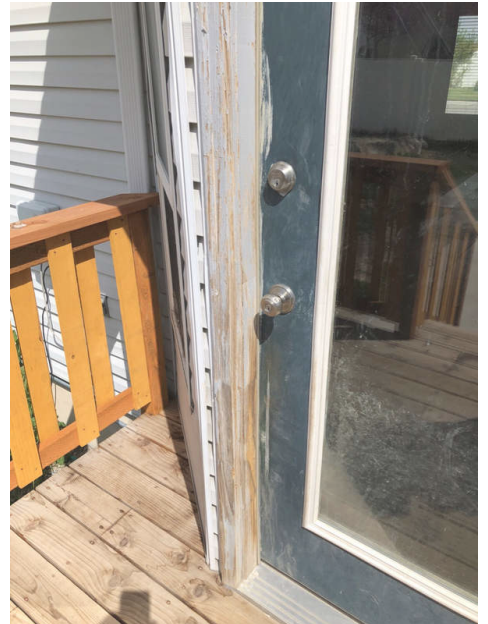
#### 14.1.1 Exterior Doors

##### **TRIM**

Trim needs painted and repaired or replaced.

Contact a qualified professional.

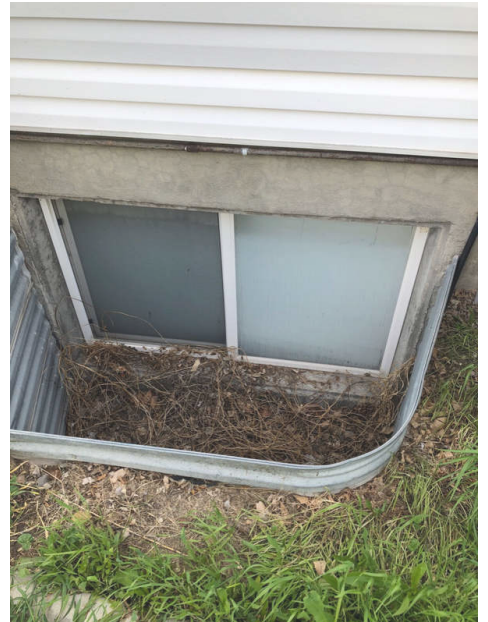
#### 14.3.1 Windows & Skylights

### FOGGING, CONDENSATION BETWEEN GLASS

Condensation or staining was visible between multi-pane glass in *one or more / many windows / skylights*. This usually indicates that the seal between the panes of glass has failed or that the desiccant material that absorbs moisture is saturated. As a result, the view through the window may be obscured, the window's R-value will be reduced, and accumulated condensation may leak into the wall structure below. Recommend that a qualified contractor evaluate and repair windows as necessary. Usually, this means replacing the glass in window frames.

Be aware that evidence of failed seals or desiccant may be more or less visible depending on the temperature, humidity, sunlight, etc. Windows or glass-paneled doors other than those that the inspector identified may also have failed seals and need glass replaced. It is beyond the scope of this inspection to identify every window with failed seals or desiccant.

Contact a qualified professional.

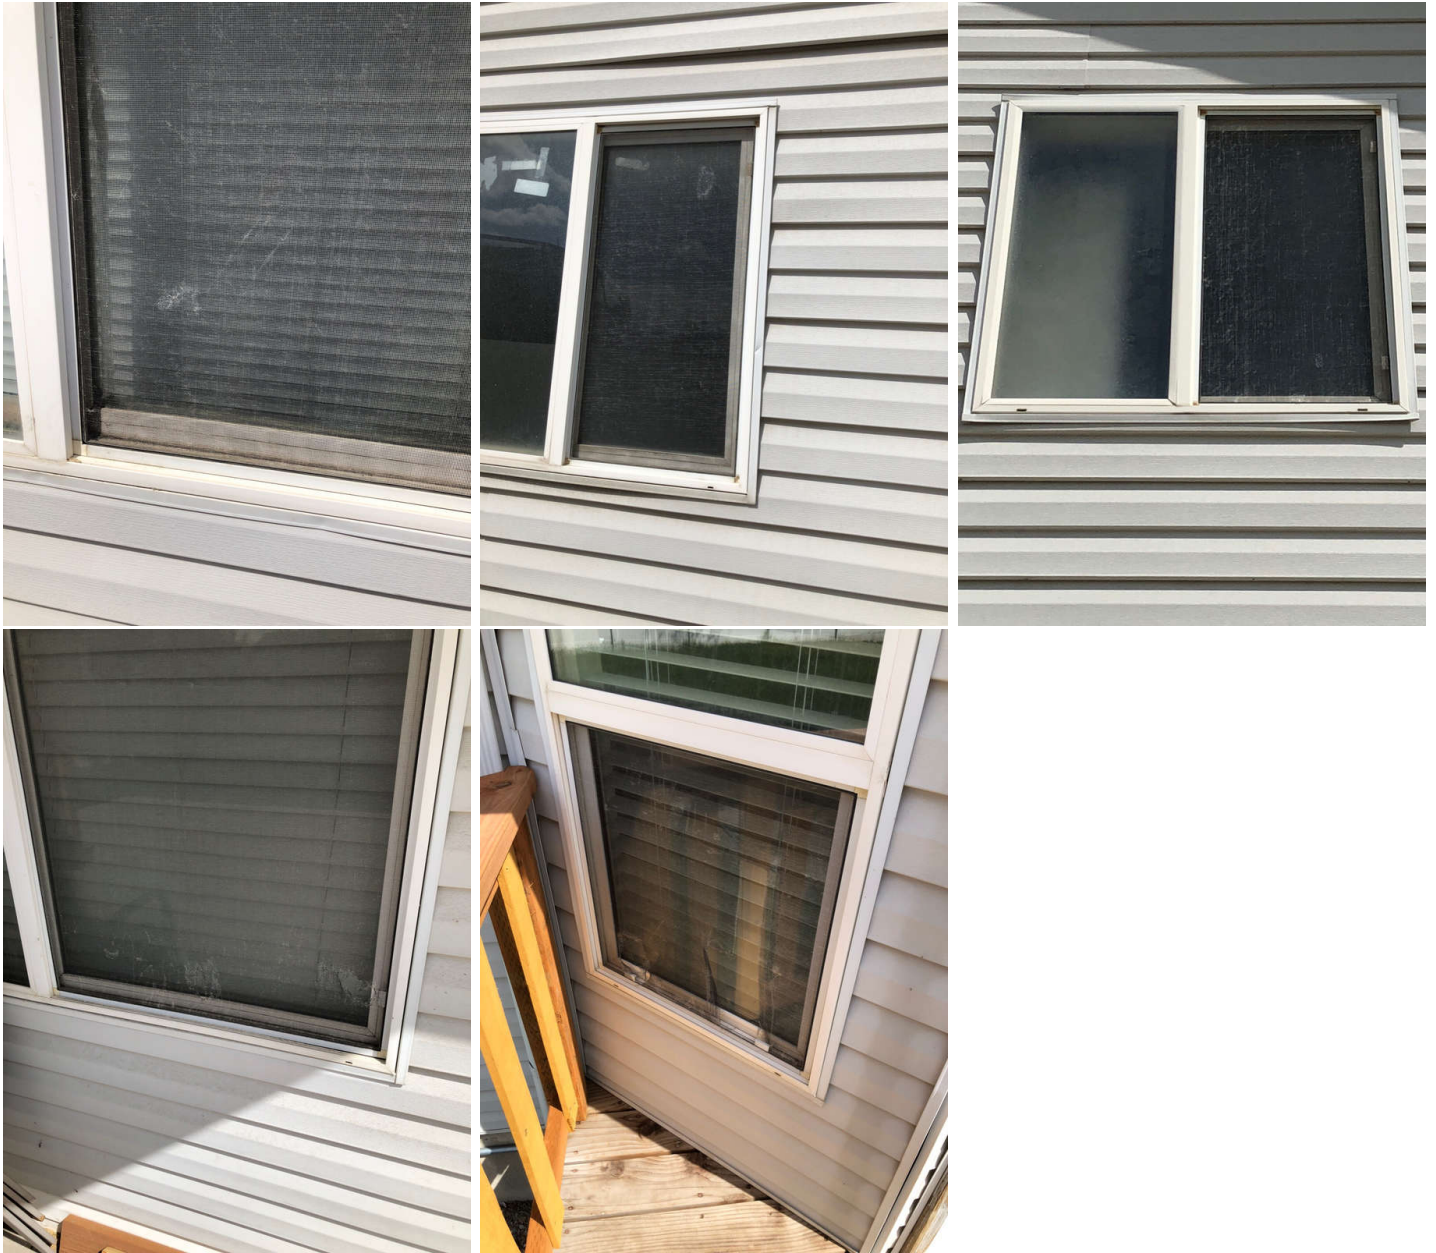
#### 14.3.2 Windows & Skylights

### SCREENS DAMAGED, DETERIORATED

One or more window screens were damaged or deteriorated. These window(s) may not provide ventilation during months when insects are active. Recommend replacing window screens as necessary.

Contact a qualified professional.

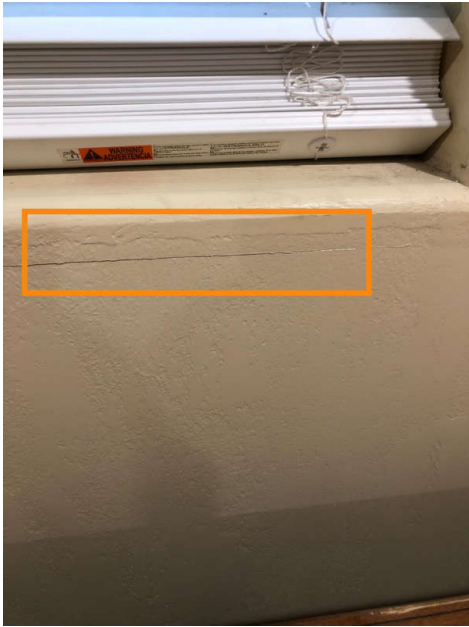
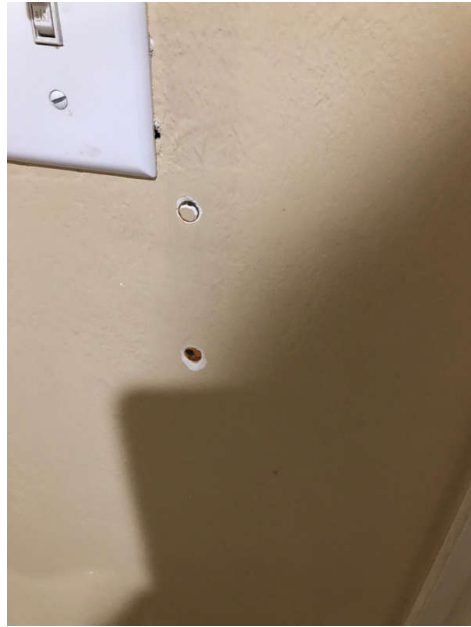
#### 14.4.1 Walls, Ceilings and Fixtures

### **MINOR CRACKS, NAIL POPS**

#### SOUTHWEST BEDROOM

Minor cracks, nail pops and/or blemishes were found in walls and/or ceilings in one or more areas. Cracks and nail pops are common, are often caused by lumber shrinkage or minor settlement, and can be more or less noticeable depending on changes in humidity. They did not appear to be a structural concern, but the client may wish to repair these for aesthetic reasons. For recurring cracks, consider using an elastic crack covering product:

Contact a qualified professional.

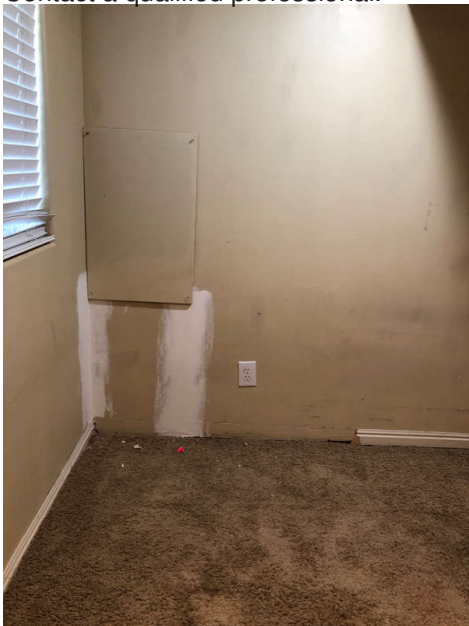
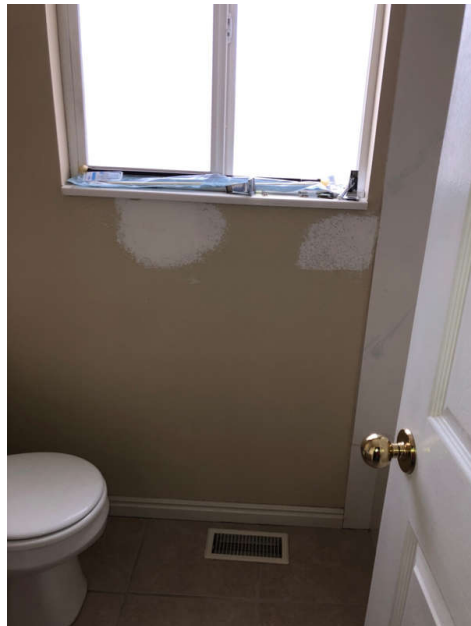
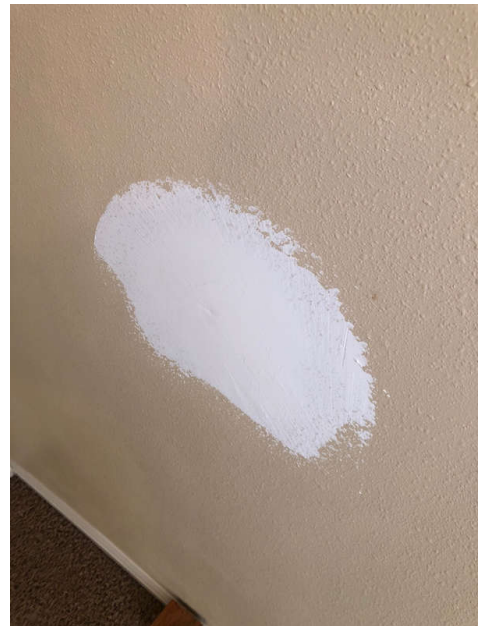
14.4.2 Walls, Ceilings and Fixtures  
**NEEDS REPAIR**

One or more *walls / ceilings were damaged / were cracked / had substandard repairs*. Recommend that a qualified person repair as necessary.

Recommendation  
Contact a qualified professional.

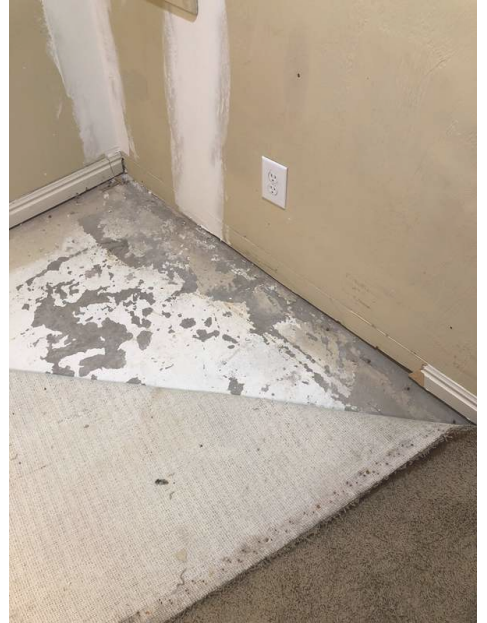
14.5.3 Floors

**BASEBOARDS**

The baseboards throughout the home are substandard.

Contact a qualified professional.
