**SUMMARY**

1234 Main St. Shippensburg 17257

Stride Home Inspections

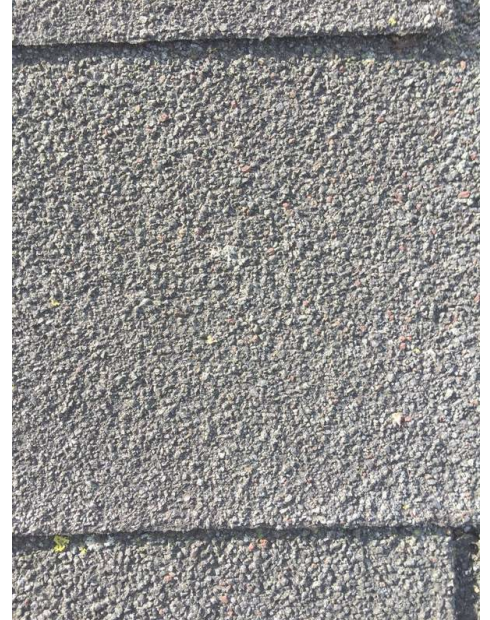
2.1.1 Coverings

DAMAGED (GENERAL)

Roof coverings showed moderate damage. Recommend a qualified roofing professional evaluate and repair.

Contact a qualified roofing professional.

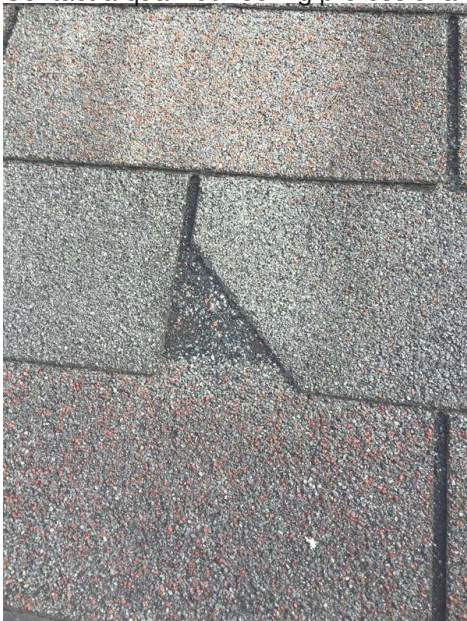
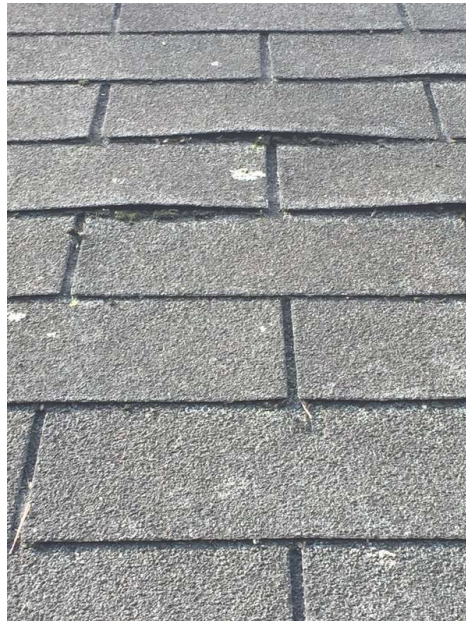
2.1.2 Coverings

SPLITTING

NORTH

The asphalt composition shingle roof had torn or split shingles which could lead to moisture intrusion. Recommend a qualified roofing contractor repair.

Contact a qualified roofing professional.

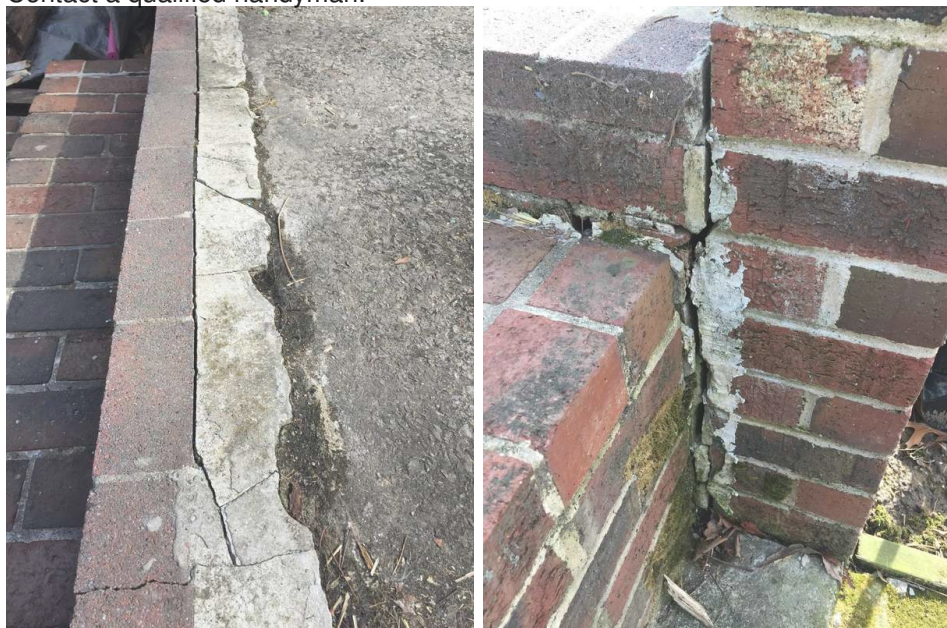
3.3.1 Walkways, Patios & Driveways

PATIO CRACKING - MINOR

SOUTH

Normal settling & cracking observed. Recommend monitor and/or patch/seal.

Contact a qualified handyman.

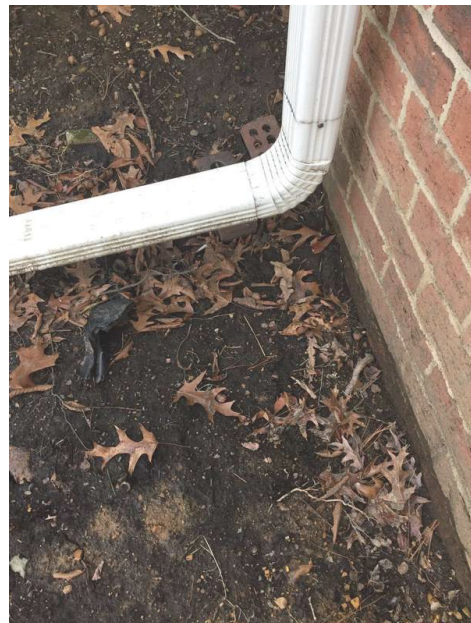
3.6.1 Vegetation, Grading, Drainage & Retaining Walls

NEGATIVE GRADING

WEST

Grading is sloping towards the home in some areas. This could lead to water intrusion and foundation issues. Recommend qualified landscaper or foundation contractor regrade so water flows away from home.

Contact a qualified landscaper or gardener.

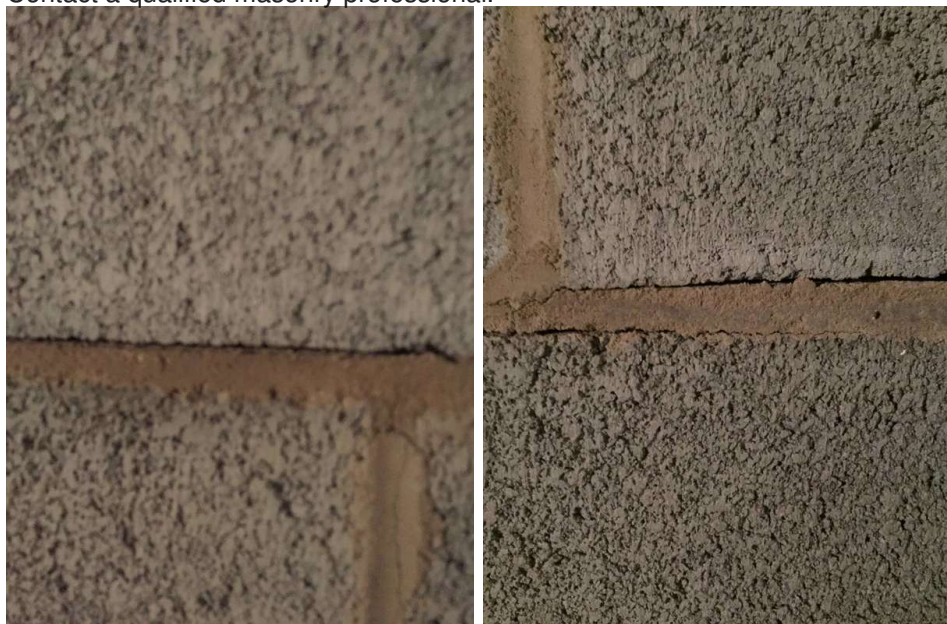
4.1.1 Foundation

FOUNDATION CRACKS - MINOR

Minor cracking was noted at the foundation. This is common as concrete ages and shrinkage surface cracks are normal. Recommend monitoring for more serious shifting/displacement.

Contact a qualified masonry professional.

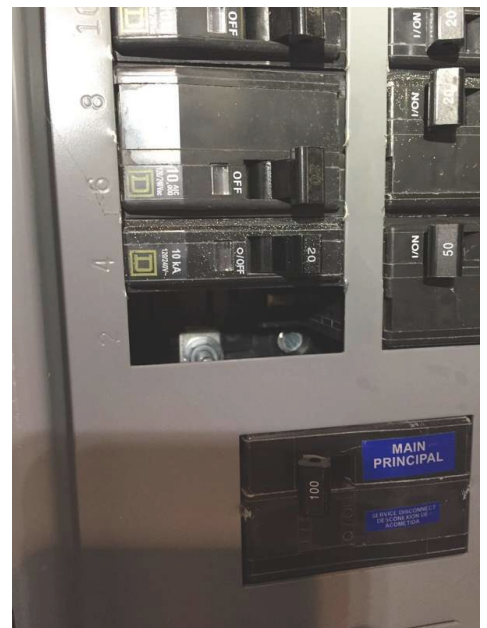
8.2.2 Main & Subpanels, Service & Grounding, Main Overcurrent Device

KNOCKOUTS MISSING

"Knockouts" are missing on the electric panel. This poses a safety hazard and it is recommended that the opening in the panel caused by the missing knockout(s) be properly sealed by a licensed electrician.

Contact a qualified electrical contractor.

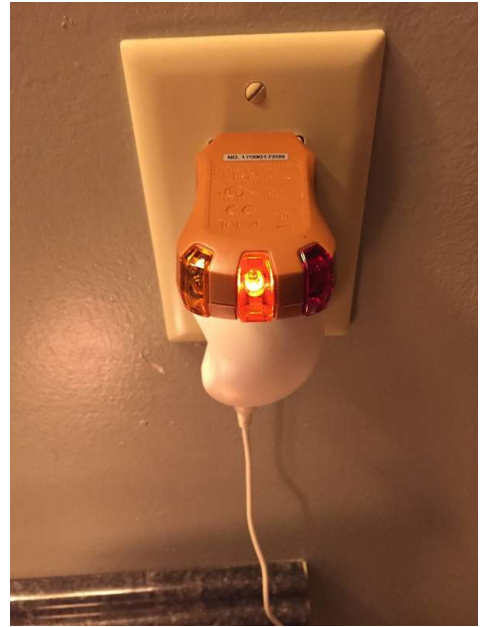
8.4.3 Lighting Fixtures, Switches & Receptacles

UNGROUNDING RECEPTACLE

BATHROOM

One or more receptacles are ungrounded. To eliminate safety hazards, all receptacles in kitchen, bathrooms, garage & exterior should be grounded.

Contact a qualified electrical contractor.

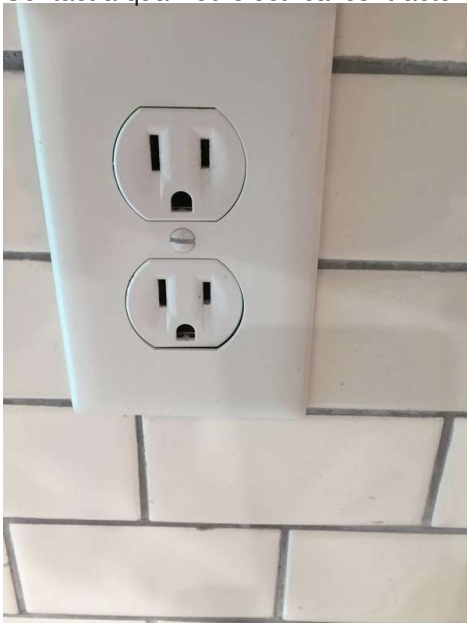
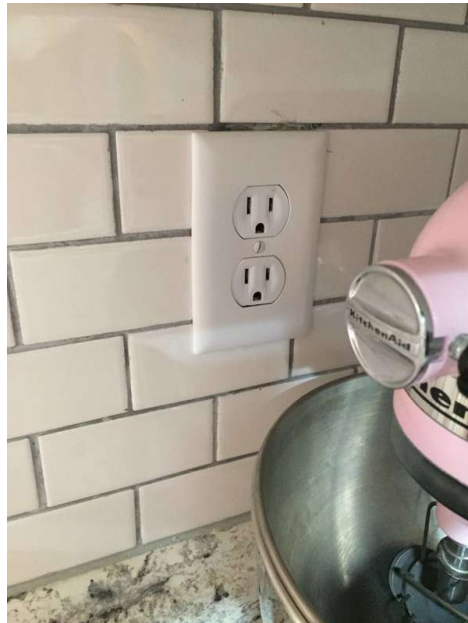
8.5.1 GFCI & AFCI

NO GFCI PROTECTION INSTALLED

KITCHEN

No GFCI protection present in all locations. Recommend licensed electrician upgrade by installing ground fault receptacles in all locations.

Contact a qualified electrical contractor.

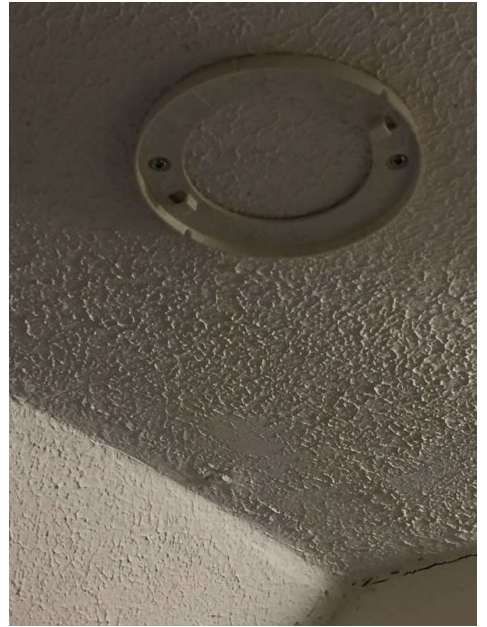
8.6.1 Smoke Detectors

DEFECTIVE

2ND FLOOR BEDROOM

Smoke detector is missing.

Recommended DIY Project

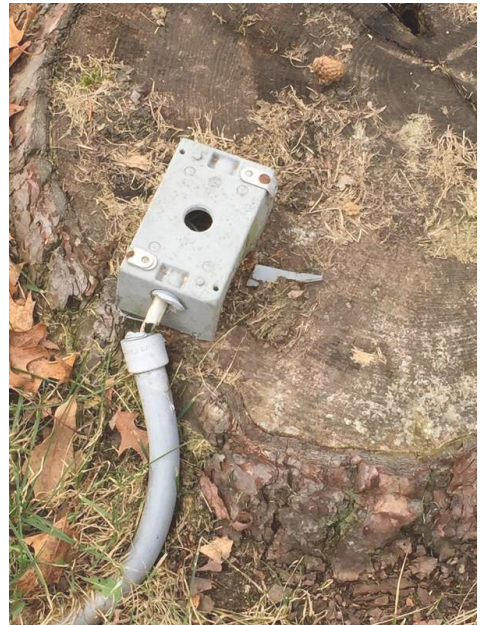
8.8.1 Exterior Light

SERVICE TO LIGHT POLE

DRIVEWAY

Service feed to light pole in driveway was broke off exposing hot wires.

Contact a qualified electrical contractor.

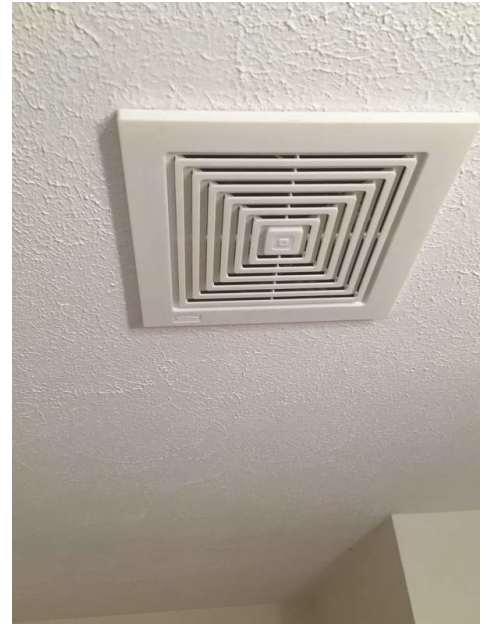
9.4.1 Exhaust Systems

BATHROOM VENTS INTO ATTIC

2ND FLOOR BATHROOM

Bathroom fan vents into the attic, which can cause moisture and mold. Recommend a qualified attic contractor properly install exhaust fan to terminate to the exterior. Bathroom fans in all three bathrooms make noise when turned on.

Contact a qualified HVAC professional.

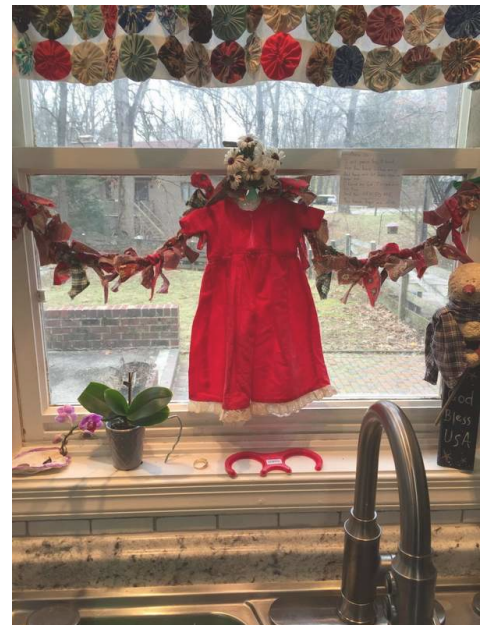
10.2.1 Windows

DAMAGED

KITCHEN

Window will not stay in the open position.

Contact a qualified window repair/installation contractor.

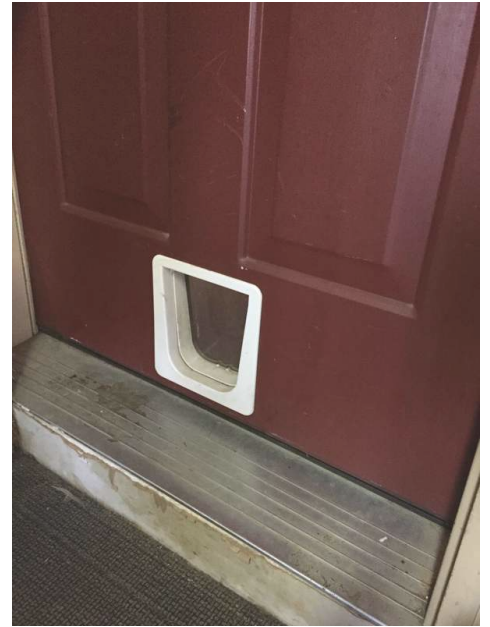
12.6.1 Occupant Door (From garage to inside of home)

DOOR DOES NOT MEET SEPARATION REQUIREMENTS

GARAGE

Door separating garage and home has a hole cut in for pet entry/exit.
This will allow harmful fumes to enter the residence.

Contact a qualified door repair/installation contractor.
