SUMMARY
 1234 Main St. Colorado Springs CO
 80916
 Buyer Name
 03/14/2018 9:00AM

Mark Jones
 Certified Master Inspector, CPI, AHIT
 Springs Top Inspector LLC
 7193597363
springstopinspector@gmail.com

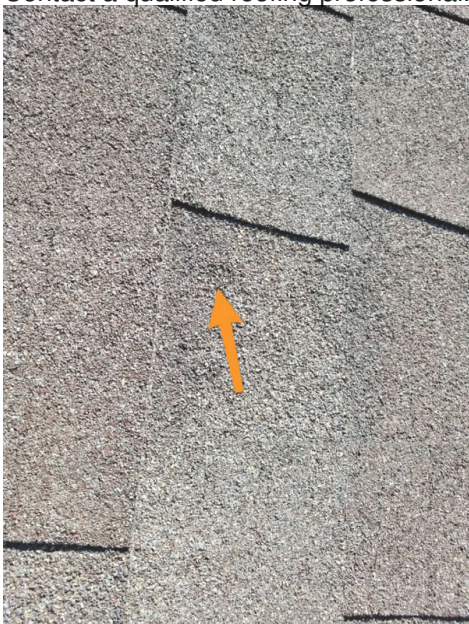
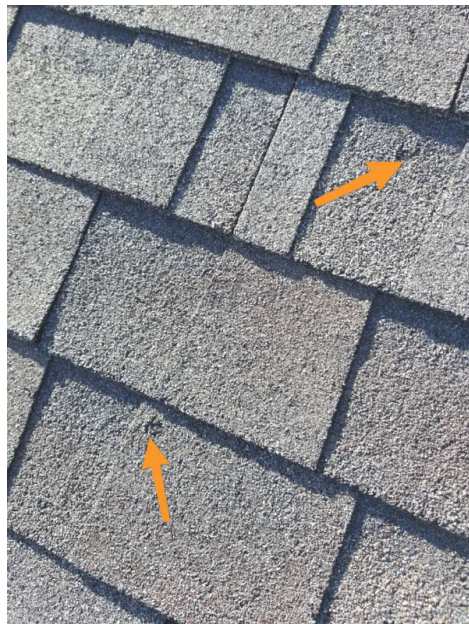
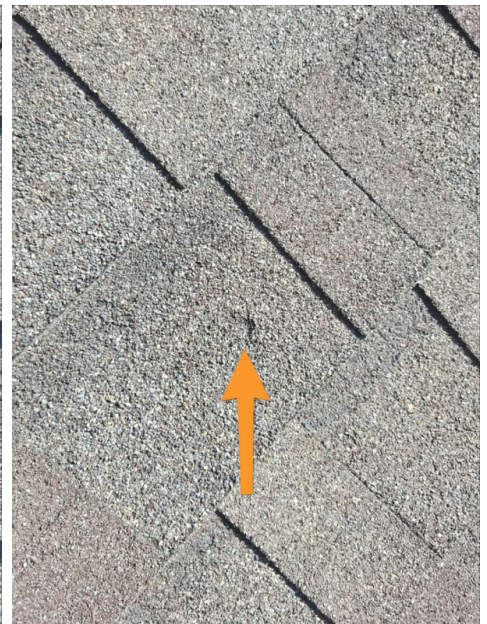
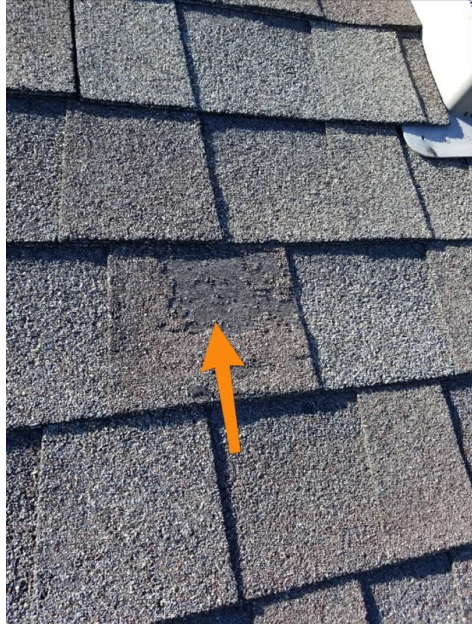
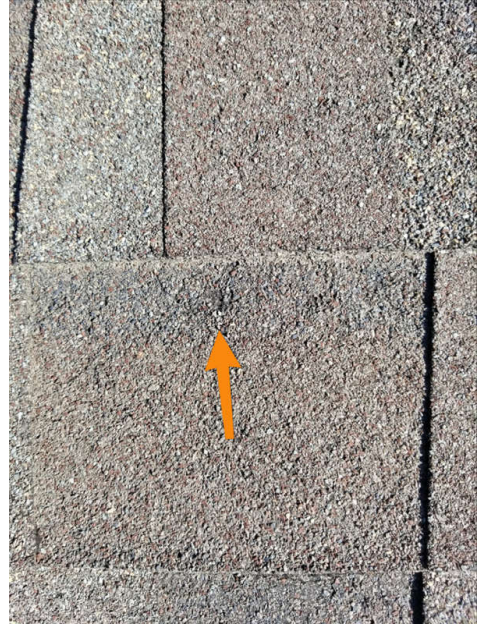
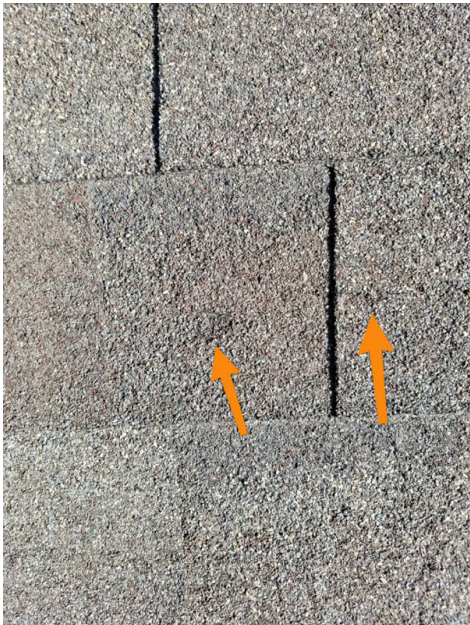
2.1.1 Coverings

DAMAGED (HAIL)

Roof coverings showed moderate damage. Consistent with hailstorm damage Recommend a qualified roofing professional evaluate and repair.

Recommendation
 Contact a qualified roofing professional.

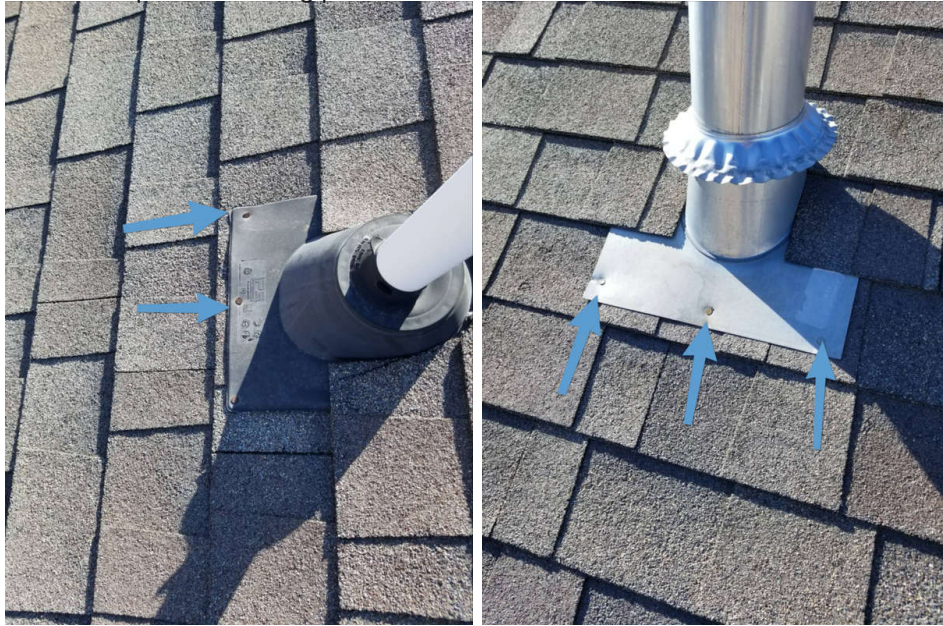
2.1.2 Coverings

NAIL HEADS NEED CAULKING

There are some exposed nailheads on the roof. Recommend sealing.

Recommendation

Contact a qualified roofing professional.

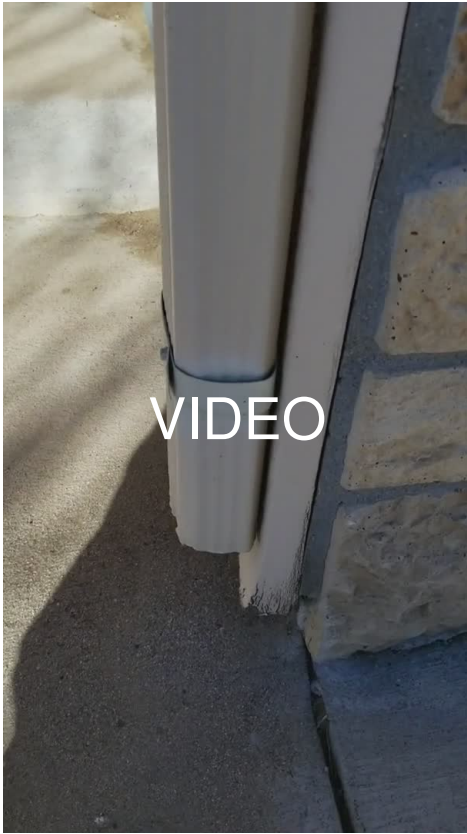
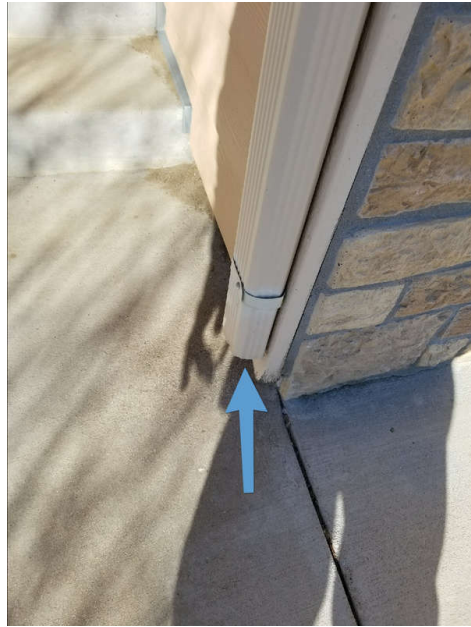
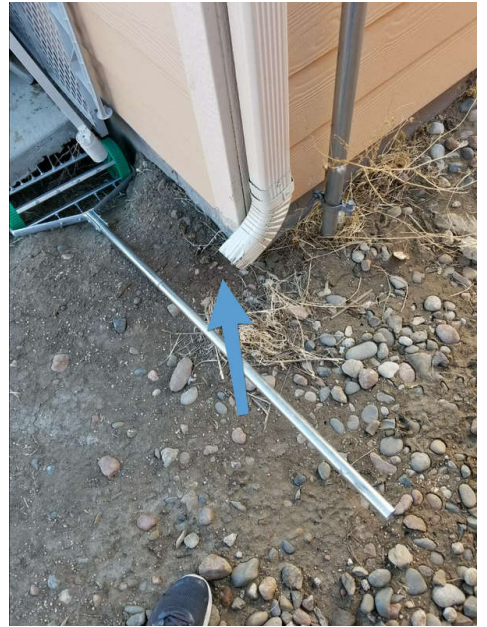
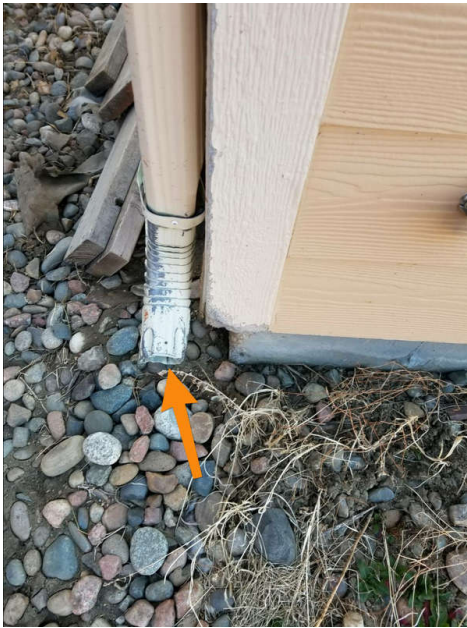
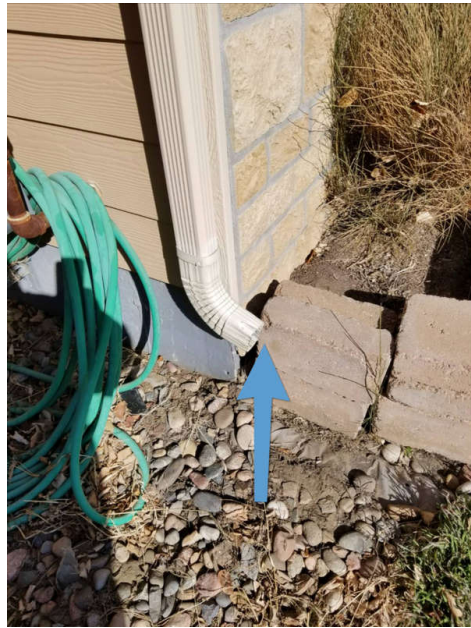
2.2.1 Roof Drainage Systems

DOWNSPOUTS DRAIN NEAR HOUSE

NORTH SOUTH WEST EAST

One or more downspouts drain too close to the home's foundation. This can result in excessive moisture in the soil at the foundation, which can lead to foundation/structural movement. Recommend a qualified contractor adjust downspout extensions to drain at least 6 feet from the foundation.

Contact a qualified roofing professional.

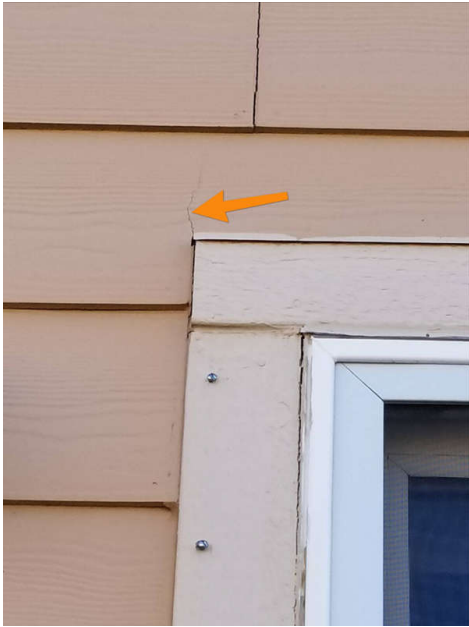
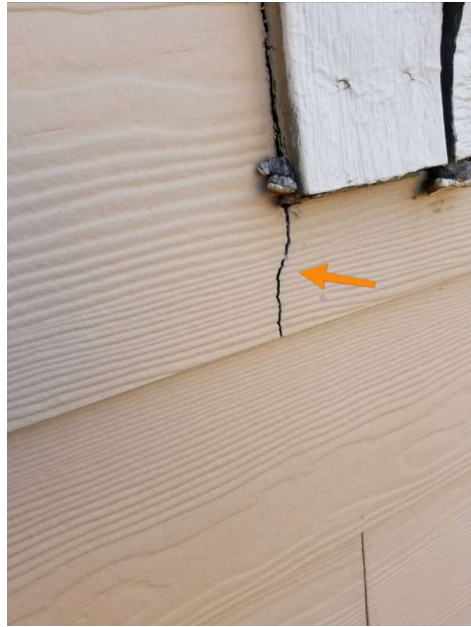
3.1.1 Siding, Flashing & Trim

SPLITTING

NORTH EAST

Siding shingles was splitting in one or more areas, which can lead to moisture intrusion and/or mold. Recommend monitoring for excessive splitting, in which case a qualified siding contractor should evaluate and repair/replace.

Recommendation
Contact a qualified professional.

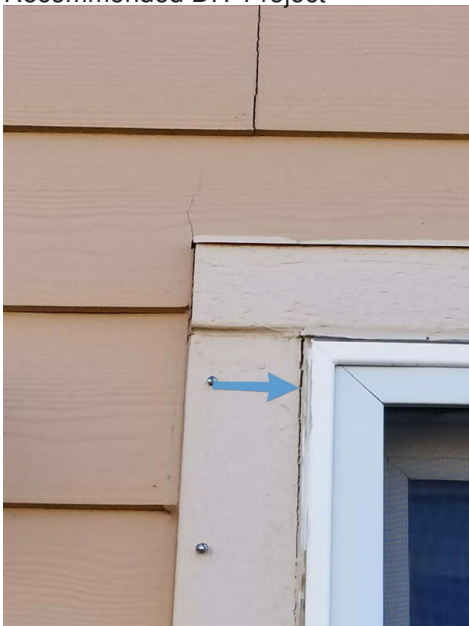
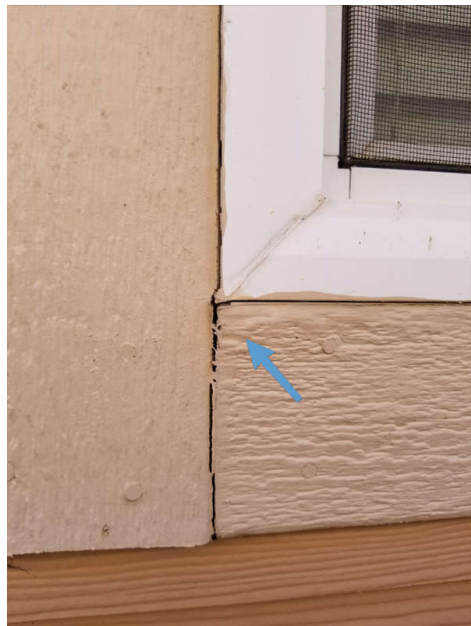
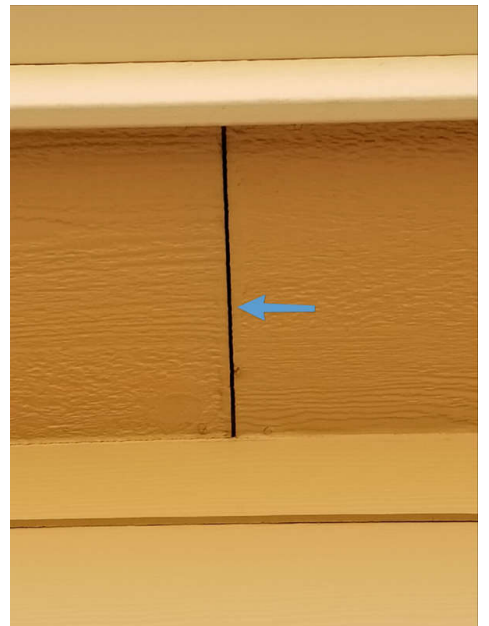
3.1.2 Siding, Flashing & Trim **CAULKING AND SEALING**

NORTH SOUTH WEST EAST

Recommend caulking maintenance around the exterior windows, door frames, trim and plumbing penetrations as needed.

Recommendation
Recommended DIY Project

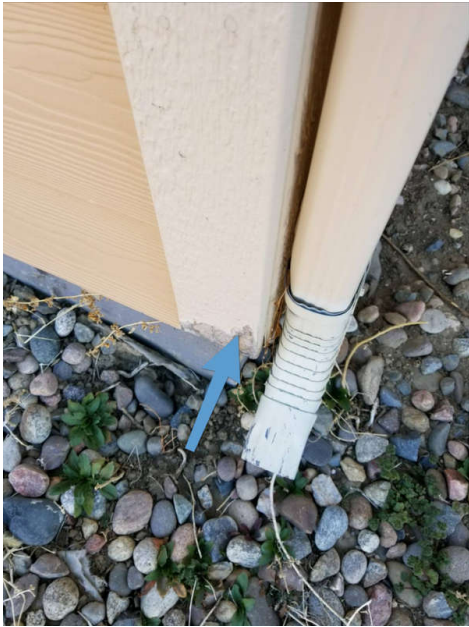
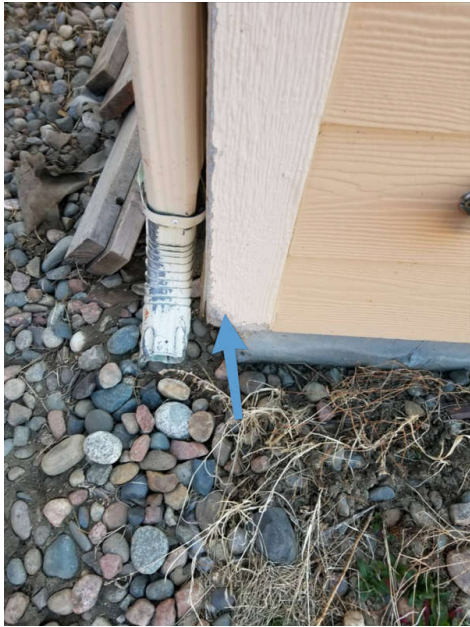
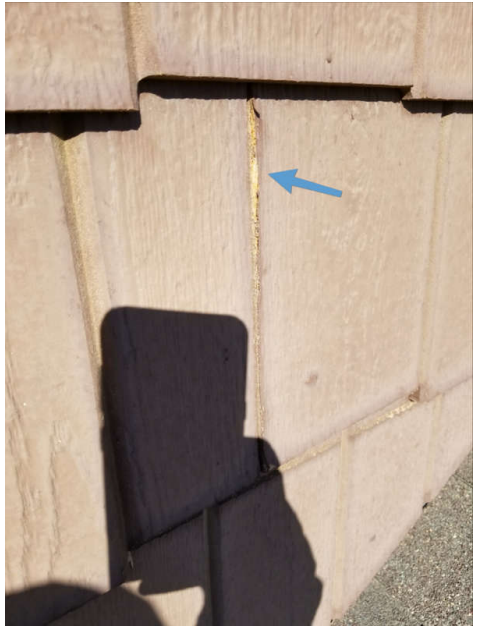
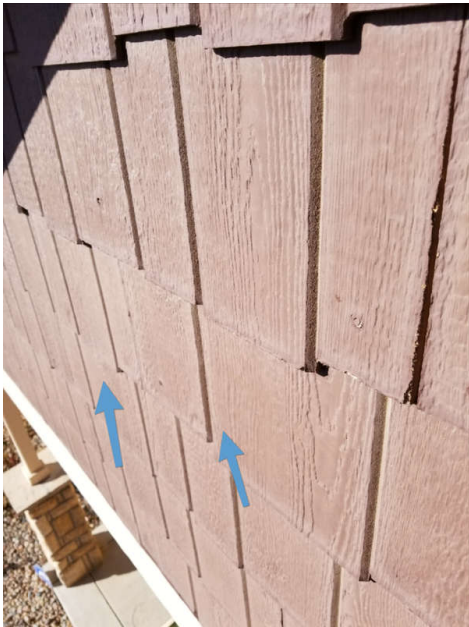
3.1.3 Siding, Flashing & Trim **PEELING/FADDING EXTERIOR PAINT**

There appears to be some exposed wood/peeling/fading paint recommend repainting as needed.

Recommendation
Contact a qualified painter.

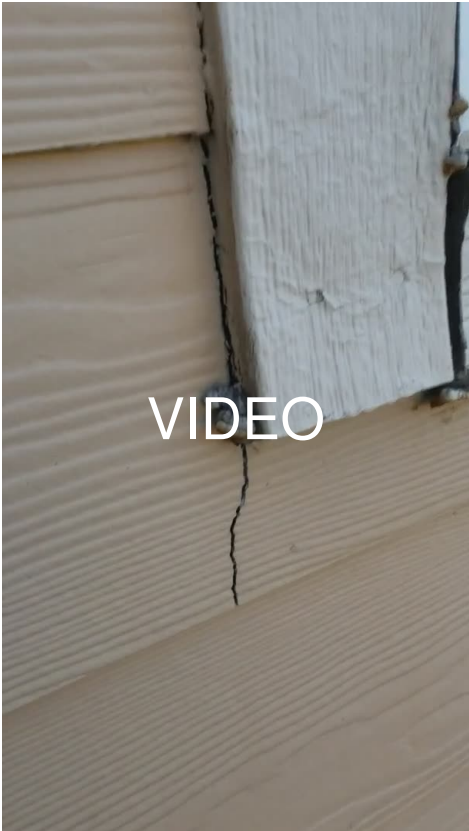
3.1.4 Siding, Flashing & Trim

ROTTING TRIM

NORTH

The exterior trim boards Around the exterior of the home appear to have some visible rot recommend replacement as needed.

Contact a qualified professional.

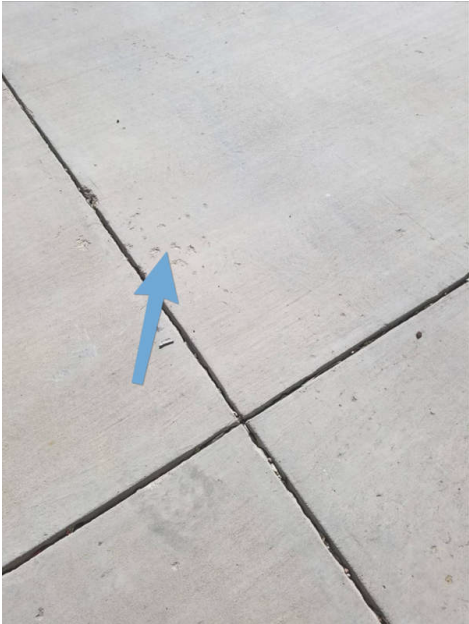
DRIVEWAY CRACKING - MINOR

Minor cosmetic cracks observed, which may indicate movement in the soil. Recommend monitor and/or have concrete contractor patch/seal.

Contact a qualified concrete contractor.

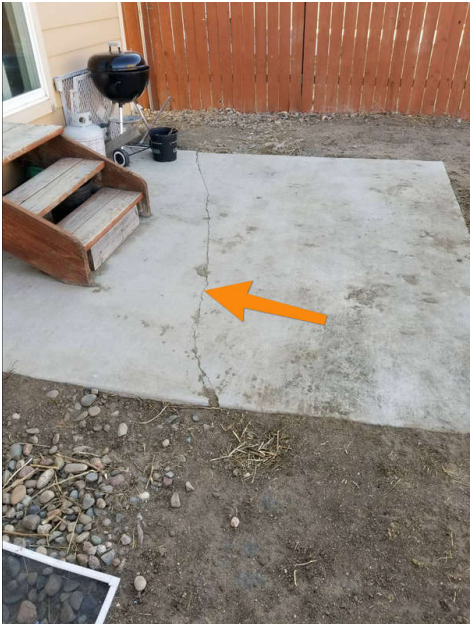
3.3.2 Walkways, Patios & Driveways

PATIO CRACKING - MINOR

NORTH

Normal settling & cracking observed. Recommend monitor and/or patch/seal.

Recommended DIY Project

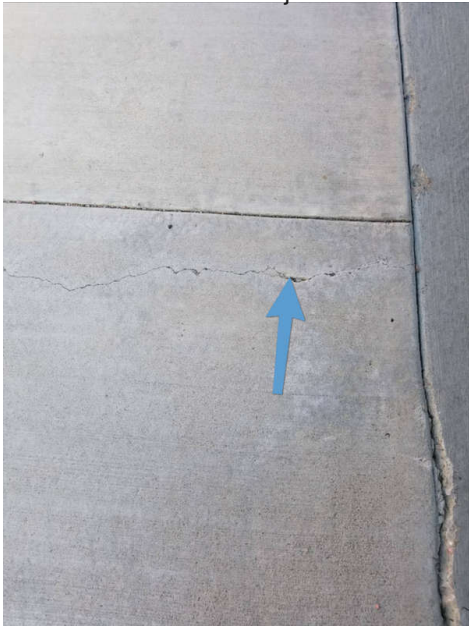
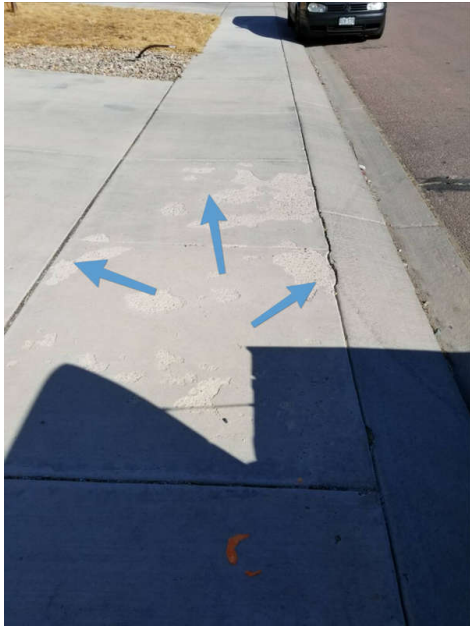
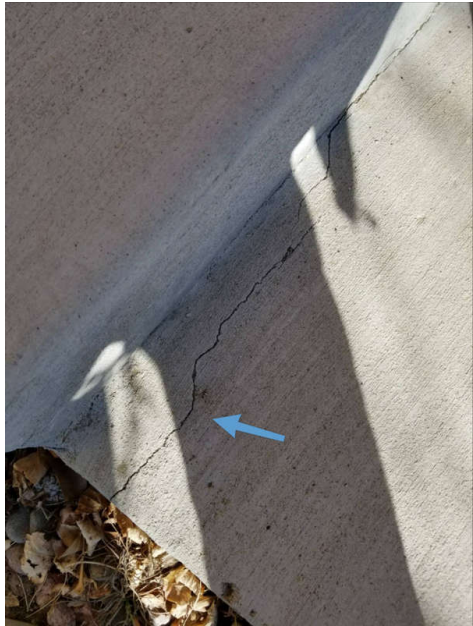
WALKWAY CRACKING - MINOR

Minor cosmetic cracks observed. Recommend monitor and/or patch/seal.

Recommendation
Recommended DIY Project

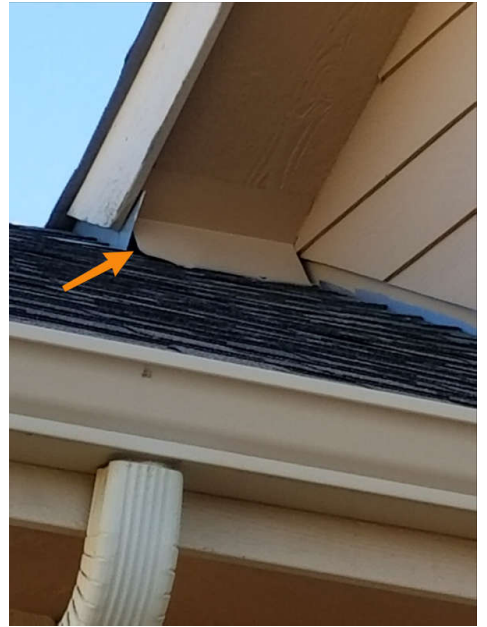
3.5.1 Eaves, Soffits & Fascia

GAP

NORTHEAST

There is opening, gap or hole in fascia / soffit which should be repaired. This can allow water intrusion and rodent infestation as well as deterioration of the surrounding material.

Contact a qualified roofing professional.

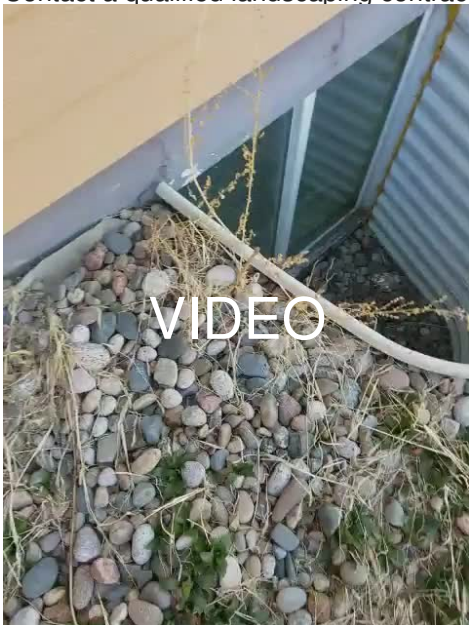
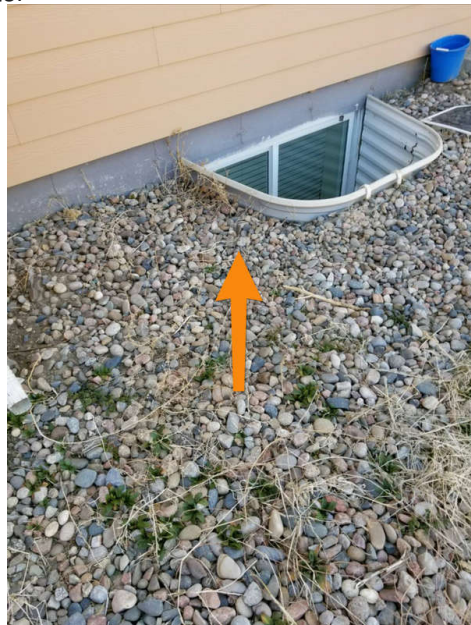
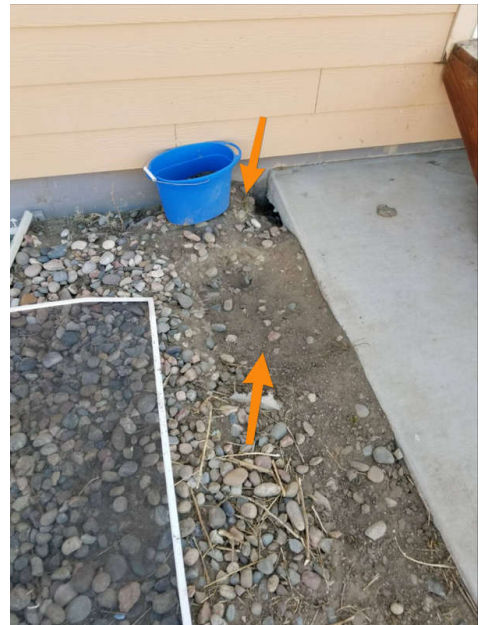
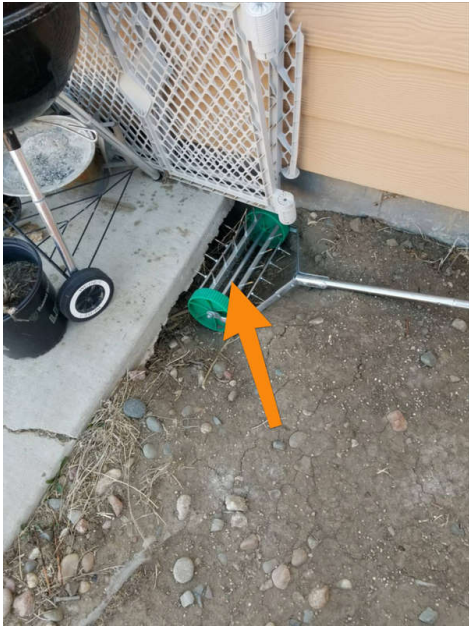
3.6.1 Vegetation, Grading, Drainage & Retaining Walls

NEGATIVE GRADING

NORTH WEST EAST

Grading is sloping towards the home in some areas. This could lead to water intrusion and foundation issues. Recommend qualified landscaper or foundation contractor regrade so water flows away from home.

Contact a qualified landscaping contractor

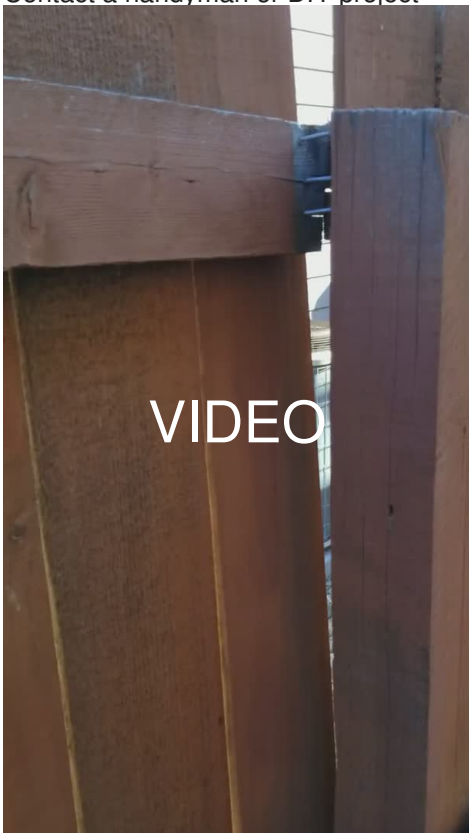
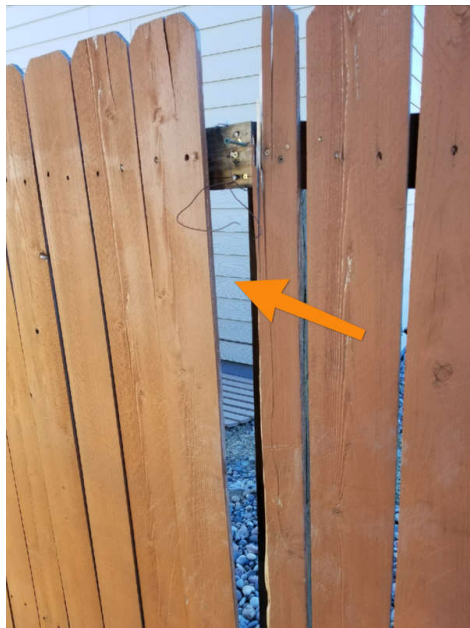
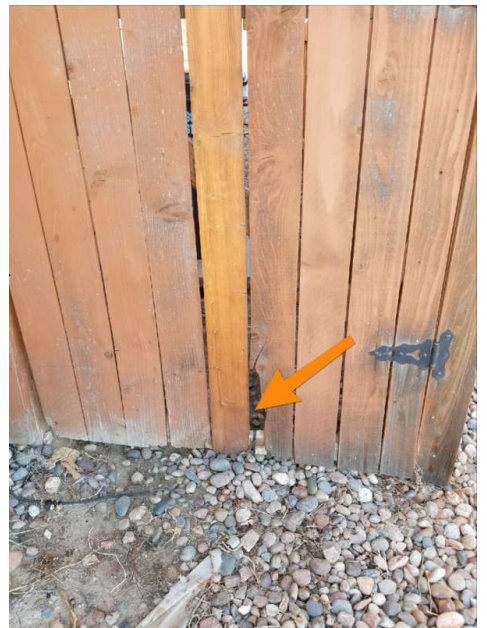
3.6.2 Vegetation, Grading, Drainage & Retaining Walls
EXTERIOR FENCING WORN, DAMAGED

NORTH WEST EAST

The exterior fencing had some wear and damaged pickets. Recommend repair as needed.

Contact a handyman or DIY project

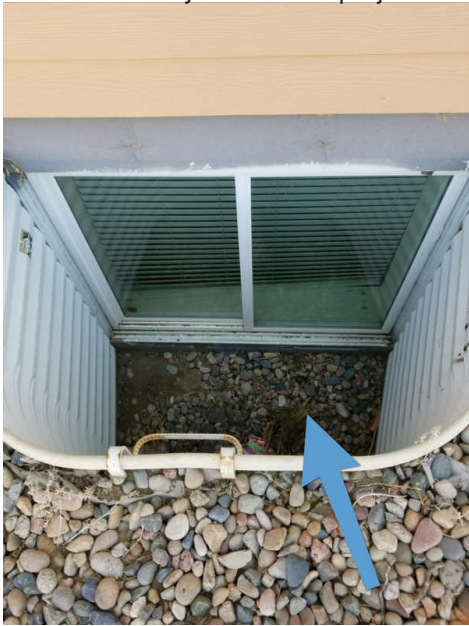
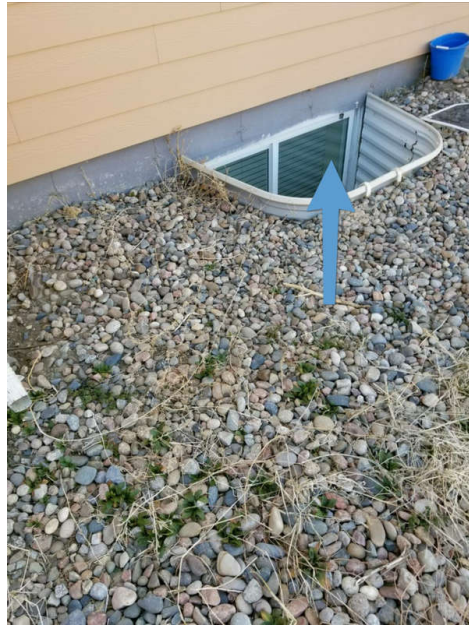
WINDOW WELL COVERS

NORTH EAST WEST

Recommend adding window well covers as needed.

Contact a handyman or DIY project

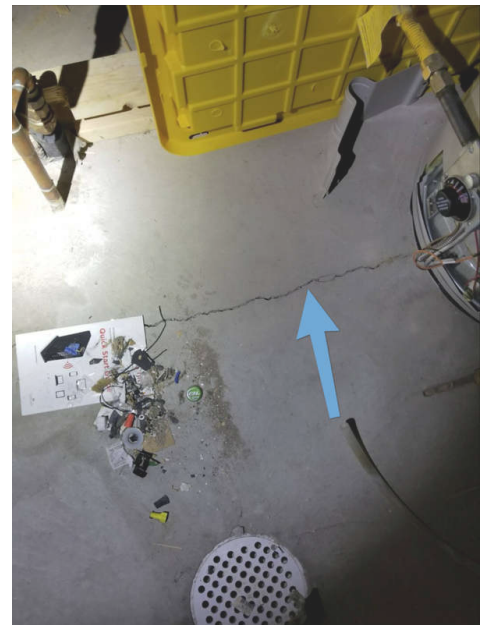
4.3.1 Floor Structure

MINOR CONCRETE SLAB SHIFTING/CRACKING

BY WATER HEATER

Concrete slab was found to be shifting/cracking at the floor structure. This can be caused by soil movement. Recommend sealing the crack and monitoring.

Contact a qualified concrete contractor.

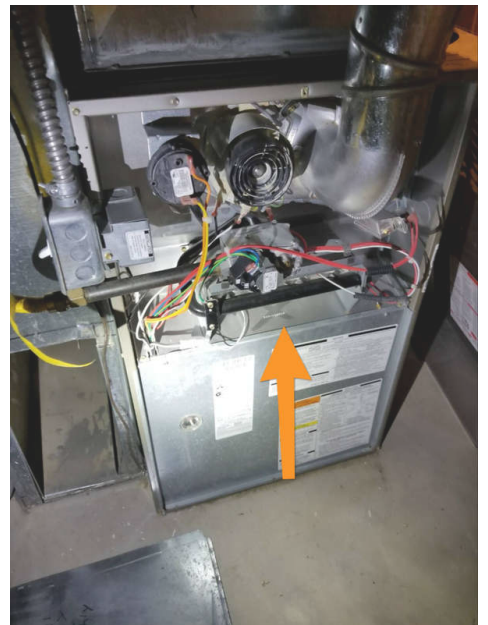
5.1.2 Equipment

NEEDS SERVICING/CLEANING

Furnace should be cleaned and serviced annually. Recommend a qualified HVAC contractor clean, service and certify furnace.

Contact a qualified HVAC professional.

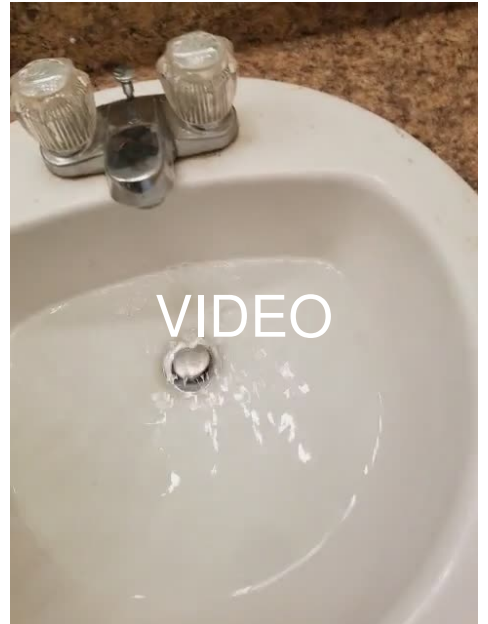
7.2.1 Drain, Waste, & Vent Systems

SINK - POOR DRAINAGE

N NORTH MASTER BATHROOM

Sink had slow/poor drainage. Recommend a qualified plumber repair.

Contact a qualified plumbing contractor.

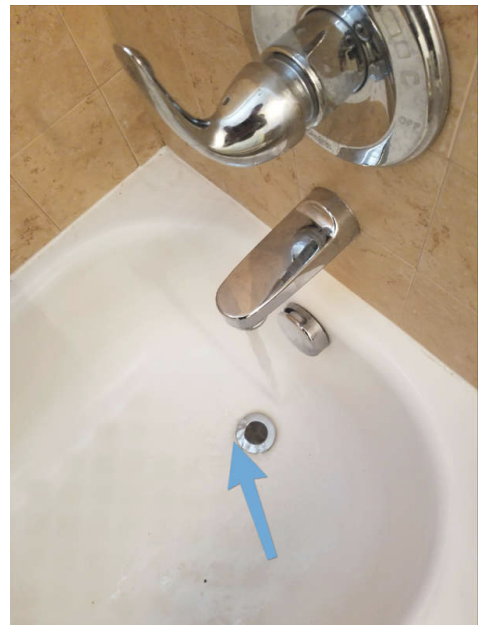
7.2.2 Drain, Waste, & Vent Systems

TUB DRAIN STOPPER INOPERABLE

1ST FLOOR HALL BATHROOM BASEMENT BATHROOM

The tub drain stopper is loose therefore not long it to seal properly
recommend repair

Contact a qualified professional.

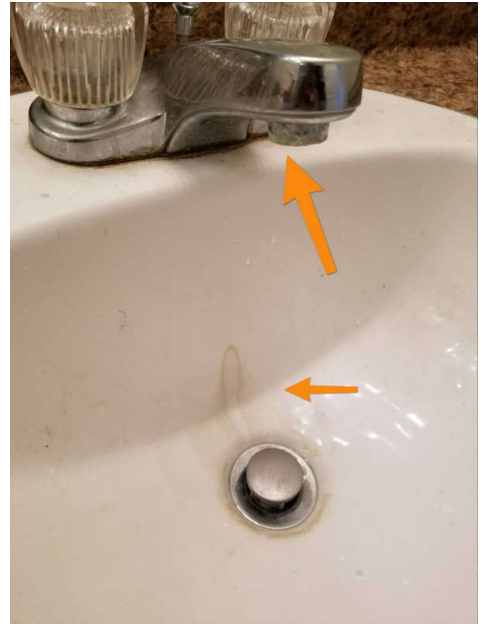
7.3.1 Water Supply, Distribution Systems & Fixtures

FAUCET/ VALVE IS LEAKING

NORTH MASTER BEDROOM

The faucet appears to be leaking at the time of the inspection;
recommend repair as needed.

Contact a qualified plumbing contractor.

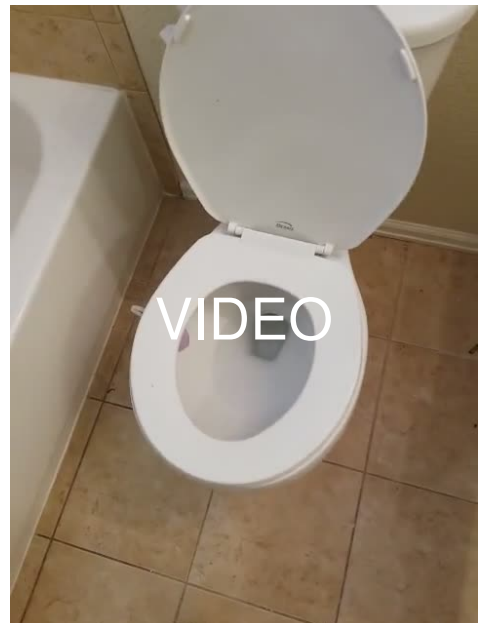
7.3.2 Water Supply, Distribution Systems & Fixtures

TOILET LOOSE

1ST FLOOR HALL BATHROOM

It appears the toilet is not secure properly to the floor recommend tightening.

Contact a handyman or DIY project

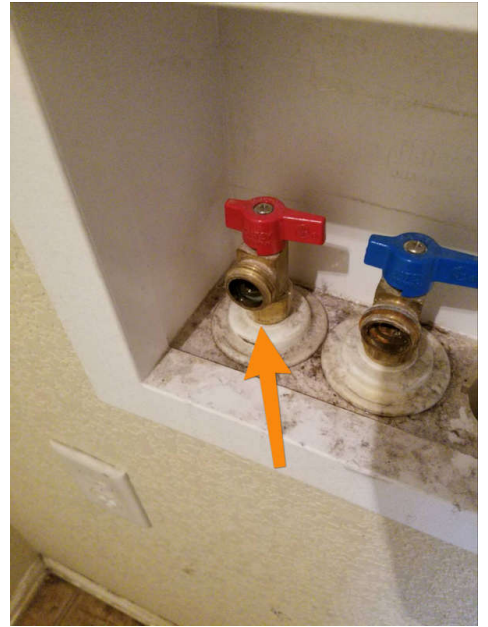
7.3.3 Water Supply, Distribution Systems & Fixtures

VALVE IS LEAKING

LAUNDRY ROOM HOT SIDE

The valve appears to be leaking at the time of the inspection; recommend repair as needed.

Contact a qualified plumbing contractor.

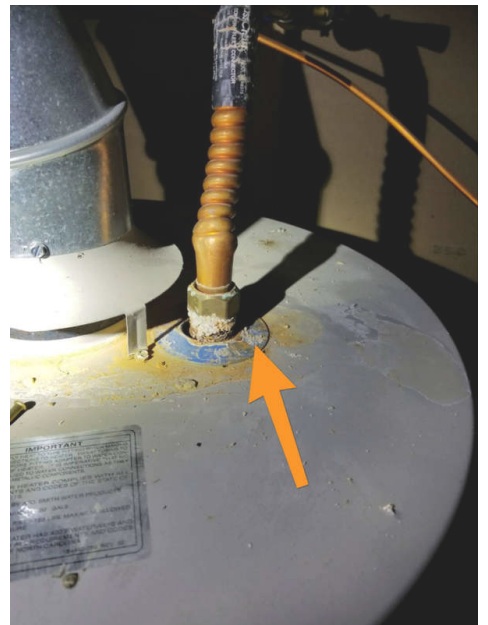
7.4.1 Hot Water Systems, Controls, Flues & Vents

CORROSION

Corrosion was noted at the burn chamber or pipe fittings. Recommend a qualified plumber evaluate for repair/replacement.

Contact a qualified plumbing contractor.

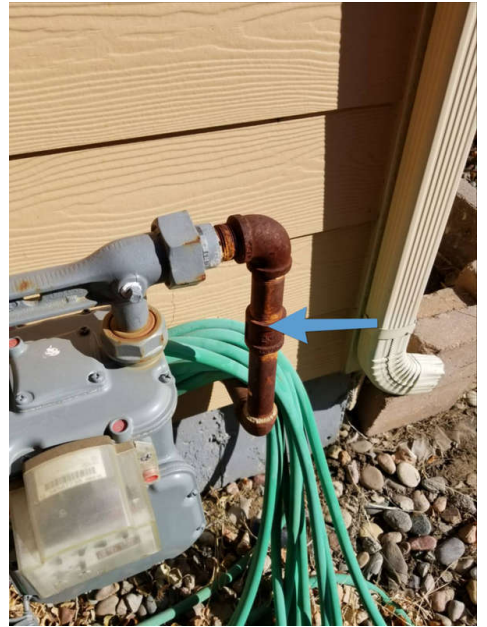
7.5.1 Fuel Storage & Distribution Systems

CORROSION

Gas pipes were corroded. Recommend contacting local utility company for evaluation and repair as needed.

Contact a qualified professional.

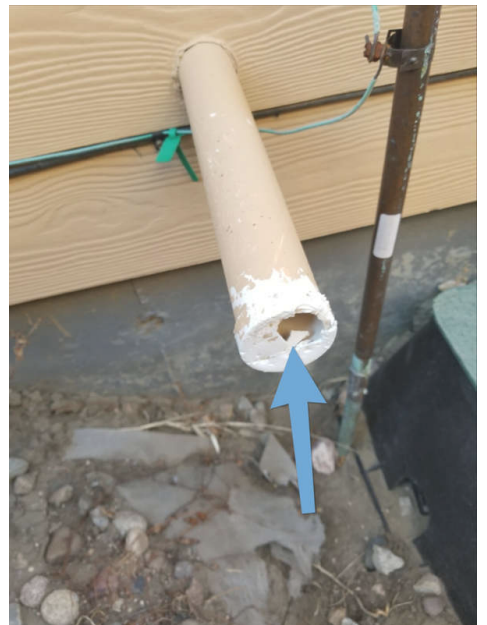
7.6.1 Sump Pump
DRAIN BROKEN

The exterior sump pump drain pipe appears to be broken recommend repair as needed.

Recommendation
Contact a qualified professional.

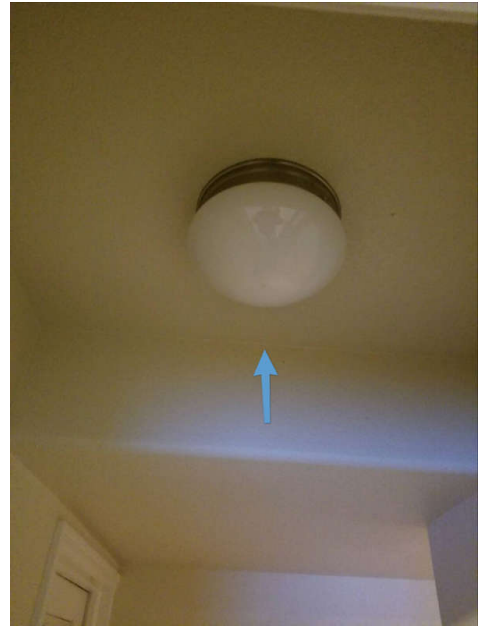
8.4.1 Lighting Fixtures, Switches & Receptacles
LIGHT INOPERABLE

BASEMENT BEDROOM HALLWAY, UTILITIES ROOM

One or more lights are not operating. New light bulb possibly needed.

Recommendation
Contact a qualified electrical contractor.

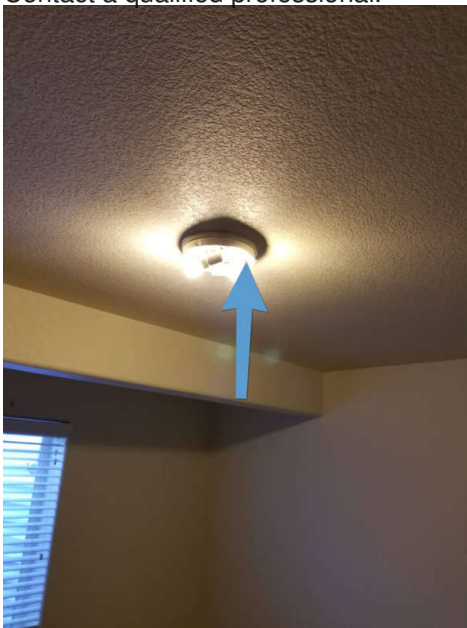
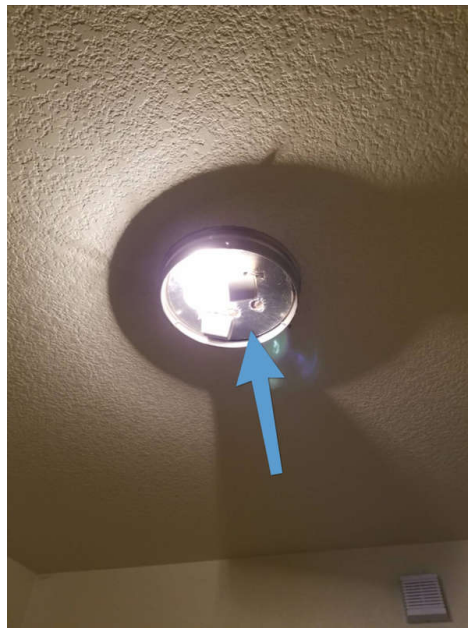
8.4.2 Lighting Fixtures, Switches & Receptacles

DAMAGED LIGHT FIXTURE

BASEMENT BEDROOM NORTHEAST, LAUNDRY ROOM

The light fixture or coverings appear to be damaged at the time of the inspection recommend repair as needed.

Recommendation
Contact a qualified professional.

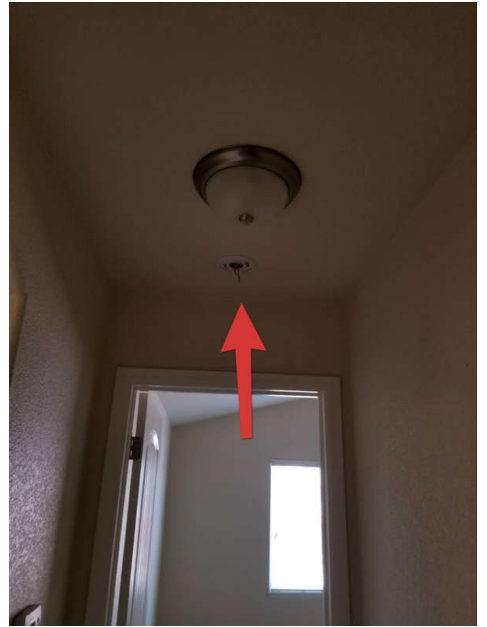
8.6.1 Smoke Detectors

MISSING

1ST FLOOR HALLWAY

There appears to be missing smoke detectors throughout the property.

Recommendation
Contact a qualified professional.

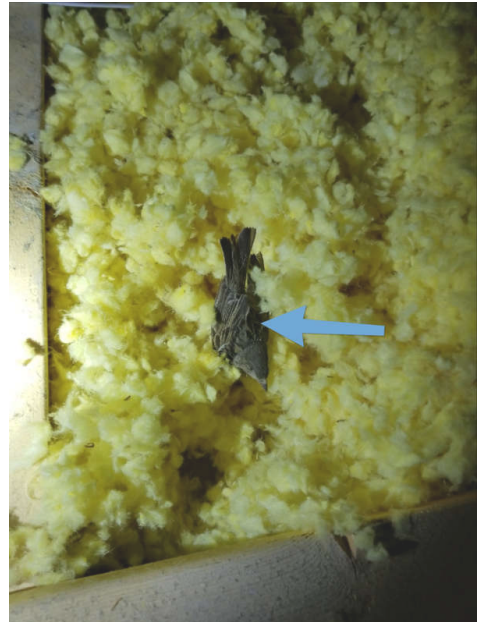
9.1.1 Attic Insulation

DEAD BIRD

There is a dead bird in the attic recommend removing.

Contact a handyman or DIY project

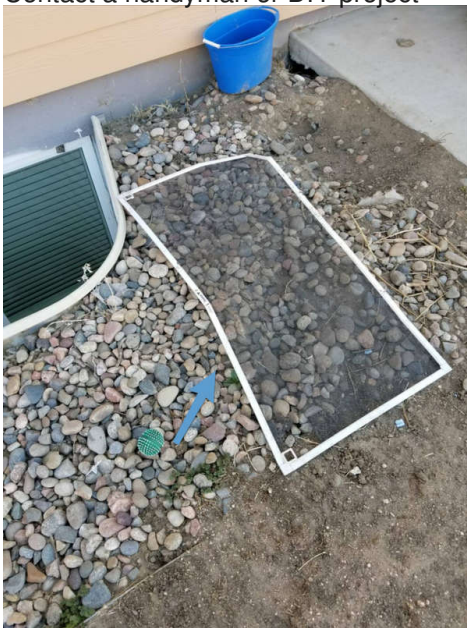
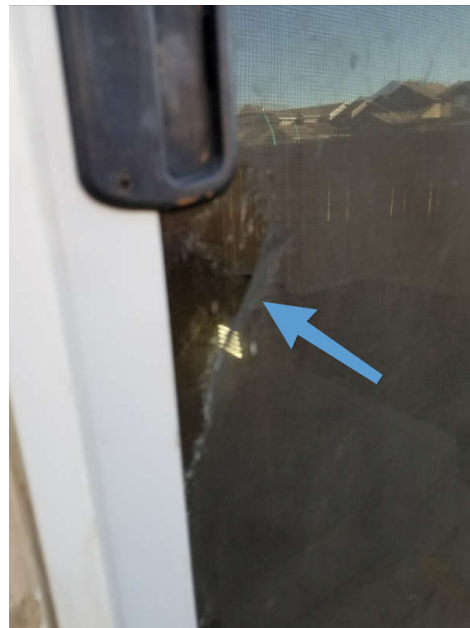
10.2.1 Windows

TORN SCREENS

NORTH

There appears to be some torn screens recommend rescreening.

Contact a handyman or DIY project

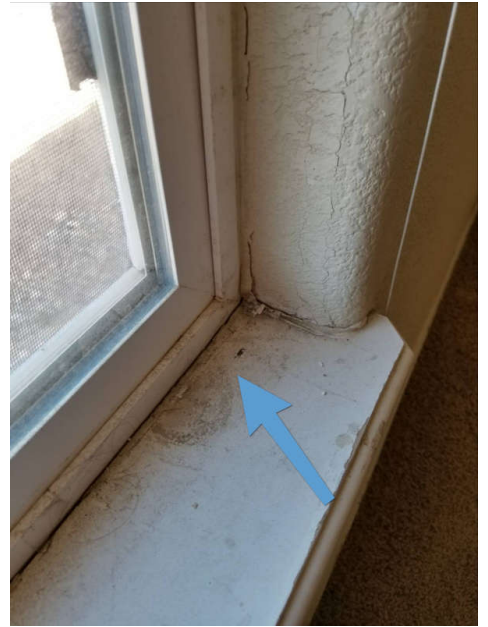
10.2.2 Windows

MOISTURE DAMAGE ON SILL

MASTER BEDROOM

There appears to be some moisture damage on the window sill recommend repair as needed.

Contact a qualified window repair/installation contractor.

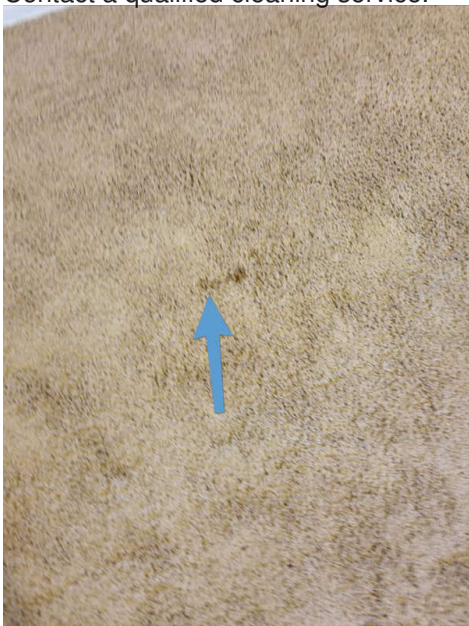
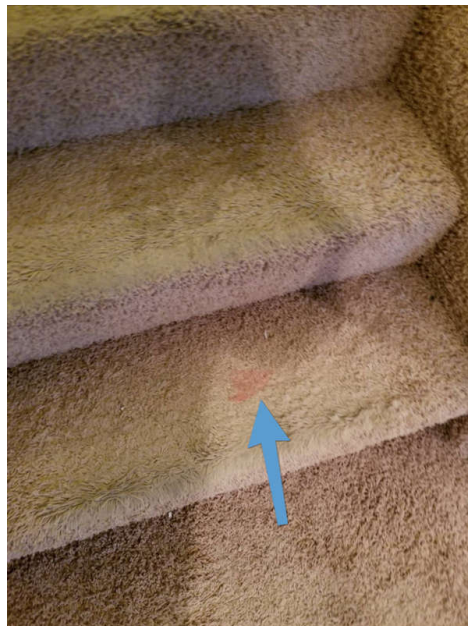
10.3.1 Floors

CARPET STAINS

THROUGHOUT THE HOME

Carpet had areas of staining or discoloration. Recommend a thorough steam clean by a qualified carpet cleaning company

Contact a qualified cleaning service.

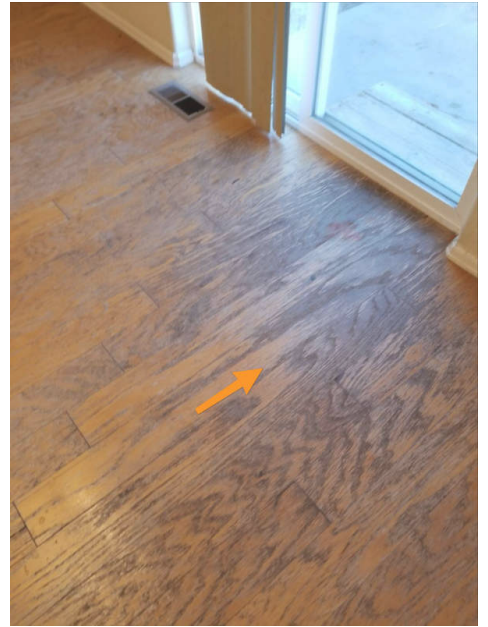
10.3.2 Floors

MODERATE WEAR

DINING ROOM

Floors in the home exhibited moderate surface wear along major paths of travel. Recommend a qualified flooring contractor evaluate for possible re-finish.

Recommendation
Contact a qualified flooring contractor

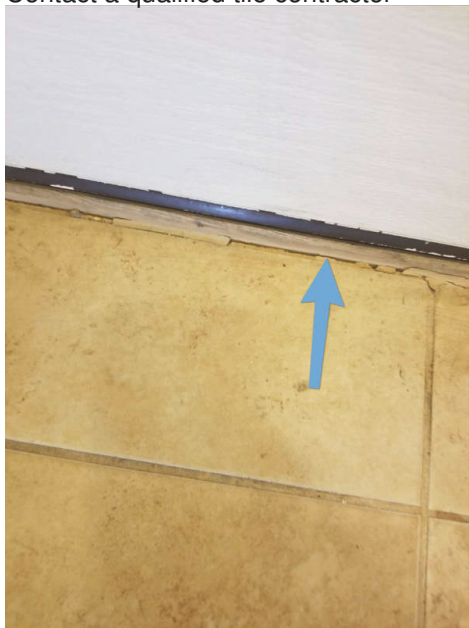
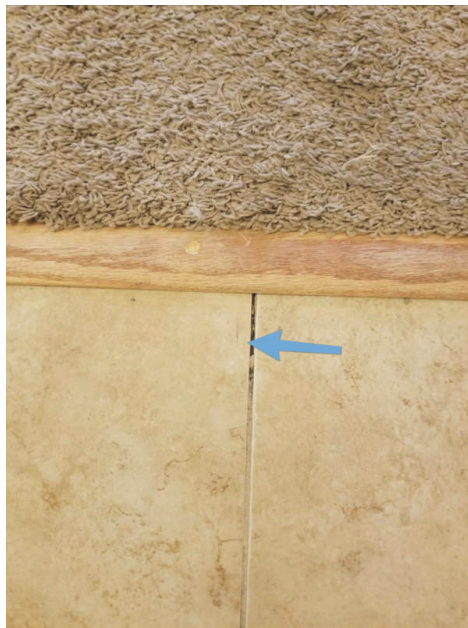
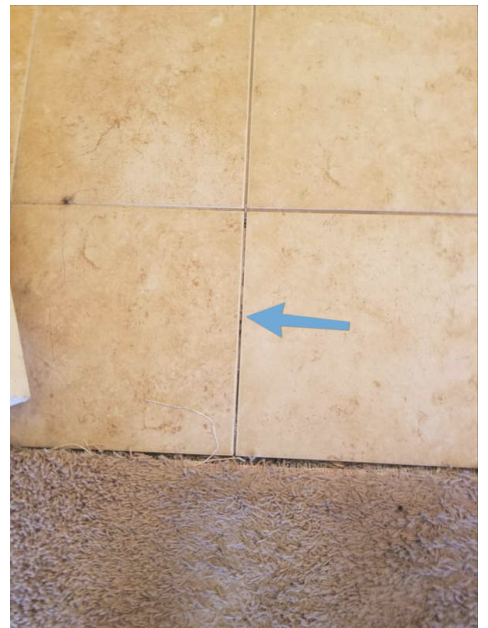
10.3.3 Floors

GROUT NEEDED

1ST FLOOR ENTRY, MASTER BATHROOM

The grout on the floor tiles needs to be repaired or replaced.

Recommendation
Contact a qualified tile contractor

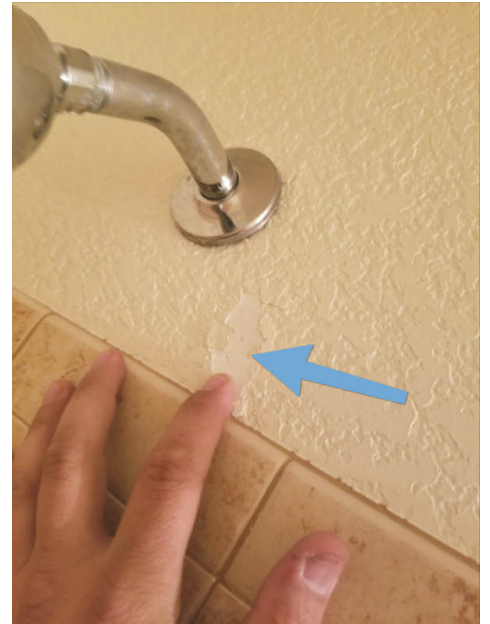
10.4.1 Walls

MOISTURE DAMAGE

BASEMENT BATHROOM

Stains on the walls visible at the time of the inspection appeared to be the result of moisture intrusion. The source of moisture may have been corrected. Recommend further examination by a qualified contractor to provide confirmation.

Recommendation
Contact a qualified professional.

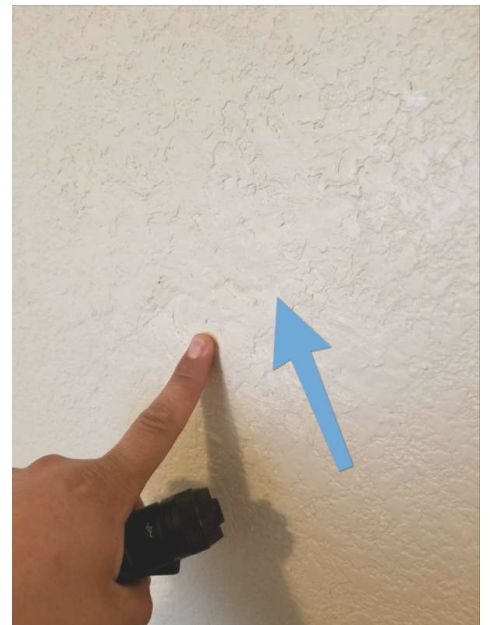
10.4.2 Walls

POOR PATCHING

SOUTHWEST BEDROOM

Sub-standard drywall patching observed at time of inspection.
Recommend re-patching.

Recommendation
Contact a qualified drywall contractor.

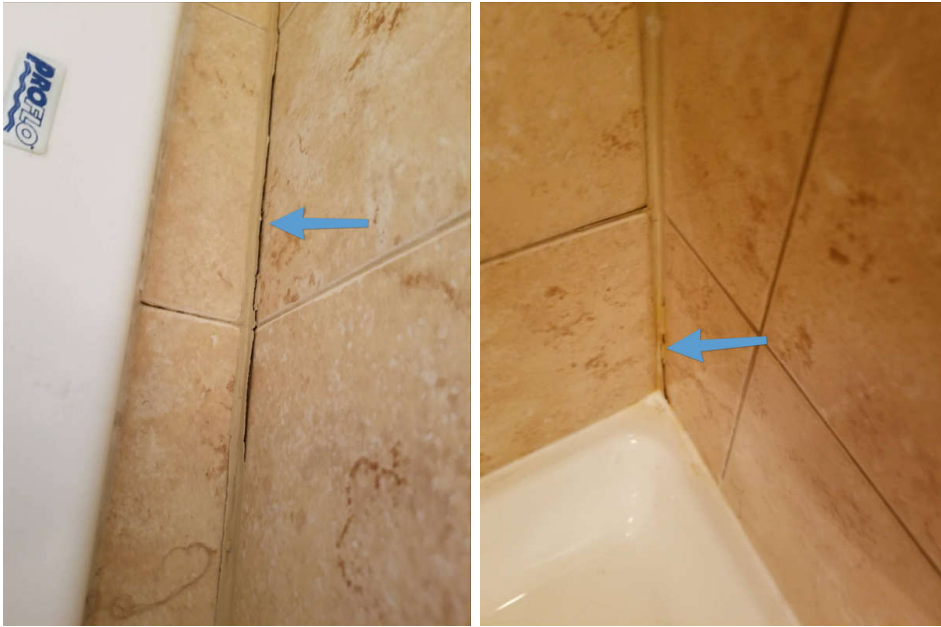
10.4.3 Walls

CAULKING MAINTENANCE

MASTER BATHROOM

The caulking Has some visible separation and cracking recommend resealing as needed.

Recommendation
Recommended DIY Project

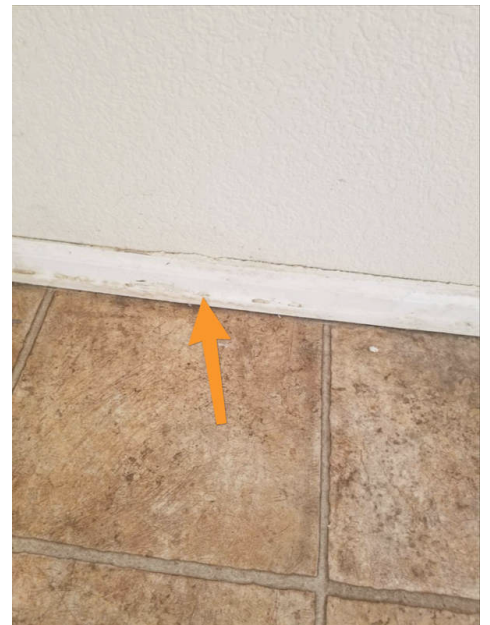
10.4.4 Walls

MOISTURE STAINING

LAUNDRY ROOM

There appears to be some visible moisture staining at time inspection recommend repair as needed.

Contact a qualified professional.

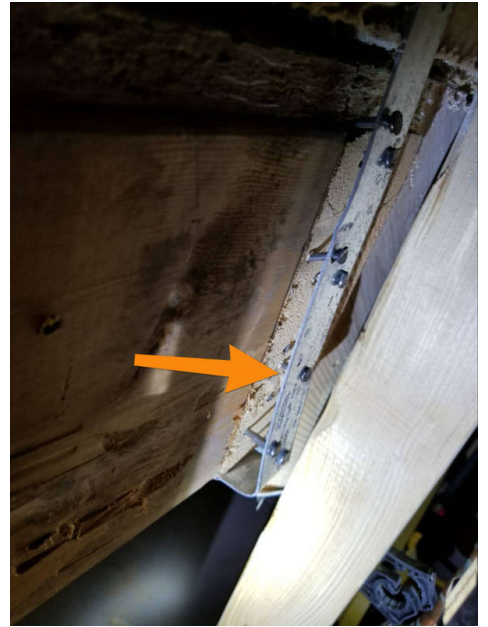
10.6.1 Steps, Stairways & Railings

SUPPORT STRAP LOOSE

The staircase support strap appears to be coming loose recommend re attaching.

Contact a qualified professional.
