SUMMARY
 1234 Main St. Colorado Springs CO
 80916
 Buyer Name
 03/14/2018 9:00AM

Mark Jones
 Certified Master Inspector, CPI, AHIT
 Springs Top Inspector LLC
 7193597363
springstopinspector@gmail.com

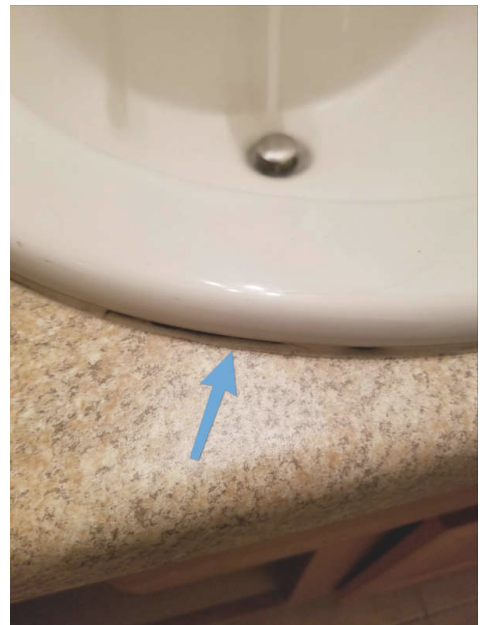
10.7.1 Countertops & Cabinets

POOR/MISSING CAULK

BASEMENT BATHROOM

Bathroom countertop was missing sufficient caulk/sealant at the wall. This can lead to water damage. Recommend adding sealant at sides and corners where counters touch walls.

Recommendation
Recommended DIY Project

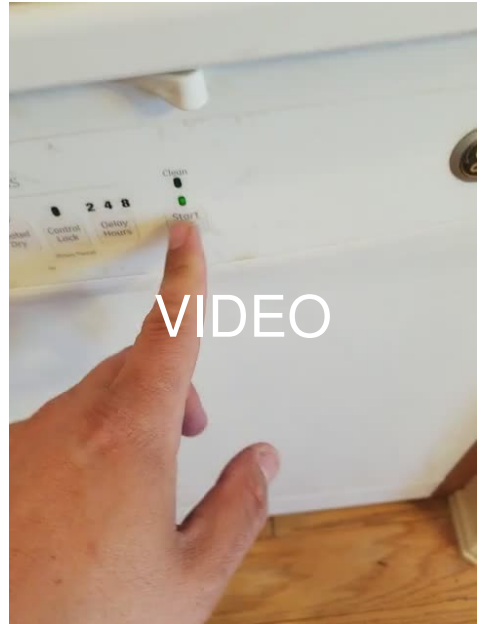
11.1.1 Dishwasher

INOPERABLE

Dishwasher was inoperable using standard controls. Recommend a qualified plumber or contractor evaluate.

Recommendation
Contact a qualified professional.

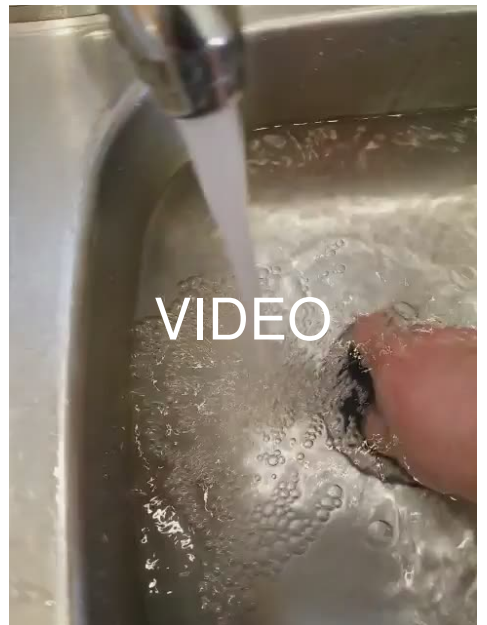
11.4.1 Garbage Disposal

LEAKING

The garbage disposal is leaking and would not turn on recommend replacement.

Contact a qualified plumbing contractor.

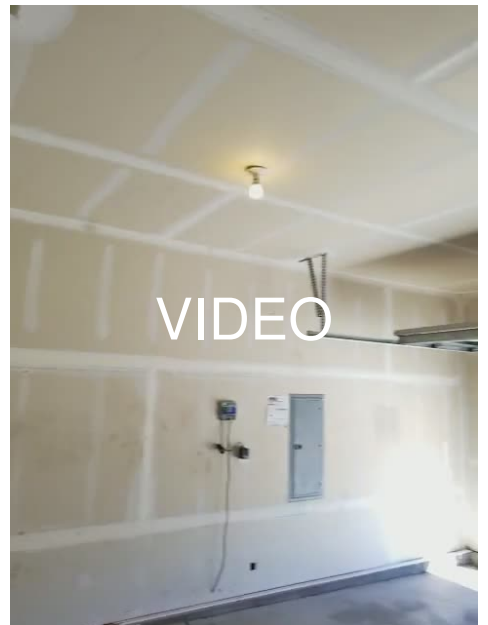
12.4.2 Garage Door

LOUD NOISES

Loud grinding or squealing observed when opening/closing garage door. This can be due to dirt or debris in the track or lack of lubrication. Recommend cleaning the track and lubricating.

Contact a qualified garage door contractor.

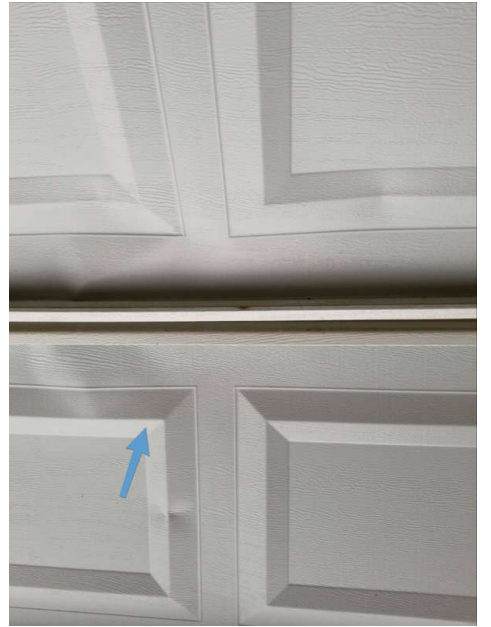
12.4.3 Garage Door

PANEL DAMAGE

Garage door panel is damaged and may need repair/replacement. Recommend a qualified garage door contractor evaluate.

Contact a qualified garage door contractor.
