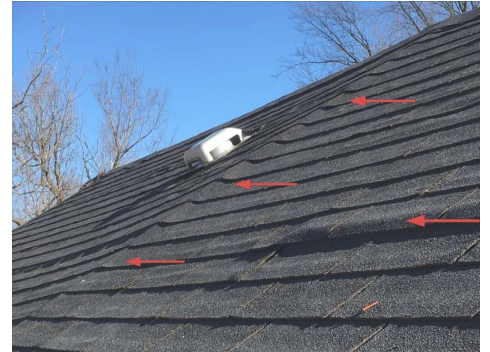
2.1.1 Coverings

DAMAGED (GENERAL)

Roof coverings showed damage. Recommend a qualified roofing professional evaluate and repair. Expect replacement within 0-1 years

Contact a qualified roofing professional.

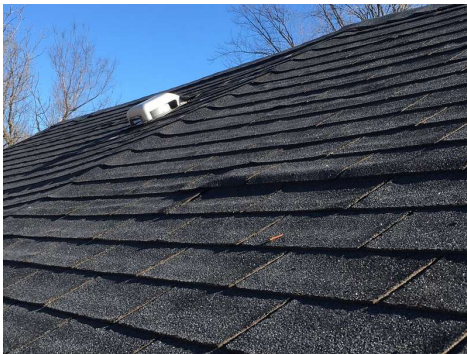
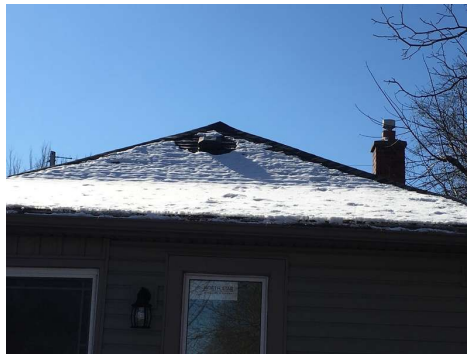
2.1.2 Coverings

AGING

Budget for replacement.

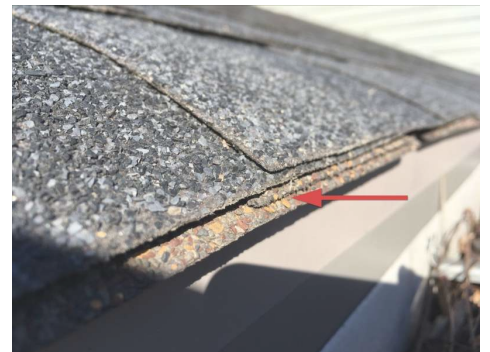
2.1.3 Coverings

NEW LAYER INSTALLED ON OLD SHINGLES

Reduced life span approx 10 years max

Contact a qualified professional.

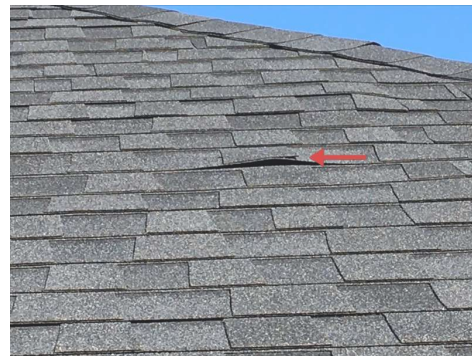
2.1.4 Coverings

SHINGLES LIFTING

FRONT

Recommendation
Contact a qualified professional.

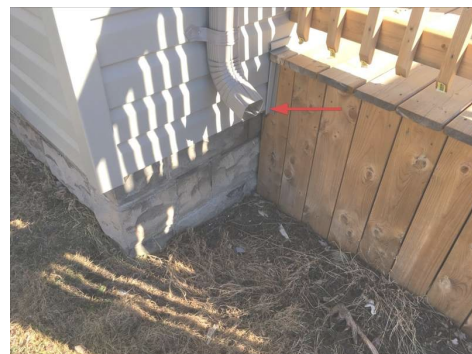
2.2.1 Roof Drainage Systems

DOWNSPOUTS DRAIN NEAR HOUSE

One or more downspouts drain too close to the home's foundation. This can result in excessive moisture in the soil at the foundation, which can lead to foundation/structural movement. Recommend a qualified contractor adjust downspout extensions to drain at least 6 feet from the foundation.

Recommendation
Contact a qualified roofing professional.

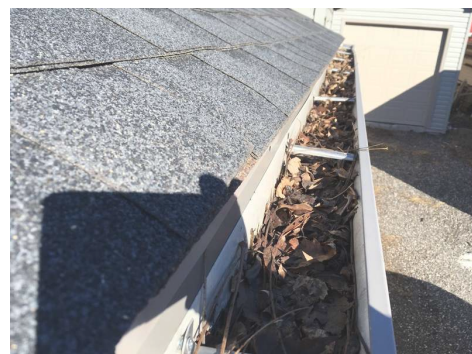
2.2.2 Roof Drainage Systems

DEBRIS

Debris has accumulated in the gutters. Recommend cleaning to facilitate water flow.

Recommendation
Contact a qualified roofing professional.

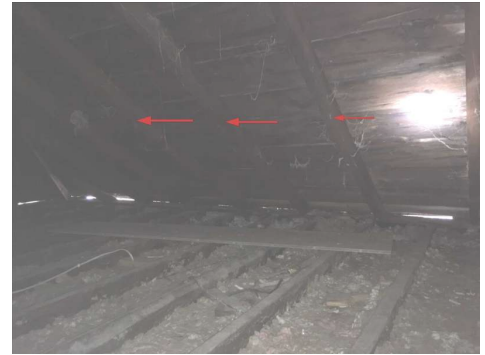
2.5.1 Structure

ROOF SUPPORTS MISSING

Additional roof supports may be required; roof on exterior shows signs of damage; see other roof shingle report.

Kneewall supports may be required to support roof and snow loading

Contact a qualified roofing professional.

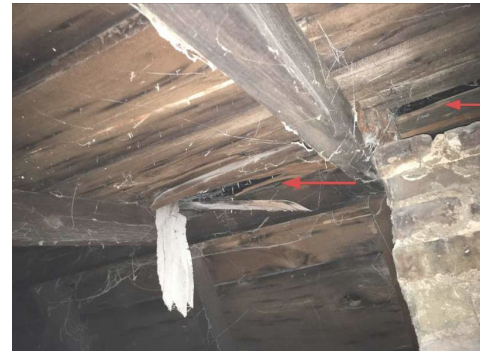
2.5.2 Structure

SHEATHING DAMAGED

Sheathing damaged; repairs required in several locations of roof

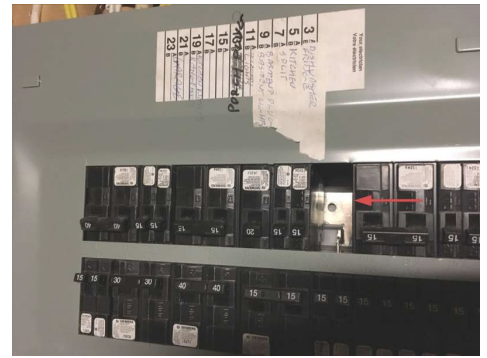
7.2.1 Main & Subpanels, Service & Grounding, Main Overcurrent Device

KNOCKOUTS MISSING

"Knockouts" are missing on the electric panel. This poses a safety hazard and it is recommended that the opening in the panel caused by the missing knockout(s) be properly sealed by a licensed electrician.

Contact a qualified electrical contractor.

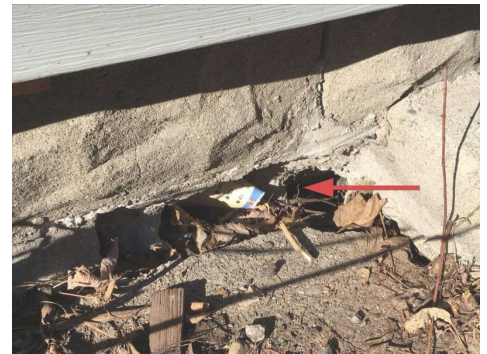
8.1.1 Foundation

FOUNDATION - SEVERE STRUCTURAL ISSUES

Severe structural issues noted at the foundation. Recommend a structural engineer evaluate and provide a report on course of action and remedy.

Contact a qualified structural engineer.

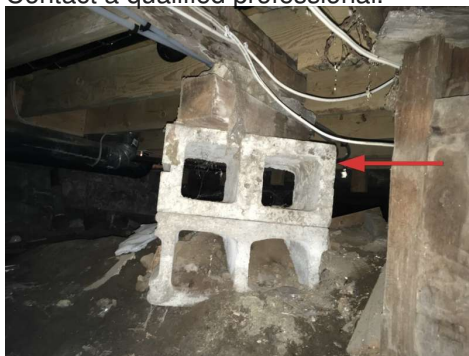
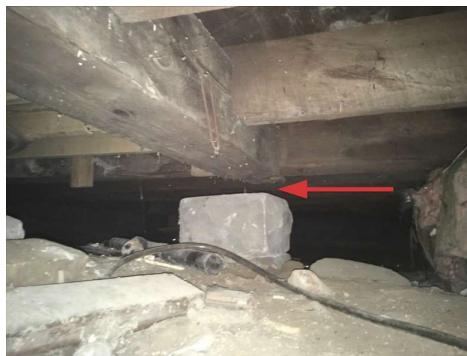
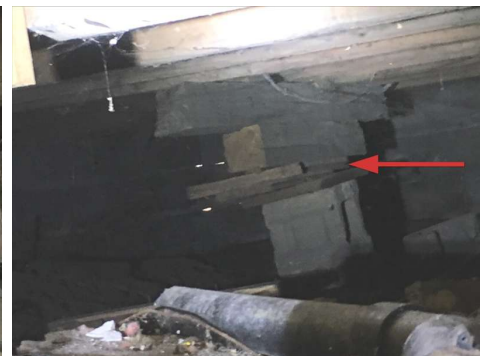
8.1.2 Foundation

IMPROPER STRUCTURAL SUPPORTS

Improper or sub-standard construction practices were noted at the foundation wall or slabs/piers. Recommend a structural engineer evaluate and advise on how to bring the construction up to standards.

Contact a qualified professional.

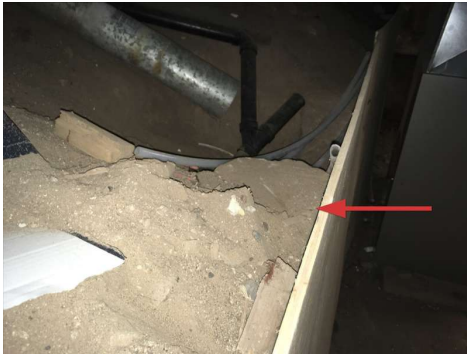
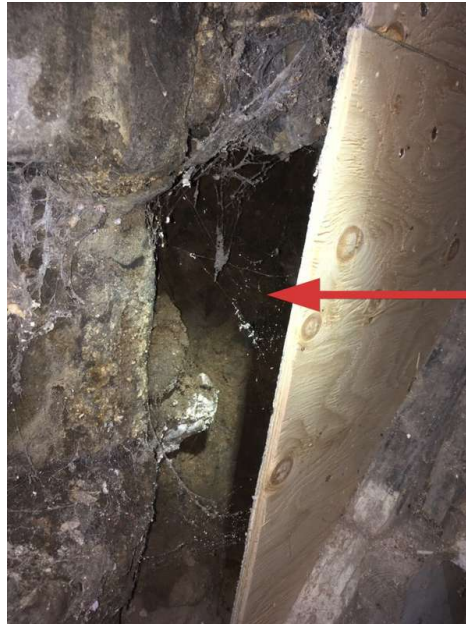
8.1.3 Foundation

WALL(S) NEED STRUCTURAL SUPPORT

Foundation wall requires substantial structural support; expect new concrete foundation to be required in this area.

side of stairs; no able to check other side of stairs due to inaccessibility

Contact a qualified structural engineer.

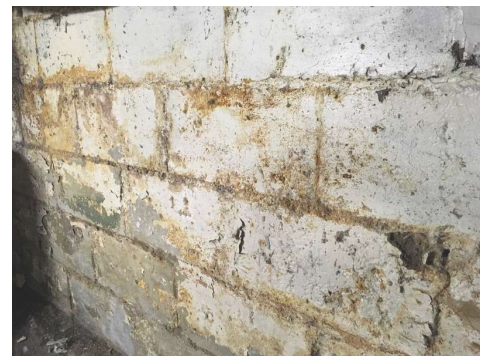
8.2.1 Basements & Crawlspace

EFFLORESCENCE

Efflorescence noted on the wall surface. This a white, powdery deposit that is consistent with moisture intrusion. This can compromise the soil's ability to support the home structure and/or lead to mould growth. This condition results from poor water management on exterior of home. Newer homes have a "weeping tile" system which controls water on the foundation exterior; older homes do not have this system, hence the water penetrates through the concrete or block wall foundation. Water penetration through wall will continue of time with increased damage to foundation wall. Recommend a qualified contractor identify source of moisture and correct.

Contact a qualified professional.

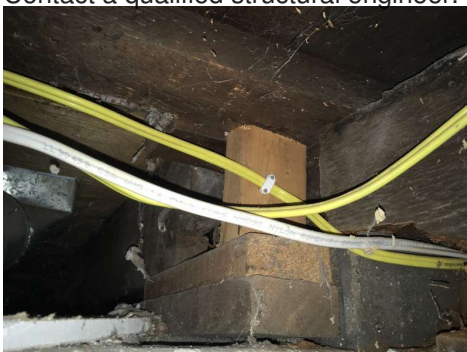
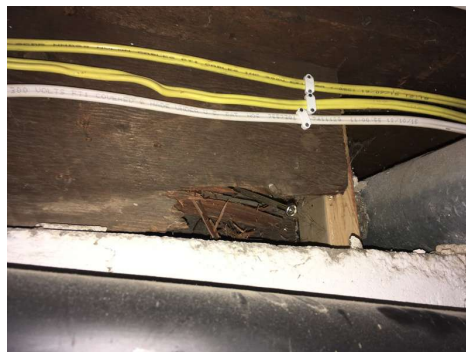
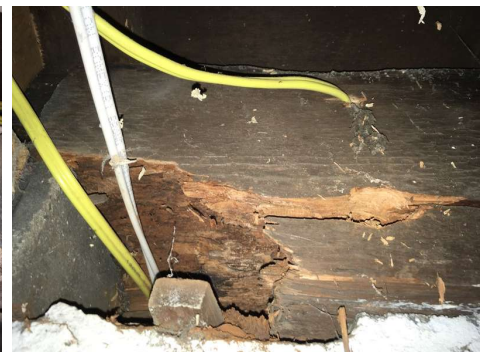
8.3.1 Floor Structure

EVIDENCE OF STRUCTURAL DAMAGE

Structural damage was observed in the underlying floor structure. Recommend a structural engineer evaluate.

Contact a qualified structural engineer.

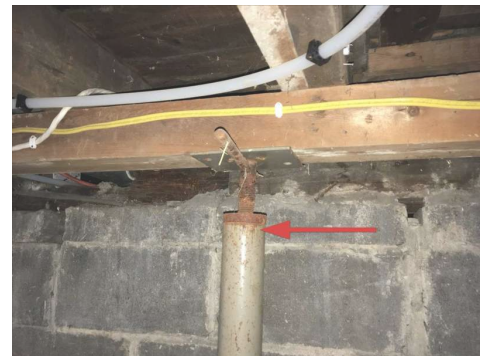
8.3.3 Floor Structure

TEMPORARY SUPPORTS

Temporary supports have been installed to support substantial floor section of home. Further assessment required by structural engineer and appropriate building permit raised to monitor upgrades.

Contact a qualified structural engineer.

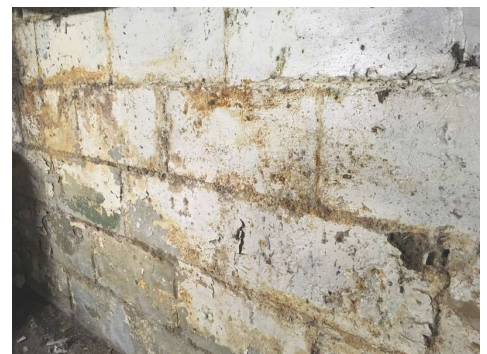
8.4.1 Wall Structure

EVIDENCE OF WATER INTRUSION

Wall structure showed signs of water intrusion, which could lead to more serious structural damage. Recommend a qualified contractor identify source or moisture and remedy.

Contact a qualified structural engineer.

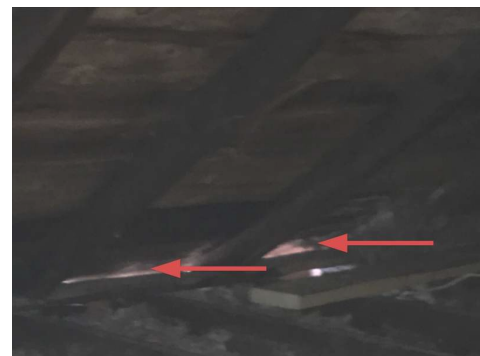
9.3.1 Ventilation

SOFFIT VENTING LIMITED / MISSING

Recommend adding or upgrading soffit vents by a qualified contractor. Soffit vents promote attic ventilation and effectively reduces probability of ice damming, mould, premature wearing of shingles and roof structure.

Recommendation
Contact a qualified roofing professional.
