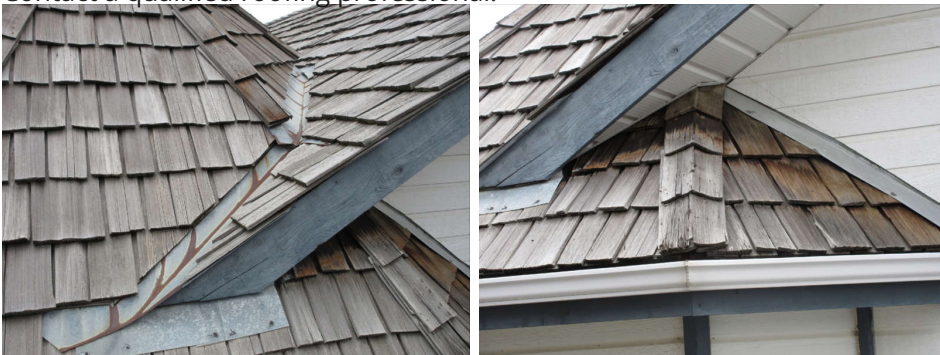
### 2.1.1 Coverings

#### **DISCOLORATION/WATER STAINS**

Roof shingles were discolored, which can be caused by moisture, rust or soot. Recommend a qualified roofing contractor evaluate and remedy to ensure that roof and lashings are allowing water to drain properly.

Contact a qualified roofing professional.

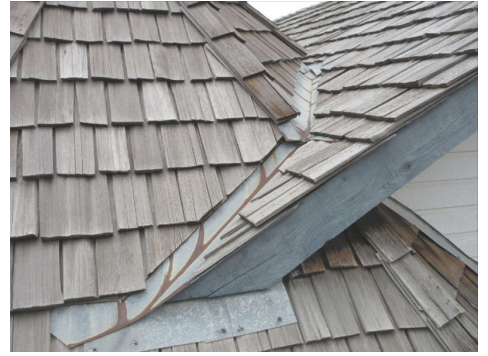
### 2.3.1 Flashings

#### **CORRODED - MINOR**

Roof flashing showed signs of corrosion, but are still in working condition. Flashing should be monitored to prevent severe corrosion leading to moisture intrusion.

Recommendation  
Contact a qualified roofing professional.

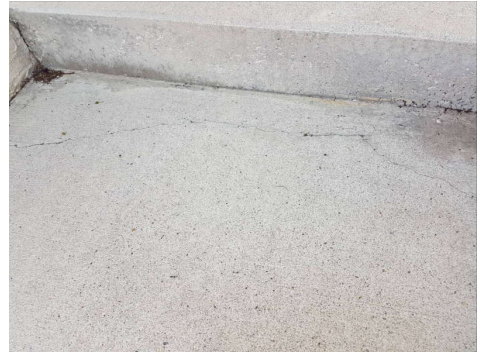
#### 3.3.1 Walkways, Patios & Driveways

### **DRIVEWAY CRACKING - MINOR**

Minor cosmetic cracks observed. Cracks greater than 1/4 inch in throw can create a trip hazard. This crack had little to no throw and is not a safety concern

Recommendation  
Recommend monitoring.

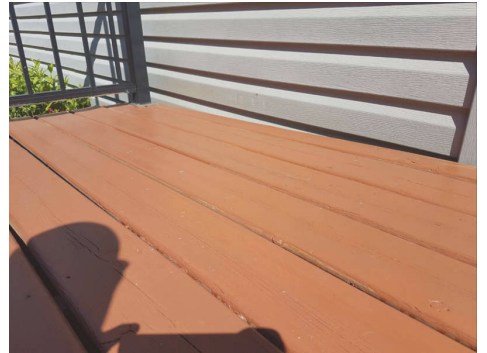
### 3.4.1 Decks, Balconies, Porches & Steps

#### **LEDGER BOARD IMPROPERLY INSTALLED**

Safety Hazard

The ledger board is partially missing and therefore not all of the deck width is attached to the building. This has caused the deck to sink at one corner in the deck. Recommend that the deck and/or ledger board be properly attached by qualified contractor, and the footing be brought to level with the other footings.

Contact a qualified deck contractor.

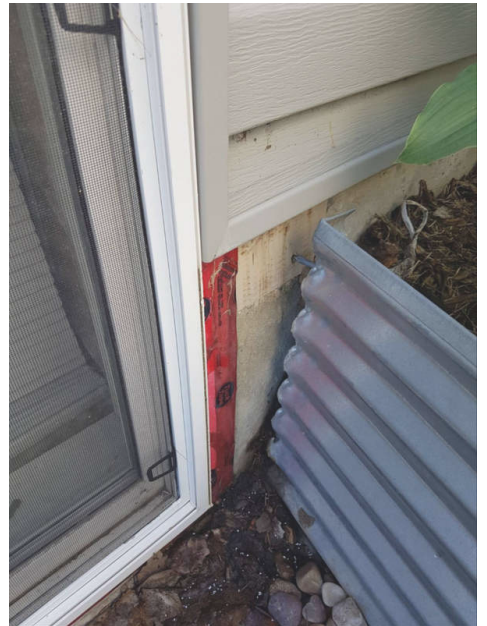
### 3.8.1 Window Wells

#### **DAMAGE**

West window well has pulled away from the foundation. Recommend a qualified professional to reattach in order to retain the earth away from the window.

Contact a qualified professional.

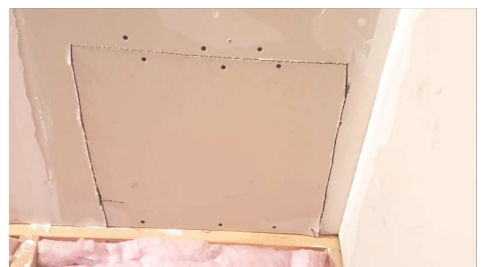
### 4.1.1 Ceiling

#### **GAS PROOFING COMPROMISED**

Safety Hazard

Garage ceiling below living space has holes or gaps in drywall that should be sealed in order to ensure that off gassing from running vehicles etc cannot permeate in to the living space. Recommend 2 layers of mudding and taping to seal up such gaps.

Contact a qualified professional.

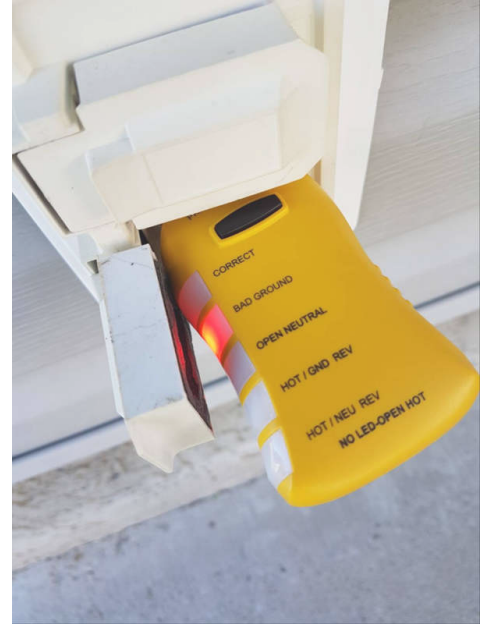
#### 9.5.1 GFCI & AFCI

### **BAD GROUND OBSERVED**

Receptacle tested as having a bad ground.

Recommend a licensed electrician to evaluate

Contact a qualified electrical contractor.
