SUMMARY

1234 Main St.Grand Rapids MI 49546 **Buyer Name** 04/22/2018 9:00AM

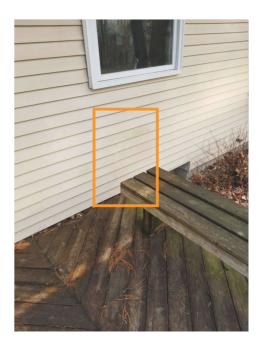
3.1.1 Siding, Flashing & Trim **MILDEW/ALGAE**

There are signs of algae and/or mildew on the siding. This is a cosmetic issue and is not uncommon especially on shaded portions of the home. Recommend that said areas be washed or cleaned or a regular basis.

Recommendation Contact a qualified professional.

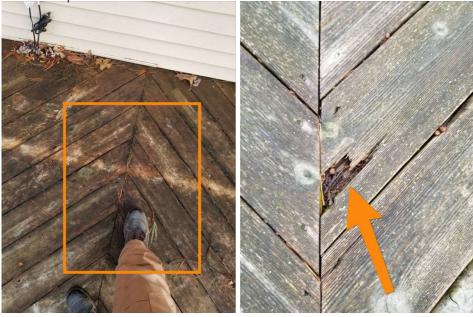
3.4.1 Decks, Balconies, Porches & Steps **DECK - ROTTED BOARDS**

Inspector noticed one or more deck boards are showing signs of rot. Recommend a qualified deck contractor replace damaged boards. You may wish to consult with a contractor on options and costs to replace deck.

Recommendation Contact a qualified deck contractor.

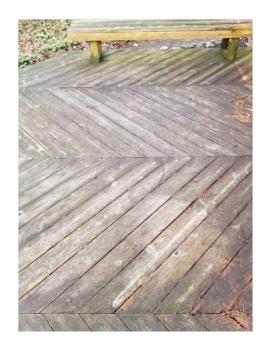
3.4.2 Decks, Balconies, Porches & Steps DECK - WATER SEALANT REQUIRED

Deck is showing signs of weathering and/or water damage. Recommend water sealant/weatherproofing be applied.

Recommendation Recommended DIY Project

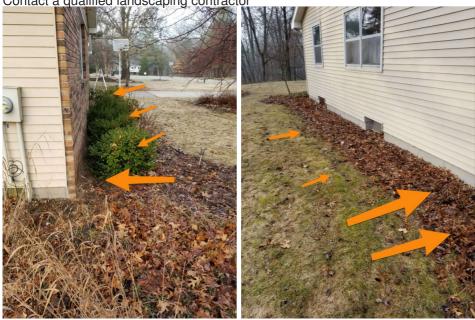
3.6.1 Vegetation, Grading, Drainage & Retaining Walls **NEGATIVE GRADING**

Grading is sloping towards the home in some areas. This could lead to water intrusion and foundation issues. Recommend qualified landscaper or foundation contractor regrade so water flows away from home.

Contact a qualified landscaping contractor

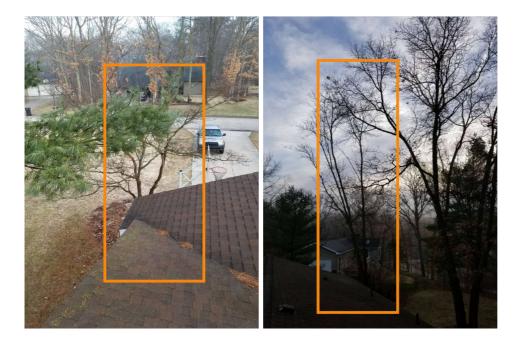
3.6.2 Vegetation, Grading, Drainage & Retaining Walls **TREE OVERHANG**

Trees observed overhanging the roof. This can cause damage to the roof and prevent proper drainage. Recommend a qualified tree service trim to allow for proper drainage.

Recommendation Contact a qualified tree service company.

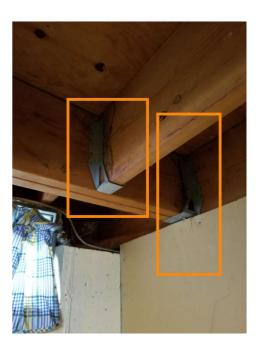
4.3.1 Floor Structure **HANGERS MISSING FASTENERS**

Inspector noticed one or more hangers were missing fasteners. Recommend installing fasteners in hangers per the manufacturers recommendation.

Recommendation Contact a qualified professional.

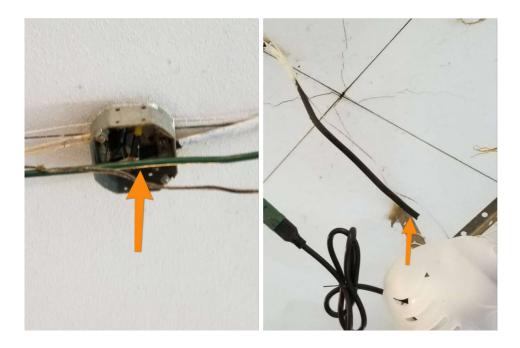
7.3.1 Branch Wiring Circuits, Breakers & Fuses **IMPROPER WIRING**

There were one or more areas were the inspector noticed incorrect wiring practices. Recommend talking to a licensed electrician on options and costs to repair or replace.

Recommendation Contact a qualified electrical contractor.

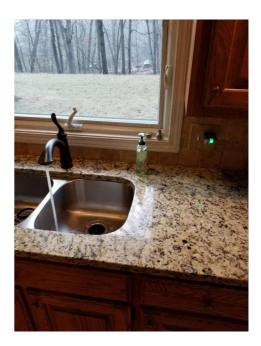
7.5.1 GFCI & AFCI NO GFCI PROTECTION INSTALLED

No GFCI protection present in all locations. Recommend licensed electrician upgrade by installing ground fault receptacles in all locations.

Recommendation Contact a qualified electrical contractor.

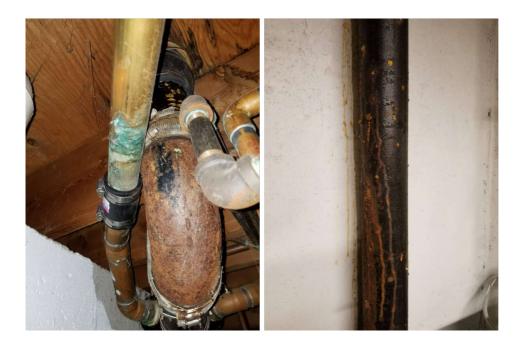
8.2.1 Drain, Waste, & Vent Systems **CORRODED PIPE**

One or more pipes was corroded at the time of inspection recommend consulting with a plumber on options and costs for repairs or replacement.

Recommendation Contact a qualified plumbing contractor.

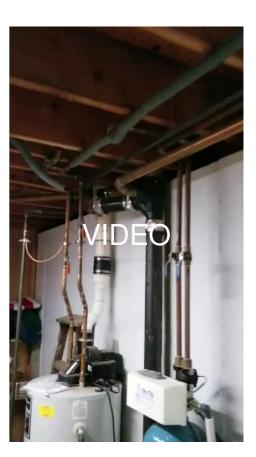
PIPE VIBRATIONS - WELL PUMP

Inspector noticed that when well pump was operating one or more distribution pipes were vibrating. You may wish to consult with a licensed plumber on options in cost to fix this issue.

Recommendation Contact a qualified professional.

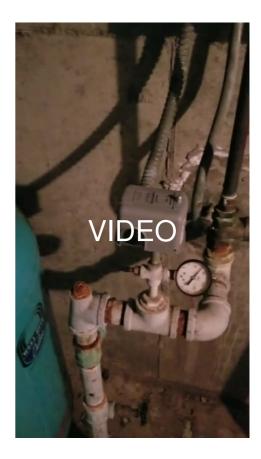
8.3.2 Water Supply, Distribution Systems & Fixtures **WATER HAMMER**

Inspector noticed that the well was making a loud water hammer noise at the end of its cycle. This may be an issue with the pressure or with one of the valves. Recommend talking to a plumber on options and costs to repair or replace.

Recommendation Contact a qualified plumbing contractor.

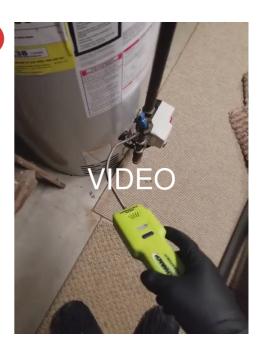
8.5.1 Fuel Storage & Distribution Systems **GAS LEAK**

Inspector noticed one or more gas leaks during the inspection. I recommend having a licensed HVAC contractor repair gas leak and retest gas lines.

Recommendation Contact a qualified professional.

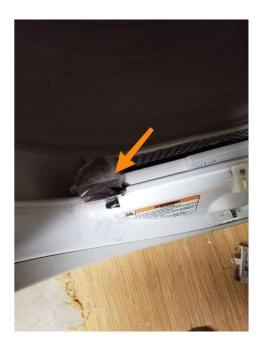
8.7.1 Dryer **DAMAGED**

Inspector noticed that although dryer appeared to be in working condition had one or more areas of damage. You may wish to Look at options in cost to repair or replace dryer.

Recommendation Contact a qualified professional.

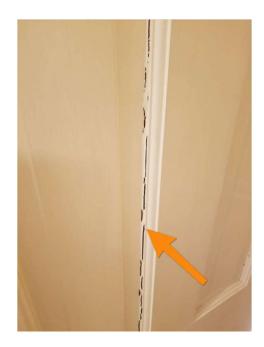
10.1.1 Doors DAMAGED DOOR

One or more doors was damaged at the time of inspection. Repair or replace.

Recommendation Contact a qualified carpenter.

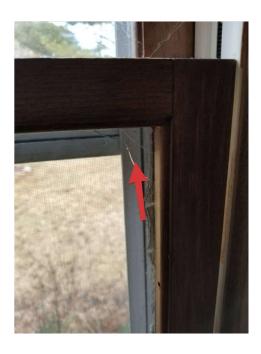
10.2.2 Windows BROKEN PANE

One or more windows have a broken pane and should be repaired or replaced to avoid injury.

Recommendation Contact a qualified window repair/installation contractor.

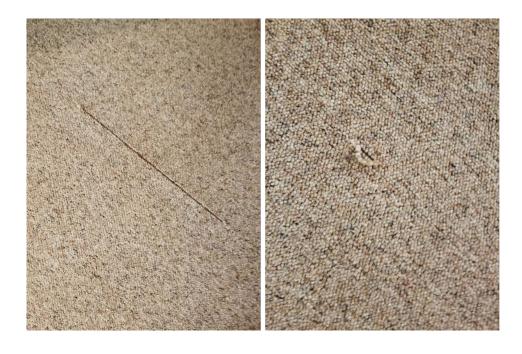
10.3.2 Floors MODERATE WEAR

Inspector noticed that the floors in the home exhibited moderate surface wear along major paths of travel. Recommend a qualified flooring contractor evaluate for possible re-finish or replacement as deemed necessary.

Recommendation Contact a qualified flooring contractor

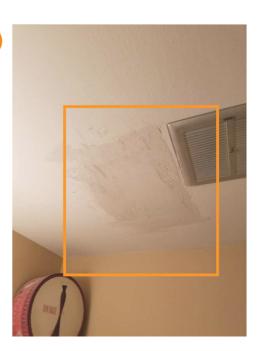
10.6.1 Ceilings POOR REPAIRS

Inspector noticed one or more areas of the ceiling with poor prior repairs. Recommend talking to a drywall professional on options and costs to repair these areas.

Recommendation Contact a qualified drywall contractor.

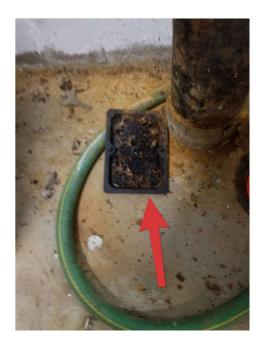
10.8.1 Pests MICE/RODENT SIGN

Inspector noticed one or more locations had sign of current or previous rodents. Inspector noticed either mousetraps, nesting material, damage or fecal matter.

Recommendation Contact a qualified pest control specialist.

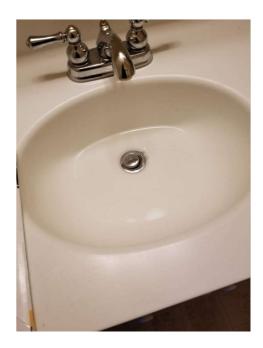
11.4.1 Sinks and Fixtures **SLOW DRAIN**

Inspector noticed one or more sinks were draining slowly during the inspection. Recommend talking to a licensed plumber on options and costs to unclog or repair.

Recommendation Contact a qualified plumbing contractor.
