SUMMARY

1234 Main St. Guyton GA 31312

K & M Home Inspections LLC
702-375-5964
kelly.j.steckler@gmail.com

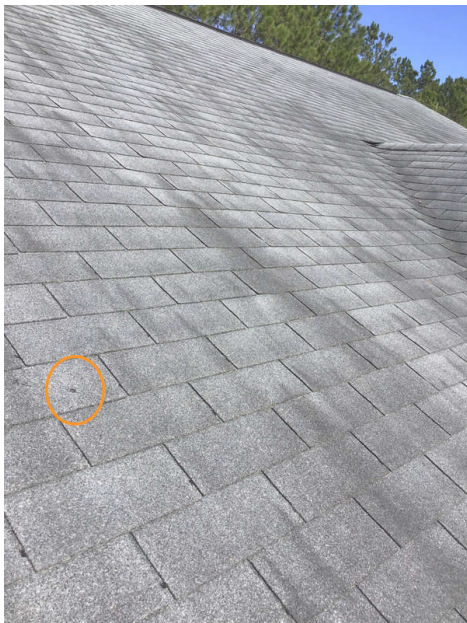
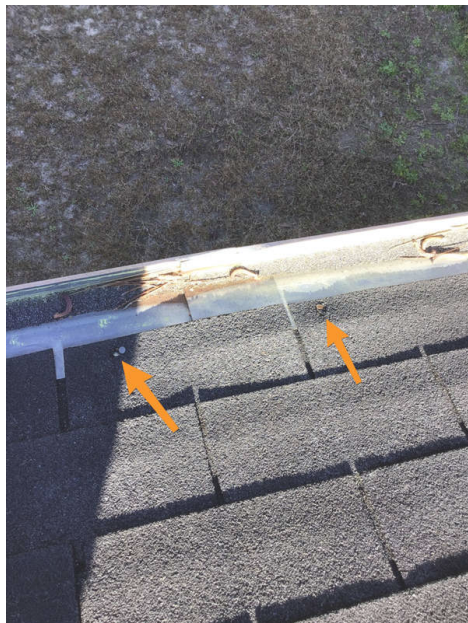
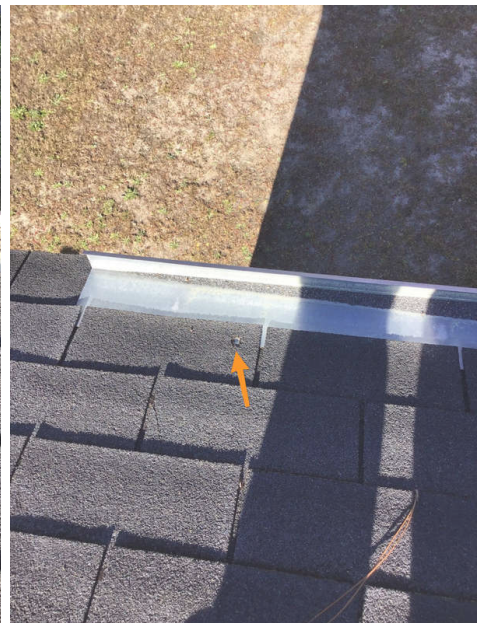
2.1.1 Coverings

DAMAGED (GENERAL)

Roof coverings showed moderate damage. Recommend a qualified roofing professional evaluate and repair.

Contact a qualified roofing professional.

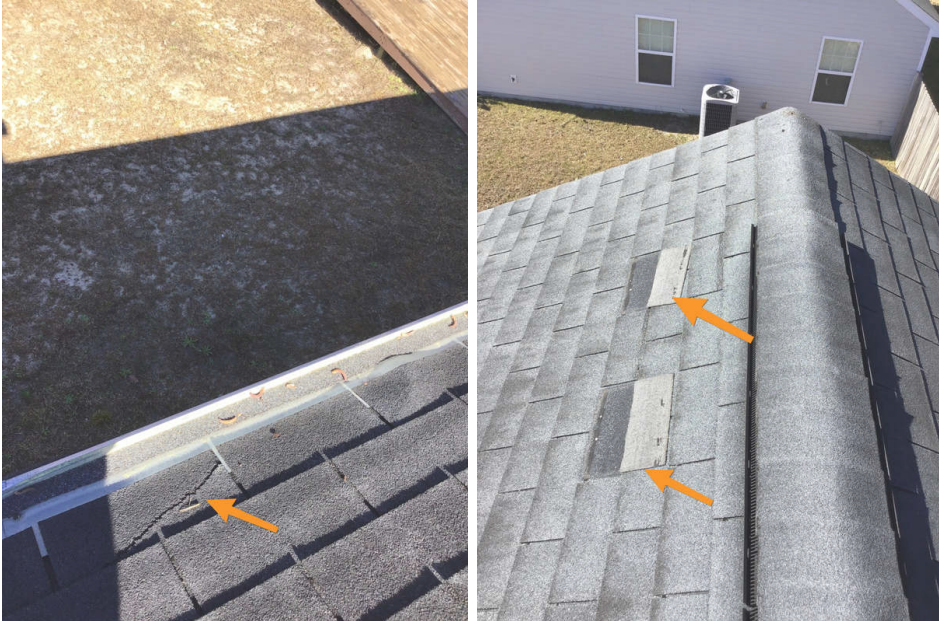
2.1.2 Coverings

CREASED OR TORN TAB DAMAGE (WIND)

The roof had areas of wind damage such as broken adhesive strips and creased or torn shingle tabs. The Inspector recommends replacement of the damaged shingles by a qualified roofing contractor to avoid damage from moisture intrusion.

Contact a qualified roofing professional.

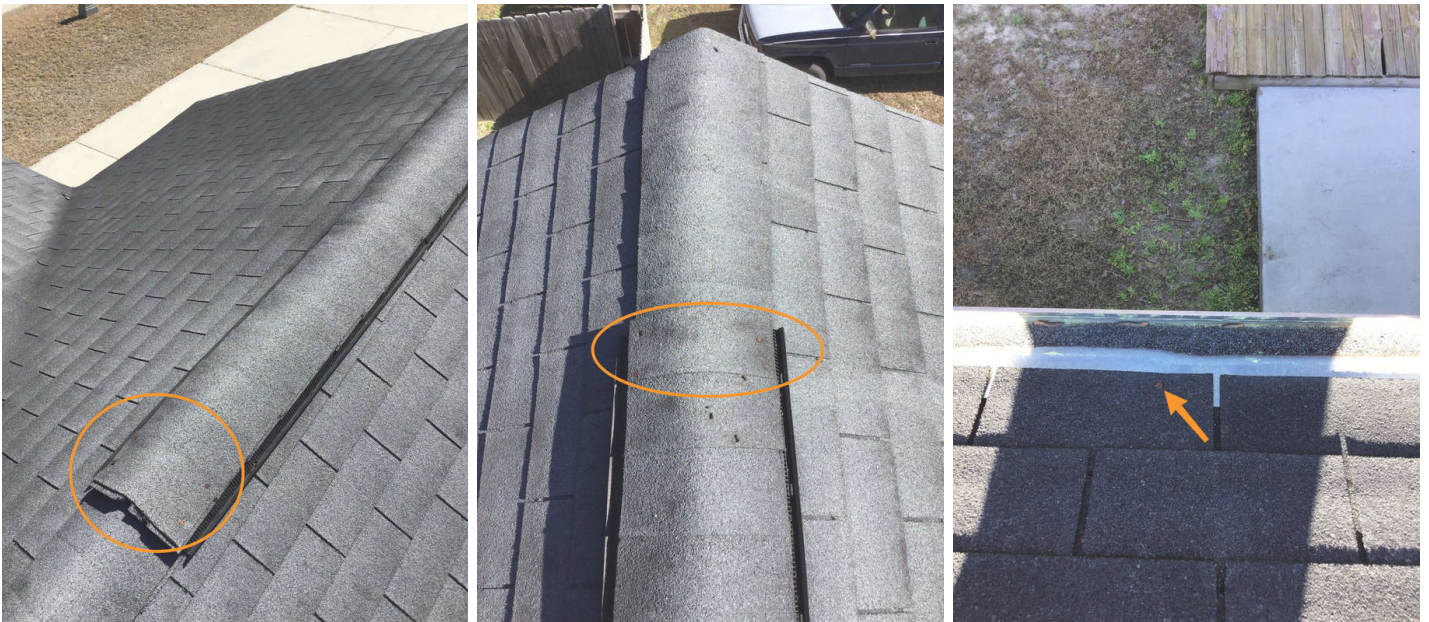
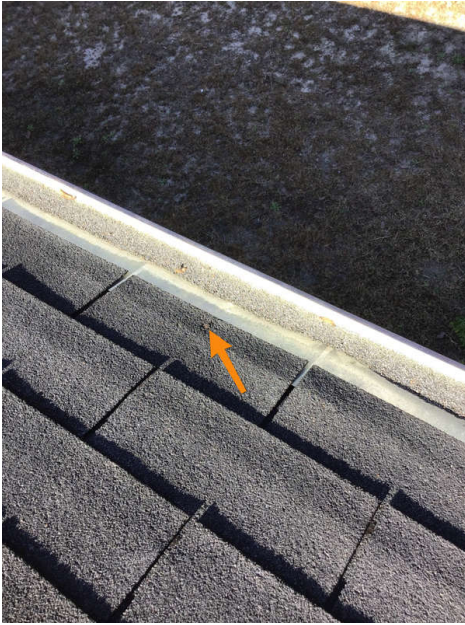
2.1.3 Coverings

EXPOSED NAILS

Exposed nails through roofing materials can allow for water intrusion, causing further damage to underlying structure. Recommend further evaluation and remediation by a qualified roofing contractor.

Contact a qualified roofing professional.

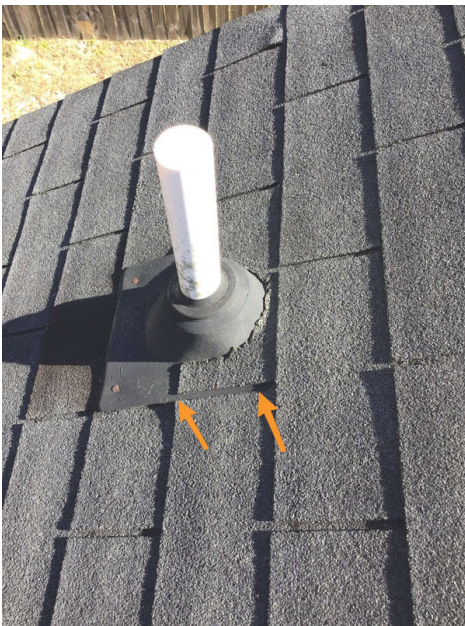
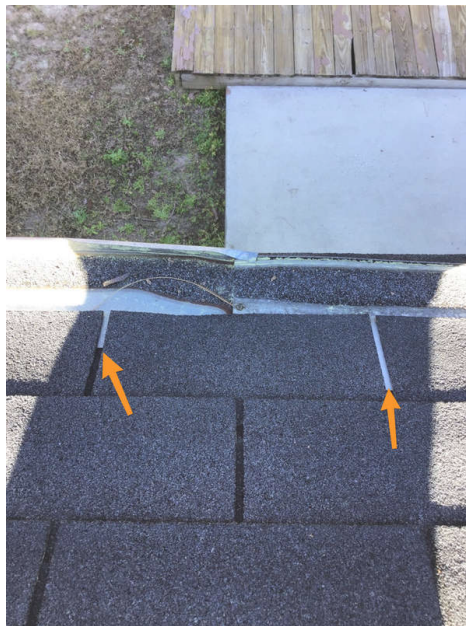
2.3.1 Flashings

EXPOSED FLASHING EDGES

The edge of the flashing is exposed, which could lead to water damage to the home. Recommend further evaluation and remediation by a qualified Roofing Contractor.

Contact a qualified professional.

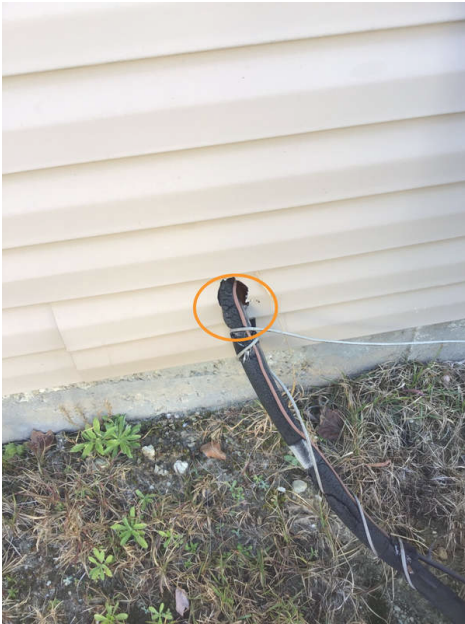
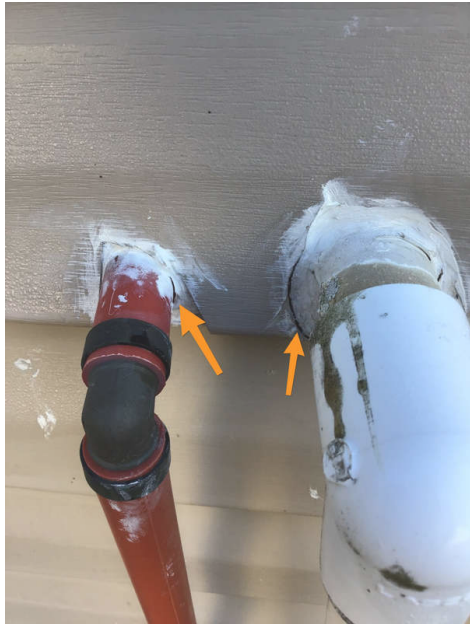
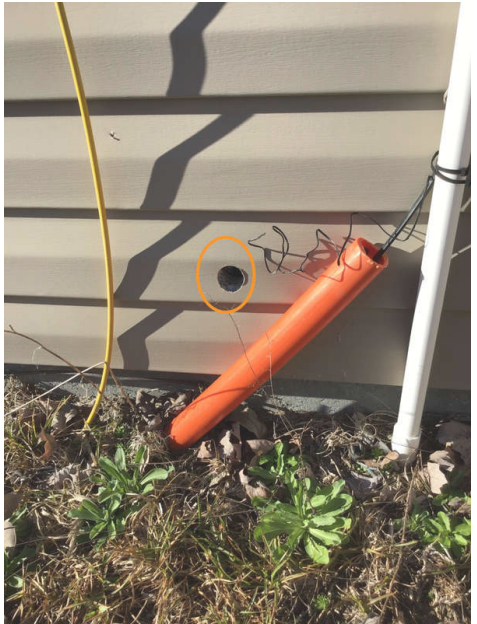
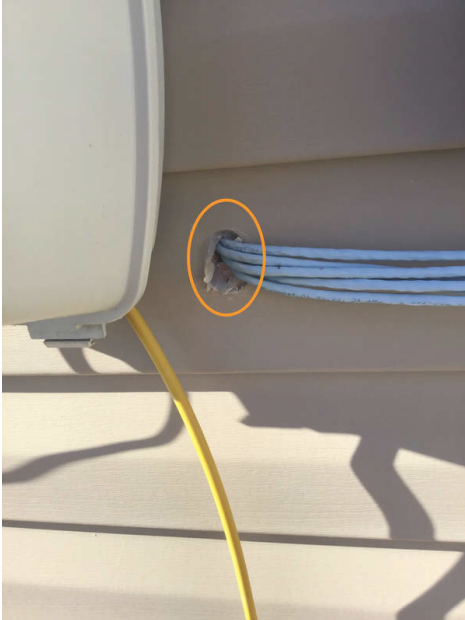
3.1.2 Siding, Flashing & Trim

GAPS AT EXTERIOR WALL PENETRATIONS

At the time of the inspection, gaps were noticed around the exterior of the home. These gaps are usually around pipes associated with faucets, drains, HVAC lines, gas/electrical. These areas should be sealed to protect the home from moisture penetration and pest infestations.

Recommendation
Contact a handyman or DIY project

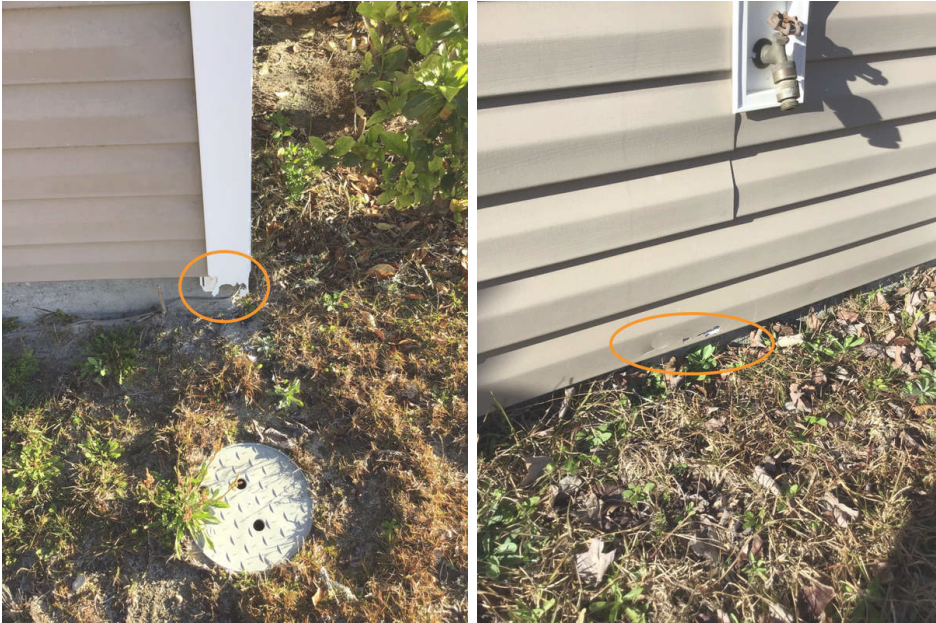
3.1.3 Siding, Flashing & Trim

TRIM/SIDING DAMAGE

Portions of the trim/Siding are damaged. This damage can allow for water intrusion causing water damage to the underlying structure. I recommend evaluation and repair by a qualified siding contractor.

Recommendation
Contact a qualified siding specialist.

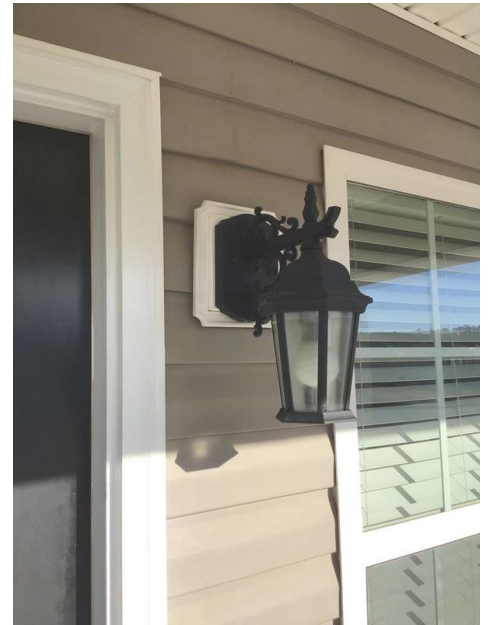
3.1.4 Siding, Flashing & Trim **LOOSE LIGHT FIXTURES**

At the time of the inspection, one or more exterior light fixture mounts were found to be loose. Recommend remediation by a qualified Handyman or DIY if able.

Recommendation
Contact a qualified professional.

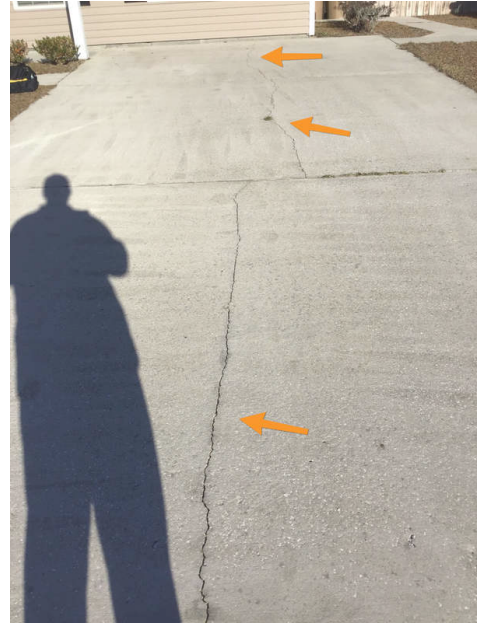
3.4.1 Walkways, Patios & Driveways **DRIVEWAY CRACKING - MINOR**

Minor cosmetic cracks observed, which may indicate movement in the soil. Recommend monitor and/or have concrete contractor patch/seal.

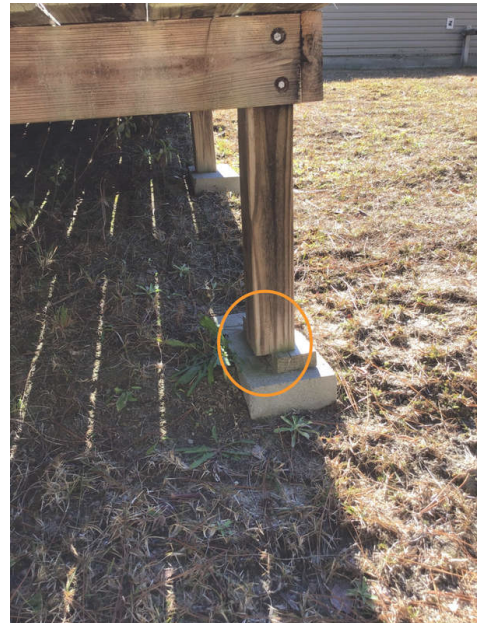
3.5.1 Decks, Balconies, Porches & Steps

DECK - UNSTABLE SUPPORT

One of more areas of the deck support appears unstable. This could cause a safety hazard and further deterioration of the deck. Recommend qualified deck contractor evaluate and repair.

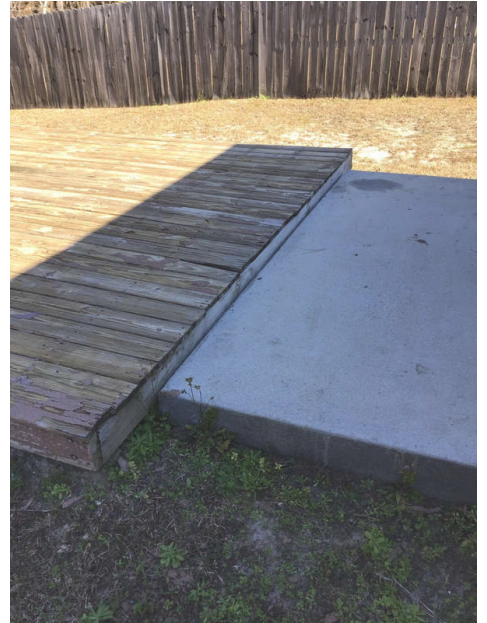
3.5.4 Decks, Balconies, Porches & Steps

TRIPPING HAZARD

The odd height of the deck transition to the concrete patio could pose as a possible tripping hazard. I recommend further evaluation by a qualified Deck/Patio Contractor.

Contact a qualified deck contractor.

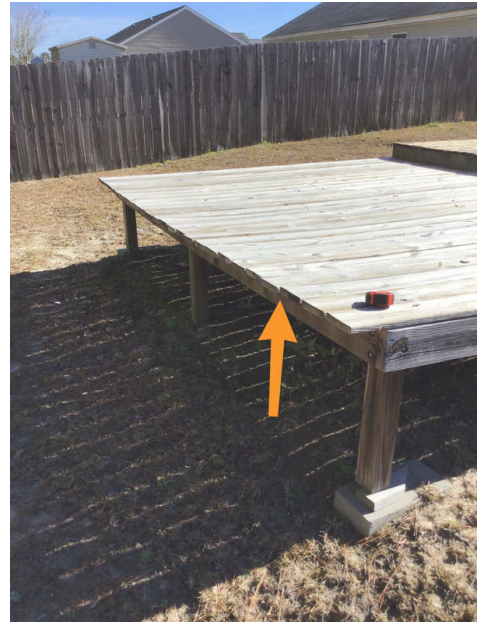
3.5.5 Decks, Balconies, Porches & Steps

NO RAILING INSTALLED

Decks and patios higher than 30" above the ground require a guardrail to be installed for safety. This deck is at 31". Recommend further evaluation by a qualified Deck/Patio Contractor.

31 inches from ground

Contact a qualified deck contractor.

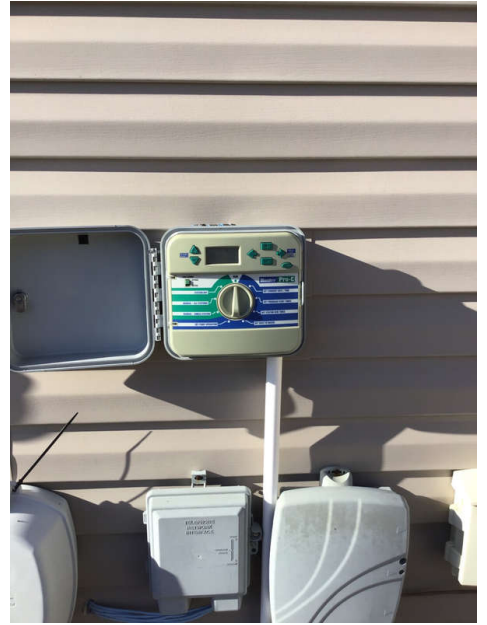
3.7.1 Vegetation, Grading, Drainage & Retaining Walls

SPRINKLER CONTROL HEAD - NO POWER

The control head for the sprinkler system has no power. Recommend further evaluation by a qualified Landscape Contractor or Handyman.

Contact a qualified professional.

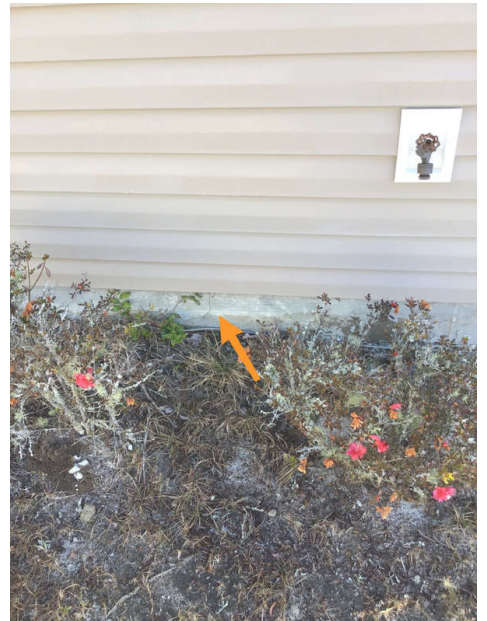
4.1.1 Foundation

FOUNDATION CRACKS - MINOR

Minor cracking was noted at the foundation. This is common as concrete ages and shrinkage surface cracks are normal. Recommend monitoring for more serious shifting/displacement.

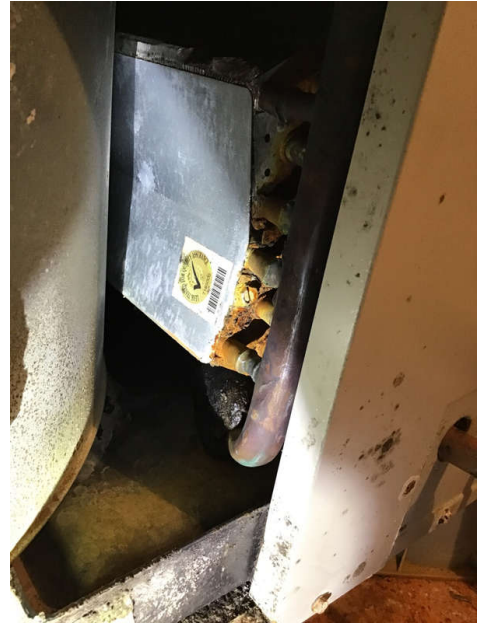
5.1.1 Equipment

HEAT EXCHANGER CORROSION

The heat exchanger inside the air handler, has excessive corrosion. Recommend further evaluation by a qualified Heating and Air Contractor.

Contact a qualified professional.

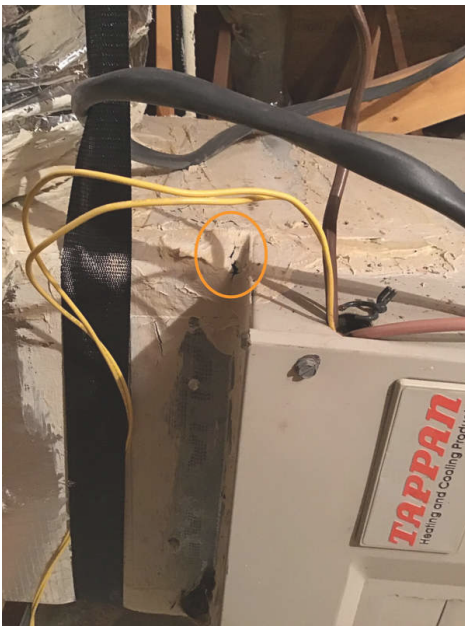
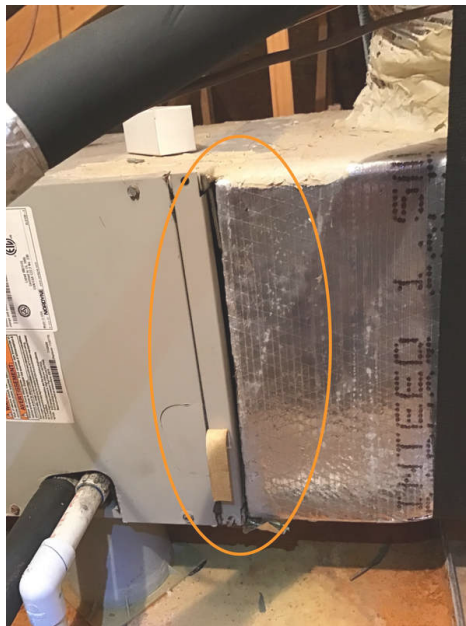
5.3.1 Distribution Systems

DUCT LEAKING

Air supply duct was leaking air. Recommend a qualified HVAC technician or vents & ducts contractor repair.

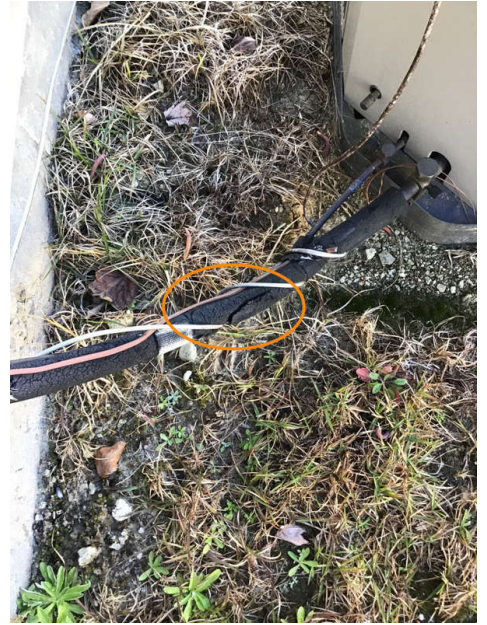
6.1.1 Cooling Equipment

INSULATION MISSING OR DAMAGED

Missing or damaged insulation on refrigerant line can cause energy loss and condensation.

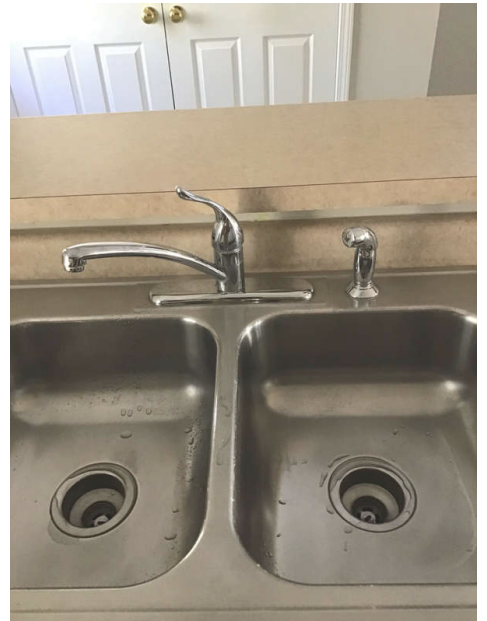
7.3.1 Water Supply, Distribution Systems & Fixtures

SINK FIXTURE - LOOSE HANDLE

At the time of the inspection, the kitchen sink faucet handle was loose. Recommend further evaluation and repair by a qualified Plumber, Handyman or DIY if able.

Contact a qualified professional.

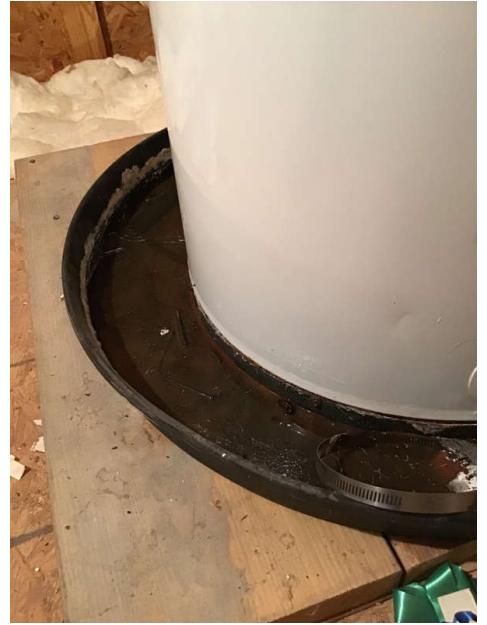
7.4.2 Hot Water Systems, Controls, Flues & Vents

WATER HEATER LEAKING

At the time of the inspection, standing water was found inside the drip pan. No water was found leaking from the water lines ontop of the unit, and suspect water is coming out of the bottom of the water heater. Recommend further evaluation by a qualified Plumber.

Contact a qualified professional.

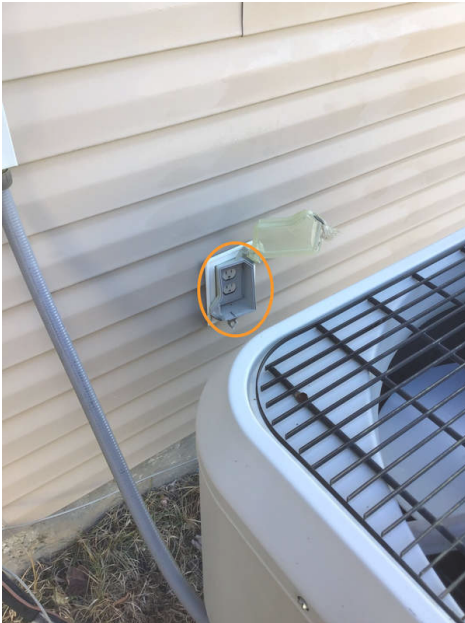
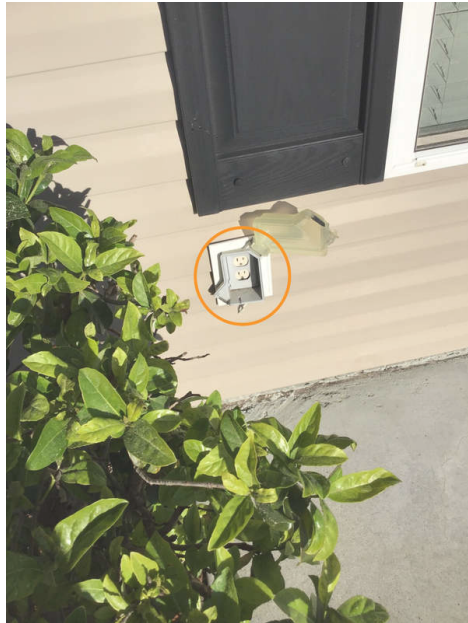
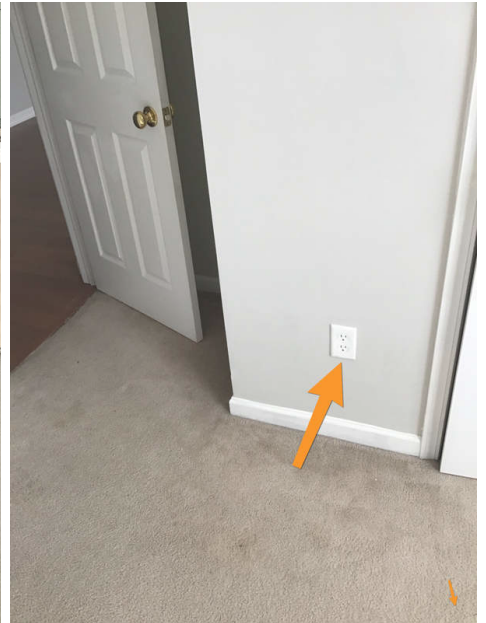
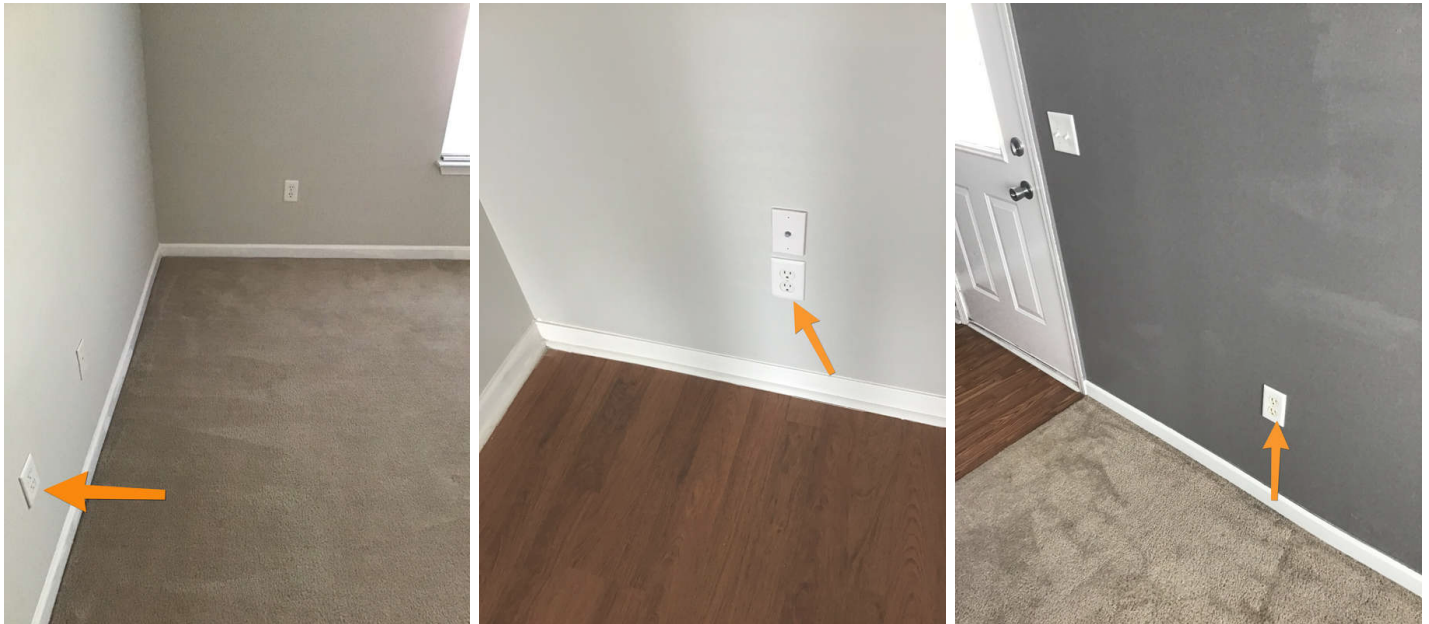
8.4.1 Lighting Fixtures, Switches & Receptacles

LOOSE ELECTRICAL OUTLETS

One or more electrical outlets were found to be loose. This could lead to possible electrical arcing and could become very dangerous. Recommend a qualified Electrician, Handyman or DIY, to remediate issue.

Contact a qualified electrical contractor.

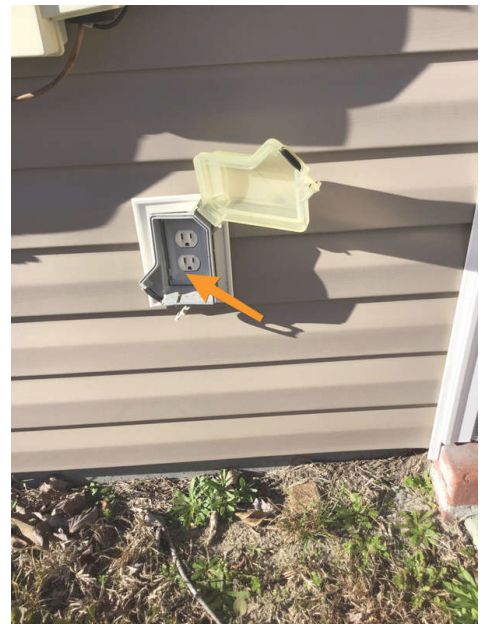
8.4.2 Lighting Fixtures, Switches & Receptacles

OUTLET DAMAGED

Electrical outlet is damaged. This could become a potential dangerous condition. Recommend replacement by a qualified Electrician.

Contact a qualified electrical contractor.

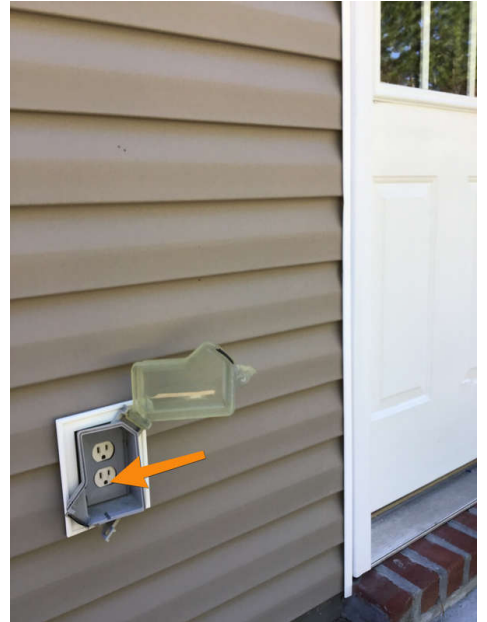
8.4.3 Lighting Fixtures, Switches & Receptacles

UN-USABLE FOR THREE-PRONG PLUGS

One or more electrical outlets are un-usable for three pronged plugs. Recommend further evaluation and replacement by a qualified Electrician.

Contact a qualified professional.

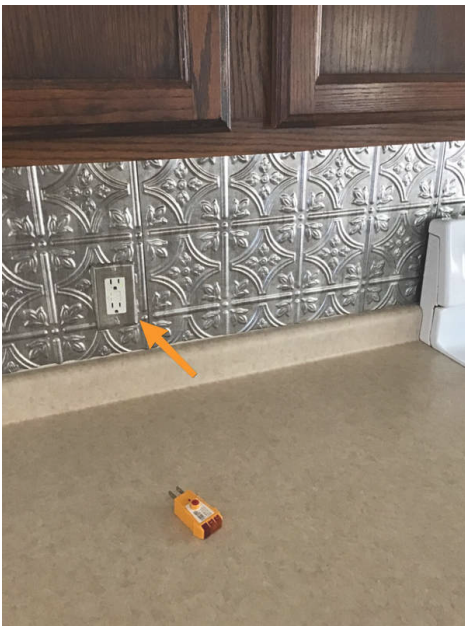
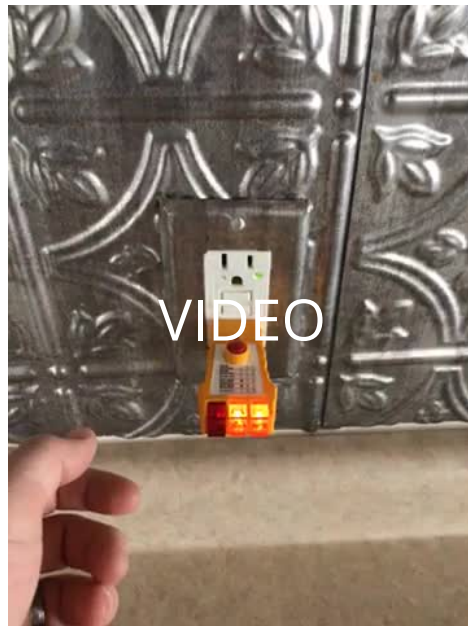
8.5.1 GFCI & AFCI

GFCI WILL NOT TRIP

At the time of the inspection, I found that one or more GFCI's were not working as intended. Recommend further evaluation by a qualified Electrician.

Contact a qualified professional.

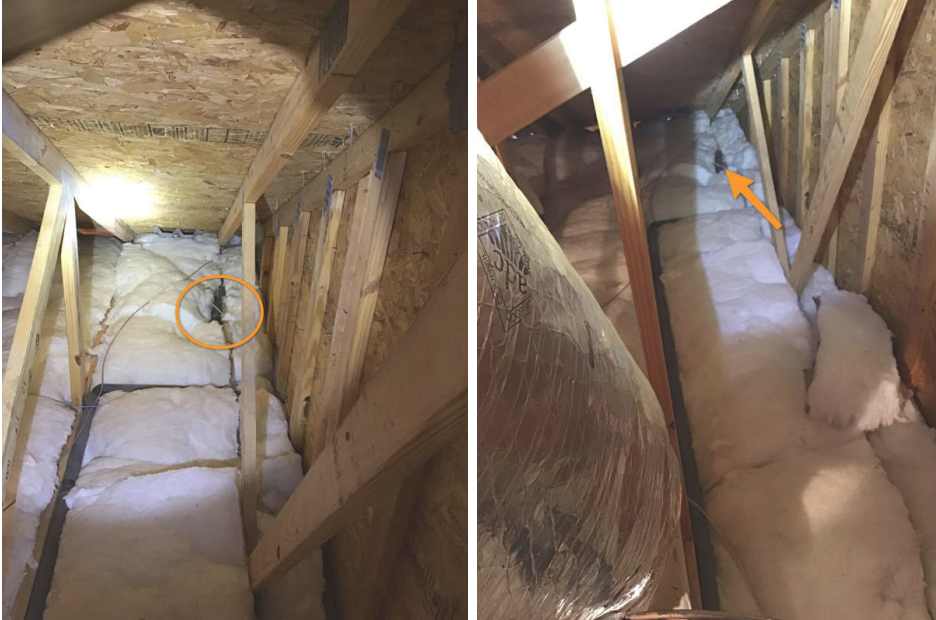
10.1.1 Attic Insulation

SIGNS OF PESTS

At the time of the inspection, I found possible rodent droppings under the insulation in the attic. Recommend further evaluation and remediation by a qualified Pest Control Contractor.

Area is behind the air handler in the corner of the attic.

Recommendation
Contact a qualified professional.

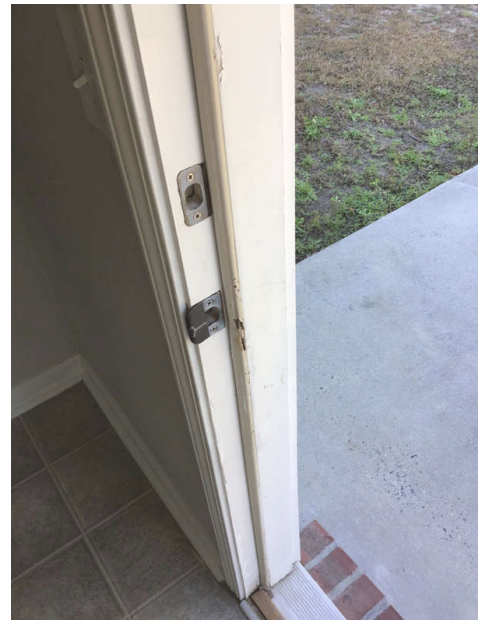
11.1.1 Doors

POOR WEATHER-STRIPPING

At the time of the inspection, weather-stripping at interior doors was generally damaged or deteriorated. The Inspector recommends replacement/installation of effective weather-stripping components as necessary by a qualified contractor.

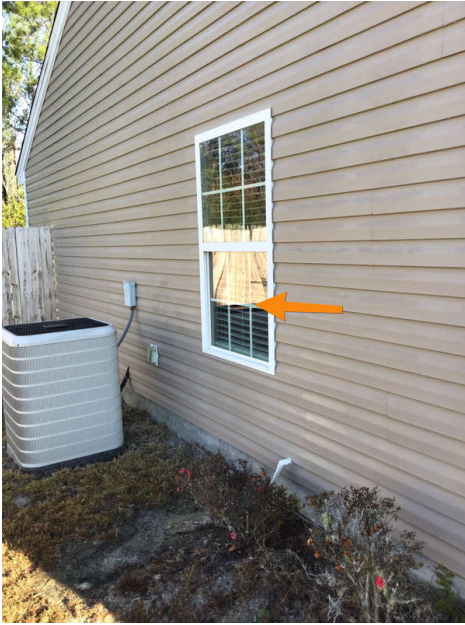
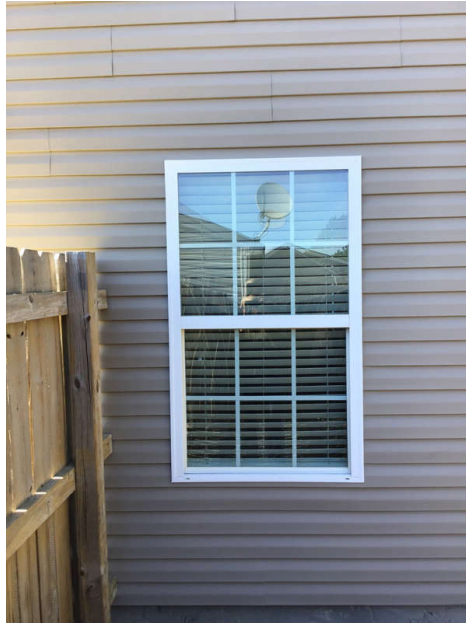
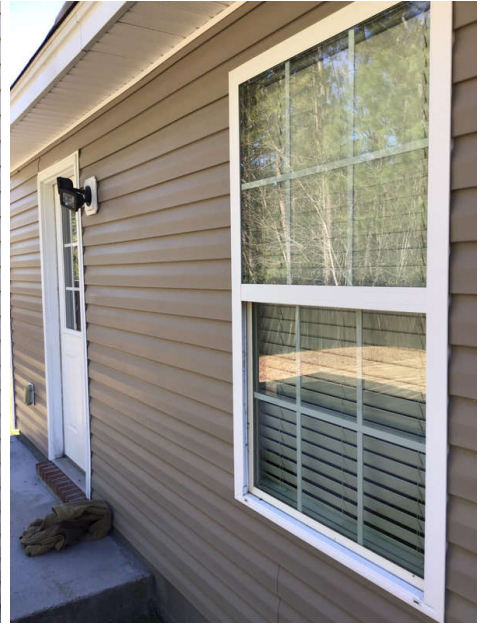
11.2.1 Windows

MISSING SCREEN

Window missing screen. Recommend replacement.

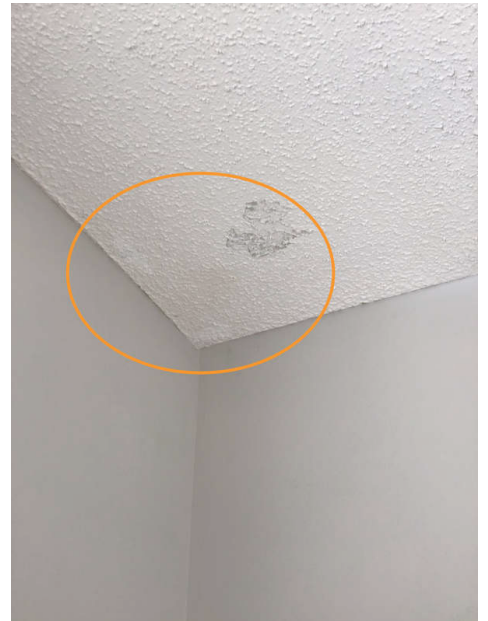
11.5.1 Ceilings

STAIN(S) ON CEILING

There is a stain on ceiling/wall that requires repair and paint. Source of staining should be determined.

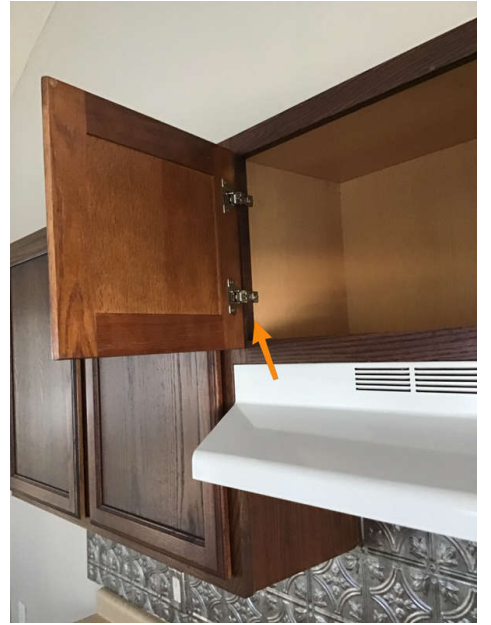
11.7.1 Countertops & Cabinets

CABINET HINGE LOOSE

One or more cabinet hinges were loose. Recommend a qualified handyman or cabinet contractor repair.
