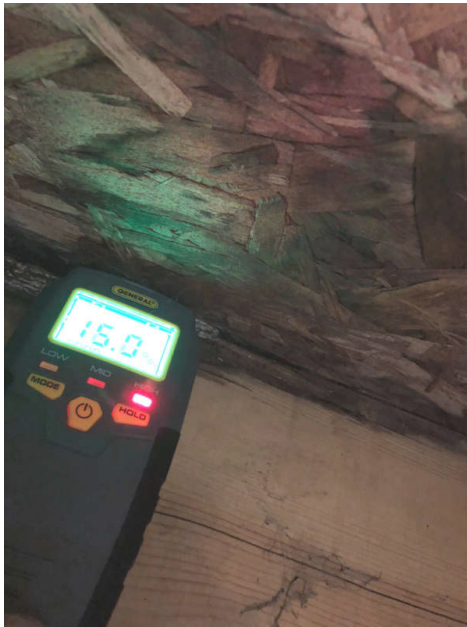
Southeast

HIGH MOISTURE LEVELS

High levels of moisture were noted in areas of the basement. Recommend finding source of moisture intrusion and making necessary repairs to prevent damage or further damage to the structure.

Recommendation
Contact a qualified professional.

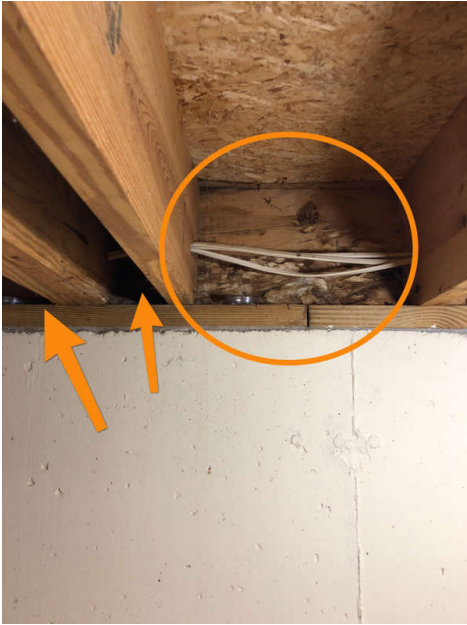
South

BIOLOGICAL GROWTH-BASEMENT

Possible biological growth noted in areas of the basement. Recommend qualified professional for testing.

Recommendation
Contact a qualified professional.

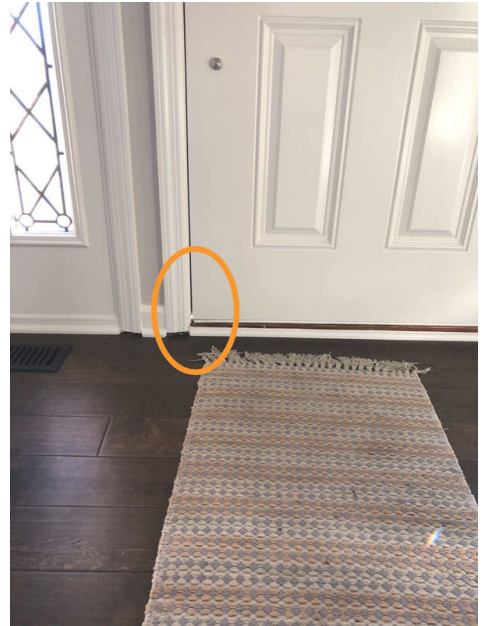
Front Door

WEATHERSTRIPPING- ADDED

A small area of weatherstripping needs to be added to ensure proper efficiency. Recommend handyman for repair.

Contact a handyman or DIY project

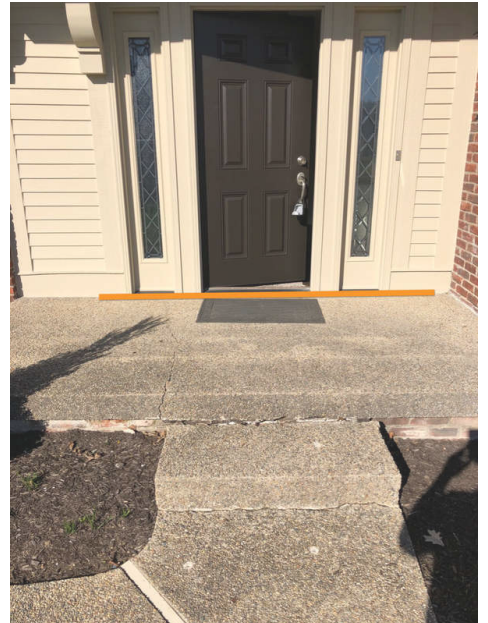
South

CONCRETE SETTLED

The concrete has settled which has caused a crack and a gap to form along the house. Recommend qualified professional to make necessary repairs.

Contact a qualified professional.

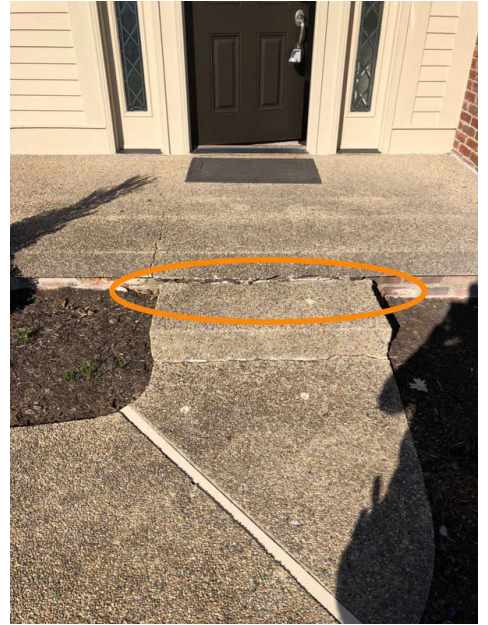
South

STEPS-SETTLED

The step(s) have settled significantly and caused a large gap to form. Recommend a qualified professional to evaluate and make necessary repairs.

Contact a qualified professional.

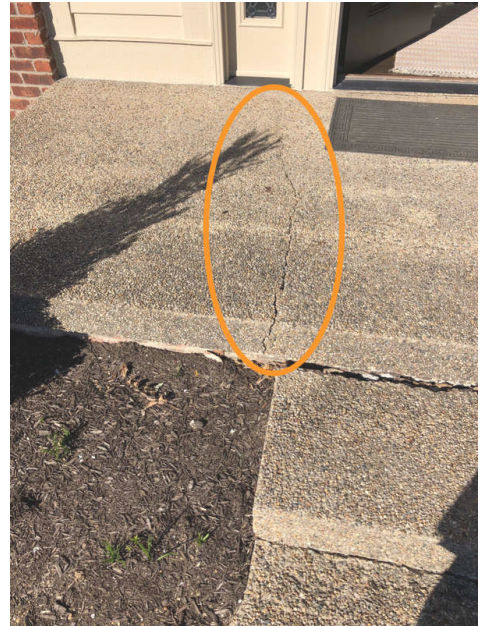
Front porch

CONCRETE-CRACK

There is a crack in the porch concrete. This can allow water to infiltrate and settle next to the foundation and cause further damage. Recommend qualified professional to evaluate and make repairs.

Contact a qualified professional.

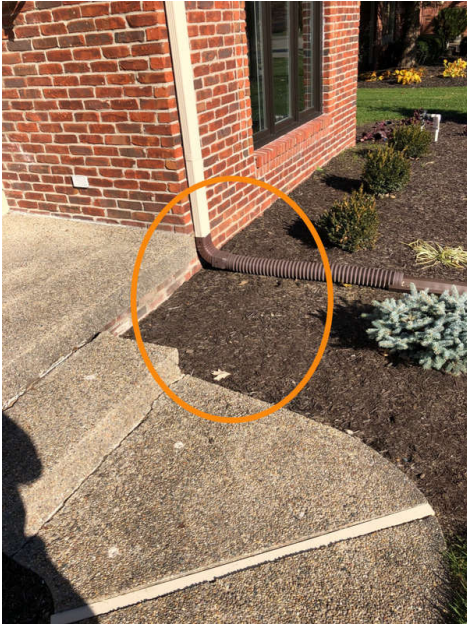
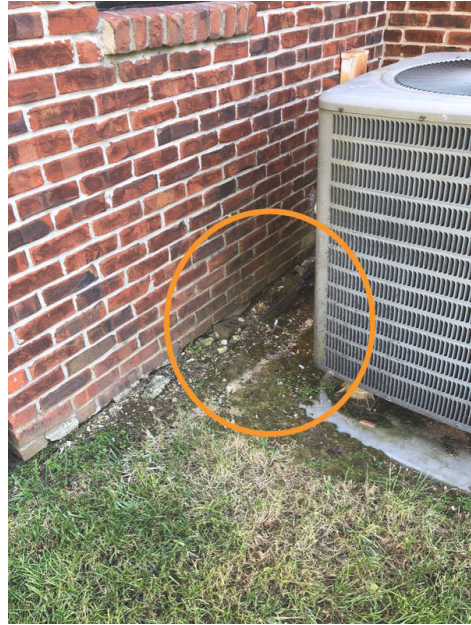
South

NEGATIVE GRADING

Grading is sloping towards the home in some areas. This could lead to water intrusion and foundation issues. Recommend qualified landscaper or foundation contractor regrade so water flows away from home.

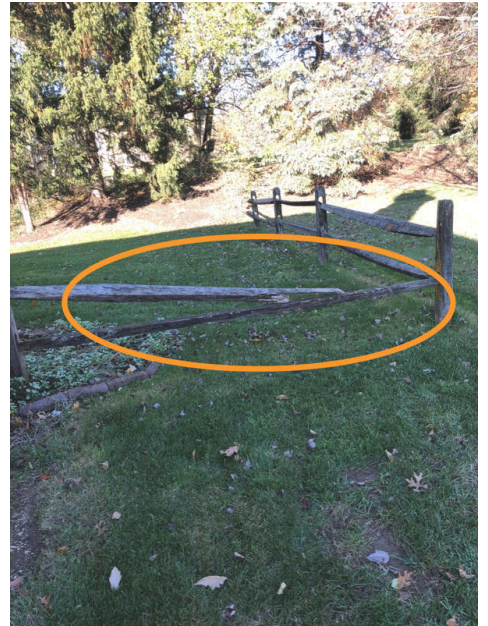
Northeast

FENCE DAMAGE

The fence was damaged. Recommend replacing affected boards.

Contact a qualified professional.

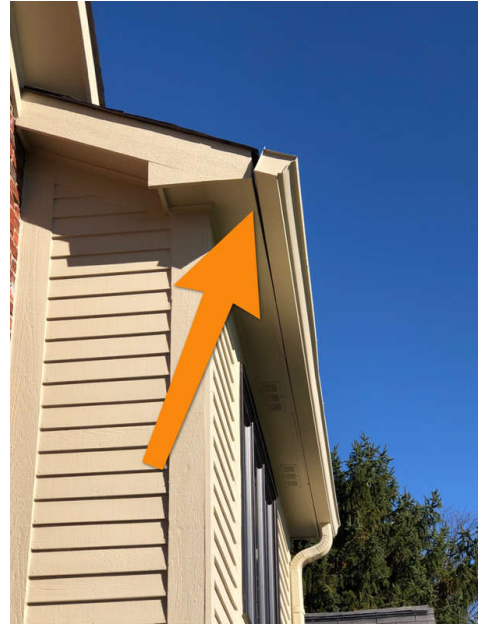
South above front door

GUTTER-SEPARATED FROM HOUSE

Gutter is separated from the house. This will cause water to run down the fascia and collect near the foundation. Recommend qualified roofing professional for repair.

Contact a qualified professional.

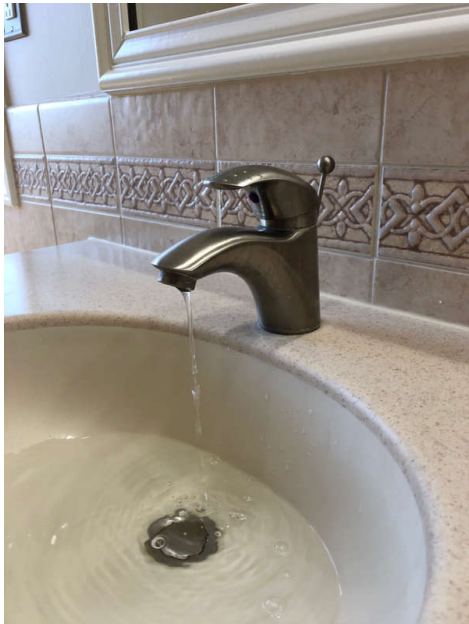
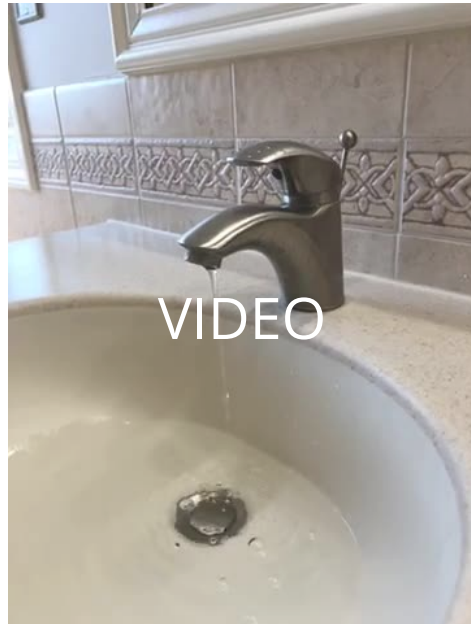
Master Bathroom

FAUCET DRIP

A faucet is dripping. Recommend qualified handyman or plumber evaluate and repair.

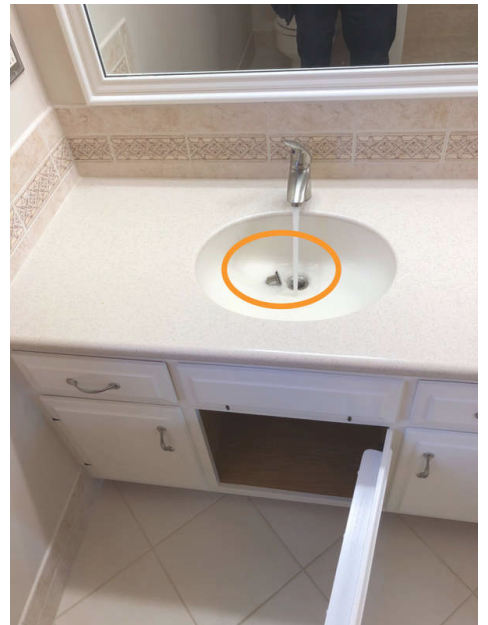
2nd Floor hall Bathroom

SINK DRAIN STOPPER

The sink drain stopper is missing or broken. Recommend handyman for replacement.

Contact a qualified handyman.

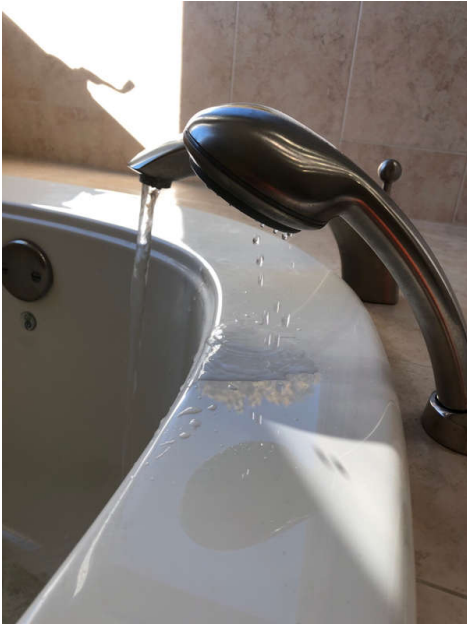
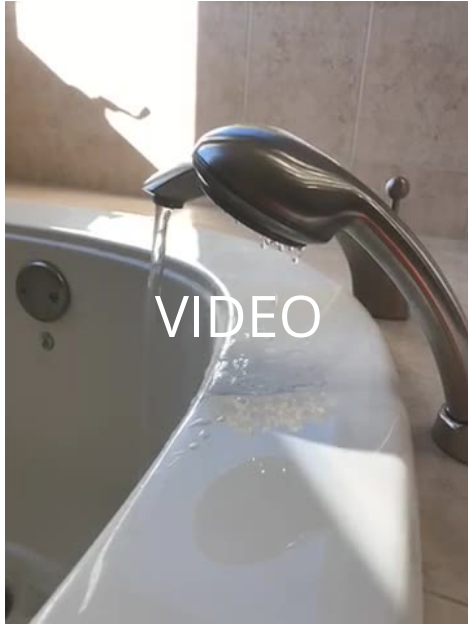
Master Bathroom

SHOWER HEAD - DRIPPING

The shower head continued to drip (run) long after the diverted valve was changed back to faucet only. Recommend qualified plumber to check for buildup of minerals which may cause this.

Contact a qualified plumbing contractor.

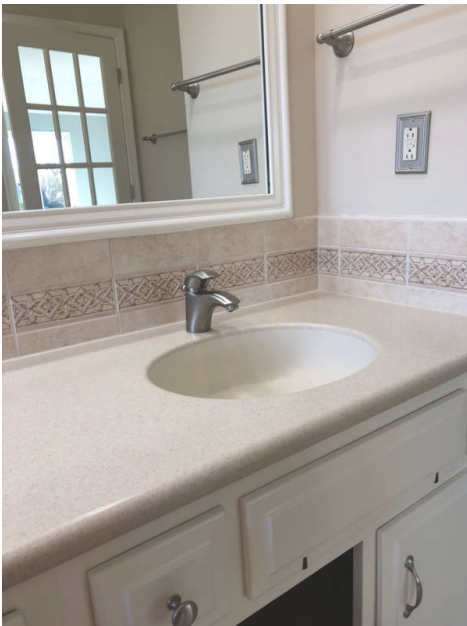
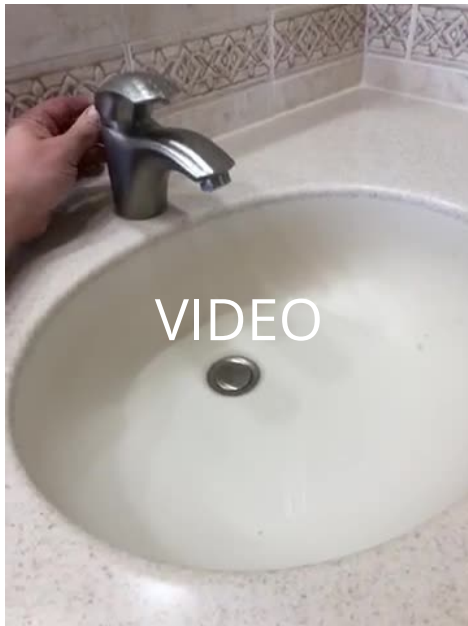
Master Bathroom

SINK DRAIN STOPPER

The sink drain stopper does not properly operate. Recommend qualified handyman for adjustments.

Contact a qualified handyman.

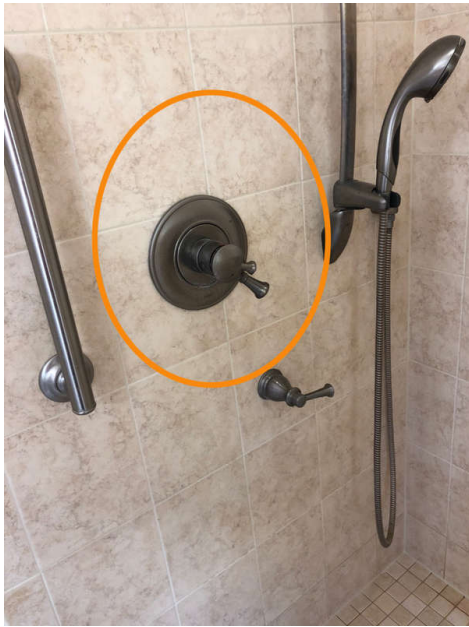
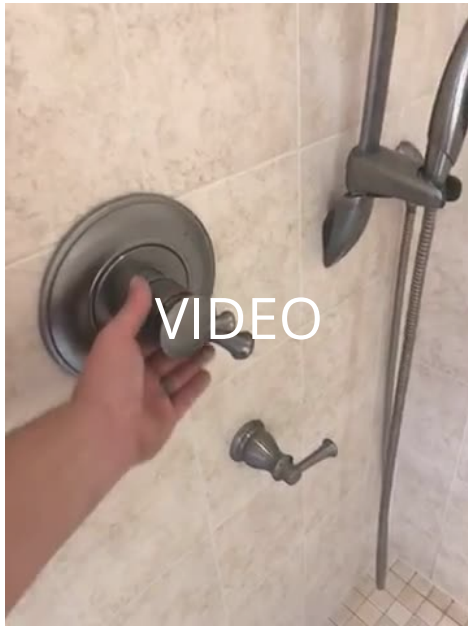
2nd Floor Hall Bathroom

SHOWER VALVE-LOOSE

The shower mixer valve is not secure in the wall. This can lead to a leak. Recommend qualified plumber for repair.

Contact a qualified plumbing contractor.

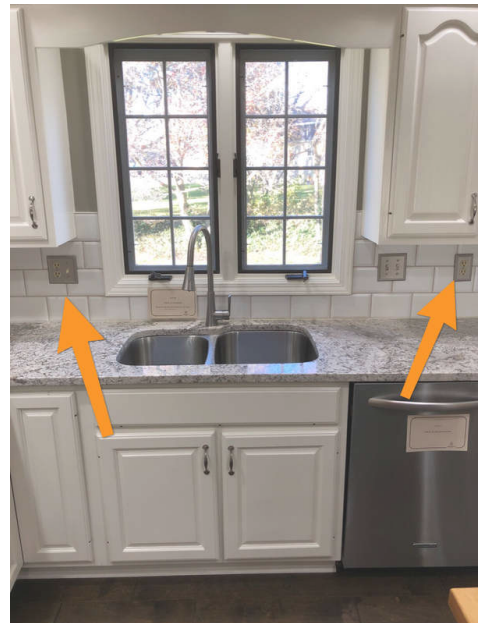
Kitchen

KITCHEN GFCI

Outlets within 6 feet of a water source need to be GFCI protected. Recommend qualified electrician for repair.

Contact a qualified professional.

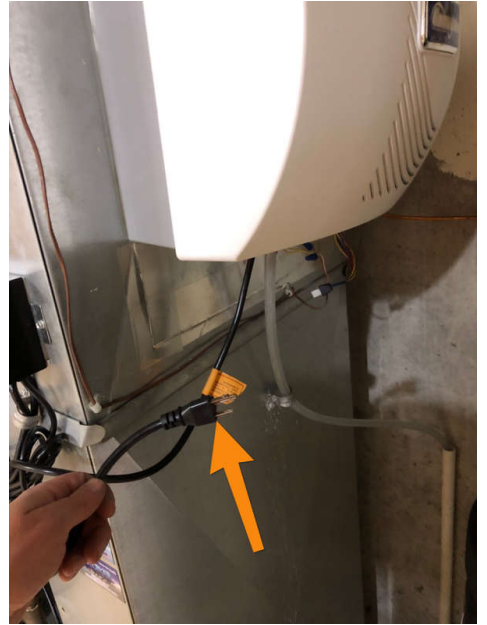
HUMIDIFIER- UNPLUGGED

The humidifier was unplugged at the time of inspection. Recommend confirming with HVAC technician that the humidifier is in working order.

Contact a qualified HVAC professional.

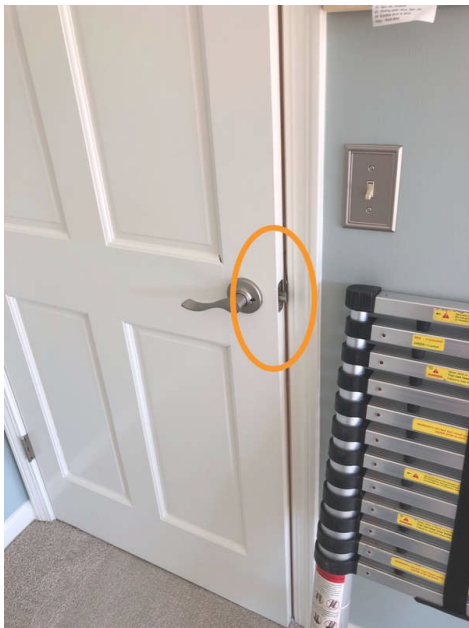
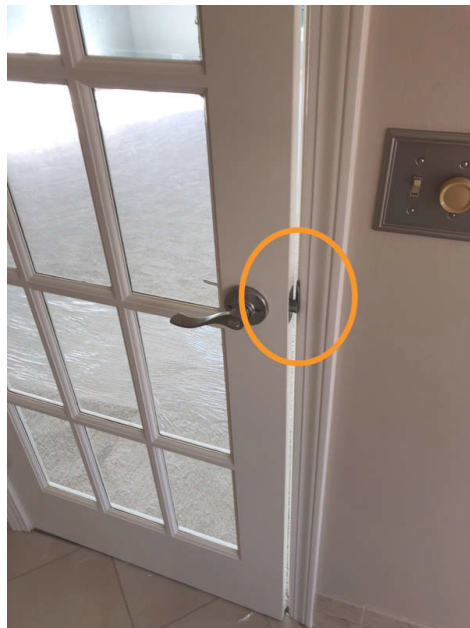
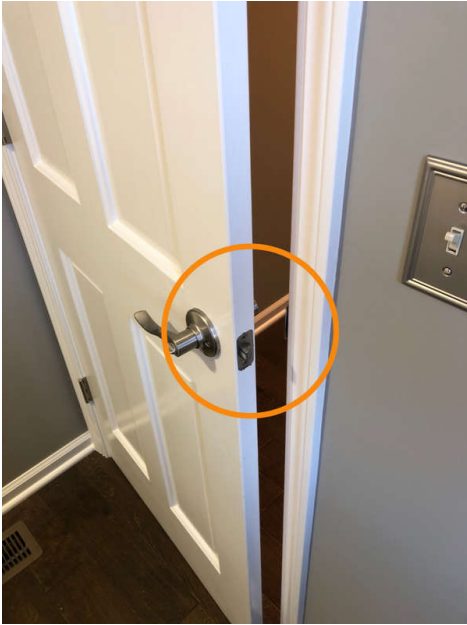
Master Bedroom

DOOR DOESN'T LATCH

Door doesn't latch properly. Recommend handyman repair latch and/or strike plate.

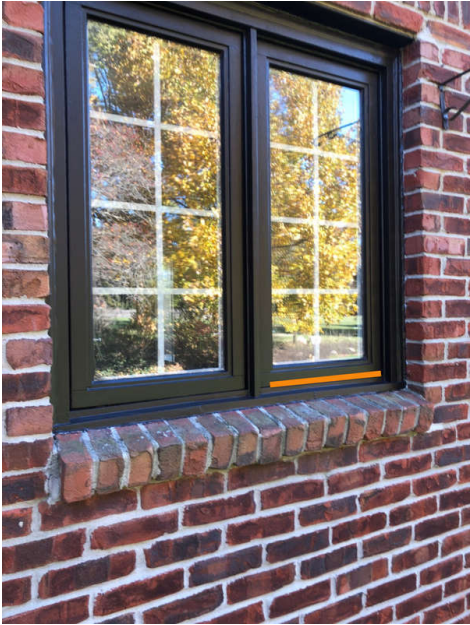
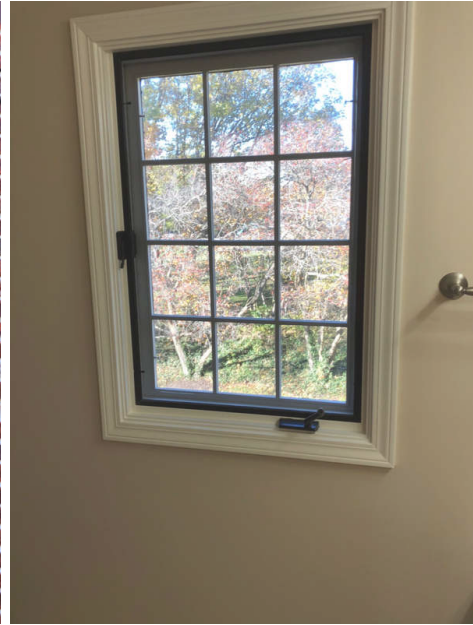
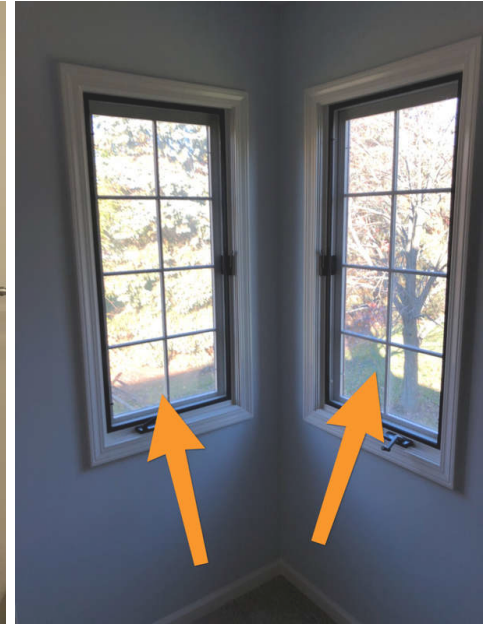
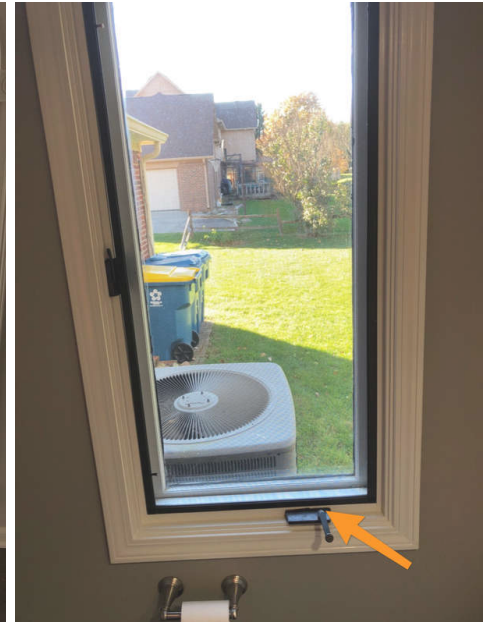
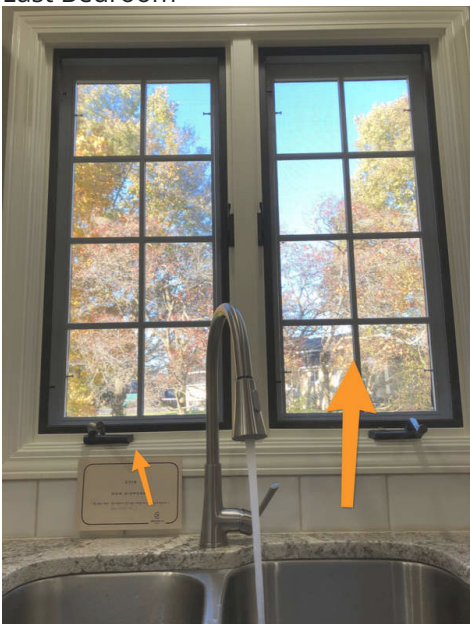
Northwest

PAINTED SHUT

One or more windows are painted shut. Recommend windows be restored to functional use.

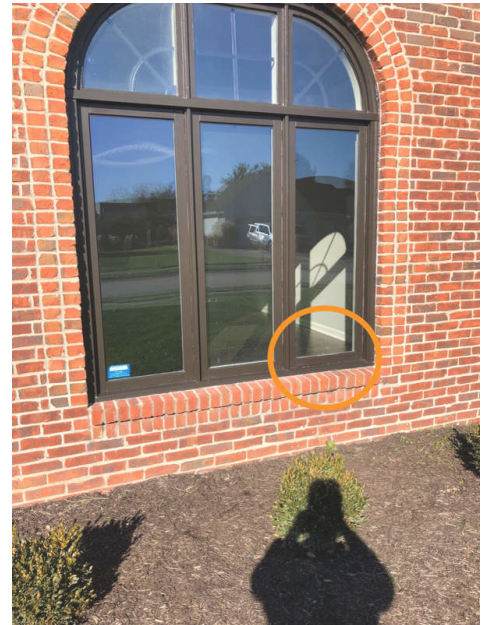
Southeast

WOOD ROT

Wood rot was noted on the exterior trim. Recommend repairing and replacing all affected materials.

Contact a qualified professional.

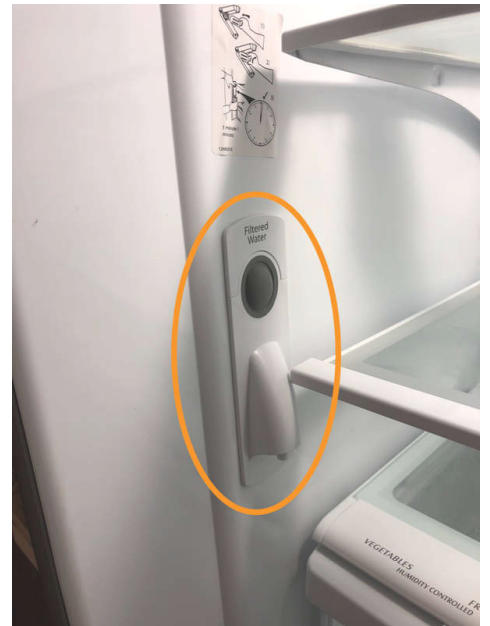
WATER OFF

Contact a qualified professional.

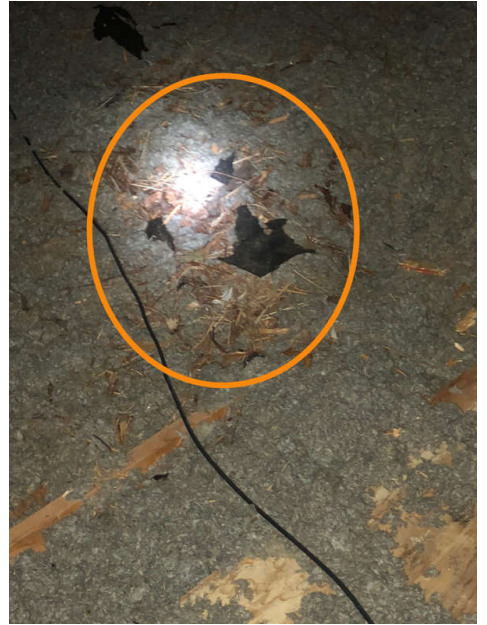
Attic near access

STRAW

Straw and other organic material noted in the attic. This is usually a sign of birds making it into the attic. Recommend qualified pest control professional for evaluation.

Contact a qualified pest control specialist.

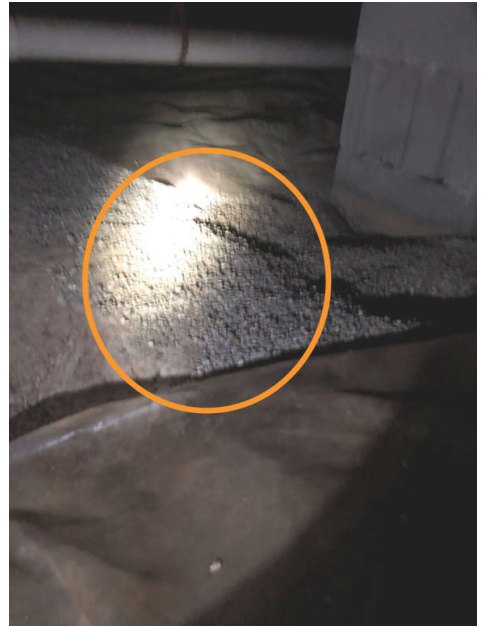
Crawlspace

VAPOR BARRIER DAMAGED

Vapor barrier is damaged in one or more areas. Recommend insulation contractor repair or replace.

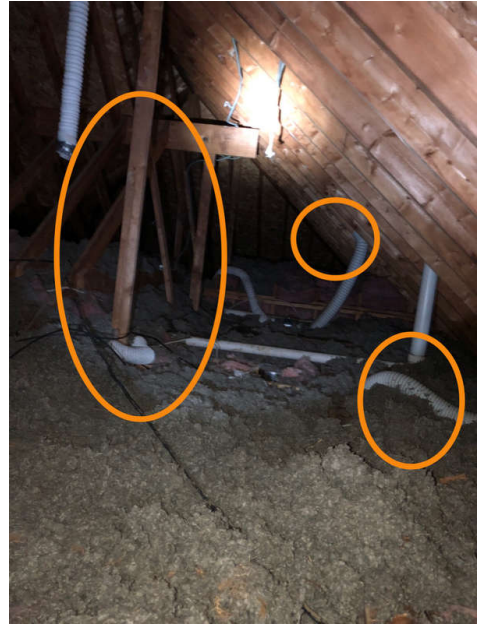
Attic

BATHROOM VENTS INTO ATTIC

Bathroom fan vents into the attic, which can cause moisture and mold. Recommend a qualified attic contractor properly install exhaust fan to terminate to the exterior.

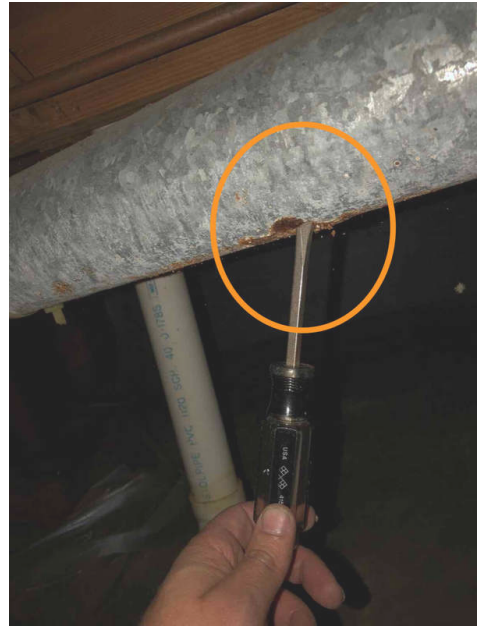
Crawlspace

CORRODED METAL VENT

The metal vent pipe is corroded and developing holes. Recommend replacing the pipe.

Recommendation
Contact a qualified professional.
