**SUMMARY**  
1234 Main St. Haymarket VA 20169  
Buyer Name  
02/24/2019 9:00AM

Aaron Bogans  
InterNACHI Certified...  
Red Carpet Home Inspections  
888.559.1939  
info@redcarpethomeinspections.com

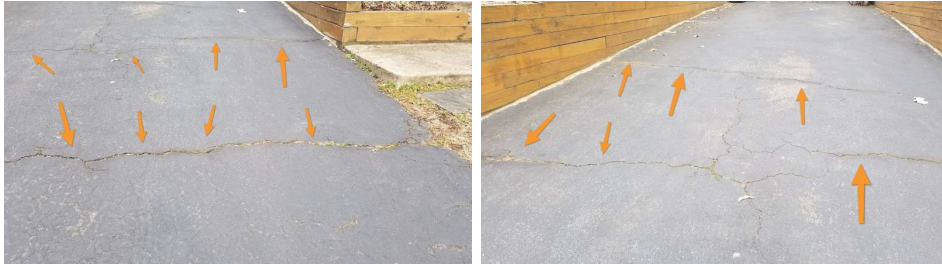
### 2.1.1 Walkways & Driveways

#### **DRIVEWAY CRACKING - MINOR**

Minor cosmetic cracks observed, which may indicate movement in the soil. Recommend to monitor and/or have concrete contractor patch/seal.

Contact a qualified driveway contractor.

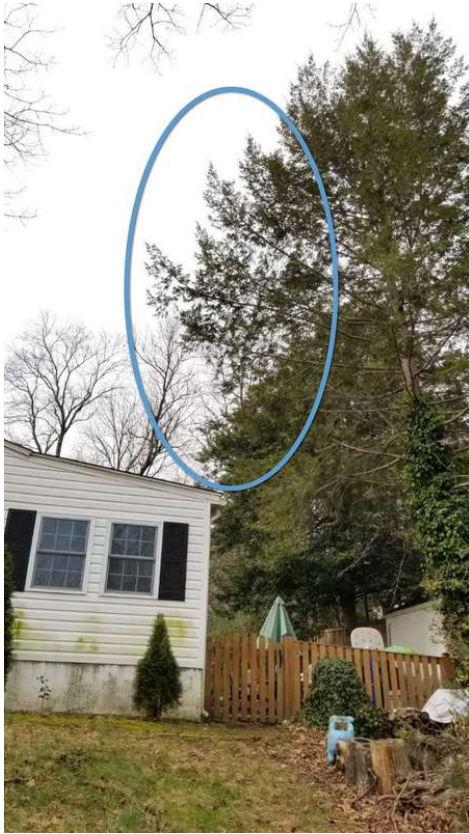
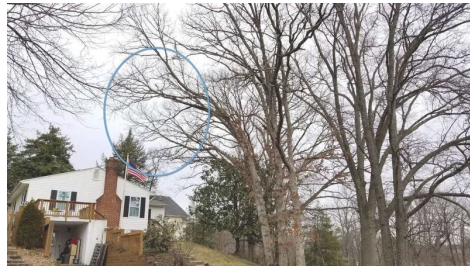
### 2.2.1 Vegetation, Grading

#### **TREE OVERHANG**

Trees observed overhanging the roof. This can cause damage to the roof and prevent proper drainage. Recommend a qualified tree service trim to allow for proper drainage.

Large tree branch overhang

Trees overhang the roof which cause debris and potential branch falling hazard

Contact a qualified tree service company.

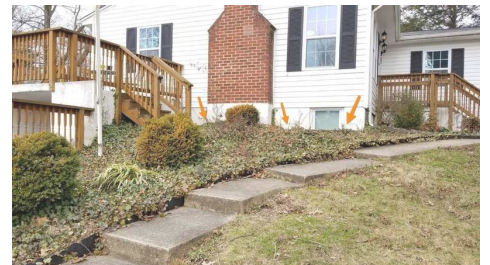
2.2.2 Vegetation, Grading

**THICK CONCENTRATION OF VEGETATION NEAR THE HOME**

Area has a large concentration of vegetation near the homes foundation that has been known to hold a lot of moisture and could potentially cause moisture intrusion into the homes foundation.

Recommend trimming back and controlling some of the vegetation be a qualified professional.

Contact a qualified lawn care professional.

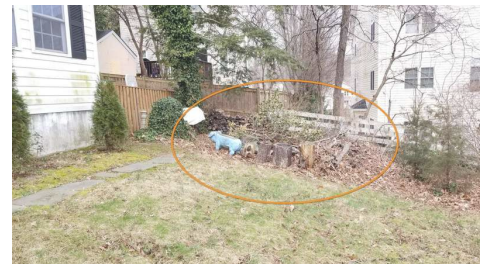
2.2.3 Vegetation, Grading

**POTENTIAL FOR WDI INFESTATION**

Wood Destroying Insects are known to inhabit lumber and fallen other various forms of vegetation. Large amounts of lumber should be kept as far away for the house structure as possible. To prevent the possibility of WDI inhabiting the dwelling. Recommend moving wood much further away from the house. At least 25 feet or so.

Recommended DIY Project

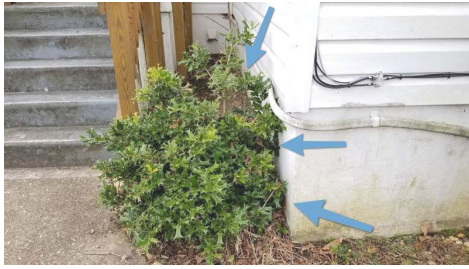
North front entryway

## VEGETATION NEAR HOME

Recommend to remove vegetation that is in contact with exterior of home.

Recommended DIY Project

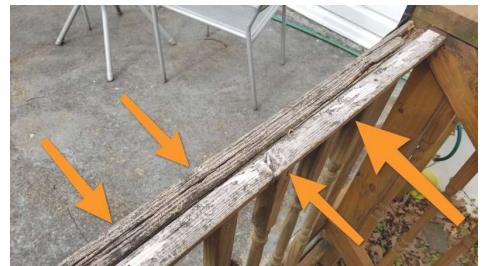
Deck gate top rail

## DECK - ROTTED BOARDS

One or more deck boards are showing signs of rot. Recommend a qualified deck contractor replace.

Contact a qualified deck contractor.

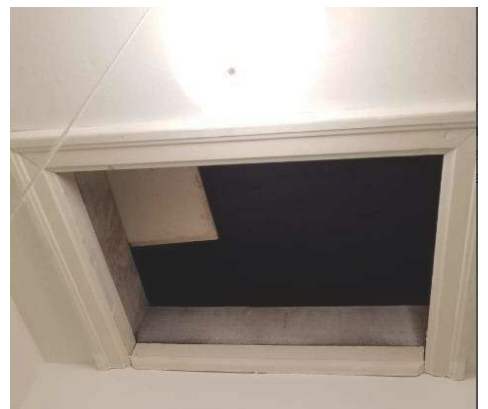
WEST BEDROOM 1

## ATTIC ACCESS ENTRANCE

One or more attic access hatches or doors were too small to allow easy access. Such hatches should be at least 22 x 30 inches in size, and in safely accessed areas. Recommend that a qualified person modify attic access points per standard building practices. Noted in upper level closet ceiling.

Contact a qualified professional.

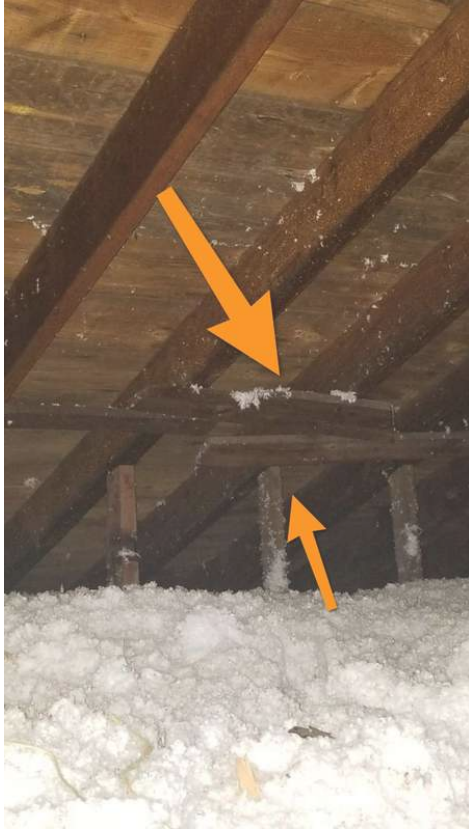
3.3.1 Roof Structures

**RAFTERS BROKEN, CUT OR NOTCHED OUT**

Observed one or more rafters broken, cut or notched out while inspecting the roofing structure. Recommend a qualified roofing professional to evaluate.

Improper bracing of rafters with wood not deemed suitable

Contact a qualified roofing professional.

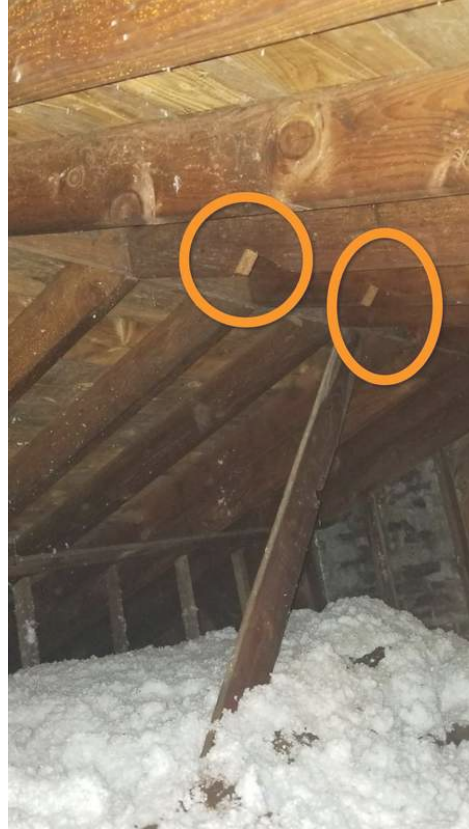
Notches cut out of rafters

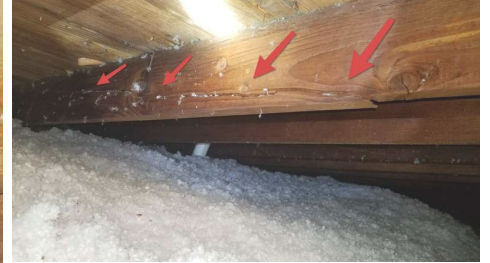
Rafter is splitting very badly and needs to be evaluated by a roofing professional

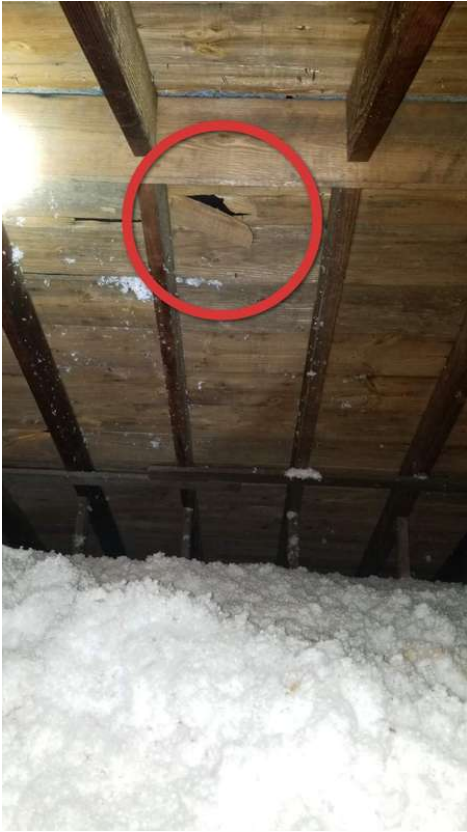
3.3.2 Roof Structures

**PLANK BOARDS BROKEN**

One or more plank boards are broken or have signs of major wear and tear. Recommend a roofing professional to further evaluate

Large hole from broken roof plank covered with underlayment and shingles

Contact a qualified roofing professional.

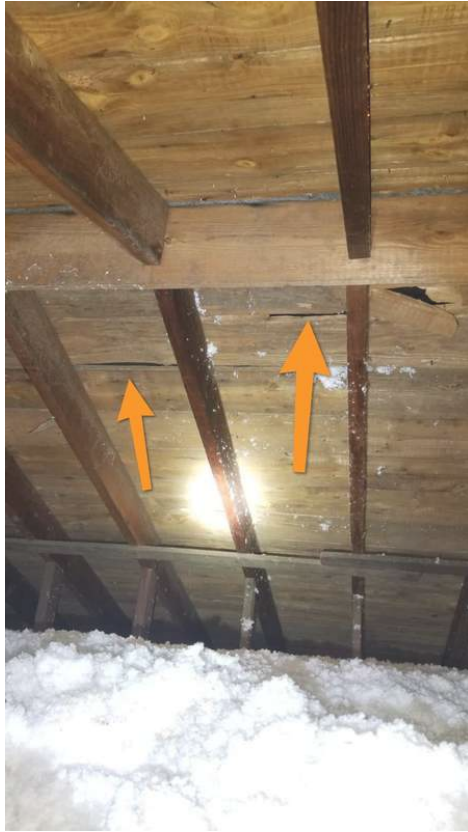
Planks are showing splitting and signs of separation occurring. Recommend a roofing professional to further evaluate

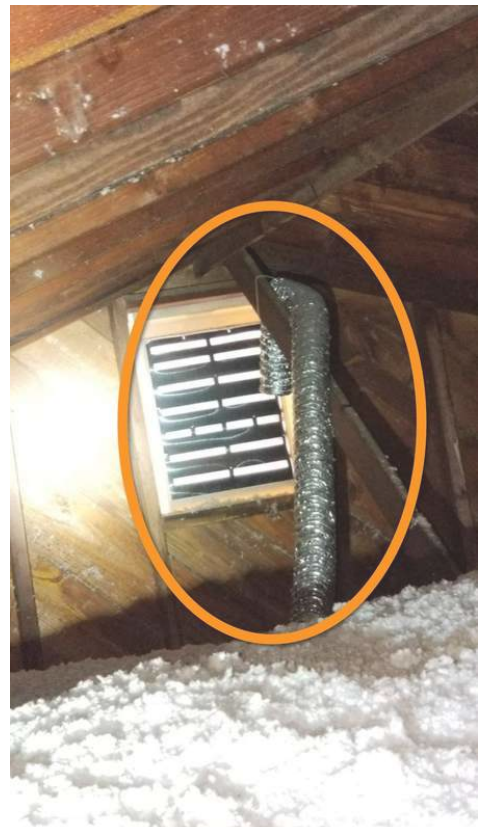
3.4.1 Ventilation

**VENT PIPE INTO ATTIC**

Observed a vent pipe possibly discharging into the attic. Was not able to determine whether or not it was hooked to anything. Nothing should exhaust into the attic. Everything should exhaust to the exterior of the home. Recommend further evaluation by a qualified HVAC professional

Vent hose appears to discharge into the attic. Proper venting is needed to discharge out of the attic and to the exterior of the house

Recommendation  
Contact a qualified HVAC professional.

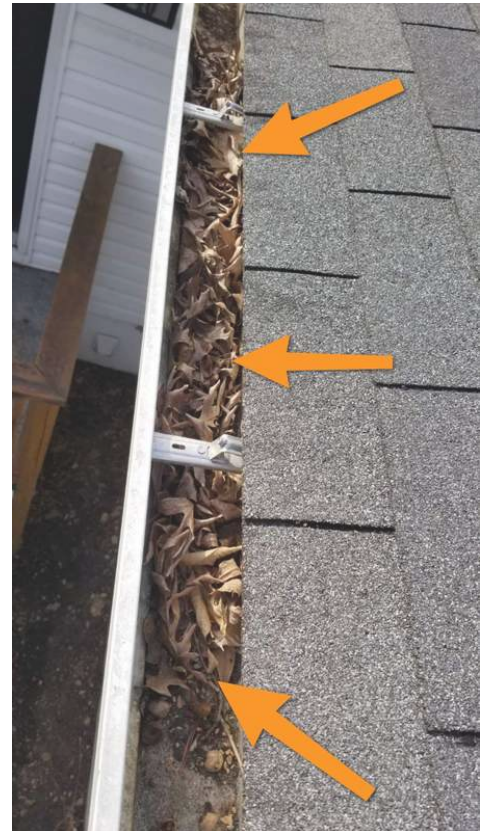
#### 4.4.1 Roof Drainage Systems

### DEBRIS

Debris has accumulated in the gutters. Recommend cleaning to facilitate water flow.

Contact a handyman or DIY project

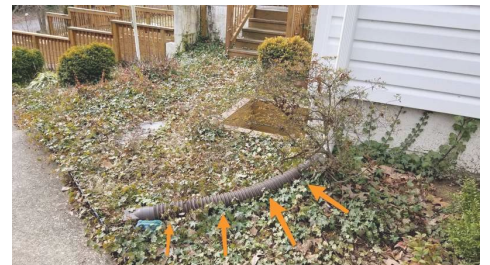
Northwest front

### DOWNSPOUTS DRAIN NEAR STEP/WALKWAY

One or more downspouts drain to nearby steps and/or walkway. This may cause a fall hazard when water freezes/thaws. Recommend adjusting or relocating downspout extensions.

Contact a handyman or DIY project

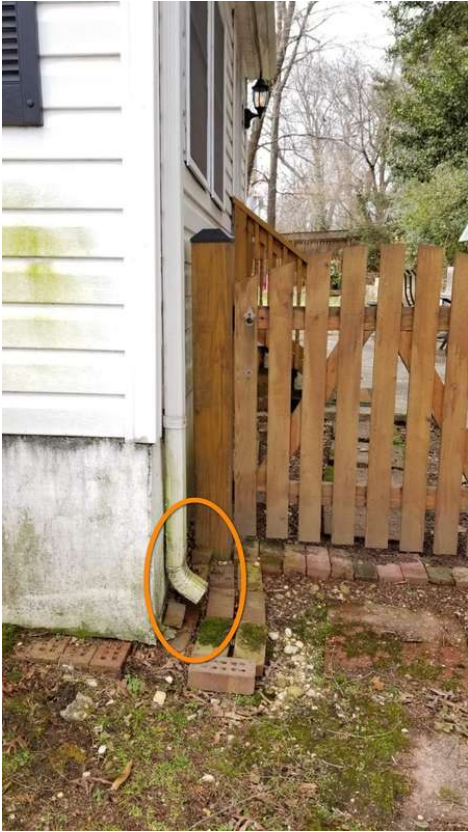
Northeast front

### DOWNSPOUT EXTENSIONS MISSING

Home was missing downspouts in one or more areas. This can result in excessive moisture in the soil at the foundation, which can lead to foundation/structural movement. Recommend a qualified person install downspout extensions that drain at least 6 feet from the foundation.

Contact a handyman or DIY project

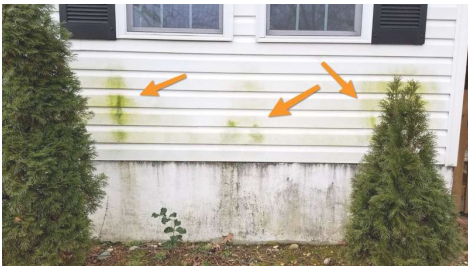
East

## POWER WASH NEEDED

Recommend power washing of siding.

#### Recommended DIY Project

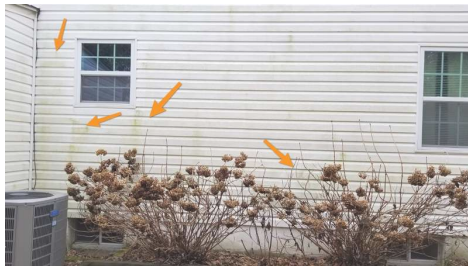
Rear east side of house

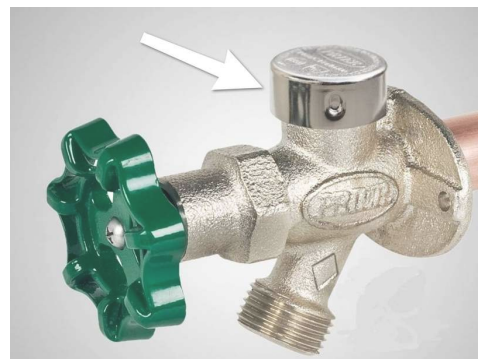
### 5.4.1 Exterior Water Source

## SIPHON VALVES NEEDED

Anti-Siphon valves should be installed on hose bibs to prevent outside water from siphoning through an outside faucet and contaminating the drinking water used in your home. Recommend qualified professional to install

Contact a qualified plumbing contractor.

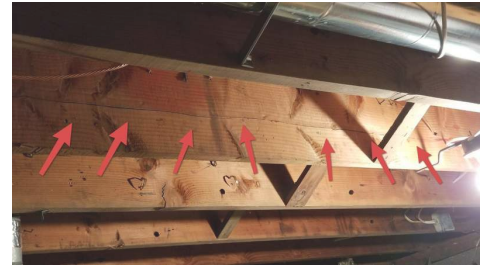
6.1.1 General

### DAMAGED FLOOR JOIST

Floor joist is damaged and could potentially cause a major structural issue. Recommend that a qualified professional structural engineer evaluate further.

Floor joist is completely split down the center throughout 80% of the beam

Contact a qualified structural engineer.

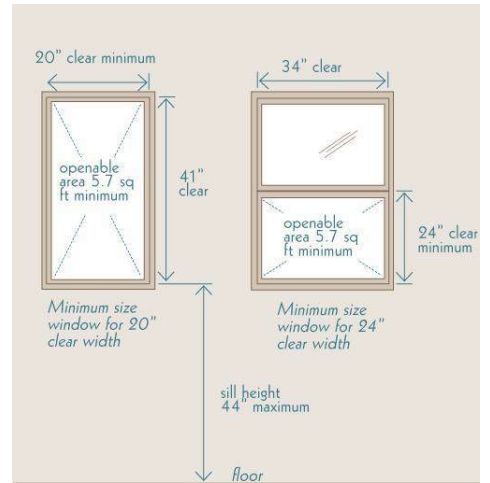
6.5.1 Windows

### WINDOW IS NOT AN EGRESS WINDOW

All windows in the basement are not satisfactory size to be considered Egress windows. Dimensions for an Egress window are illustrated in the picture below.

Contact a qualified window repair/installation contractor.

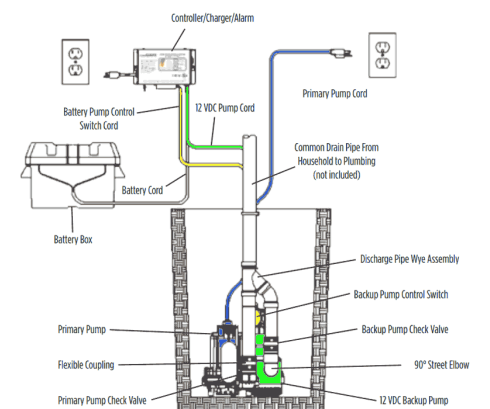
6.7.1 Sump Pump

### BATTERY BACKUP FOR SUMP PUMP

Recommend installing a battery backup for the sump pump, in case of power failure to home. Example of battery in picture below.

Contact a qualified professional.

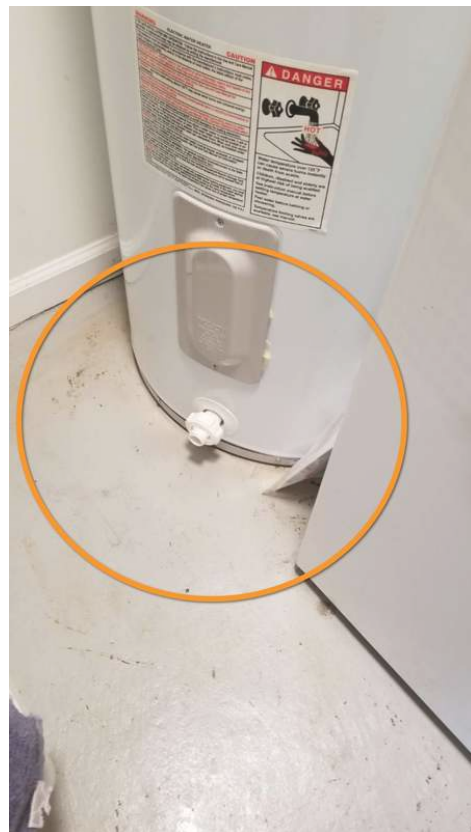
7.4.1 Hot Water Systems

### NO DRIP PAN

No drip pan was present. Drip pan must also drain into a floor drain. Recommend installation by a qualified plumber.

Recommendation  
Contact a qualified plumbing contractor.

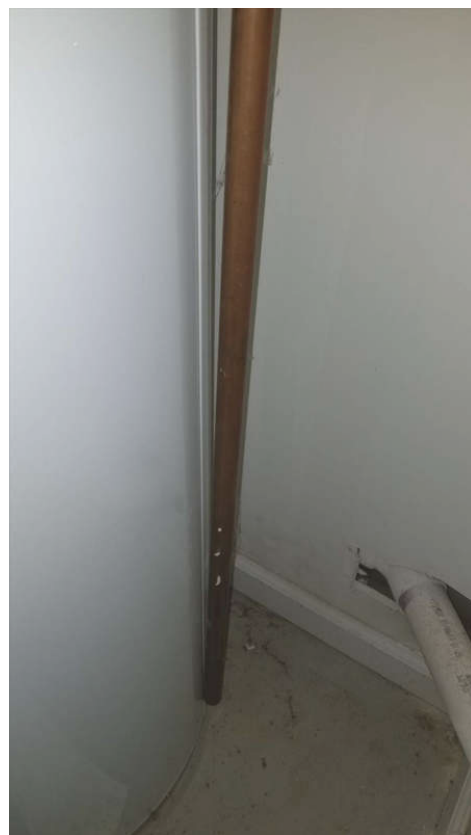
#### 7.4.2 Hot Water Systems

##### **TPR VALVE**

The TPR valve was too close to the ground, should be 6 inches from the floor and into a drip pan.

Recommendation  
Contact a qualified plumbing contractor.

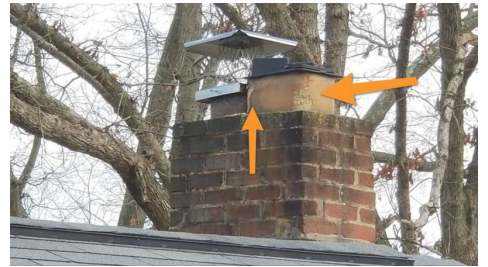
#### 9.1.1 General

##### **CHIMNEY FLUE CRACKED**

The chimney flue had one or more cracks, which can lead to further damage to the chimney structure. Recommend a qualified contractor repair.

Contact a qualified roofing professional.

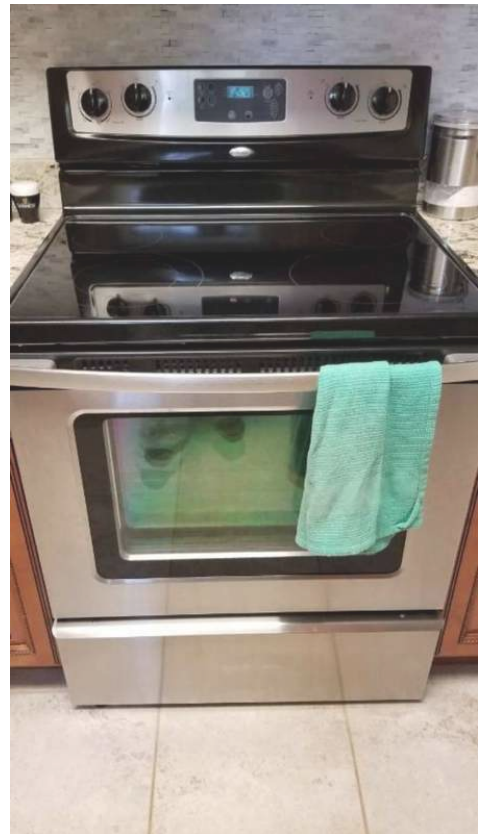
10.7.1 Range/Oven/Cooktop

### **RANGE NOT FASTENED**

Range was not fastened to the wall with anti tip mechanism. This poses a safety hazard to children. Recommend a qualified contractor secure range so it will not tip over and potentially cause harm.

No anti tip attached to the range

Contact a qualified professional.

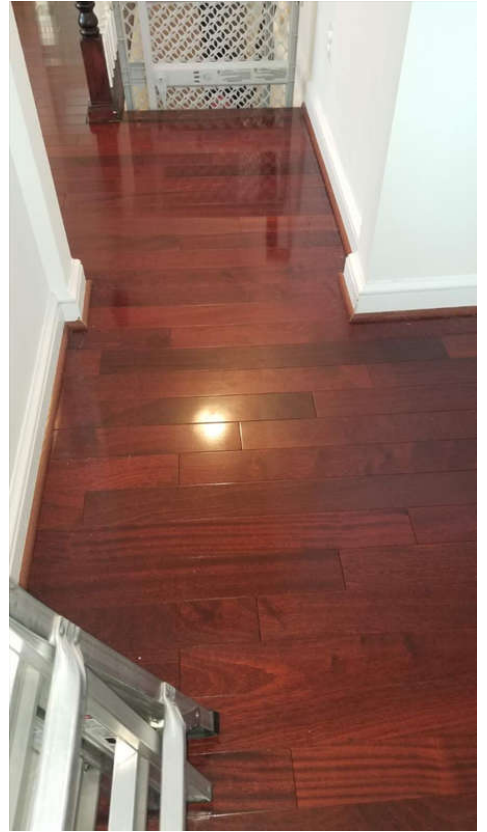
13.2.1 Floors

### **FLOOR SLOPES**

Floor slopes at second floor.

Contact a qualified professional.

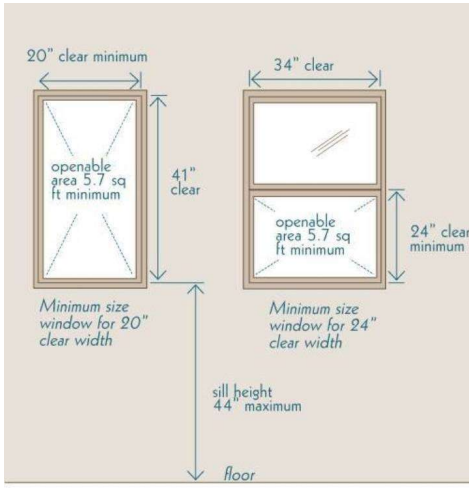
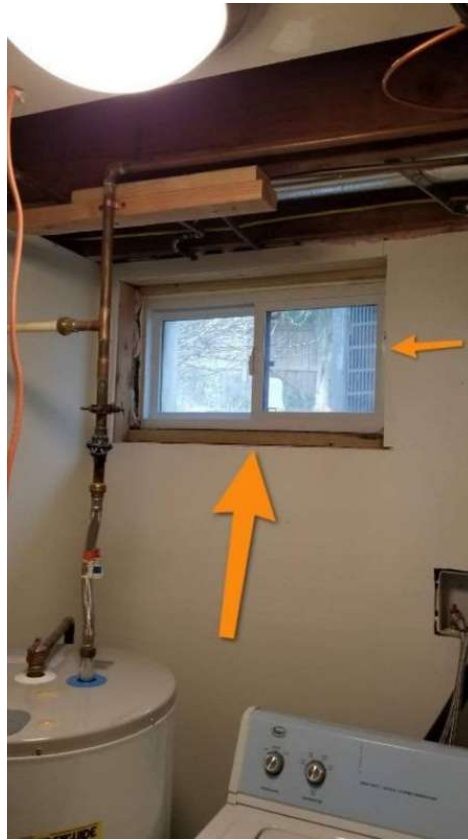
#### 14.4.1 Windows

### **WINDOW IS NOT AN EGRESS WINDOW**

All windows in the basement are not satisfactory size to be considered Egress windows. Dimensions for an Egress window are illustrated in the picture below.

Laundry room window. Not an egress window

Contact a qualified window repair/installation contractor.

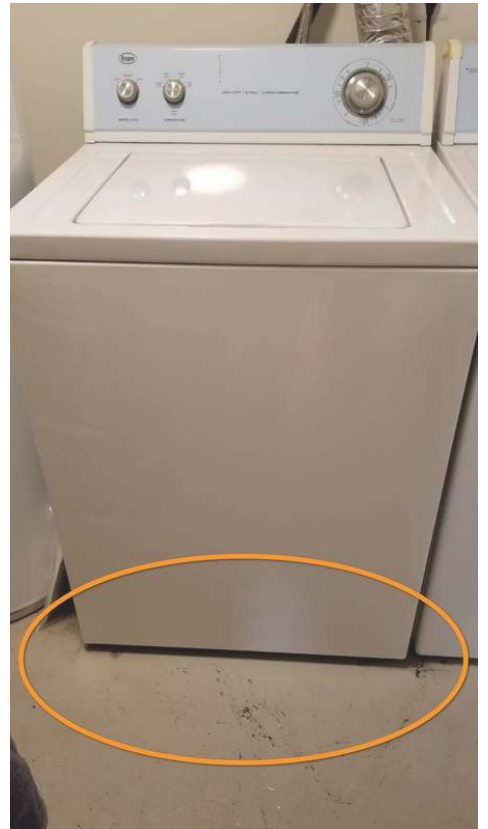
#### 14.7.1 Washer/Dryer **NO CATCH PAN**

Drip pan needed under washer to prevent flooding if leakage occurs

Contact a qualified professional.

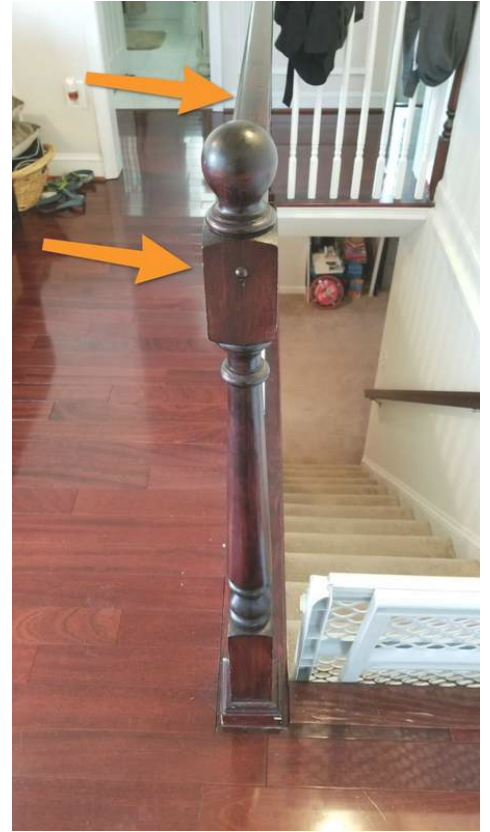
15.3.1 Steps, Stairways & Railings

**LOOSE RAILING**

Railing is loose and needs to be secure tightly to prevent accidental leaning on and railing breaking

Contact a qualified professional.

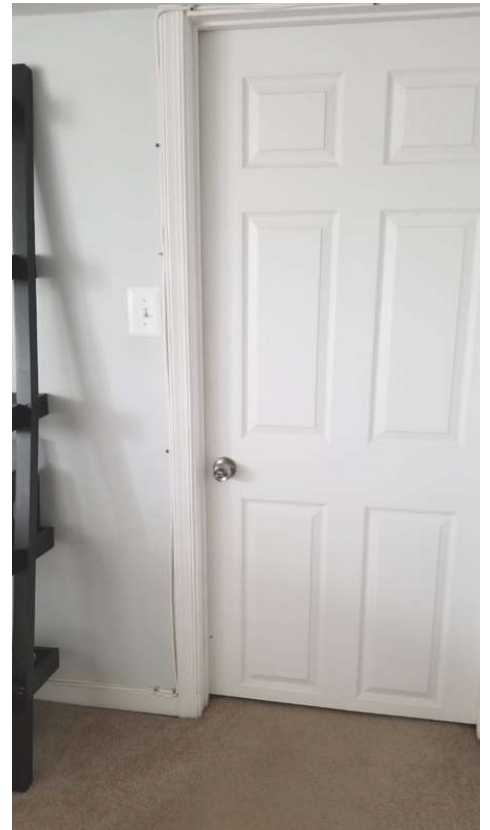
16.4.1 Doors

**DOOR KNOB AND LATCH ALIGNMENT**

Door knob, latch and/or strike plate is out of alignment. Should be installed a minimum of 34 inches to a maximum of 48 inches above the floor. Recommend a professional qualified door contractor.

Basement bedroom door handle low. Should be installed a minimum of 34 inches to a maximum of 48 inches above the floor

Contact a qualified door repair/installation contractor.

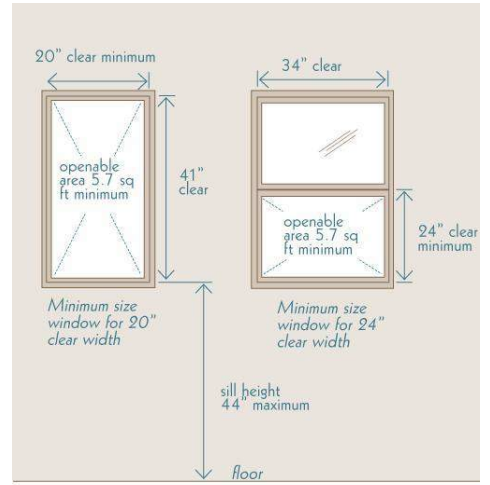
16.5.1 Windows

**EGRESS WINDOW - EXIT**

Recommend installing a egress window in the bedroom. Current window installed does not meet specs.

Openable only to 16 inches and not the required 24 inches minimum

Contact a qualified professional.

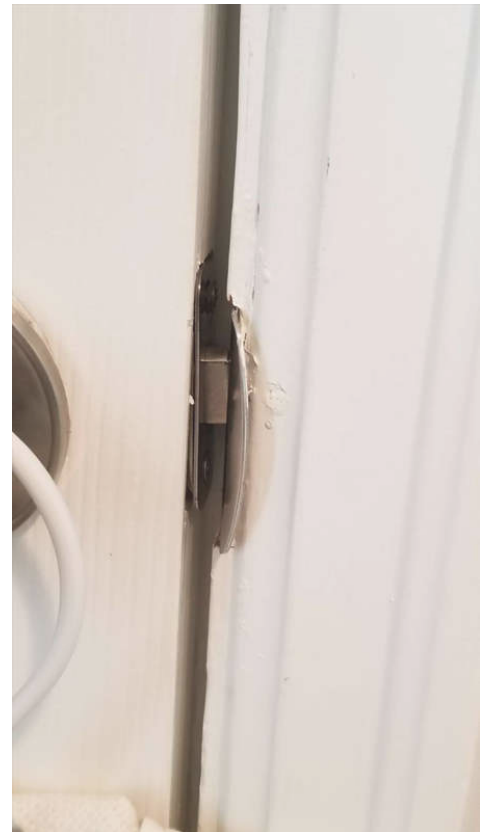
East bedroom closet

**DOOR DOESN'T LATCH**

Door doesn't latch properly. Recommend handyman repair latch and/or strike plate.

Contact a qualified handyman.

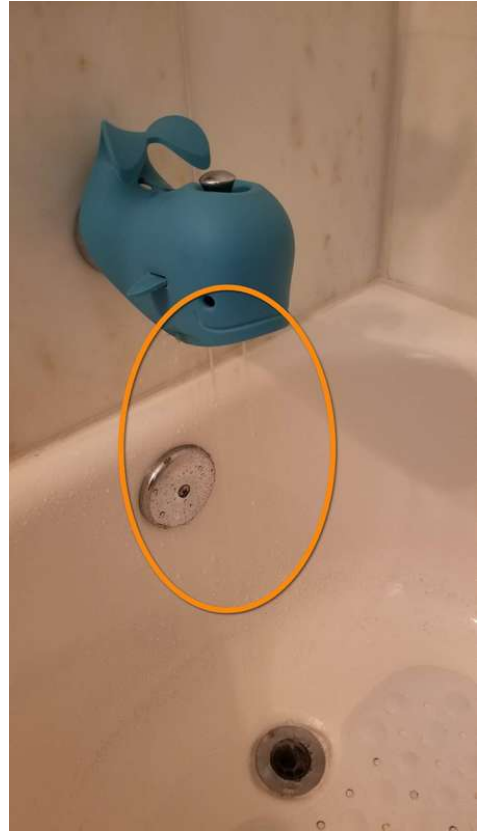
19.2.1 Plumbing & Fixtures

**DIVERTER NOT WORKING PROPERLY**

Tub/Shower diverter was not working properly, recommend repair.

Water not properly diverting to the shower head

Contact a qualified professional.

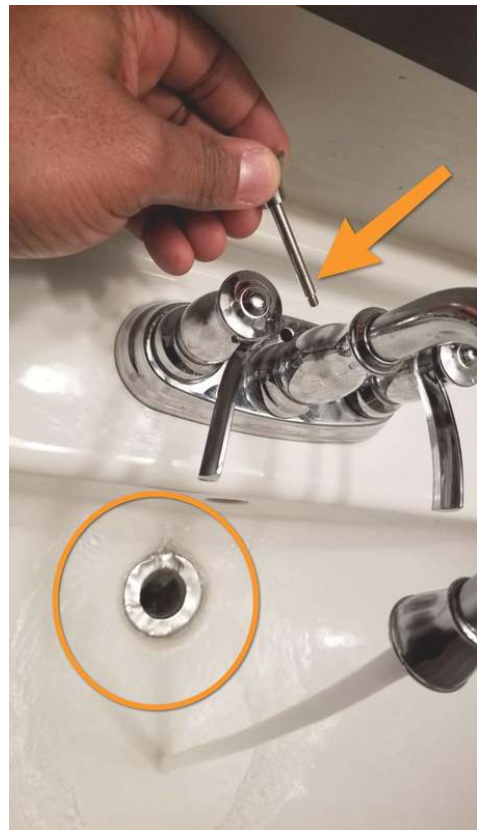
20.2.1 Plumbing & Fixtures

**SINK - DRAIN STOP NOT CONNECTED/MISSING**

Sink drain stop was not operating as intended or was missing, recommend repair.

Stopper missing and broken

Contact a qualified plumbing contractor.
