SUMMARY

1234 Main St.Canton MI 48188

Matthew Cottenham
Certified Master Inspector (CMI)
Trademark Home Inspection, LLC
734-331-3269
matt@trademarkhomeinspection.com

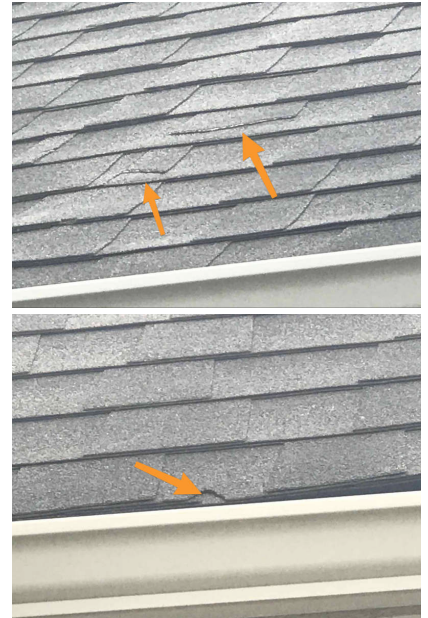
2.1.1 Coverings

DAMAGED/MISSING

One or more composition shingles are damaged, deteriorated and/or missing, and should be replaced. Leaks may occur as a result. A qualified roofing contractor should evaluate and make repairs as necessary.

Contact a qualified roofing professional.

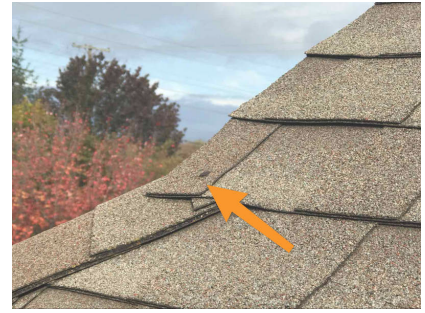
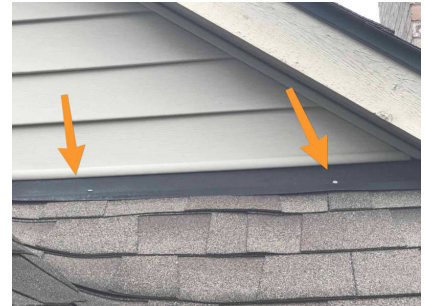
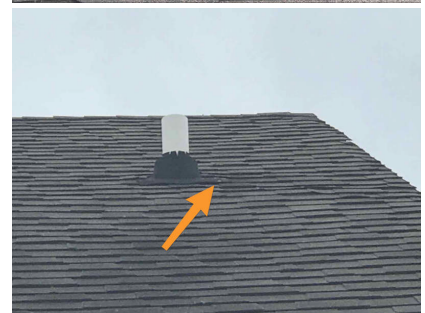
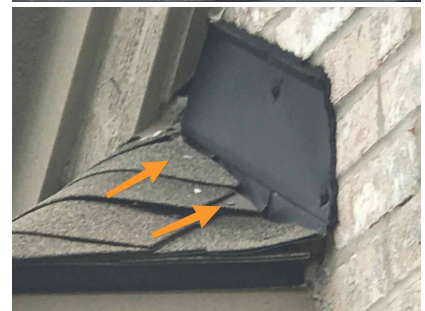
2.1.2 Coverings

EXPOSED FASTENERS

There are exposed fasteners on the roof. These should be sealed over to prevent water leaks.

Contact a quality handyman.

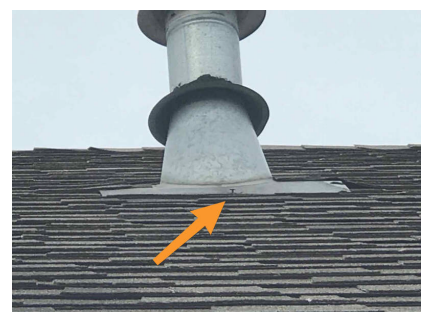
2.1.3 Coverings

UNDER-DRIVEN NAILS

Observed one or more under-driven nails/fasteners. Recommend a qualified roofing contractor evaluate and repair.

Contact a qualified roofing professional.

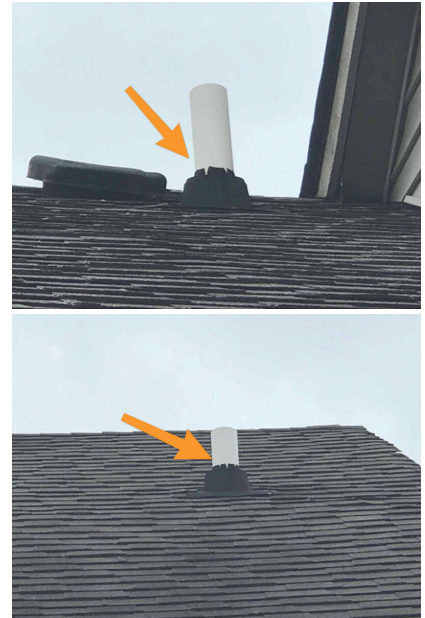
2.2.1 Flashings

DETERIORATED BOOT FLASHING(S)

One or more "rubber boot" flashings are damaged or deteriorated and may result in leaks or vermin intrusion. A qualified contractor should replace flashings where necessary.

Contact a qualified roofing professional.

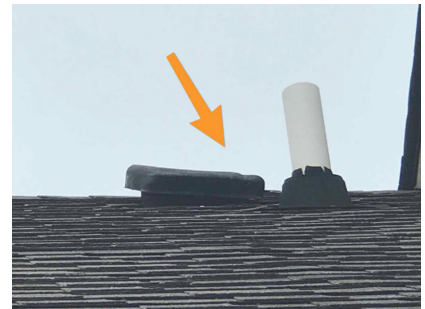
2.3.1 Skylights, Chimneys & Other Roof Penetrations

DAMAGED ROOF VENT

Damaged roof vent

Contact a qualified roofing professional.

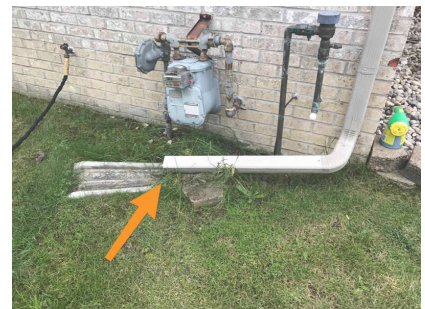
2.4.1 Roof Drainage Systems

DOWNSPOUTS DRAIN NEAR HOUSE

One or more downspouts drain too close to the home's foundation. This can result in excessive moisture in the soil at the foundation, which can lead to foundation/structural movement. Recommend a qualified contractor adjust downspout extensions to drain at least 6 feet from the foundation.

Contact a qualified professional.

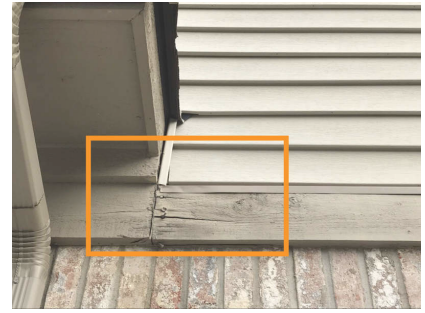
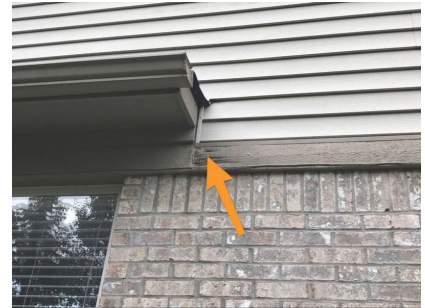
3.1.1 Siding, Flashing & Trim

SIDING DAMAGED

Siding is damaged and/or deteriorated in one or more areas. A qualified contractor should evaluate and make repairs and/or replace siding as necessary to prevent water and vermin intrusion.

Contact a qualified siding specialist.

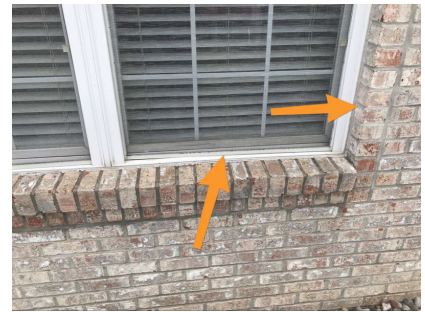
3.1.2 Siding, Flashing & Trim

DETERIORATED CAULKING

Caulking is missing or deteriorated in some areas and should be replaced and/or applied where necessary.

Recommended DIY Project

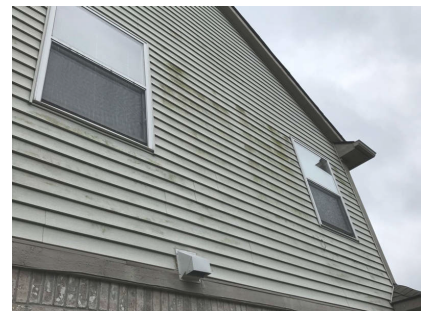
3.1.3 Siding, Flashing & Trim

MILDEW/ALGAE

There are signs of algae and/or mildew on the siding. This is a cosmetic issue and is not uncommon especially on shaded portions of the home. Recommend that said areas be washed or cleaned on a regular basis.

Contact a qualified professional.

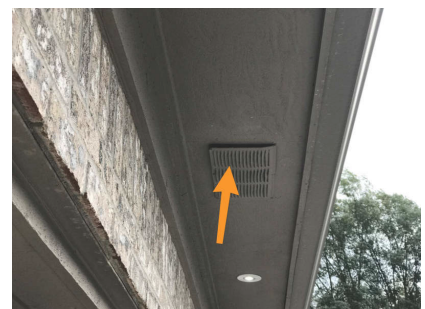
3.2.1 Eaves, Soffits & Fascia

SCREENS MISSING OR DETERIORATED

One or more soffit vent screens are missing and/or deteriorated. Birds and vermin may enter the attic because of this. Screens should be replaced or repaired where necessary, or installed where missing.

Contact a quality handyman.

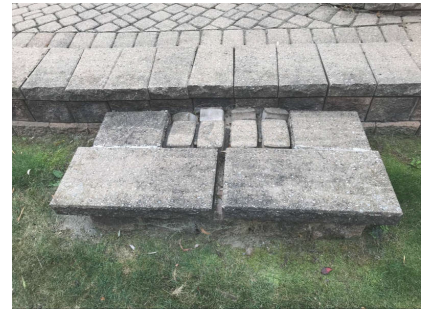
3.3.1 Decks, Balconies, Porches & Steps

STAIRS WOBBLY/DETERIORATED

⚠ Safety Hazard and/or Requires Immediate Attention

The steps are wobbly and/or deteriorated and need to be repaired or replaced by a qualified contractor

Contact a qualified professional.

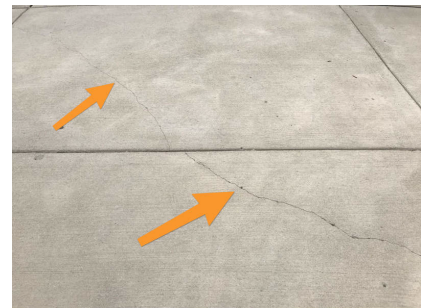
3.5.1 Walkways, Patios & Driveways

DRIVEWAY CRACKING - MINOR

Minor cosmetic cracks observed, which may indicate movement in the soil. Recommend monitor and/or have concrete contractor patch/seal.

Contact a qualified concrete contractor.

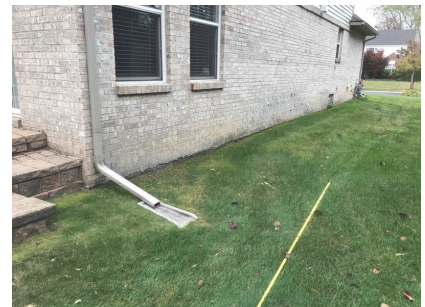
3.6.1 Vegetation, Grading, Drainage & Retaining Walls

NEGATIVE GRADING

Grading is sloping towards the home in some areas. This could lead to water intrusion and foundation issues. Recommend qualified landscaper or foundation contractor regrade so water flows away from home.

Contact a qualified landscaper or gardener.

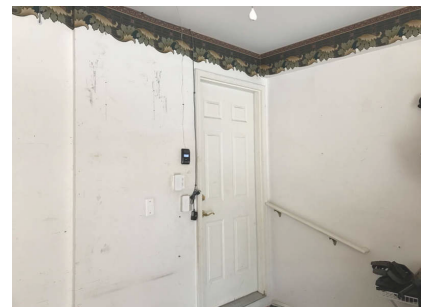
4.6.1 Garage Service Door(s)

NO AUTO CLOSE

⚠ Safety Hazard and/or Requires Immediate Attention

The garage-house door isn't equipped with an automatic closing device such as sprung hinges. This door should close and latch automatically to prevent vehicle fumes from entering living spaces and/or to slow the spread of fire from the garage to living spaces. A qualified contractor should install automatic closing device(s) as necessary, and as per standard building practices, so this door closes and latches automatically.

Contact a quality handyman.

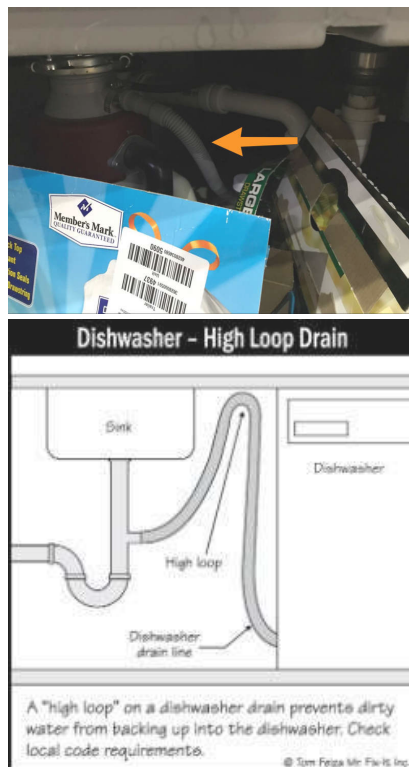
5.1.1 Dishwasher

NO HIGH LOOP

The dishwasher drain line is not configured with a "high loop" or "air gap". A high loop is created by routing the drain line up to the bottom surface of the counter top above, and securely fastening it to that surface. It is meant to prevent water from siphoning out of the dishwasher, and to prevent water from the sink drain or food disposal from entering the dishwasher. Some dishwashers have a builtin high loop where one is not required to be configured in the drain line. The clients should try to determine if a high loop is required for this brand and model of dishwasher (review installation instructions, etc.). If one is required, or it cannot be determined if one is not required, then a qualified contractor should install a high loop as per standard building practices.

Contact a qualified appliance repair professional.

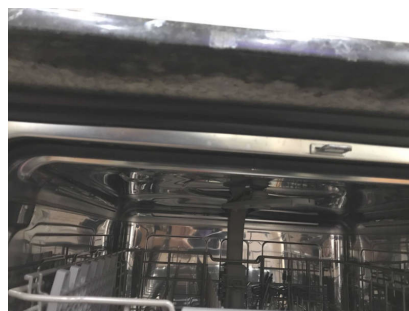
5.1.2 Dishwasher

DETERIORATED BRACKET

The bracket that attaches the dishwasher to the underside of the countertop is loose, missing or installed in a substandard way.

Contact a quality handyman.

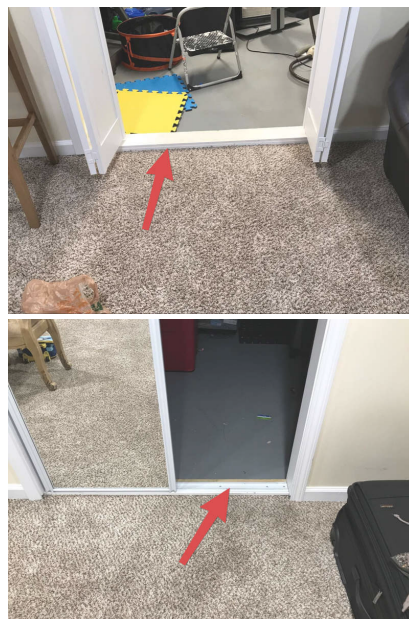
7.3.1 Floors

TRIP HAZARD

⚠ Safety Hazard and/or Requires Immediate Attention

One or more doors are installed in a way where the sill plate was not cut out creating a trip hazard. Recommend a qualified contractor properly install doors.

Contact a qualified professional.

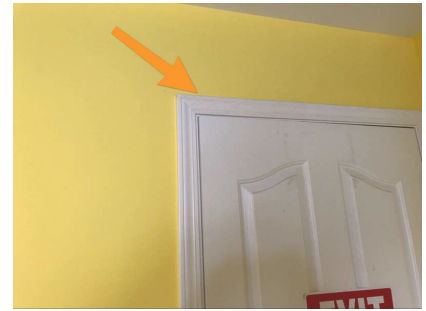
7.5.1 Doors

DOOR STICKS

Door sticks and is tough to open. Recommend sanding down offending sides.

Contact a quality handyman.

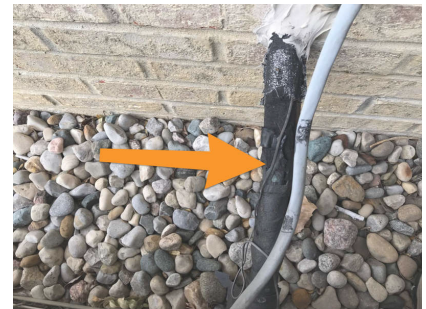
8.1.1 Cooling Equipment

INSULATION MISSING OR DAMAGED

Insulation for the outside condensing unit's refrigerant lines is damaged, deteriorated and/or missing in one or more areas. This may result in reduced efficiency and increased energy costs. A qualified heating and cooling contractor should replace insulation as necessary.

Contact a quality handyman.

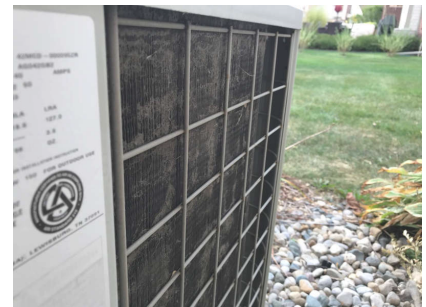
8.1.2 Cooling Equipment

DIRTY COOLING FINS

The cooling fins on the outdoor condensing unit's evaporator coils are dirty. This may result in reduced efficiency and higher energy costs. A qualified heating and cooling contractor should clean the evaporator coils as necessary.

Recommended DIY Project

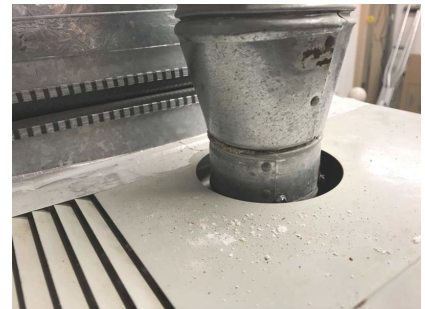
9.3.1 Vents, Flues & Chimneys

WHITE POWDERY DEPOSITS

White, powdery deposits on the furnace exhaust flue and/or cabinet top indicate the presence of excessive amounts of moisture, typically related to condensation formed by improper furnace exhaust flue conditions. This condition may result in premature failure of furnace components. The Inspector recommends that the furnace be serviced by a qualified HVAC contractor.

Contact a qualified HVAC professional.

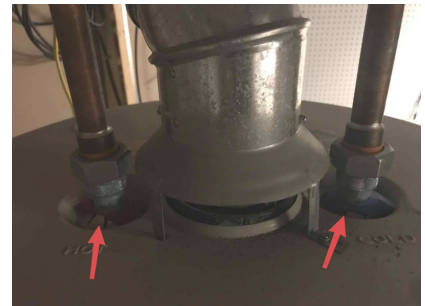
10.3.1 Hot Water Systems, Controls, Flues & Vents

MELTED INSULATION/PLASTIC

⚠ Safety Hazard and/or Requires Immediate Attention

Foam insulation on water supply pipe(s) at the top of the water heater or plastic on the top of the water heater has melted due to the heat from the draft hood. This is a safety hazard since and should be repaired by a qualified contractor.

Contact a qualified plumber.

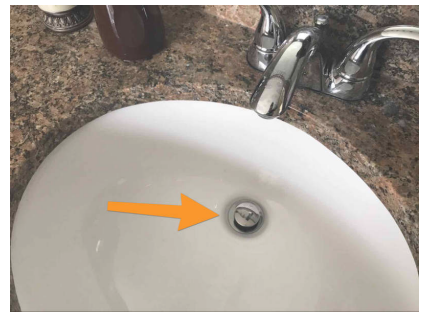
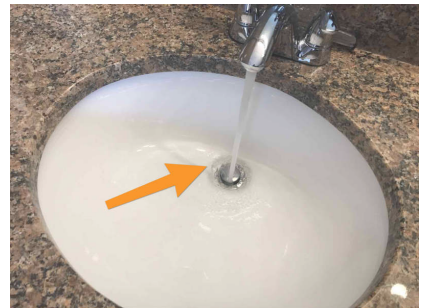
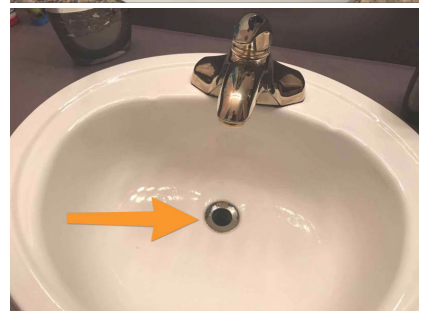
10.5.1 Drain, Waste, & Vent Systems

DRAIN STOPPER(S) DEFECTIVE

One or more drain stoppers are inoperable or missing. Recommend repairing or replacing stoppers as needed.

Contact a quality handyman.

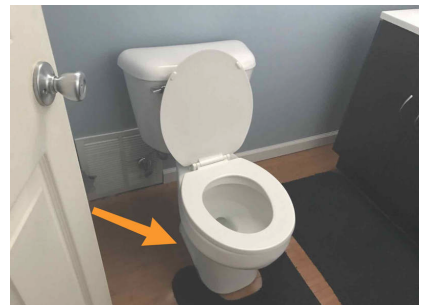
10.5.2 Drain, Waste, & Vent Systems

LOOSE TOILET

One or more toilets are loose and should be tightened to help prevent leaking.

Contact a qualified plumber.

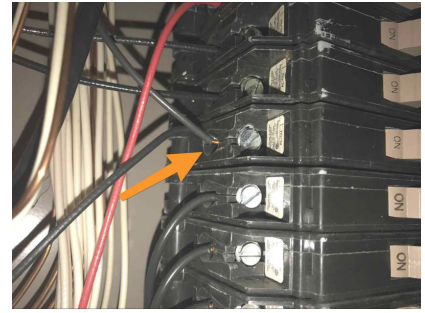
11.2.1 Main & Subpanels, Service & Grounding, Main Overcurrent Device

DOUBLE TAPS

One or more overcurrent protection devices (circuit breakers or fuses) are "double tapped", where 2 or more wires are clamped in a terminal designed for only one wire. This is a safety hazard since the bolt or screw may tighten securely against one wire, but leave others loose. Arcing, sparks and fires may result. A qualified electrician should evaluate and repair as necessary.

Contact a qualified electrician.

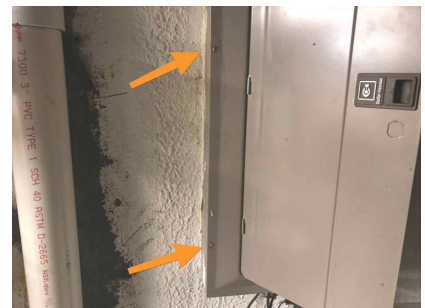
11.2.2 Main & Subpanels, Service & Grounding, Main Overcurrent Device

SCREWS MISSING

One or more screws are missing from the main service panel cover and should be replaced. Because energized wiring may exist behind the holes with the missing screws, recommend that a qualified, licensed electrician replace these screws, or that care be taken to ensure that the new screws do not come in contact with wiring inside the panel when they are installed. Stock screws from the panel manufacturer should be used, or their equivalent.

Contact a quality handyman.

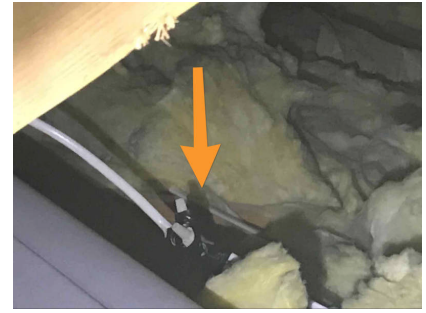
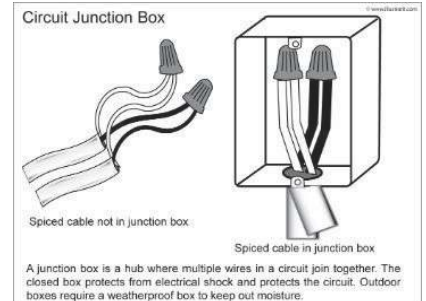
11.3.1 Branch Wiring

WIRE SPLICES EXPOSED

Wire splices are exposed due to not being contained in a covered junction box. This is a safety hazard due to the risk of shock and fire. A qualified electrician should evaluate and make repairs as necessary. For example, install securely mounted junction boxes with cover plates where needed to contain wiring splices.

Contact a qualified electrician.

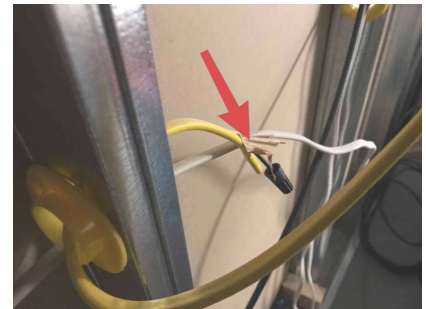
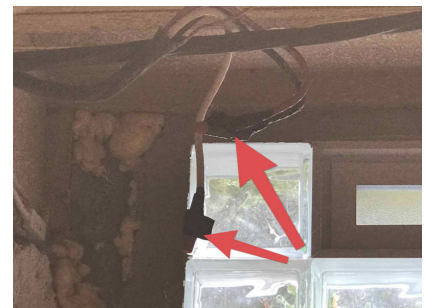
11.3.2 Branch Wiring

WIRING NOT TERMINATED

⚠ Safety Hazard and/or Requires Immediate Attention

One or more sections of wiring that weren't terminated were found. This is a potential safety hazard due to the risk of shock. A qualified electrician should evaluate and repair as necessary. For example, cutting the wire to length and terminating the wire with wire nuts in a securely anchored, covered, properly sized junction box.

Contact a qualified electrician.

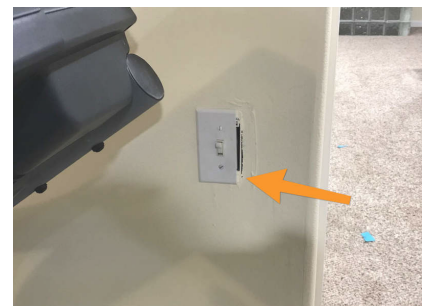
11.4.1 Lighting Fixtures, Switches & Receptacles

COVER PLATES DAMAGED

One or more receptacles have a damaged cover plate. Recommend replacement.

Recommended DIY Project

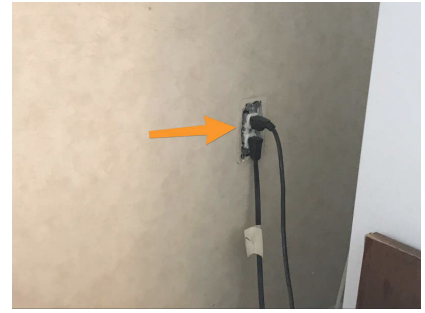
11.4.2 Lighting Fixtures, Switches & Receptacles

COVER PLATES MISSING

One or more receptacles are missing a cover plate. This causes short and shock risk. Recommend installation of plates.

Recommended DIY Project

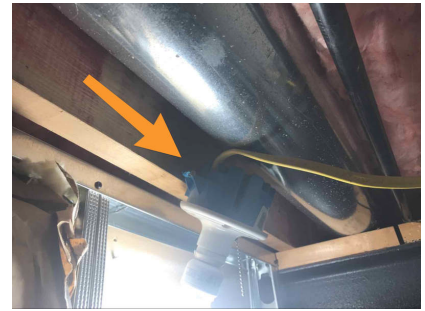
11.4.3 Lighting Fixtures, Switches & Receptacles

LIGHTS LOOSE

One or more light fixtures have missing bulbs and could not be fully evaluated. Bulbs may simply need to be installed, or repairs or replacement may be necessary.

Contact a quality handyman.

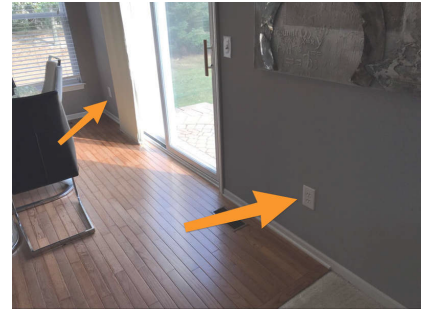
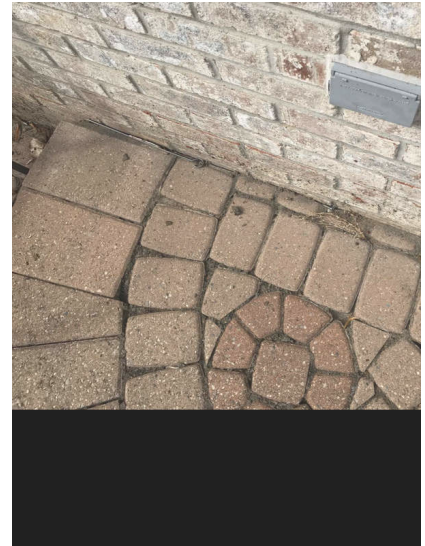
11.4.5 Lighting Fixtures, Switches & Receptacles

NO POWER RECEPTACLES

One or more electric receptacles appear to have no power. Recommend asking the property owner(s) about this. Switches may need to be operated to make some receptacles energized. If necessary, a qualified electrician should evaluate and make repairs as necessary.

Contact a qualified electrician.

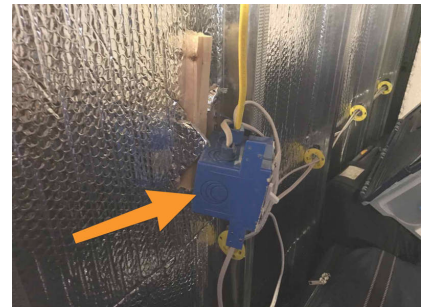
11.4.6 Lighting Fixtures, Switches & Receptacles

RECEPTACLES/BOXES LOOSE

One or more electric receptacles and/or the boxes they are installed in are loose and/or not securely anchored. Wire conductors may be damaged due to repeated movement and/or tension on wires, or insulation may be damaged. This is a safety hazard due to the risk of shock and fire. A qualified electrician should evaluate and repair as necessary.

Contact a quality handyman.

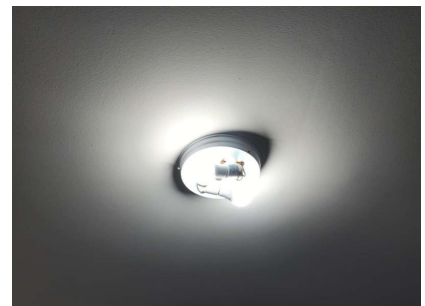
11.4.7 Lighting Fixtures, Switches & Receptacles

MISSING/DETERIORATED GLOBE

One or more light fixtures are missing And or have deteriorated globes. Recommend repairing or replacing the globes.

Recommended DIY Project

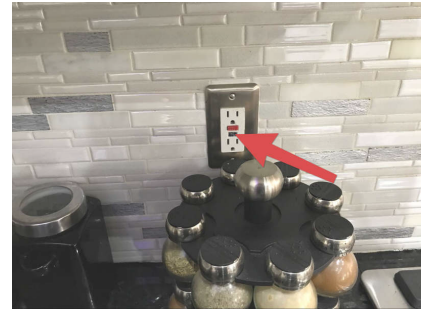
11.5.1 GFCI & AFCI

GFCI DIDN'T RESET

⚠ Safety Hazard and/or Requires Immediate Attention

One or more ground fault circuit interrupter (GFCI) electric receptacles are tripped and will not reset. This is a safety hazard due to the risk of fire and/or shock. A qualified electrician should evaluate and make repairs as necessary.

Contact a qualified electrician.

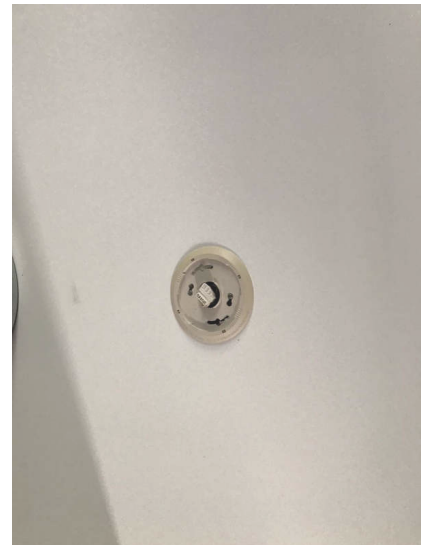
11.6.1 Smoke Detectors

DISCONNECTED

⚠ Safety Hazard and/or Requires Immediate Attention

One or more smoke detector(s) have been disconnected. Without a working smoke detector(s) in your home you have no first alert to a possible fire. I recommend repair or replace as needed using a qualified person.

Contact a quality handyman.

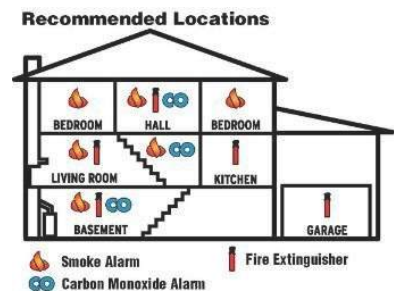
11.6.2 Smoke Detectors

TO FEW

⚠ Safety Hazard and/or Requires Immediate Attention

An insufficient number of smoke alarms are installed. Additional smoke alarms should be installed as necessary so a functioning one exists in each hallway leading to bedrooms, and in each bedroom.

Contact a quality handyman.

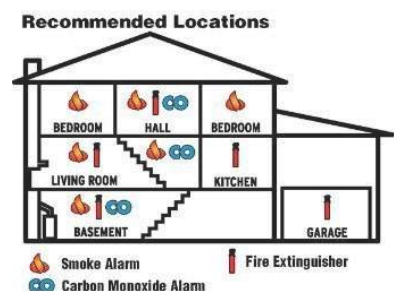
11.7.1 Carbon Monoxide Detectors

NONE FOUND

⚠ Safety Hazard and/or Requires Immediate Attention

The inspector was unable to locate a carbon monoxide detector in the home. It is recommended that one be installed according to the manufacturer's instructions.

Recommended DIY Project

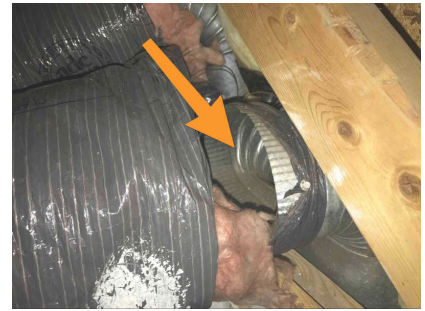
12.4.1 Exhaust Systems

DUCTS BROKEN

One or more exhaust fan ducts are broken and/or have fallen down, or somehow terminate in the attic. This is a conducive condition for wood destroying insects and organisms due to increased moisture levels in the attic from the exhaust air. A qualified contractor should evaluate and make permanent repairs as necessary and as per standard building practices, so all exhaust air is vented outside.

Contact a quality handyman.

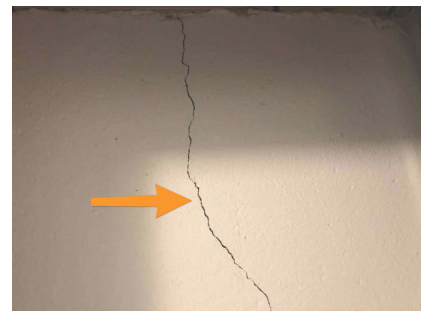
13.2.1 Wall(s)

MODERATE CRACKS

One or more moderate cracks (1/8 inch to 3/4 inch) were found in the foundation. These may be a structural concern, or an indication that settlement is ongoing. The client(s) should consider hiring qualified contractors and/or engineers as necessary for further evaluation. Such contractors may include:

At a minimum, recommend sealing cracks to prevent water infiltration. Numerous products exist to seal such cracks including:

Hydraulic cement. Requires chiseling a channel in the crack to apply.

Resilient caulks (easy to apply).

Epoxy sealants (both a waterproof and structural repair).

Contact a qualified general contractor.

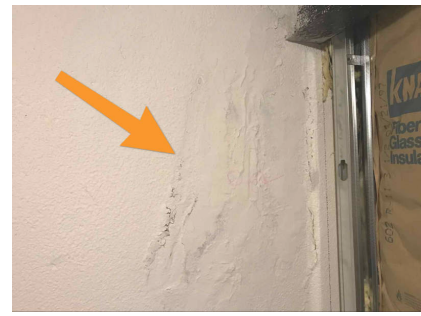
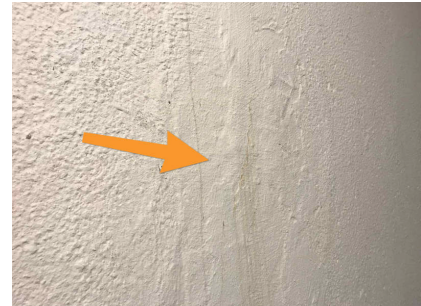
13.2.2 Wall(s)

LEAKING CRACK

One or more wall cracks appear to have Leaked or are leaking and need to be evaluated and repaired by a qualified contractor.

Contact a qualified professional.

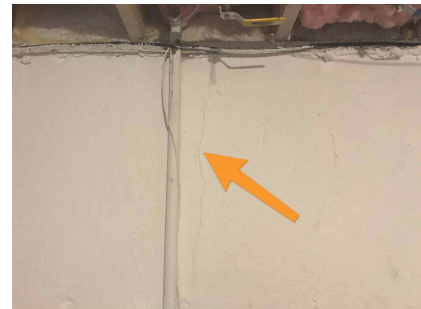
13.2.3 Wall(s)

MINOR CRACKS

One or more minor cracks (1/8 inch or less) were found in the foundation. These don't appear to be a structural concern, but recommend monitoring them in the future. Numerous products exist to seal such cracks including:

Hydraulic cement. Requires chiseling a channel in the crack to apply.

Resilient caulks (easy to apply).

Epoxy sealants (both a waterproof and structural repair).

Recommend monitoring.
