**SUMMARY**  
1234 Main St. Coral Springs FL 33071  
Buyer Name  
05/21/2019 9:00AM

Oscar Lora  
Florida Licensed Home...  
Ohana Inspections  
(954) 440-9960  
[connect@ohanainspections.co](mailto:connect@ohanainspections.co)

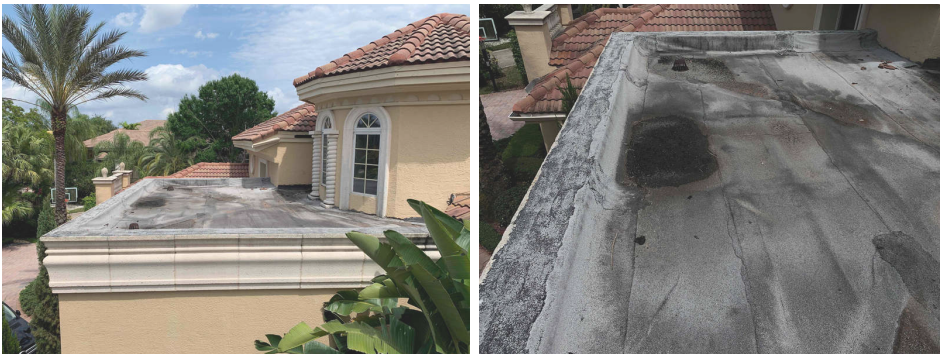
### 2.1.1 Coverings

#### **PONDING**

Observed ponding in one or more areas of roof. Ponding can lead to accelerated erosion and deterioration. Recommend a qualified roofing contractor evaluate and repair.

Recommendation  
Contact a qualified roofing professional.

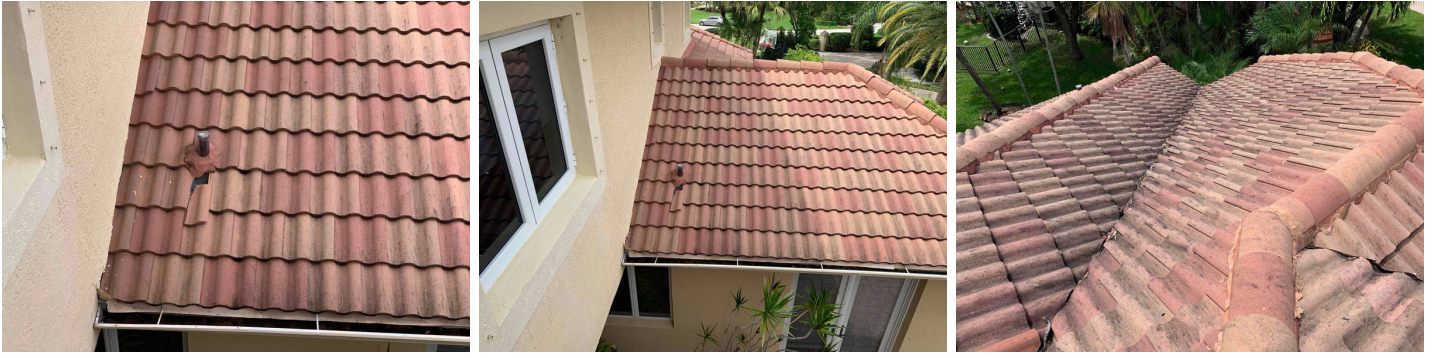
### 2.1.2 Coverings

#### **TILES CRACKED/BROKEN AND MISSING**

Roof had cracked/broken tiles. Inspector recommends a licensed roofing contractor repair or replace to prevent moisture intrusion and/or mold.

Recommendation  
Contact a qualified roofing professional.

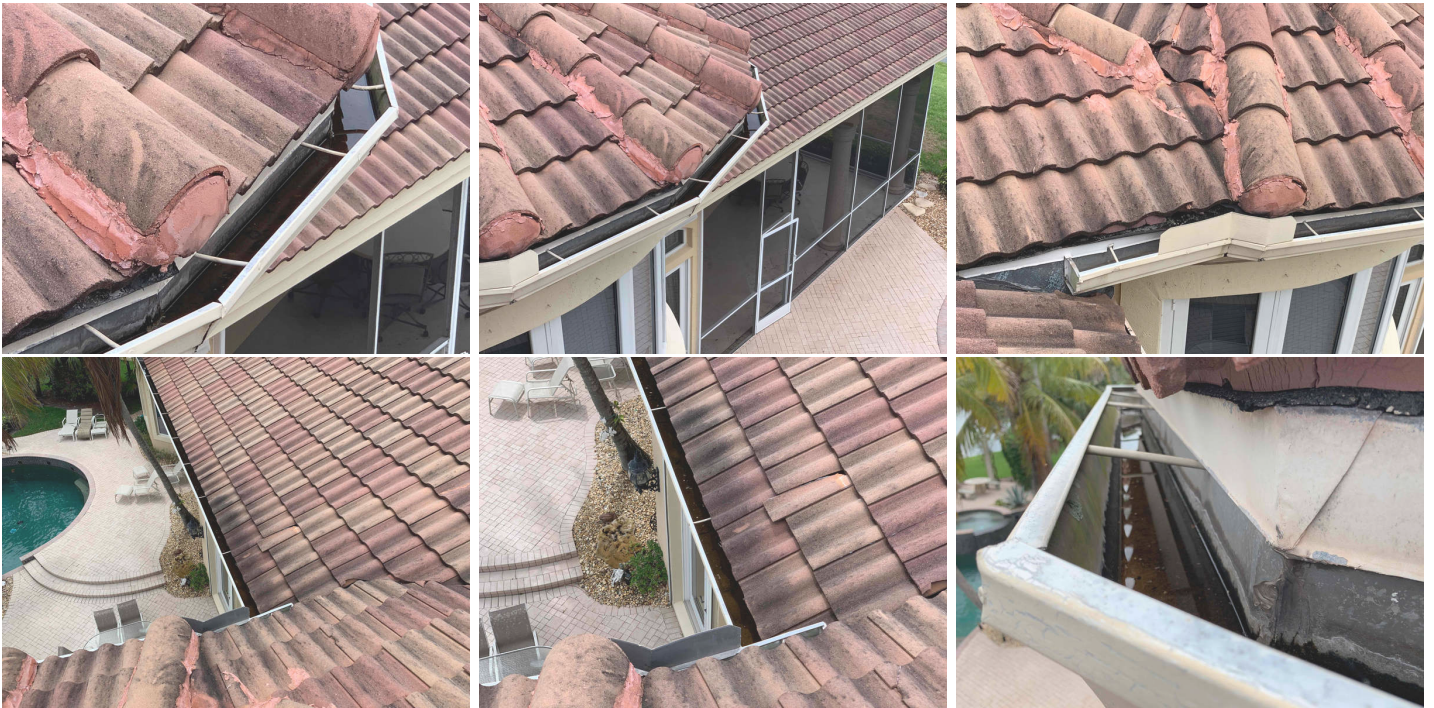
### 2.2.1 Roof Drainage Systems

#### **DEBRIS**

Debris has accumulated in the gutters. Recommend cleaning to facilitate water flow.

Contact a qualified roofing professional.

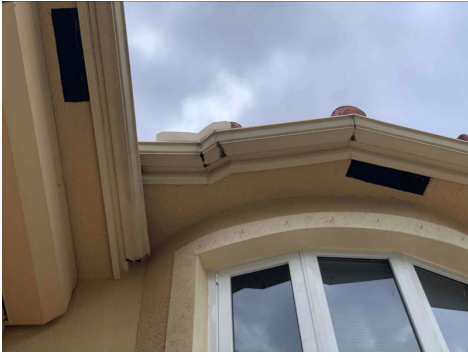
### 2.2.2 Roof Drainage Systems

#### **GUTTER LEAKAGE**

Gutters were observed to be leaking in one or more areas. This can result in excessive moisture in the soil at the foundation, which can lead to foundation/structural movement. Recommend a qualified contractor evaluate and repair gutters to proper functionality.

Contact a qualified roofing professional.

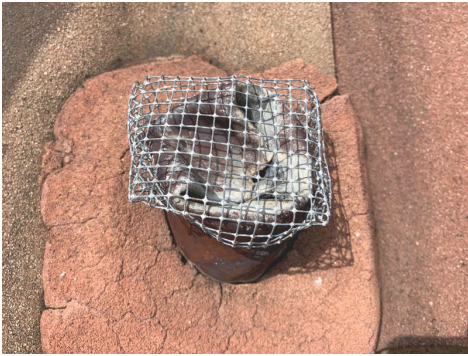
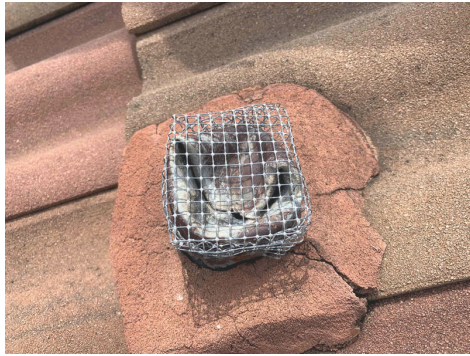
### 2.4.1 Skylights, Chimneys & Other Roof Penetrations

#### **VENT STACK BOOT**

Vent stack boot was not properly placed. Inspector recommends hammering down the inner edges a little further.

Contact a qualified professional.

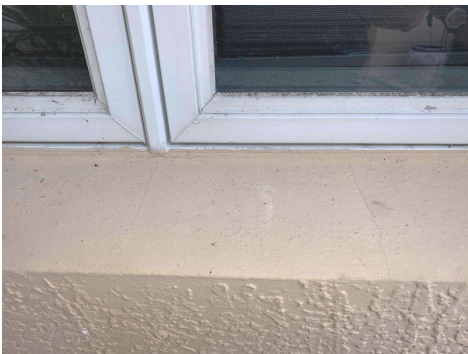
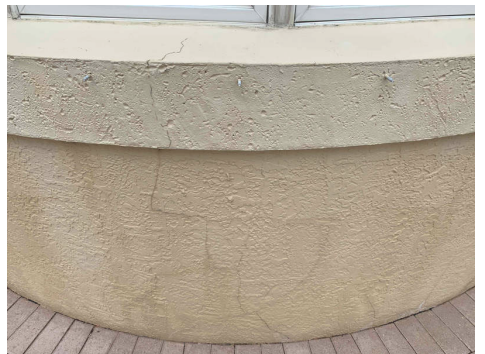
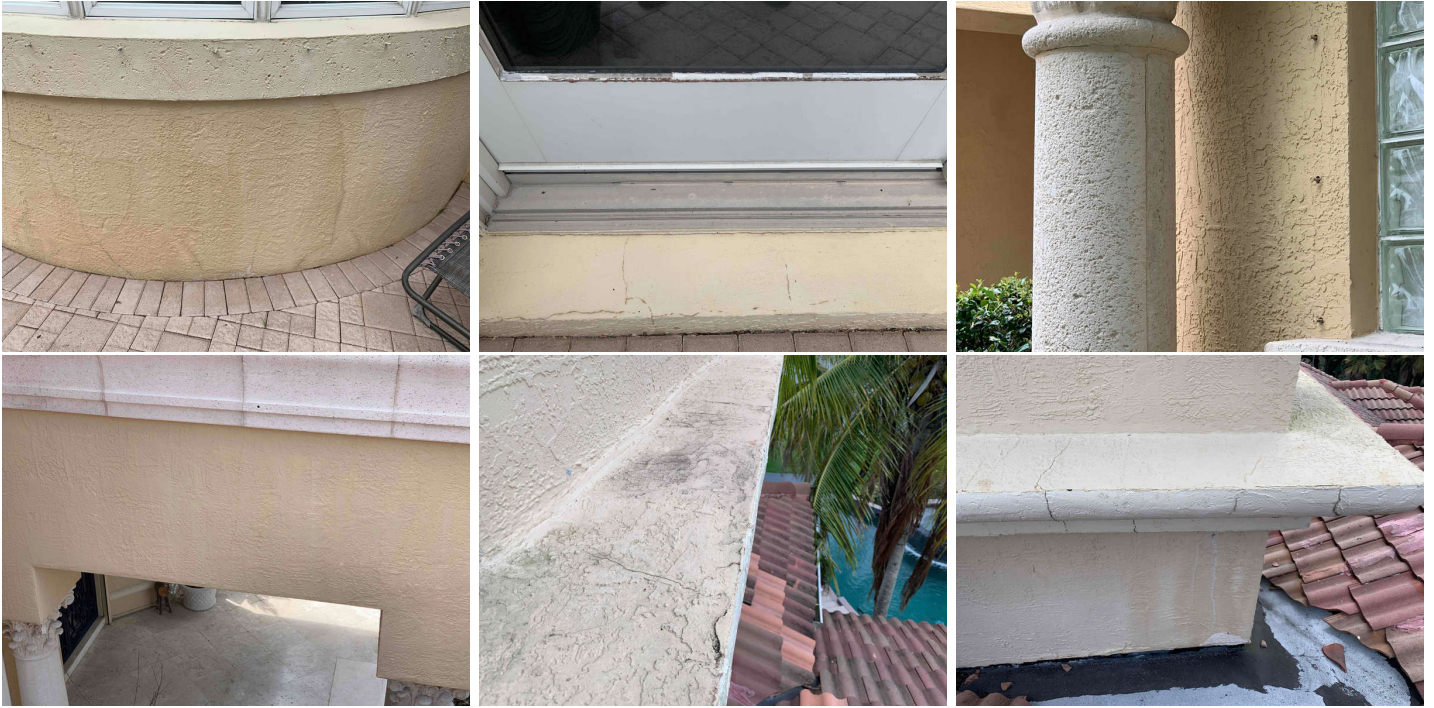
### 3.1.1 Siding, Flashing & Trim

#### **CRACKING - MINOR**

Siding showed cracking in one or more places. This is a result of temperature changes, and typical as homes with stucco age. Stucco cracking is not a normal symptom of a new construction home. Recommend repair and monitoring.

Recommended DIY Project

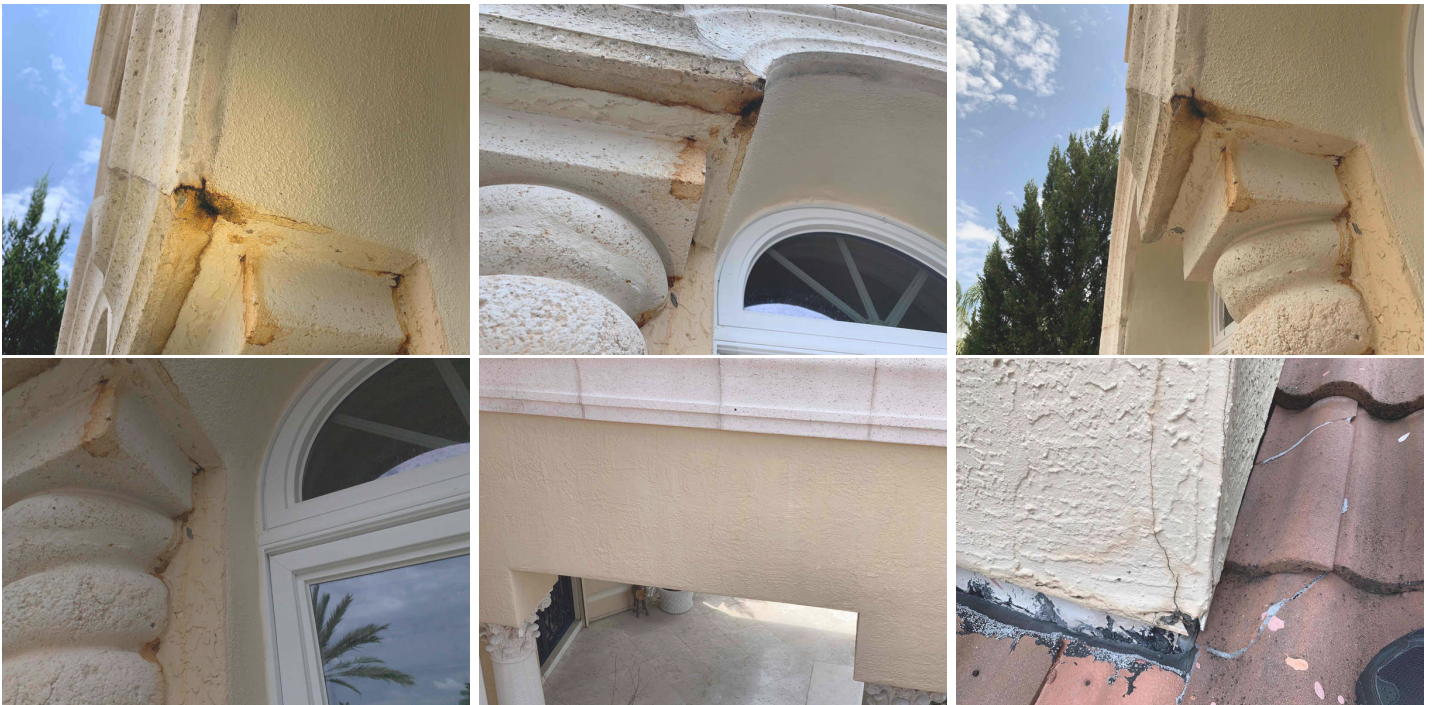
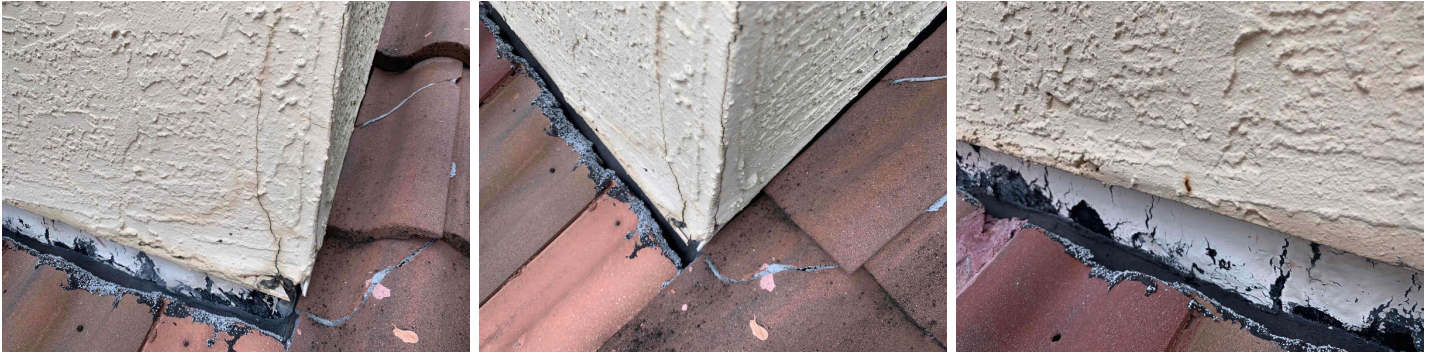
3.1.2 Siding, Flashing & Trim

**EVIDENCE OF WATER INTRUSION**

Siding showed signs of water intrusion. This could lead to further siding deterioration and/or mold. Recommend a qualified siding contractor evaluate and repair.

Contact a qualified professional.

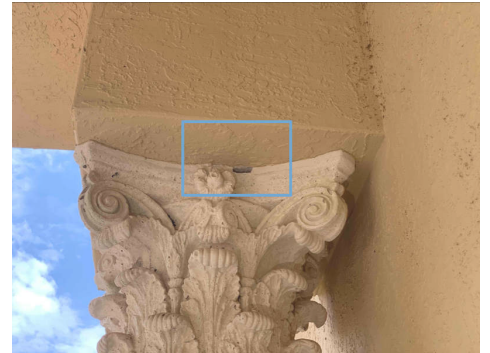
3.1.3 Siding, Flashing & Trim

**MISSING TRIM**

Contact a qualified professional.

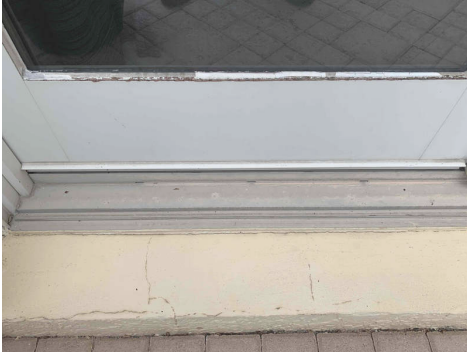
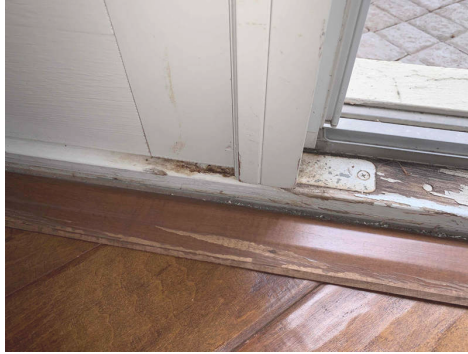
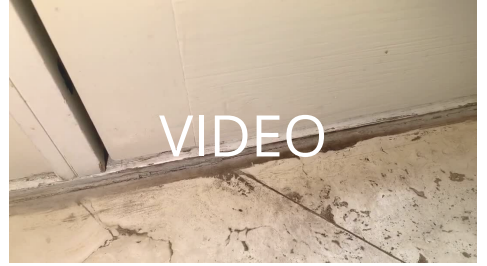
3.2.1 Exterior Doors

**DOOR SILL/TRIM**

Door sill and/or trim is loose, deteriorated or worn and repair or replacement should be considered.

Contact a qualified door repair/installation contractor.

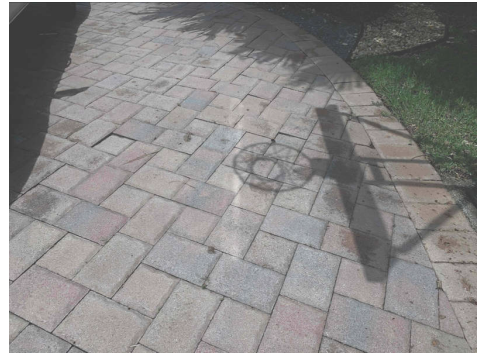
3.3.1 Walkways, Patios & Driveways

**WALKWAY TRIP HAZARD**

Trip hazards observed. Patch or repair recommended.

Contact a qualified professional.

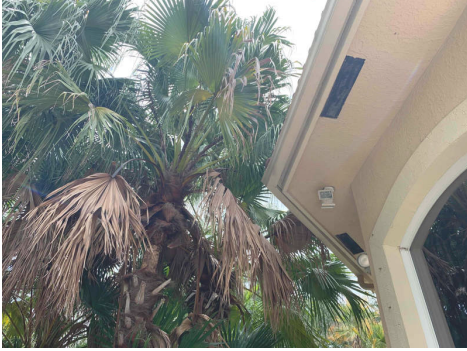
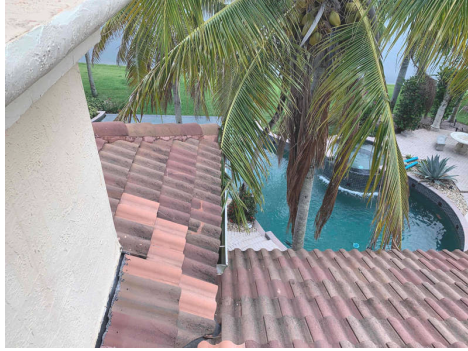
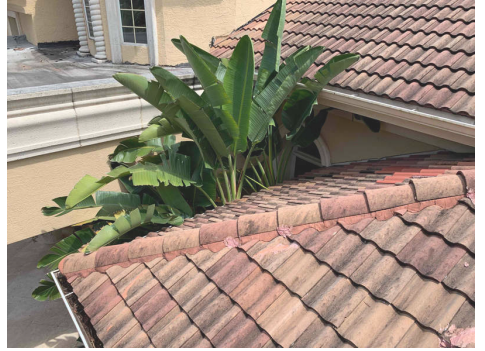
3.6.1 Vegetation, Grading, Drainage & Retaining Walls

**TREE OVERHANG**

Trees observed overhanging the roof. This can cause damage to the roof and prevent proper drainage. Recommend a qualified tree service trim to allow for proper drainage.

Contact a qualified tree service company.

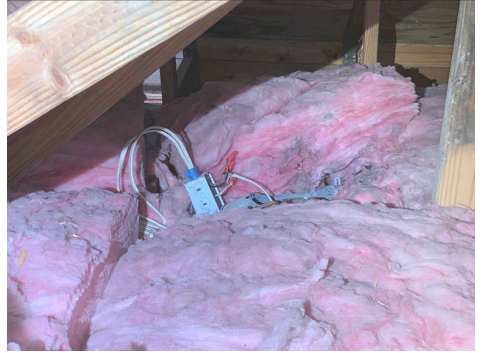
4.3.1 Electrical

**COVER PLATE MISSING**

Cover plate(s) are missing from one or more electric boxes, such as for receptacles, switches and/or junction boxes. They are intended to contain fire and prevent electric shock from exposed wires. This is a safety hazard due to the risk of fire and shock. Cover plates should be installed where missing.

Contact a qualified electrical contractor.

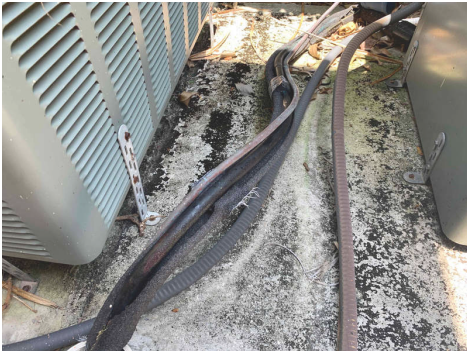
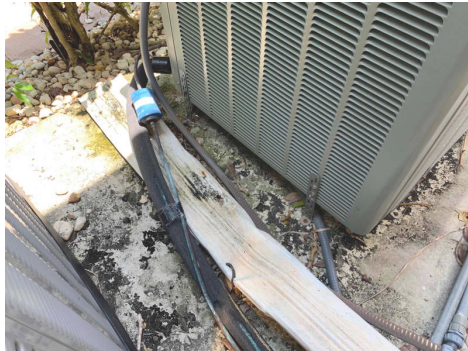
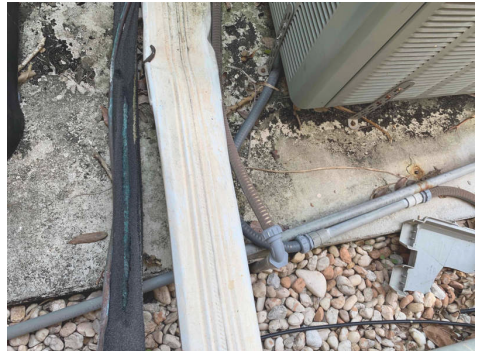
5.1.1 Cooling Equipment

**INSULATION MISSING OR DAMAGED**

Missing or damaged insulation on refrigerant line can cause energy loss and condensation.

Contact a qualified HVAC professional.

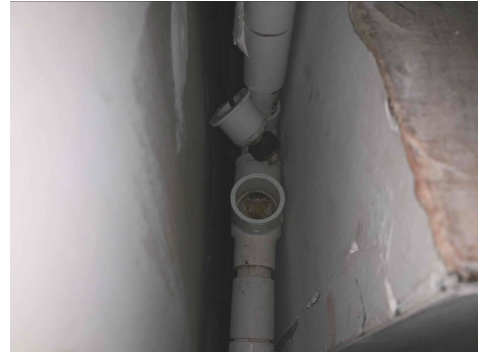
5.2.1 Normal Operating Controls

**FLOAT SWITCH NOT IN PLACE**

Recommendation  
Contact a qualified professional.

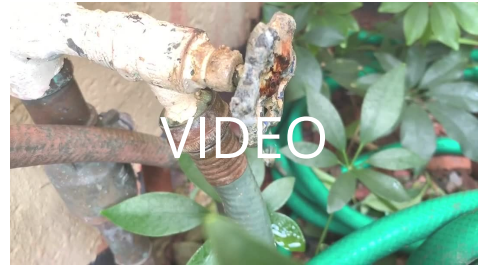
#### 6.1.1 Main Water Shut-off Device

### MINOR LEAK

Minor leak coming from spicket at house main shut off.

Recommendation  
Contact a qualified professional.

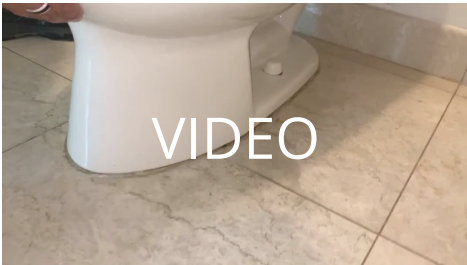
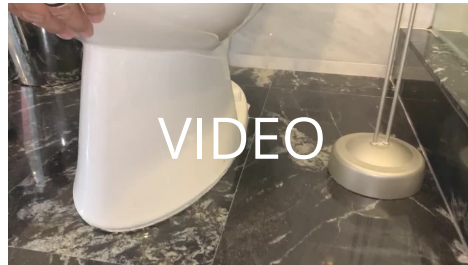
### TOILET LOOSE

Toilet is loose at the base. Recommend a qualified plumber evaluate and repair to prevent further water damage.

Recommendation  
Contact a qualified plumbing contractor.

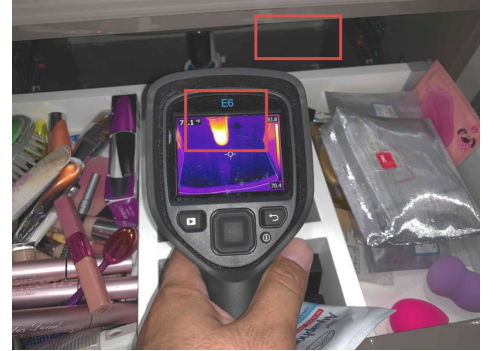
6.3.4 Water Supply, Distribution Systems & Fixtures

**LEAK UNDER SINK**

Leak detected under bathroom sink. Inspector recommends hiring a qualified plumbing professional to repair. Monitor for possible mold growth.

Contact a qualified plumbing contractor.

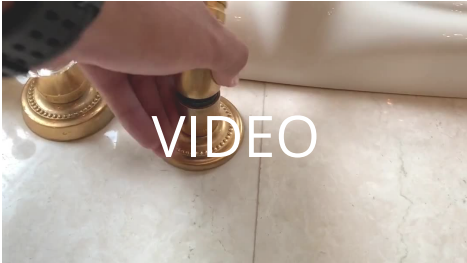
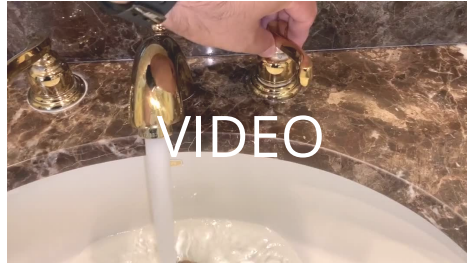
**LOOSE WATER FIXTURE**

Handle on master bathroom tub and sink were not properly attached. Recommend repair.

Recommendation

Contact a qualified professional.

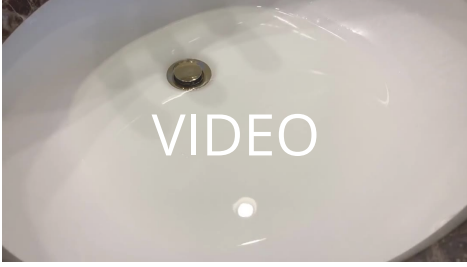
One of the sinks in the master bathroom was slow to drain.

Recommendation  
Contact a qualified professional.

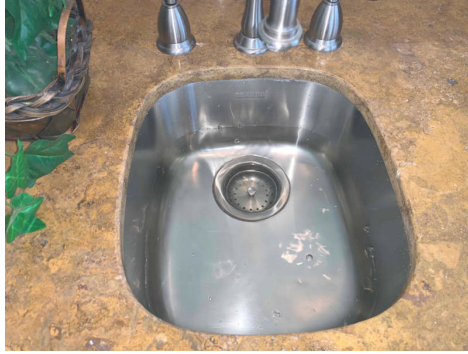
6.3.7 Water Supply, Distribution Systems & Fixtures

**SLOW DRAIN**

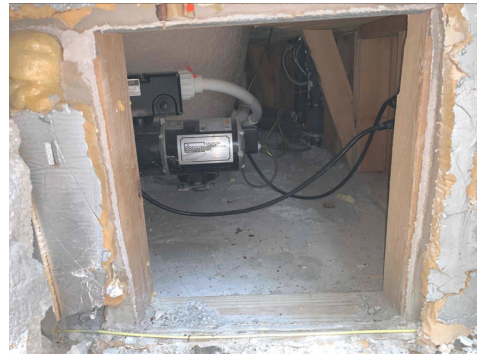
6.3.8 Water Supply, Distribution Systems & Fixtures

**BATHTUB ACCESS COVER OPEN**

Inspector recommends locking to avoid unwanted guests.

Recommendation  
Contact a qualified professional.

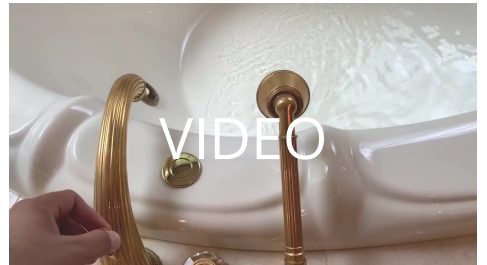
**BATHTUB HOSE NOT FUNCTIONAL**

Recommendation  
Contact a qualified professional.

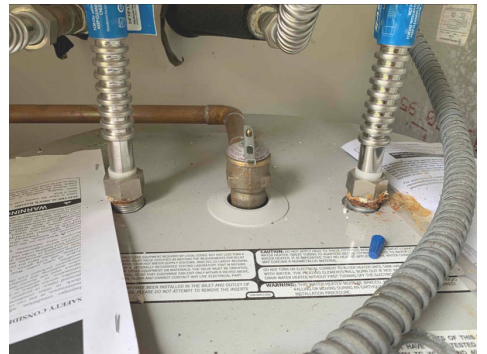
6.4.1 Hot Water Systems, Controls, Flues & Vents

**CORROSION**

Corrosion was noted at the burn chamber or pipe fittings.  
Recommend a qualified plumber evaluate for repair/replacement.

Recommendation  
Contact a qualified plumbing contractor.

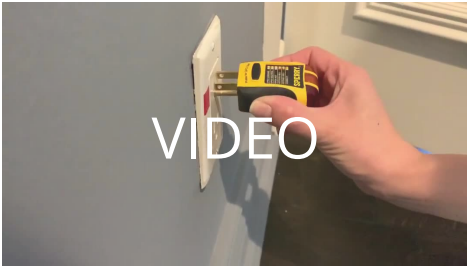
### **COVER PLATES DAMAGED**

One or more receptacles have a damaged cover plate. Recommend replacement.

Recommendation

Contact a qualified electrical contractor.

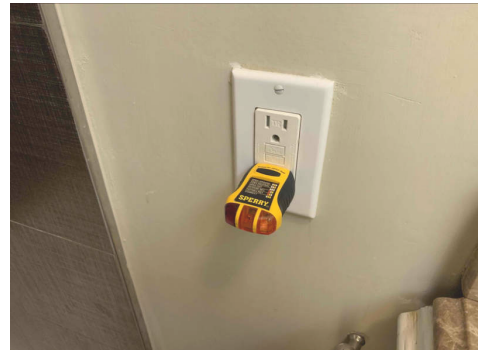
7.5.1 GFCI & AFCI

### **GFCI NOT FUNCTIONAL**

Contact a qualified professional.

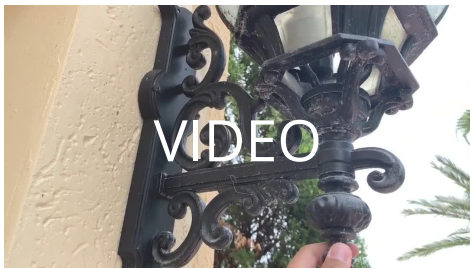
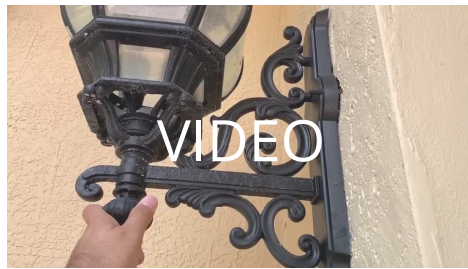
### 7.7.2 External Components

#### **EXTERIOR LIGHT FIXTURE IN NEED OF REPAIR**

Recommendation

Contact a qualified professional.

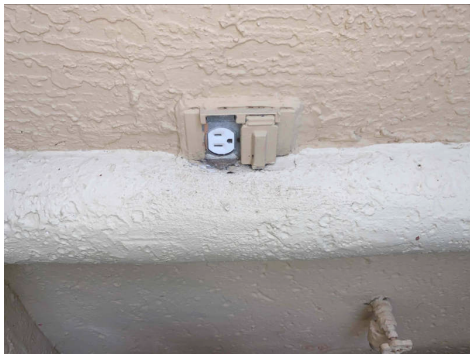
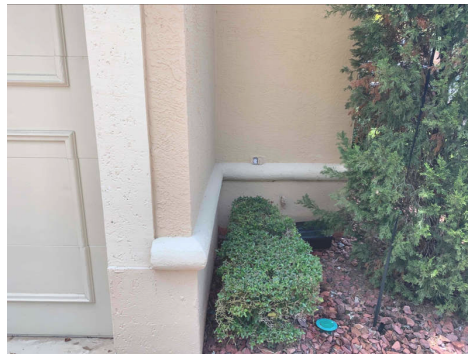
### 7.7.3 External Components

#### **MISSING COVER**

Contact a qualified professional.

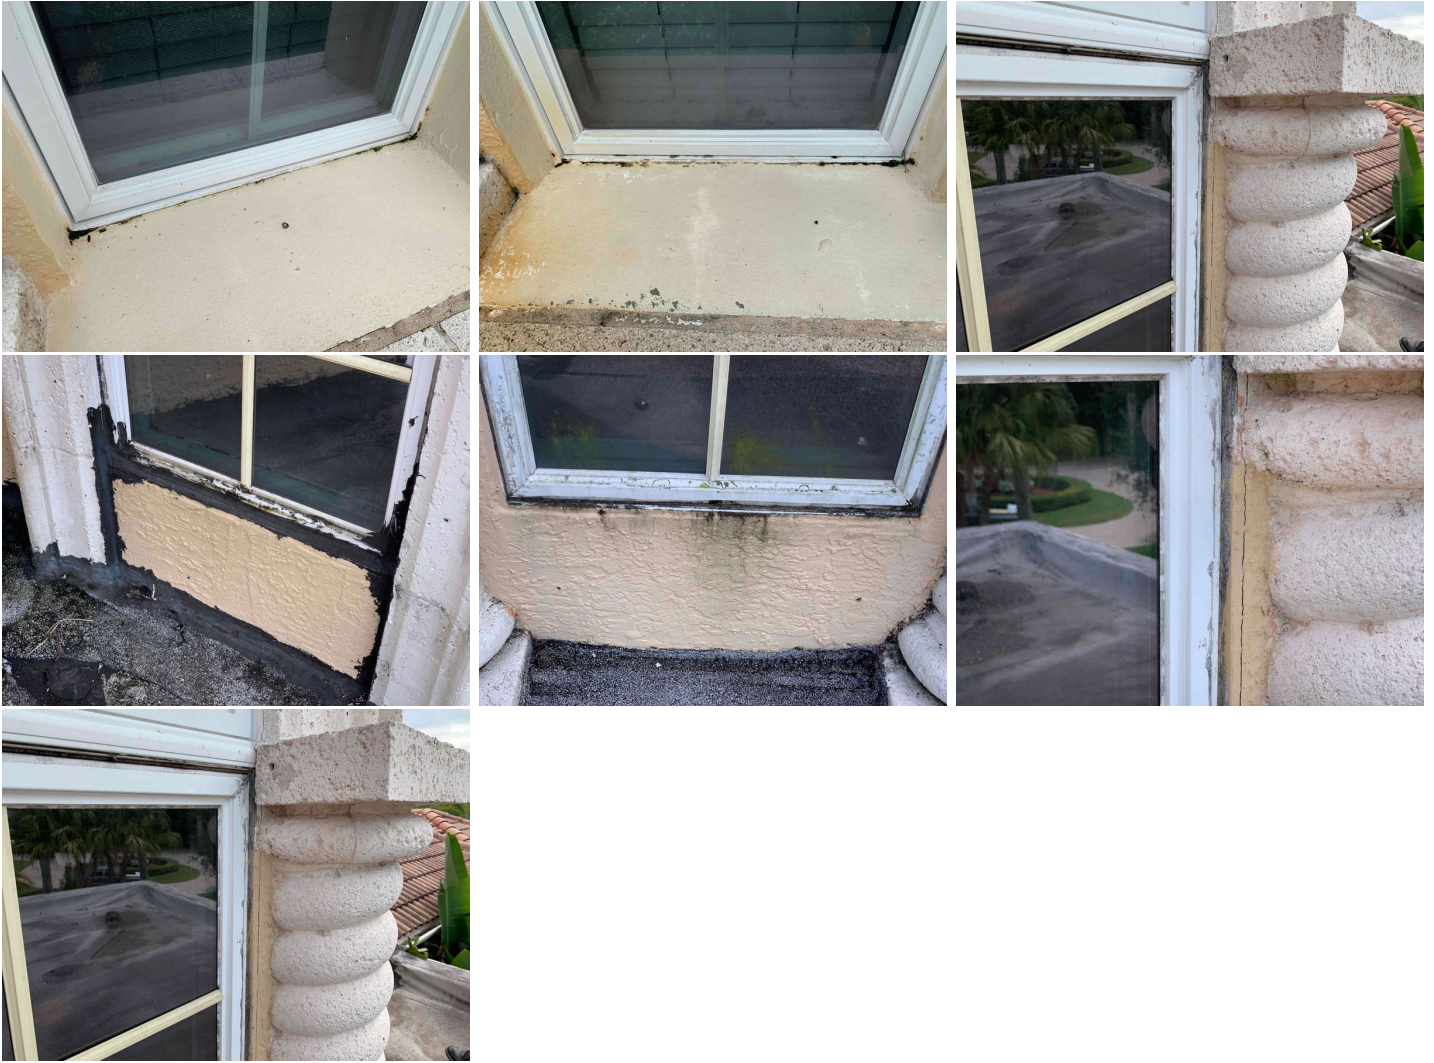
### 8.2.1 Windows

#### **WINDOWS NEED CAULKING**

Windows show signs of dry caulking recommend repair to prevent water intrusion.

Contact a qualified professional.

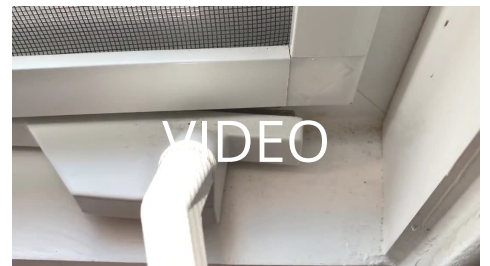
8.2.2 Windows

**HARDWARE DAMAGE**

Locking mechanism was damaged at time of inspection.

Contact a qualified professional.

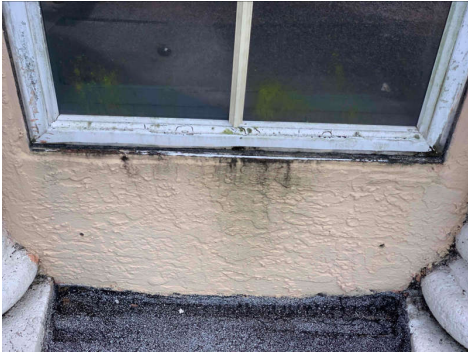
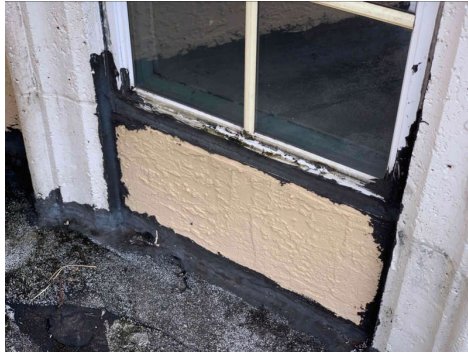
8.2.3 Windows

**WINDOWS IN NEED OF CLEANING**

Contact a qualified professional.

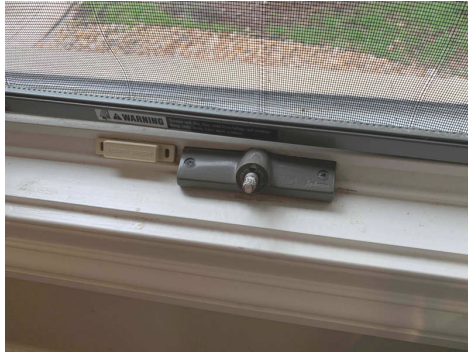
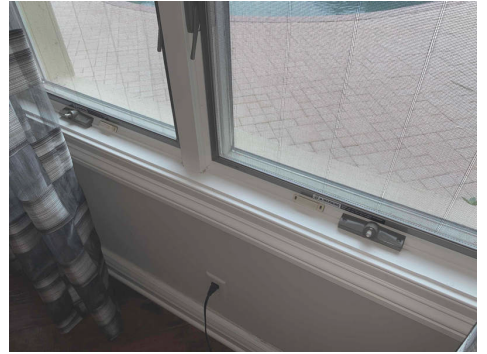
#### 8.2.4 Windows

### WINDOW HARDWARE MISSING

Locking hardware for master bedroom windows was not present at time of inspection.

Contact a qualified professional.

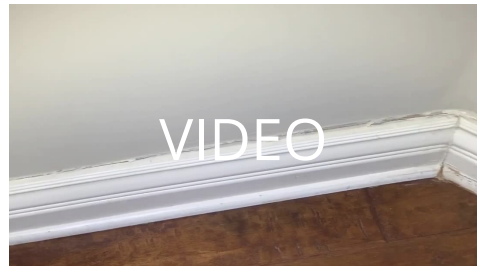
### BASEBOARD DAMAGE

Recommendation

Contact a qualified professional.

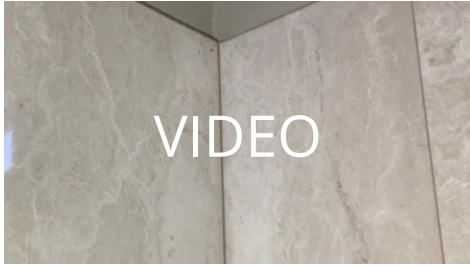
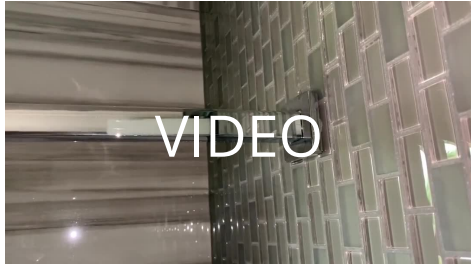
#### 8.4.1 Walls

Certain areas of the showers need more grout. Inspector recommends fixing immediately to avoid water damage.

Recommendation

Contact a qualified professional.

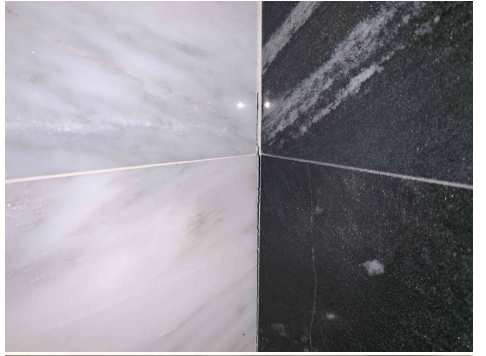
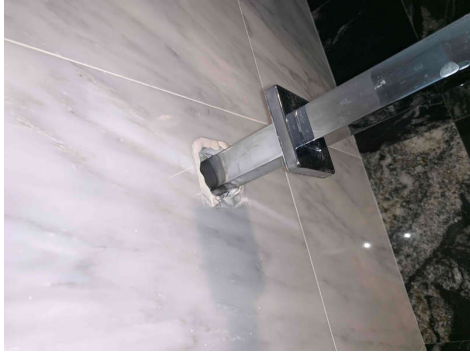
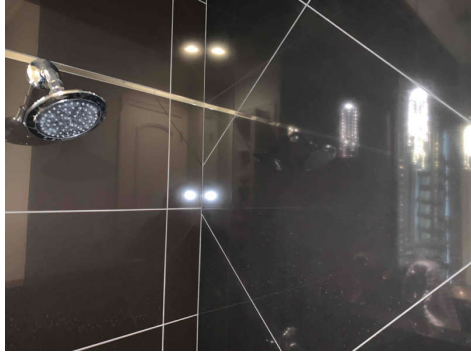
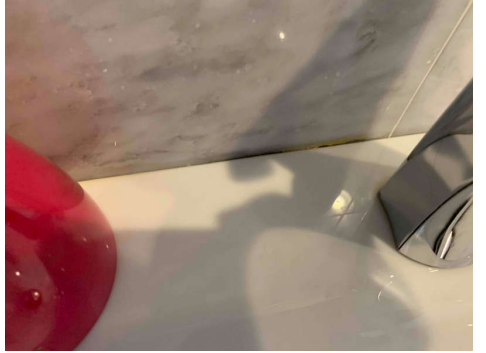
### SHOWER NEEDS GROUT

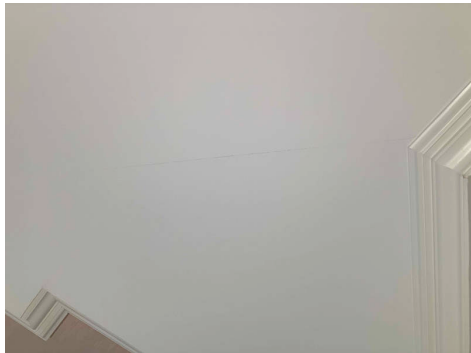
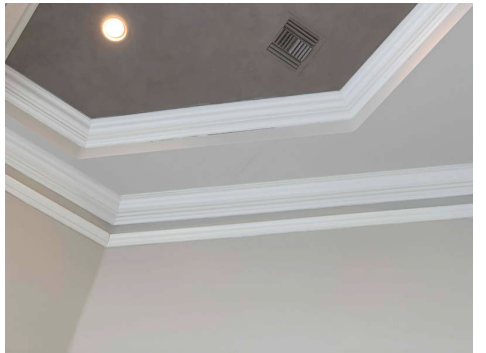
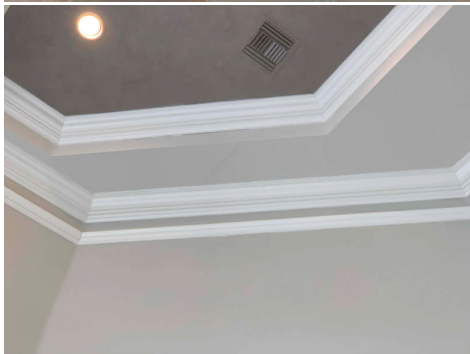
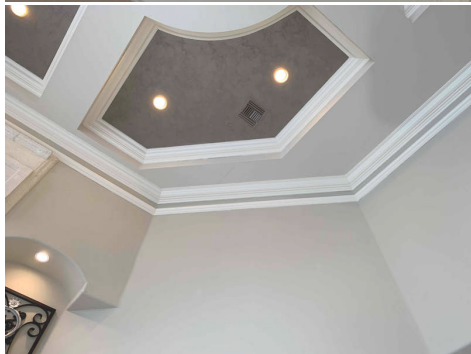
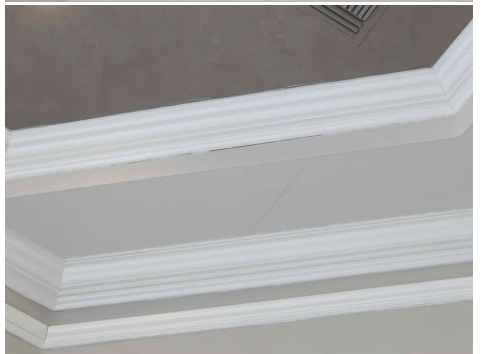
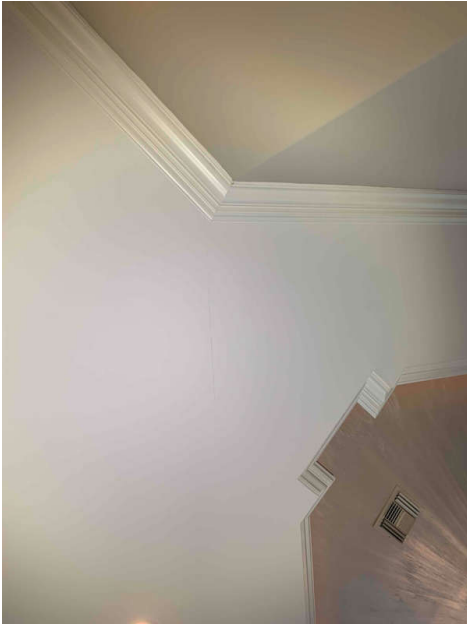
### 8.5.1 Ceilings

#### **CRACKS ON CEILING**

Cracks were discovered on interior ceiling. This could be indication of water intrusion, structural issues, settlement or excess weight on trusses in the attic. Inspector recommends determining the cause of the cracking and evaluating for repairs.

Contact a qualified professional.

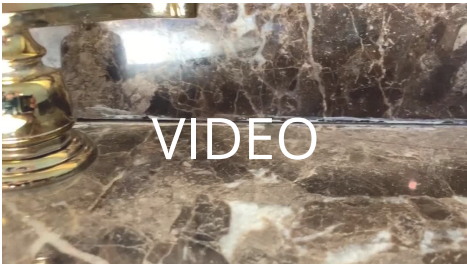
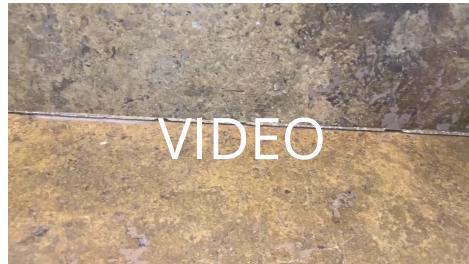
8.7.1 Countertops & Cabinets  
**POOR/MISSING CAULK**

Bathroom shower and Kitchen are missing sufficient caulk/sealant at the wall. This can lead to water damage. Recommend adding sealant at sides and corners where counters touch walls.

Recommendation  
Recommended DIY Project

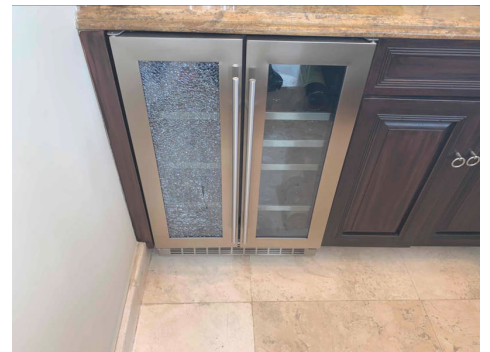
9.6.1 Wine Cooler  
**BROKEN GLASS**

Recommendation  
Contact a qualified professional.

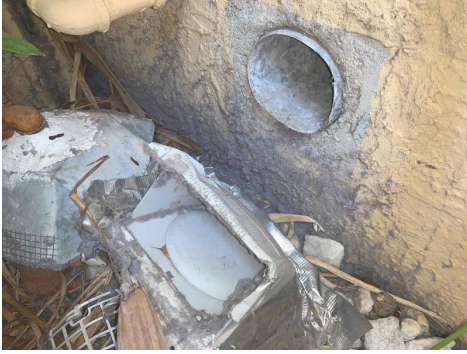
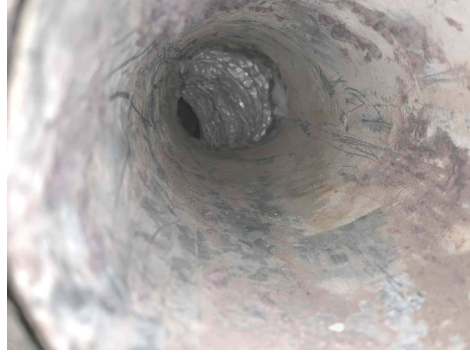
10.1.1 General  
**DRYER VENT COVER DAMAGE**

This could permit unwanted guest to enter home.

Recommendation  
Contact a qualified professional.

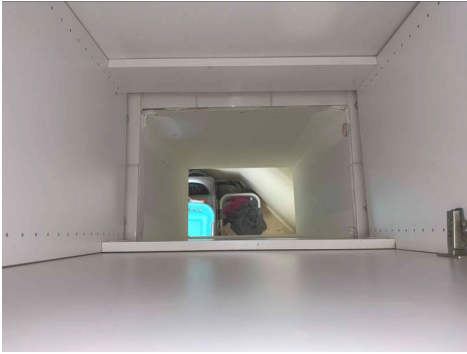
10.1.2 General

### THE LAUNDRY CHUTE

Laundry Chute was a straight shot down. This could pose a potential fall risk for young children.

Recommendation  
Contact a qualified professional.

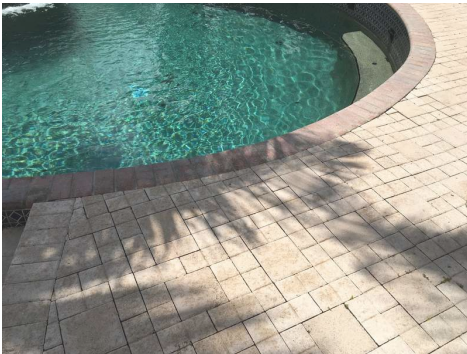
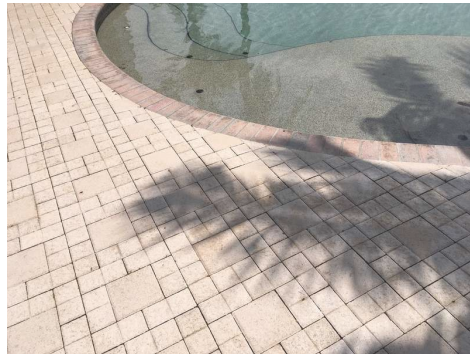
11.2.1 Fencing

### NO FENCING

There were no holes showing around pool deck for fencing

Recommendation  
Contact a qualified professional.

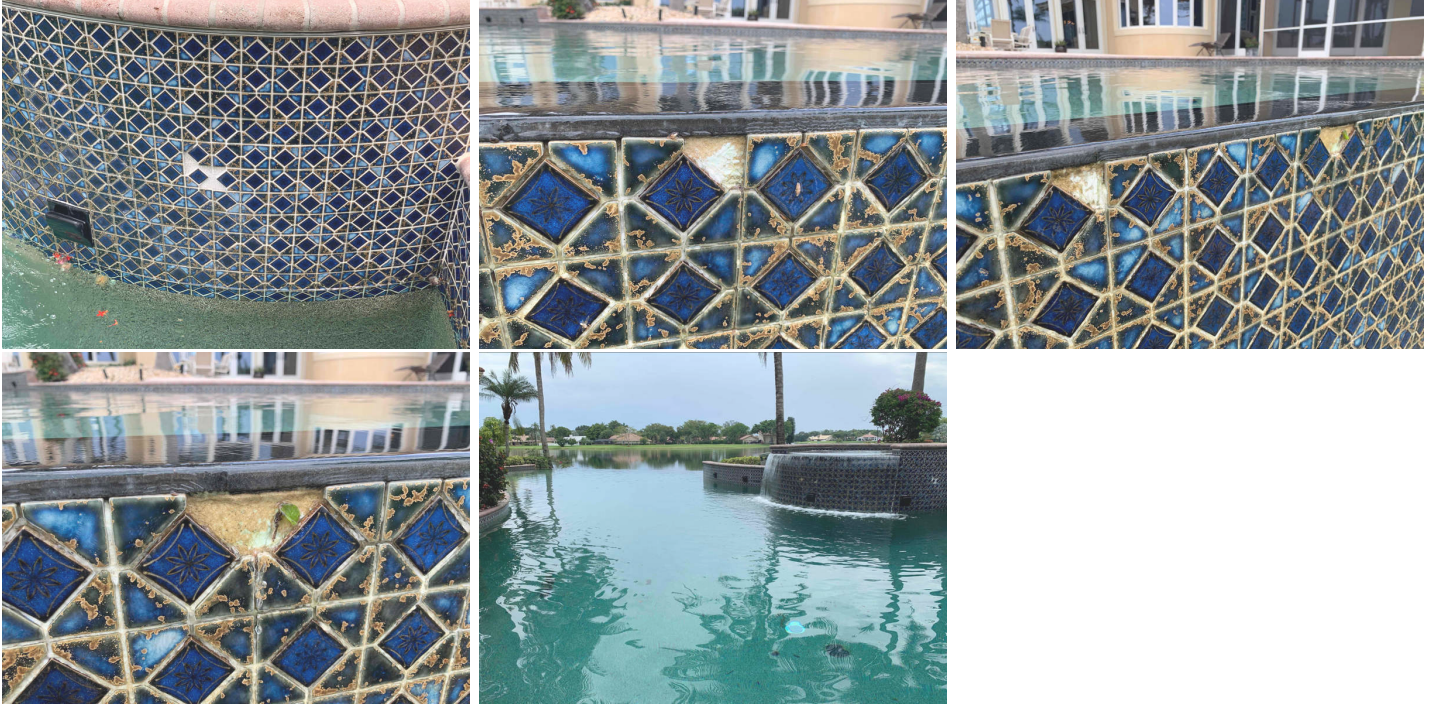
11.5.1 Pool and decking

### TILE AND GROUT DETERIORATION

Several of the tiles and grout around the pool and/or spa are deteriorated. The tiles and the grout should be repaired to help prevent water intrusion behind the tile work which can cause them to loosen up.

Contact a qualified Swimming Pool Contractor

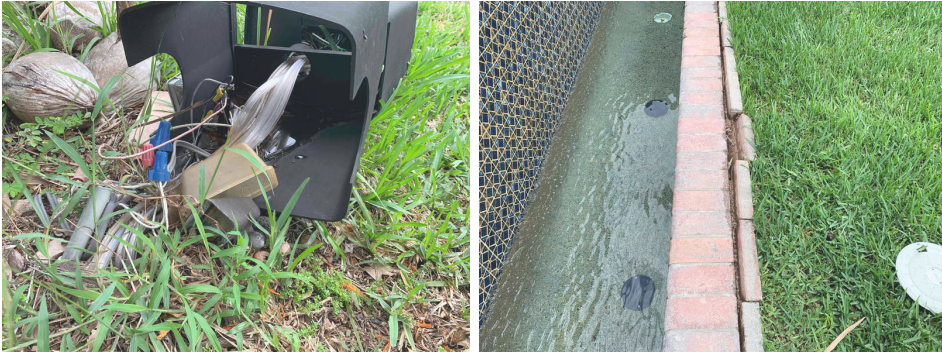
11.5.2 Pool and decking

**PAVERS NEED TO BE EVALUATED**

Contact a qualified professional.

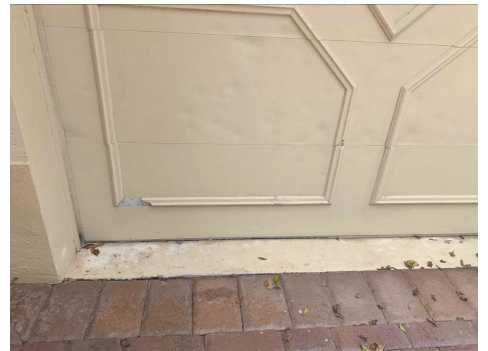
12.2.1 Garage Door

**TRIM DAMAGE**

Garage door trim showed signs of damage at time of inspection.

Contact a qualified professional.
