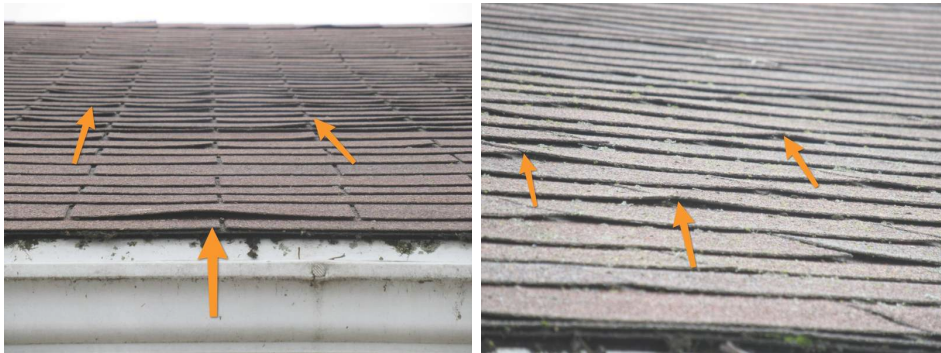
2.1.1 Coverings

DAMAGED (GENERAL)

Roof coverings showed moderate damage. Recommend a reputable roofing contractor.

Contact a qualified roofing professional.

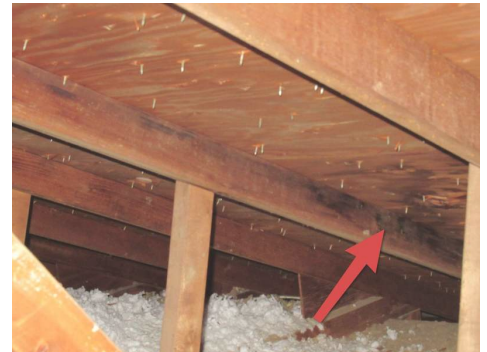
2.1.2 Coverings

MOLD/FUNGI GROWTH

ATTIC

Signs of mold on rafter and sheathing within attic. Any possible health effects related to mold growth are beyond the scope of this inspection. This will allow for serious health issues. Recommend a reputable certified mold tester

Contact a qualified mold inspection professional.

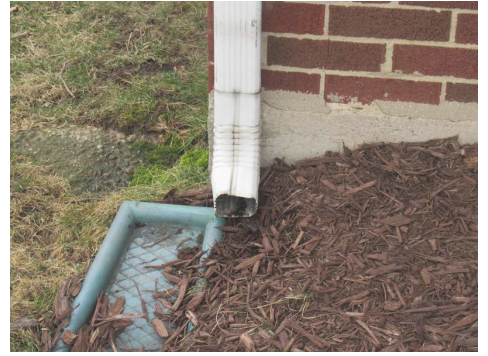
2.2.2 Roof Drainage Systems

DOWNSPOUTS DRAIN NEAR HOUSE

One or more downspouts drain too close to the home's foundation. This can result in excessive moisture in the soil at the foundation, which can lead to foundation/structural movement. Recommend a reputable contractor adjust downspout extensions to drain at least 6 feet from the foundation.

Recommendation
Contact a qualified general contractor.

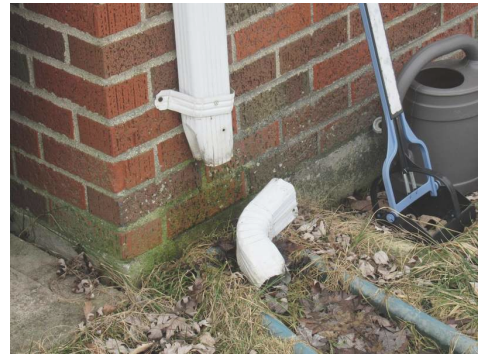
2.2.3 Roof Drainage Systems

DOWNSPOUT ELBOW

Down spout elbow is missing/not attached. This will allow for water penetration into the foundation area. Recommend a reputable contractor.

Recommendation
Contact a qualified general contractor.

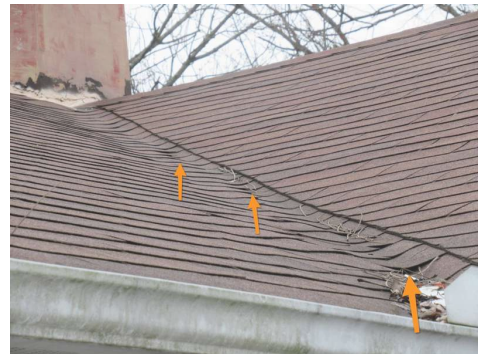
2.2.4 Roof Drainage Systems

WOVEN VALLEY

Woven valley shows signs of shingle uplift. This will allow for water penetration into the attic. Recommend a reputable roofing contractor.

Recommendation
Contact a qualified roofing professional.

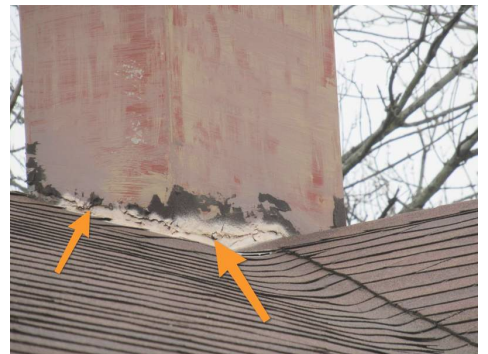
2.3.1 Flashings

CORRODED - SEVERE

Roof flashing showed signs of severe corrosion, which can lead to moisture intrusion and/or mold. Recommend a reputable roofing contractor.

Recommendation
Contact a qualified roofing professional.

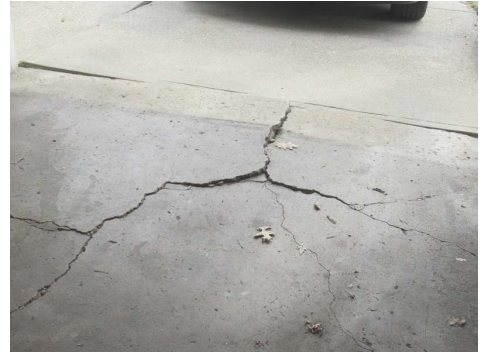
3.3.1 Walkways, Patios & Driveways

DRIVEWAY CRACKING - MAJOR

Major cracks observed. Recommend concrete contractor for further evaluation.

Contact a qualified driveway contractor.

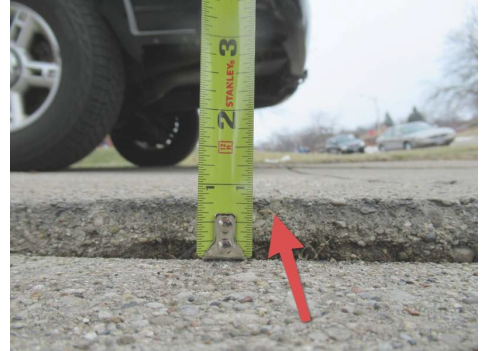
3.3.2 Walkways, Patios & Driveways

DRIVEWAY TRIP HAZARD

Signs of settlement present in driveway/walkway. This is a trip hazard and will allow for serious injury or worse. Recommend a reputable concrete contractor.

Contact a qualified concrete contractor.

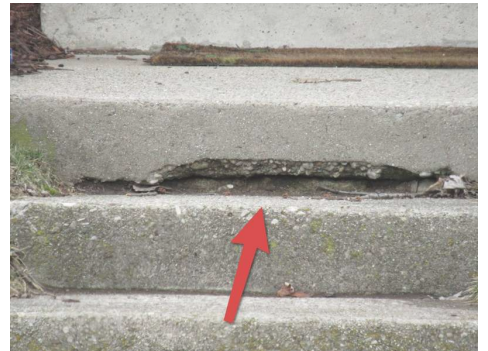
3.3.3 Walkways, Patios & Driveways

WALKWAY CRACKING - MAJOR

1. Major cracks observed. Recommend a reputable concrete contractor evaluate and correct to prevent trip hazard & preserve appearance.

Contact a qualified concrete contractor.

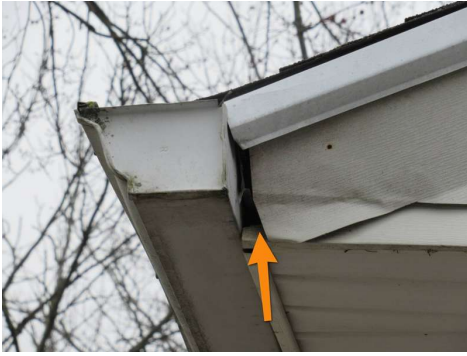
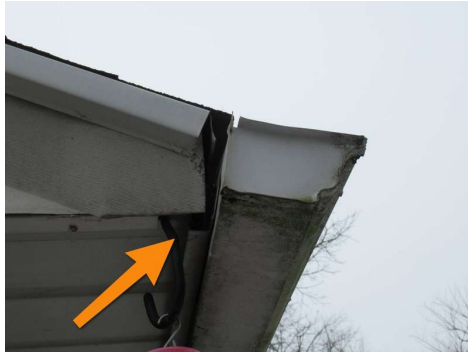
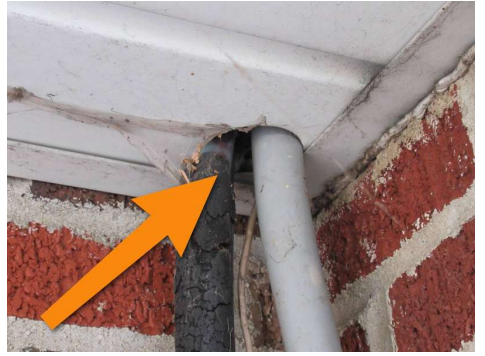
3.5.1 Eaves, Soffits & Fascia

GAP

There is opening, gap or hole in fascia / soffit which should be repaired. This can allow water intrusion and pest infestation as well as deterioration of the surrounding material. Recommend a reputable roofing contractor.

Contact a qualified roofing professional.

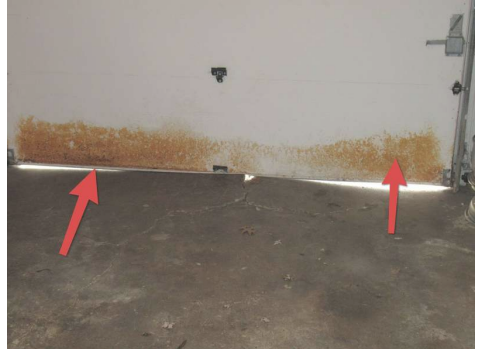
4.1.2 Foundation

WATER INTRUSION

GARAGE

Water intrusion was evident on the surface of the floor slab or in the basement/crawlspace. This can compromise the soil's ability to stabilize the structure and could cause damage. Recommend a reputable water proofing contractor.

Contact a qualified waterproofing contractor

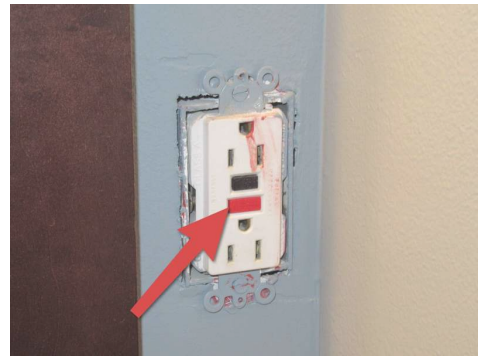
8.5.1 GFCI & AFCI

IMPROPER INSTALLATION

BATHROOM MASTER

GFCI outlets present but did not trip when tested. Recommend a reputable licensed electrical contractor.

Recommendation
Contact a qualified electrical contractor.

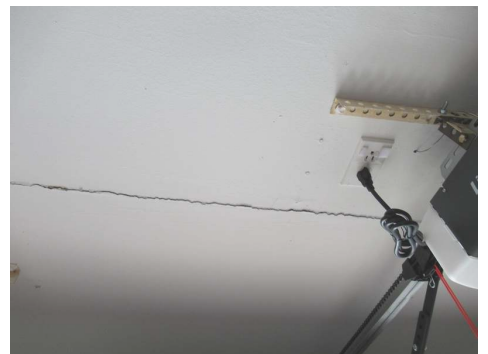
12.1.1 Ceiling

DAMAGED

Garage ceiling was damaged. Recommend a reputable contractor to evaluate.

Recommendation
Contact a qualified general contractor.
