SUMMARY

1234 Main St. Spokane wa 99205

Aaron Storer
WA License #1936
Golden Star Home Inspections
509-720-6279

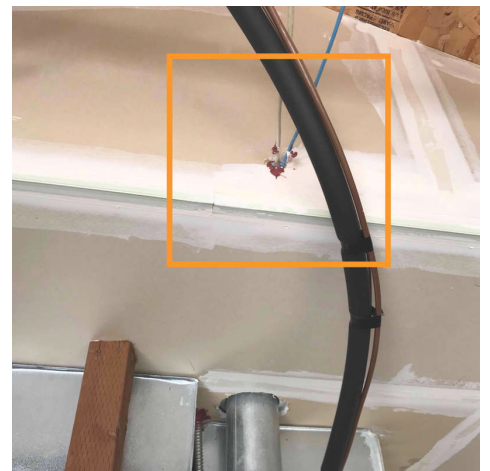
4.5.1 Ceilings, Walls & Fire Separation

FIRE BLOCK CAULKING

Moderate Observation

Some loose/missing fire block caulking observed in the garage ceiling. Recommend recaulking to preserve fire separation by a qualified drywall contractor

Recommendation

Contact a qualified drywall contractor.

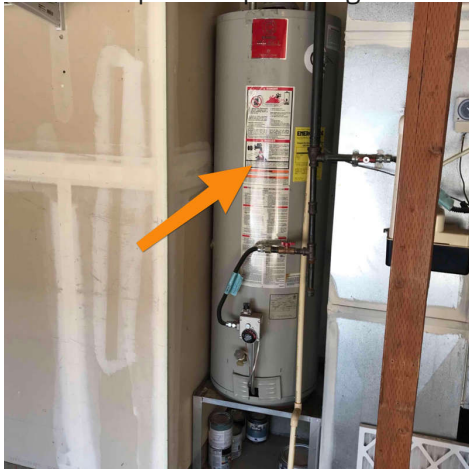
SEISMIC STRAPPING

The seismic strapping was missing around the water heater. Recommend proper strapping be installed by a licensed plumber.

Recommendation
Contact a qualified plumbing contractor.

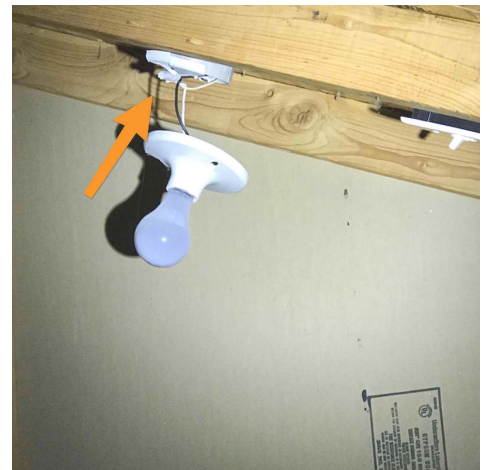
12.6.1 Attic Electrical EXPOSED WIRING

ATTIC

Some exposed wiring observed at a loose/damaged light fixture. Recommend repair by a licensed electrician.

Recommendation
Contact a qualified electrical contractor.
