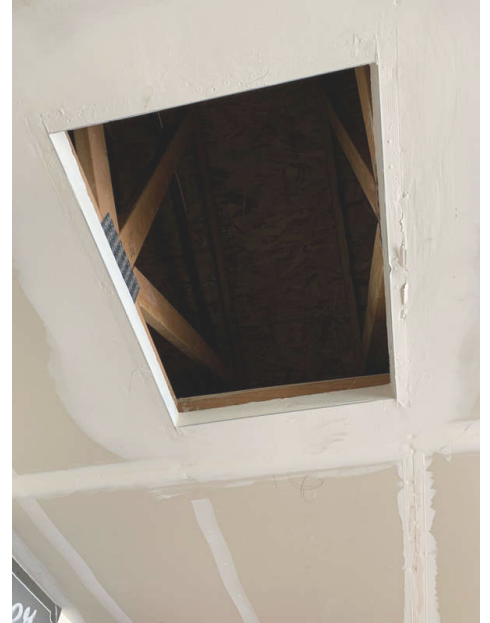
5.2.1 Walls, Firewalls and Ceiling

FIREWALL DAMAGED/MISSING

Firewall separating the home and garage is not compliant with modern building standards. Firewalls should be built with materials to prevent the spreading of a fire into the home living space. Recommend a qualified contractor evaluate and bring firewall up to standards.

Contact a qualified professional.

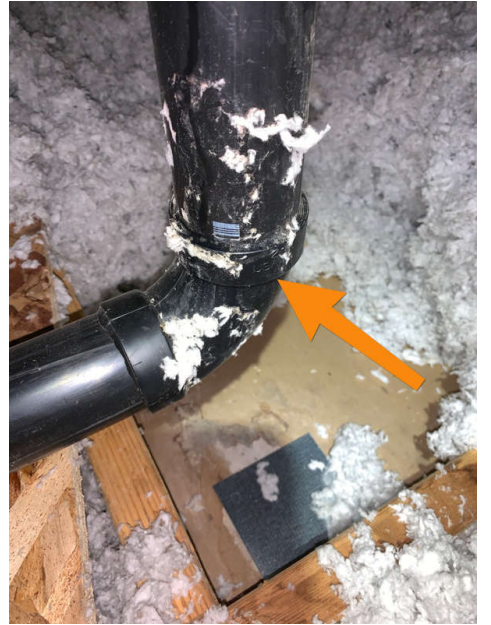
16.2.1 Attic

ATTIC, PLUMBING VENT LEAKING, RECOMMEND REPAIR

Attic, plumbing vent leaking, recommend repair

Recommendation
Contact a qualified professional.
