SUMMARY
1234 Main St. Bakersfield California
93306
Buyer Name
02/13/2018 9:00AM

Mike Hazelwood
InterNACHI #0731201
Cal-Pro Real Estate Inspections
(661) 873-5200
calpro@calproinspections.com

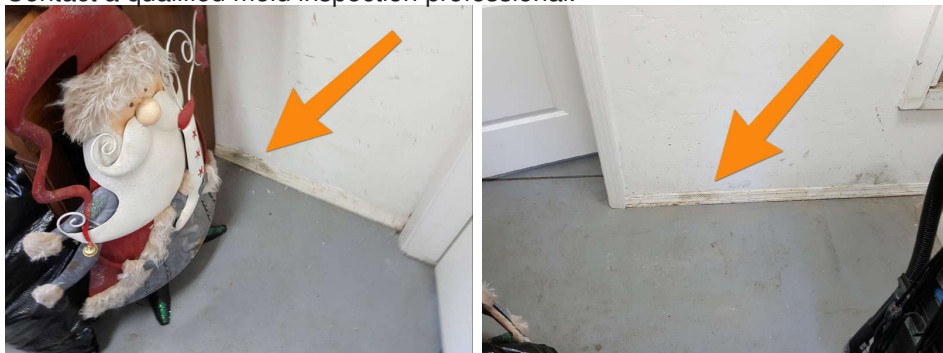
GARAGE STORAGE ROOM

MICROBIAL LIKE GROWTHS

Microbial like growths were found at one or more locations. It is beyond the scope of this inspection to identify what substance or organism this staining is. However such staining is normally caused by excessively moist conditions, which in turn can be caused by plumbing or building envelope leaks and/or substandard ventilation. These conducive conditions should be corrected before making any attempts to remove or correct the staining. Normally affected materials such as drywall are removed, enclosed affected spaces are allowed to dry thoroughly, a mildewcide may be applied, and only then is drywall reinstalled. For evaluation and possible mitigation, consult with a qualified industrial hygienist or mold/moisture mitigation specialist.

Contact a qualified mold inspection professional.

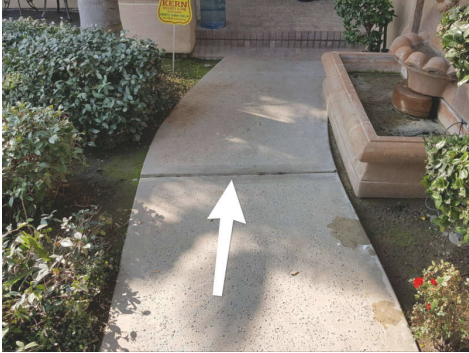
FRONT

**SIDEWALK / PATIO CRACKS /
DETERIORATION - TRIP HAZARD -
REPAIR**

Cracks, holes, settlement, heaving and/or deterioration resulting in trip hazards were found in the sidewalks or patios. For safety reasons, recommend that a qualified contractor repair as necessary to eliminate trip hazards.

Contact a qualified concrete contractor.

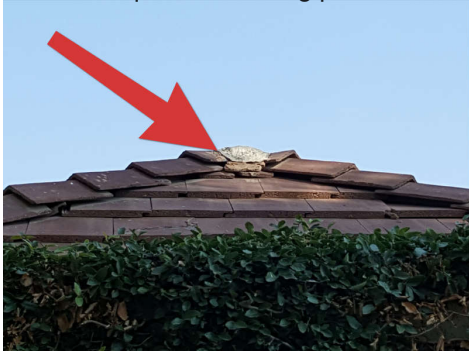
Front (broken / loose)

ROOF TILE(S) CRACKED, BROKEN, LOOSE AND/OR MISSING

Roof tiles were cracked, broken, missing and/or loose. Leaks may occur as a result. This is a conducive condition for wood-destroying organisms. Recommend that a qualified person replace tiles or make repairs as necessary.

Contact a qualified roofing professional.

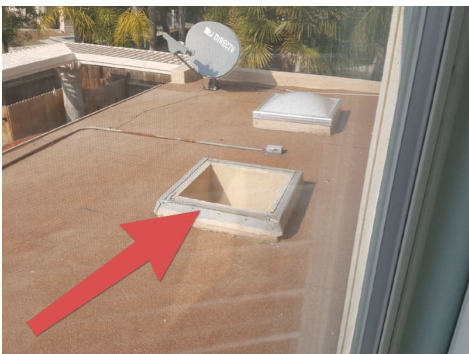
REAR PATIO COVER

**SKYLIGHT: GLAZING CRACKED,
DAMAGED AND/OR MISSING**

Glass in one or more skylights was cracked, broken and/or missing. Recommend that a qualified contractor replace glass as necessary.

Contact a qualified roofing professional.

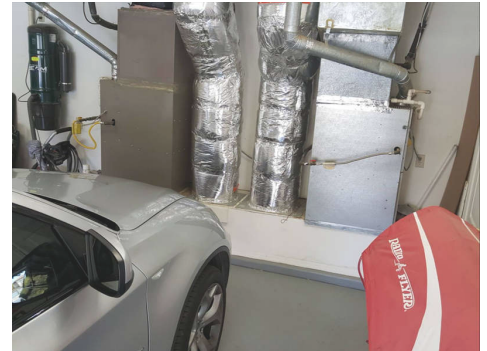
UNPROTECTED FURNACE

Appliances such as the water heater and/or furnace were subject to damage from vehicles because no protective barrier was installed in front of them. This is a potential safety hazard for fire and/or shock. A qualified contractor should install a barrier per standard building practices. For example, a steel post or specially made wood partition anchored in the concrete slab floor.

Contact a qualified professional.

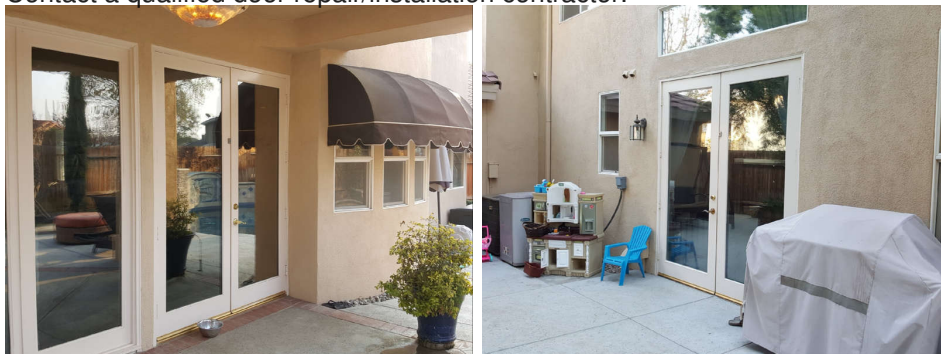
REAR, RIGHT SIDE

EXTERIOR DOOR OPENS OUTWARD

One or more exterior entry doors opened outwards and didn't appear to have security hinges and/or an anti pry plate over the lockset area. Doors that open outwards have hinges oriented so the pins are exposed outside and can easily be removed also strikers and/or deadbolts can be pried open. Without security hinges, the door can also be removed allowing someone to gain entry. Recommend that a qualified person install security hinges and an anti pry plate on outward-opening doors where needed for better security.

Contact a qualified door repair/installation contractor.

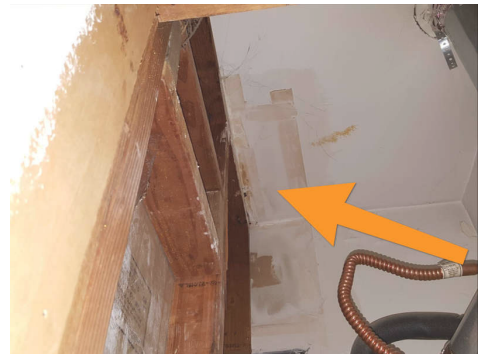
WATER HEATER CLOSET

WATER STAINS (DRY)

Stains were found in one or more ceiling areas. However, no elevated levels of moisture were found. The stain(s) may be due to past roof and/or plumbing leaks. Consult with the property owner and monitor the stained area(s) in the future, especially after heavy or prolonged rain. If elevated moisture is found in the future, then recommend that a qualified contractor evaluate and repair as necessary. The inspector is limited to only being able to evaluate conditions at time of inspection and in a non-invasive manner.

Recommendation
Contact a qualified professional.

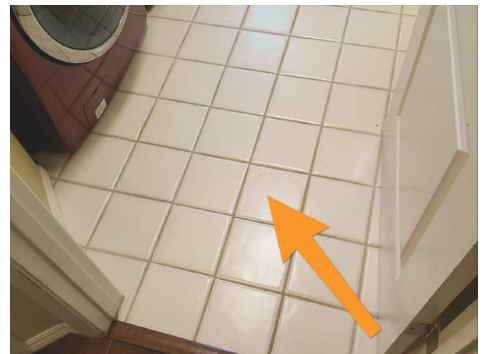
Laundry

TILE / GROUT LOOSE / CRACKED / DAMAGED / DETERIORATED

Tile or grout in the flooring in one or more areas was loose, cracked, damaged and/or deteriorated. Recommend that a qualified contractor repair as necessary.

Recommendation
Contact a qualified flooring contractor

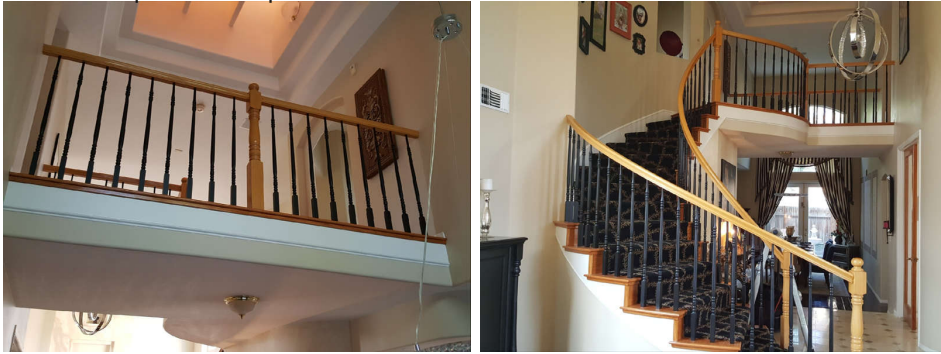
GUARDRAIL GAPS WIDER THAN 4"

Guardrails at one or more locations with drop-offs higher than 30 inches had gaps that were too large. This poses a safety hazard for children (e.g. falling, getting stuck in railing). Although a common building practice in older homes, guardrails should not have gaps or voids that allow passage of a sphere equal to or greater than 4 inches in diameter, or 6 inches in diameter at triangular spaces between stair edges and guardrails. Recommend that a qualified contractor repair or replace guardrails per standard building practices.

Contact a qualified carpenter.

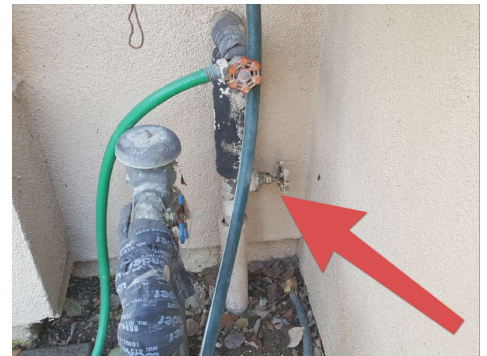
RIGHT SIDE

MAIN LEAKING

The main water shut-off valve was leaking. Recommend that a qualified plumber repair or replace the valve as necessary.

Contact a qualified plumbing contractor.

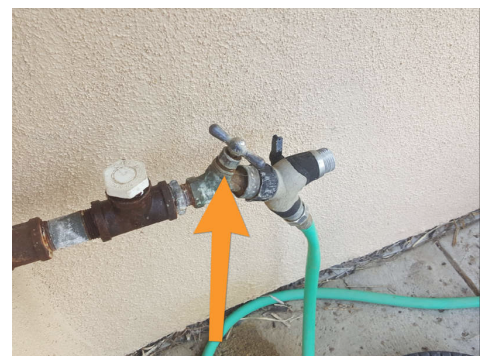
Rear

HOSE BIB LEAKED WHILE OFF

One or more hose bibs (outside faucets) leaked while off. When hose bibs leak while turned off, it's often caused by a worn valve seat or a loose bonnet. Recommend that a qualified plumber repair as necessary.

Contact a qualified plumbing contractor.

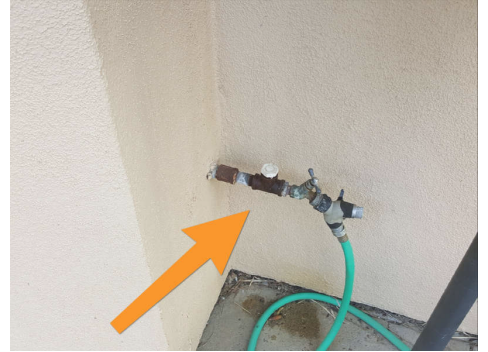
Rear

EXTERIOR HOSE BIB NOT SECURE

One or more hose bibs weren't anchored securely to the structure's exterior. Water supply pipes can be stressed when hose bibs are turned on and off and when hoses are pulled. Leaks may occur as a result. Recommend that a qualified person install fasteners per standard building practices.

Recommendation
Contact a qualified plumbing contractor.

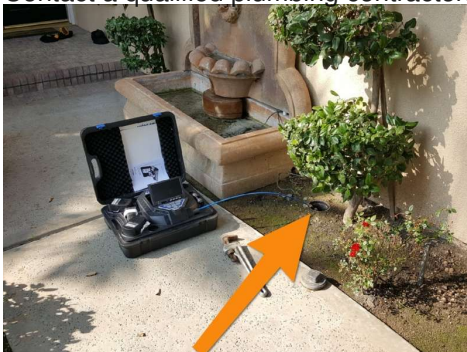
SewerScan started from the clean-out located at the clean-out located at the left side of the garage to the city connection all measurements stated in the locations above are from the point of the SewerScan equipment in the photo below.

SewerScan started at the clean-out located at the left side of garage

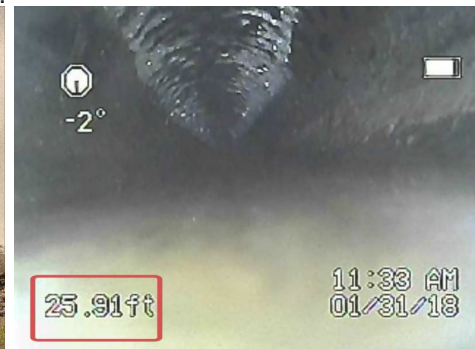
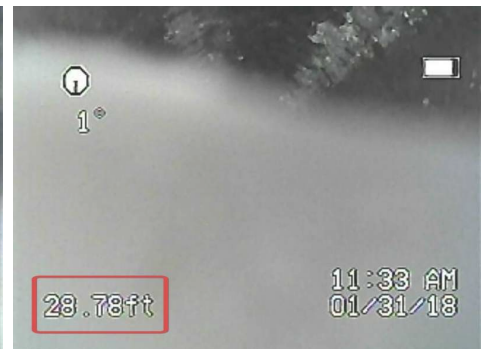
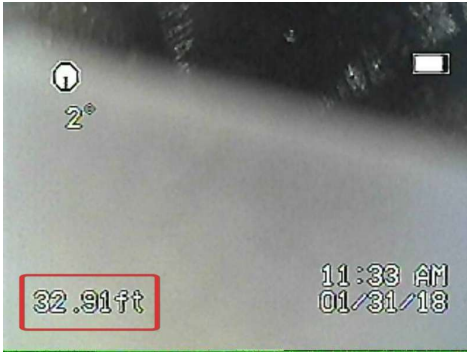
Belly: There is a low point in the drain line which can promote clogging. We recommend further review and repair as needed.

Location(s): 26.8 ft to 36.5 ft

Start of belly

Belly continued

Summary of findings: We recommend all repairs be evaluated and repaired by a qualified C42 licensed sewer contractor. It should be understood that sometimes due to extent of debris or roots found, we are unable to fully access the sewer line. We recommend further review of lines by a qualified plumbing contractor in these cases when cleared and the lines can be better accessed at that time.

Recommendation
Contact a qualified plumbing contractor.

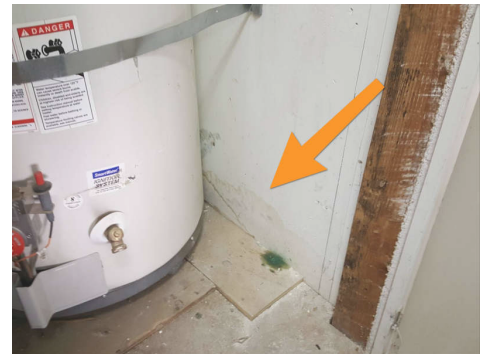
STAINS / DAMAGE BELOW / AROUND WATER HEATER

Water stains and/or damage were found below or near the water heater. This may be a sign that the water heater is failing, a sign of a past leak, or that the TPR valve is discharging. Consult with the property owner about this and review any disclosure statements. Depending on what information is available about the stains, a qualified plumber should evaluate and make repairs or replace the water heater as necessary.

Contact a qualified plumbing contractor.

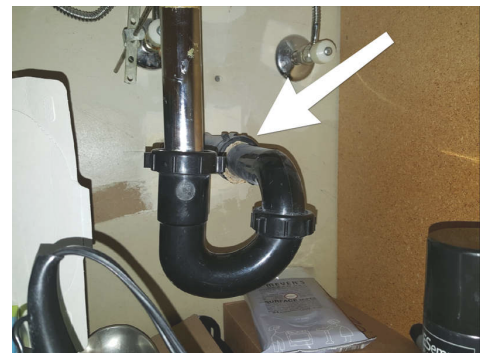
Master Bathroom

DRAIN LINES / FITTINGS CORRODED

Corrosion was found at drain lines and/or fittings under one or more sinks. This can indicate past leaks, or that leaks are likely to occur in the future. Recommend that a qualified plumber evaluate and repair as necessary.

Contact a qualified plumbing contractor.

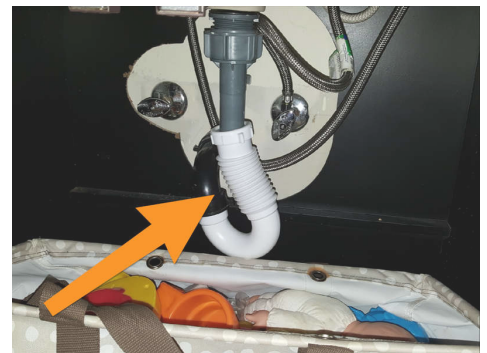
2nd Floor Hallway Bathroom

FLEXIBLE PIPE

Ribbed, flexible drain pipe was used at the sink. This type of drain pipe accumulates debris more easily than smooth wall pipe and is likely to clog. Recommend that a qualified plumber replace flexible piping with standard plumbing components (smooth wall pipe) to prevent clogged drains.

Contact a qualified plumbing contractor.

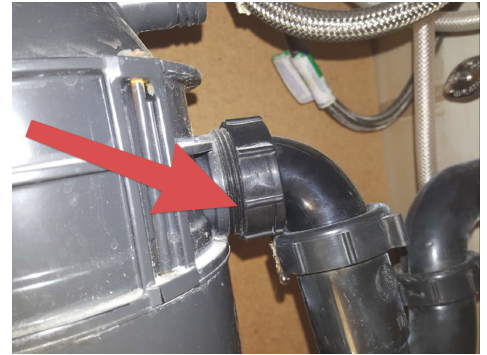
Kitchen (small sink)

DRAIN LEAK

One or more leaks were found at the sink drain. A qualified plumber should repair as necessary.

Contact a qualified plumbing contractor.

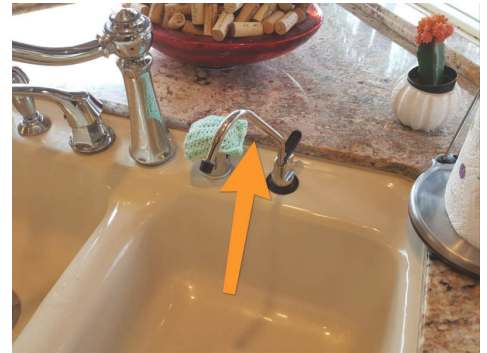
KITCHEN

WATER FILTER SERVICE SPOUT DAMAGED / INOPERABLE

The water filter dispenser was damaged and/or inoperable. Recommend repairs by a qualified person.

Note: The filter system appears to have been removed.

Contact a qualified plumbing contractor.

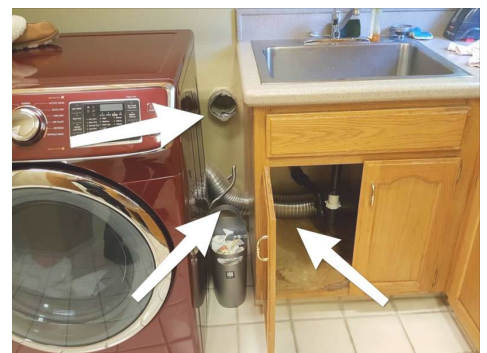
DRYER VENT NEEDS CLEANING - NOW

The clothes dryer exhaust duct appeared to terminate at the roof or routed upward. As a result significant amounts of lint can build-up and may reduce air flow over time. This can become a fire hazard if not properly maintained. Recommend that a qualified person clean this duct now and as necessary in the future. Some chimney sweeps or heating/cooling duct cleaners perform this service.

Note: There are two vents installed, the upper connection is the vent that should be clean if going to be used. The lower vent that extend to the exterior side wall does not appear to require cleaning at this time. Client should ask the current homeowner as to why a second vent was installed.

Clean upper vent if upper vent is going to be connected to the dryer

Contact a qualified professional.

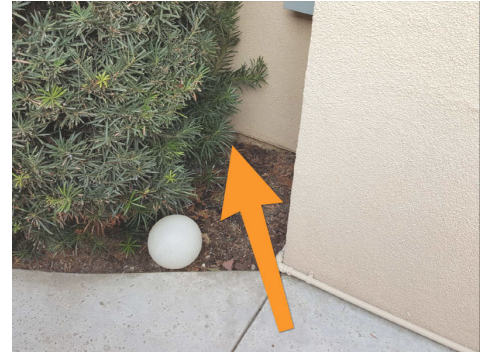
Left Side

SPRINKLERS HITTING STRUCTURE.

Sprinklers appear to be hitting the structure. Recommend to redirect or change spray patterns of sprinkler heads.

Contact a qualified professional.

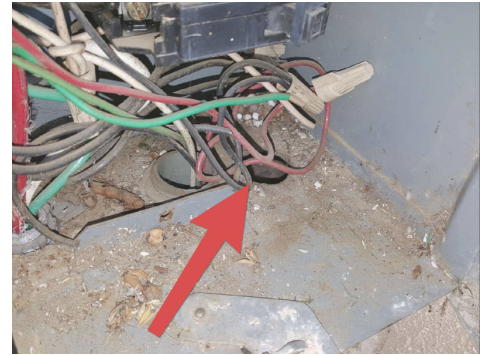
Main Panel

OPEN KNOCKOUTS

One or more knockouts were missing. Holes in panels are a potential fire hazard if a malfunction ever occurs inside the panel. Rodents can also enter panels through holes. Recommend that a qualified person install knockout covers where missing and per standard building practices.

Contact a qualified electrical contractor.

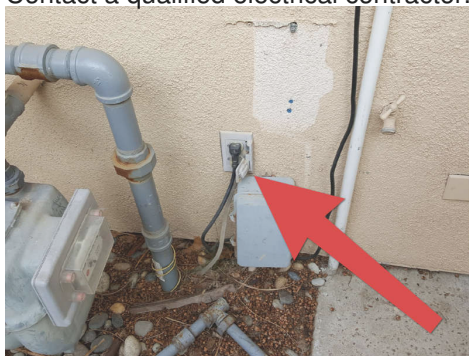
Exterior Left Side

MISSING GFCI PROTECTION

One or more locations at this property were noted as not having GFCI protection or the inspector was unable to verify if GFCI protection existed at these locations. Adoption of GFCI outlets was generally phased in over numerous years/decades. Recommend client evaluate upgrading these areas to GFCI protection at their discretion.

Contact a qualified electrical contractor.

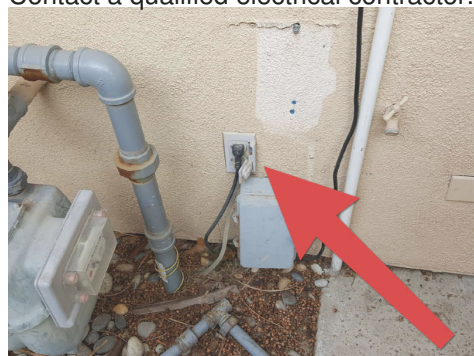
Left Side

EXTERIOR RATED COVER PLATE DAMAGED / MISSING

One or more exterior receptacle covers were broken and/or missing. This is a potential shock hazard. Recommend that a qualified person replace covers where necessary.

Contact a qualified electrical contractor.

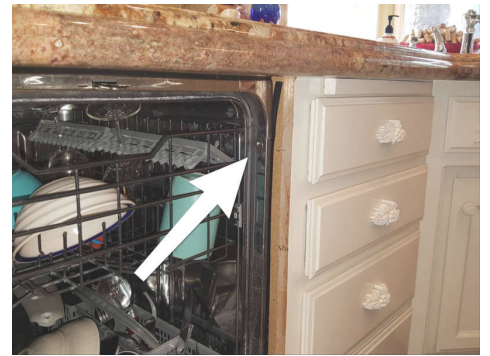
NOT SECURE, MISSING / DAMAGED SCREW(S) AND/OR BRACKET(S)

The dishwasher wasn't securely attached to the counter or cabinets (missing or damaged fasteners). Dishwasher movement is possible due to vibrations. Recommend that a qualified person install fasteners per standard building practices.

Loose

Recommendation
Contact a handyman or DIY project

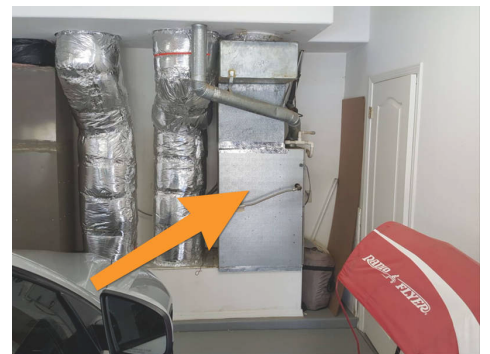
LIFESPAN (15-20 YRS)

The estimated useful life for most forced air furnaces is 15-20 years. This furnace appeared to be near, at or beyond this age and/or its useful lifespan and may need replacing or significant repairs at any time. Recommend budgeting for a replacement in the near future.

Recommendation
Recommend monitoring.

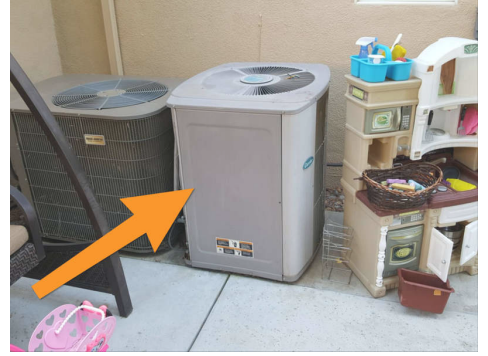
LIFESPAN (10-15 YEARS)

The estimated useful life for most heat pumps and air conditioning condensing units is 10-15 years. This unit appeared to be near, at or beyond this age and/or its useful lifespan and may need replacing or significant repairs at any time. Recommend budgeting for a replacement in the near future.

Recommendation
Recommend monitoring.

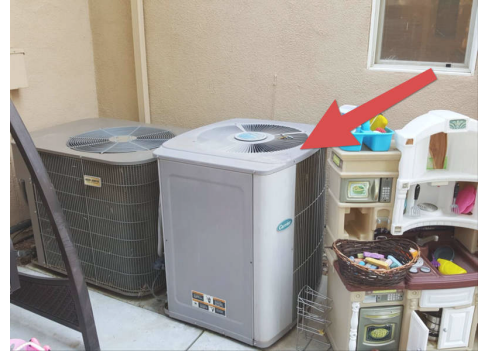
A/C NOISY DURING OPERATION

The air conditioner was noisy during operation. Recommend further evaluation and needed repairs be made by a qualified licensed HVAC contractor.

Recommendation
Contact a qualified HVAC professional.

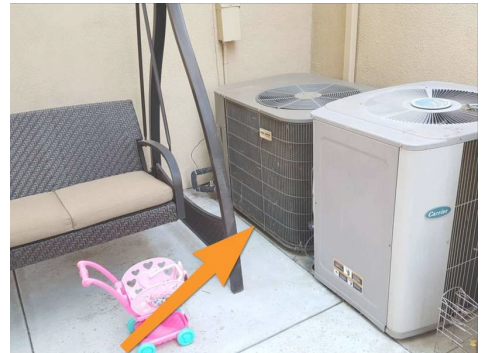
NOT SECURED TO PAD

The outside condenser unit was not secured to the concrete pad. Building standards require units to be secured to the pad to prevent damage, theft, and injury. Recommend a qualified person secure to the pad properly.

Recommendation
Contact a qualified HVAC professional.

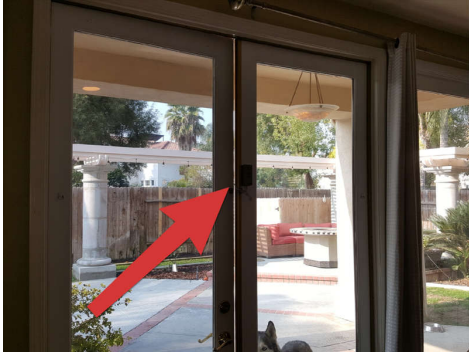
Family Room

ALARMS ON DOORS INOPERABLE

The alarm for one or more doors between the house and the pool and/or spa was inoperable. All doors which give access to a swimming pool should be equipped with an audible alarm. A qualified person should evaluate and repair as necessary.

Contact a qualified professional.
