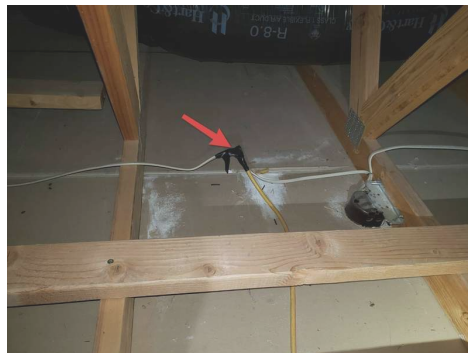
GARAGE ATTIC

#### **OPEN SPLICING**

Open conductor splices are present at the noted location(s) of the home. Recommend further evaluations and proper repairs be performed by qualified licensed electrical contractor to correct and protect, as needed. The installation of a junction box(es) is recommended to correct.

Contact a qualified electrical contractor.

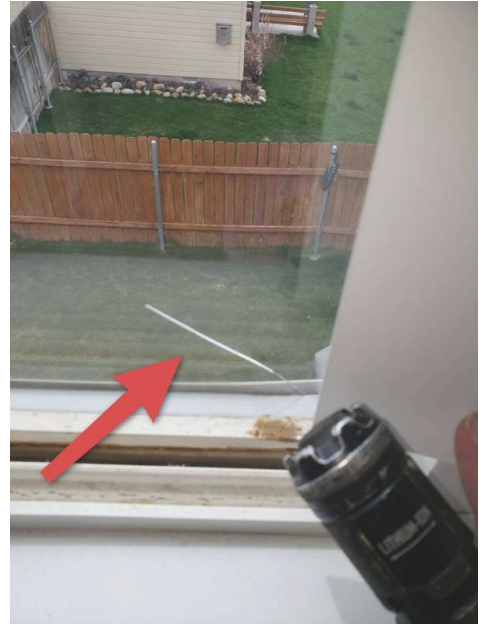
2ND FLOOR SOUTH

#### **GLAZING DAMAGED**

Some damage appears present to the window glazing at the noted location of the home. Recommend further evaluations and proper repairs/replacement be performed by qualified licensed glazing contractor to correct as needed.

Recommendation  
Contact a qualified window repair/installation contractor.
