SUMMARY

1234 Main St. Medina Ohio 44256

North Ohio Property Inspection

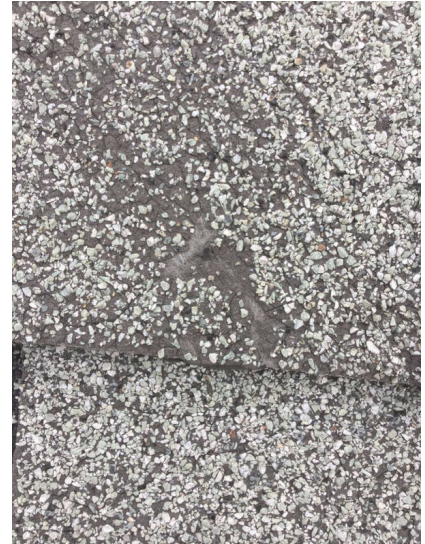
2.1.1 Coverings

DELAMINATION

The asphalt shingle roof shows signs of delamination. Delamination is separation of the surface layer of asphalt. Recommend a qualified roofing contractor evaluate and repair to prevent further deterioration that results in leaking and moisture intrusion.

Contact a qualified roofing professional.

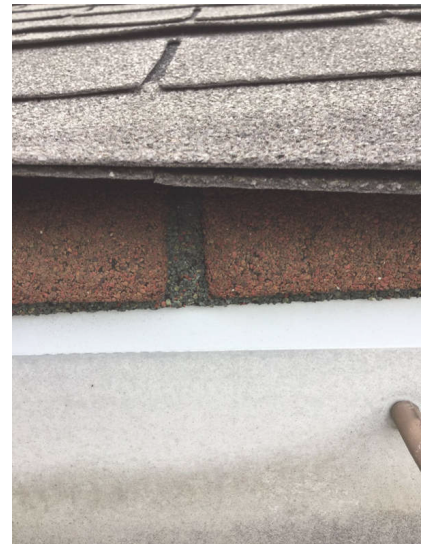
2.1.2 Coverings

MULTIPLE LAYERS OF ROOF PRESENT

Multiple layers of roof present. Multiple layers of roofing material can affect the warranty on the roof. Multiple layers of roofing are associated with shortened life on the roof covering. The costs of tearing off multiple layers of roofing also typically exceed the costs of tearing off a single layer.

Recommend monitoring.

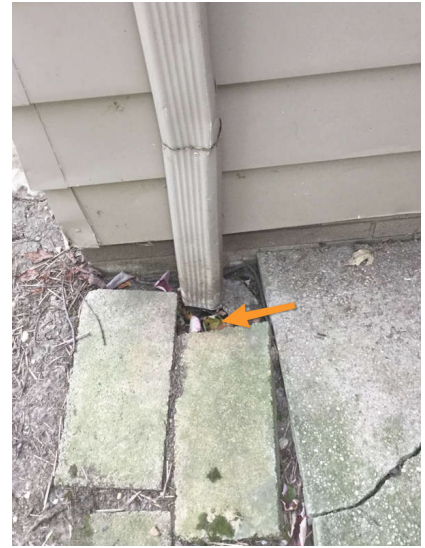
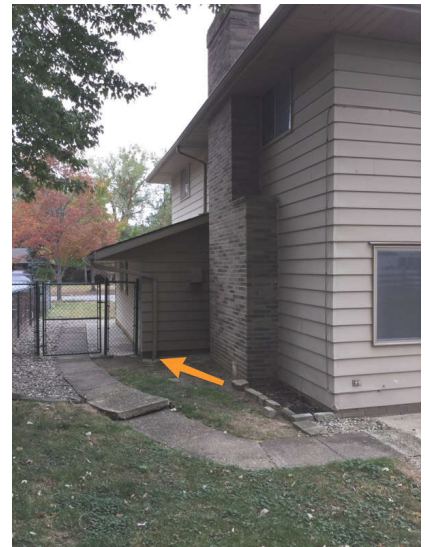
2.2.1 Roof Drainage Systems

DOWNSPOUT DISCONNECTED-FOUNDATION

Downspout is disconnected at the foundation. This can lead to leaks inside of the basement and deterioration of the foundation. I recommend completing the connection between the downspout to the storm sewer line to prevent damage and moisture penetration.

Contact a quality handyman.

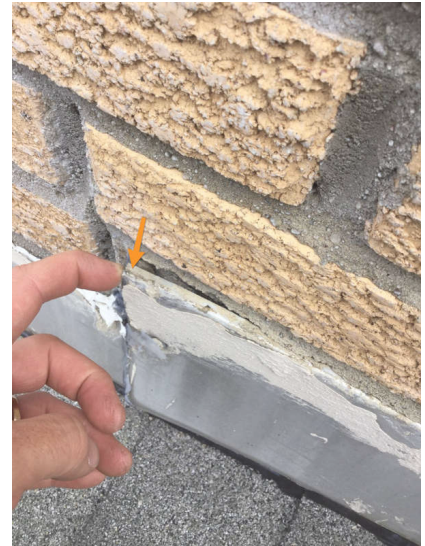
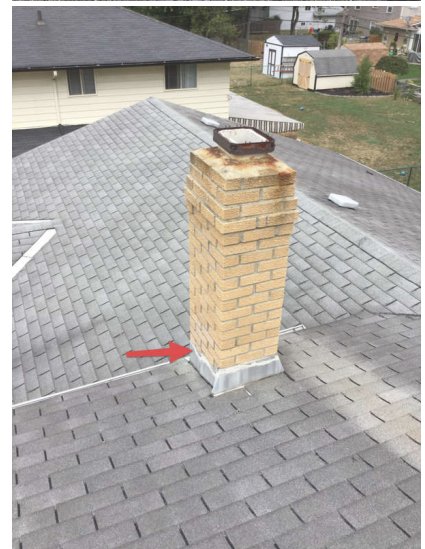
2.3.1 Flashings

LOOSE/SEPARATED

NORTH CHIMNEY

Flashings observed to be loose or separated, which can lead to water intrusion and/or mold. Recommend a qualified roofing contractor repair.

Contact a qualified roofing professional.

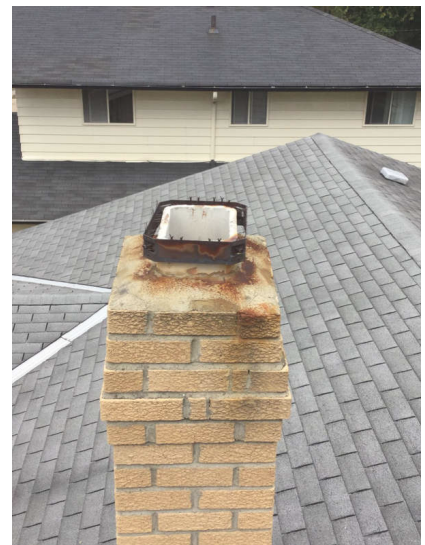
2.4.1 Skylights, Chimneys & Other Roof Penetrations

CHIMNEY CAP MISSING

No chimney cap was observed. This is important to protect from moisture intrusion and protect the chimney. Recommend a qualified roofer or chimney expert install.

Contact a qualified roofing professional.

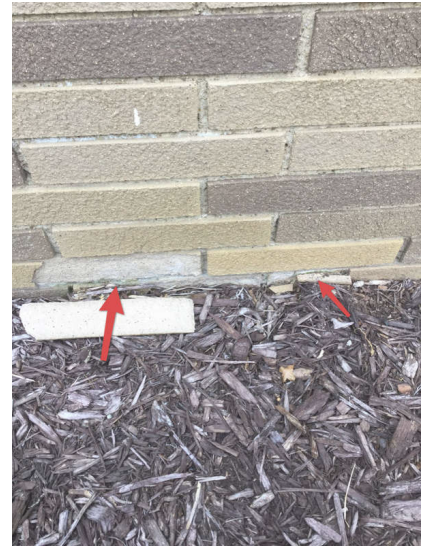
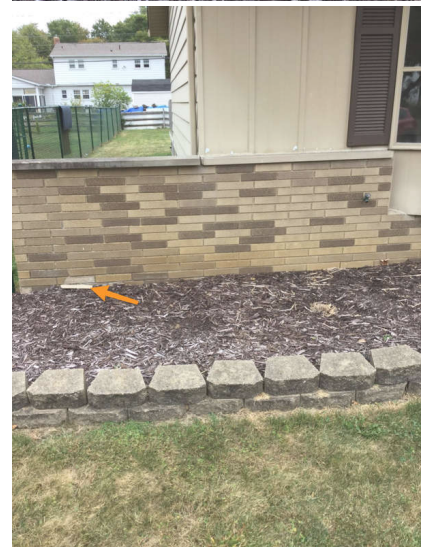
3.1.1 Siding, Flashing & Trim

BRICK SPALLING

Some areas of brickwork were spalling. This is from water freezing under the surface of the brick. If you wish to restore the appearance I recommend contacting a qualified mason.

Contact a qualified masonry professional.

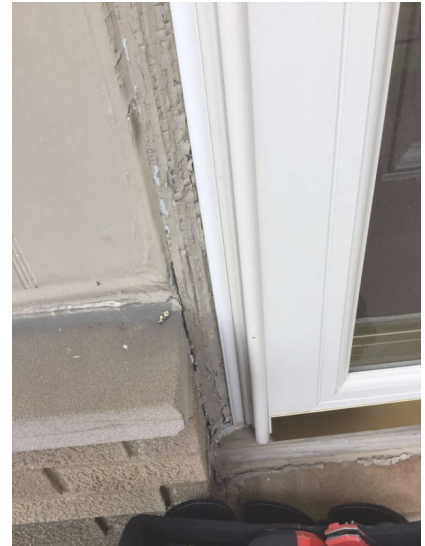
Front door

TRIM ROT

Trim around one or more doors and/or windows is rotted/deteriorated. Replace wood where necessary and properly prime and paint.

Contact a qualified general contractor.

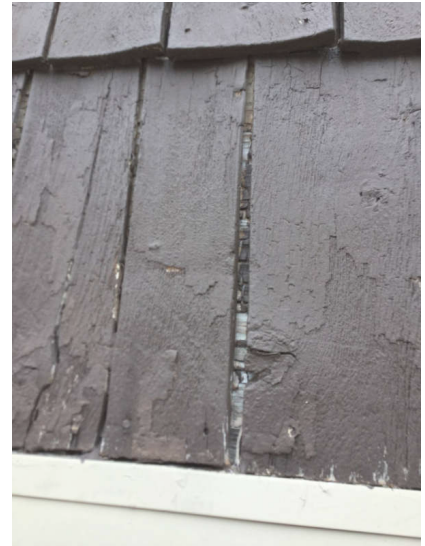
Garage

WOOD ROT - MINOR

One or more areas of the siding exhibit minor wood rot. I recommend replacing rotted sections of wood and re painting.

Contact a qualified professional.

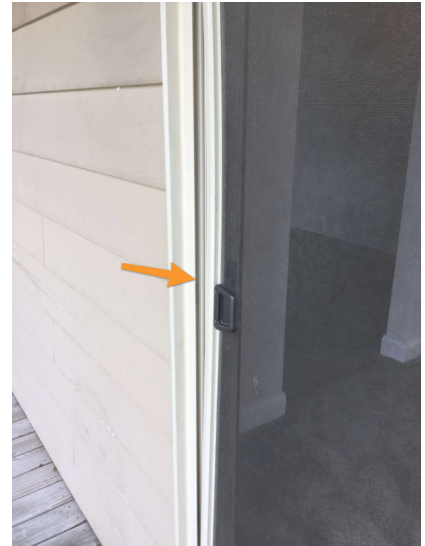
HARDWARE DAMAGED

One or more pieces of door hardware are damaged. The back screen door does not close properly due to being bent. Recommend repair or replace.

Back screen door damaged.

Recommended DIY Project

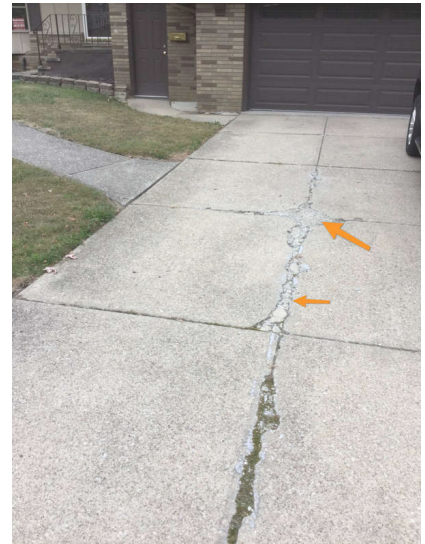
3.3.1 Walkways, Patios & Driveways

DRIVEWAY CRACKING - MINOR

Minor cosmetic cracks observed, which may indicate movement in the soil. Recommend monitor and/or have concrete contractor patch/seal.

Contact a qualified concrete contractor.

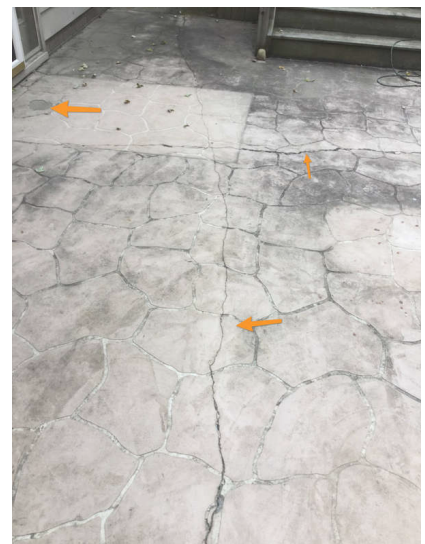
3.3.2 Walkways, Patios & Driveways

PATIO CRACKING - MINOR

Normal settling & cracking observed. Recommend monitor and/or patch/seal.

Recommended DIY Project

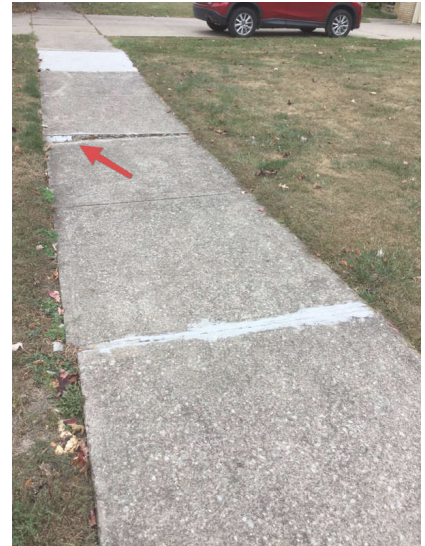
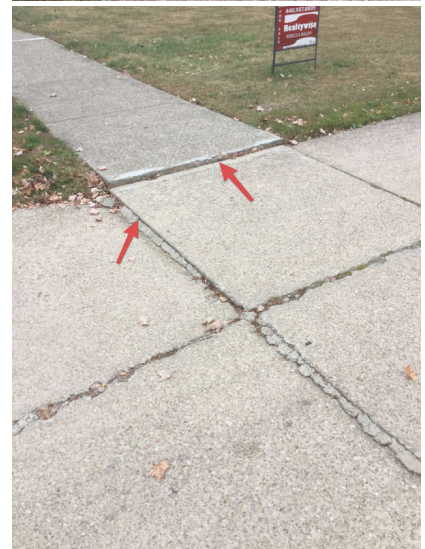
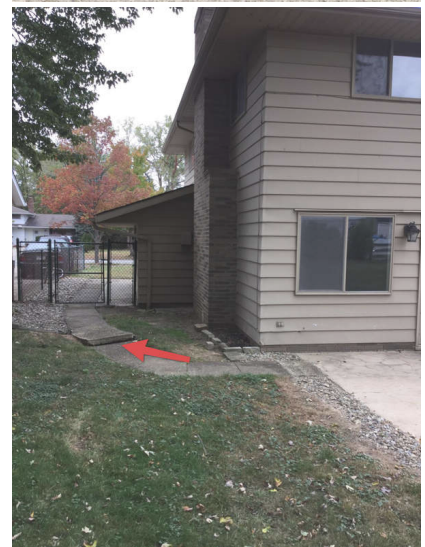
Back sidewalk

WALKWAY TRIP HAZARD

⚠ Safety Hazard and/or Requires Immediate Attention

Uneven surfaces exist on the walkways. This can cause a trip hazard. Recommend qualified concrete contractor level cement.

Contact a qualified concrete contractor.

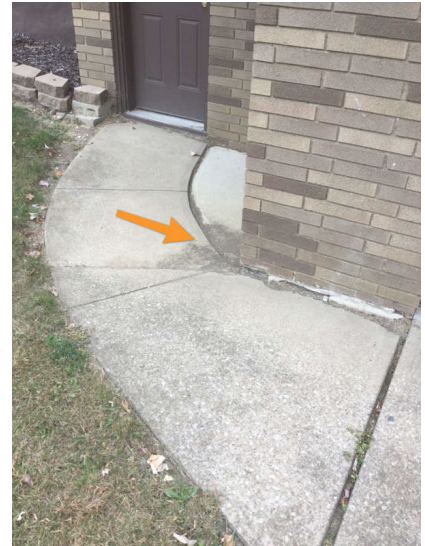
SIDEWALK SLOPES TOWARDS HOME

One or more areas of the sidewalk slope towards the home. This directs water towards the foundation and could lead to water intrusion or damage to the foundation. I recommend a concrete contractor evaluate and repair the sloped areas.

Dirt buildup from water runoff

Contact a qualified concrete contractor.

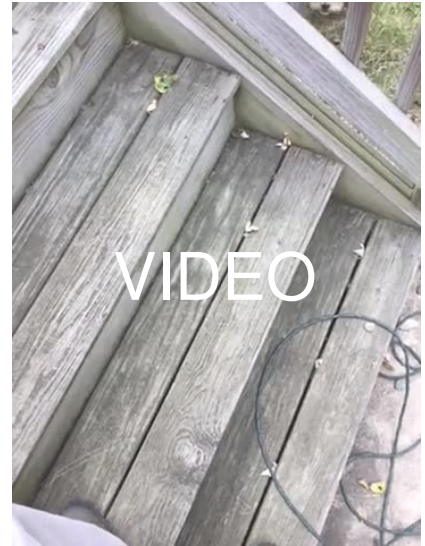
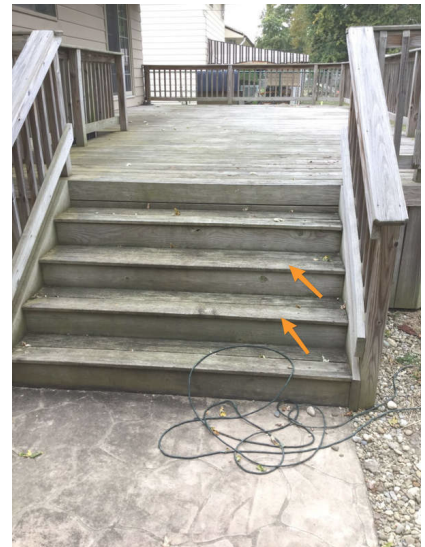
3.4.1 Decks, Balconies, Porches & Steps

DECK - LOOSE BOARDS

One or more deck boards were observed to be loose. Recommend they be refastened.

Contact a qualified deck contractor.

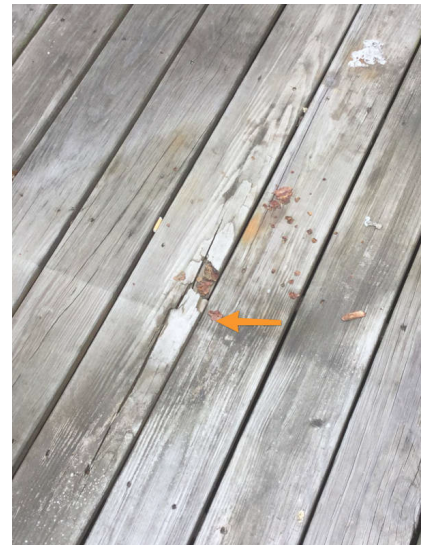
3.4.2 Decks, Balconies, Porches & Steps

DECK - ROTTED BOARDS

One or more deck boards are showing signs of rot. Recommend a qualified deck contractor replace.

Contact a qualified deck contractor.

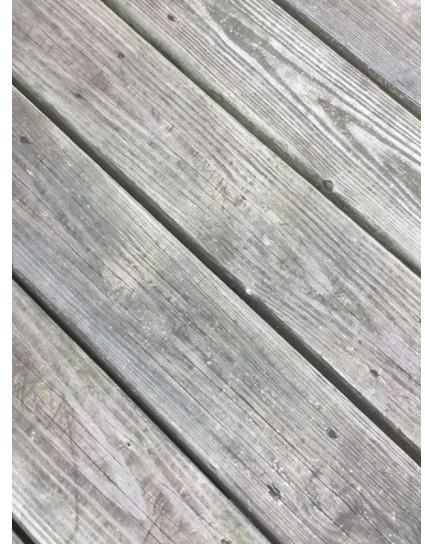
3.4.3 Decks, Balconies, Porches & Steps

DECK - WATER SEALANT REQUIRED

Deck is showing signs of weathering and/or water damage. Recommend sanding the surface and applying water sealant/weatherproofing.

Recommended DIY Project

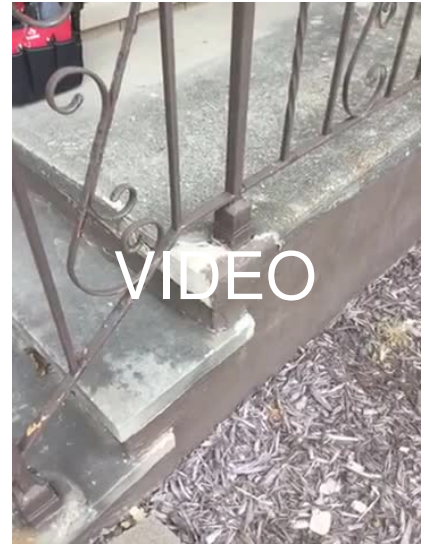
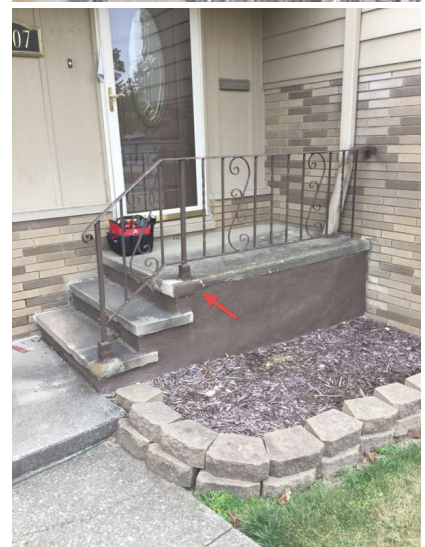
3.4.4 Decks, Balconies, Porches & Steps

LOOSE HANDRAIL

FRONT PORCH

⚠ Safety Hazard and/or Requires Immediate Attention

A handrail is loose. I recommend securing the handrail to prevent trips/falls.

Contact a qualified general contractor.

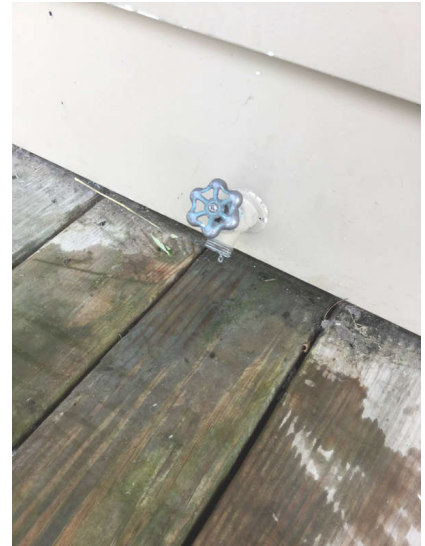
3.7.1 Exterior fixtures

EXTERIOR SPIGOT LEAK FROM VALVE

BACK PORCH

There is a leak in the valve on the exterior spigot that is evident when the spigot is operated. Recommend replacing a ring on spigot.

Contact a qualified plumber.

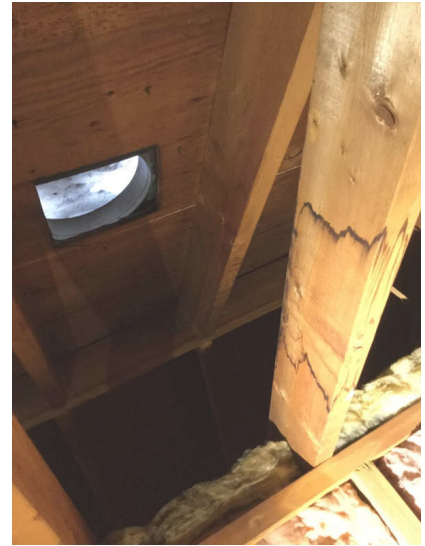
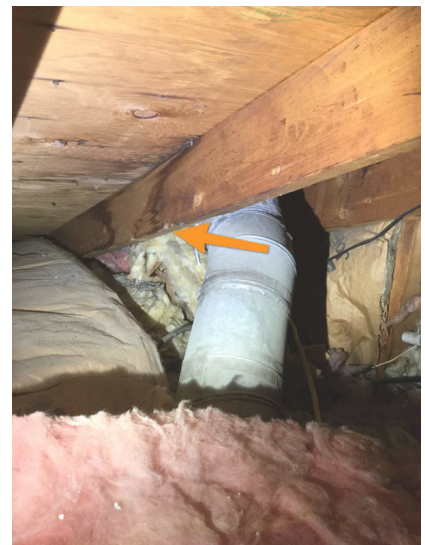
4.1.1 Attic Insulation

EVIDENCE OF PRIOR LEAK

There was evidence of a prior leak in the attic. At the time of inspection the area was dry to the touch and elevated moisture was not detected with a moisture meter. This indicates that the issue may have been corrected and was not active in the days leading up to the inspection. I recommend monitoring the area for changes and make corrections if necessary.

Recommend monitoring.

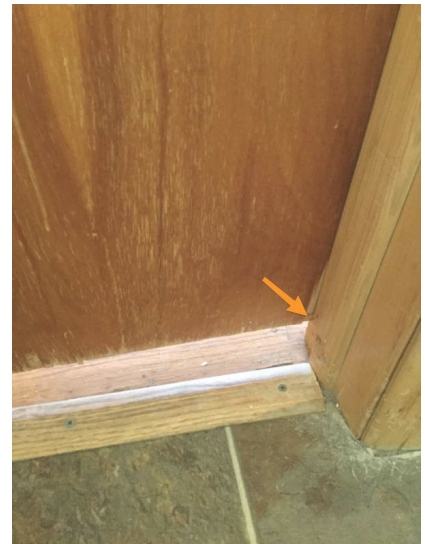
5.1.1 Doors

DOOR STICKS

2ND FLOOR BATHROOM

Door sticks and is tough to open. Recommend sanding down offending sides.

Contact a quality handyman.

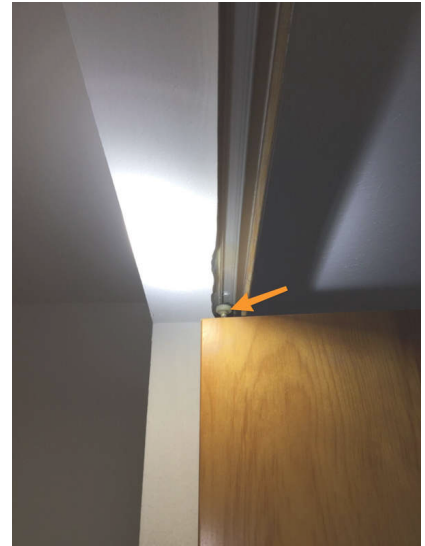
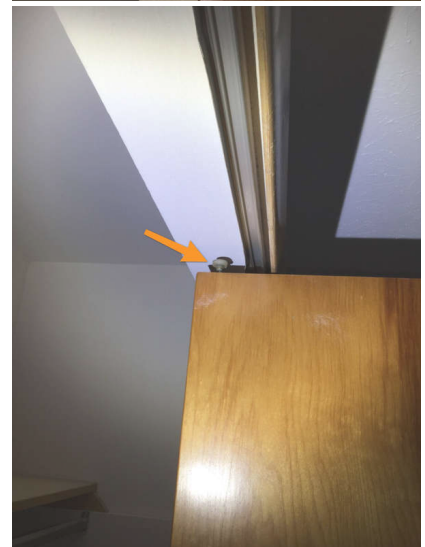
Door comes off track when opening

DOOR DAMAGED

2ND FLOOR BEDROOM

Damage is visible on one or more doors. The closet door in the 2nd floor bedroom (back left) has damage to the track which causes the door to come off track whenever it is opened. Recommend repair or replacement by qualified handyman.

Contact a quality handyman.

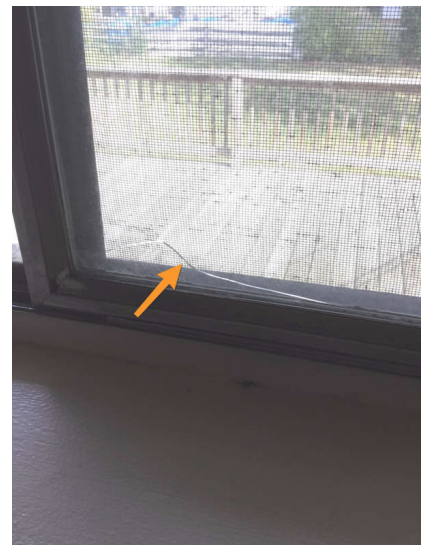
5.2.1 Windows

CRACKED GLASS

KITCHEN

The glass was cracked on one or more windows. I recommend having the cracked glass replaced by a qualified window/glass professional.

Contact a qualified window repair/installation contractor.

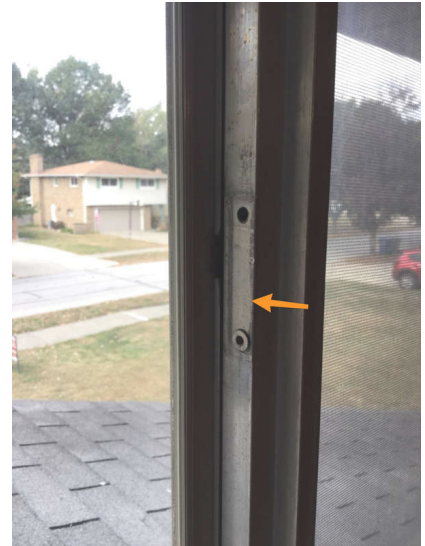
5.2.2 Windows

MISSING HANDLE

2ND FLOOR BEDROOM

Missing handle on window

Contact a qualified window repair/installation contractor.

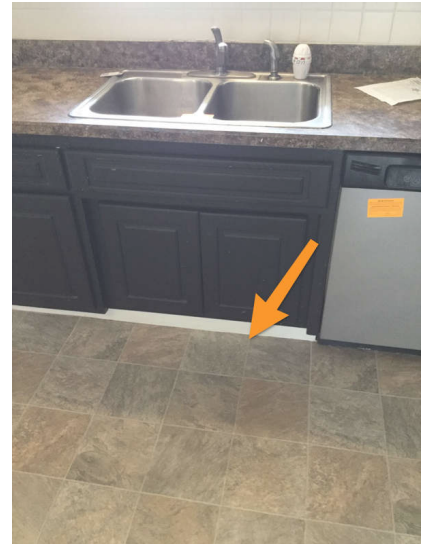
5.3.1 Floors

MOISTURE DAMAGE

KITCHEN

Floors had areas of visible moisture damage. The floor in front of the kitchen sink is soft when stepped on. Recommend a qualified flooring contractor evaluate & repair areas of moisture.

Contact a qualified flooring contractor

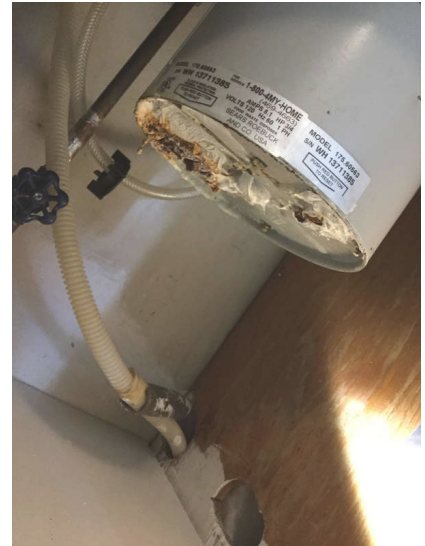
INOPERABLE

⚠ Safety Hazard and/or Requires Immediate Attention

Garbage disposal was inoperable at the time of inspection. It also leaks from the bottom when the water in the sink is ran. Recommend qualified plumber replace the unit.

Bottom of unit is corroded and power is disconnected

Contact a qualified plumber.

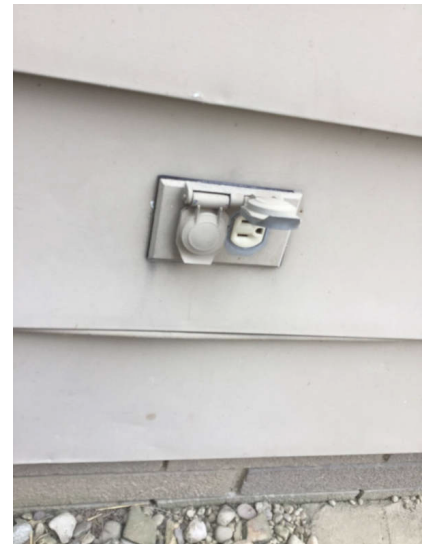
7.5.2 GFCI & AFCI

NO GFCI PROTECTION INSTALLED

KITCHEN

One or more outlets within 6 feet of plumbing fixtures did not have GFCI protection. Although GFCI protection may not have been required at the time the home was built, for safety reasons, the Inspector recommends that electrical receptacles located in basements, crawlspaces, garages, the home exterior, and interior receptacles located within 6 feet of a plumbing fixture be provided with ground fault circuit interrupter (GFCI) protection in good working order to avoid potential electric shock or electrocution hazards. This can be achieved relatively inexpensively by:

1. Replacing an individual standard receptacle with a GFCI receptacle.
2. Replacing the electrical circuit receptacle located closest to the overcurrent protection device (usually a breaker) with a GFCI receptacle.
3. Replacing the breaker currently protecting the electrical circuit that contains the receptacles of concern with a GFCI breaker

Contact a qualified electrician.

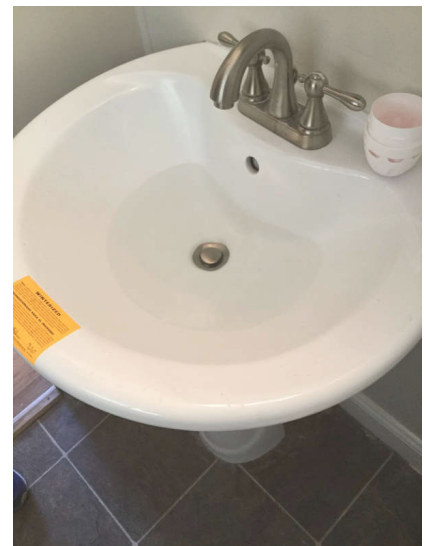
8.2.1 Drain, Waste, & Vent Systems

SINK - POOR DRAINAGE

2ND FLOOR BATHROOM

Sink had slow/poor drainage. Recommend a qualified plumber repair.

Contact a qualified plumber.

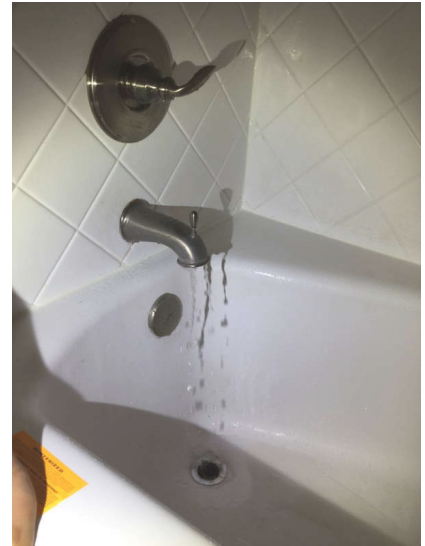
8.3.1 Water Supply, Distribution Systems & Fixtures

DIVERTER VALVE IN SHOWER DEFICIENT

2ND FLOOR HALLWAY BATHROOM

Diverter valve in shower is not working as intended. When diverter valve is turned on water should be directed to the shower head. A significant amount of water is being allowed to exit through the faucet which results in wasted water and reduced water pressure at the shower head.

Contact a qualified plumber.

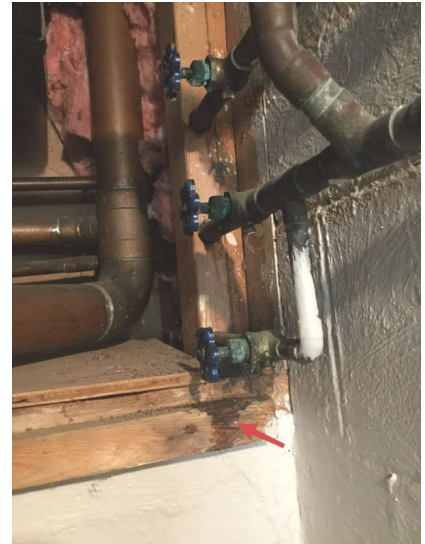
8.3.2 Water Supply, Distribution Systems & Fixtures

LEAK FROM SHUTOFF VALVE

BASEMENT

⚠ Safety Hazard and/or Requires Immediate Attention

One or more shutoff valves have water leaks. Recommend qualified plumber evaluate and repair shutoff valves.

Contact a qualified plumber.

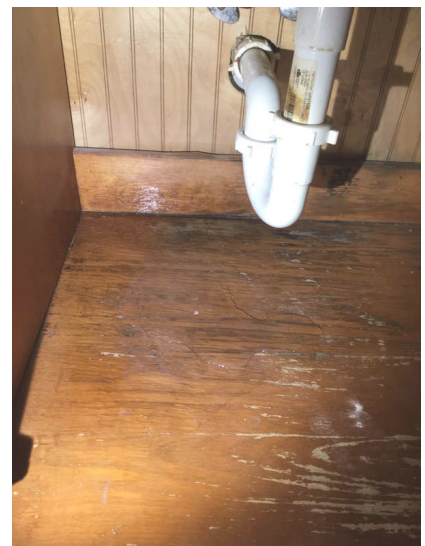
8.3.3 Water Supply, Distribution Systems & Fixtures

LEAK UNDER SINK

2ND FLOOR HALLWAY BATHROOM

⚠ Safety Hazard and/or Requires Immediate Attention

A supply pipe is leaking under the sink. Recommend qualified plumber evaluate and repair.

Contact a qualified plumber.

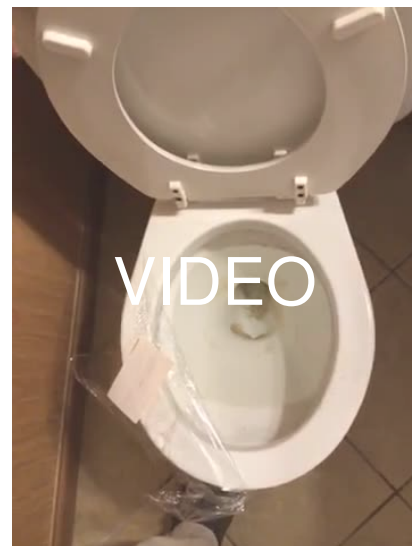
8.3.4 Water Supply, Distribution Systems & Fixtures

TOILET DOESN'T FLUSH

2ND FLOOR HALLWAY BATHROOM

The toilet does not flush. Water flows through and it does not back up but it does not flush completely. I recommend evaluation and repair/replacement by a qualified plumber.

Contact a qualified plumber.

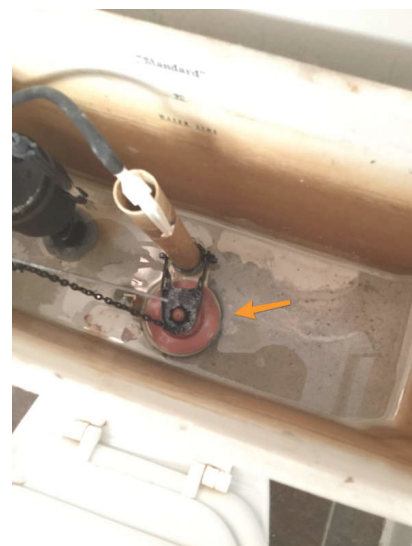
8.3.5 Water Supply, Distribution Systems & Fixtures

TOILET FLUSH VALVE

The flush valve on one or more toilets is not functioning as intended. I recommend replacing the flush valve for proper operation of the toilet.

Contact a qualified plumber.

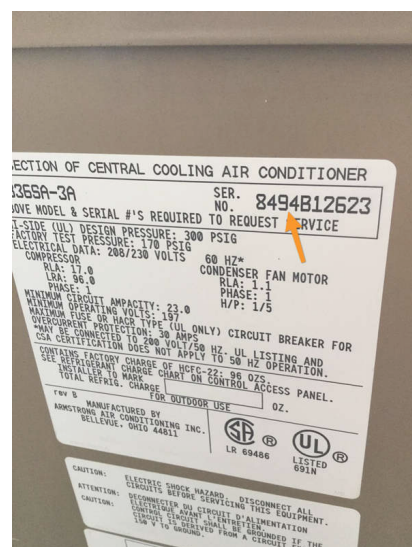
9.1.1 Cooling Equipment

AIR CONDITIONER - AGE

Central air conditioning unit is in the second half of its useful life. It is common for properly maintained units to exceed estimated service life but it is difficult or impossible to predict when an appliance will stop functioning correctly. I recommend monitoring the condition and consider budgeting for a future replacement.

Serial number indicates 1994 manufacture date

Recommend monitoring.
