## SUMMARY

1234 Main St. Rossville GA 30741

Matthew Hyde  
NACHI18021421  
Hyde Home Inspections  
4236816136  
hydehomeinspections@gmail.com

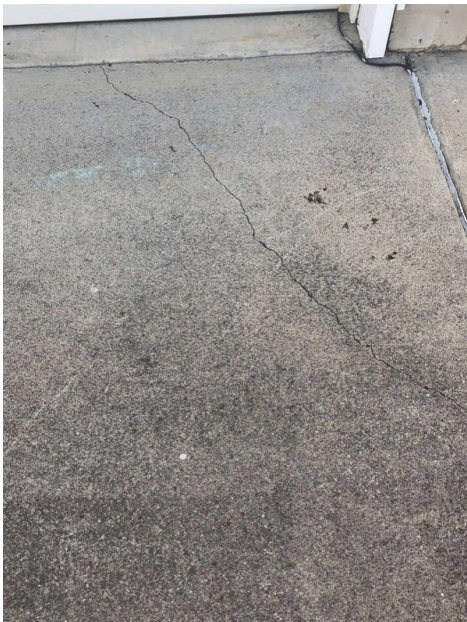
### 2.2.1 Driveways and Walkways

#### **DRIVEWAY CRACKING - MINOR**

Minor cosmetic cracks were observed at time of inspection, which may indicate movement in the soil. Settling and shrinkage over time causes small cracks in concrete. I recommend a professional to evaluate and suggest repairs.

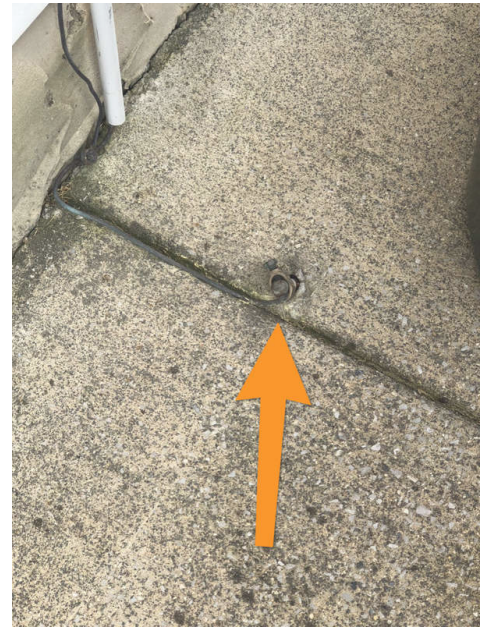
### 2.2.2 Driveways and Walkways

#### **WALKWAY TRIP HAZARD**

At the time of the inspection, there was a trip hazard noticed. This should be evaluated by a professional for the material used such as asphalt, dirt, concrete, or gravel.

Grounding rod

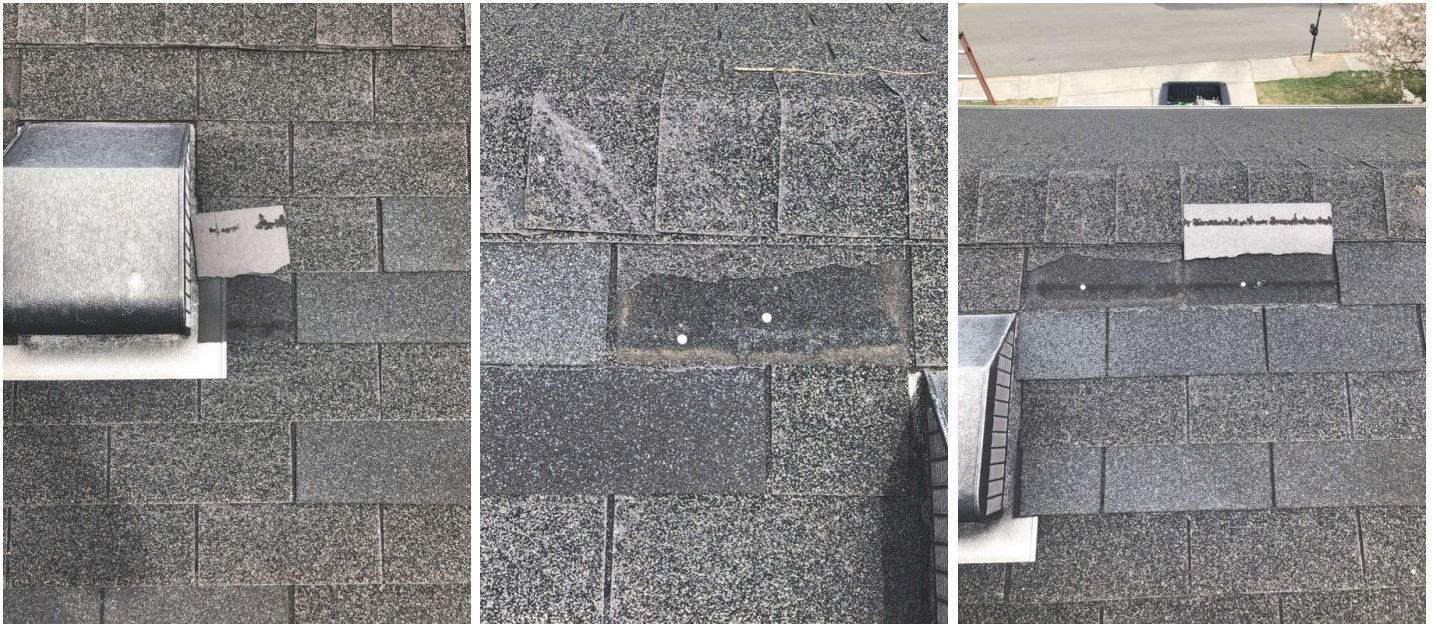
### 3.1.1 Roof Coverings

#### **DAMAGED COVERING**

Damaged and/or missing areas of the roof covering was noted at the time of the inspection. Roof covering should be evaluated and areas repaired and/or replaced by a licensed qualified roofing contractor to avoid damage to the underlying home structure from moisture intrusion.

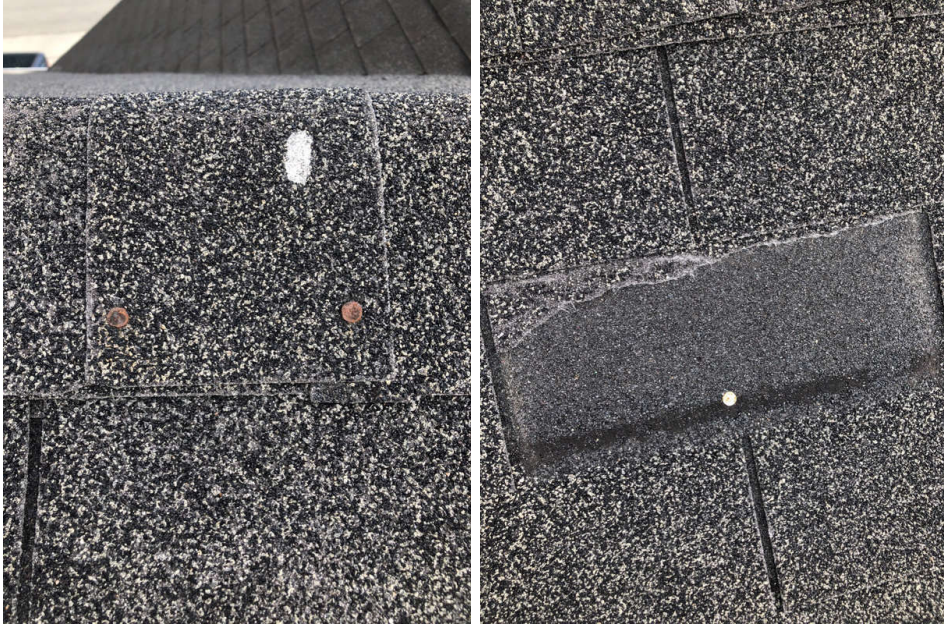
### 3.1.2 Roof Coverings

#### **IMPROPER/INCOMPLETE NAILING**

Roof coverings showed signs of improper installation and fastening. Nails that are exposed or not sealed can allow water intrusion. I recommend a qualified roofing contractor evaluate and repair.

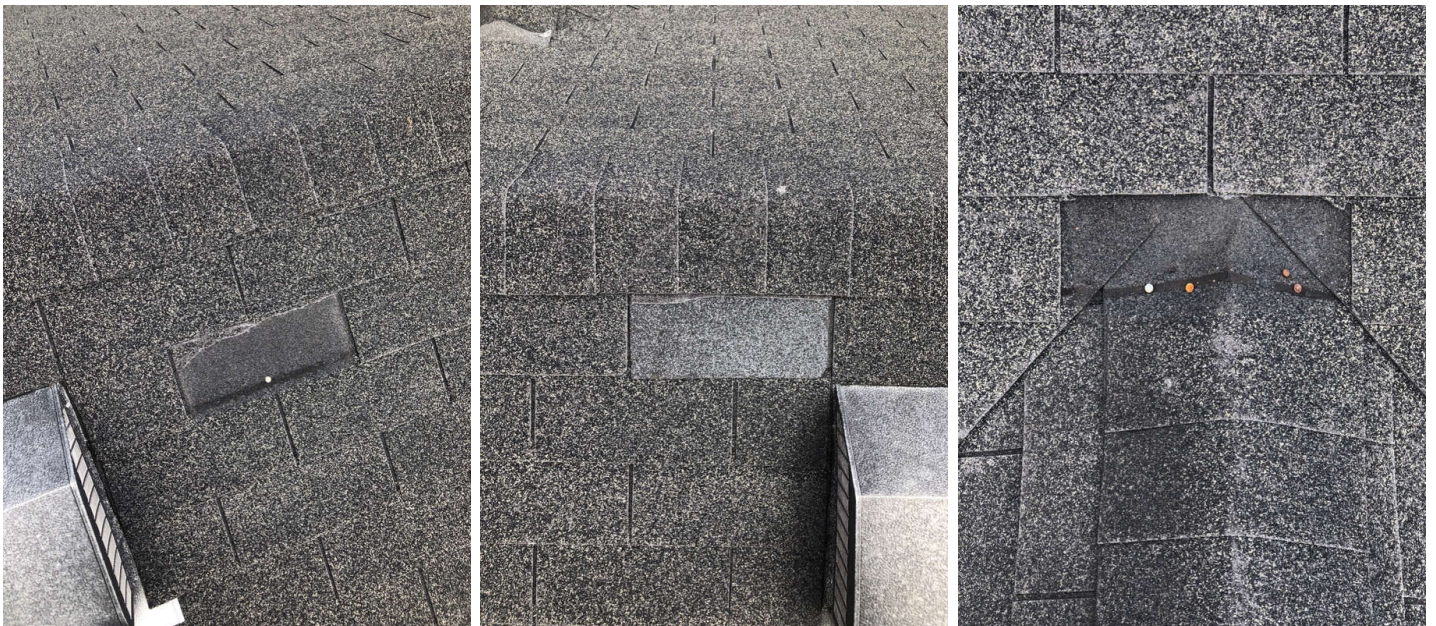
### 3.1.3 Roof Coverings

#### **SHINGLES MISSING**

Observed areas that appeared to be missing sufficient coverings. Recommend qualified roofing contractor evaluate & repair.

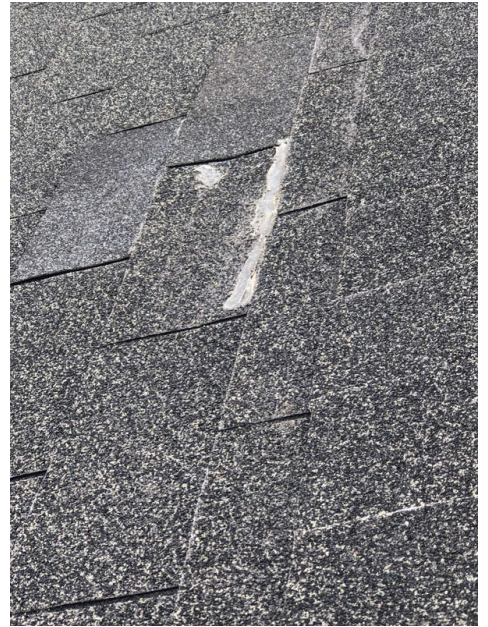
### 3.1.4 Roof Coverings

#### **TEMPORARY/NON-PROFESSIONAL REPAIRS**

Previous repairs were noted on the roof covering at the time of inspection. The repairs appeared to be non professional and/or temporary. I recommend a qualified licensed roofing contractor to evaluate the repair and correct as needed.

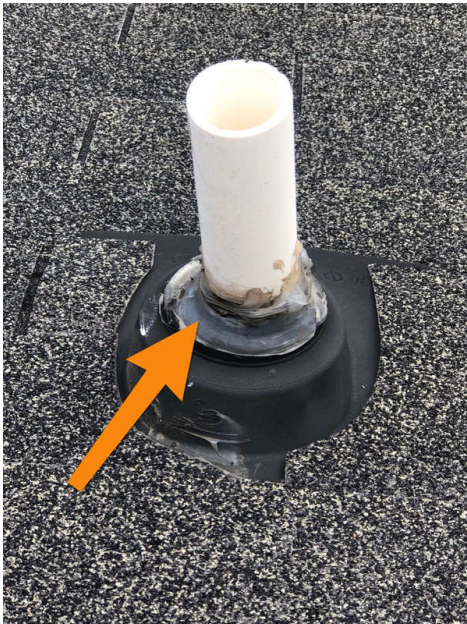
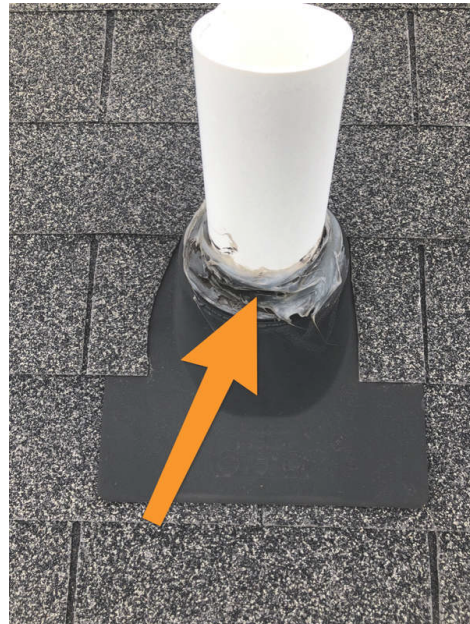
### 3.2.1 Plumbing Vents

#### **PLUMBING VENT DAMAGE OR DEFICIENCY NOTED**

One or more plumbing vent(s) had deficiencies and/or damage noted at the time of inspection. Further evaluation is needed by a qualified roofing contractor. Repair or replace as needed.

Caulk

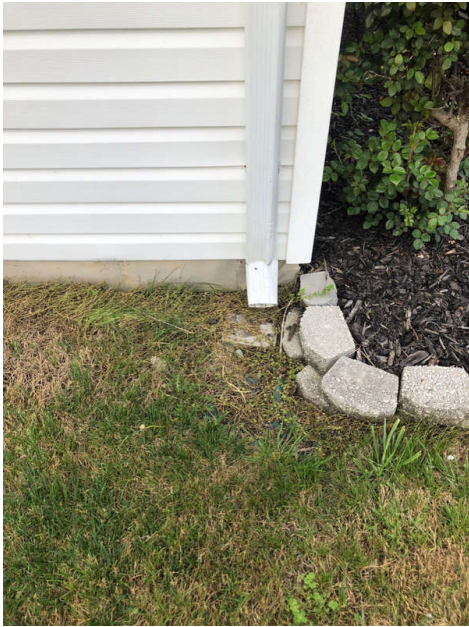
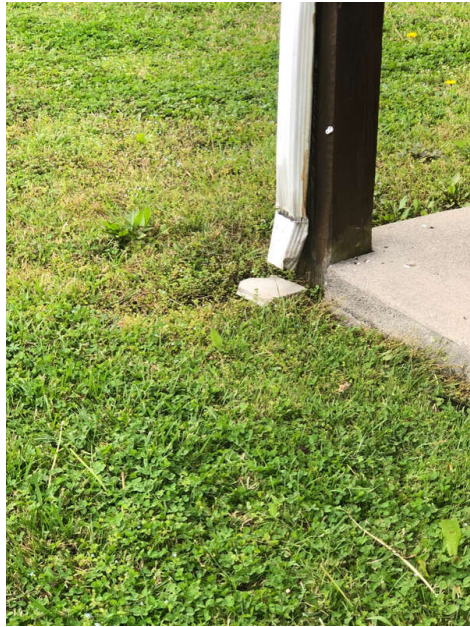
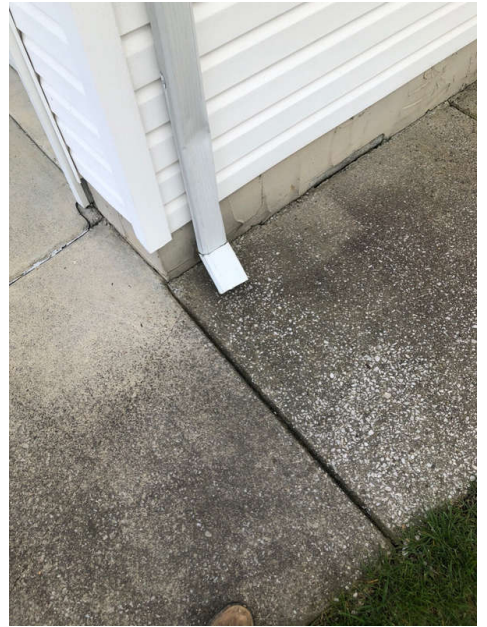
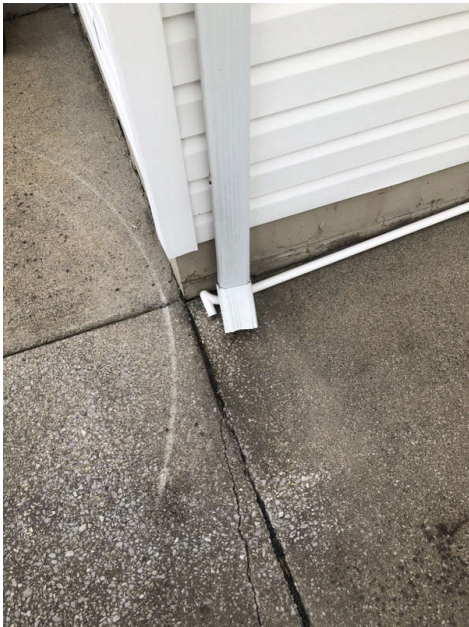
### 3.5.1 Roof Drainage Systems

#### **DOWNSPOUTS DRAIN NEAR HOUSE**

One or more downspouts drain too close to the home's foundation. This can result in excessive moisture in the soil at the foundation, which can lead to foundation/structural movement. Recommend a qualified contractor adjust downspout extensions to drain at least 6 feet from the foundation.

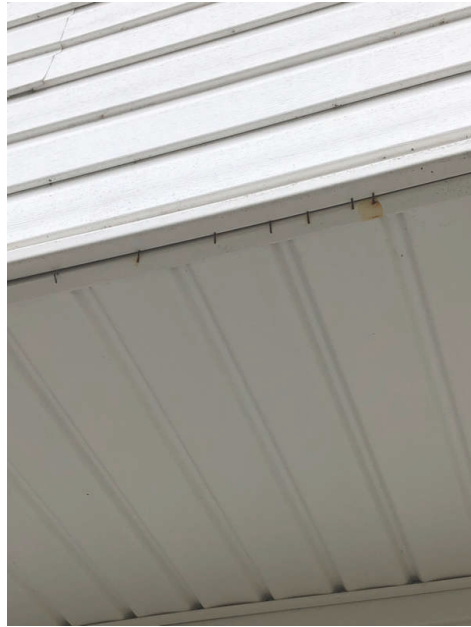
#### 4.1.1 Siding, Flashing & Trim

### **TEMPORARY/NON-PROFESSIONAL REPAIR**

At the time of inspection there were repairs made that were not to professional standards or temporary. I recommend having a qualified professional to evaluate and repair.

Non sealed screw exposed

Contact a qualified professional.

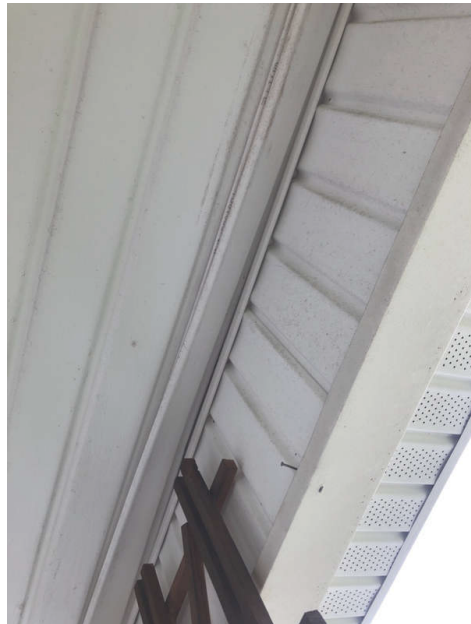
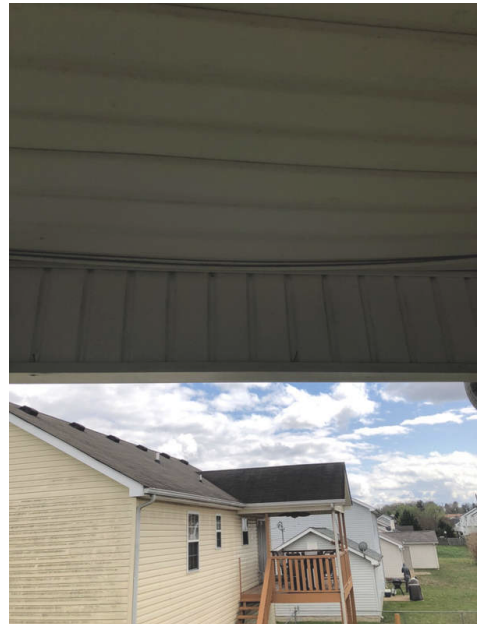
#### 4.1.2 Siding, Flashing & Trim

### **WARPING/BUCKLING**

Vinyl siding was warping or buckling in areas. This is often as a result of nailing siding boards too tight to the home, preventing expansion/contraction. Recommend a qualified siding contractor evaluate and repair.

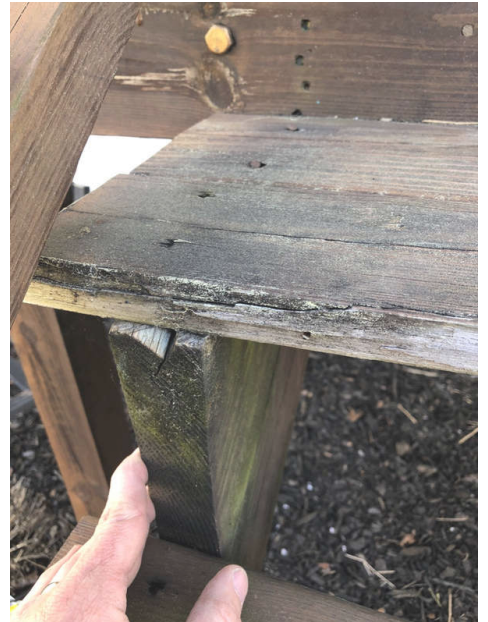
#### 4.3.3 Porch

### STEPS - DETERIORATED

At the time of inspection, one or more steps were deteriorated. This could cause someone to fall or be injured. I recommend contact a qualified professional to repair.

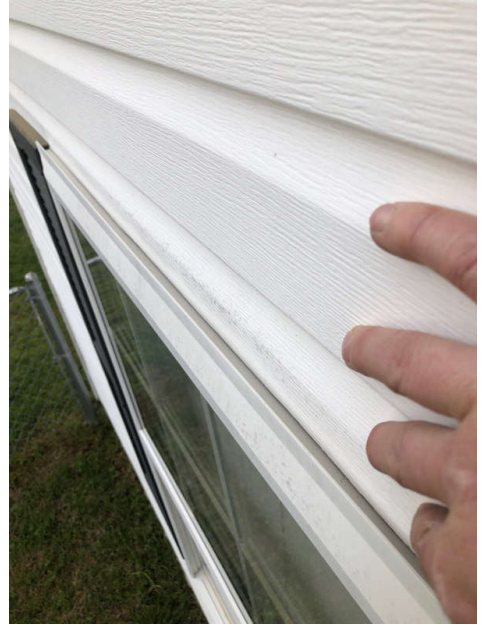
#### 4.6.1 Windows (exterior)

### NO HEAD FLASHING/SEALANT

At the time of the inspection, the windows had no flashing installed above openings or no sealant had been applied. I recommend the application of an appropriate sealant such as a premium grade of exterior acrylic latex to help prevent moisture intrusion. Because sealants will eventually dry, shrink and crack, leaving the home exposed to possible moisture intrusion, you should examine sealed areas on an annual basis and re-apply sealant as necessary. I recommend having a qualified professional repair.

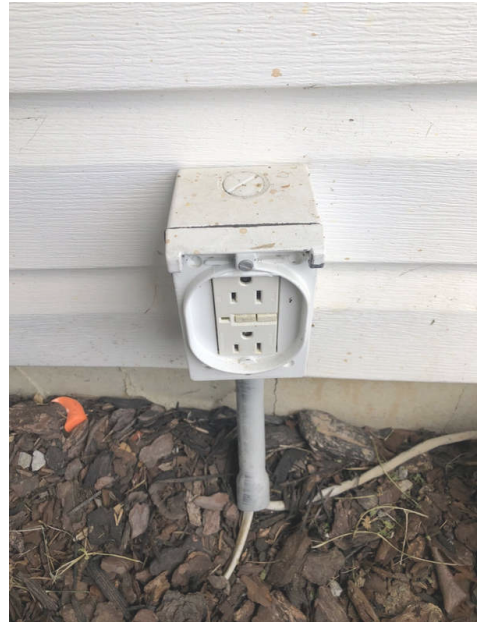
#### 4.7.1 Exterior Outlets

### **DAMAGED OUTLET/COVER**

An exterior outlet/cover was damaged at the time of inspection. This is a safety hazard should be corrected by a qualified electrical contractor.

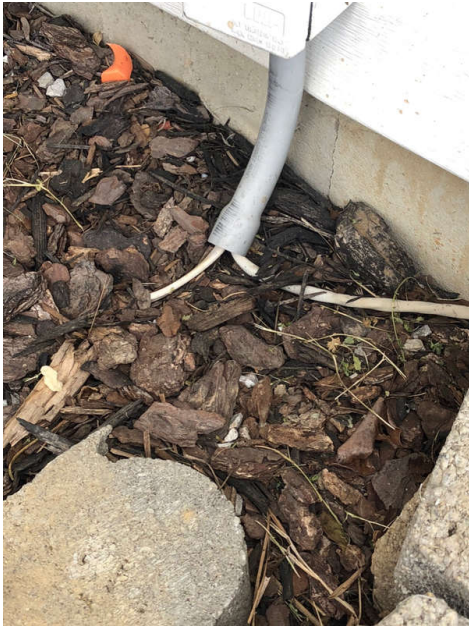
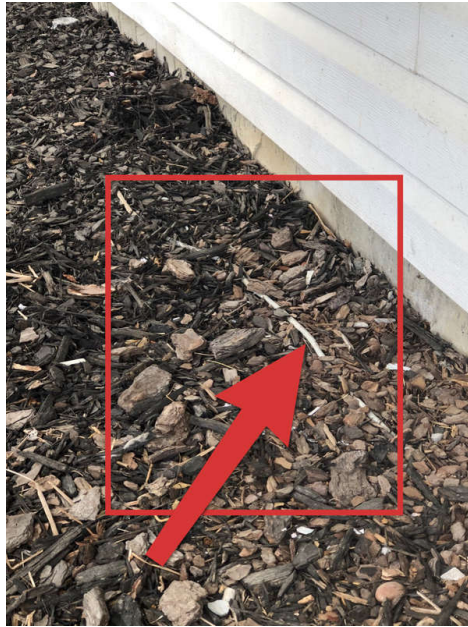
#### 4.7.2 Exterior Outlets

### **EXPOSED WIRING**

At the time of inspection the wiring was exposed. This could be a safety issue. I recommend a qualified professional to repair.

Contact a qualified electrical contractor.

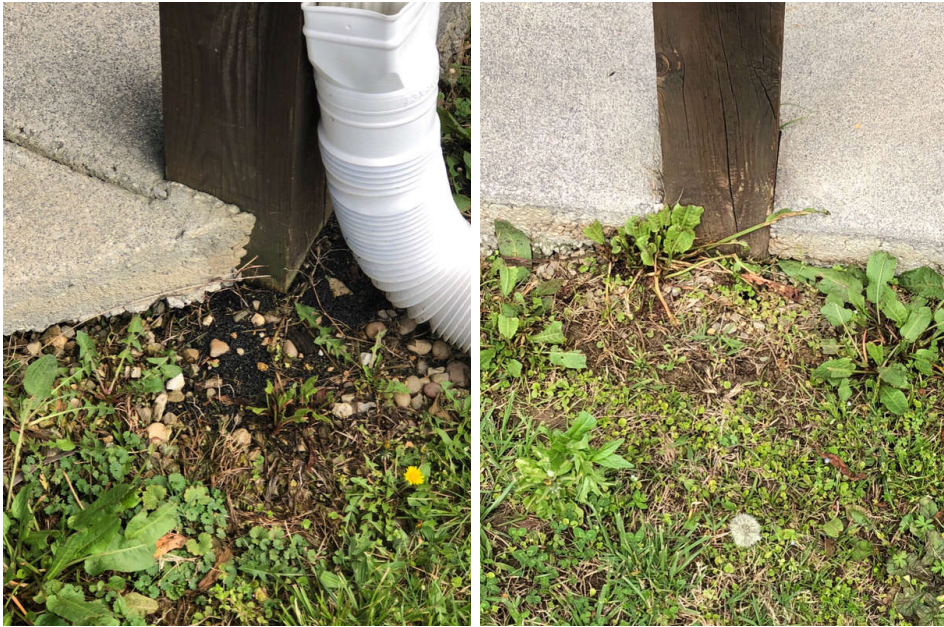
#### 4.8.1 Deck

### **DECK IN CONTACT WITH SOIL**

At the time of inspection, the deck framing was in contact with soil. This condition will result in damage from decay. Weakening of the support member can cause collapse if not repaired. I recommend contacting a qualified professional to repair.

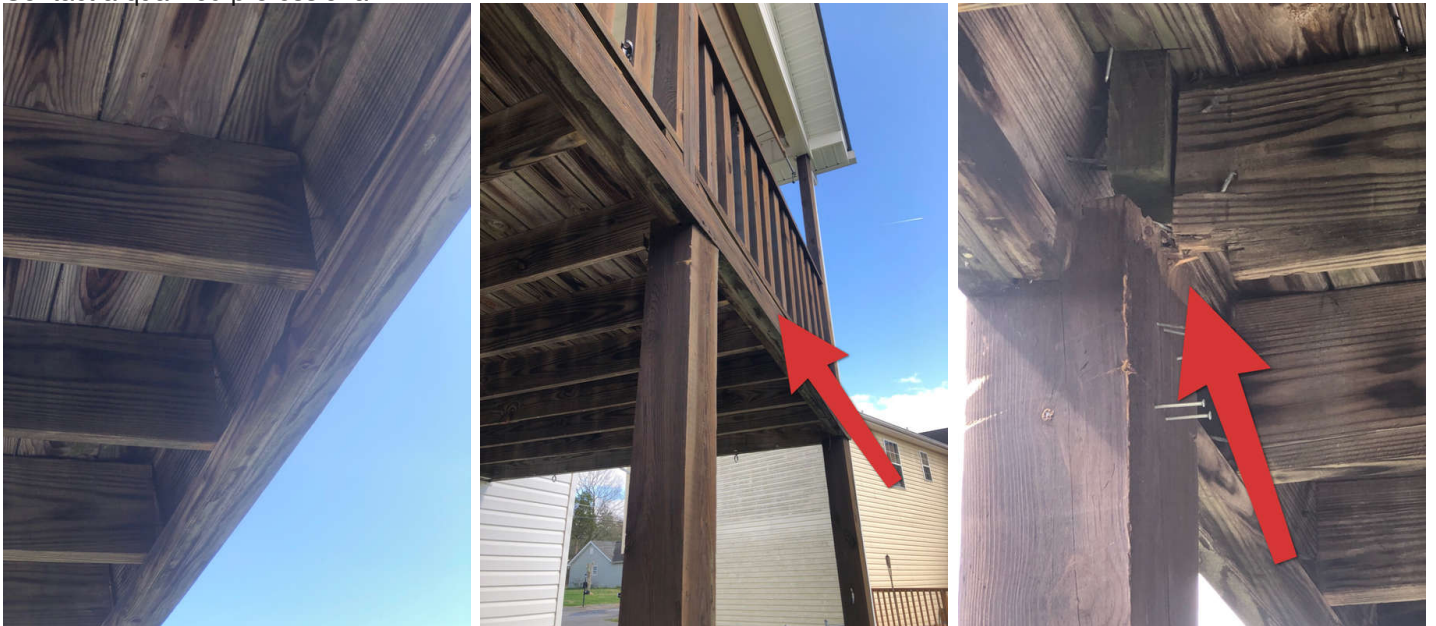
#### 4.8.2 Deck

### FRAMING TWISTED/PULLING AWAY

At the time of inspection there were one or more board in the framing themat were twisted or pulling away. This could be a safety issue and contribute to the failing of the structure. I recommend a qualified professinal to evaluate and repair.

Contact a qualified professional.

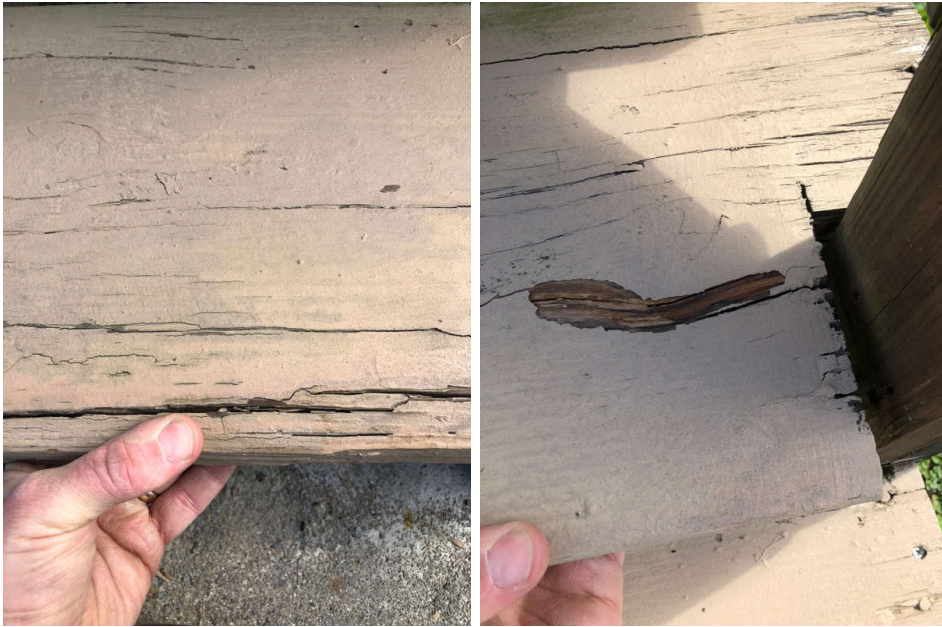
#### 4.8.5 Deck

### **STEPS - DETERIORATED**

At the time of inspection, one or more steps were deteriorated. This could cause someone to fall or be injured. I recommend contact a qualified professional to repair.

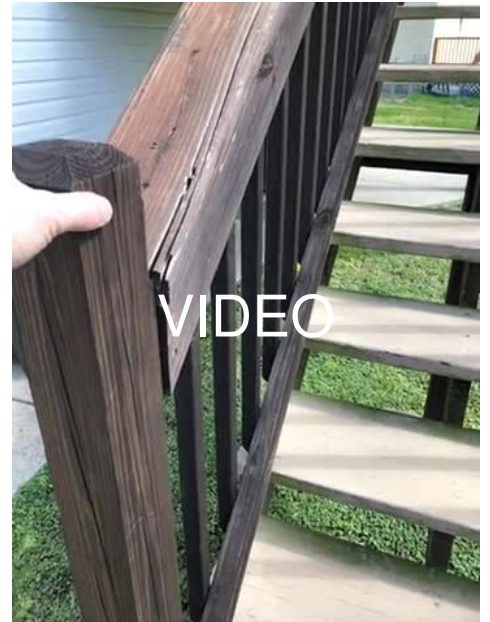
#### 4.8.6 Deck

### STEPS-HANDRAILS LOOSE

At the time of inspection, the handrails were loose. This could cause someone to pull the handrails away and cause the person to fall or be injured. I recommend contacting a qualified professional to correct or repair.

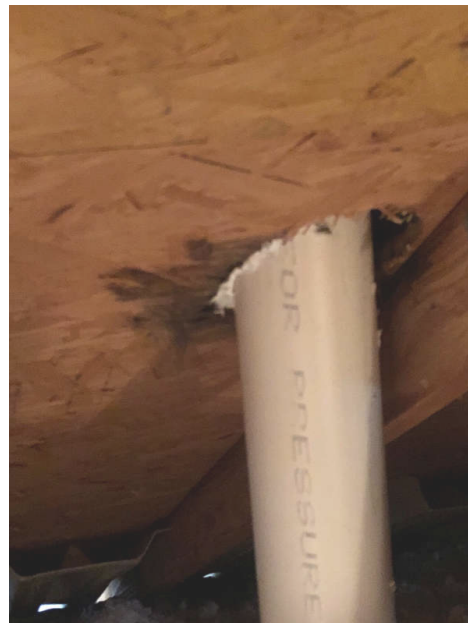
#### 6.1.1 Roof Structure

### WATER INTRUSION

At the time of inspection, there was water intrusion noted in the attic. This can be from poor sealed roof penetrations, missing/torn shingles, damage roof coverings, etc . Water intrusion can lead to mold and rot. Rot will compromise the structure's integrity. I recommend a qualified professional repair.

Around vent pipe

Contact a qualified roofing professional.
