## SUMMARY

1234 Main St. Warrior AL 35180

Patrick Dean  
InterNACHI Certified...  
HomeScan Home Inspection Services,  
LLC  
(256) 338-2931  
[homescanalabama@gmail.com](mailto:homescanalabama@gmail.com)

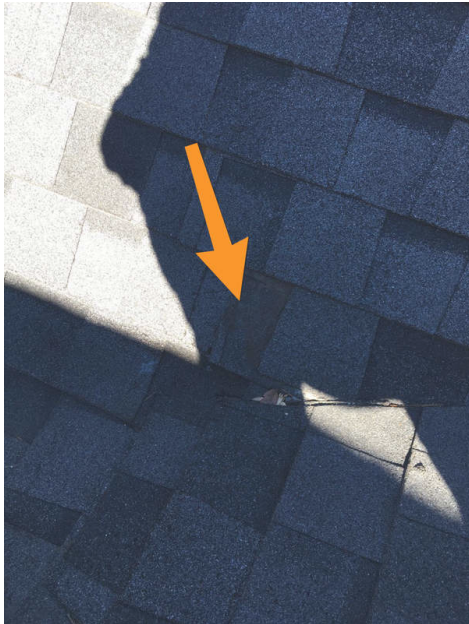
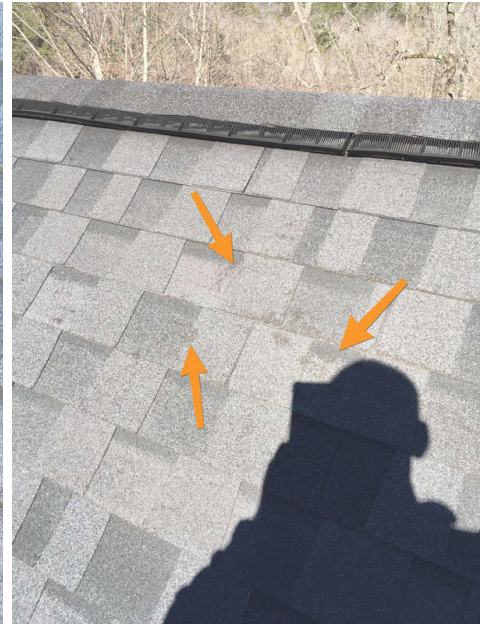
### 2.1.1 Coverings

#### DAMAGED (GENERAL)

Roof coverings showed signs of mechanical damage in several locations. Recommend a qualified roofing professional evaluate and repair.

Contact a qualified roofing professional.

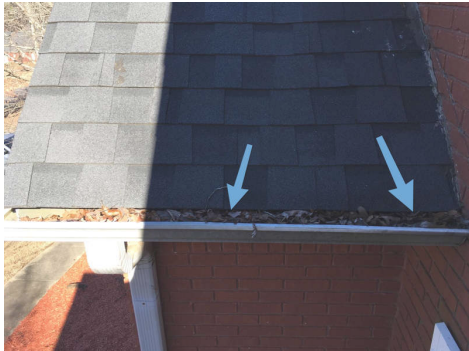
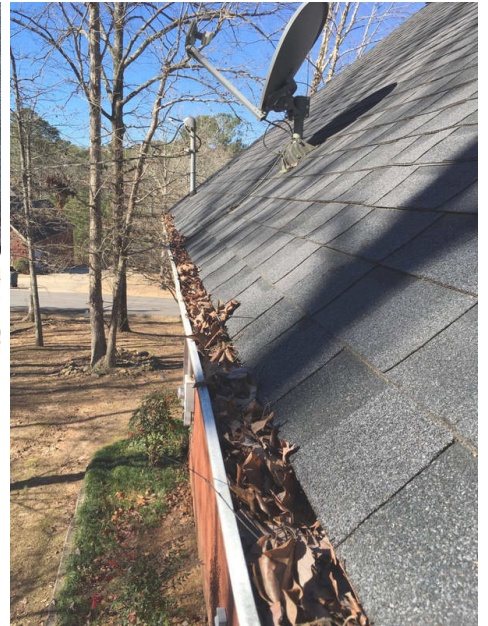
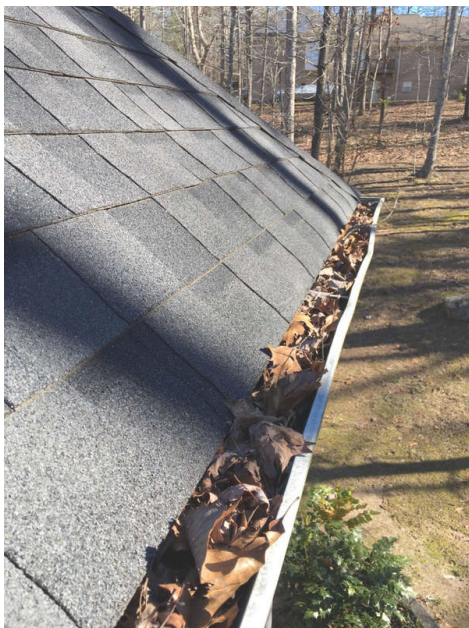
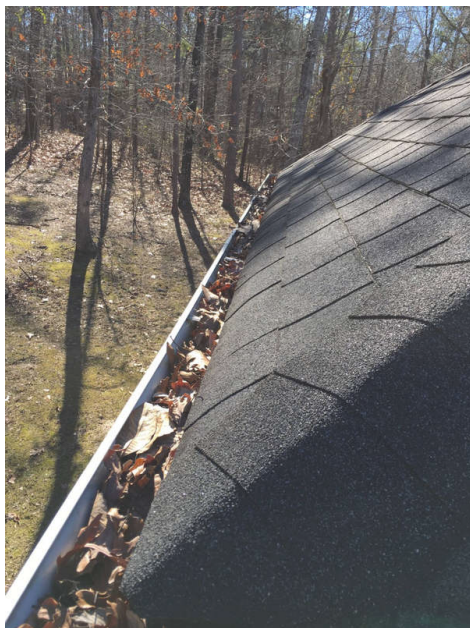
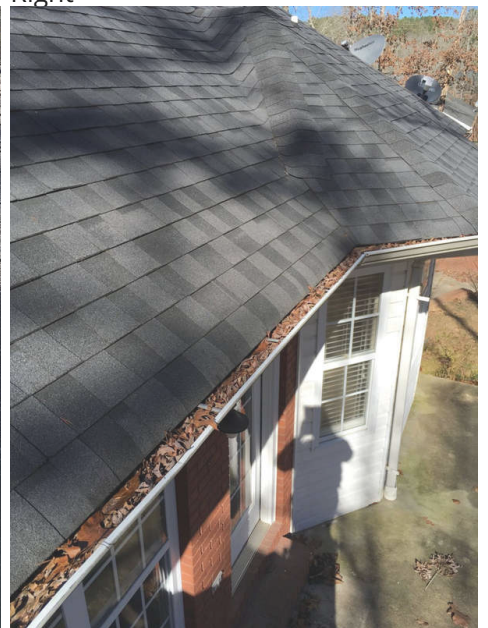
## DEBRIS

Debris has accumulated in the gutters. Recommend cleaning to facilitate water flow.

Contact a handyman or DIY project

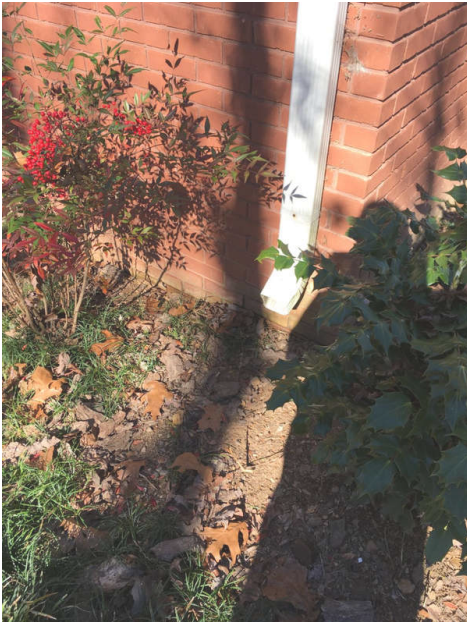
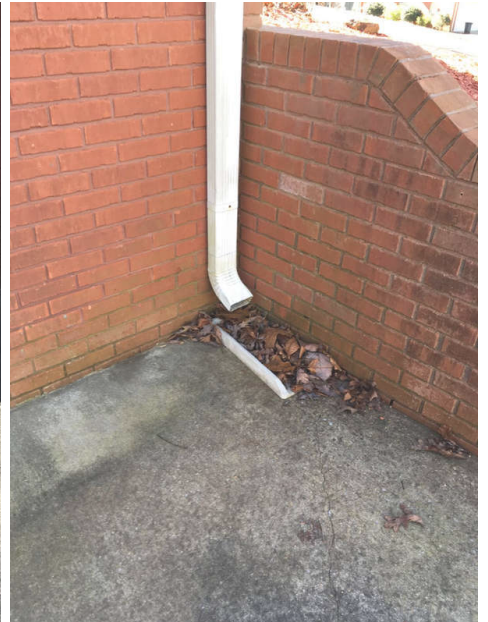
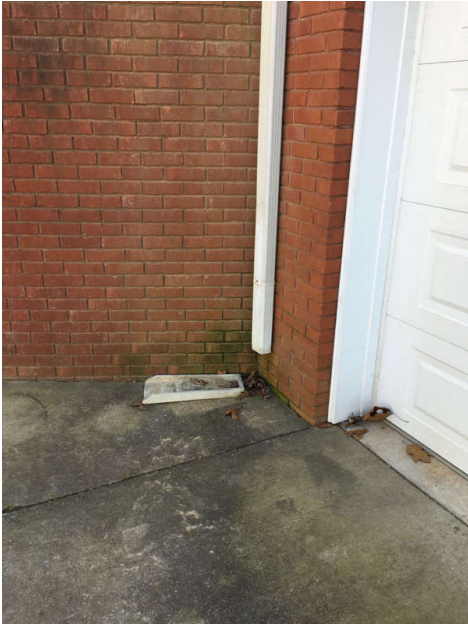
## 2.2.2 Roof Drainage Systems

### DOWNSPOUTS DRAIN NEAR HOUSE

One or more downspouts drain too close to the home's foundation. This can result in excessive moisture in the soil at the foundation, which can lead to foundation/structural movement. The two gutters at the rear of the structure appear to be one of the causes for excess moisture in the basement. Recommend a qualified contractor adjust downspout extensions to drain at least 6 feet from the foundation.

Contact a handyman or DIY project

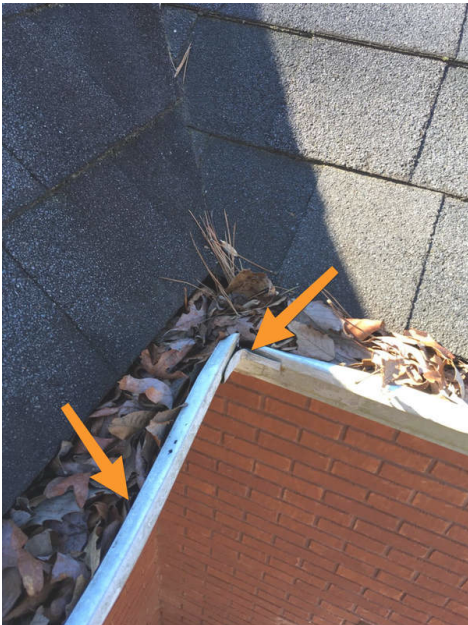
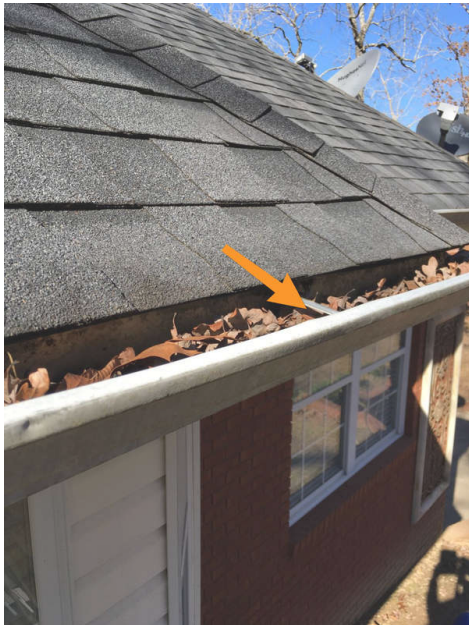
2.2.3 Roof Drainage Systems  
**GUTTER DAMAGED**

Multiple gutters had mechanical damage and also what appeared to be poor workmanship at the joints. This can result in excessive moisture in the soil at the foundation, which can lead to foundation/structural movement. Recommend a qualified contractor evaluate and repair.

Recommendation  
Contact a qualified gutter contractor

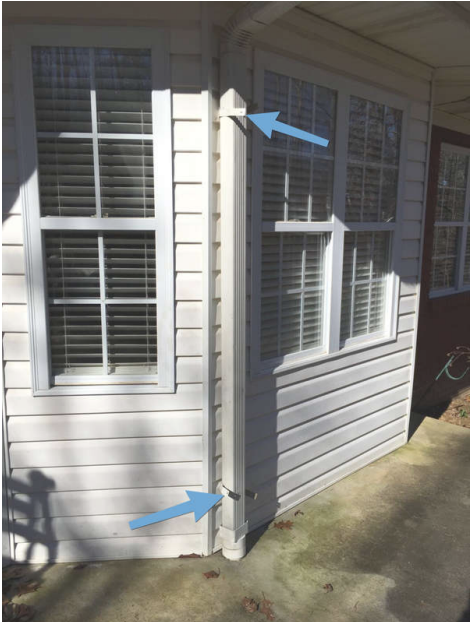
2.2.4 Roof Drainage Systems  
**GUTTER/DOWNSPOUT LOOSE**

The gutter/downspout is loose and needs to be re-fastened to fascia/siding and pitched properly (if required).

Recommendation  
Contact a handyman or DIY project

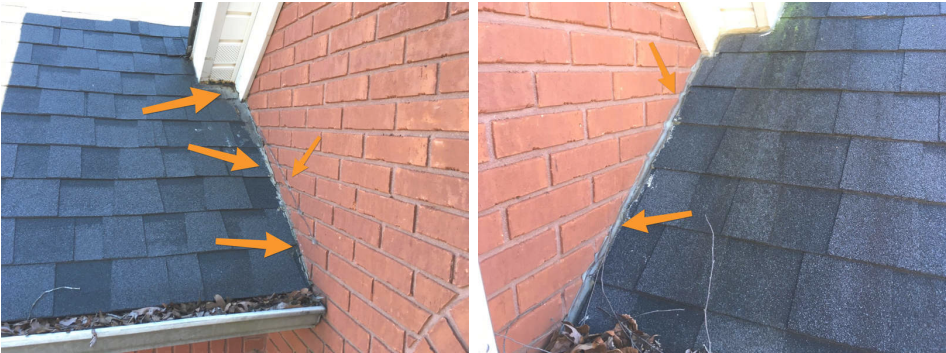
2.3.1 Flashings  
**MISSING**

Flashings were not visible at time of inspection. Flashings provide protection against moisture intrusion. It appears as though certain flashings were left off when the most recent roofing job was performed. Moisture intrusion was visualized in one of these areas during the attic inspection. Recommend a qualified roofing contractor evaluate and remedy.

Recommendation  
Contact a qualified roofing professional.

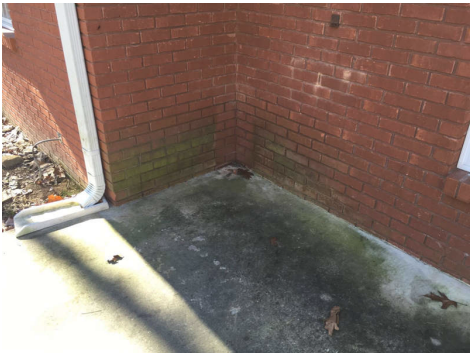
3.1.1 Siding, Flashing & Trim  
**MILDEW/ALGAE**

There are signs of algae and/or mildew on the siding. This is a cosmetic issue and is not uncommon especially on shaded portions of the home. Recommend that said areas be washed or cleaned on a regular basis.

Recommendation  
Contact a handyman or DIY project

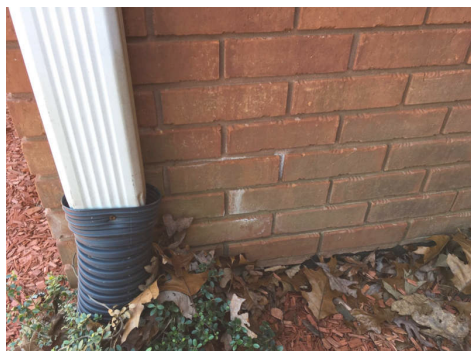
#### **EFFLORESCENCE**

Efflorescence was visualized on multiple areas of the brick siding on the front of the structure. This indicates that moisture is being worked up through the brick. Recommendation for cleaning of these areas and determining reason for the excess moisture.

Contact a handyman or DIY project

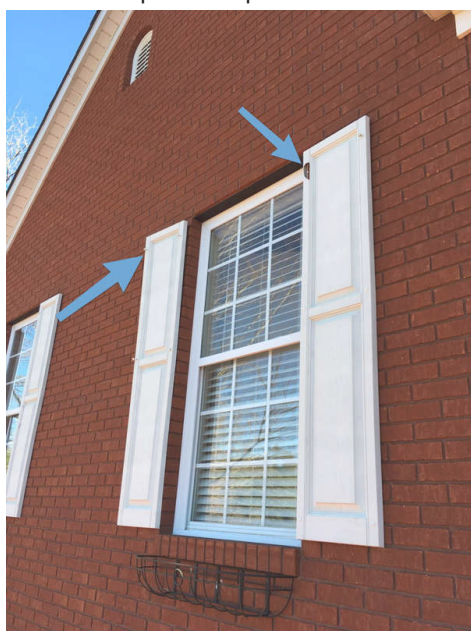
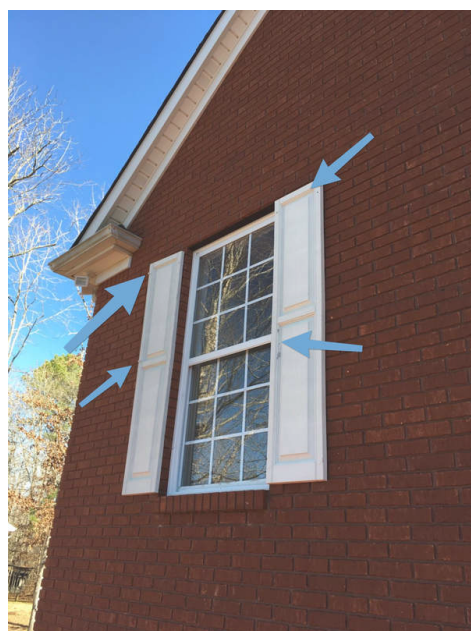
#### **DAMAGE TO SHUTTERS**

The vinyl shutters on the front of the structure were poorly attached and had mechanical damage present.

Contact a qualified professional.

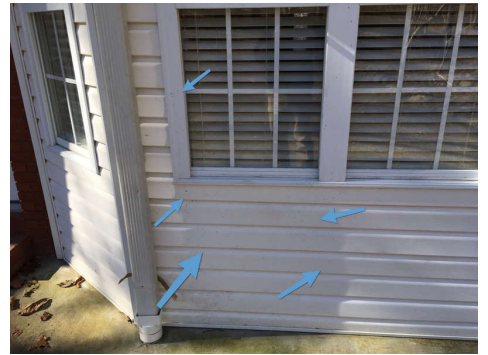
#### **PAINT**

Paint splashing was noted on the siding and kitchen window trim at the patio area.

Contact a qualified professional.

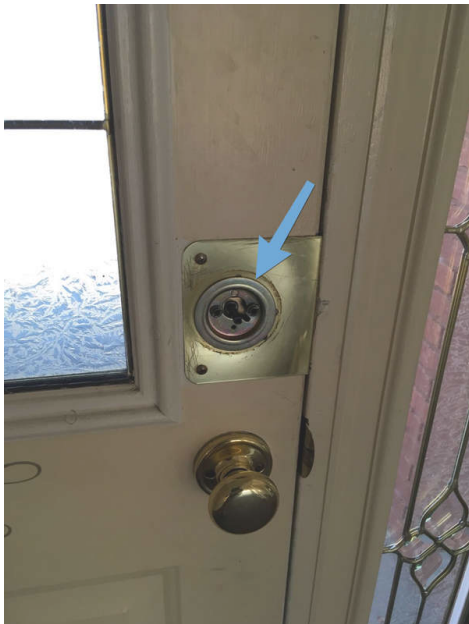
#### **HARDWARE DAMAGED**

One or more pieces of door hardware are damaged. Recommend repair or replacement.

Contact a handyman or DIY project

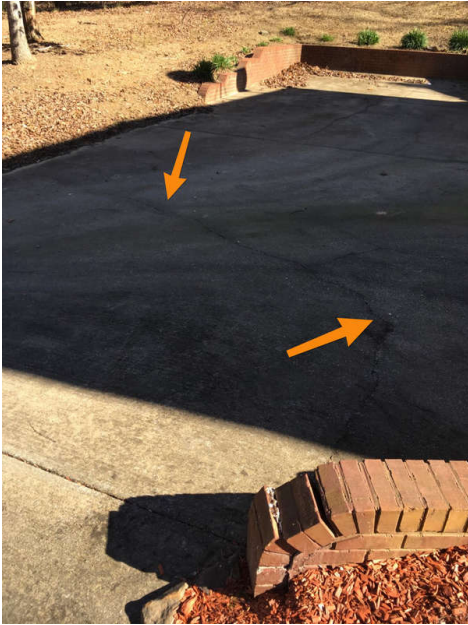
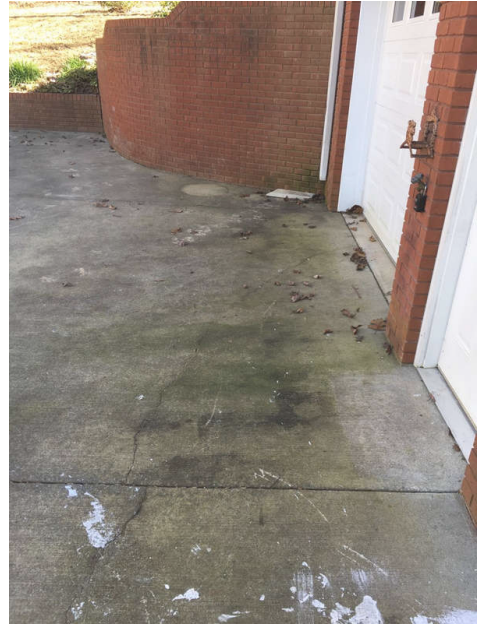
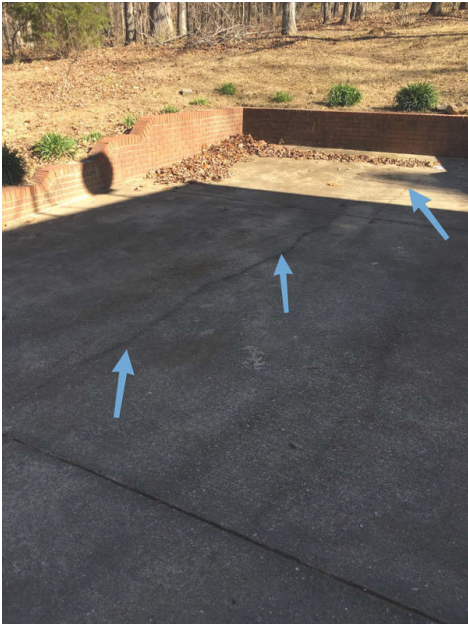
#### **DRIVEWAY CRACKING - MINOR**

Minor cosmetic cracks observed, which may indicate movement in the soil. Recommend monitor and/or have concrete contractor patch/seal.

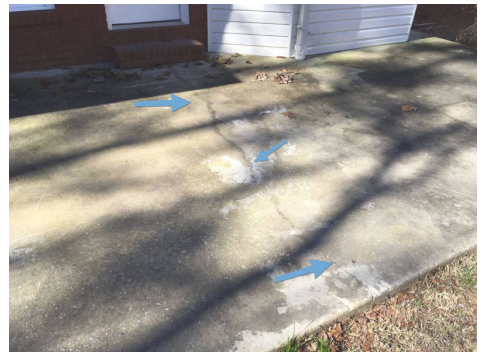
Rear

#### **PATIO CRACKING - MINOR**

Normal settling & cracking observed. Recommend monitor and/or patch/seal.

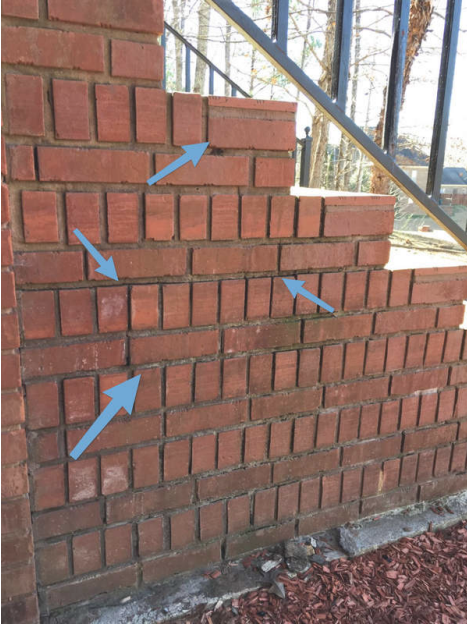
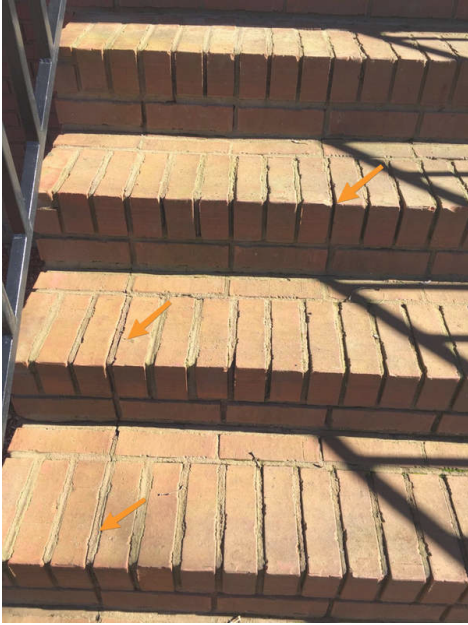
#### **STAIRS - DETERIORATED**

One or more sections of the exterior stairs are deteriorated. Recommend qualified contractor evaluate & repair.

Recommendation  
Contact a qualified professional.

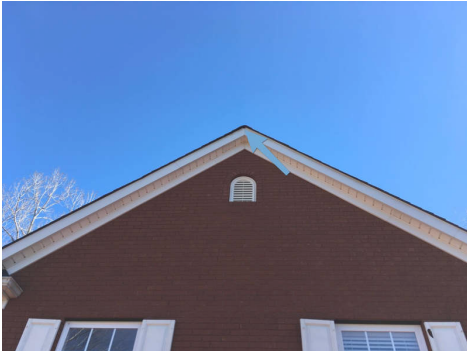
Front Left

3.5.1 Eaves, Soffits & Fascia  
**FASCIA - DAMAGED**

One or more sections of the fascia are damaged. Recommend qualified roofer evaluate & repair.

Recommendation  
Contact a qualified roofing professional.

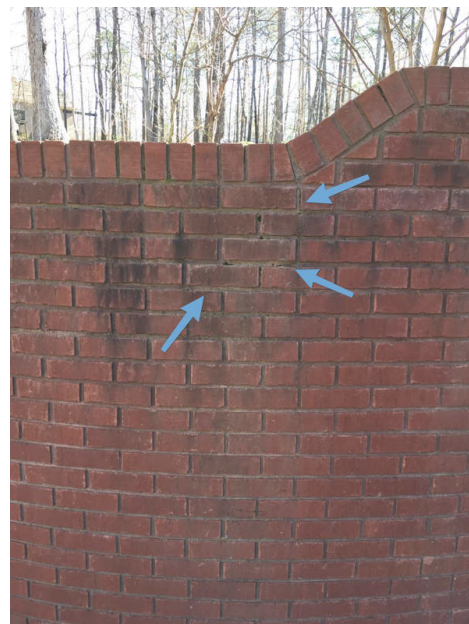
### RETAINING WALL CRACKS

Retaining wall showed signs of minor cracking and appeared to be cosmetic.

Contact a qualified professional.

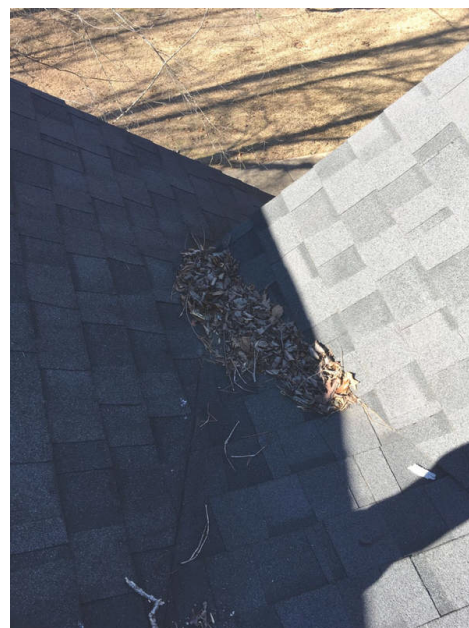
### TREE DEBRIS ON ROOF

Tree debris observed on roof. This can cause decreased and/or improper drainage to gutters and deterioration to roofing material. Recommend clearing debris.

Contact a handyman or DIY project

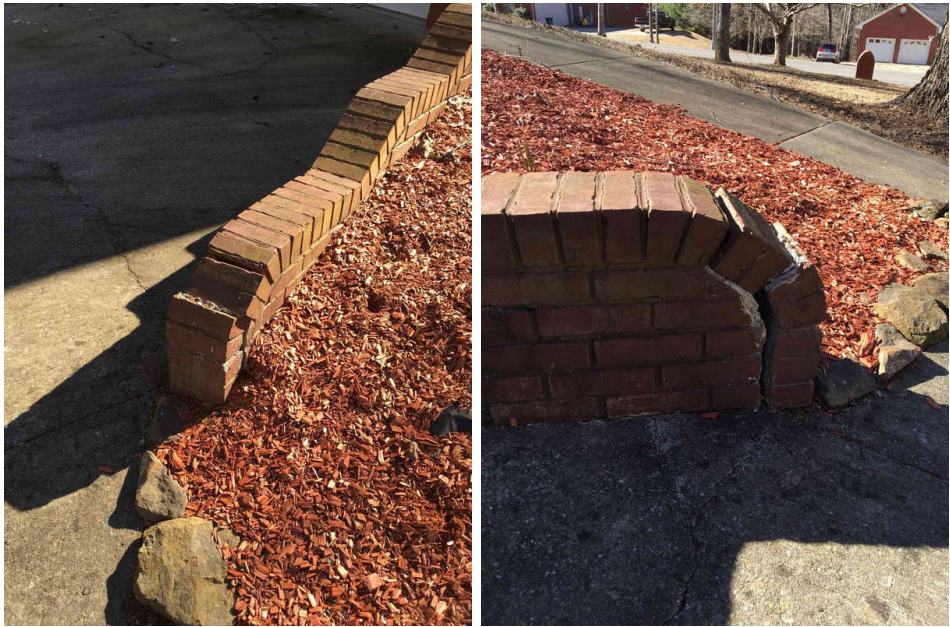
### RETAINING WALL - DAMAGE

The retaining wall showed signs of mechanical damage, possibly from a vehicle. Recommend contacting a concrete contractor to make repairs.

Contact a qualified professional.

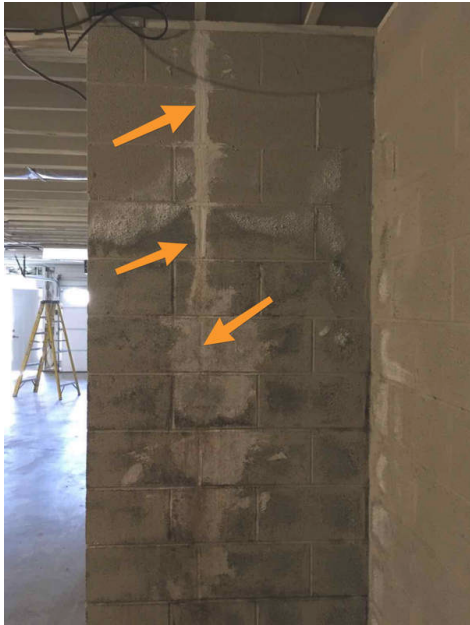
**FOUNDATION CRACKS**

Cracking noted at the foundation. This is typically consistent with soil movement and could lead to serious damage to structural components, foundation and/or slabs. Recommend a structural engineer evaluate and provide a report on course of action and remedy.

Recommendation  
Contact a qualified structural engineer.

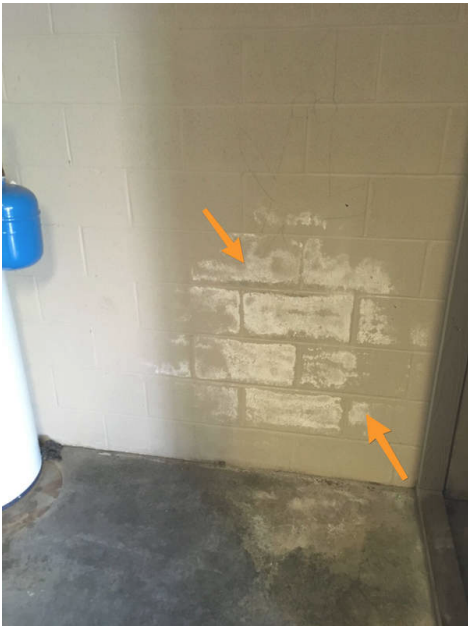
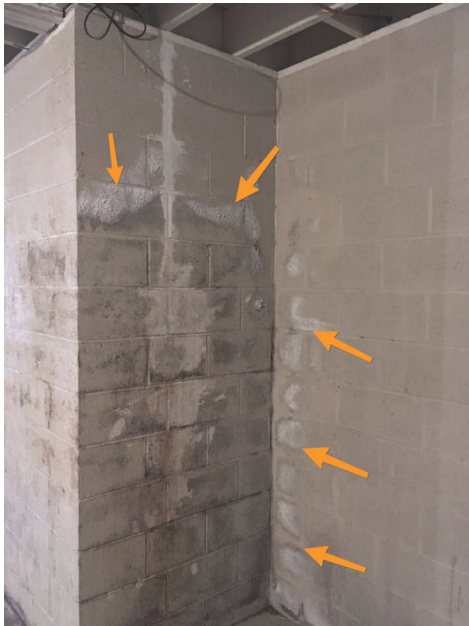
4.2.1 Basements & Crawlspaces  
**EFFLORESCENCE**

Efflorescence noted on the block surface. This a white, powdery deposit that is consistent with moisture intrusion. This can compromise the soil's ability to support the home structure and/or lead to mold growth. Recommend a qualified contractor identify source or moisture and correct.

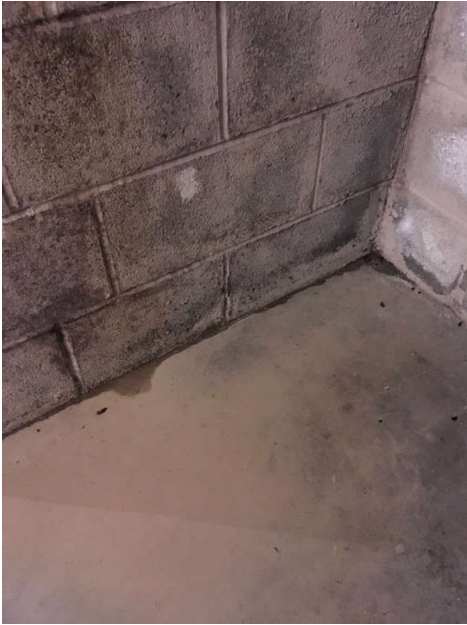
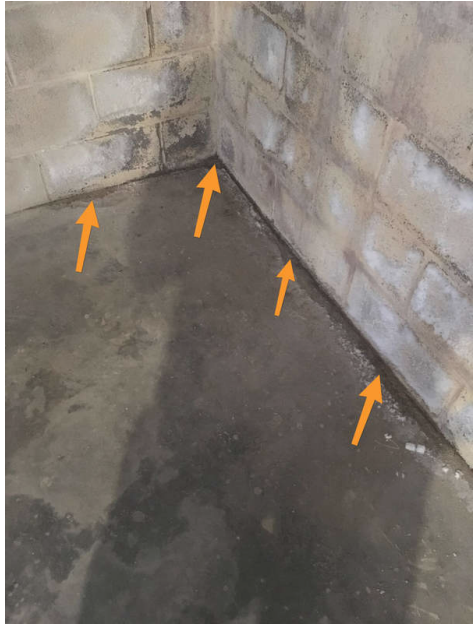
4.2.2 Basements & Crawlspaces  
**HIGH MOISTURE LEVELS**

High levels of moisture were noted in areas of the basement. Recommend monitoring and finding source of moisture intrusion to prevent damage to structure.

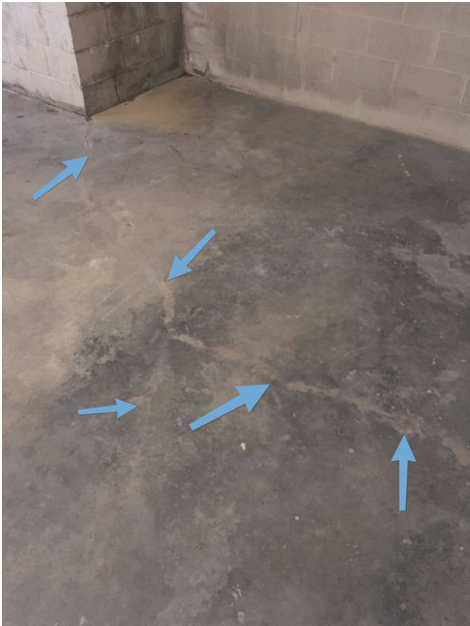
**MINOR CRACKING**

Minor cracks found in the basement floor near the right rear corner. These cracks appeared cosmetic in nature. Recommend monitoring.

Recommendation  
Contact a qualified professional.

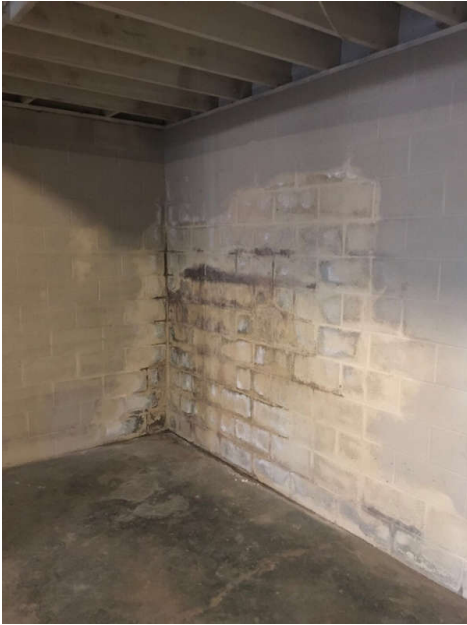
**EVIDENCE OF WATER INTRUSION**

Wall structure showed signs of water intrusion, which could lead to more serious structural damage and mold issues. These areas are directly below where two gutter downspouts empty next to the structure. Recommend a qualified contractor identify source of moisture and remedy.

Recommendation  
Contact a qualified professional.

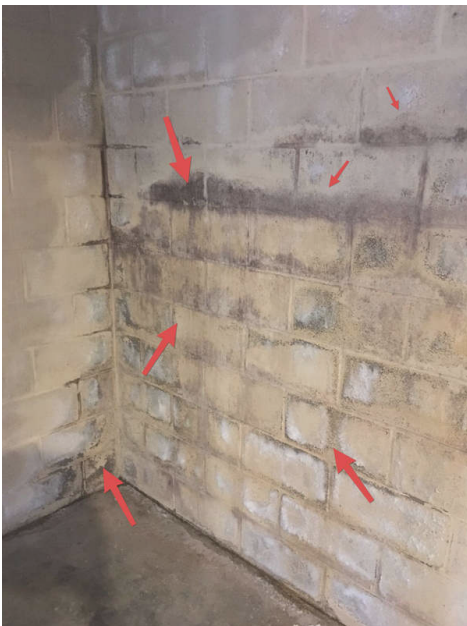
### MICROBIAL GROWTH

Observed signs of microbial growth in one or more areas in the wall structure. Recommend identifying source or moisture intrusion and sending samples to a lab for testing.

Contact a qualified professional.

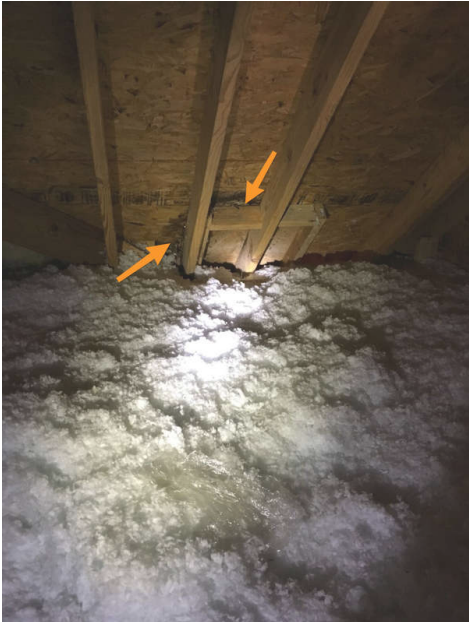
### EVIDENCE OF WATER INTRUSION

Ceiling structure (roof decking) in attic space showed signs of water intrusion, which could lead to more serious structural damage. Recommend a qualified contractor identify source or moisture and remedy.

Recommendation  
Contact a qualified professional.

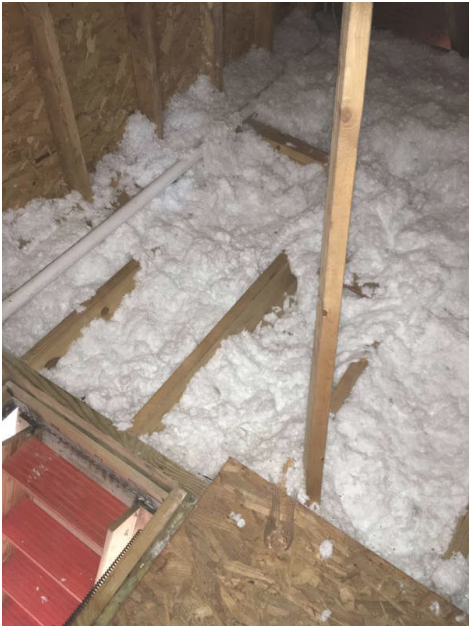
5.1.1 Attic Insulation  
**INSUFFICIENT INSULATION**

Insulation depth was inadequate around the attic access. Recommend a qualified attic insulation contractor install additional insulation.

Recommendation  
Contact a qualified insulation contractor.

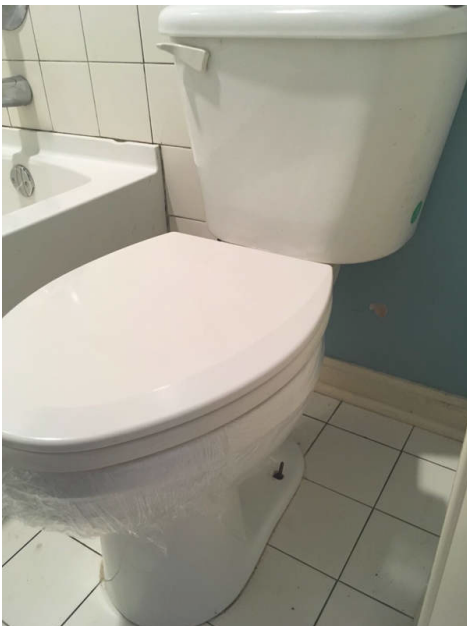
##### **TOILET LOOSE**

The toilet bolts were loose which allowed excessive movement. Recommend a plumber to reset the toilet to prevent moisture damage to surrounding area.

Contact a qualified professional.

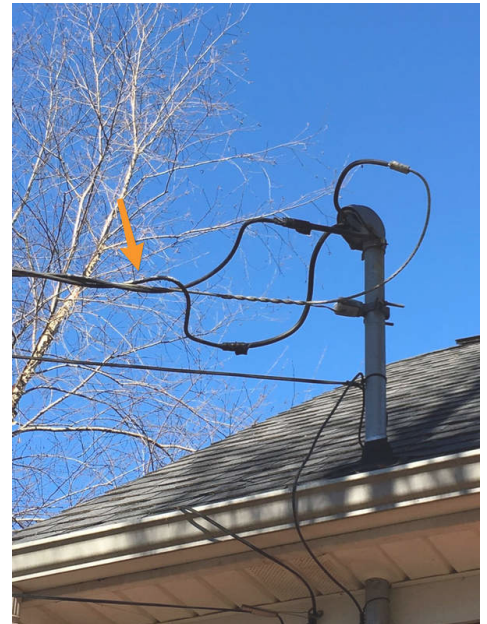
##### **FRAYED SHEATHING**

Wires on service entrance appear damaged or frayed. Recommend contacting your electric utility company or a qualified electrician to evaluate and repair.

Recommendation  
Contact your local utility company

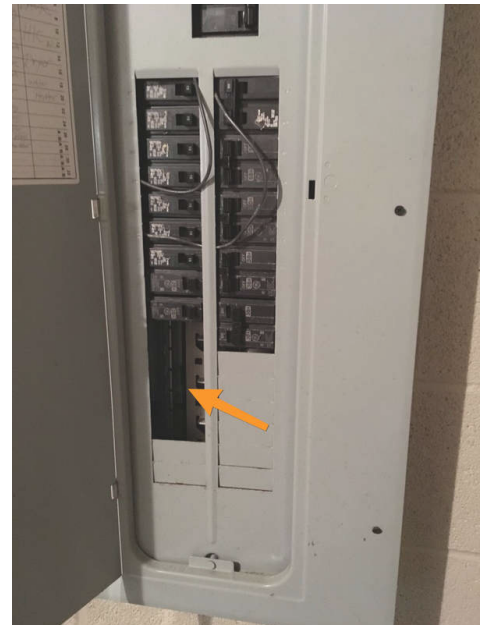
### **KNOCKOUTS MISSING**

"Knockouts" are missing on the electric panel. This poses a safety hazard and it is recommended that the opening in the panel caused by the missing knockout(s) be properly sealed by a licensed electrician.

Recommendation  
Contact a qualified electrical contractor.

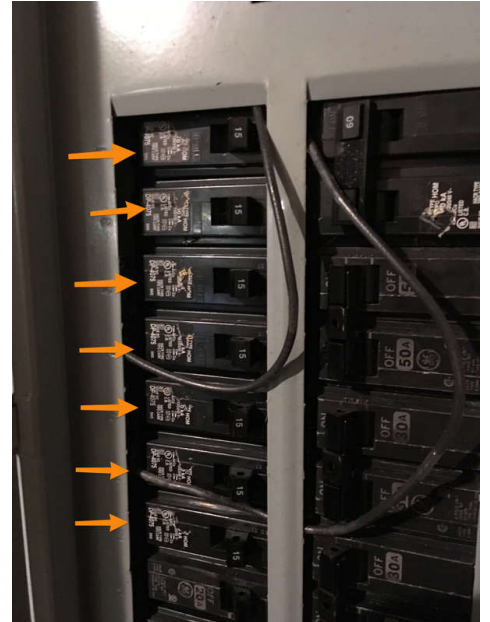
### **ODD BREAKERS**

Some of the breakers used are not recommended by the panel manufacturer. Recommend replacement of odd breakers by a licensed contractor.

Recommendation  
Contact a qualified electrical contractor.

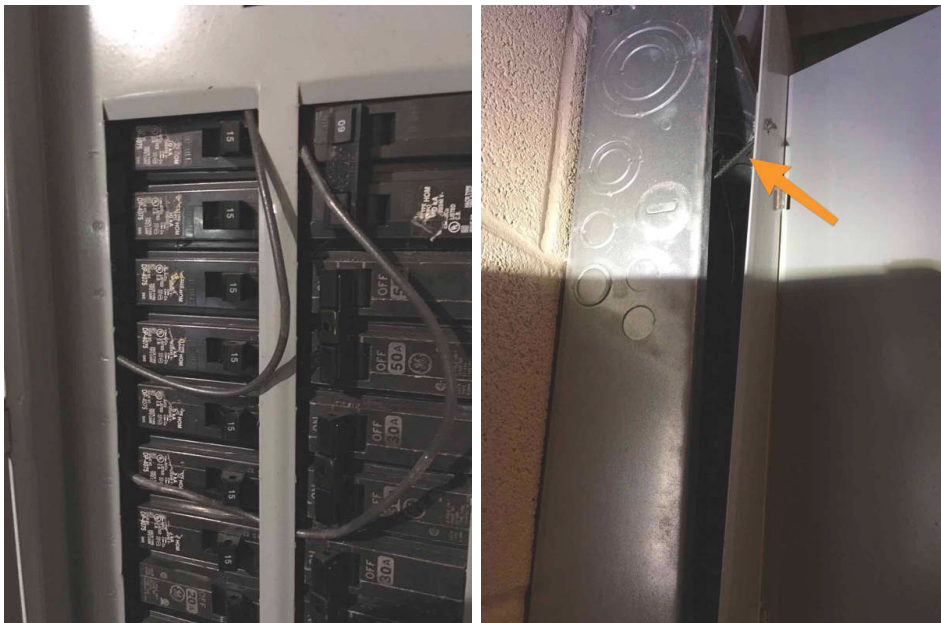
#### **PANEL COVER LOOSE**

The dead panel cover was loose and inappropriately attached with sheet rock screws. Wires were also visible around the breakers through the knockouts. Recommendation is for an evaluation by a licensed electrician.

Contact a qualified electrical contractor.

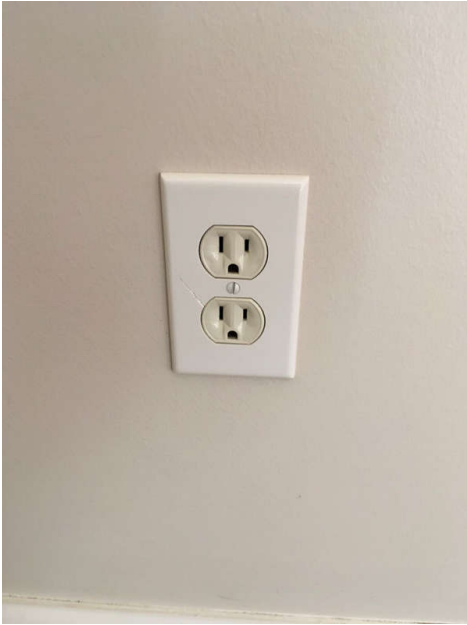
#### **COVER PLATES DAMAGED**

One or more receptacles have a damaged cover plate. Recommend replacement.

Contact a handyman or DIY project

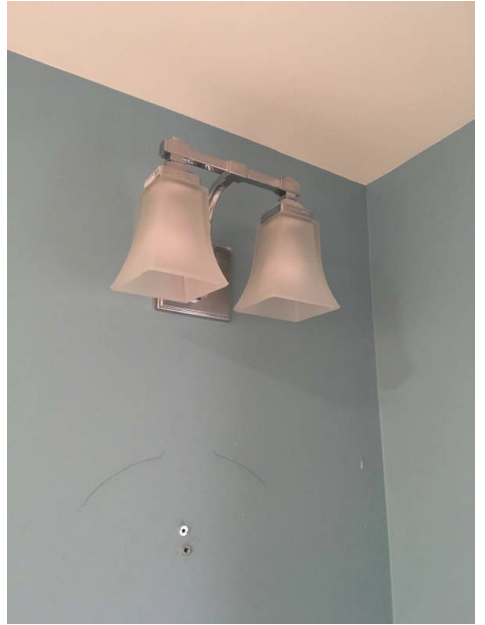
**LIGHT INOPERABLE**

One or more lights are not operating. New light bulb possibly needed.

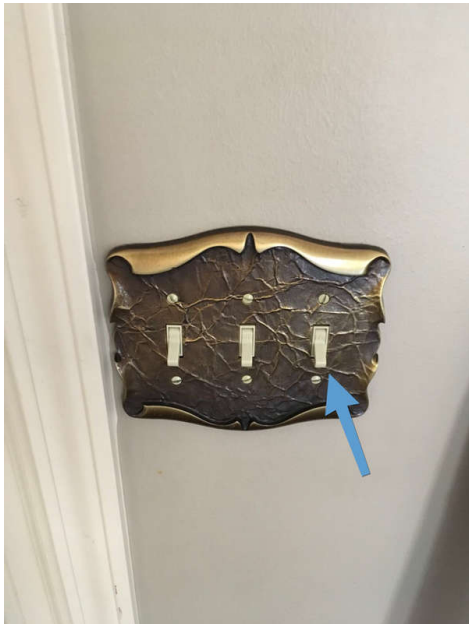
Front Door

Unable to determine what fixture is controlled by the switch.

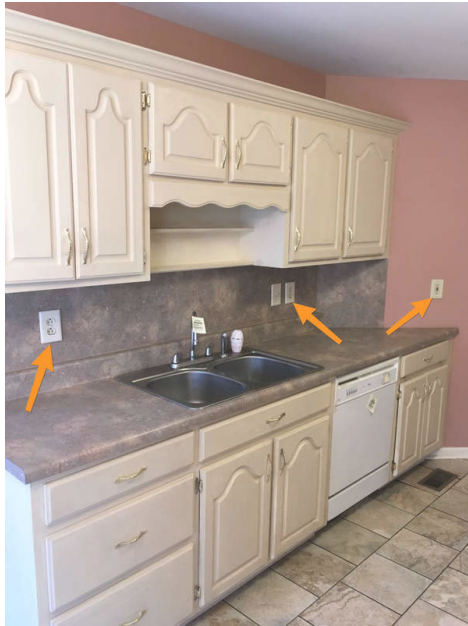
7.4.4 Lighting Fixtures, Switches & Receptacles  
**DEAD CIRCUIT**

The circuit in the kitchen on the sink wall had no power. The GFCI receptacle was not operational either. Recommend evaluation by a licensed electrician.

Recommendation  
Contact a qualified professional.

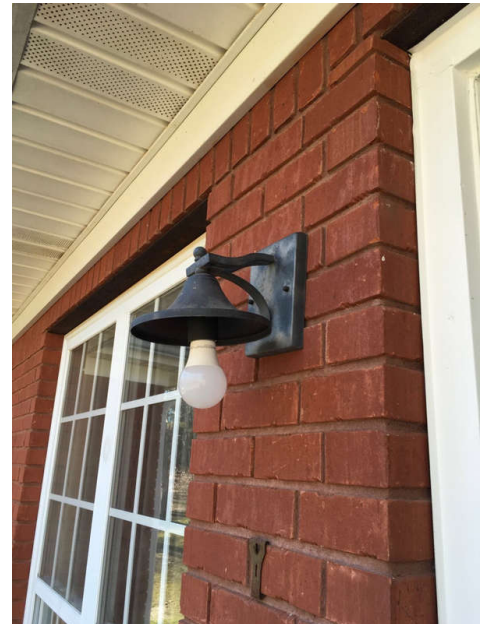
7.4.5 Lighting Fixtures, Switches & Receptacles  
**FIXTURE DAMAGED**

The light fixture at the rear door is missing a globe. Recommend replacement.

Recommendation  
Recommended DIY Project

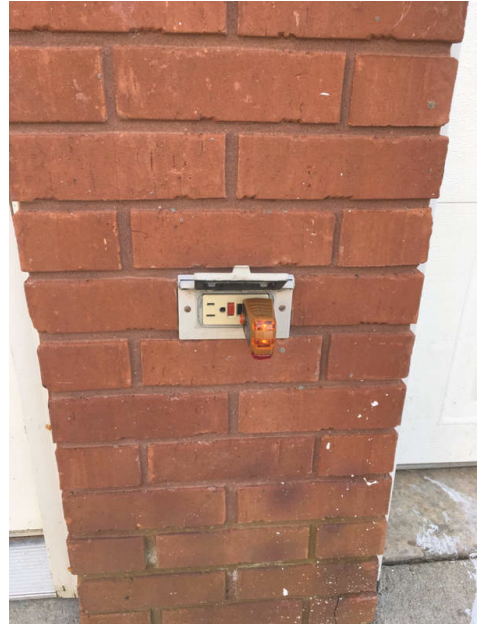
##### **GFCI FAILED TEST**

Receptacle failed test and/or would not reset. Recommend evaluation by a licensed and qualified professional.

Recommendation  
Contact a qualified electrical contractor.

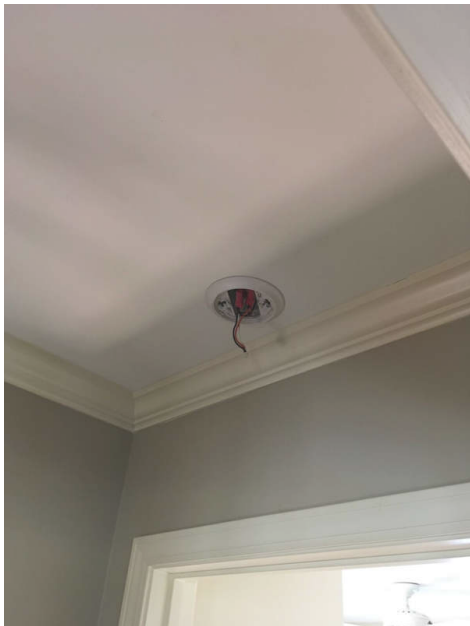
### MISSING

Smoke detectors have been removed from multiple locations. Recommend re-installation.

Contact a qualified professional.

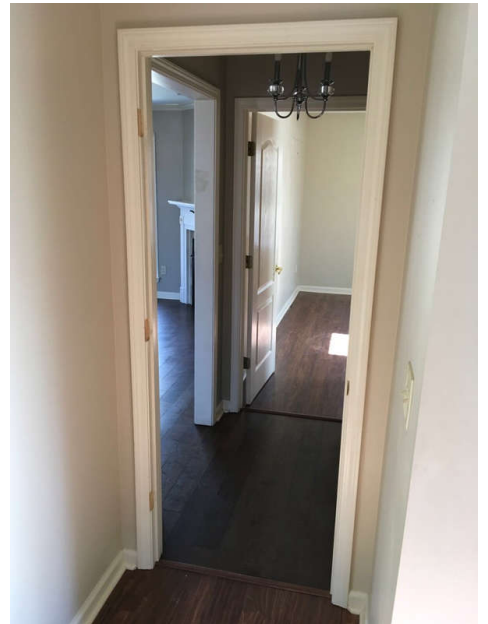
### DOOR MISSING

The door to the bedroom is completely missing. There does not appear to be damage to the jamb or strike plate. Replacement is recommended by a qualified professional.

Contact a qualified professional.

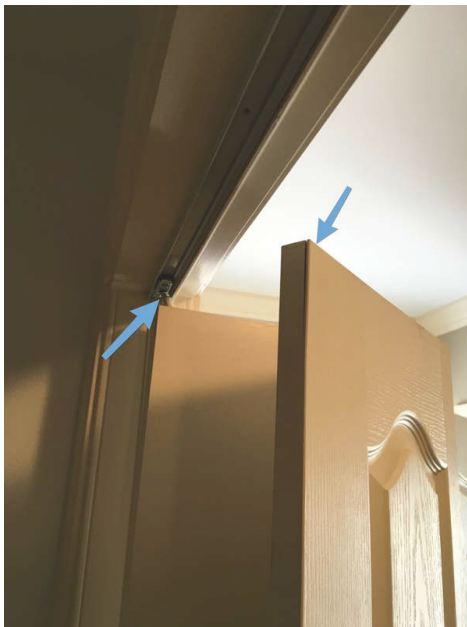
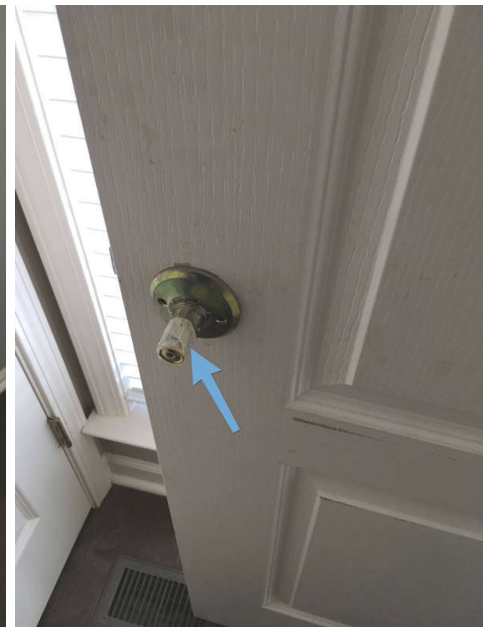
### HARDWARE MISSING/DAMAGED

The bifold doors for the laundry area will not remain inside the track. Part of the hardware is missing that assists in this. The door going from the living area to the basement has damage to the handles on both sides. Recommend replacement.

Contact a qualified professional.

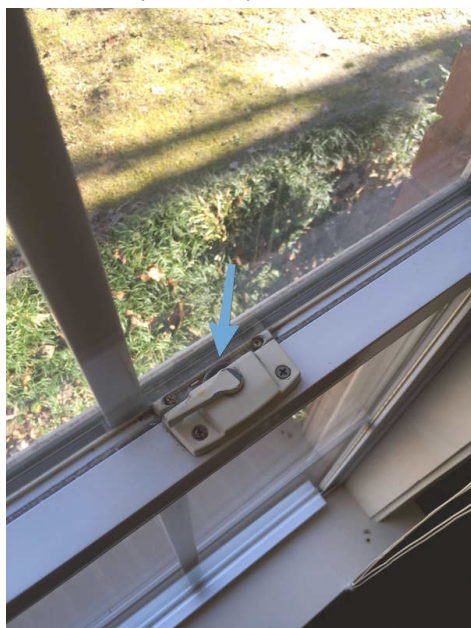
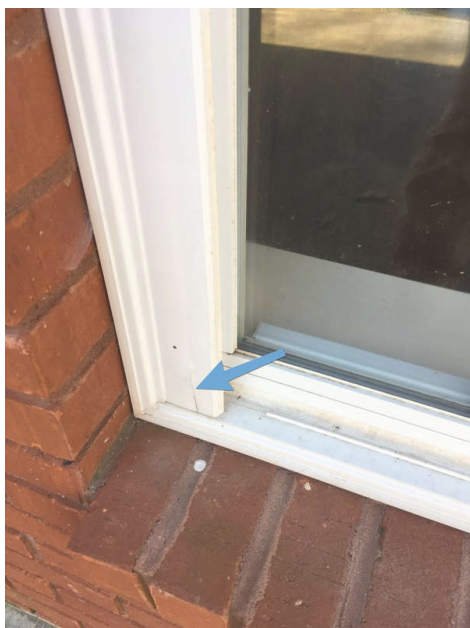
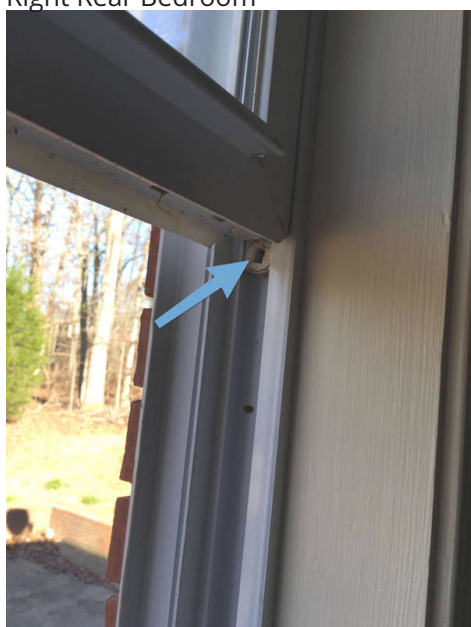
### DAMAGED

One or more windows appears to have general damage, but are operational. Recommend a window professional clean, lubricate, adjust, or repair as necessary.

Recommendation  
Contact a qualified professional.

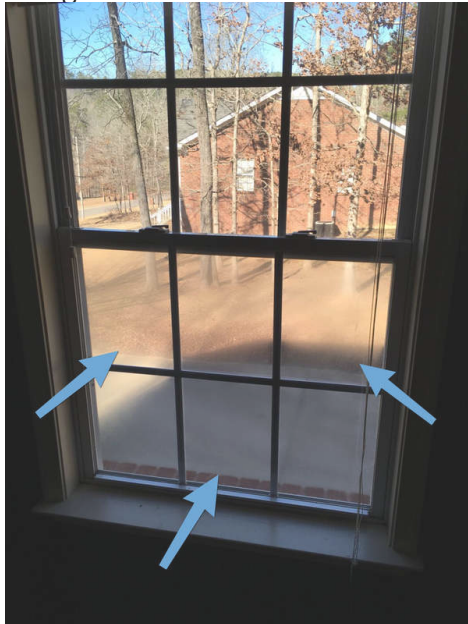
##### **FAILED SEAL**

Observed condensation between the window panes, which indicates a failed seal. Recommend qualified window contractor evaluate & replace.

Contact a qualified window repair/installation contractor.

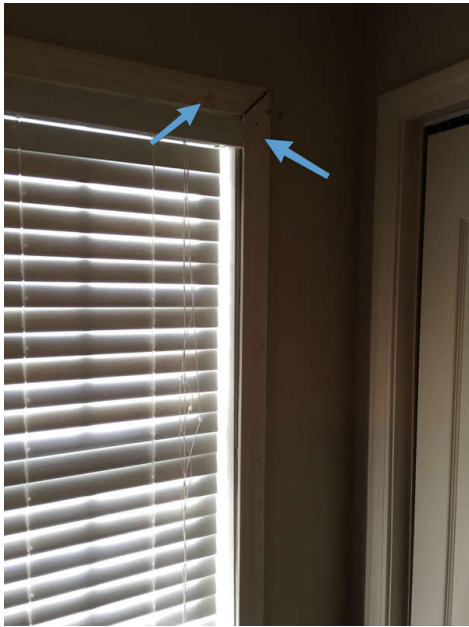
9.2.4 Windows  
**WINDOW TRIM DAMAGED/MISSING**

Recommendation  
Contact a qualified professional.

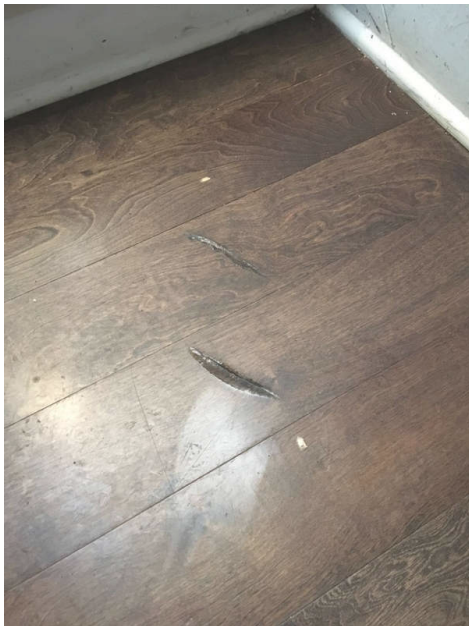
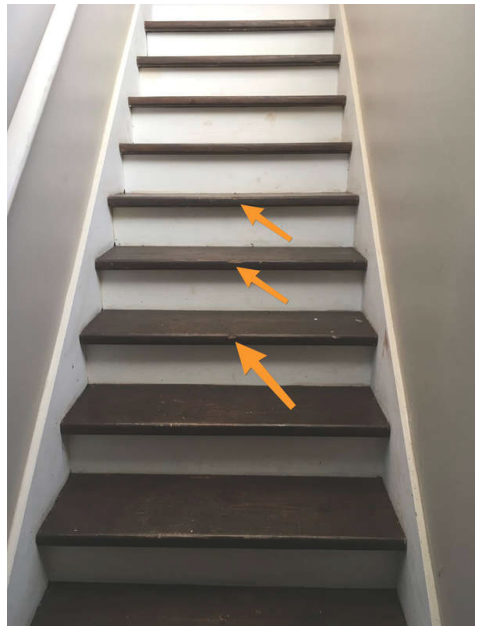
#### **DAMAGED (GENERAL)**

The home had generalized moderate damage visible at the time of the inspection. Recommend service by a qualified contractor.

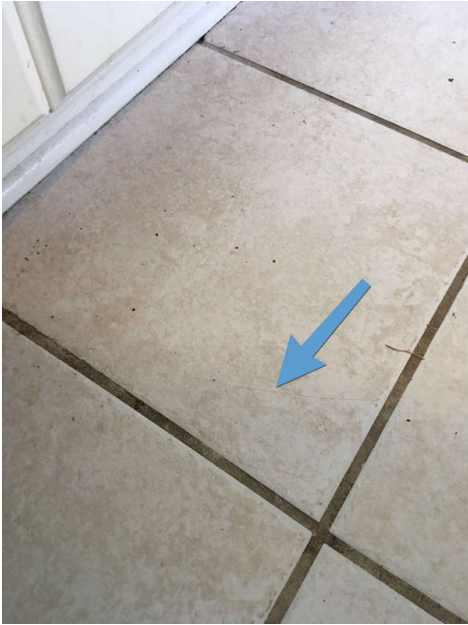
#### **TILE CRACKED**

The tile in the master bathroom is cracked in multiple places. Recommend replacement of damaged tiles by a qualified professional .

Recommendation  
Contact a qualified professional.

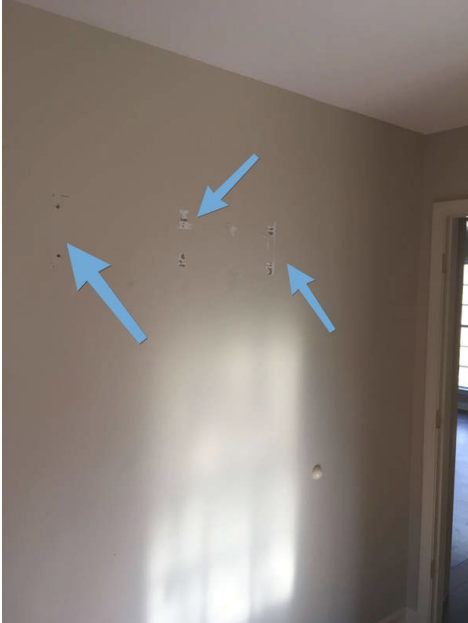
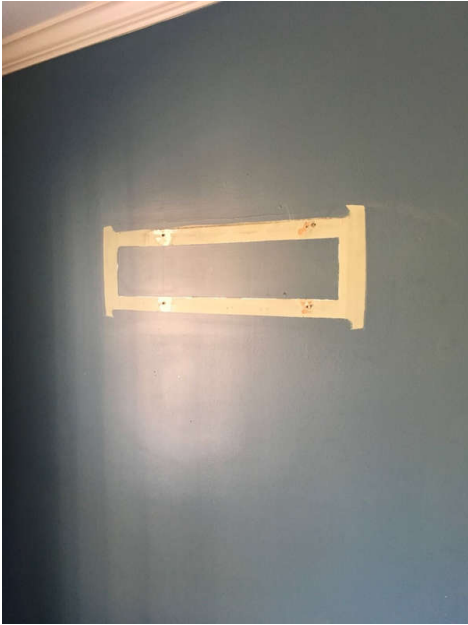
**GENERAL DAMAGE**

General areas of damage were noticed in one or more areas during the inspection. This appeared to be cosmetic.

Recommendation  
Contact a handyman or DIY project

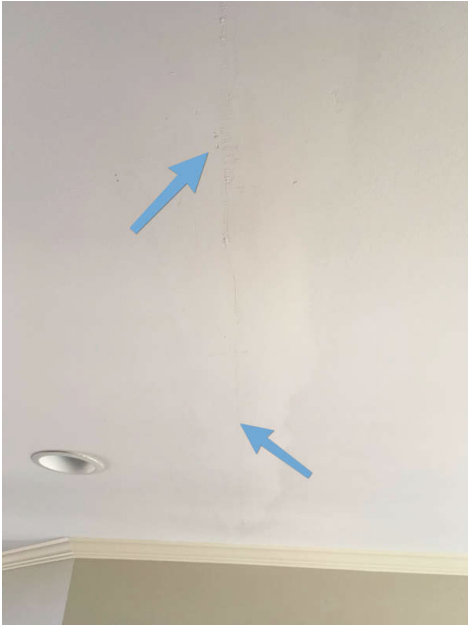
9.5.1 Ceilings  
**MINOR DAMAGE**

Minor damage or deterioration to the ceiling was visible at the time of the inspection. This appeared to be an attempted patch of a previous crack. Recommend proper patching by qualified professional.

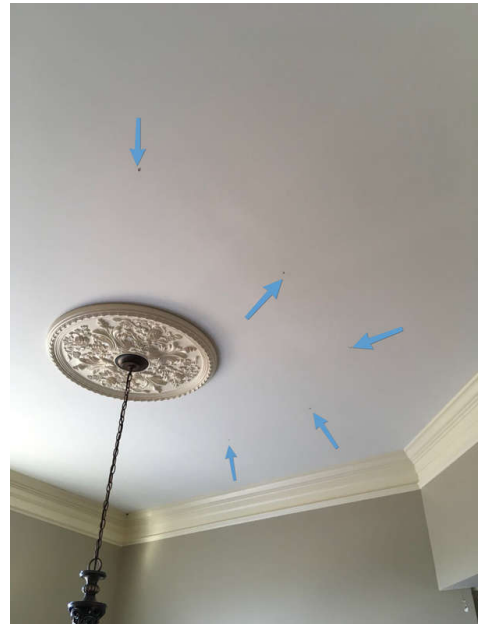
9.5.2 Ceilings  
**NAIL POPS**

Nail pops were present in the dining room ceiling. Recommend patching and painting by a qualified professional.

Recommendation  
Contact a qualified professional.
