## SUMMARY

1234 Main St. Warrior AL 35180

Patrick Dean  
InterNACHI Certified...  
HomeScan Home Inspection Services,  
LLC  
(256) 338-2931  
[homescanalabama@gmail.com](mailto:homescanalabama@gmail.com)

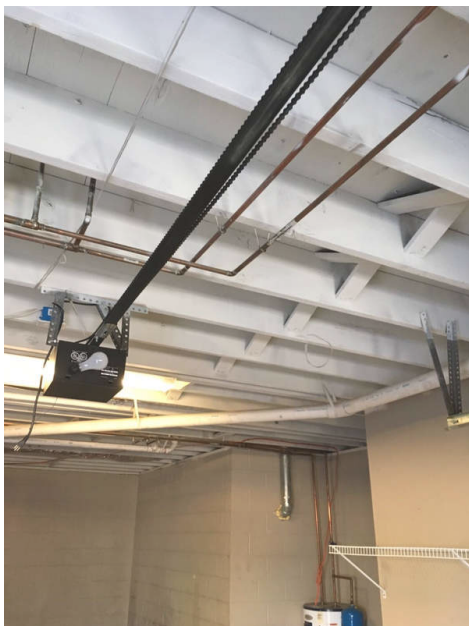
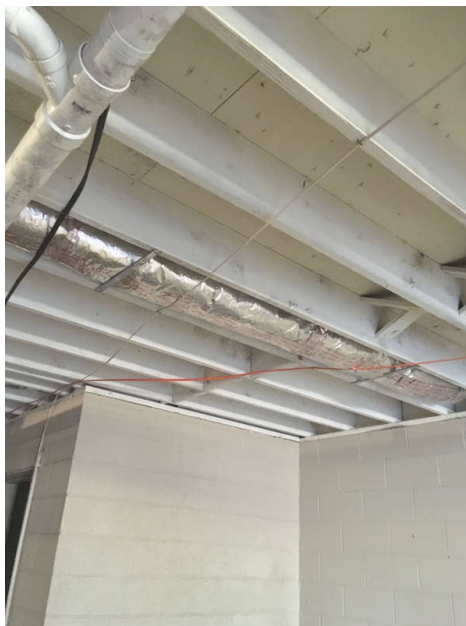
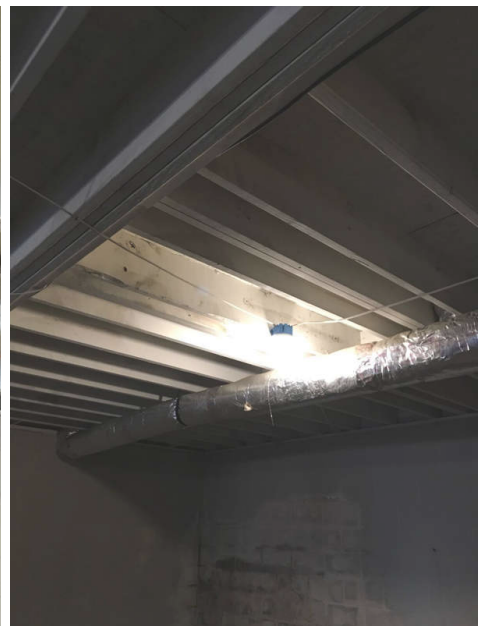
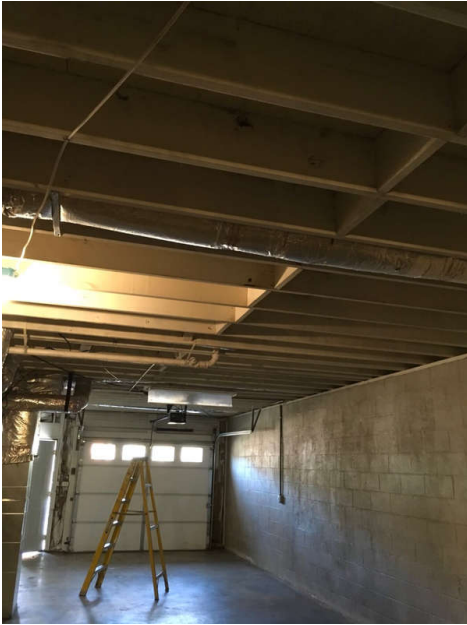
### NO FIRE SEPARATION

No fire separation between garage and living area. This may not be required by local jurisdiction.

Contact a qualified professional.

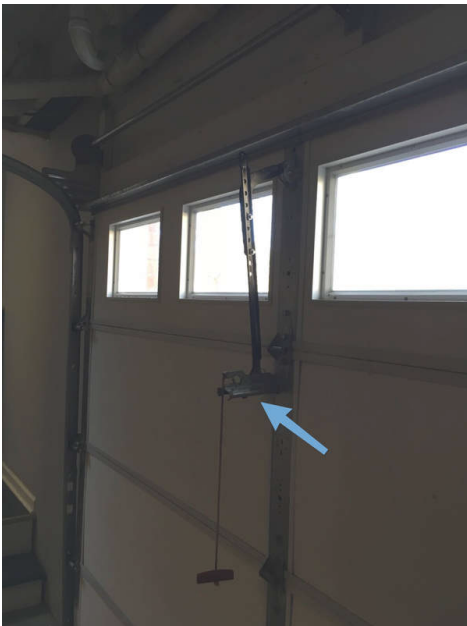
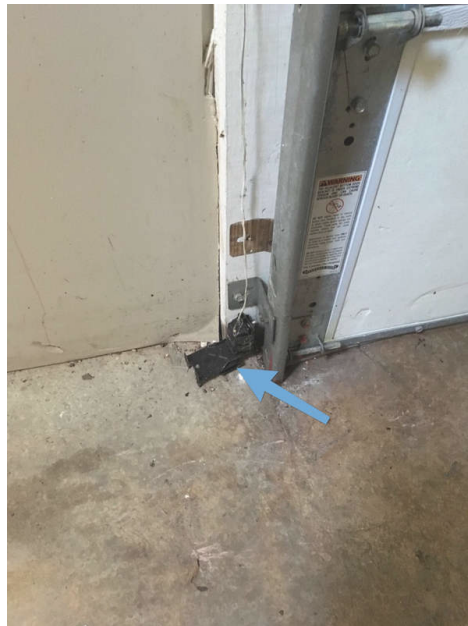
##### **DAMAGE**

One of the two garage doors had an arm that attaches the door to the track was damaged. Also damaged was the photo electric eye on the same door.

Contact a qualified professional.
