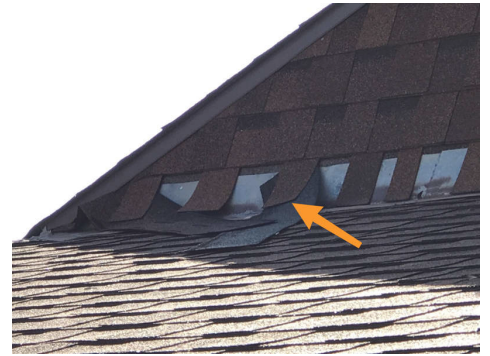
UNIT 4 East

DAMAGED (GENERAL)

Roof coverings showed moderate damage. Recommend a qualified roofing professional evaluate and repair.

Recommendation
Contact a qualified roofing professional.

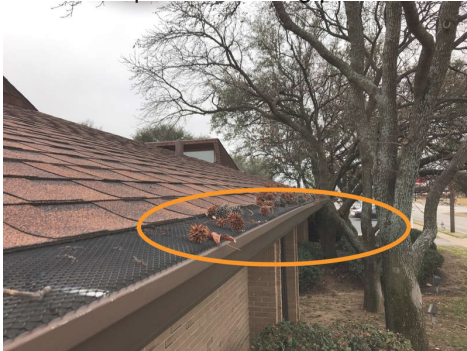
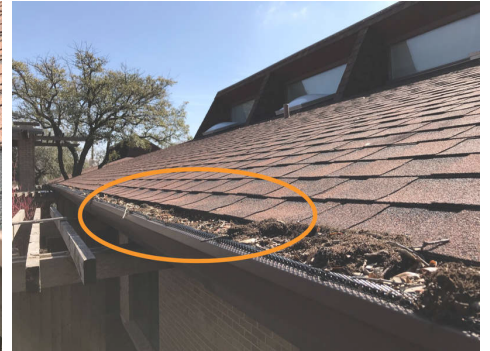
DEBRIS

Debris has accumulated in the gutters. Recommend cleaning to facilitate water flow.

Recommendation
Contact a qualified roofing professional.

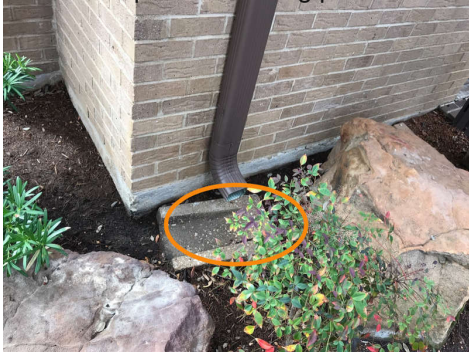
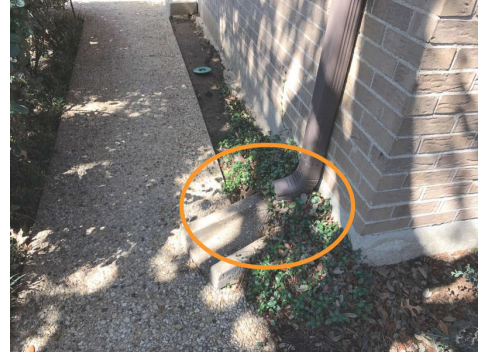
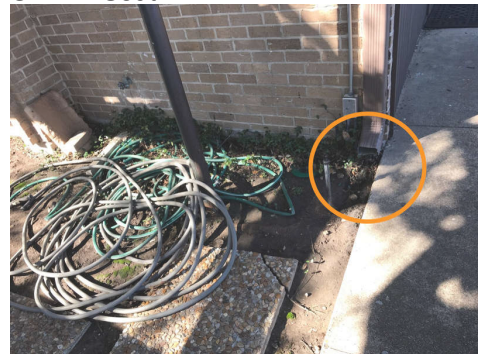
DOWNSPOUTS DRAIN NEAR HOUSE

One or more downspouts drain too close to the home's foundation. This can result in excessive moisture in the soil at the foundation, which can lead to foundation/structural movement. Recommend a qualified contractor adjust downspout extensions to drain at least 6 feet from the foundation.

Recommendation

Contact a qualified roofing professional.

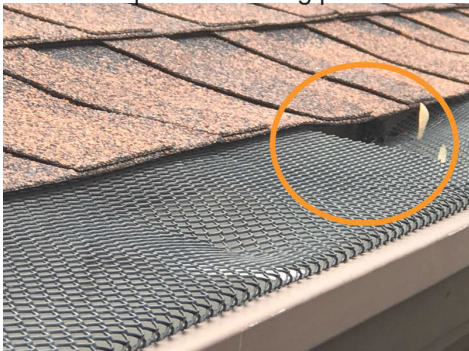
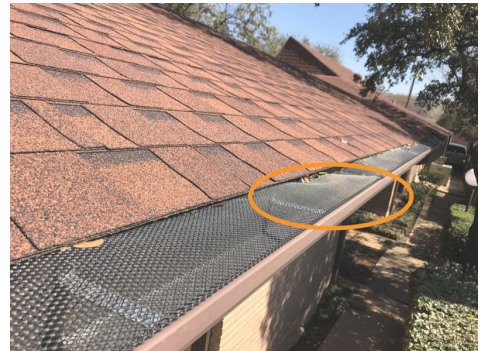
GUTTER COVER DAMAGED

Gutters were damaged. This can result in excessive moisture in the soil at the foundation, which can lead to foundation/structural movement. Recommend a qualified contractor evaluate and repair.

Recommendation

Contact a qualified roofing professional.

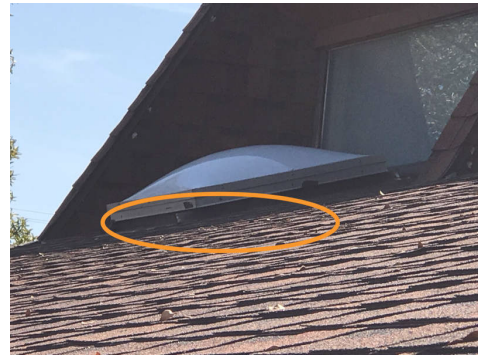
UNIT 2 North

SKYLIGHT CRACKED

Skylight was cracked in one or more places. Recommend a qualified roofing contractor repair.

Recommendation

Contact a qualified roofing professional.

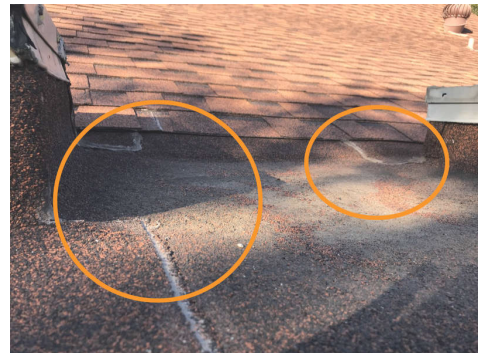
UNIT 4 South

SKYLIGHT PREVIOUS REPAIR

Recommendation

Contact a qualified professional.

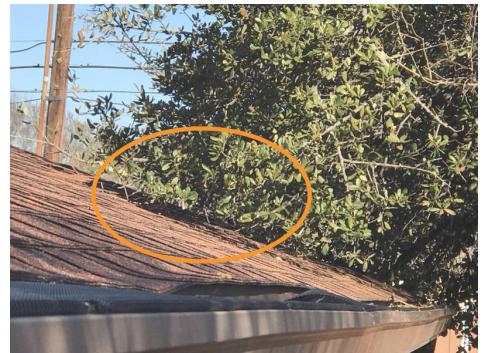
UNIT 3 South

TREE BRANCHES TOO CLOSE TO THE ROOF

Recommendation

Contact a qualified professional.

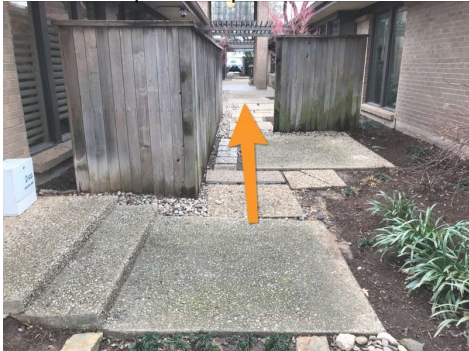
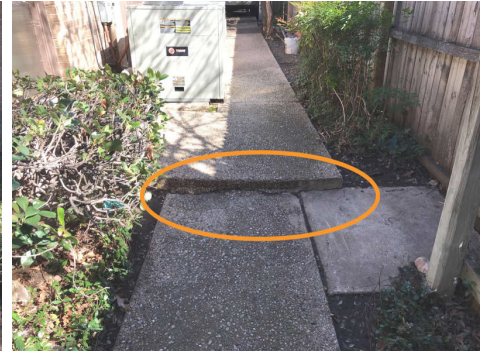
DRIVEWAY TRIP HAZARD

Trip hazards observed. Patch or repair recommended.

Recommendation
Contact a qualified professional.

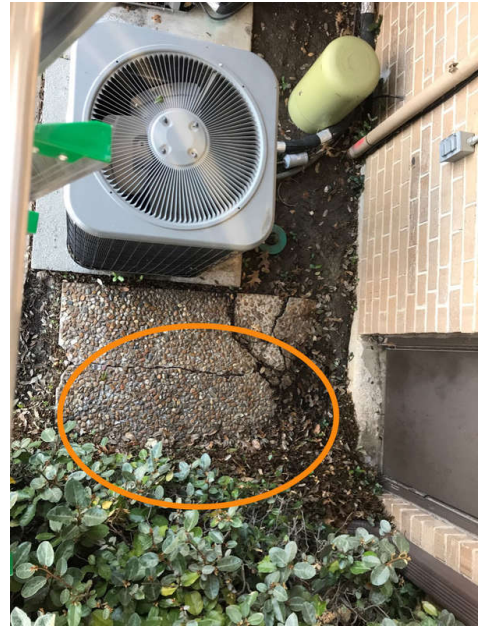
UNIT 4 East

PATIO CRACKING - MINOR

Normal settling & cracking observed. Recommend monitor and/or patch/seal.

Recommendation
Contact a qualified professional.

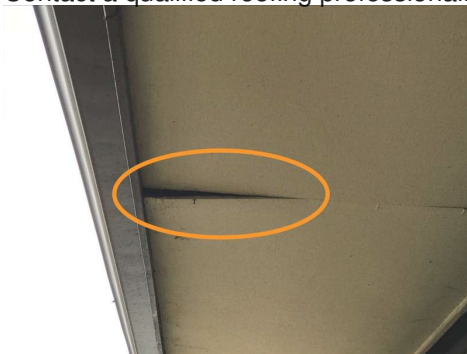
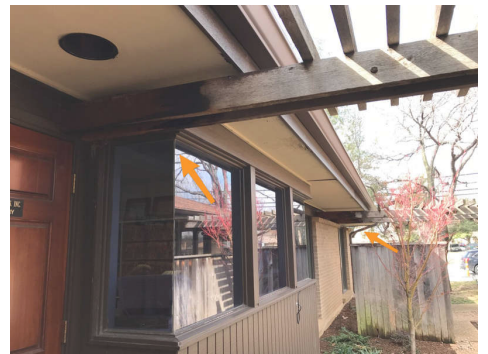
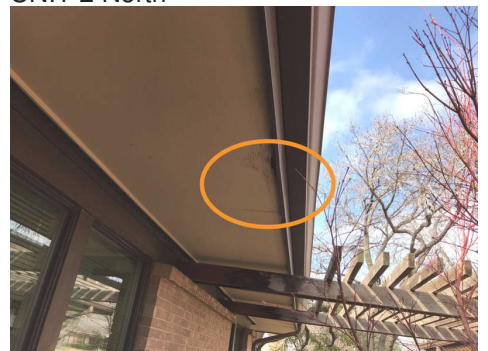
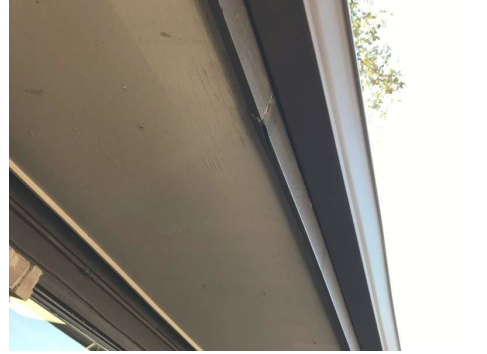
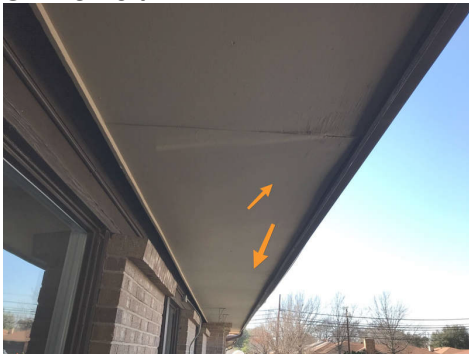
EAVES - DAMAGED

One or more sections of the eaves are damaged. Recommend qualified roofer evaluate & repair.

Recommendation

Contact a qualified roofing professional.

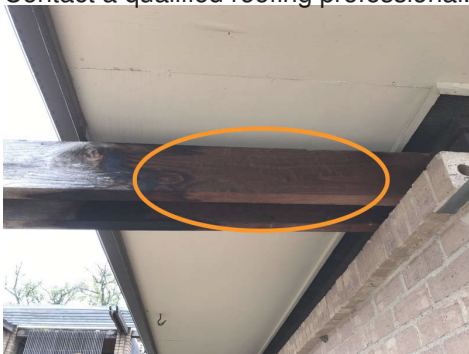
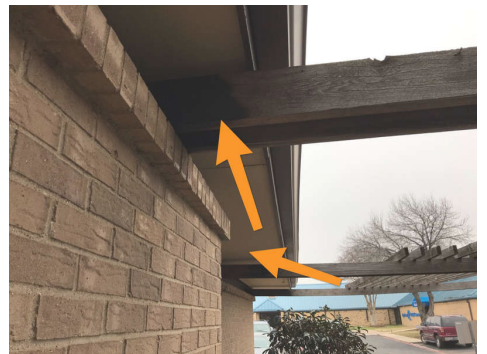
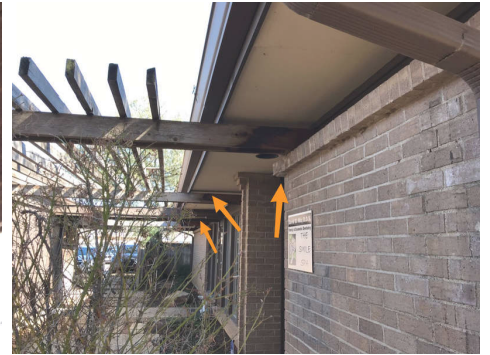
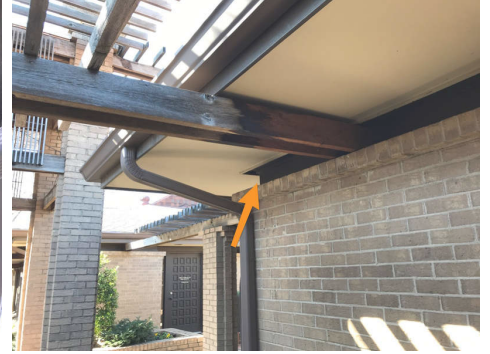
3.4.2 Eaves, Soffits & Fascia **EAVES - WATER STAINS**

Water stains were observed under the roof eaves. This may indicate an active leak. Recommend qualified roofer evaluate & repair.

Recommendation

Contact a qualified roofing professional.

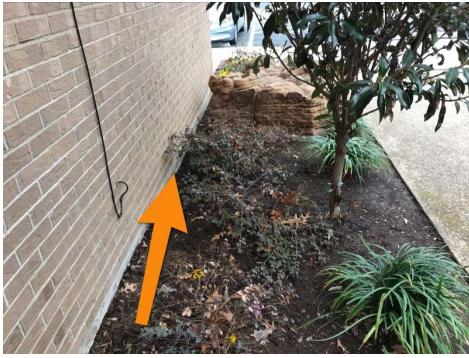
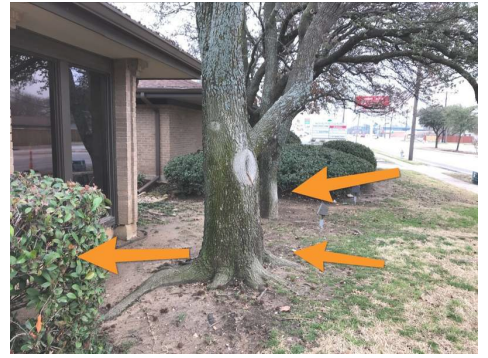
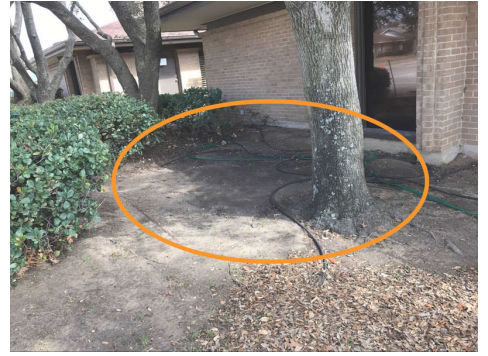
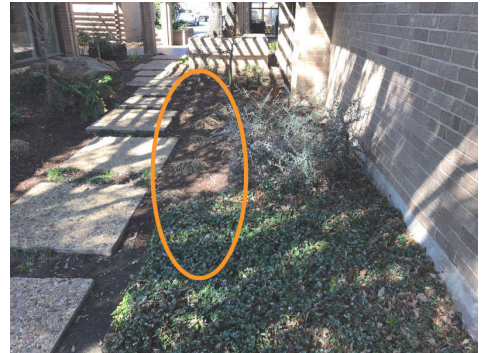
3.5.1 Vegetation, Grading, Drainage & Retaining Walls **NEGATIVE GRADING**

Grading is sloping towards the home in some areas. This could lead to water intrusion and foundation issues. Recommend qualified landscaper or foundation contractor regrade so water flows away from home.

Recommendation

Contact a qualified landscaper or gardener.

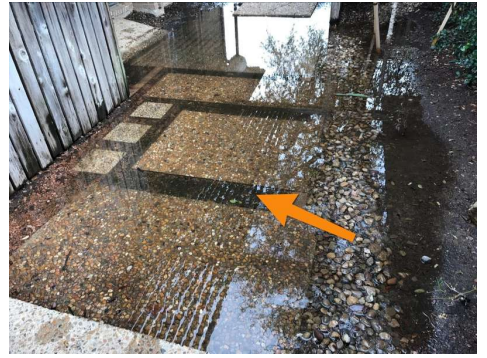
Between Unit 3 and Unit 4

STANDING WATER

Standing water observed, which could indicate poor drainage and/or grading. Recommend monitor and/or have landscaper correct.

Recommendation

Contact a qualified landscaper or gardener.

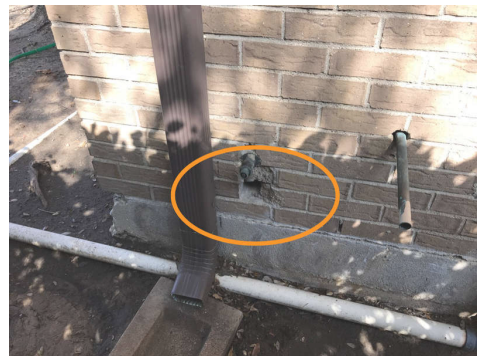
ANTISIPHON DEVICE MISSING ON HOSEBIB

Recommendation

Contact a qualified professional.

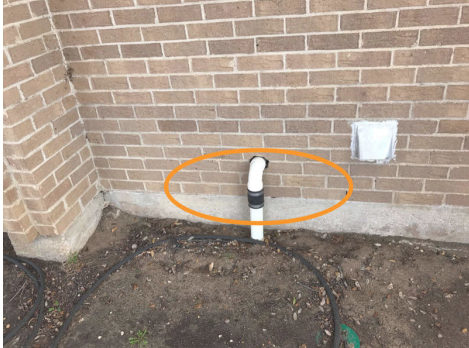
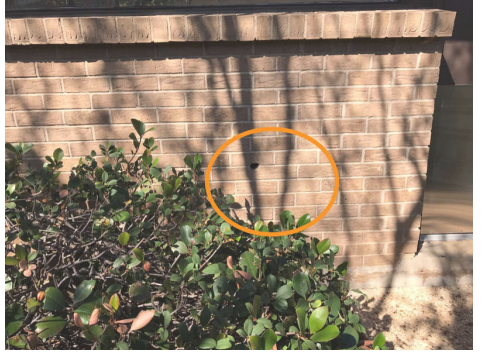
DRAIN PIPE/HOLE NEEDS TO BE CAULKED / CLOSED

Recommendation

Contact a qualified professional.

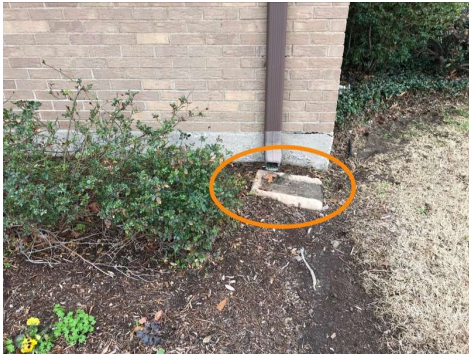
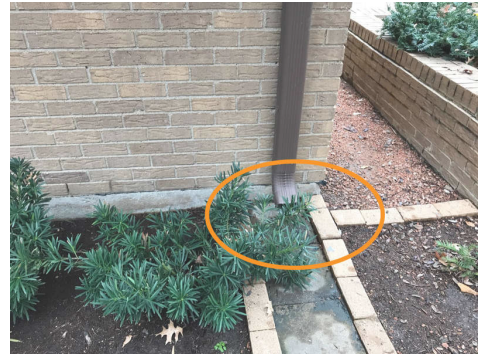
GUTTER TO CLOSE TO FOUNDATION

Recommendation

Contact a qualified professional.

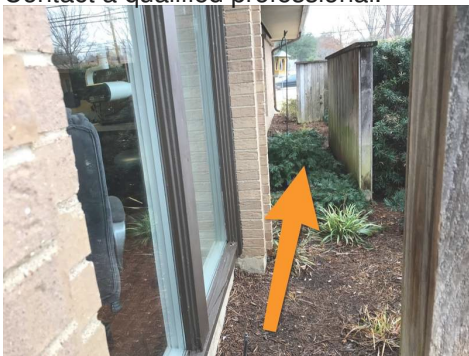
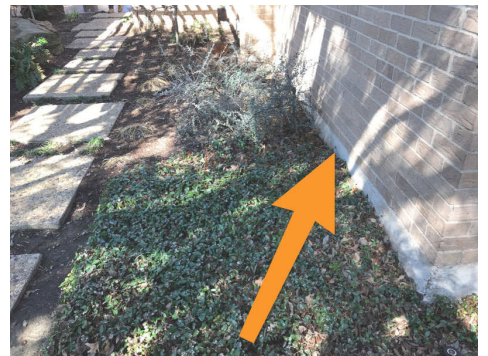
3.5.6 Vegetation, Grading, Drainage & Retaining Walls
VEGETATION TOO CLOSE TO FOUNDATION

Recommendation
Contact a qualified professional.

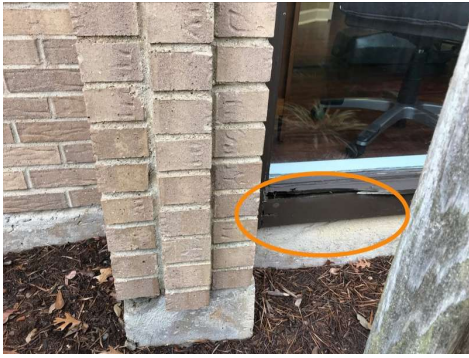
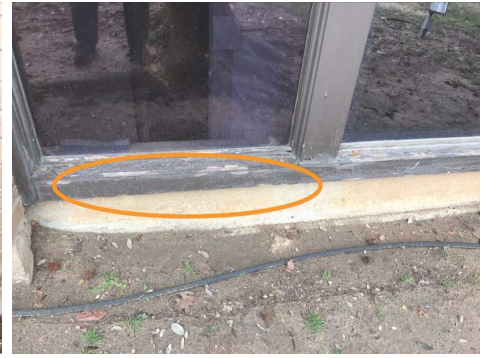
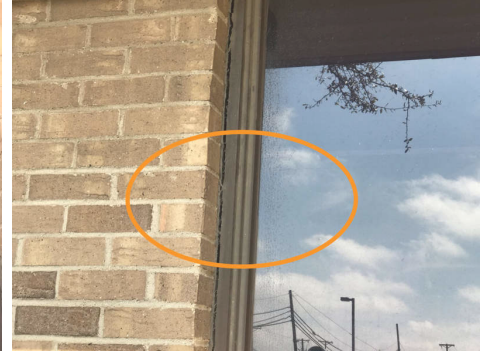
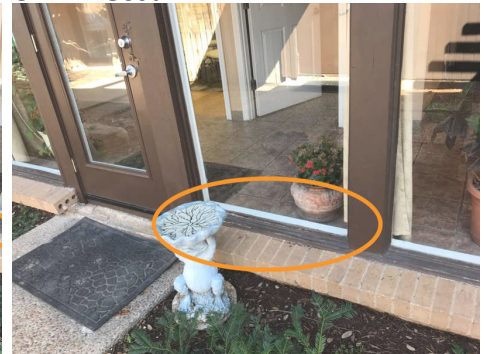
3.6.1 Exterior Windows
WINDOW TRIM ROTTED

UNIT 1 NORTH
Recommendation
Contact a qualified professional.

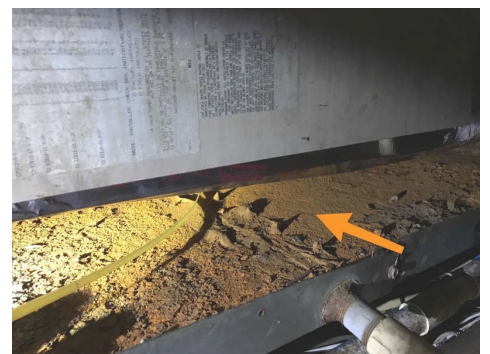
6.1.1 Equipment
CORROSION

Furnace was corroded in one or more areas. This could be the result of improper venting, which the source would need to be identified. Recommend a HVAC contractor evaluate and repair.

Recommendation
Contact a qualified HVAC professional.

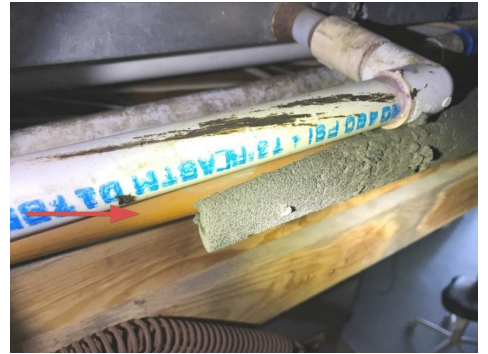
UNIT 4

INSULATION MISSING ON SUCTION LINE

Recommendation

Contact a qualified professional.

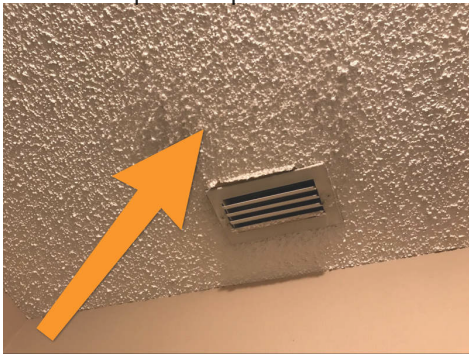
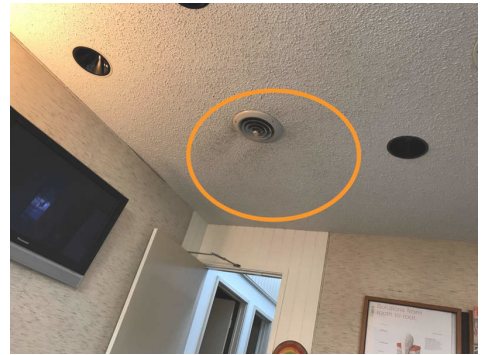
RETURN AIR VENT DIRTY

Recommendation

Contact a qualified professional.

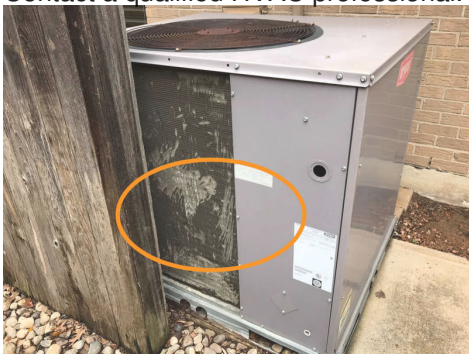
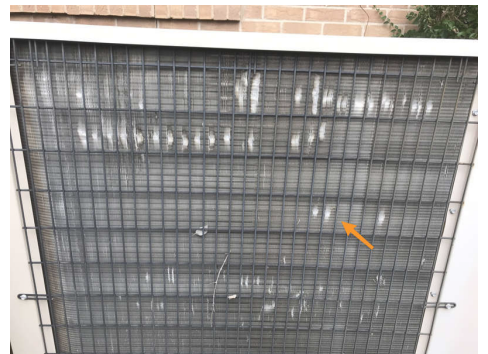
AIR FLOW RESTRICTED

Air flow to the air conditioner condenser was restricted. This may result in inefficient operation. Recommend cleaning dirt and/or debris from unit.

Recommendation

Contact a qualified HVAC professional.

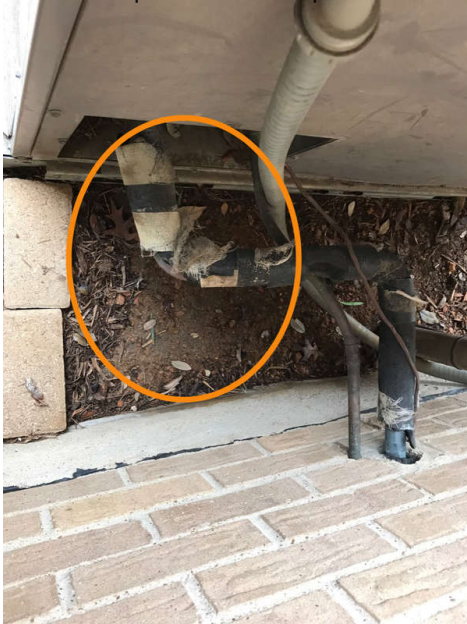
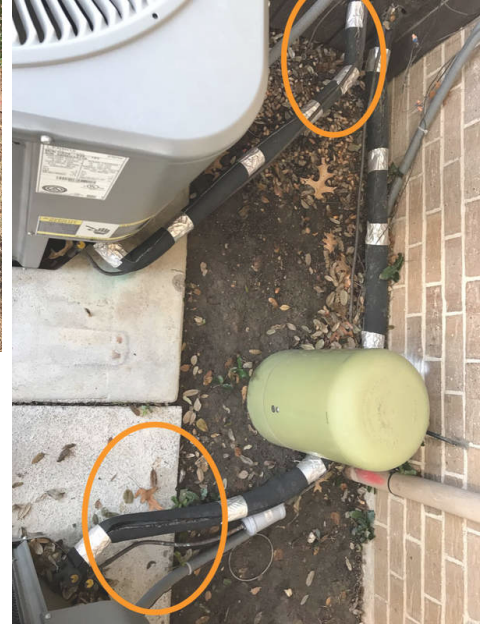
INSULATION MISSING OR DAMAGED

Missing or damaged insulation on refrigerant line can cause energy loss and condensation.

Recommendation

Contact a qualified HVAC professional.

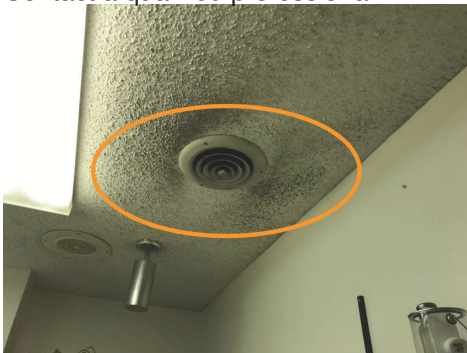
VENT DIRTY

Recommendation

Contact a qualified professional.

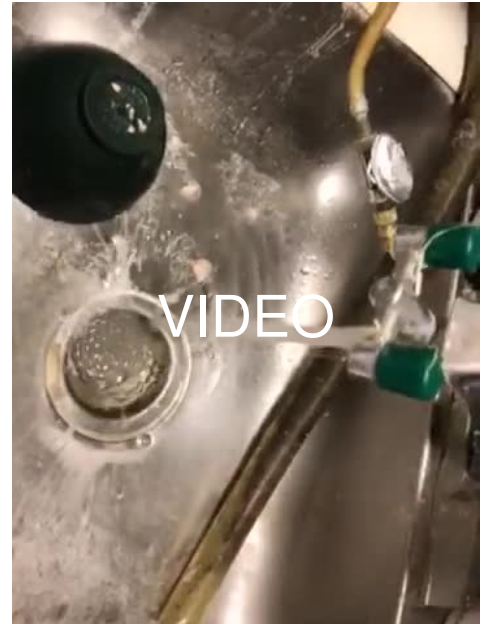
UNIT 4 EAST ENTERANCE,

SINK - POOR DRAINAGE

Sink had slow/poor drainage. Recommend a qualified plumber repair.

Recommendation

Contact a qualified plumbing contractor.

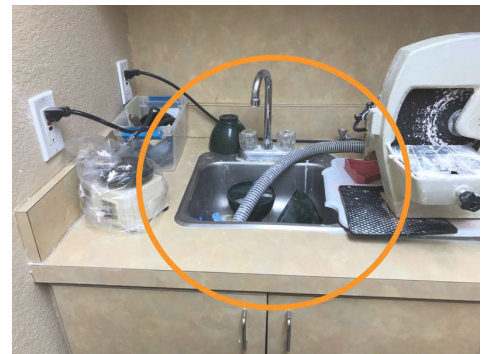
UNIT 3 East Kitchen

SINK INACCESSIBLE

Recommendation

Contact a qualified professional.

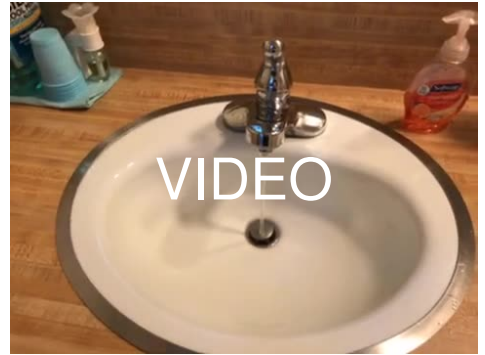
UNIT 2 SOUTH BATHROOM / UNIT 4 BATHROOM

WATER PRESSURE LOW

Recommendation

Contact a qualified professional.

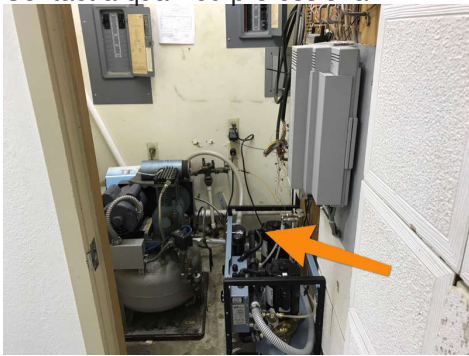
PANEL INACCESSIBLE

Recommendation

Contact a qualified professional.

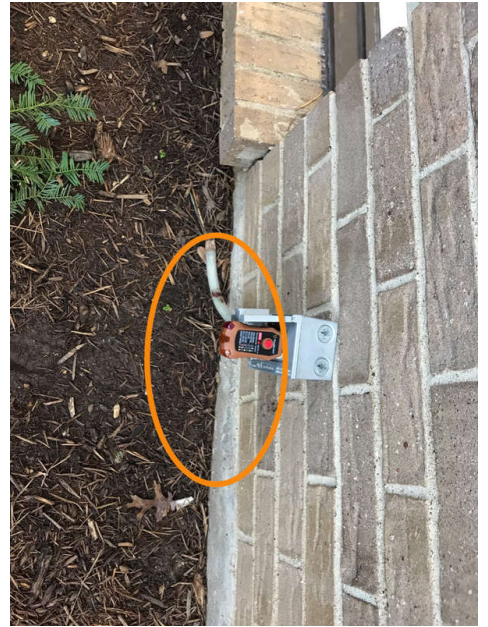
UNIT 4 NORTH OUTSIDE

RECEPTACLE NOT WORKING

Recommendation

Contact a qualified electrical contractor.

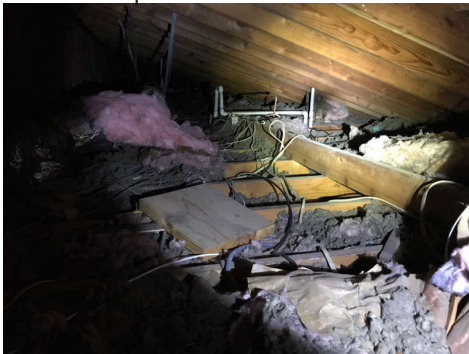
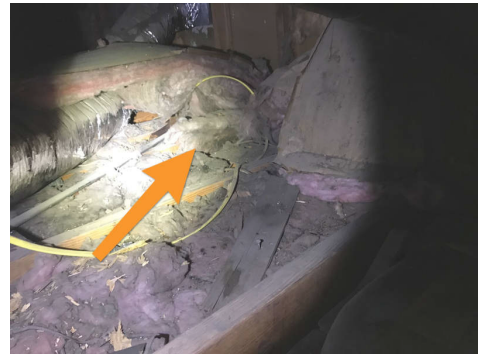
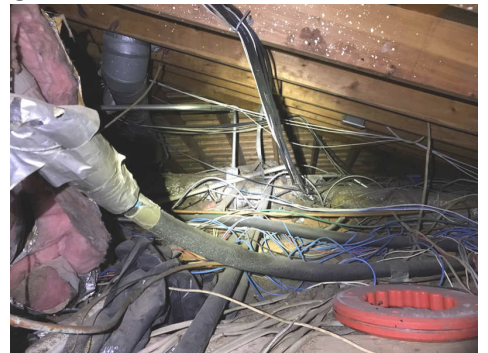
INSUFFICIENT INSULATION

Insulation depth was inadequate. Recommend a qualified attic insulation contractor install additional insulation.

Recommendation

Contact a qualified insulation contractor.

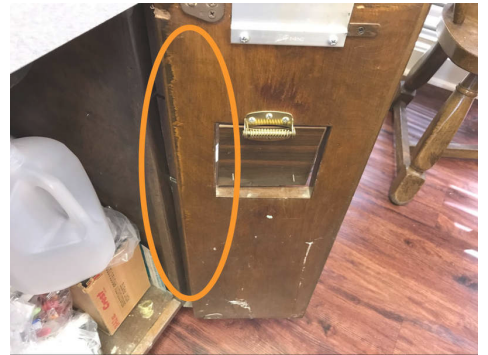
UNIT 1 South 2nd office from west

HINGES LOOSE

Loose hinges can cause door to stick or eventually fall out of place. Recommend handyman tighten hinges.

Recommendation

Contact a qualified handyman.

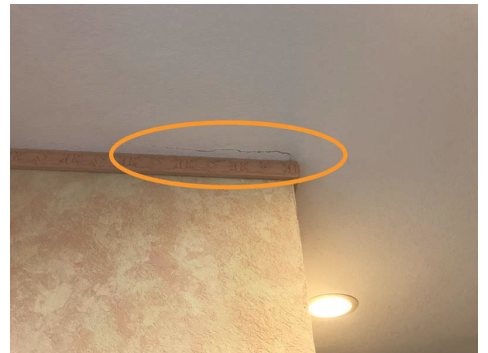
UNIT 3 South behind reception

MINOR DAMAGE

Minor damage or deterioration to the ceiling was visible at the time of the inspection.

Recommendation

Contact a qualified professional.

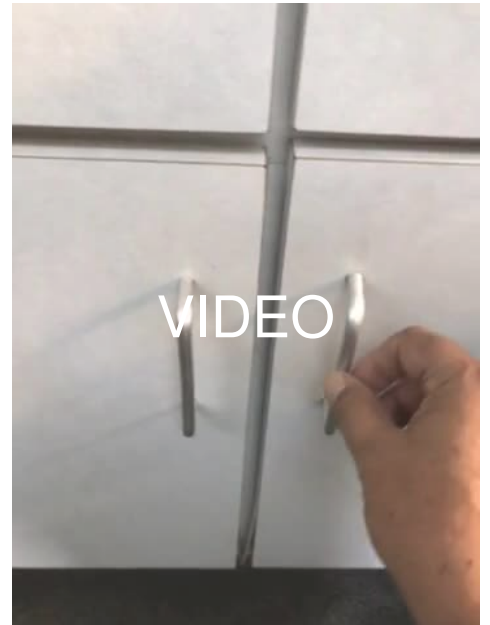
UNIT 4 RECEPTION

CABINET HANDLE LOOSE

Recommendation

Contact a qualified professional.

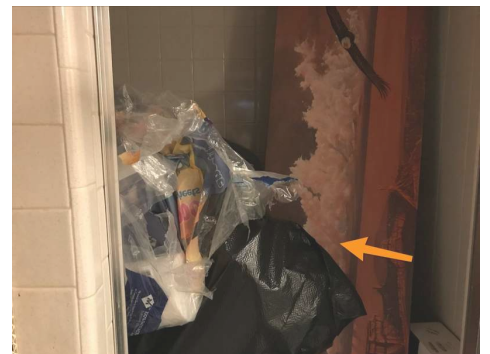
Unit 2 Main Office

SHOWER INACCESSIBLE

Recommendation

Recommended DIY Project
