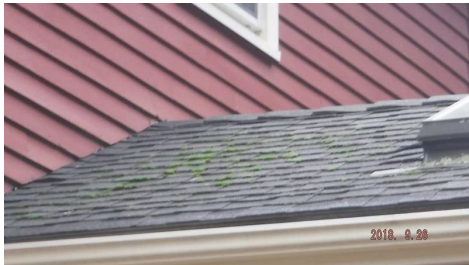
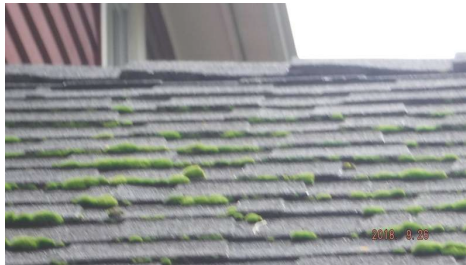
2.1.1 Coverings

ORGANIC GROWTH - MOSS LICHENS

Roof shingles display organic growth, moss and lichen which can reduce roof life. Recommend a qualified roofing contractor evaluate and remedy with a roof cleaning or repair including metal roof strips. See link below:

Contact a qualified roofing professional.

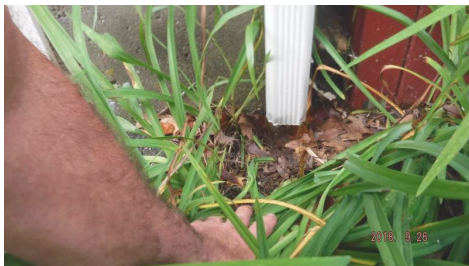
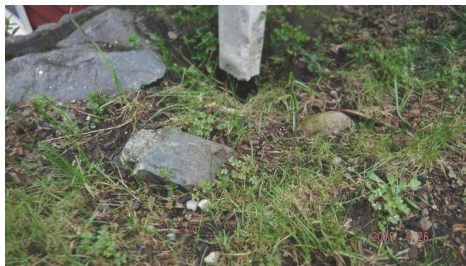
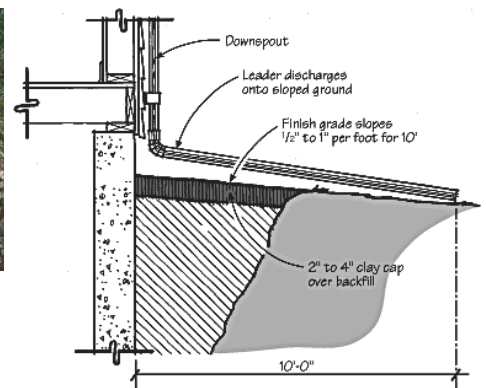
2.2.1 Roof Drainage Systems

DOWNSPOUTS DISCHARGE TOO CLOSE TO FOUNDATION

Recommend adding 6' downspout extensions to move roof water at least 6' away from foundation. This will aid in keeping water/moisture out of basement.

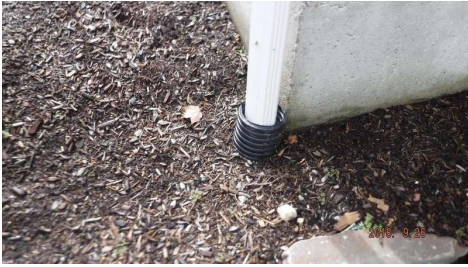
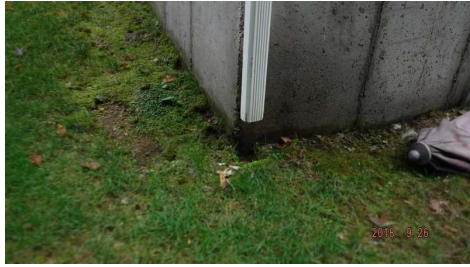
2.2.2 Roof Drainage Systems

DOWNSPOUTS DISCHARGE INTO IN-GROUND RECEPTORS

Monitor in-ground receptors as signs they are not taking water is present. Discharge on ground is better than backup.

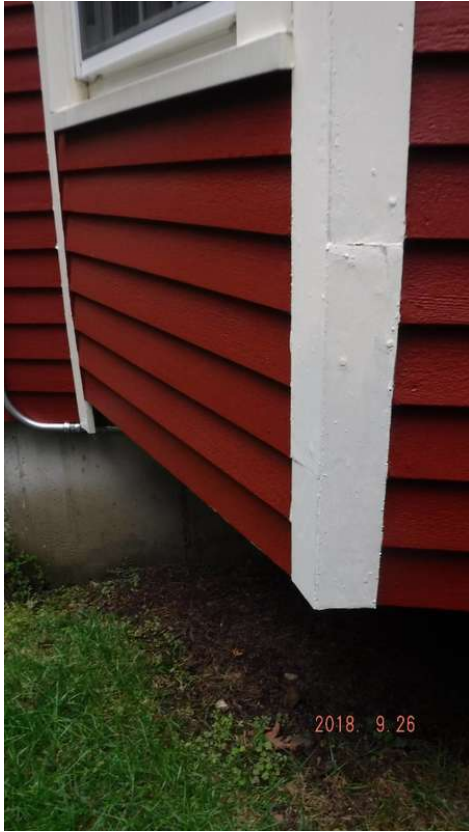
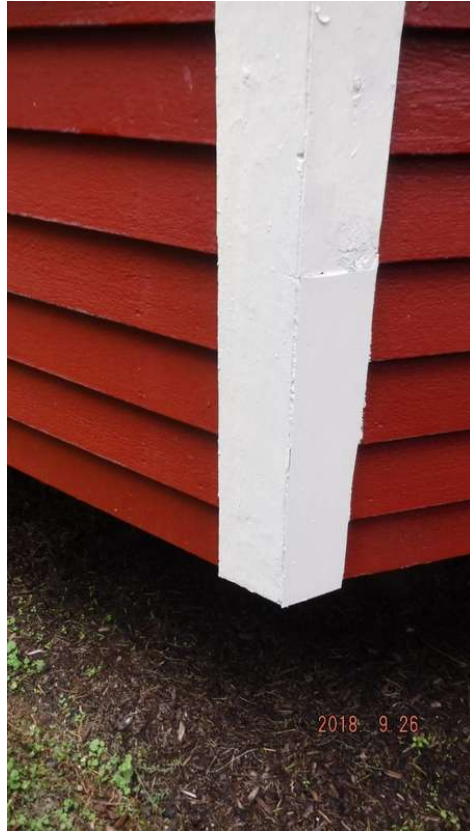
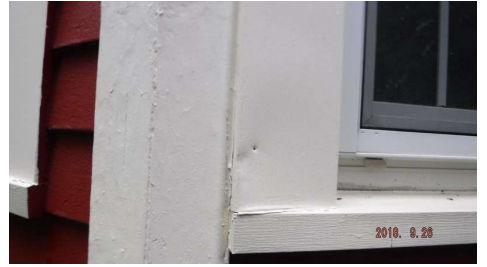
3.1.1 Siding, Flashing & Trim
DETERIORATED WOOD TRIM AND PRIOR REPAIRS

Some deteriorated wood trim and/or siding noted. Keep all wood trim well painted. Recommend replacing all damaged wood trim with PVC type materials. Replace any heavily damaged siding.

Recommendation
Contact a qualified general contractor.

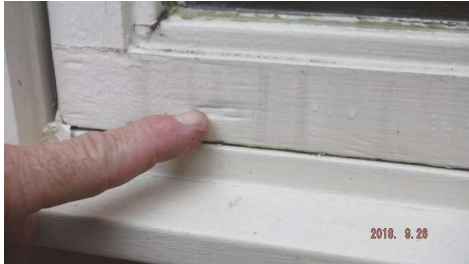
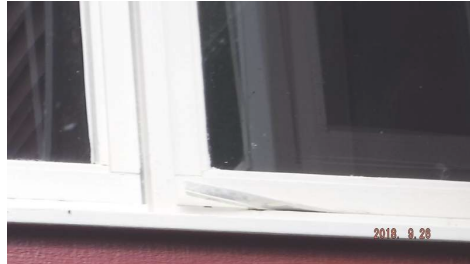
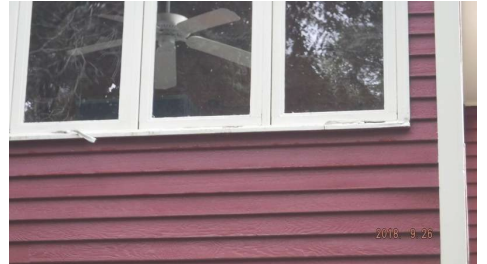
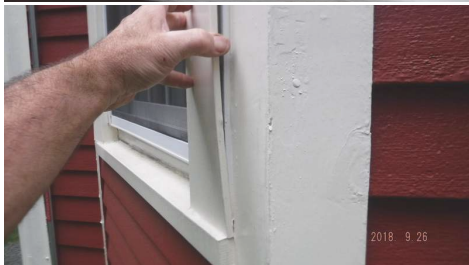
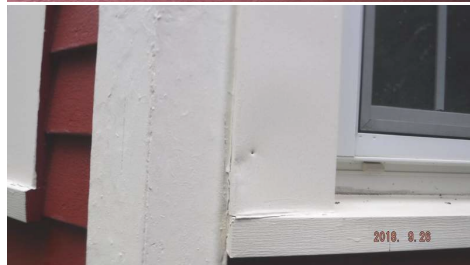
3.2.1 Exterior Doors and Windows

WATER DAMAGE TO WINDOW/DOOR TRIM/FRAME/SASHES

Water damage to door/frame/sashes noted. Recommend having contractor evaluate and repair or replace as needed. Damaged jambs/frames/sashes may require replacement.

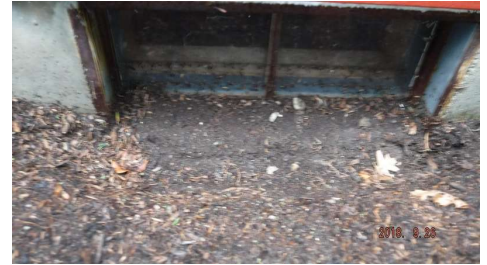
3.2.2 Exterior Doors and Windows

WINDOW WELLS - MISSING

Window wells not present. Recommend installing window wells to protect basement windows and allow for proper grading.

Contact a qualified general contractor.

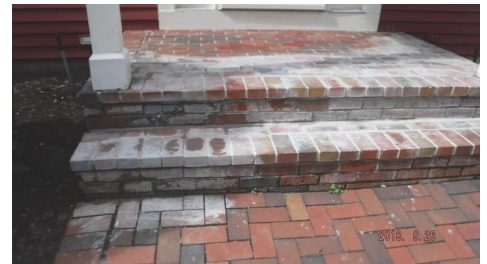
3.4.1 Decks, Balconies, Porches & Steps

PRIOR REPAIRS

Have contractor wash off mortar residue.

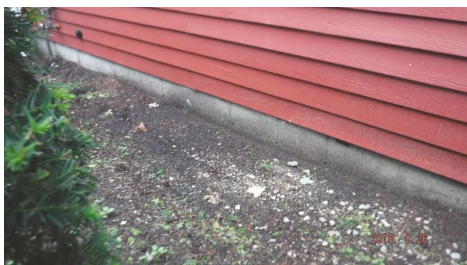
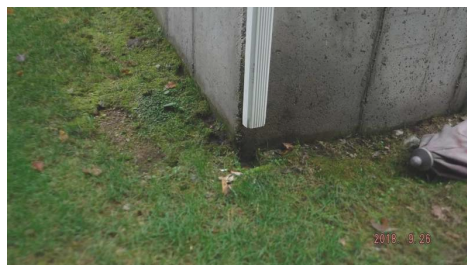
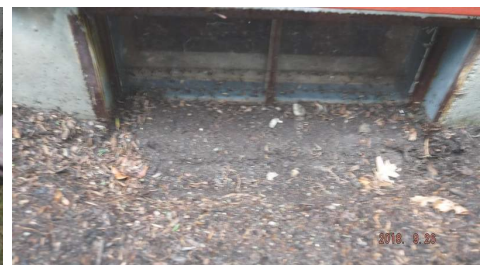
3.5.1 Vegetation, Grading, Drainage & Retaining Walls

NEGATIVE GRADING

Grading is sloping towards the home in some areas. This could lead to water intrusion and foundation issues. Recommend qualified landscaper or foundation contractor regrade so water flows away from home.

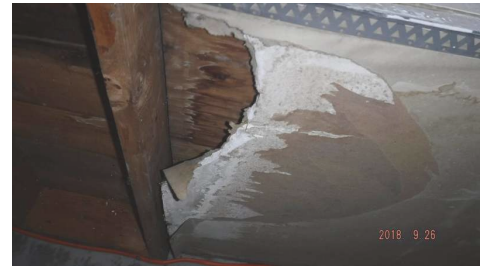
4.2.1 Flame and Fume Retarding

VOIDS NOTED

LAUNDRY ROOM

Ensure all walls attached to living spaces are fully covered with wall board and fire-tape to minimize/slow fume and flame spread to living space.

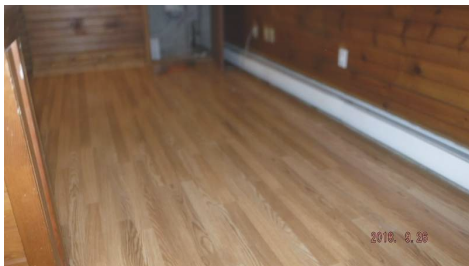
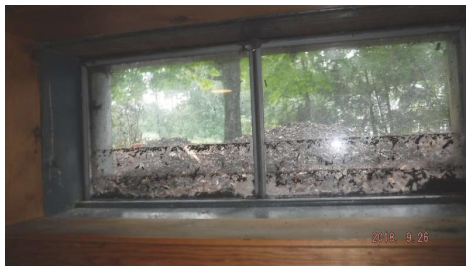
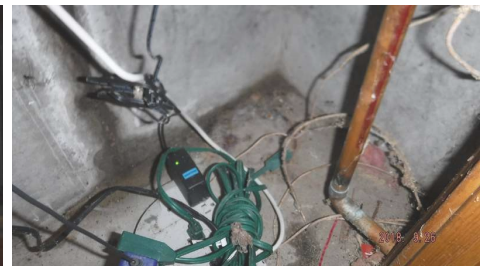
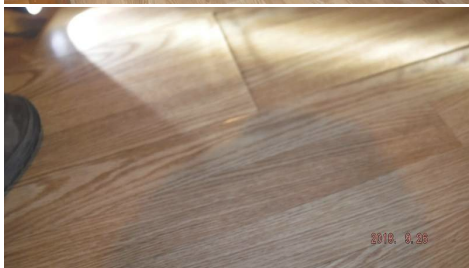
5.2.1 Basement

ACTIVE WATER SEEPAGE

BASEMENT FRONT LEFT

Ensure gutters and downspouts are working properly to bring roof water to the ground and move at least 6' away from foundation. Regrade exterior to create positive slope away from foundation for 6 plus feet.

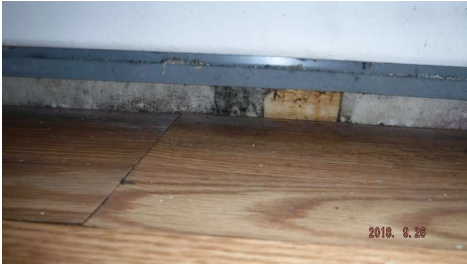
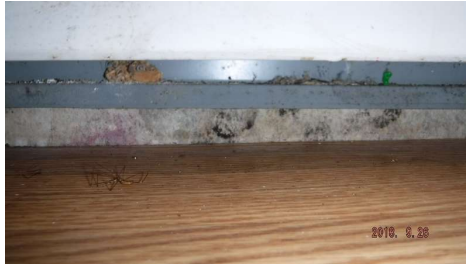
5.2.2 Basement

MOLD-LIKE GROWTH

Extensive mold-like growth noted throughout basement with recent unprofessional attempts at covering up several areas. Recommend having environmental specialist evaluate, remediate and provide all documentation. Abatement will most likely involve removal of walls and finishes in effected area. Risk of concealed damage.

Contact a qualified environmental contractor

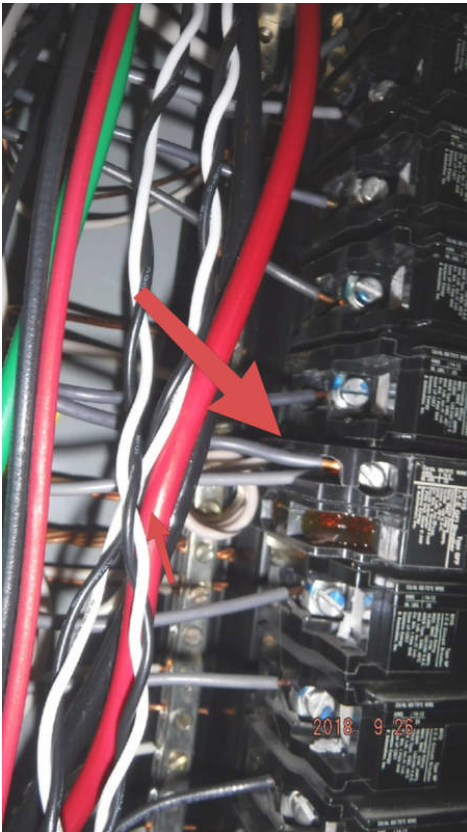
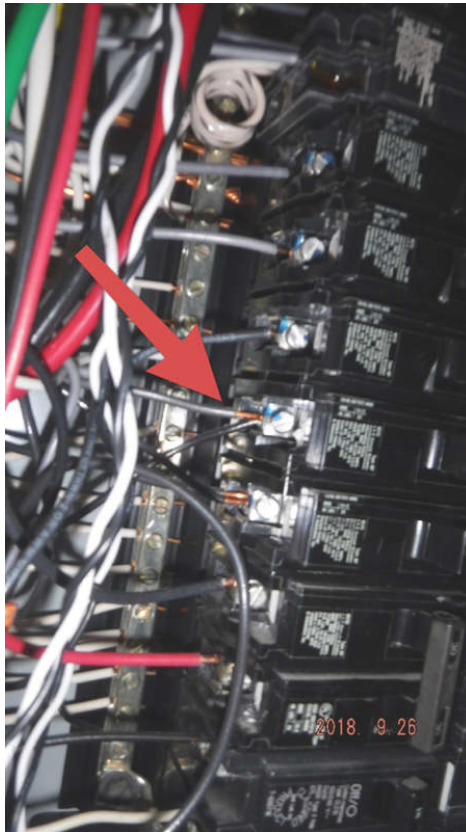
6.2.1 Main & Subpanels, Service & Grounding, Main Overcurrent Device

DOUBLE TAPPING

Double Tapping at Breakers noted. This breaker is not manufactured to accept multiple wires connected to one breaker. Have Lic Electrician remove all double tap conditions.

Contact a qualified electrical contractor.

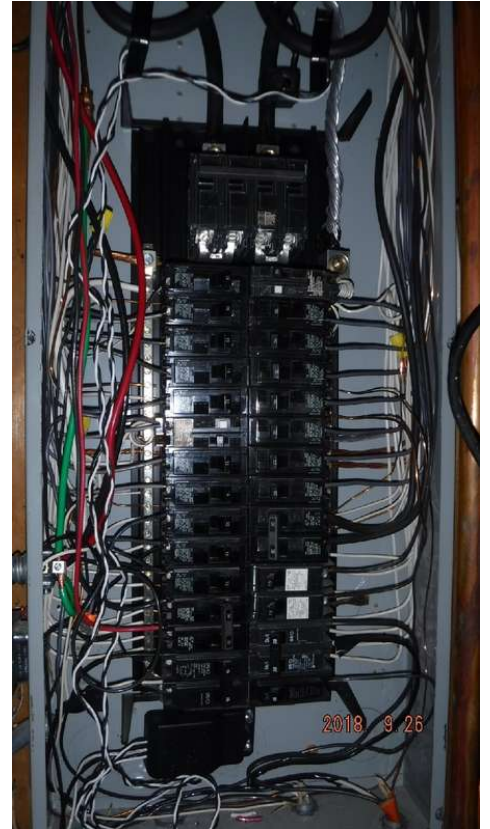
6.2.2 Main & Subpanels, Service & Grounding, Main Overcurrent Device

PANEL FULLY UTILIZED

Future electrical needs to require main panel replacement or additional sub panel. Have license electrician price panel replacement.

Contact a qualified electrical contractor.

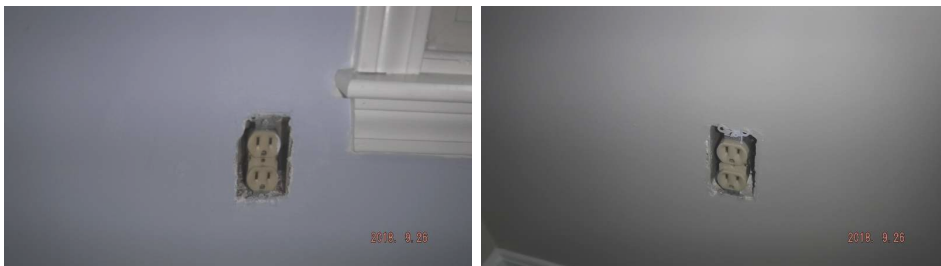
6.4.1 Lighting Fixtures, Switches & Receptacles

COVER PLATES MISSING

One or more receptacles are missing a cover plate. This causes short and shock risk. Recommend installation of plates.

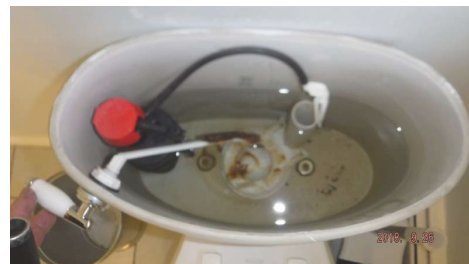
7.2.1 Water Supply, Distribution Systems & Fixtures

TOILET FLUSH LEAKING/NOT FUNCTIONING PROPERLY

Repair or replace.

Recommendation
Contact a qualified plumbing contractor.

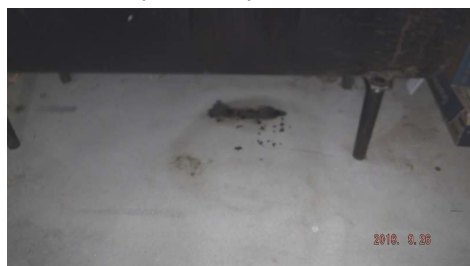
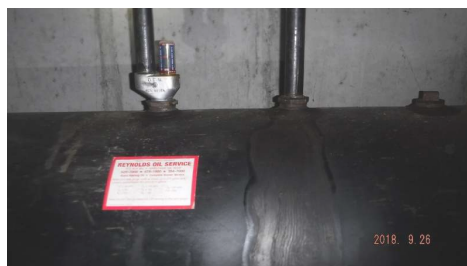
7.5.1 Fuel Storage & Distribution Systems

OIL DRIPS ON FLOOR

Have oil delivery contractor evaluate fill pipes and reseal as necessary.

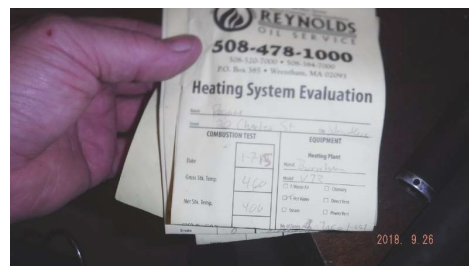
8.1.1 Equipment - Hydronic

OIL BOILER - OUTDATED/MISSING SERVICE TAGS

Oil Boiler with outdated /Missing service tags. Recommend having Oil Burner Technician service and evaluate boiler prior to use and annually thereafter.

Recommendation
Contact a qualified heating and cooling contractor

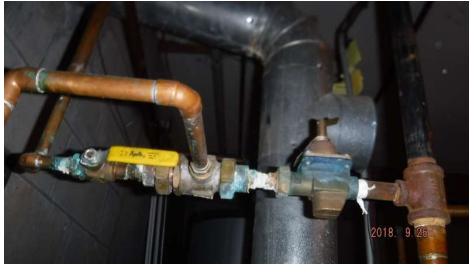
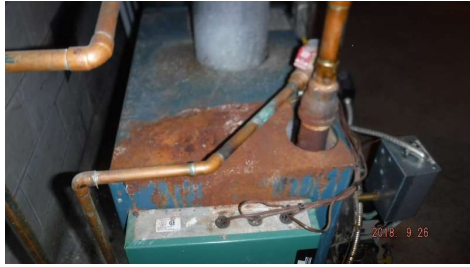
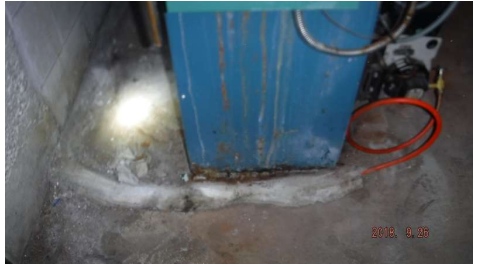
8.1.2 Equipment - Hydronic

RUST AND CORROSION

Boiler has history of servicing yet boiler has excessive rust and corrosion at piping and components. Recommend having competent heating contractor fully evaluate and repair or replace any damage components.

Recommendation
Contact a qualified professional.

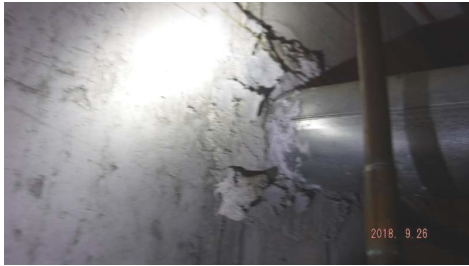
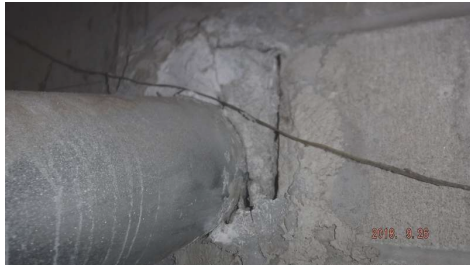
8.4.1 Vents, Flues & Chimneys
FLUE PIPE NOT SEALED PROPERLY
Recommendation
Contact a qualified heating and cooling contractor

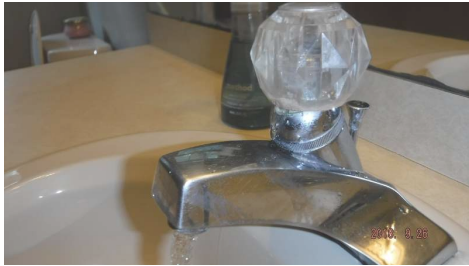
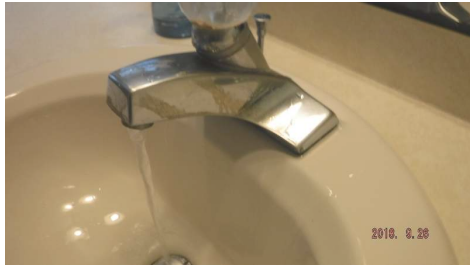
10.4.1 Baths/Showers
FAUCET NOT FUNCTIONING/LEAKING/DAMAGED/LOOSE
2ND FLOOR BATHROOM
Have plumbing contractor repair or replace.
Recommendation
Contact a qualified plumbing contractor.

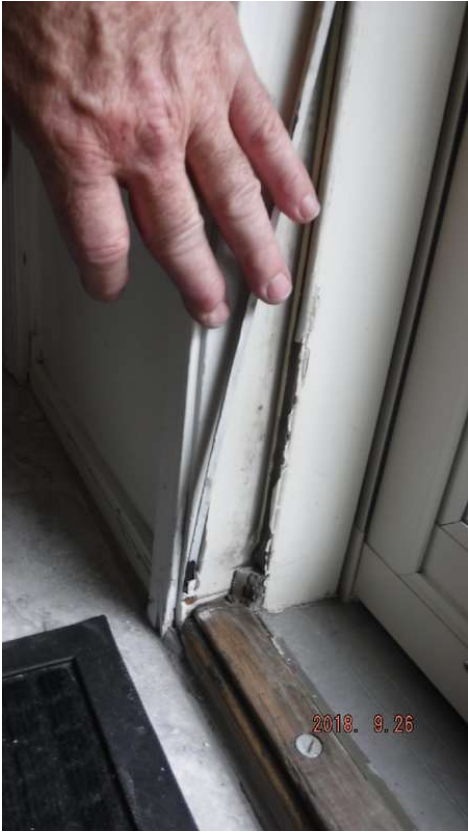
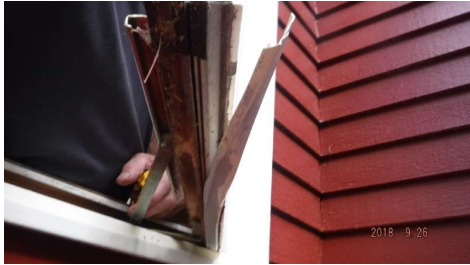
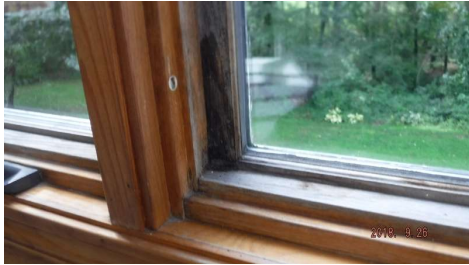
10.6.1 Doors and Windows
WEATHERSTRIPPING MISSING/DAMAGED
REAR SUNROOM FRONT DOOR
Repair or replace to obtain tight seal at windows and doors.

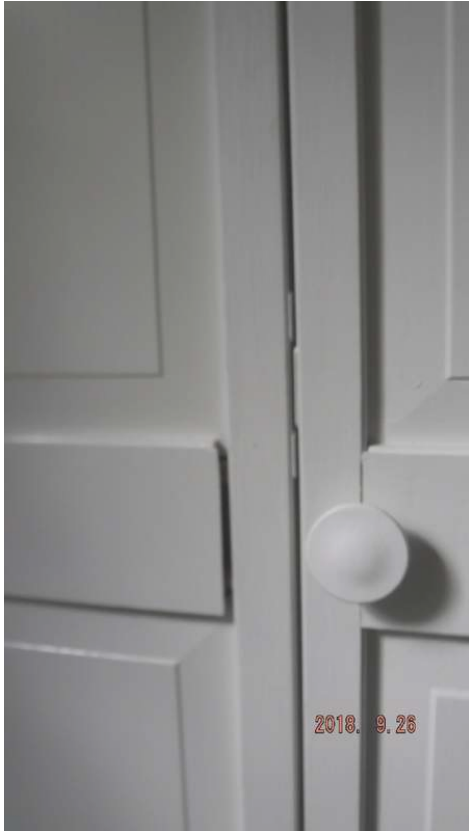
10.6.2 Doors and Windows

DOOR DAMAGE

Repair or replace.

Contact a qualified professional.

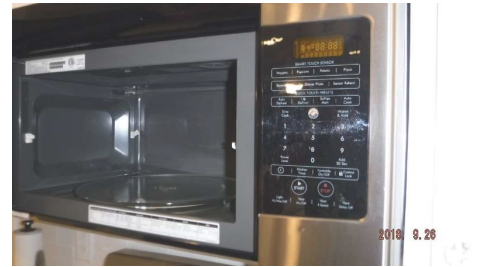
10.7.1 Built-in appliances

**MICROWAVE NOT
FUNCTIONING/DAMAGED**

Microwave appears to have power to Unit but not functioning. Have appliance repair person repair or replace.

Contact a qualified professional.

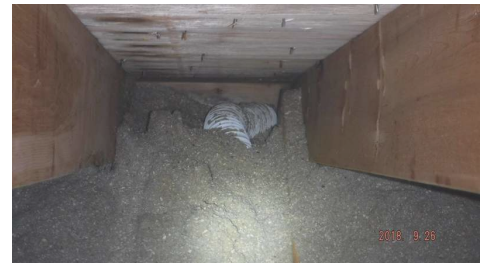
11.4.1 Exhaust Systems

BATHROOM FAN DISCHARGING IN ATTIC

This can lead to high levels of moisture and associated mold growth. Have contractor properly terminate all exhaust fans at exterior of building.

Contact a qualified general contractor.

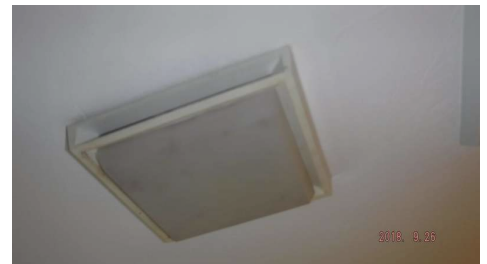
11.4.2 Exhaust Systems

NOISY FAN

Replace may be needed.

Contact a qualified electrical contractor.
