Summary of items inspected.

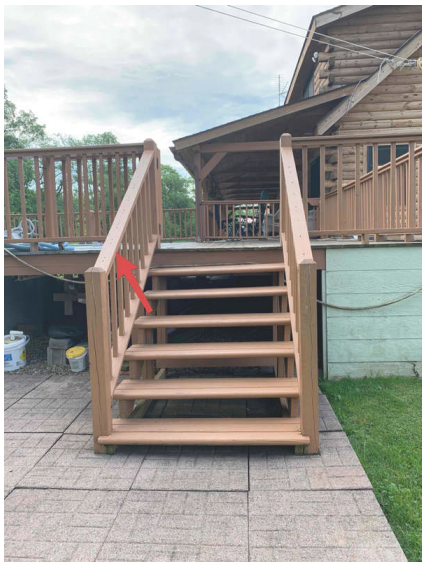
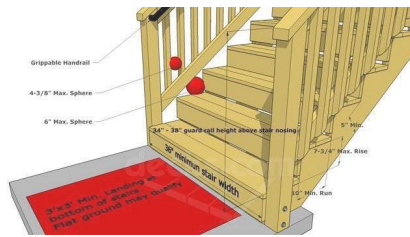
IMPROPER HANDRAIL

Handrail is improper per current safety standards, handrails are required to meet graspability dimensions. Recommend licensed contractor to repair to current safety standards.

Example photo only

Recommend updating railing
current safety standards

Recommendation
Contact a qualified carpenter.

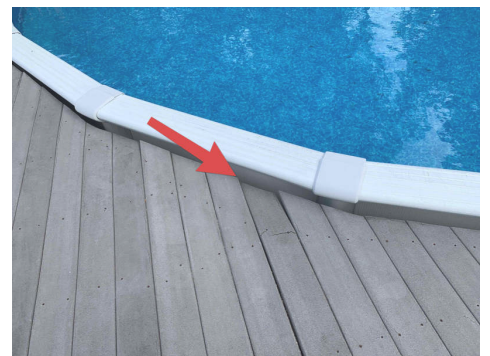
DECK - LOOSE BOARDS

One or more deck boards were observed to be loose. Loose deck boards may present a possible trip hazard. Recommend they be refastened to prevent possible injuries.

Composite deck board near pool is damaged this is a potential trip hazard

Recommendation
Contact a qualified deck contractor.

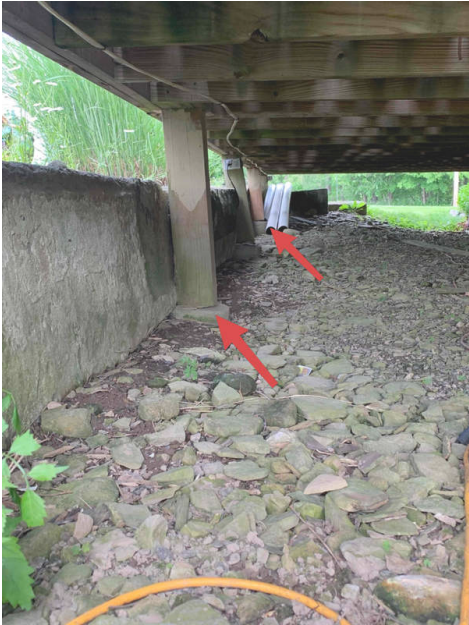
DECK - UNSTABLE SUPPORT

One of more areas of the deck support appears unstable. This could cause a safety hazard and further deterioration of the deck. Recommend qualified deck contractor evaluate and repair.

Front deck support posts show signs of movement

Contact a qualified deck contractor.

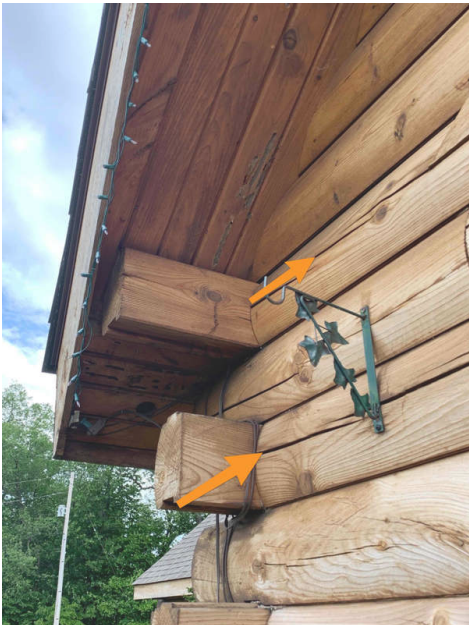
CHECKING

Wood veneer shows typical amount of checking. Recommend sealing wood surface as needed to prevent damage.

Checking of lumber observed on exterior siding. This is normal as material ages recommend applying

Contact a qualified professional.

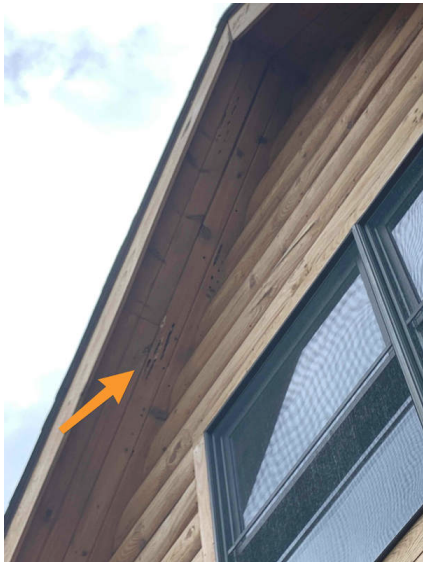
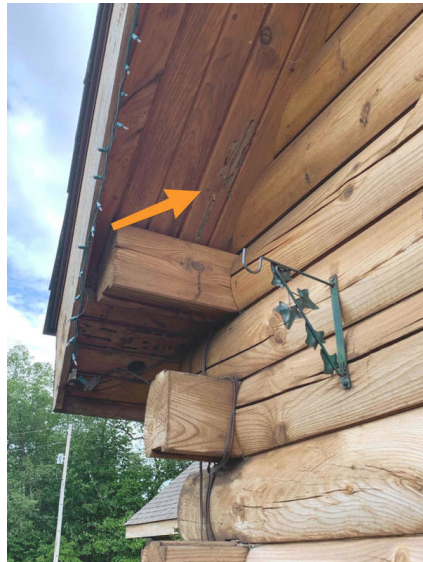
PEST DAMAGE

Evidence of carpenter bee damage observed on areas of wood siding, fascia and rake boards recommend licensed pest control professional to evaluate and repair as needed.

Carpenter bee type damage

Contact a qualified pest control specialist.

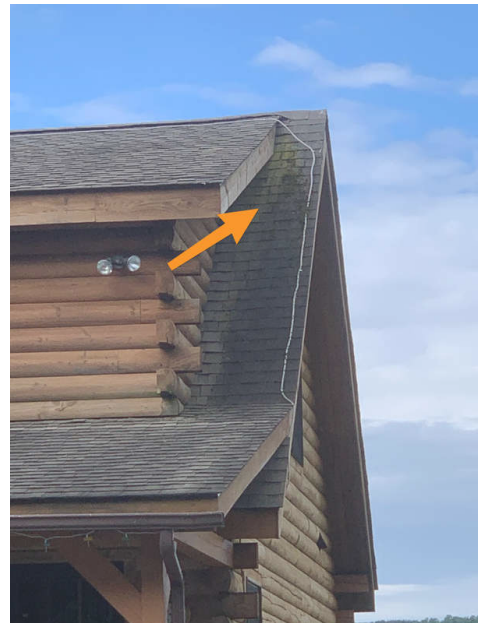
MOSS

Recommend cleaning moss buildup from roof material to prevent premature failure of materials

Moss observed on roof surface, recommend cleaning to prevent premature failure of roof material

Contact a qualified roofing professional.

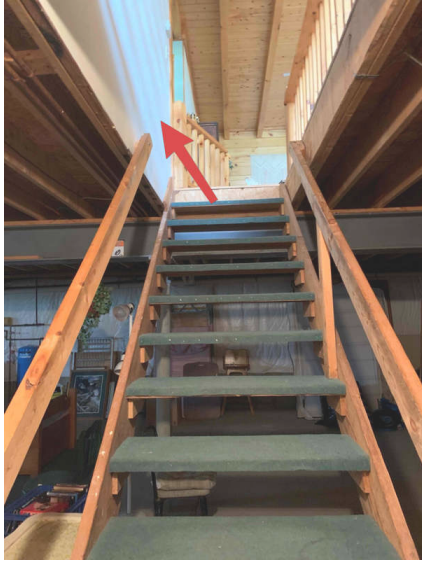
HANDRAIL IMPROPER

Interior staircase handrails do not meet current safety standards. Recommend licensed contractor to repair to current safety standards to prevent possible injuries.

Improper handrail

R311.7.8.2 **Continuity.** Handrails for stairways shall be continuous for the full length of the flight, from a point directly above the top riser of the flight to a point directly above the lowest riser of the flight. Handrail ends shall be returned or shall terminate in newel posts or safety terminals. Handrails adjacent to a wall shall have a space of not less than 1-1/2 inches (38 mm) between the wall and the handrails.

Contact a qualified carpenter.

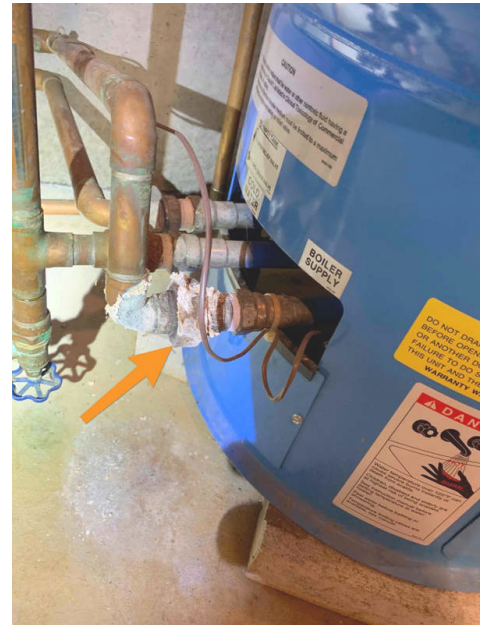
CORRODED CONNECTIONS

Evidence of corrosion was observed on some piping connections. Recommend licensed plumber to repair as needed.

Corroded connections are prone to failure

Contact a qualified plumbing contractor.

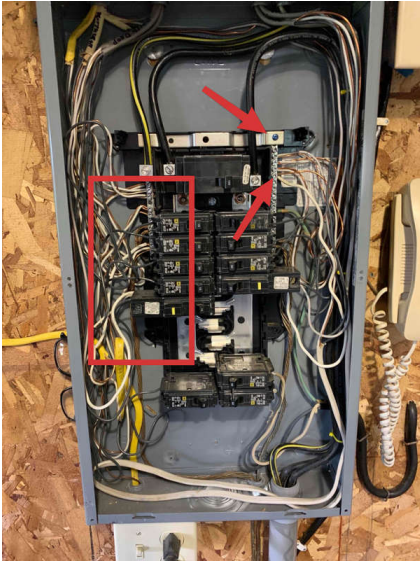
IMPROPER SUB-PANEL

Electrical sub-panels require the "Neutrals to be Isolated and Grounds separated" This is not the case in this sub-panel. Recommend licensed electrician to repair to prevent possible injuries.

Sub electric panel in out building is improper

Contact a qualified electrical contractor.

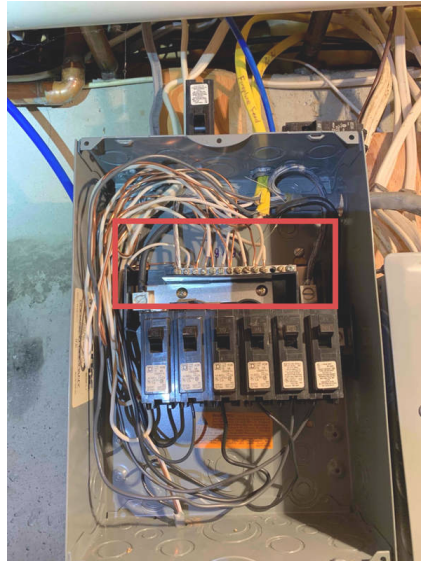
Sub electric panel in basement is improper

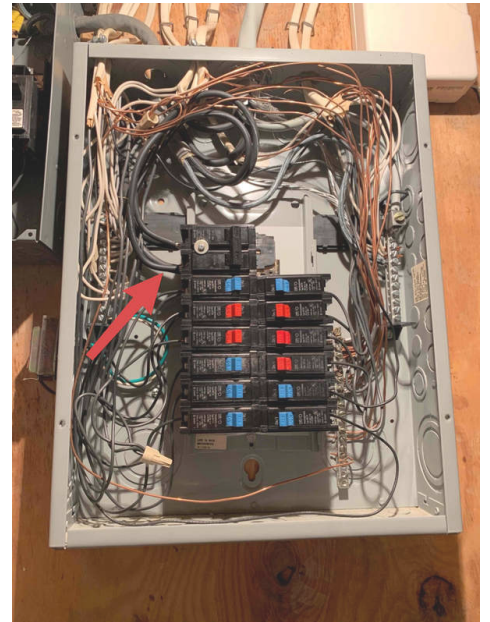
DOUBLE TAPPED BREAKER

Circuit breakers are double tapped. This manufacturer prohibits this practice, recommend licensed electrician to repair to manufacturers specifications.

Circuit breaker manufacture prohibits double tapping of this model

Contact a qualified electrical contractor.
