RECOMMENDATIONS SUMMA

1234 Main St.Grand Rapids MI 49503 Buyer Name Daniel Geurink InterNACHI Certified Home Inspector Ink Home Services 616-848-9401 inkhomeservices@gmail.com

07/31/2017 9:00AM

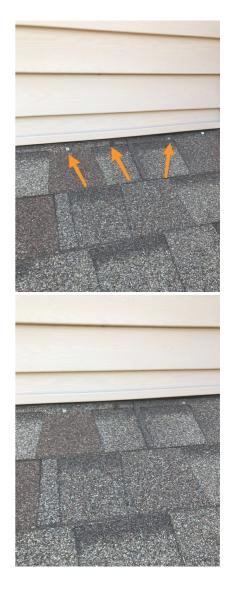
### 2.1.1 Coverings IMPROPER/INCOMPLETE NAILING

Roof coverings showed signs of improper installation and fastening. Recommend a qualified roofing contractor evaluate and repair.

Recommendation Contact a qualified roofing professional.

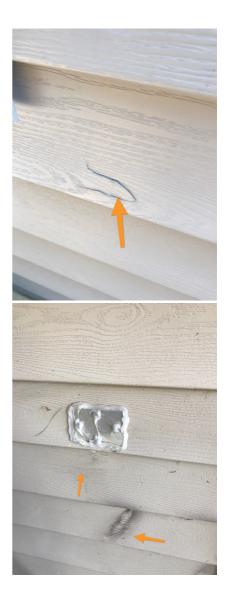
# 3.1.3 Siding, Flashing & Trim SMALL LOCALIZED DAMAGE

There was on or more areas with small localized damage to the exterior siding

Recommendation Contact a qualified professional.

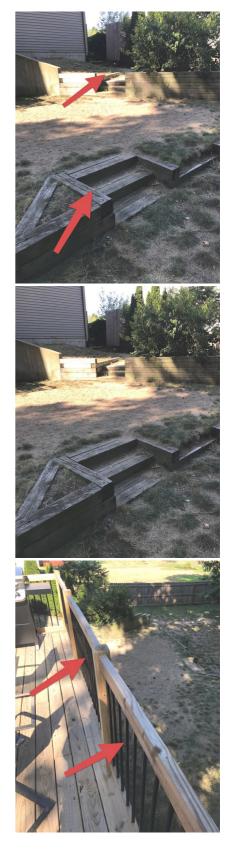
# 3.4.2 Decks, Balconies, Porches & Steps **RAILING UNSAFE/MISSING**

There was one or more areas with 3 steps or more that had an unsafe or missing railing. This is a safety concern and should be addressed by a qualified contractor.

Railings on deck were wobbly and should be properly secured.

Recommendation Contact a qualified carpenter.

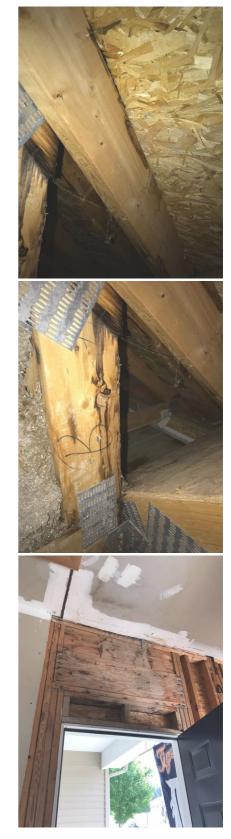
#### 4.6.1 Garage Structure EVIDENCE OF WATER INTRUSION GARAGE

Wall structure showed signs of previous water intrusion, which if not properly fixed could lead to more serious structural damage. Recommend a qualified contractor identify source or moisture and remedy.

Note: this may have already been repaired but since there has not been recent rain it is hard to tell.

Recommendation Contact a qualified roofing professional.

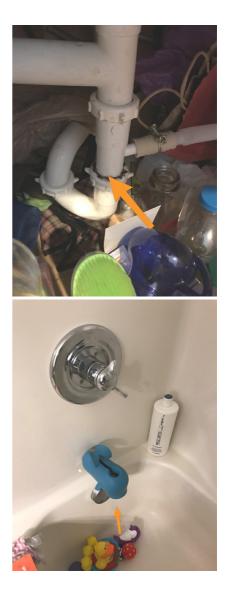
7.2.1 Drain, Waste, & Vent Systems

A drain, waste and/or vent pipe showed signs of a leak. Recommend a qualified plumber evaluate and repair.

Recommendation Contact a qualified plumber.

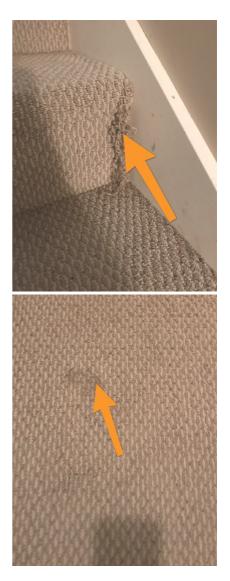
### 10.3.2 Floors MODERATE WEAR

Floors in the home exhibited moderate surface wear along major paths of travel. Recommend a qualified flooring contractor evaluate for possible re-finish.
