SUMMARY

1234 Main St. Laurelton NJ 08723

RICK VECCHIO
License # 24GI00167600
GCA Home Inspections
732-232-1092
richardv@gcahomeinspections.com

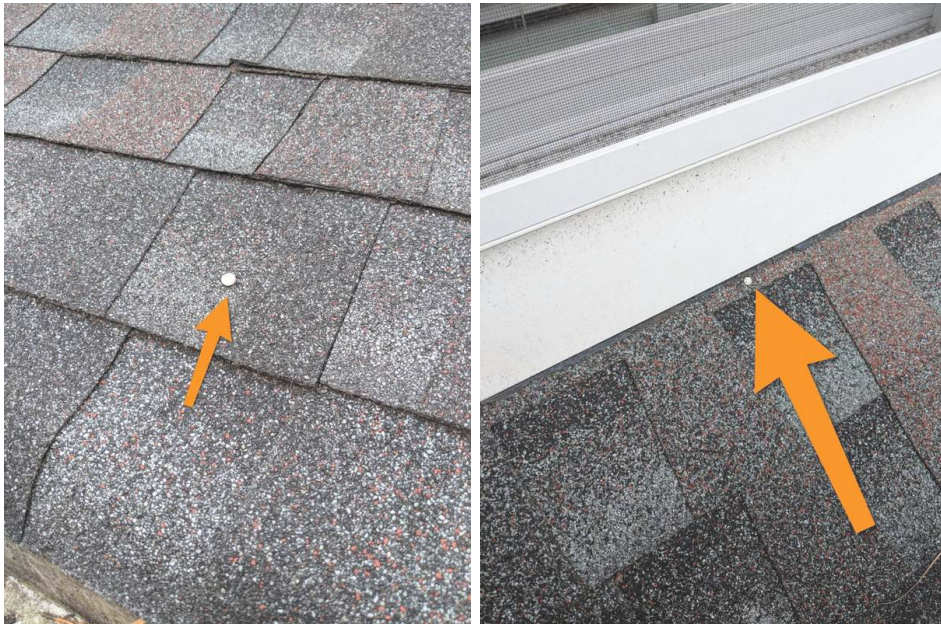
2.1.1 Coverings

EXPOSED NAILS

Under-driven or exposed nails were found in one or more roof coverings. Recommend a qualified person caulk with roofing mastic.

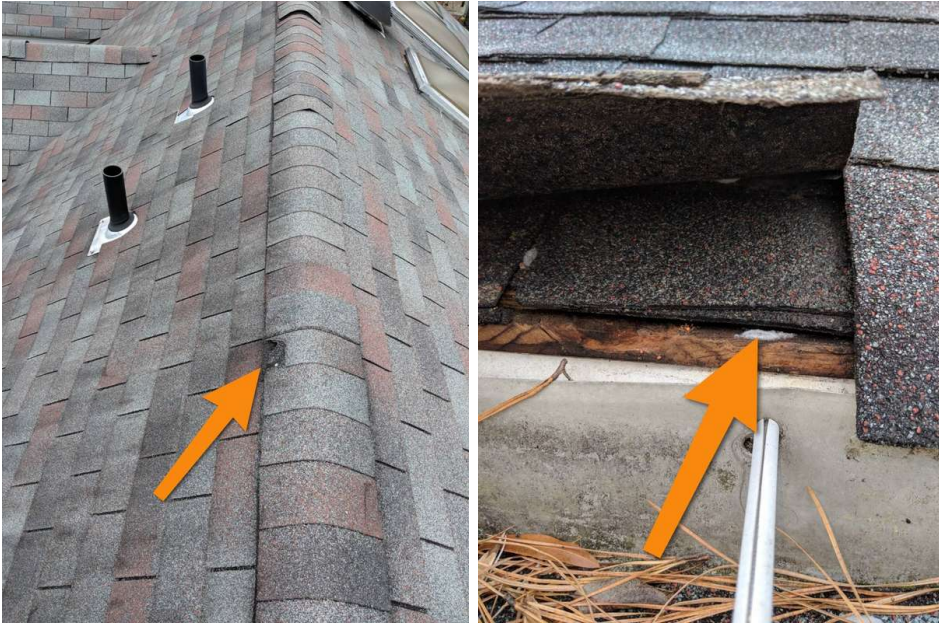
2.1.2 Coverings

CRACKED/BROKEN/BUCKLED/MISSING

The roof had one or more cracked/broken/buckled/missing shingle/s. Recommend a qualified roof contractor repair or replace to prevent moisture intrusion.

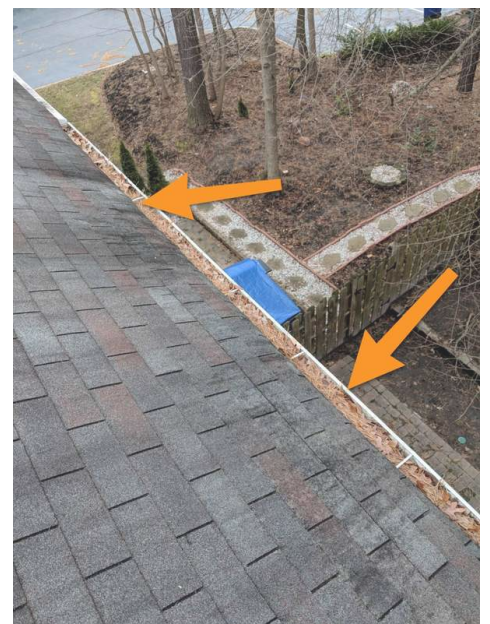
2.2.1 Roof Drainage Systems

DEBRIS

Debris has accumulated in the gutters. Recommend cleaning to facilitate water flow.

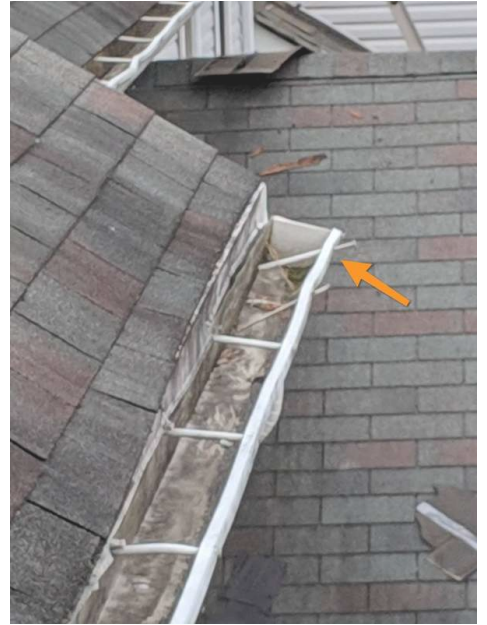
2.2.2 Roof Drainage Systems

GUTTER DAMAGED

In some areas, the gutters were damaged and the aluminum nails holding the gutter were backing out in others. This can result in excessive moisture in the soil at the foundation, which can lead to foundation/structural movement.

Recommend a qualified contractor evaluate and repair.

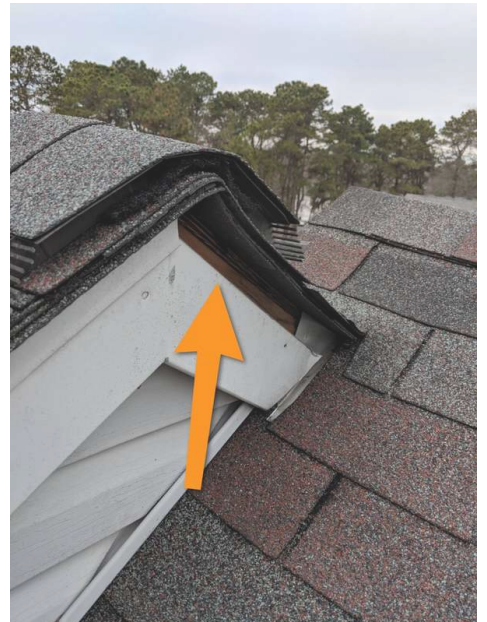
2.3.1 Flashings

MISSING

Flashings were missing in one area. Flashings provide protection against moisture intrusion.

Recommend a qualified roofing contractor evaluate and remedy.

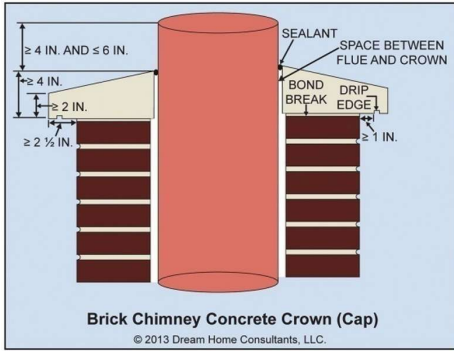
2.4.1 Chimney Exterior

CHIMNEY CROWN MISSING

No chimney crown was observed. This is important to protect from moisture intrusion and protect the chimney.

Recommend a qualified roofer or chimney expert install.

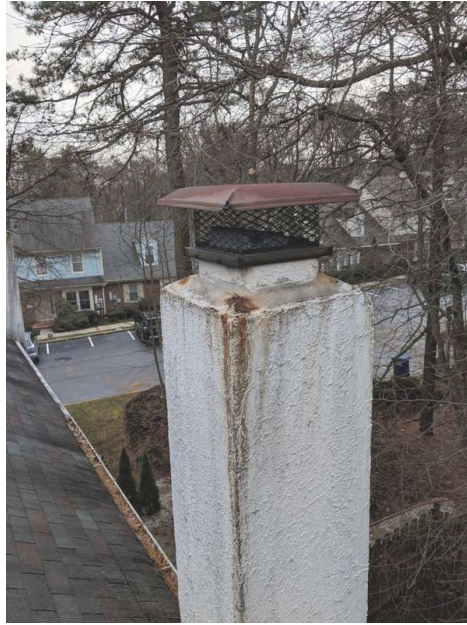
Cross section of a Crown

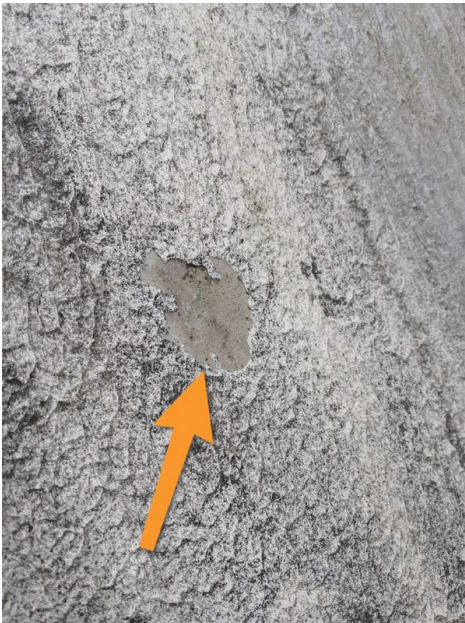
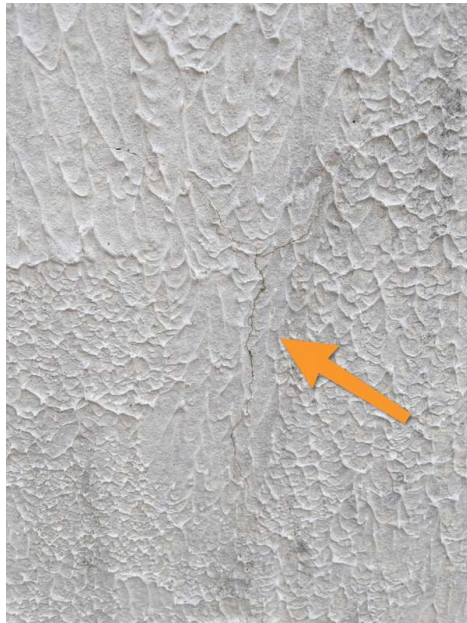
2.4.2 Chimney Exterior

CHIMNEY MASONRY PAINT/STUCCO DETERIORATED

The Chimney masonry paint/stucco showed signs of being deteriorated. To extend the lifespan of the chimney and to ensure that safe conditions exist, the Inspector recommends evaluation and any necessary work be performed by a qualified masonry contractor.

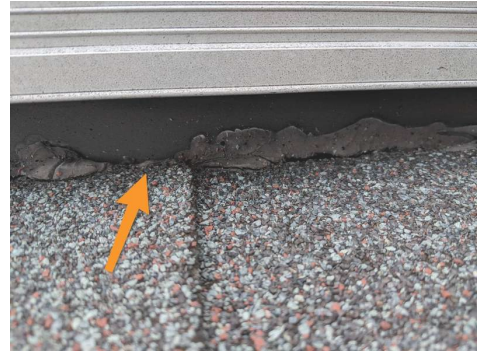
2.5.1 Skylights/Lightshafts (Exterior)

CAULKING DETERIORATED

Caulking around the skylights flashing showed signs of deterioration. If the roof is not replaced immediately recommend re-caulking by a qualified person to reduce the chances of leakage..

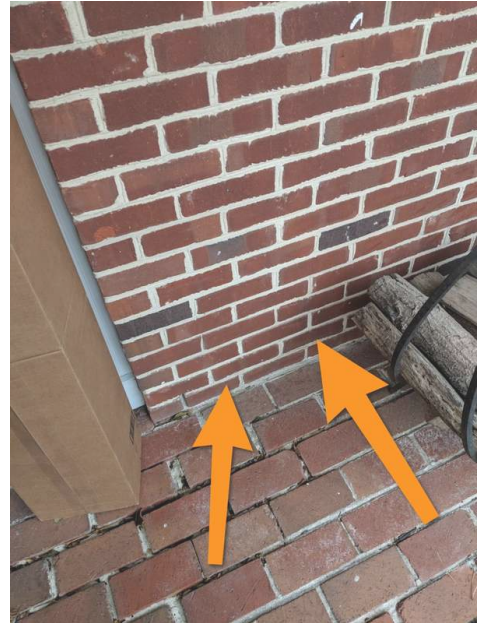
3.2.1 Siding, Flashing & Trim **WEEP HOLES MISSING**

Weep holes were not apparent on the brick or stone veneer siding. Weep holes are small holes in the base of a brick or stone veneer walls, they are exit points for humidity that has permeated into the walls.

Excessive humidity can deteriorate prematurely the wall structure. Recommended qualified siding contractor evaluate and correct.

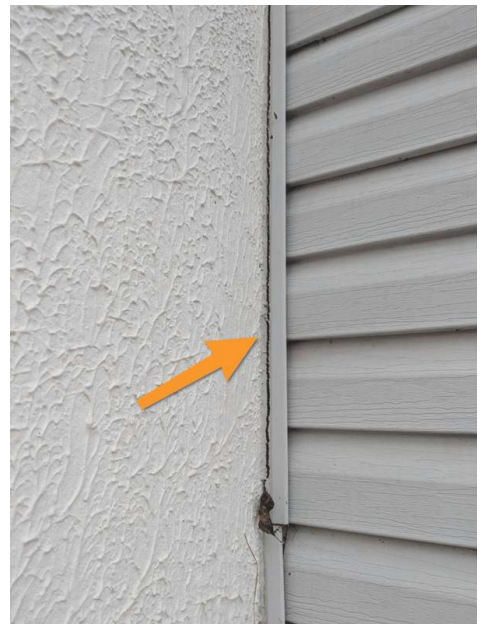
3.2.2 Siding, Flashing & Trim **CAULKING DETERIORATIONS**

Caulkings around the exterior showed signs of deterioration. These caulking keep water from entering the wall cavities.

Recommend assessment of all caulking and re-caulking where needed by a qualified person.

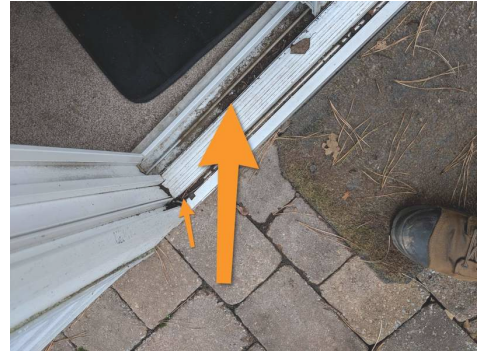
3.4.1 Exterior Doors/Slider

SLIDER TRACKS DEBRIS

The tracks of the sliding door had debris accumulating.
Recommend cleaning of track and weep holes to prevent any water from entering the home.

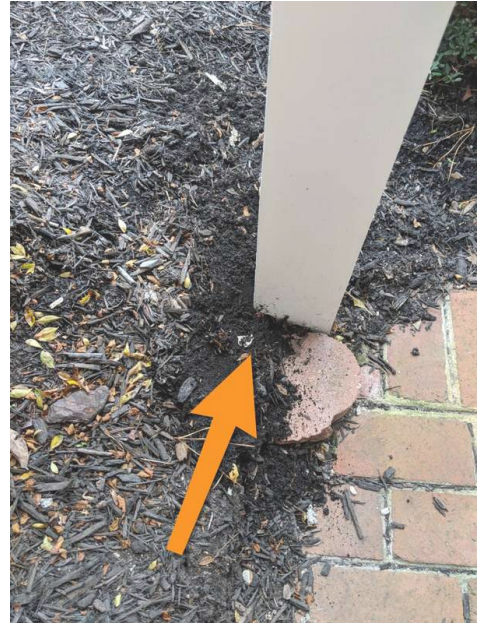
3.5.1 Decks, Balconies, Porches, and Steps

POST DETERIORATED

The base of the post holding up the front porch was rotted due to contact with the mulch pile.

Recommend a qualified person repair the post and make the necessary corrections to keep the mulch from covering the post.

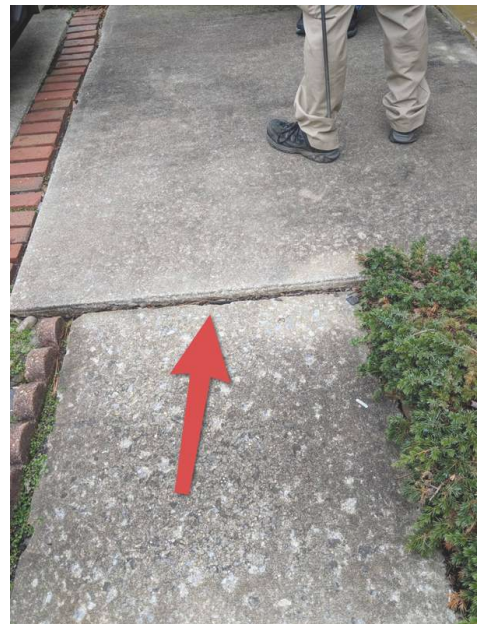
3.6.1 Walkways, Patios & Driveways

(WALKWAY) TRIP HAZARD

Trip hazards (vertical difference of 3/8 or higher) in the (walkway) appeared to be the result of the expansion or contraction (heaving or settling) of the underlying soil. For safety reasons and at a minimum, I highly recommend beveling the edge to a slope no steeper than a 1:2 ratio. Recommend a complete evaluation by a qualified contractor.

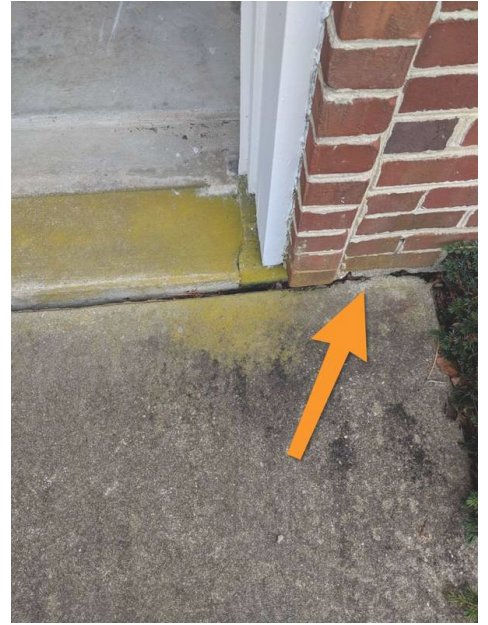
3.6.2 Walkways, Patios & Driveways

GENERAL SETTLEMENT AND HEAVING

The driveway and walkways showed signs of settlement and heaving. This is a common occurrence.

The inspector recommends a qualified contractor assess and make any repairs as deemed necessary.

Also recommend at minimum if nothing else is done, to caulk any cracks or openings with a masonry caulk to limit the process of further deterioration.

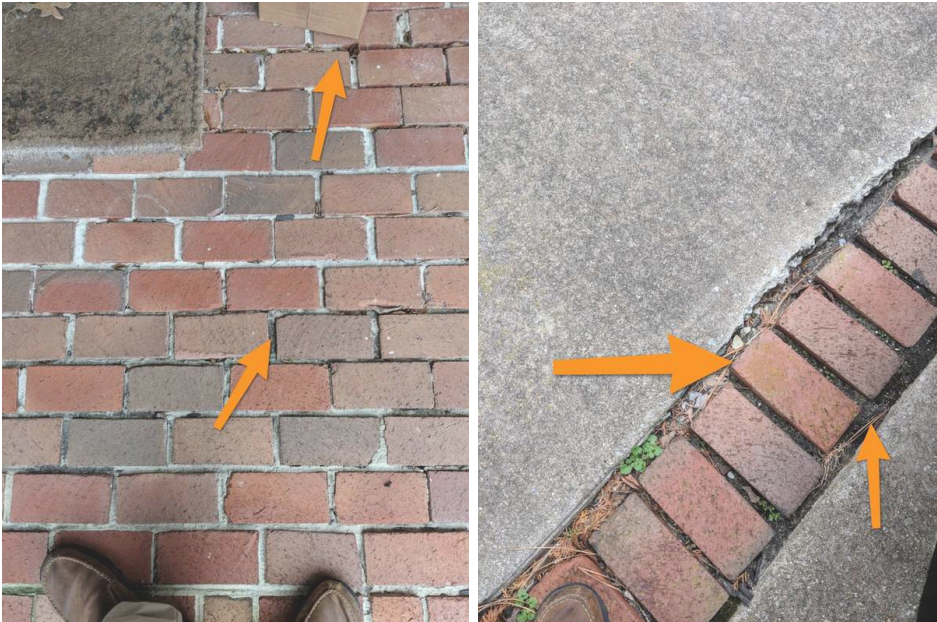
3.6.3 Walkways, Patios & Driveways

BRICK PAVER DETERIORATION

Bricks were used as pavers in the front of the house and show signs of deterioration.

Most notably the mortar joints.

Recommend repair by a qualified contractor.

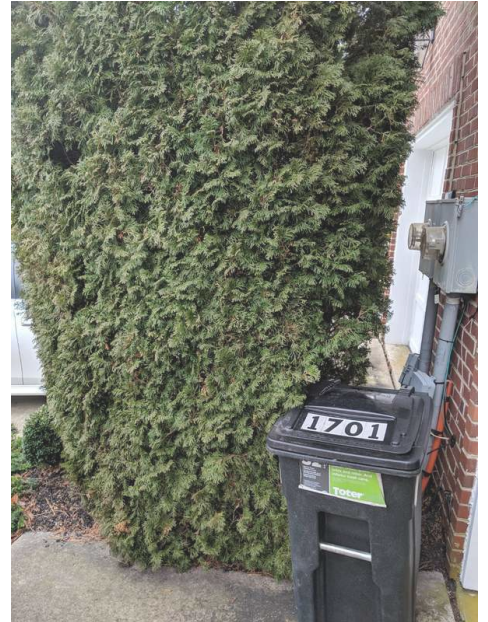
3.7.1 Vegetation, Grading, & Drainage

TREES NEAR DWELLING

Trees were observed within 10 ft of the dwelling. Trees should be more than 10ft from a home. The tree's root system can put pressure on the foundation, and exposed roots can be a trip hazard.

Recommend evaluation and correction by a qualified contractor.

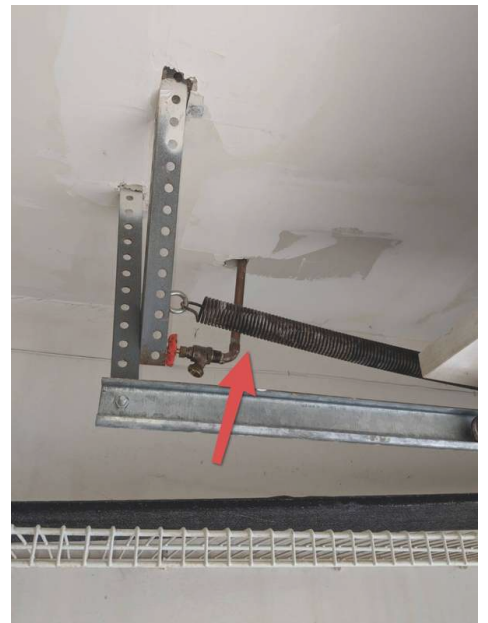
3.8.2 Garage Door

MISSING SAFETY CABLES

Installing garage door safety cables can help reduce the risk of damage and serious injury should a garage door spring break when it is under pressure. The garage door safety cable will prevent the spring from flying across the garage if it breaks. If a spring breaks it is usually when it is under pressure, and that is when it is most dangerous.

Recommend installation of safety cables by a qualified person.

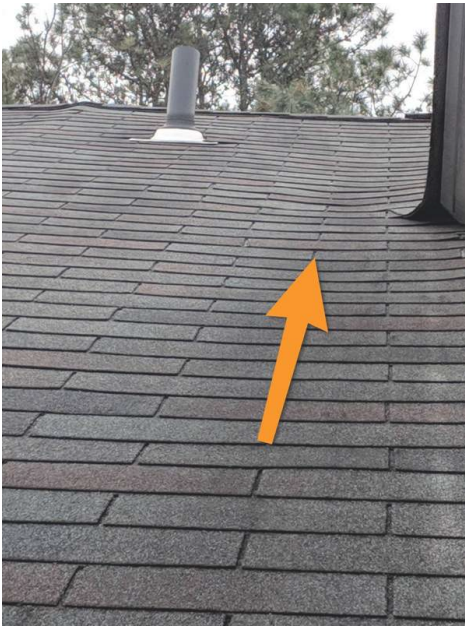
The sheathing showed visible signs of damage near the firewalls separating the dwelling units. The sheathing near the dormers also seemed to be weak and soft when the inspector was walking on the roof.

They said that the fire rated plywood deteriorates much more rapidly than normal plywood and that the plywood found in areas that are covering vaulted ceilings are prone to deterioration from lack of ventilation.

Visible dips

The inspector recommends qualified contractor assess the situation and repair as necessary.

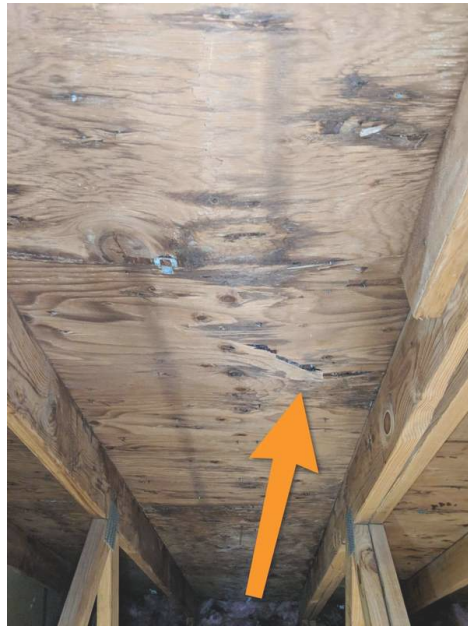
Cracked Sheathing

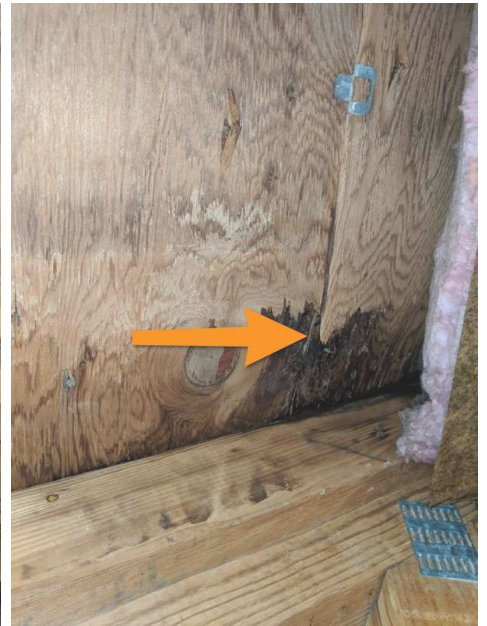
Cracked Sheathing

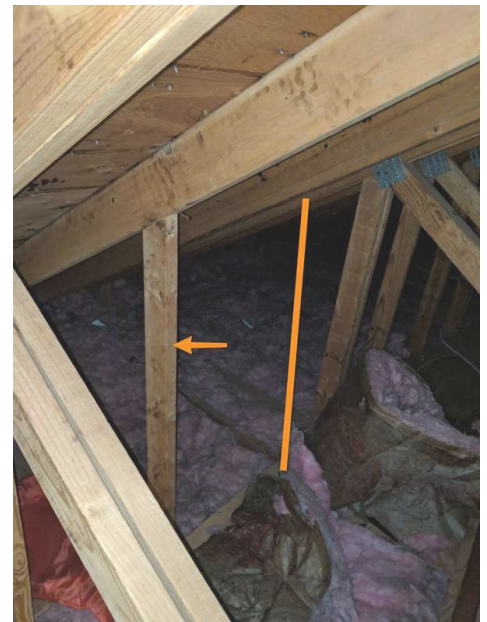
4.5.2 Roof Structure & Attic

It appears at the time of the construction certain trusses were installed to facilitate the possibility of dormers or eventual skylights.

It appears the extra supports may be installed incorrectly and missing altogether in some areas.

Arrow indicates added support. The line indicates missing support

Recommend a qualified contractor evaluate and repair as necessary

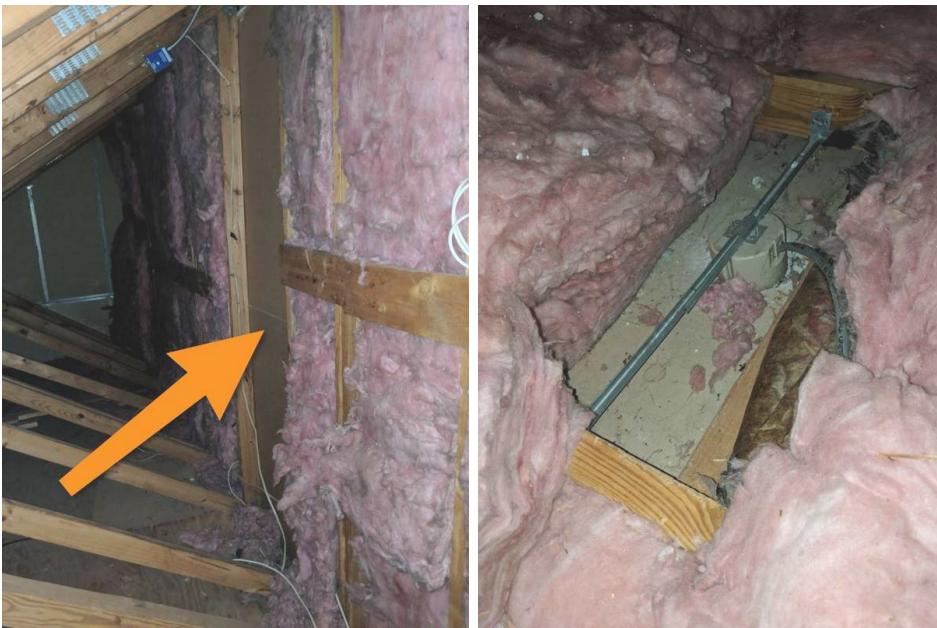
5.2.1 Attic Insulation

DISPLACED INSULATION

Insulation in one or more areas has been displaced.

This will lead to additional energy consumption.

Recommend a qualified contractor install insulation where needed.

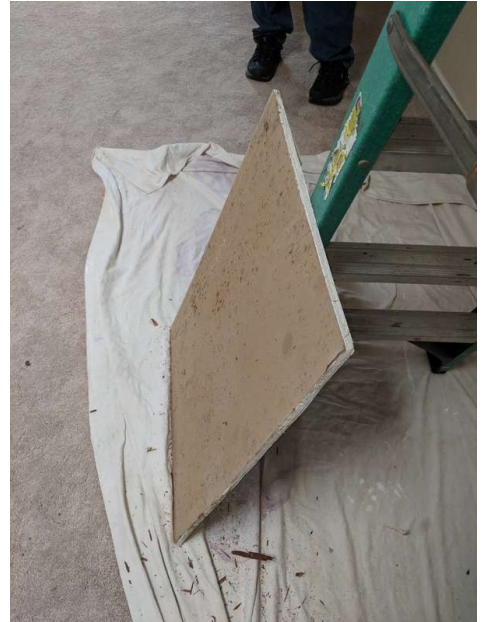
5.2.2 Attic Insulation

The attic access trap was not insulated. To reduce heat loss through this area, recommend installing an insulated access panel.

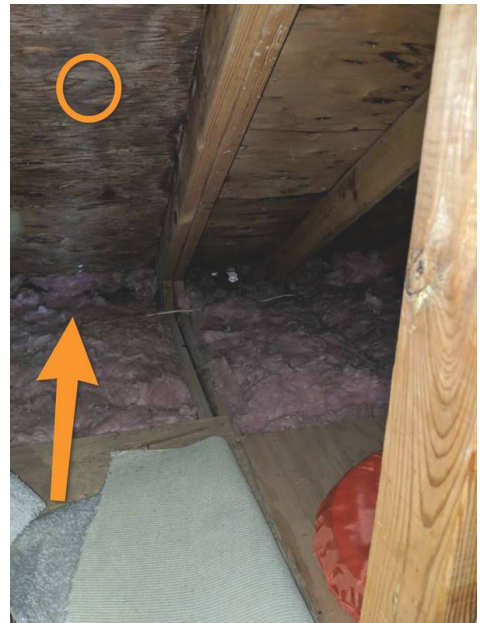
5.5.1 Ventilation

Attic venting seemed insufficient at the time of inspection.

Evidence of past condensation was visible in areas. (water stained wood)

The sheathing appeared to be deteriorated in areas where the ceiling is vaulted. (More than likely due to insufficient and/or no ventilation in these areas.)

Baffles, which permit air to flow above the insulation were missing in certain areas.

Arrow- Missing baffles Circle - Evidence of condensation (Water stains)

Nonetheless, recommend a qualified contractor evaluate and remedy.

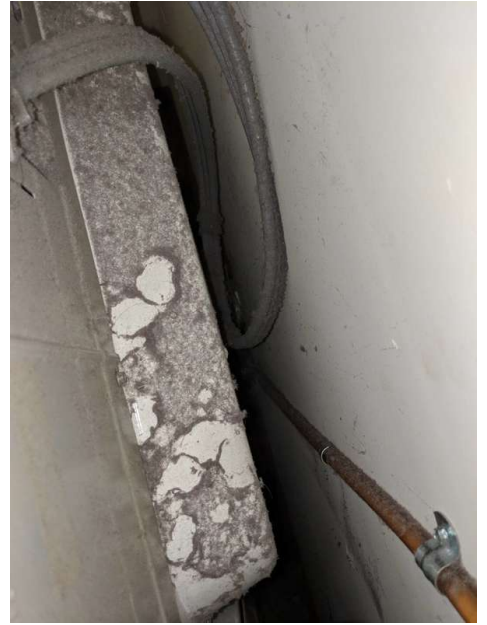
5.7.1 Exhaust Systems Dryer

DUCTS LOOSE

Excessive lint was found around the dryer, this could be a result of loose ductwork or clogged ductwork.

Recommend a qualified person evaluate repair and clean ductwork as necessary.

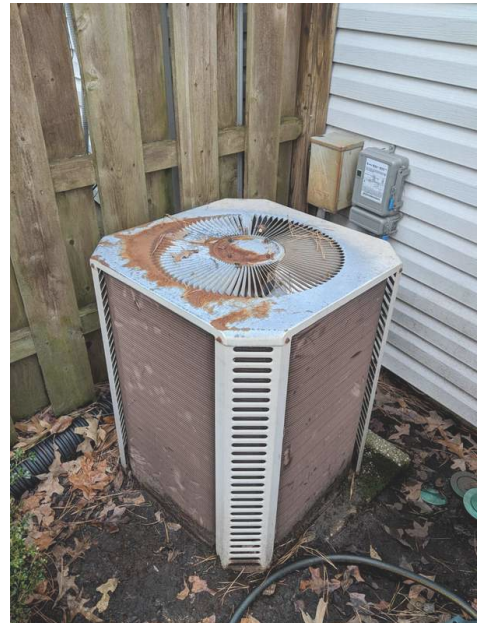
6.1.2 Cooling Equipment System 1
CONDENSER UNIT NOT ELEVATED

The pad supporting the outdoor condensing unit was not elevated enough above the ground level.

This is causing accelerated deterioration of the component.

Recommend a competent person excavate around the pad so the unit is not in contact with dirt, leaves, or debris.

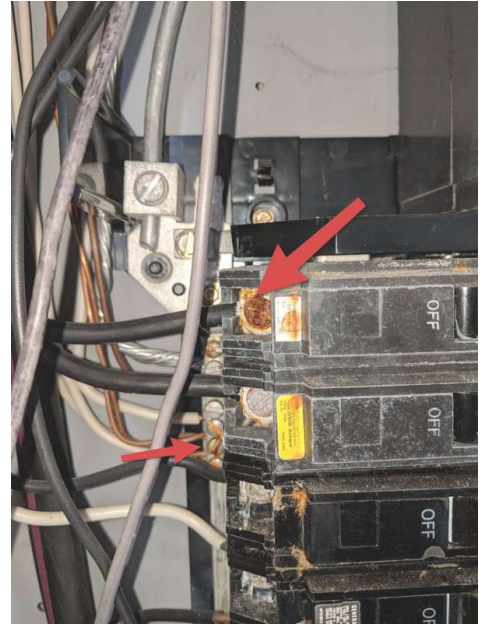
7.3.1 Main Disconnect/Panel

RUST IN PANEL

Corrosion was observed in the panel. Moisture can deteriorate the electrical equipment. This is a fire hazard.

Recommend that a licensed electrician inspect and repair as necessary.

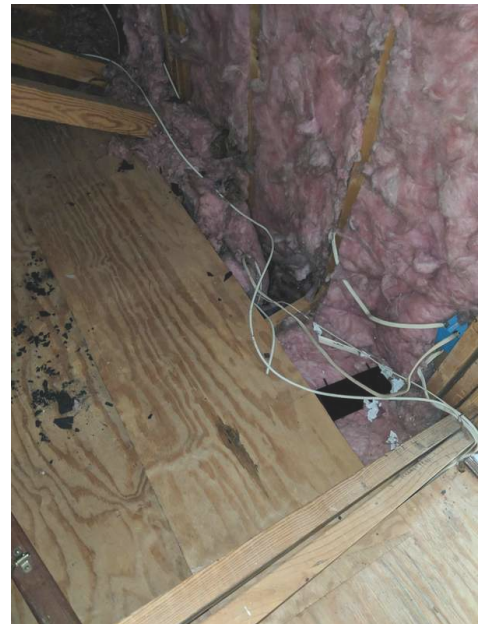
7.4.1 Branch Circuit Conductors

IMPROPER WIRING (SUPPORT)

Improper wiring (wires and electrical boxes not supported or attached correctly) was observed at the time of inspection in the attic. This can be a shock hazard. Recommend a licensed electrician evaluate the whole house and make necessary repairs.

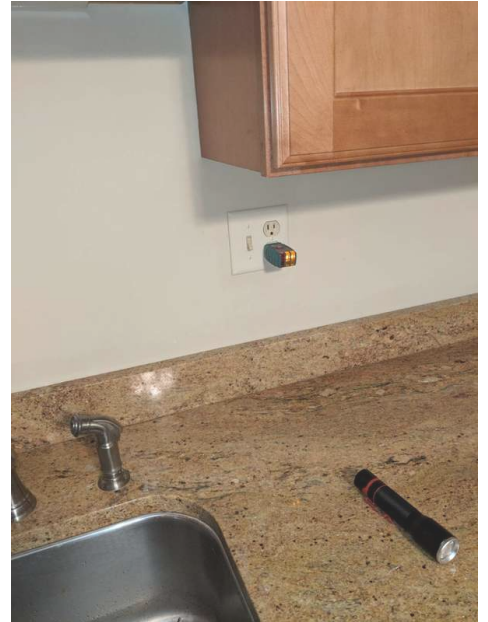
7.7.1 GFCI

NO GFCI PROTECTION INSTALLED

No GFCI protection present in the kitchen.

Recommend licensed electrician upgrade by installing ground fault receptacles in all places required by current standards.

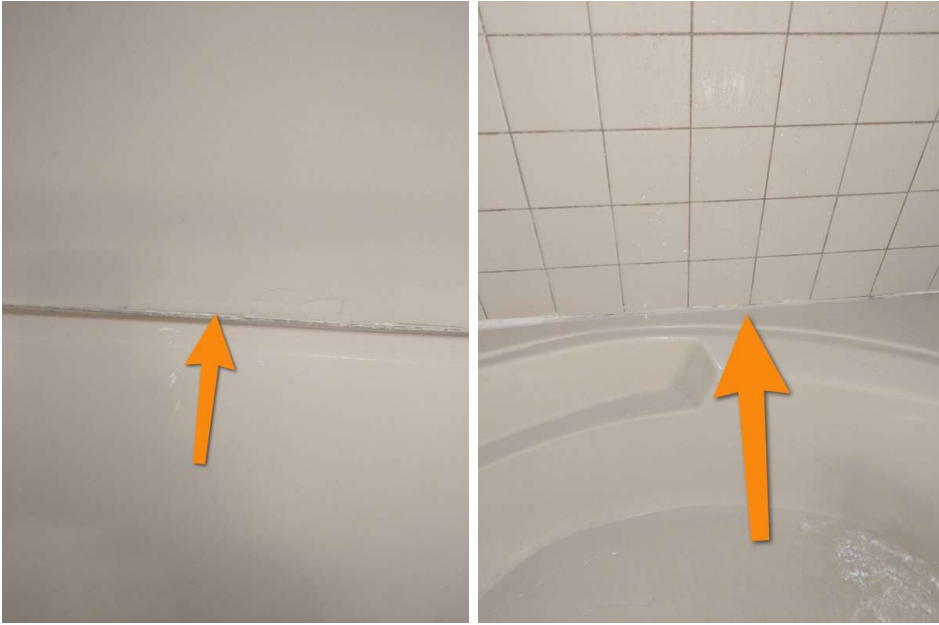
9.4.1 Fixtures / Faucets

BATHTUB NEEDS CAULKING

The caulking in the bathroom tubs second-floor main bathroom and master bathroom are deteriorated.

To prevent water from entering the wall cavity, recommend recaulking by a qualified person

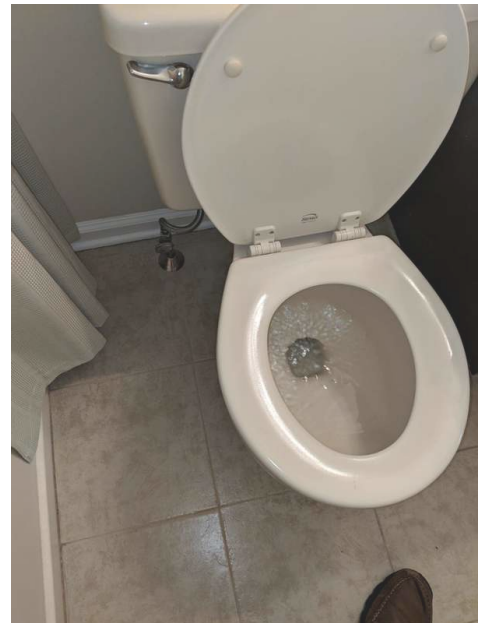
9.4.2 Fixtures / Faucets

TOILET NOT SECURED WELL

The toilet in the main bathroom 2nd floor was not secured well and have a little movement. Recommend a qualified plumber secure the toilet

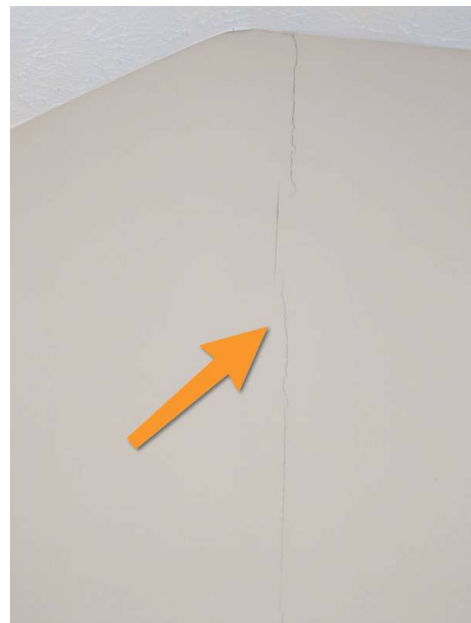
10.1.1 Walls

SHEETROCK CRACK

A crack along sheetrock seams in the wall was visible at the time of the inspection.

This problem is often reoccurring and very common when sheetrock is fixed directly to wood framing members.

Recommend repair by a qualified contractor

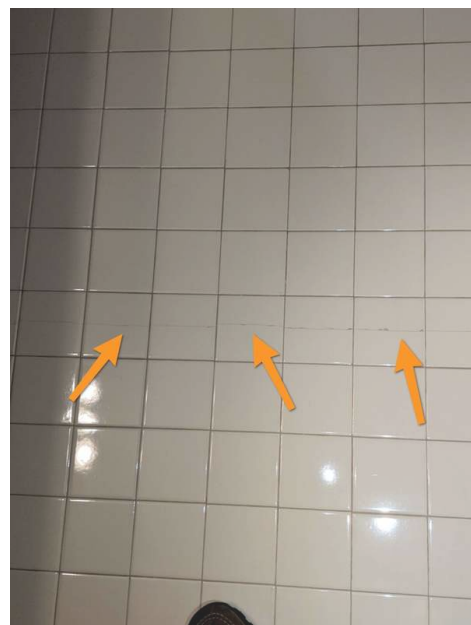
10.3.1 Floors

TILES CRACKED

The floor tiles in the bathroom had cracks.

Recommend repair by a qualified person.

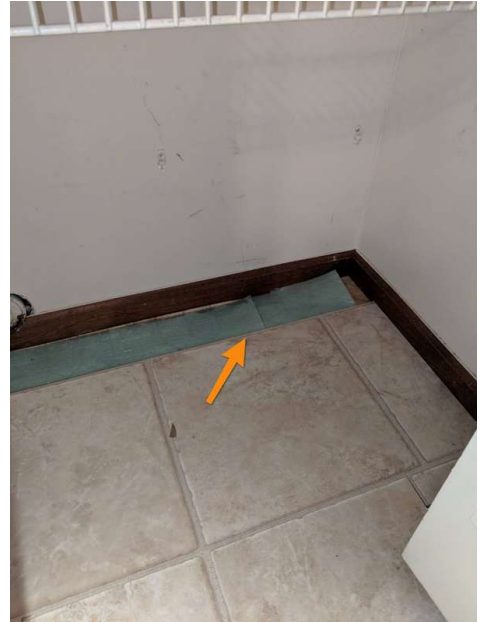
10.3.2 Floors

MISSING FLOORING

Laminate flooring was missing in the broom closet (kitchen)

Recommend installation by a qualified person.

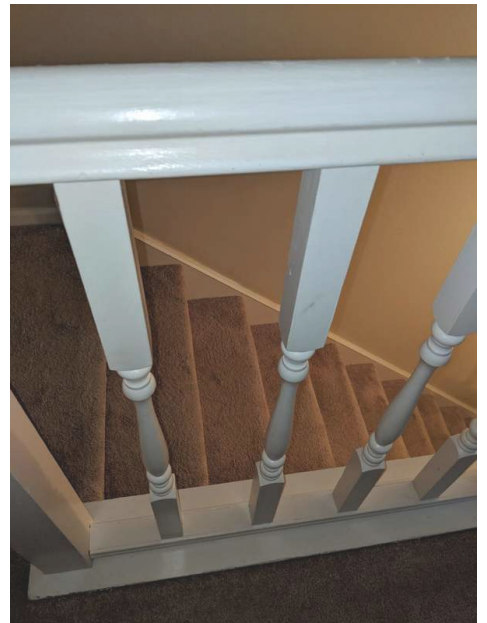
10.4.1 Steps, Stairways & Railings

BALUSTER SPACES TOO WIDE

The baluster space is not up to modern safety standards. The space between balusters should not allow passage of a 4 inch sphere for child safety. Recommend a qualified contractor repair and bring up to current standards.

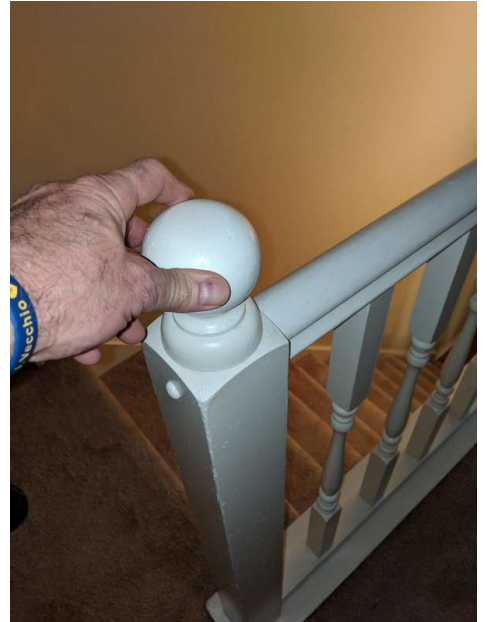
10.4.2 Steps, Stairways & Railings

LOOSE POST

A stair case post was becoming loose. This could eventually pose a safety hazard.

Recommend a qualified handyman evaluate and repair.

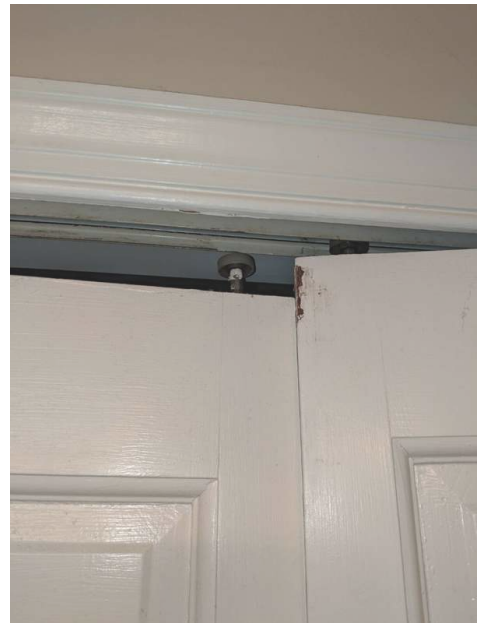
10.5.1 Doors

BI-FOLD DOOR NEEDS ADJUSTMENT

Bi-fold door was not operating correctly and needs adjustments by a competent person.

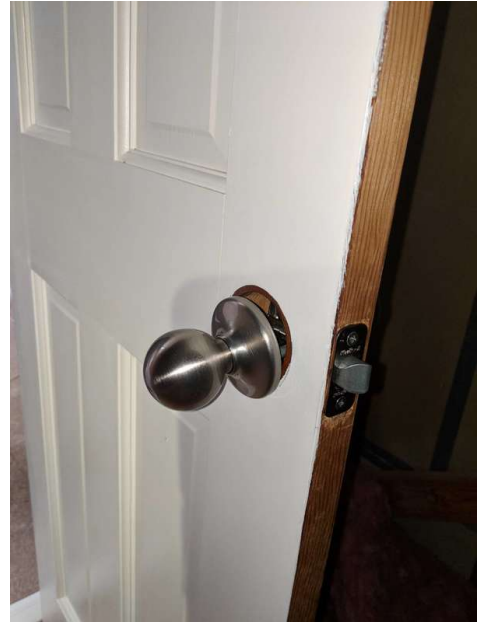
10.5.2 Doors

DOORKNOB LOOSE

The door to the attic area had a doorknob that was loose and needs to be tightened by a qualified person.
