SUMMARY

1234 Main St. Guyton GA 31312

Kelly Steckler
ICA Certified
K & M Home Inspections
702-375-5964
kelly.j.steckler@gmail.com

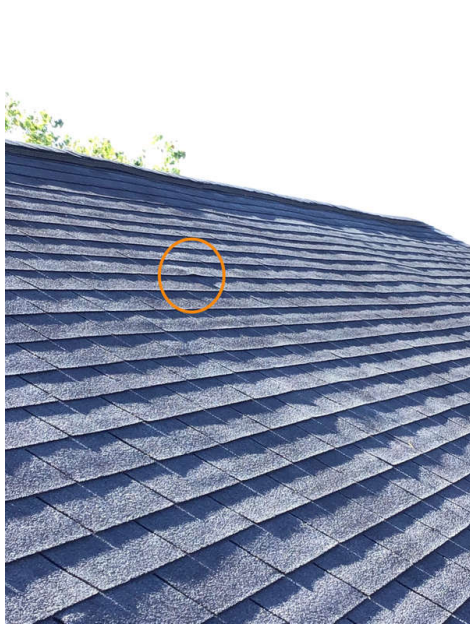
2.1.2 Coverings

UNDER-DRIVEN NAILS

Observed one or more under-driven nails/fasteners. Recommend a qualified roofing contractor evaluate and repair.

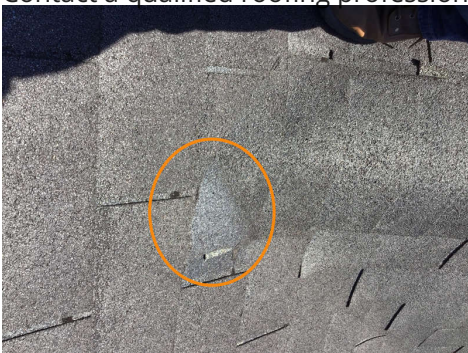
2.1.3 Coverings

CREASED OR TORN TAB DAMAGE (WIND)

The roof had areas of wind damage such as broken adhesive strips and creased or torn shingle tabs. The Inspector recommends replacement of the damaged shingles by a qualified roofing contractor to avoid damage from moisture intrusion.

Contact a qualified roofing professional.

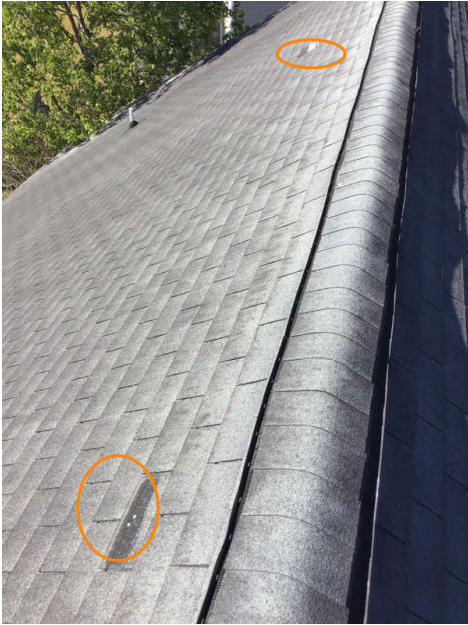
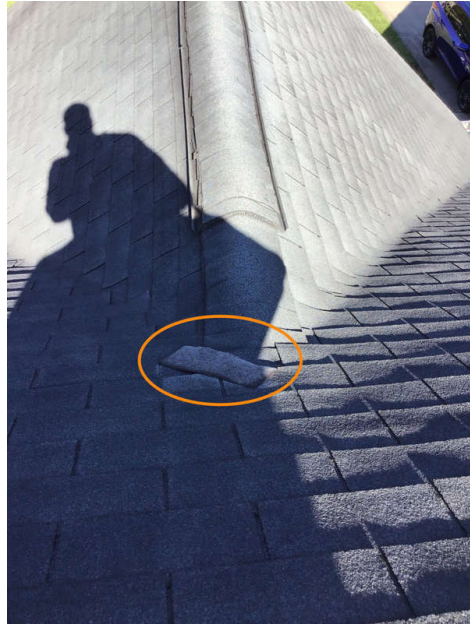
2.1.4 Coverings

LOOSE OR MISSING SHINGLES

I recommend replacement of any loose or missing shingles to avoid damage from moisture intrusion by a qualified roofing contractor.

Contact a qualified roofing professional.

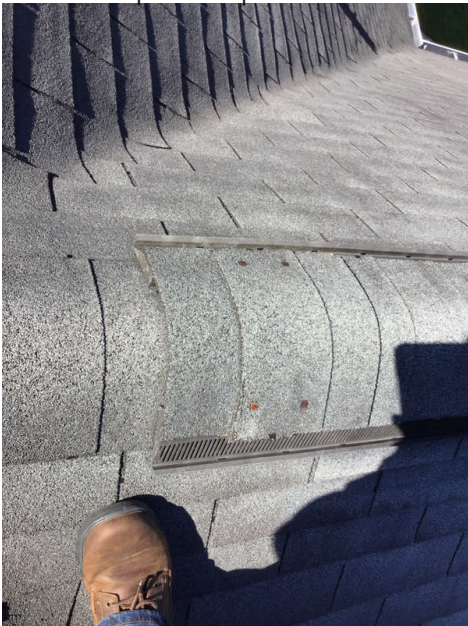
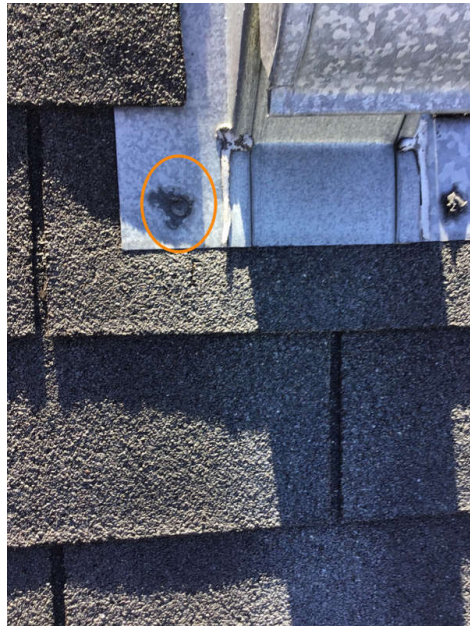
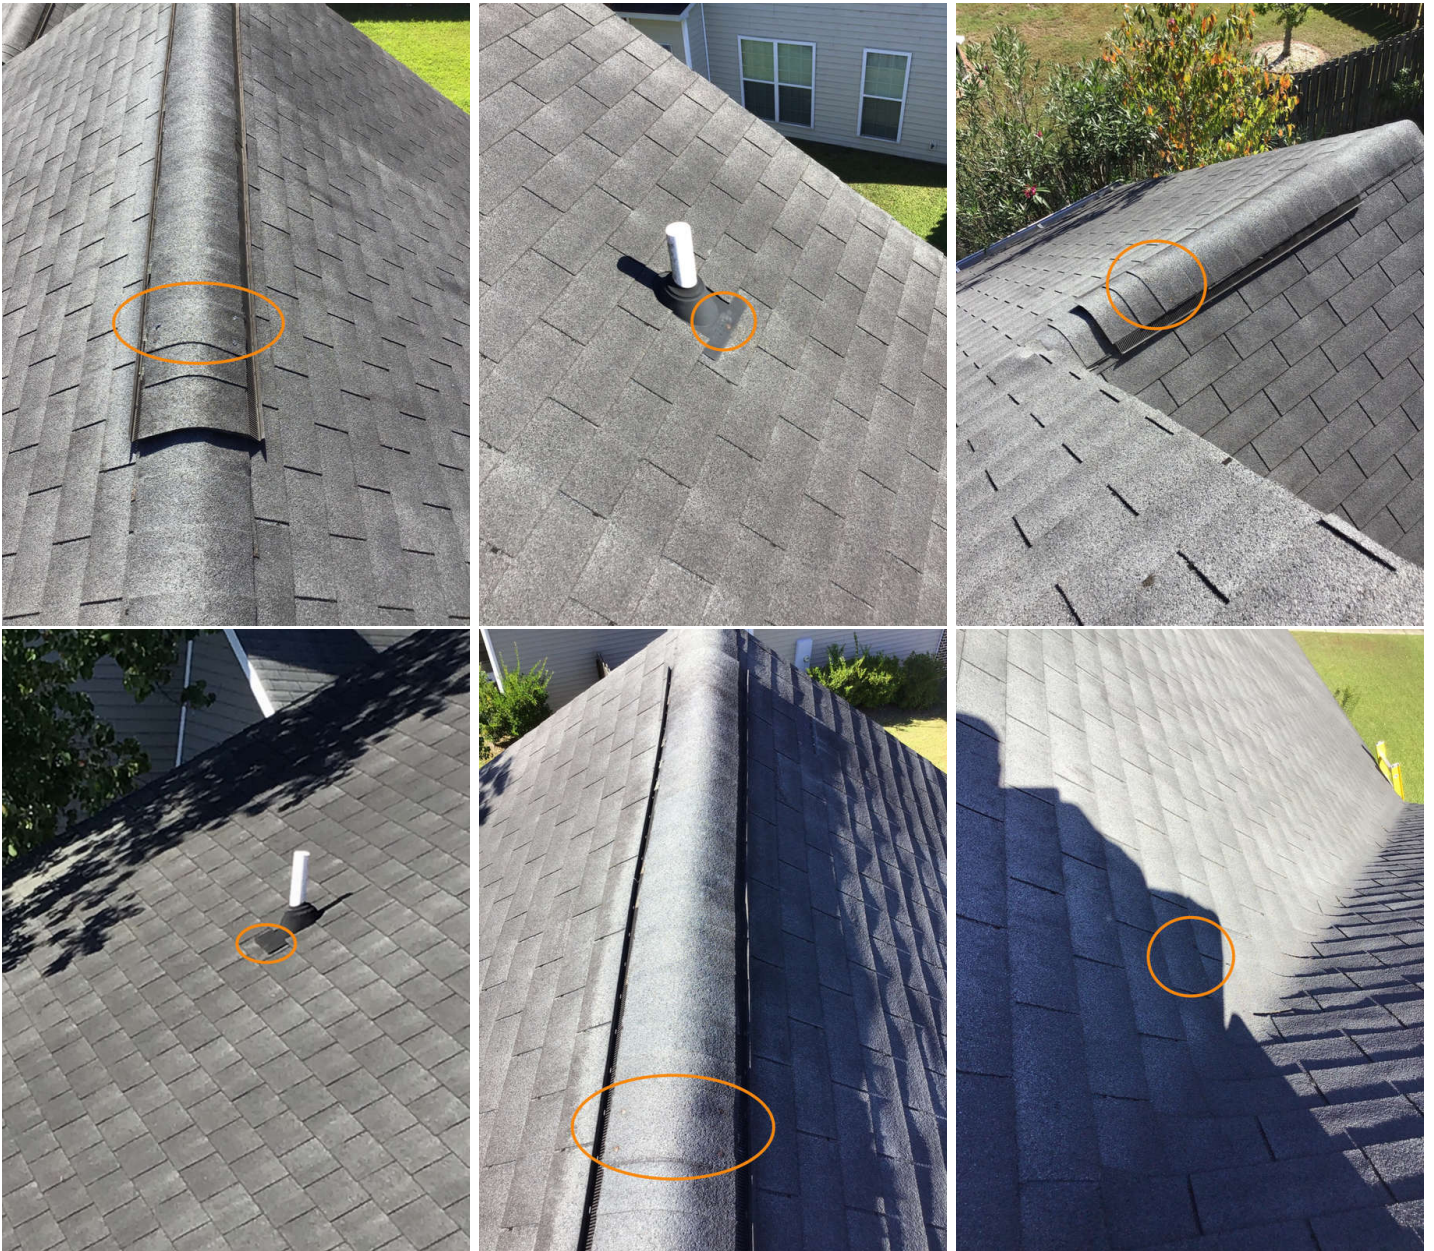
2.1.5 Coverings

EXPOSED NAILS

Exposed nails allows for water penetration to underlying stricter.

Contact a qualified professional.

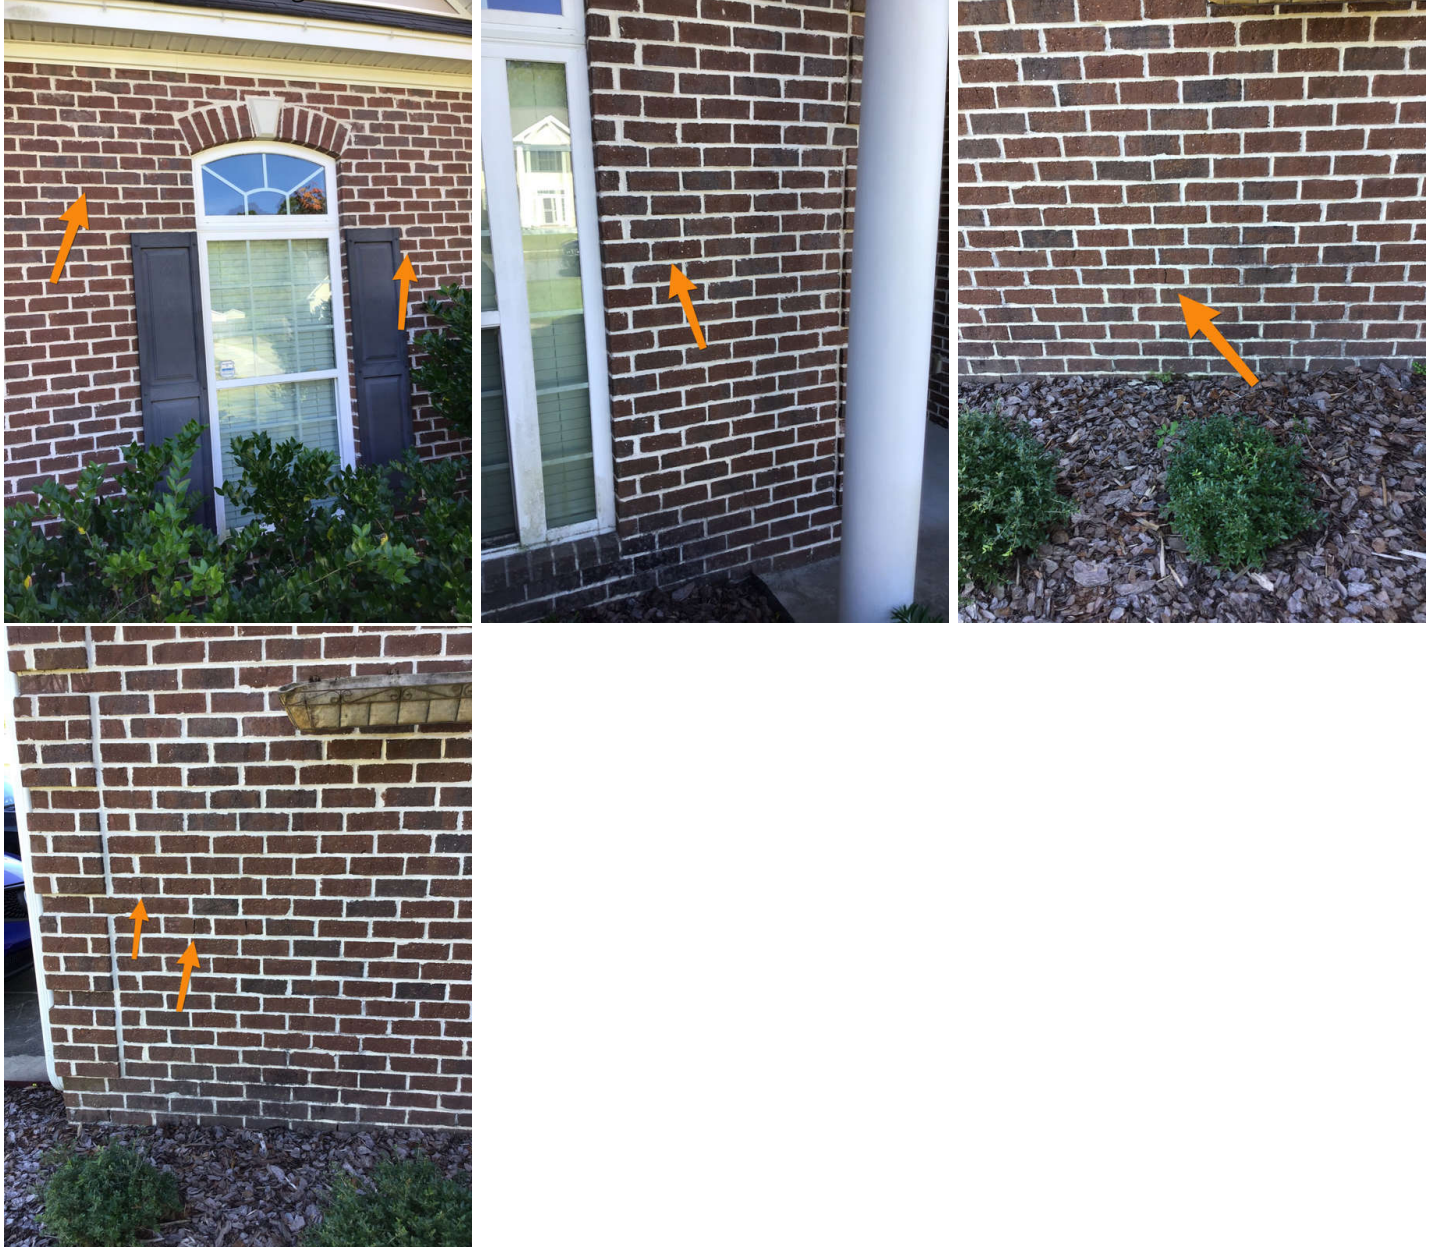
3.1.1 Siding, Flashing & Trim

CRACKING - MINOR

Siding showed cracking in one or more places. This is a result of temperature changes, and typical as homes with age. Recommend monitoring.

Recommendation
Recommend monitoring.

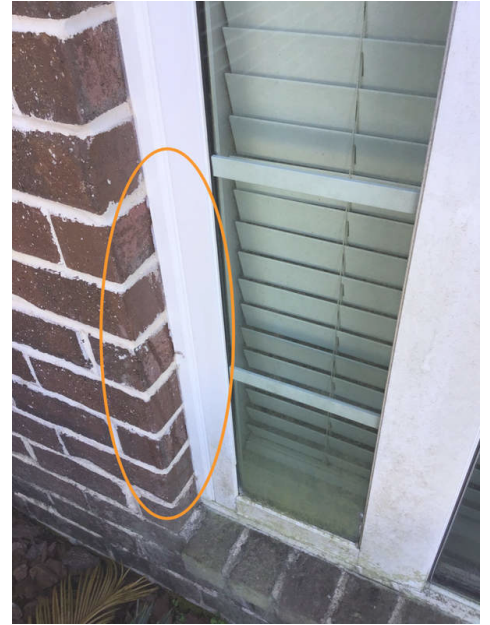
3.1.3 Siding, Flashing & Trim

GAPS AT EXTERIOR WALL PENETRATIONS

At the time of the inspection, gaps were noticed around the exterior of the home. These gaps are usually around pipes associated with faucets, drains, HVAC lines, gas/electrical. These areas should be sealed to protect the home from moisture penetration and pest infestations.

Contact a handyman or DIY project

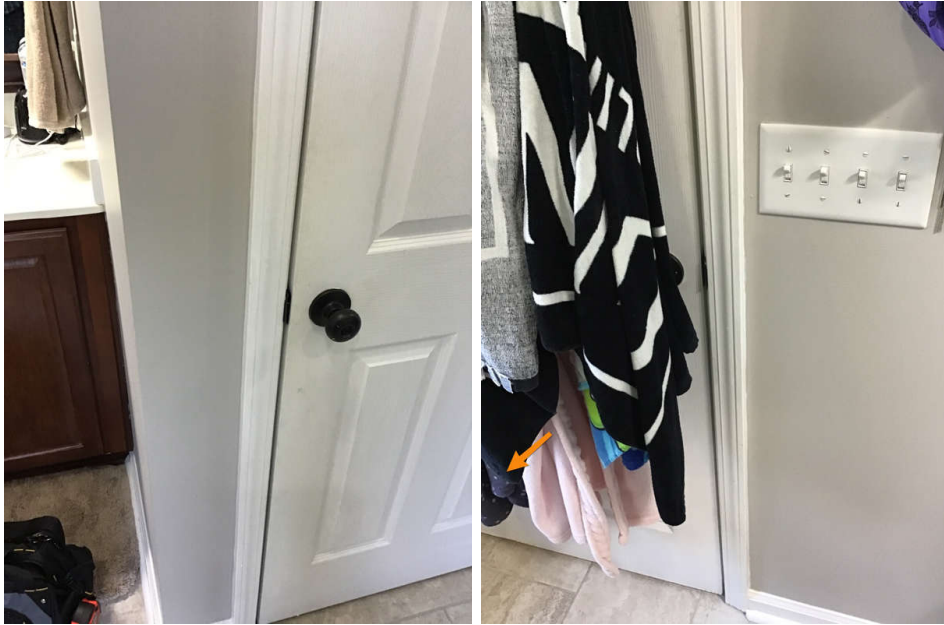
11.1.1 Doors

DOOR DOESN'T LATCH

Door doesn't latch properly. Recommend handyman repair latch and/or strike plate.

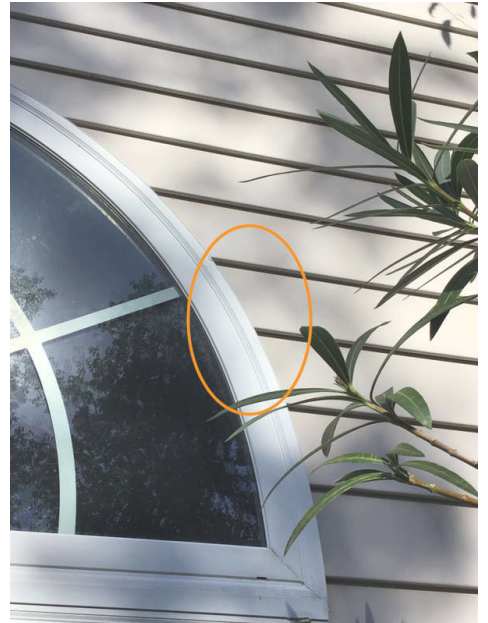
11.2.1 Windows

DAMAGED

One or more windows appears to have general damage, but are operational. Recommend a window professional clean, lubricate & adjust as necessary.
