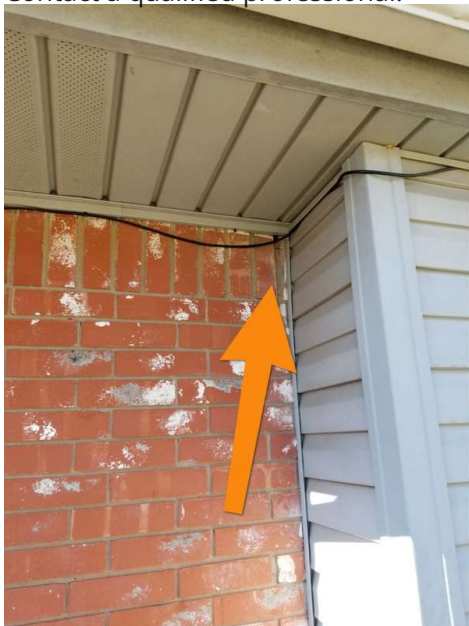
2.1.1 Exterior Walls & Trim

BRICK - REPOINT NEEDED/CRACKED/DAMAGED

FRONT OF HOME NEXT TO MASTER BED WINDOW.

Joints in the masonry have deteriorated and should be repointed. (Repointing is the restoration of the mortar joints in the masonry).

Contact a qualified professional.

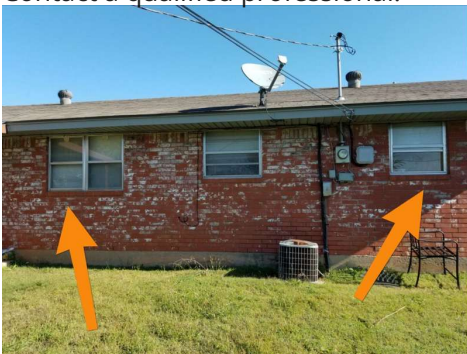
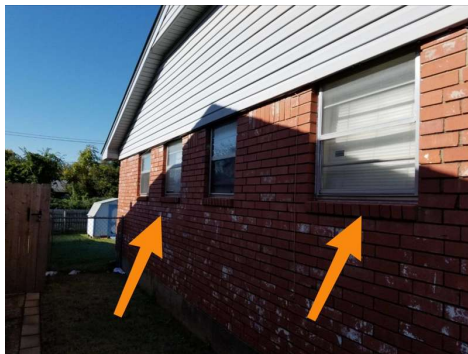
2.3.1 Windows

MISSING SCREEN OR DAMAGED

REAR AND SIDE OF HOME.

Missing screen or damaged at windows

Contact a qualified professional.

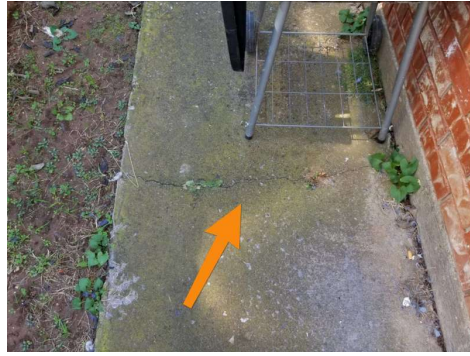
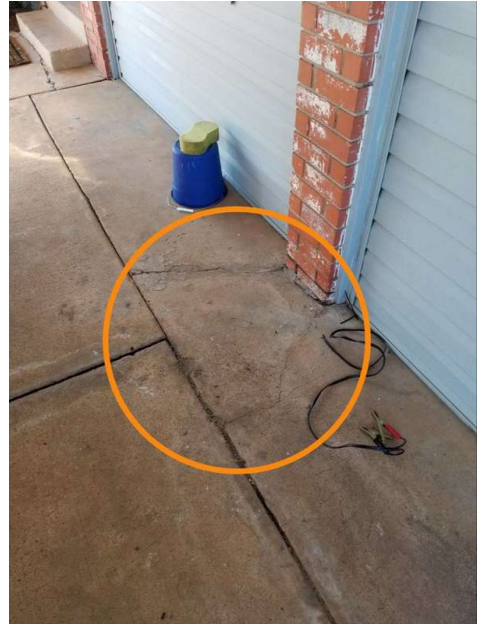
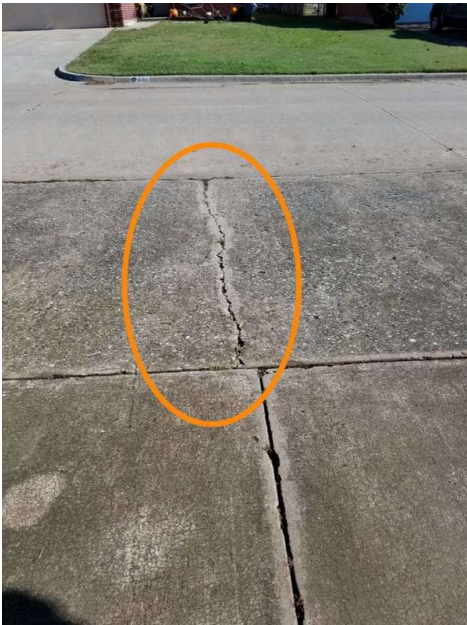
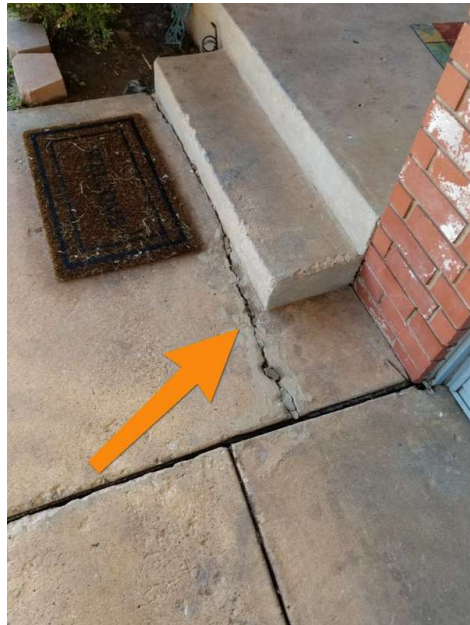
2.4.1 Walkways, Patios & Driveways

CRACKING - MINOR

REAR, FRONT AND SIDE OF HOME.

Minor cracks observed, Recommend patching/sealing and monitor cracks. This is also a potential trip hazard. Should crack widen, recommend contacting a qualified professional.

Recommend monitoring.

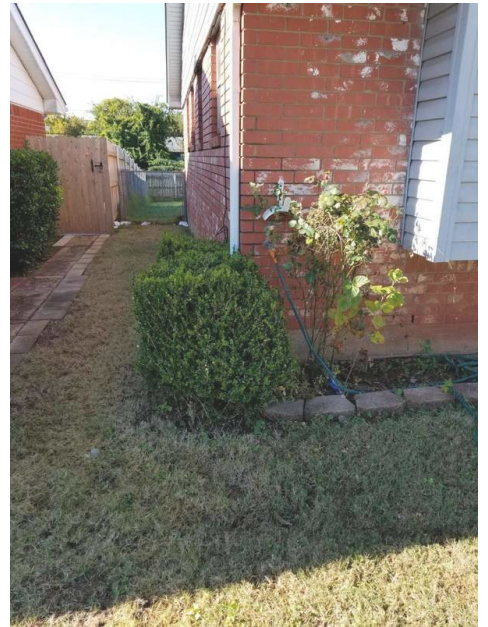
2.7.1 Vegetation, Grading, Drainage & Retaining Walls

VEGETATION NEAR HOME

FRONT OF HOME.

Recommend to remove vegetation that is in contact with exterior of home. This can allow ants/critters to enter the home.

Recommendation
Recommended DIY Project

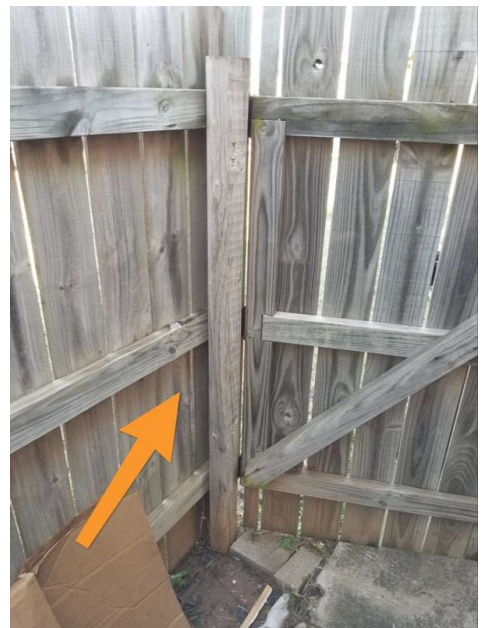
2.8.1 Fences/Gates

FENCE REPAIR

MAIN POST SUPPORTING GATE TO BACK YARD.

Fences and/or gates are damaged and/or deteriorated in some areas. A qualified contractor should evaluate and make repairs or replace sections as necessary.

Recommendation
Contact a qualified fencing contractor

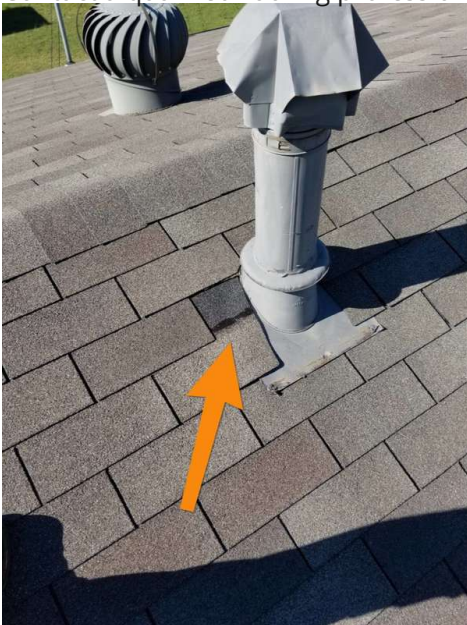
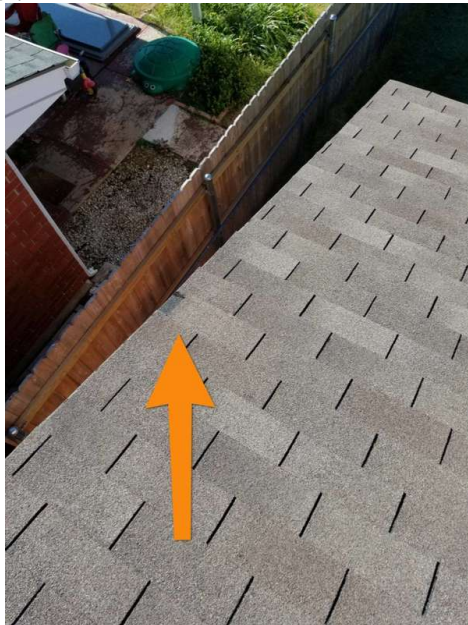
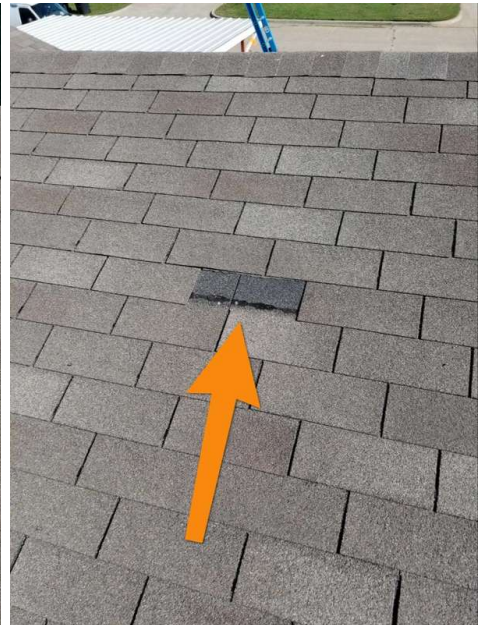
3.2.2 Roof Coverings

SHINGLES MISSING

Observed areas that appeared to be missing sufficient coverings. Recommend qualified roofing contractor evaluate & repair.

Contact a qualified roofing professional.

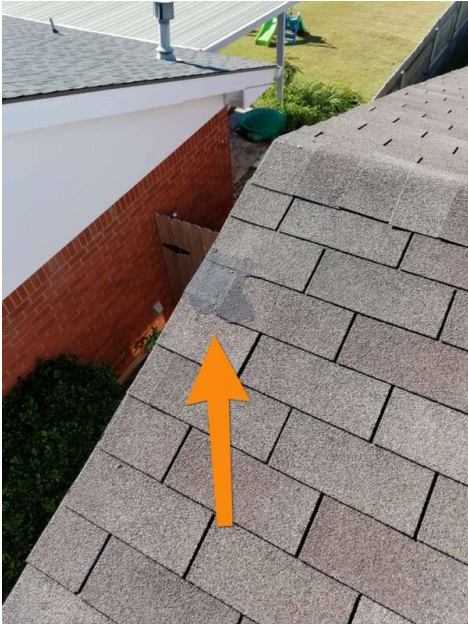
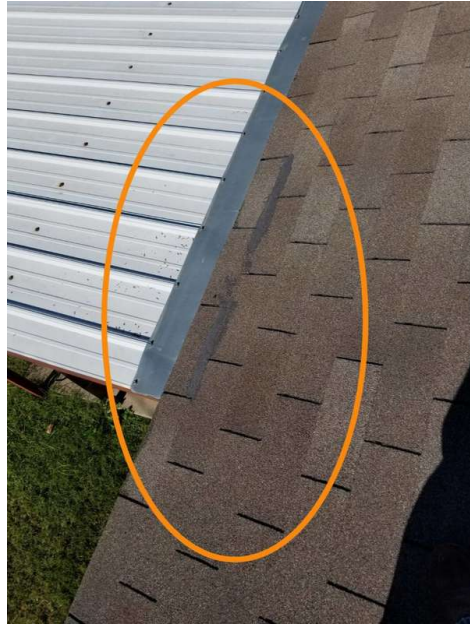
3.2.3 Roof Coverings

PREVIOUS REPAIR

Evidence of previous repair to shingles was apparent. Recommend asking seller if repair work was performed and why.

Recommend monitoring.

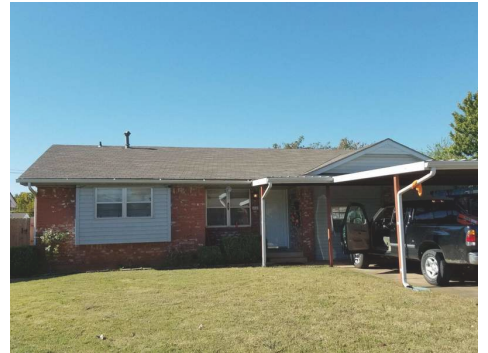
3.2.4 Roof Coverings
MULTIPLE LAYERS

Multiple layers of shingles were observed. This may add excess weight to the structure and may also void the manufacturers warranty.

Recommendation
Contact a qualified roofing professional.

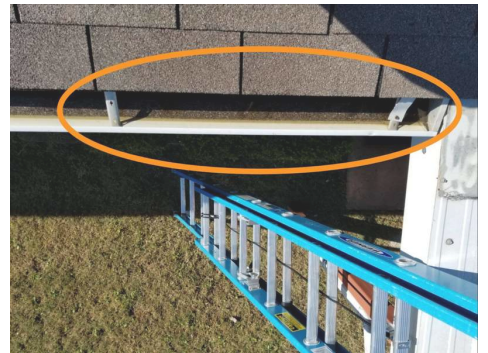
3.3.1 Roof Drainage Systems
DEBRIS

FRONT OF HOME.

Debris has accumulated in the gutters. Recommend cleaning to facilitate water flow. Here is a DIY resource for cleaning your gutters.

Recommendation
Contact a handyman or DIY project

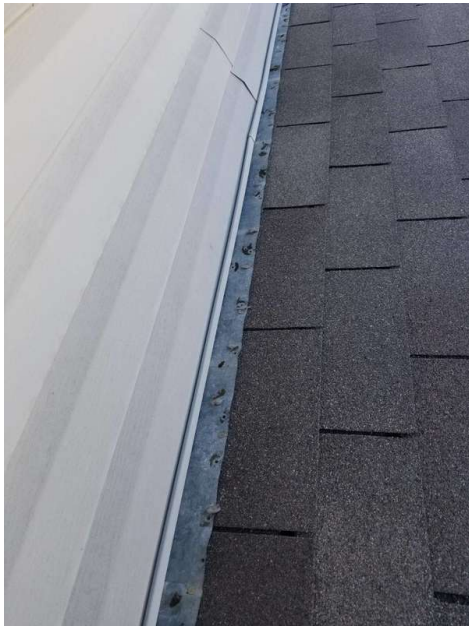
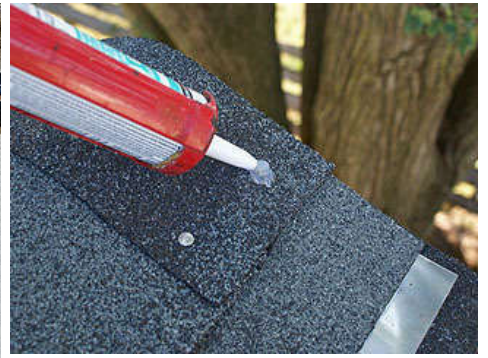
3.5.1 Flashings
CAULK NAIL HEADS

ABOVE CARPORT.

As part of ongoing home maintenance, recommend caulking/sealing nail heads.

Recommendation
Contact a qualified professional.

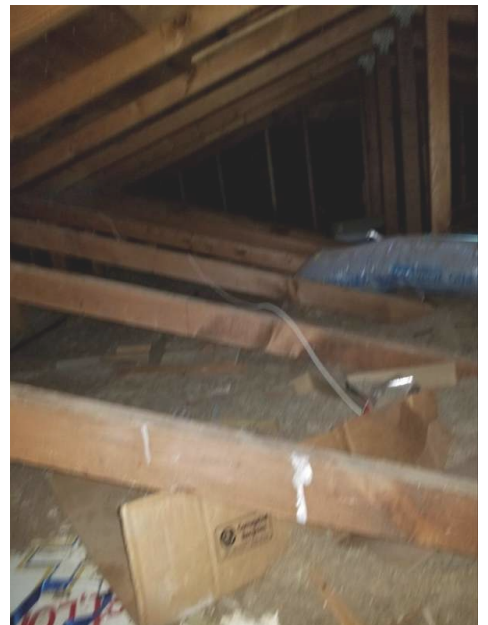
3.7.1 Attic Insulation

INSUFFICIENT INSULATION

Insulation depth was inadequate in comparison to current industry standards and building energy efficiency guidelines. Recommend a qualified attic insulation contractor install additional insulation.

Contact a qualified insulation contractor.

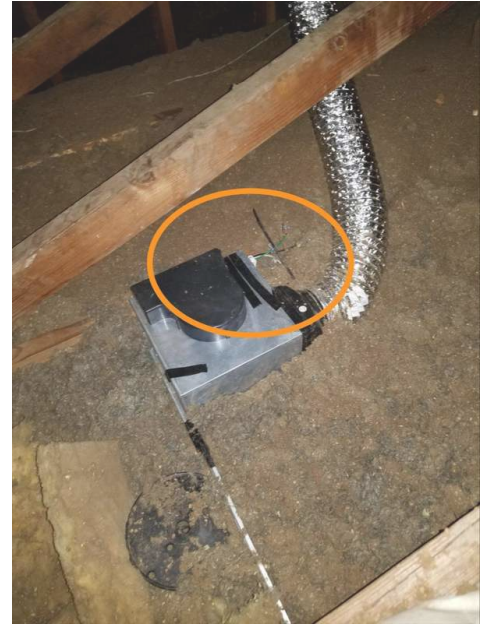
3.9.2 Exhaust Systems

EXHAUST FAN WIRING

GUEST BATHROOM

Electrical wiring connection for exhaust fan in bathroom should be contained in an approved junction box. Recommend repair.

Contact a qualified electrical contractor.

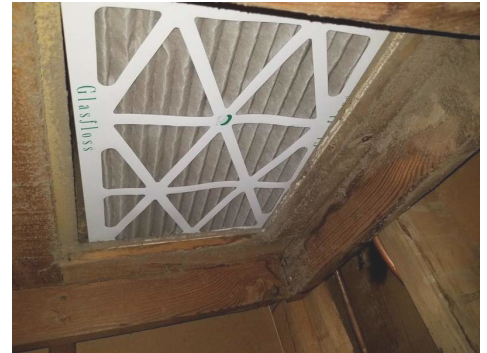
5.1.1 Equipment

FILTER DIRTY

The furnace filter is dirty and needs to be replaced per the manufacturer recommendations.

Contact a handyman or DIY project

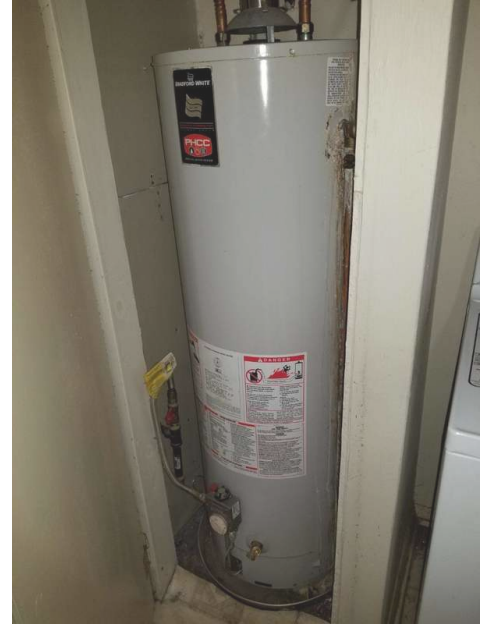
7.3.1 Hot Water Systems, Controls, Flues & Vents

NEAR END OF LIFE

Water heater showed normal signs of wear and tear. Recommend monitoring it's effectiveness and replacing in the near future. The average life expectancy of a water heater is 6-12 years.

Recommendation
Recommend monitoring.

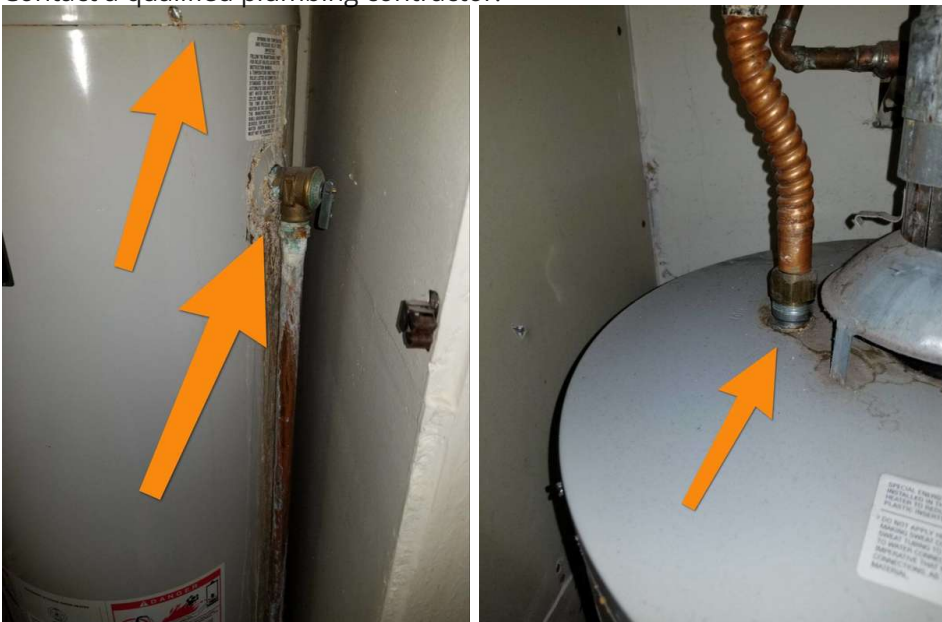
7.3.2 Hot Water Systems, Controls, Flues & Vents

CORROSION

SIDE AND TOP OF WATER HEATER

Corrosion was noted at pipe fitting on water heater. Recommend a qualified plumber evaluate for repair/replacement.

Recommendation
Contact a qualified plumbing contractor.

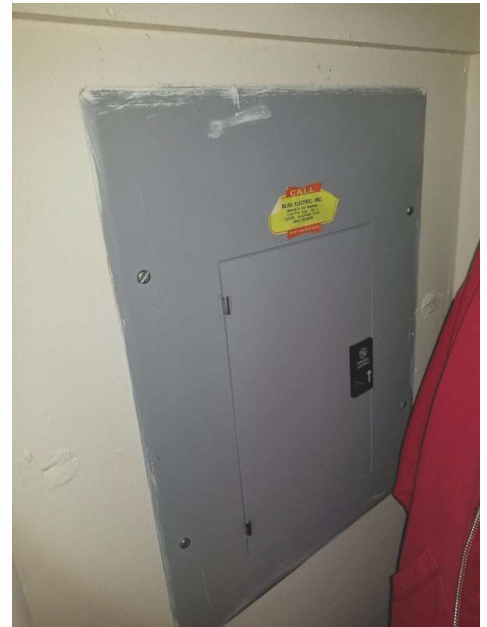
8.1.1 Main & Subpanels, Service & Grounding, Main Overcurrent Device

MISSING LABELS ON PANEL

At the time of inspection, panel was missing labeling. Recommend a qualified electrician or person identify and map out locations.

Recommended DIY Project

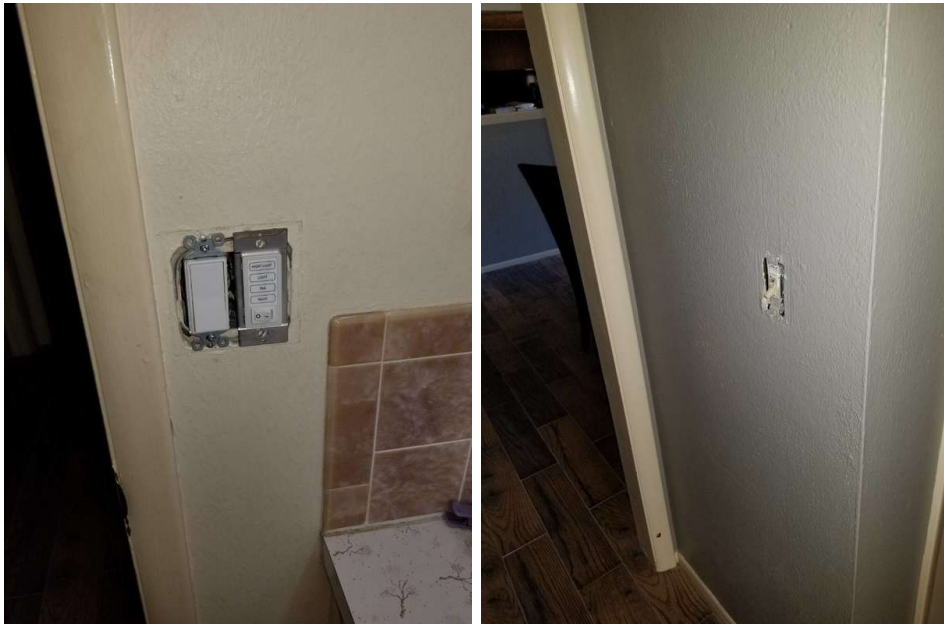
8.3.2 Lighting Fixtures, Switches & Receptacles

COVER PLATES MISSING

HALLWAY AND GUEST BATHROOM.

One or more receptacles are missing a cover plate. This causes short and shock risk. Recommend installation of plates.

Contact a qualified electrical contractor.

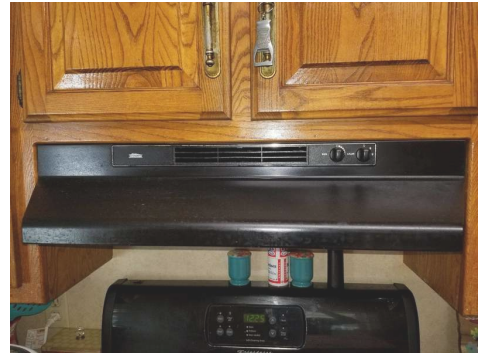
9.11.1 Ventilation

FAN RECIRCULATES

The exhaust fan over the range recirculated the exhaust air back into the kitchen. This may be due to no duct being installed, baffles not being installed, or problems with duct work. This can be a nuisance for odor and grease accumulation. Where a gas-fired range or cook top is installed, carbon monoxide and excessive levels of moisture can accumulate in living spaces. Recommend that a qualified contractor evaluate and repair as necessary so exhaust air is ducted outdoors.

Contact a qualified professional.

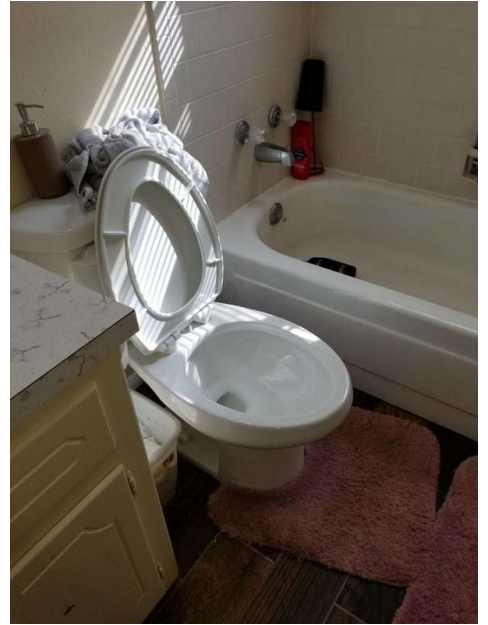
12.3.2 Plumbing & Fixtures

TOILET - LOOSE BOWL

Toilet was not securely fastened to the floor. Recommend a qualified plumber repair.

Contact a qualified plumbing contractor.

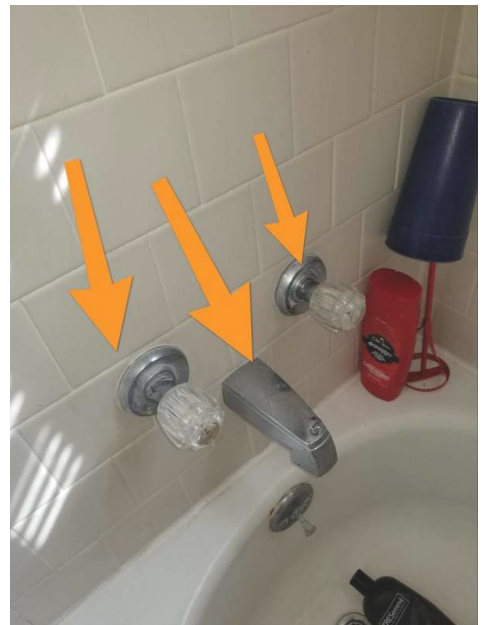
12.3.3 Plumbing & Fixtures

CAULKING AT TUB SPOUT

Caulking at spout area is in need of repair. Recommend caulking as part of preventative home maintenance.

Contact a handyman or DIY project

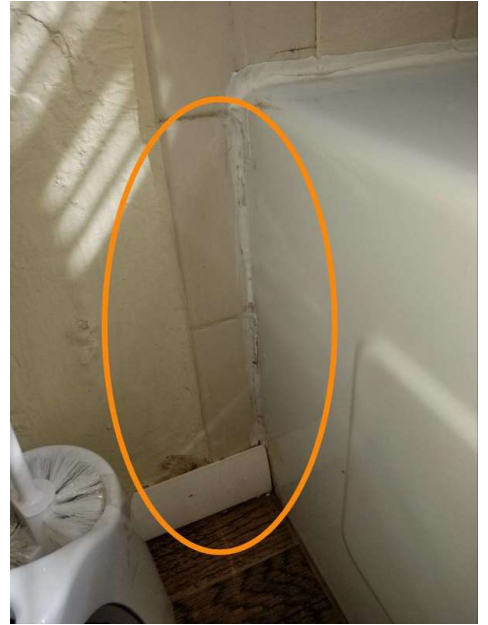
12.3.4 Plumbing & Fixtures

CAULKING AT TUB/WALL AREA

Recommend caulking at intersection of wall and tub to prevent moisture intrusion.

Contact a handyman or DIY project

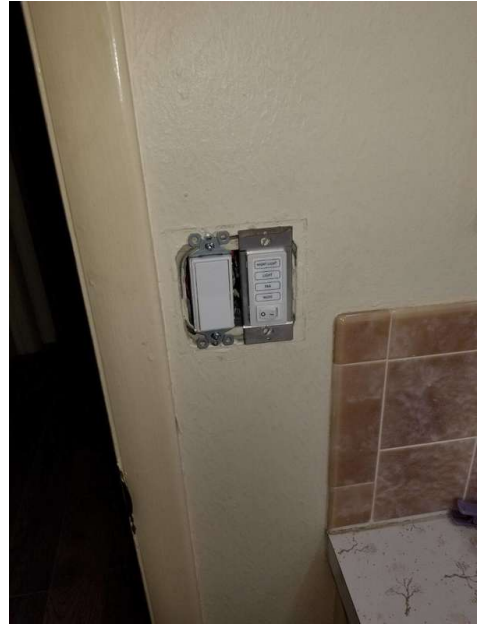
12.4.2 Electrical & Other
COVER PLATES MISSING

One or more receptacles are missing a cover plate. This causes short and shock risk. Recommend installation of plates.

Contact a qualified electrical contractor.
