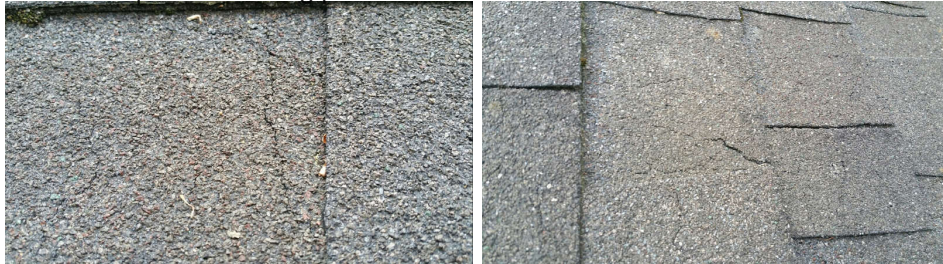
2.1.1 Coverings

ROOF IS NEAR THE END OF SERVICE LIFE

The roof is near the end of its service life. It's showing signs of wear and cracking is visible in places.

Contact a qualified roofing professional.

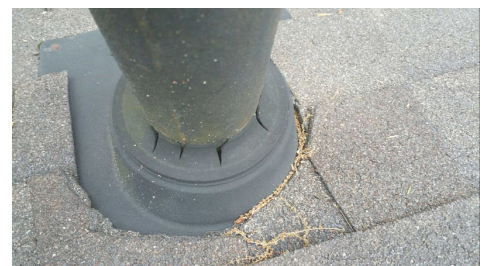
2.3.2 Flashings

PLUMBING BOOT CRACKED

The plumbing boot is cracked which can lead to moisture intrusion. Recommend further evaluation by a roofing contractor.

Contact a qualified roofing professional.

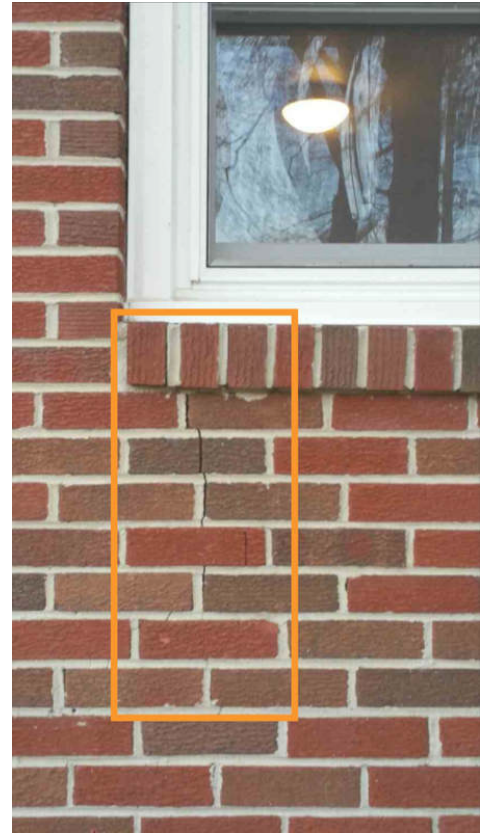
3.1.1 Siding, Flashing & Trim

CRACKING - MINOR

There was minor cracking under the kitchen window. Recommend a masonry contractor for repair.

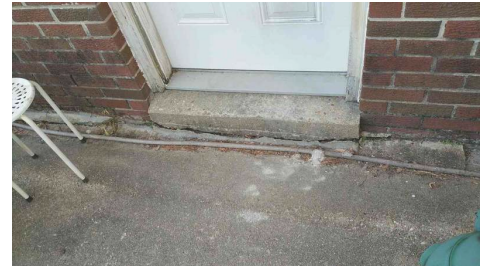
3.3.1 Driveways, Walkways, & Patios

WALKWAY SETTLING

The walkway has settled near the back door. This is likely due to the water undermining the concrete.

Recommendation
Contact a qualified professional.

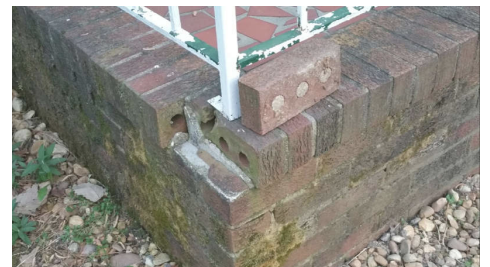
3.4.2 Decks, Balconies, Porches & Steps

LOOSE BRICK

There is a brick that has broken off the corner and should be replaced. A masonry contractor is recommended for further evaluation.

Recommendation
Contact a qualified masonry professional.

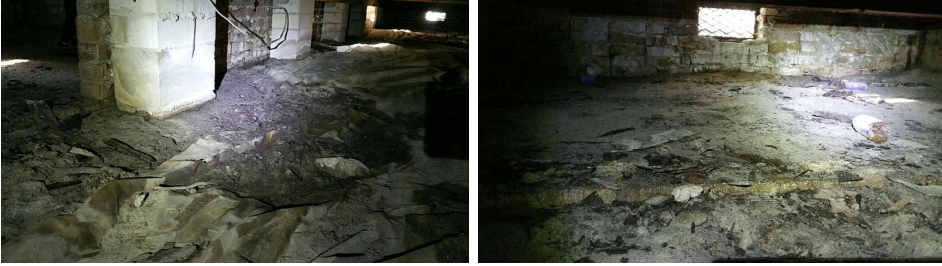
4.2.1 Crawlspace

HIGH MOISTURE LEVELS

High levels of moisture were noted in the Crawlspace near the front stoop. High moisture levels can result in mold and deterioration of the foundation and floor. Recommend a crawlspace or foundation contractor to determine a remediation plan.

Recommendation
Contact a qualified professional.

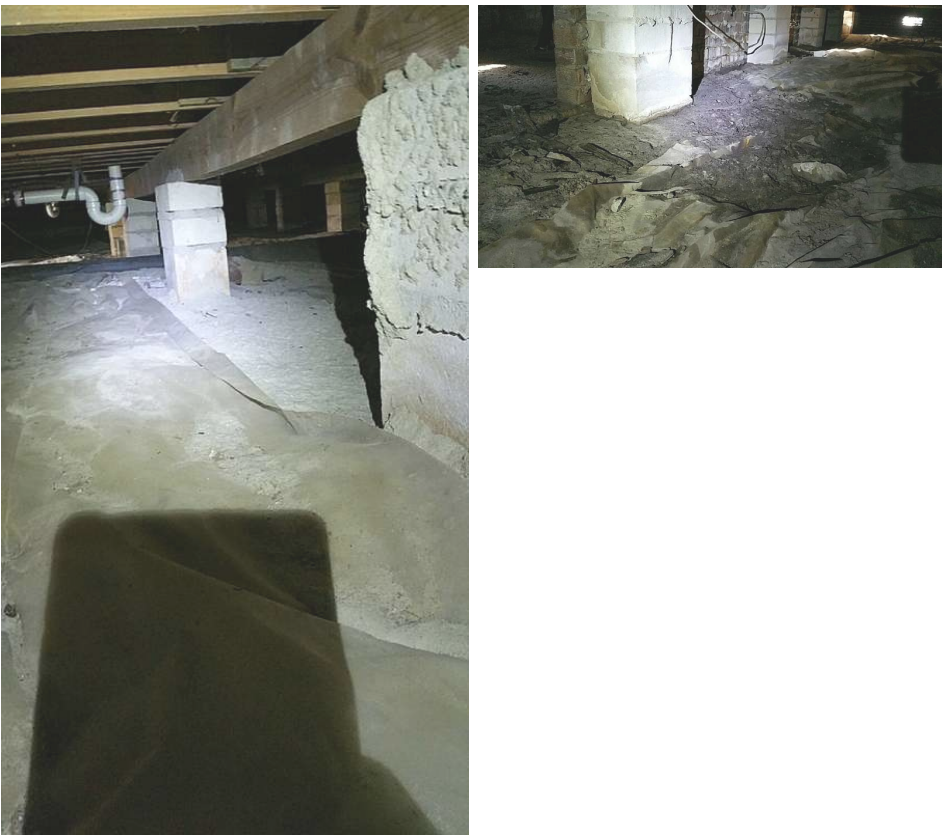
4.3.1 Vapor Retarders (Crawlspace or Basement)

VAPOR BARRIER DAMAGED AND INADEQUATE

The vapor barrier is damaged and there are also gaps limiting coverage. Recommend insulation contractor repair or replace.

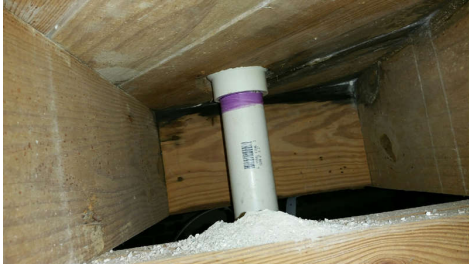
4.4.1 Floor Structure

EVIDENCE OF PRIOR LEAKS

There was evidence of prior leaks below the bathtub of the hallway bathroom. Recommend monitoring and contact a licensed plumber if it gets worse.

Recommendation
Contact a qualified plumbing contractor.

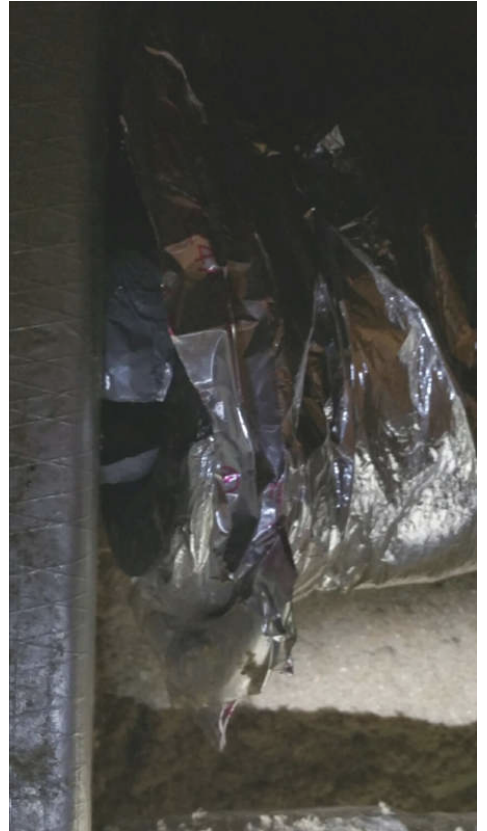
6.3.1 Distribution System

LOOSE DUCT IN THE ATTIC

There is a loose duct in the attic allowing conditioned air to escape. Recommend licensed HVAC contractor resecure.

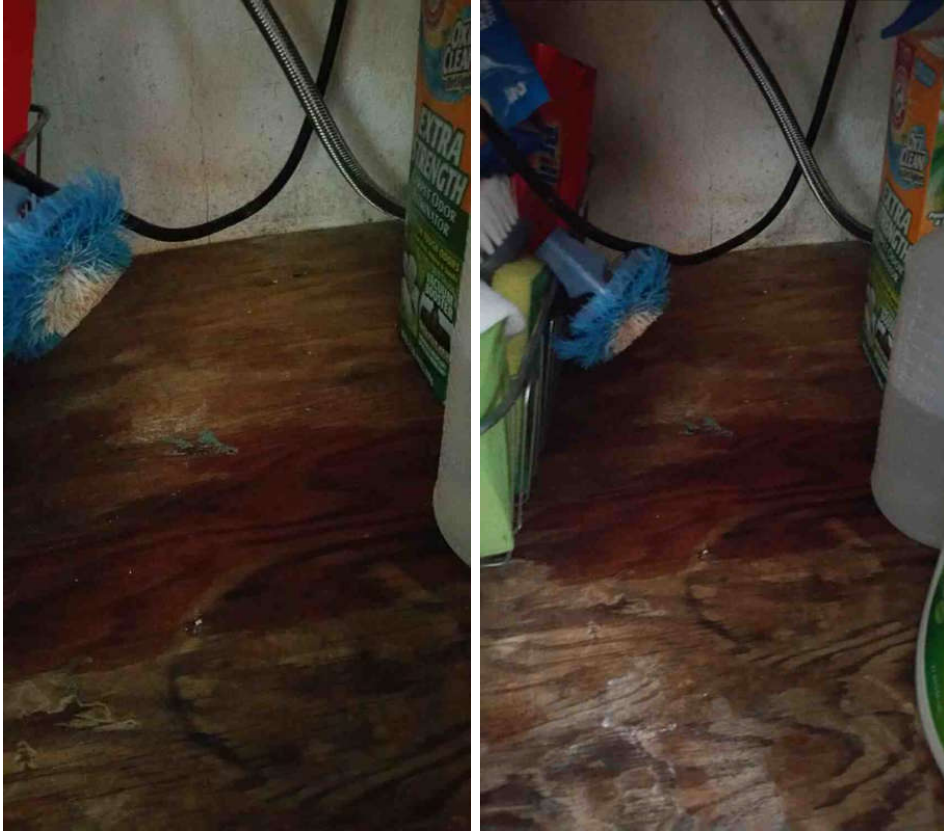
7.7.1 Sinks/Faucets

SIGNS OF PRIOR WATER DAMAGE WAS OBSERVED

Water damage was observed under the kitchen sink but the leak didn't appear to be active at the time of the inspection. Recommend monitoring and contacting a licensed plumber if an active leak is observed.

Recommend monitoring.

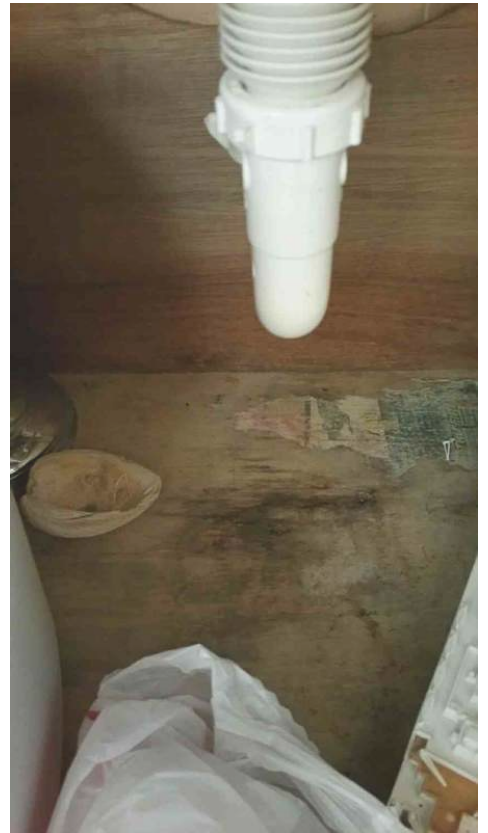
7.7.2 Sinks/Faucets

SIGNS OF PRIOR WATER DAMAGE WAS OBSERVED

Water damage was observed in the hallway sink but the leak didn't appear to be active at the time of the inspection. Recommend monitoring and contacting a licensed plumber if an active leak is observed.

Recommendation
Recommend monitoring.

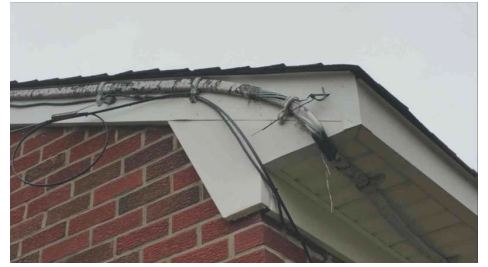
8.1.1 Service Entrance Conductors

FRAYED SHEATHING

Wires on service entrance are damaged or frayed. Recommend contacting your electric utility company or a qualified electrician to evaluate and repair.

Contact a qualified electrical contractor.

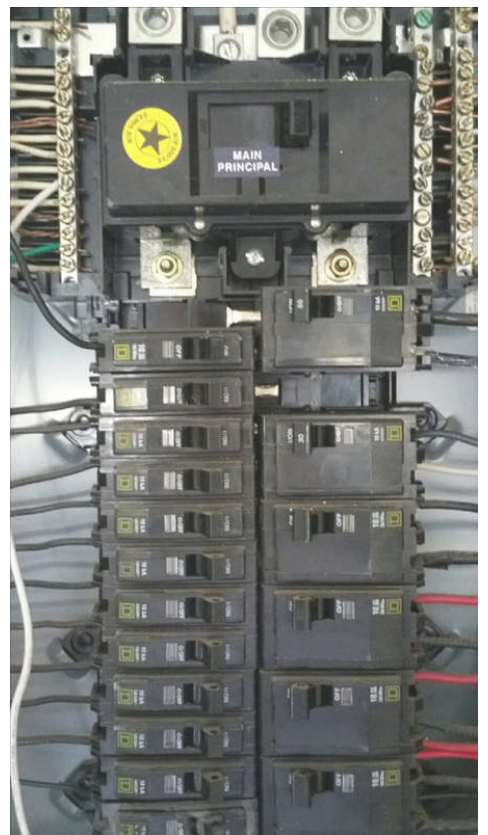
8.2.1 Main & Subpanels, Service & Grounding, Main Overcurrent Device

POSSIBLE MISSING GROUND

The electrical panel doesn't appear to be grounded. This corresponds with what the tester was showing at the outlets also. Recommend a licensed electrician for further evaluation to bring up to current safety standards.

Contact a qualified electrical contractor.

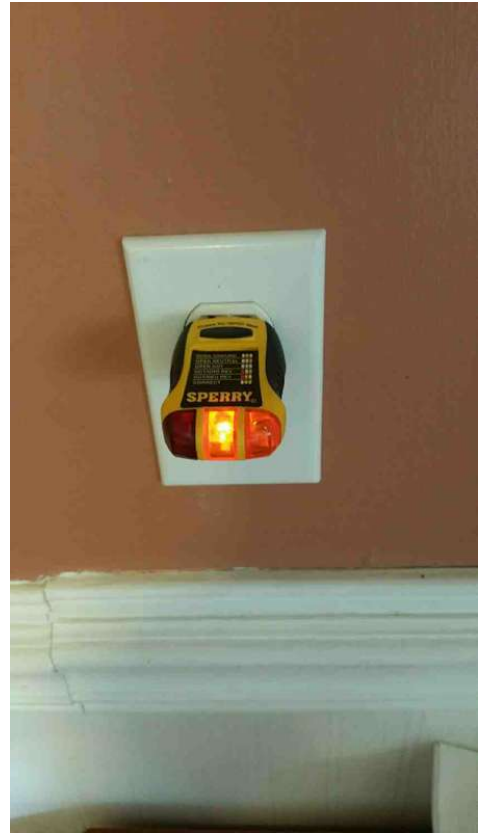
8.4.1 Lighting Fixtures, Switches & Receptacles

UNGROUND RECEPTACLES

The receptacles in the original part of the house are reading ungrounded. The sunroom addition is reading grounded. To help alleviate safety hazards, all receptacles should be grounded. A licensed electrician is recommended for further evaluation.

Contact a qualified electrical contractor.

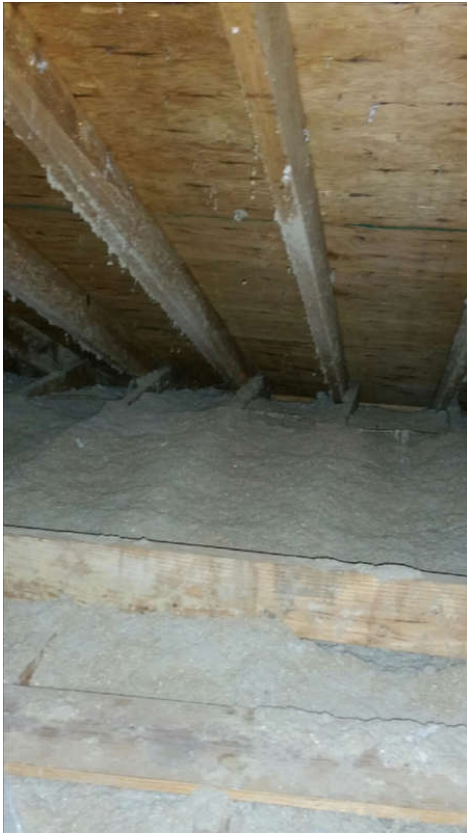
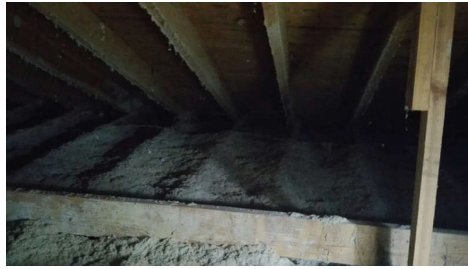
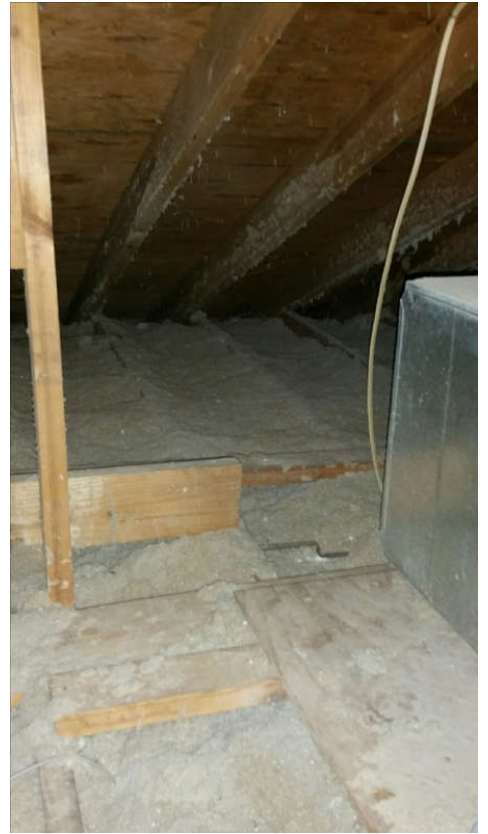
9.1.1 Attic Insulation

INSUFFICIENT INSULATION

Insulation depth was inadequate. Recommend a qualified attic insulation contractor install additional insulation.

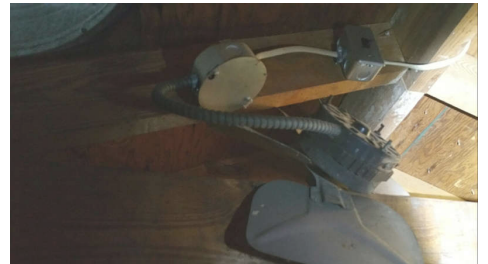
9.2.1 Attic Ventilation

ABANDONED FAN IN THE ATTIC

There was an abandoned fan in the attic that was still wired. Recommend removal of the fan and capping the wires by a qualified electrician.

Contact a qualified electrical contractor.

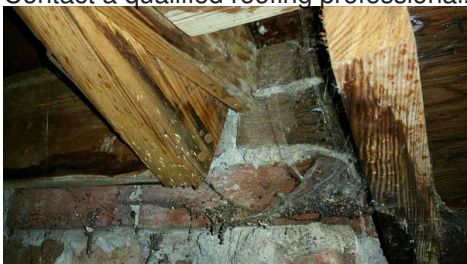
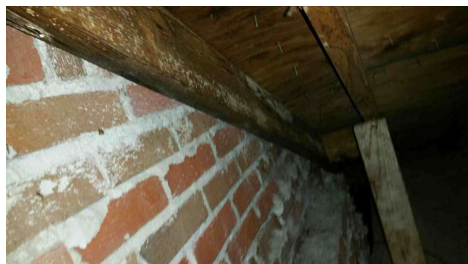
9.4.1 Roof Sheathing

INDICATIONS OF A LEAK

There was a leak observed in the attic at the high side of the chimney. This corresponds with the chimney flashing issue noted in the roofing section. Recommend a qualified roofer for further evaluation.

Contact a qualified roofing professional.

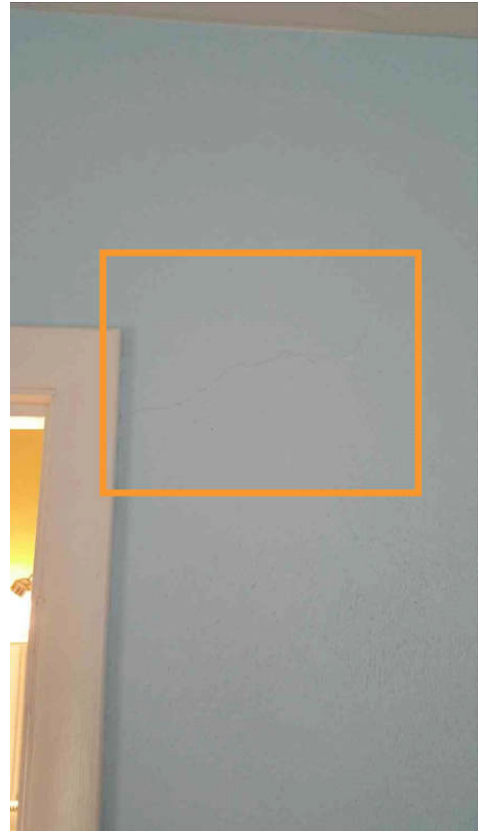
10.4.1 Walls

MINOR CORNER CRACK

Minor crack at the master bathroom door that has been repaired. Some settling is not unusual in a home of this age and these cracks are not a structural concern. Recommend monitoring.

Recommendation
Recommend monitoring.

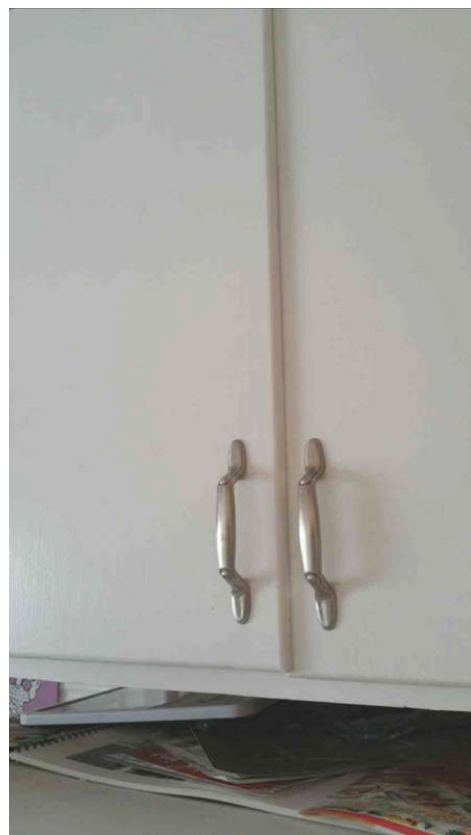
10.7.2 Countertops & Cabinets

CABINET DOORS NOT CLOSING PROPERLY

The cabinet doors above the refrigerator don't line up and close properly. Recommend adjusting by a handyman.

Contact a handyman or DIY project

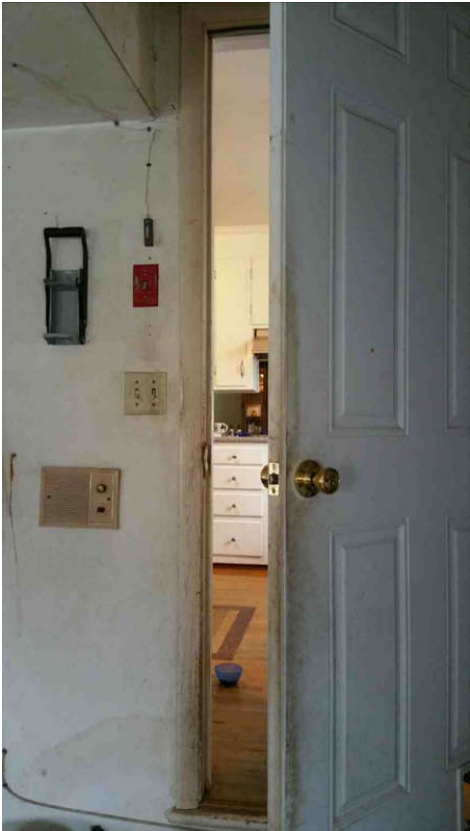
12.6.1 Occupant Door (From garage to inside of home)

NOT SELF-CLOSING

Door from garage to home should have self-closing hinges to help prevent spread of a fire to living space. Recommend a qualified contractor install self-closing hinges.

Recommendation
Contact a qualified handyman.
