## SUMMARY

1234 Main St.Lake Elmo MN 55042

Randy Erickson  
InterNachi Certified...  
Sky Blue Inspections, LLC  
651-675-8895  
randy@skyblueinspects.com

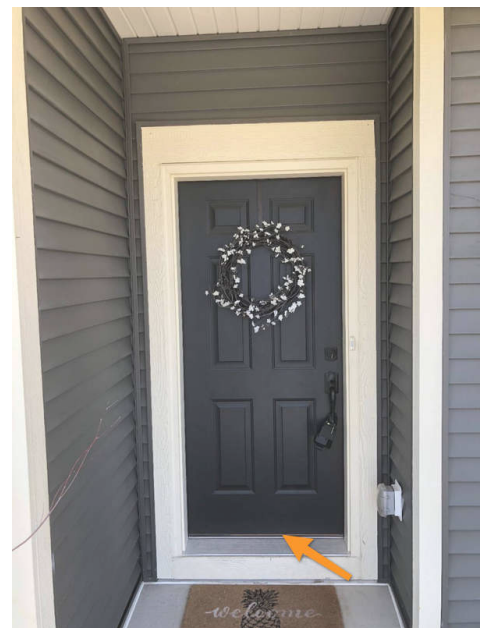
### 3.2.1 Exterior Doors

#### **WEATHERSTRIPPING DAMAGED**

FRONT DOOR

Weatherstripping Damaged on bottom of front entry door. This can be a source of heat loss. Recommend replacement or repairs.

Recommendation  
Contact a qualified professional.

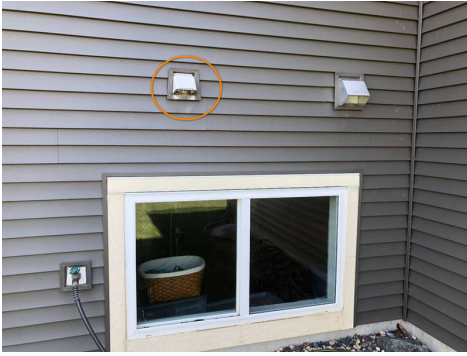
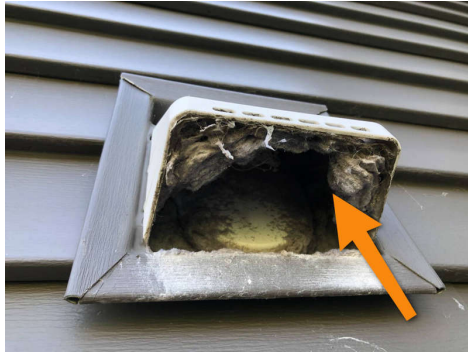
### 3.8.1 Exterior Ventilation Hoods

#### **DRYER VENT NEEDS CLEANING**

REAR OF HOUSE

Dryer Vent Needs Cleaning. Clogged dryer vents can lead to fires or inefficient drying. Recommend cleaning vent and duct as needed.

Recommendation  
Contact a qualified professional.

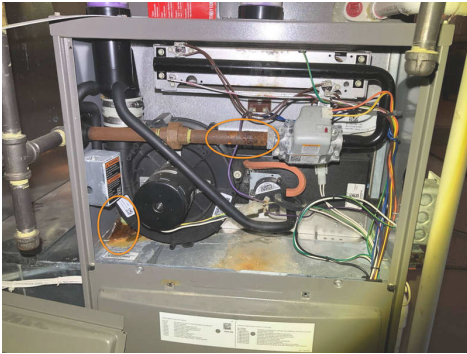
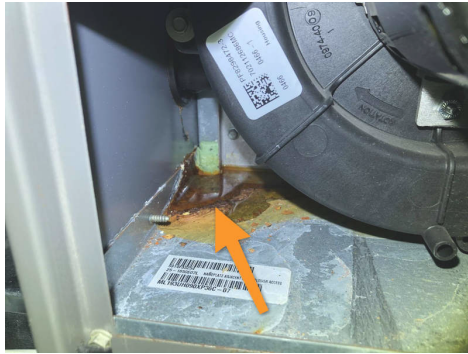
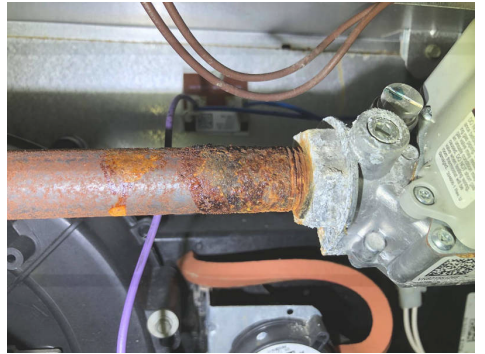
5.1.1 Equipment

**CORROSION & WATER**

BASEMENT

Furnace was corroded in one or more areas with puddled water. This could be the result of clogged drain lines, condensate or possibly a heat exchanger problem. Recommend a HVAC contractor evaluate, clean and repair.

Contact a qualified HVAC professional.

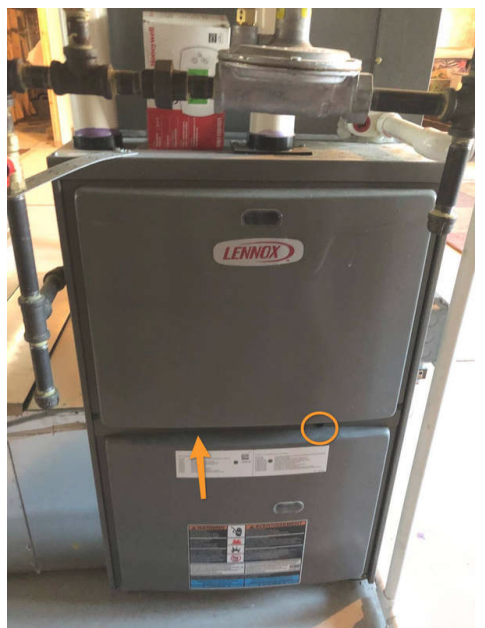
5.1.2 Equipment

**FRONT PANEL SCREW MISSING**

FURNACE

Front Panel Screw Missing. This should be replaced to insure proper fit of the removable panel.

Left one missing, Right One OK

Contact a qualified professional.

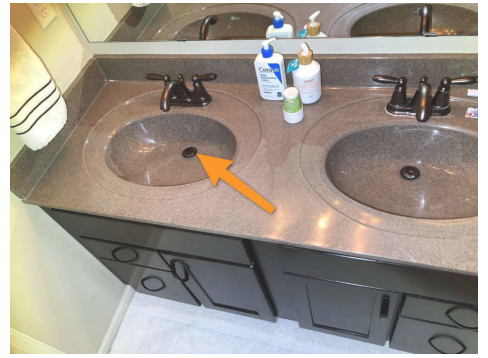
7.2.1 Drain, Waste, & Vent Systems

**SINK - SLOW DRAINAGE**

UPSTAIRS BATHROOM

Sink - Slow Drainage. Recommend cleaning the drain to insure proper drainage.

Slow Drain on left

Contact a qualified plumbing contractor.

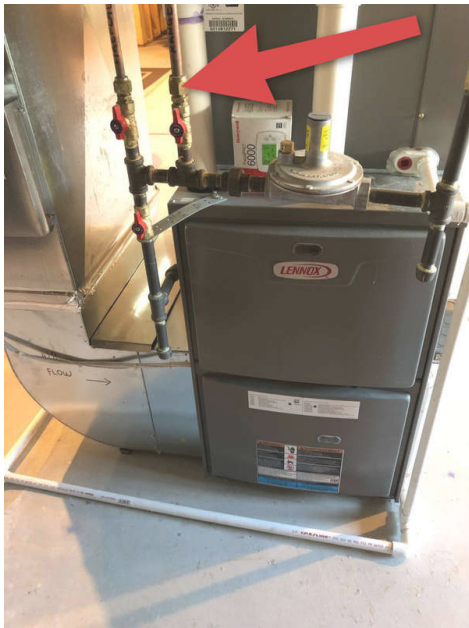
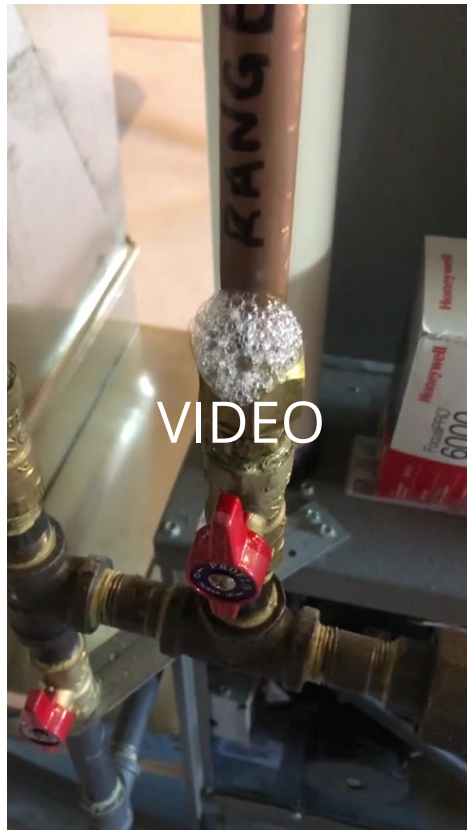
7.5.1 Fuel Storage & Distribution Systems

**GAS LEAK**

BASEMENT

A Natural Gas Leak was detected in the supply lines in the utility Room. It was above the shut off valve for the kitchen Range. Gas leaks of any size are dangerous and need correction. Contacted the Listing Agent and recommended evaluation and repair by a qualified professional.

Significant Defect

Gas leak area

Contact a qualified professional.

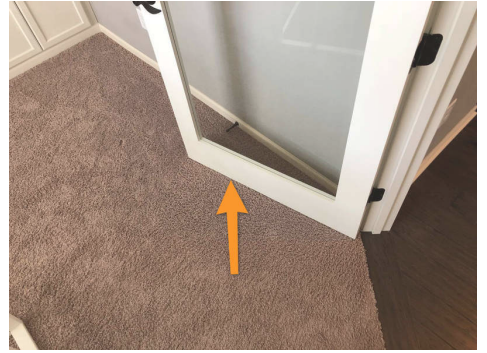
10.1.1 Doors

**DOOR DRAGS ON CARPET**

FRONT OFFICE/DEN

Door drags on Carpet can lead to carpet damage. Recommend shortening door by Handyman or DIY

Recommendation  
Contact a qualified professional.
