## SUMMARY

1234 Main St. Killeen TX 76547

Rick Jansen  
TREC ID# 23159

Done Right Inspecting and Adjusting  
254-285-4156  
donerightinspecting@gmail.com

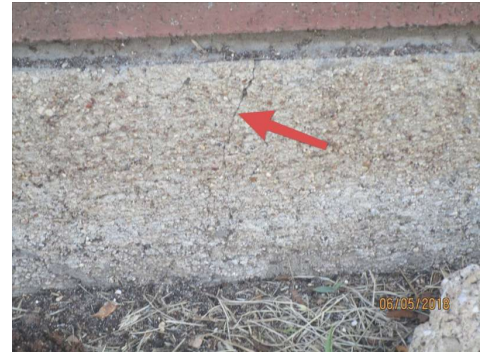
Foundation has multiple small cracks (North side of home). These cracks should be monitored for further deterioration.

Multiple minor cracks in foundation (North side of home)

Recommendation  
Contact a foundation contractor.

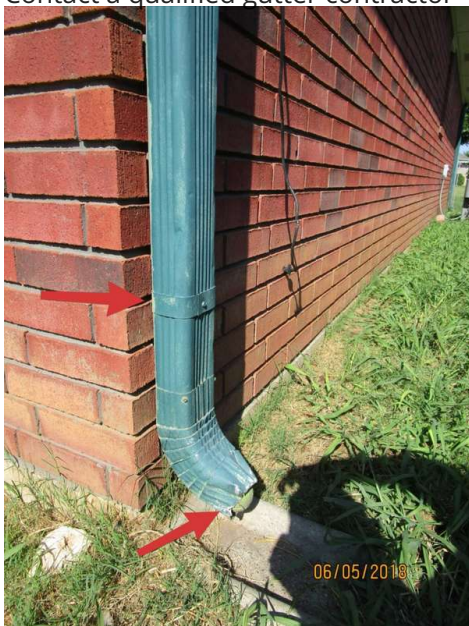
Two downspouts were loose and damaged (Southwest and Southeast corners of home). This can lead to improper drainage and foundation issues. Recommend a handyman or gutter company fix the discrepancies.

Downspout not secured properly, damaged, and plugged. (Southwest corner of home)

Recommendation  
Contact a qualified gutter contractor

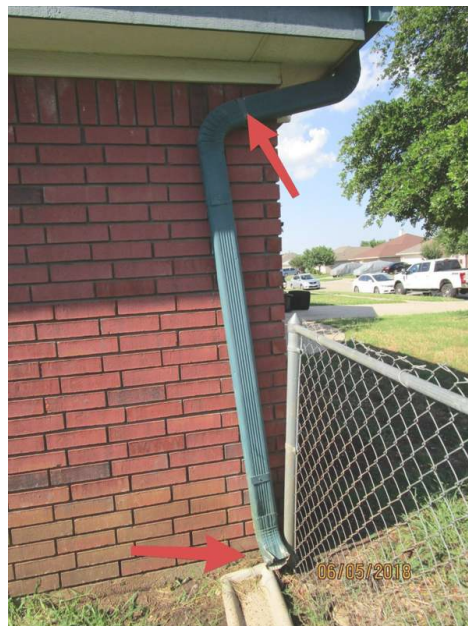
Downspout loose, damaged, and not aligned with splash block. (Southeast corner of home)

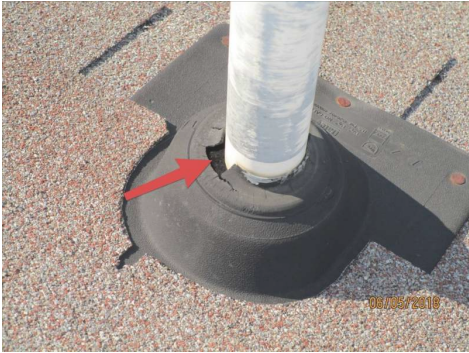
Multiple vent "boots" were deteriorated (North, South, and West sides of roof). This could cause both pest and water intrusion and needs to be corrected. Recommend a qualified roofer evaluate and repair.

Multiple vent "boots" were deteriorated (South, North, and West sides of home).

Recommendation  
Contact a qualified roofing professional.

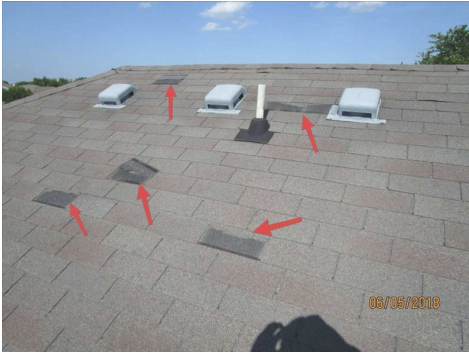
Numerous shingles missing, and other shingles not laying properly (West side of roof facing backyard). Recommend qualified roofing contractor evaluate & repair.

Numerous shingles missing, and other shingles not laying properly. (this pic is on West side of roof facing backyard).

Recommendation  
Contact a qualified roofing professional.

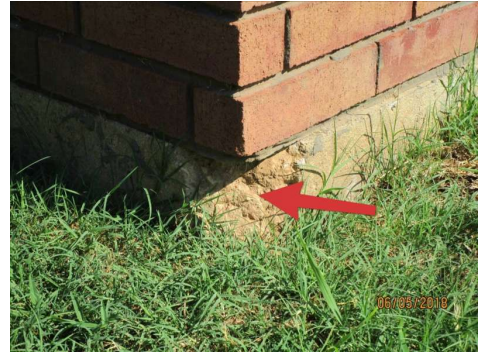
Foundation on both Southwest and Northwest corners of home chipping away, commonly called "Corner Pops." This is typically not serious and tends to happen when the concrete cures over time. Recommend monitoring for further deterioration

Foundation on both Southwest and Northwest corners of home chipping away, commonly called "Corner Pops."

Recommendation  
Recommended DIY Project

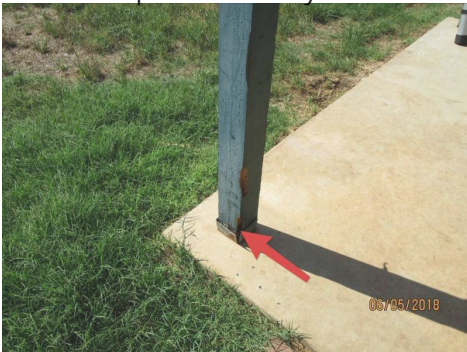
Support column on back patio shows signs of water damage. This could lead to structural failure, so it needs to be addressed. Recommend a handyman or contractor assess and correct the deficiency.

Support column on back patio shows evidence of water damage.

Contact a qualified handyman.

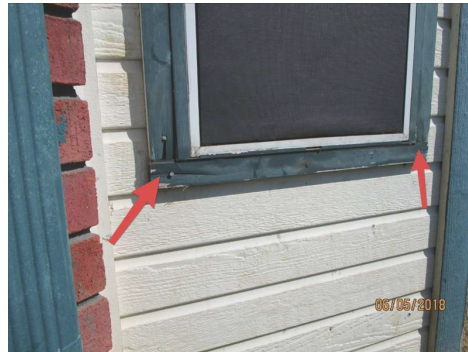
Wood trim around multiple windows in backyard (mainly around bay window) and back door show signs of water intrusion, which could lead to more serious structural damage. Recommend a qualified contractor identify and fix source of moisture, and replace all damaged wood.

Trim around window shows signs of water damage. (Northwest corner of home)

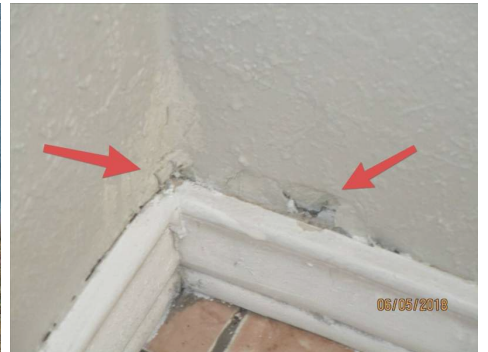
Drywall shows signs of previous water damage (master bedroom closet on wall opposite side of sinks). Recommend a handyman and/or plumber ensure there is no active leak, and repair the damaged area.

Drywall shows signs of previous water damage (master bedroom closet on wall opposite side of sinks)

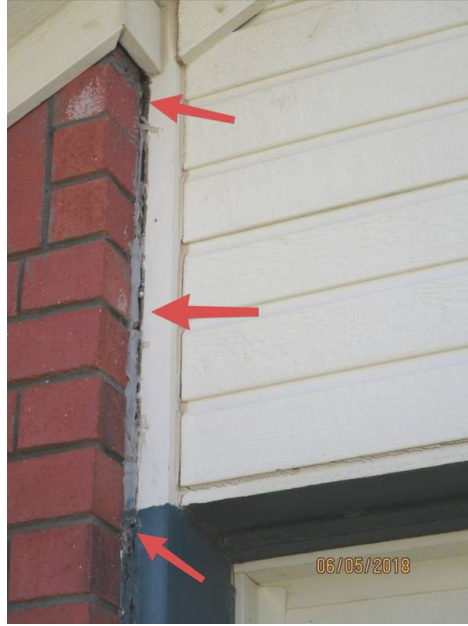
Caulking around multiple exterior walls (near windows) is dry rotted and is creating openings. This could lead to water and/or pest intrusion. Recommend a handyman or contractor re-caulk all gaps and cracks around home.

Caulking around multiple windows is dry rotted. This photo taken in front (East side) of home.

Recommendation  
Contact a qualified masonry professional.

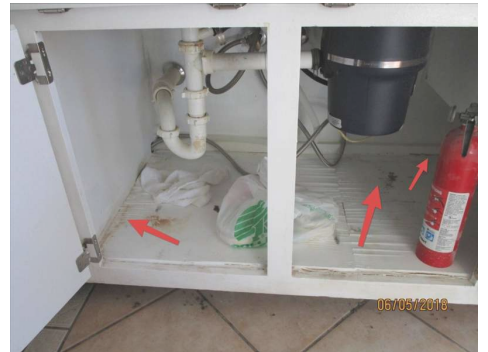
Wood cabinetry under the kitchen sink shows signs of previous water damage. Depending on extent of previous water damage, this could pose a health issue. Recommend a handyman replace water damaged wood under sink.

Wood cabinetry under the kitchen sink shows signs of previous water damage.

Recommendation  
Contact a qualified handyman.

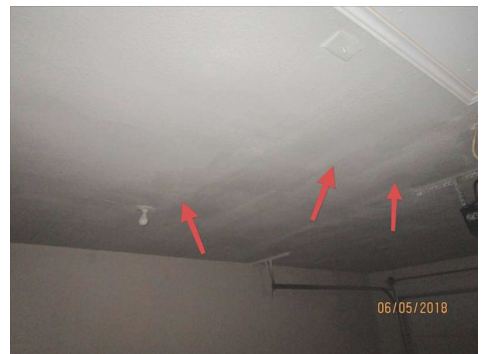
Ceiling drywall sagged visibly at the time of the inspection. This situation should be monitored for further deterioration.

Drywall on ceiling in garage is sagging in multiple locations.

Recommendation  
Recommended DIY Project

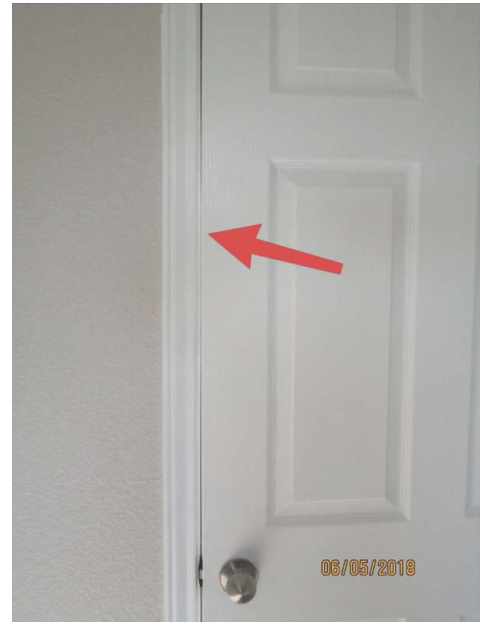
Multiple doors throughout home stick when opening and closing, to include pantry door. Recommend a handyman repair all doors that stick.

Door sticks when opening and closing. (This pic is in Northeast bedroom)

Recommendation  
Contact a qualified handyman.

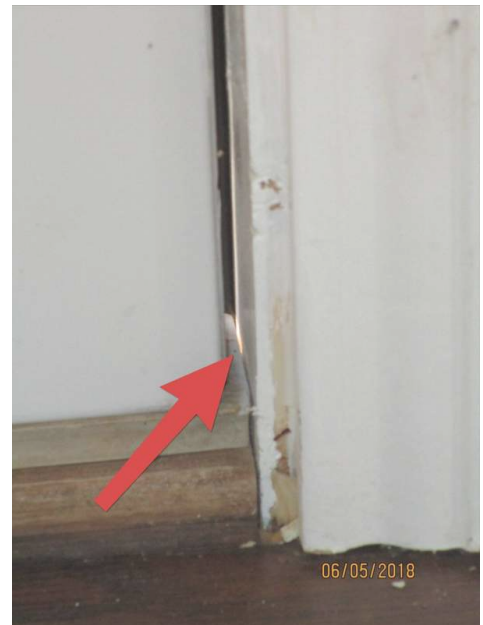
Gap in bottom (right) of back door. This could result in in energy loss, water and/or pest intrusion. Recommend handyman or door contractor evaluate and repair as necessary.

Noticeable gap on bottom (right) of back door.

Recommendation  
Contact a qualified door repair/installation contractor.

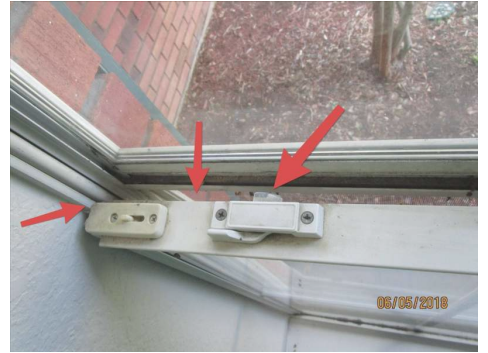
Window in front bedroom (right of front door) is out of adjustment, and cannot be secured. This is a security risk and needs to be addressed. Recommend a window specialist evaluate.

Window in front bedroom (right of front door) is out of adjustment, and cannot be secured.

Contact a qualified window repair/installation contractor.

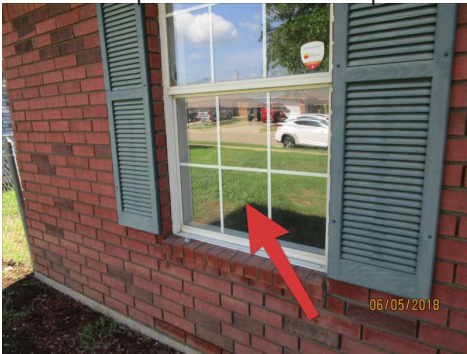
One window (Southeast corner facing street) was missing a screen, and multiple other screens around the home were either torn, or did not fit properly. Recommend a handyman or window specialist repair and/or replace damaged screens.

Window screen missing (Southeast corner of home facing street)

Contact a qualified window repair/installation contractor.

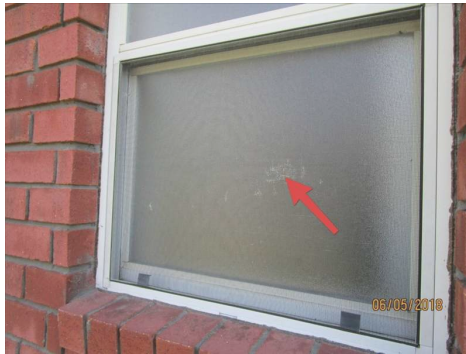
Multiple screens have holes in them (this is on North side of home)

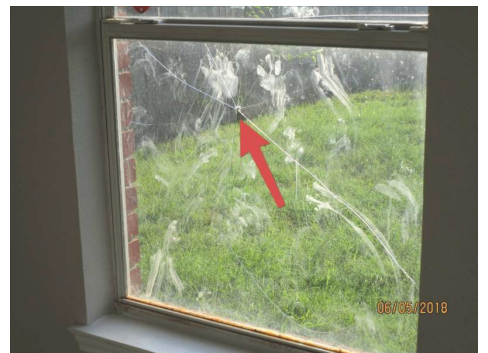
Glass in window (bedroom in Southwest corner of home) is cracked. This presents an unsafe situation and needs to be fixed. Recommend a window repair specialist replace the cracked glass.

Glass is cracked in window (Southwest bedroom)

Contact a qualified window repair/installation contractor.

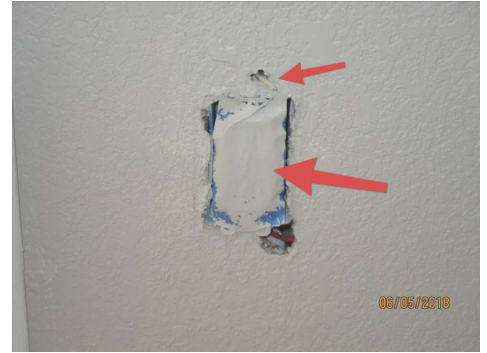
No cover plate on receptacle and questionable exposed wire above receptacle in closet (across from sink in master bathroom). This causes a short and/or shock risk. Recommend a licensed electrician assess the wiring and corrects the discrepancy.

No cover plate on receptacle and questionable exposed wire above receptacle. This photo taken in closet (across from sink) in master bathroom.

Contact a qualified electrical contractor.

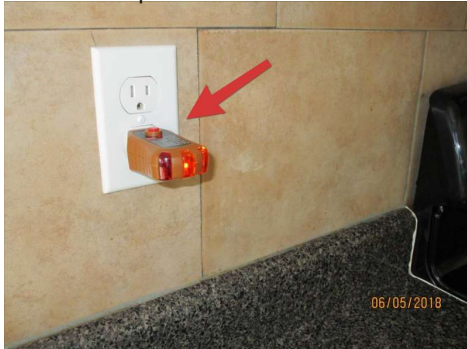
No GFCI protection found in receptacle "left" of stove in kitchen. (could not get GFCI tester into receptacle to the "right" of stove to test it).

GFCI protection is required for receptacles in kitchen and bathrooms, so this must be corrected.

No GFCI protection detected (outlet left of stove).

Recommend a licensed electrician assess all GFCI receptacles in the home, and repair and/or replace as necessary.

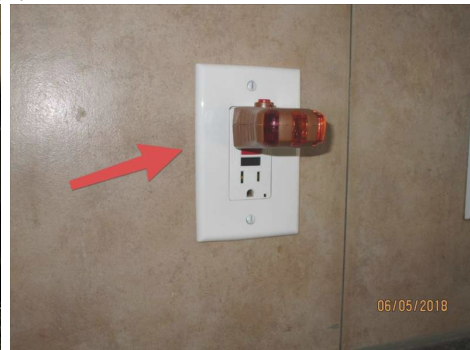
No electricity detected on GFCI outlet to the "left" of sink.

No electricity detected at GFCI receptacle to the "left" of kitchen sink.

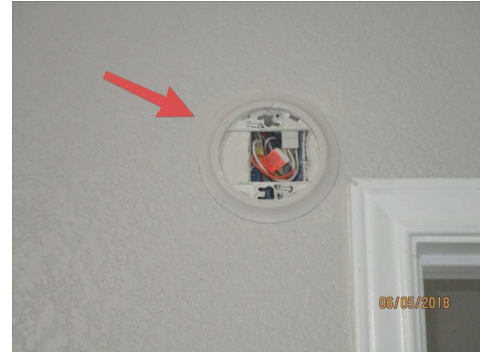
Smoke detectors missing throughout home. This is a safety issue that must be corrected. Recommend installation of smoke detectors.

Smoke detector missing (front bedroom to "right" of front door).

Contact a handyman or DIY project

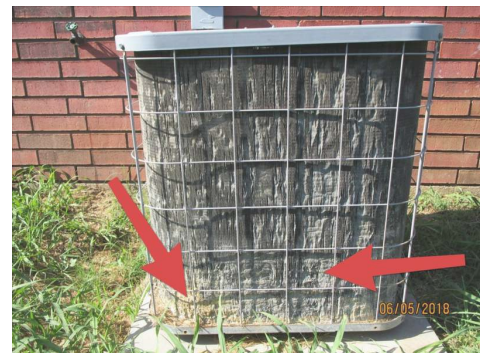
Condenser unit fins in very poor condition, and unit seems to be near end of it's useful life. Air flow to the air conditioner condenser was restricted. This may result in inefficient operation. Recommend a licensed HVAC professional assesses the unit and gives the client their opinion on unit's condition.

Condenser unit fins in very poor shape.

Contact a qualified HVAC professional.

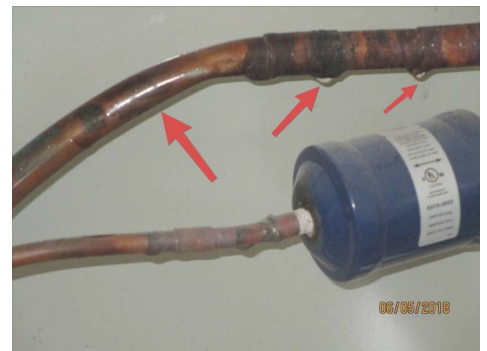
Insulation on Suction line missing on both inside (HVAC closet) and outside (near condenser unit) lines. Inside suction line was also "sweating," which could cause damage to surrounding structure. Missing or damaged insulation can also cause energy loss. Recommend a handyman correct the deficiency.

Insulation missing from Suction line, and line is "sweating." (this photo taken in HVAC closet on inside of

home).

Contact a qualified handyman.

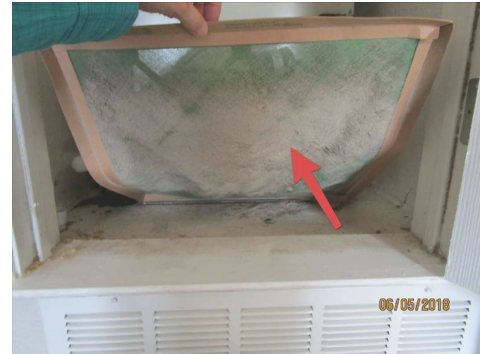
A/C filter was dirty and was being sucked up into evaporator. This decreases efficiency, and could cause mechanical problems. Recommend a new (more sturdy) filter is installed.

A/C filter dirty and flimsy.

Recommendation  
Recommended DIY Project

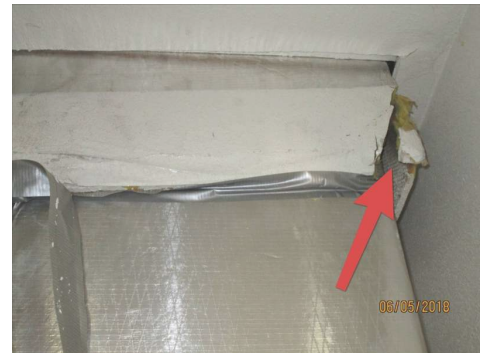
Duct system (above evaporator unit in HVAC closet) not sealed properly. This results in loss of efficiency, and needs to be corrected. Recommend a qualified HVAC contractor seal ducts.

Duct system (above evaporator unit in HVAC closet) not sealed properly.

Recommendation  
Contact a qualified HVAC professional.

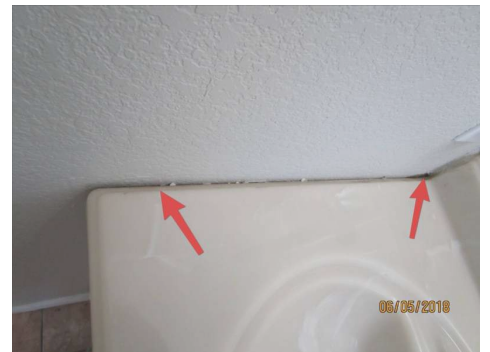
Gap between wall and sink in master bathroom. This gap is most likely the cause of drywall damage in closet on opposite side of wall. Recommend a handyman caulk this gap.

Gap between wall and sink in master bathroom.

Recommendation  
Contact a qualified handyman.
