HALL'S HOME INSPECTION LLC

MOLD INSPECTION

1234 Main Street
, WV

12/04/2024 9:00AM

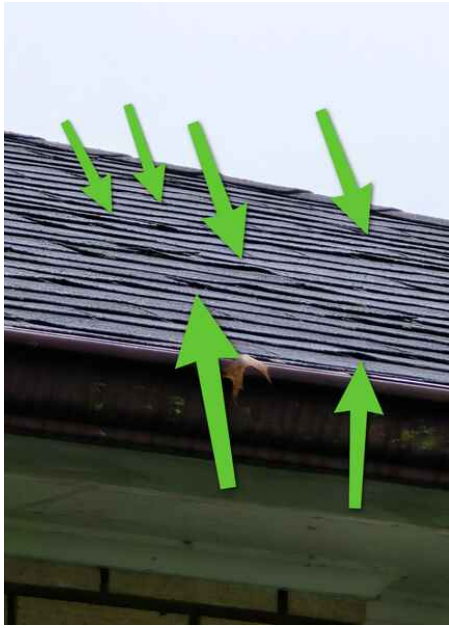
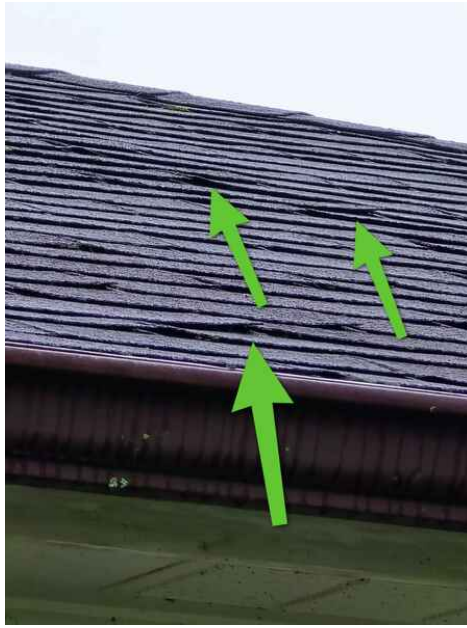
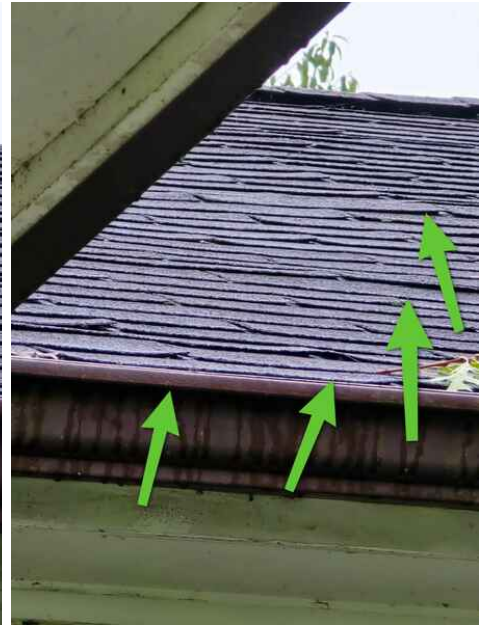
General: Shingles Uplifted

Shingles were uplifted. This can increase the chance of shingle damage or leaks. A roofer should be contacted to improve/correct.

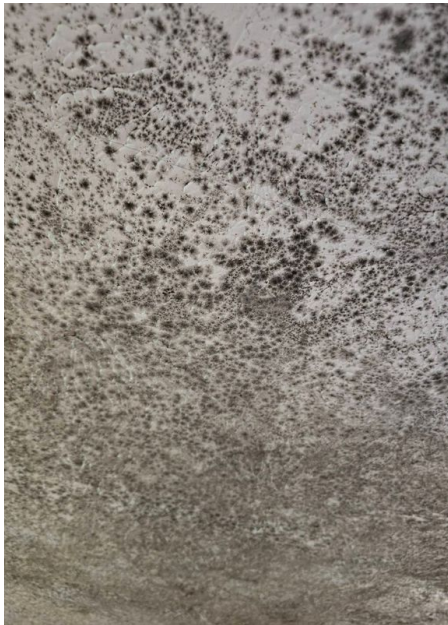
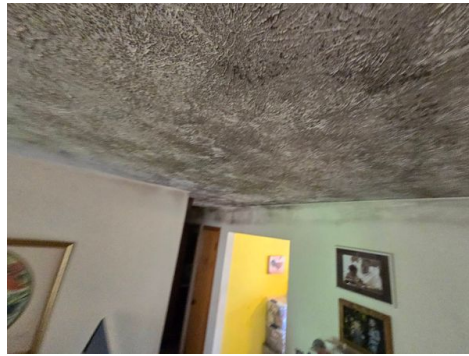
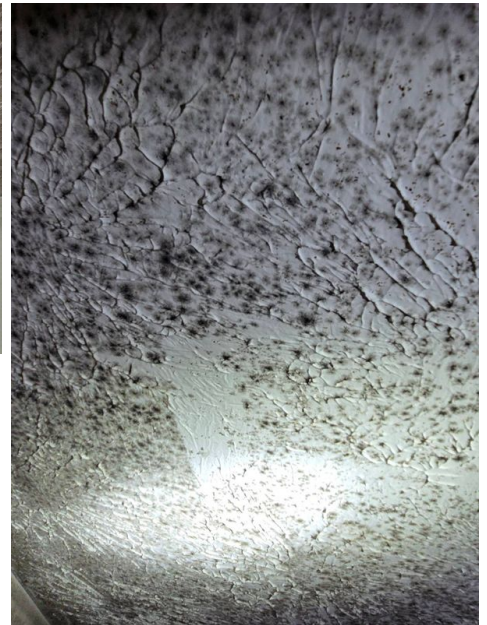
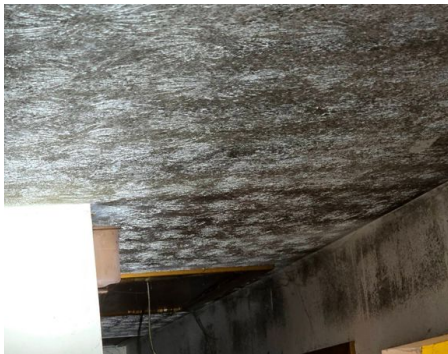
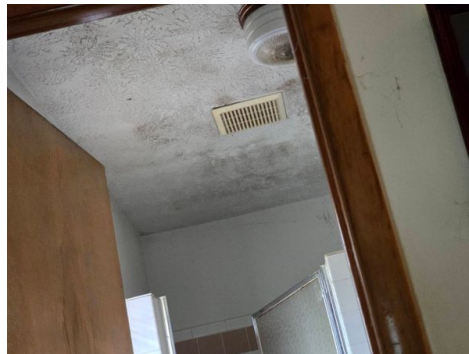
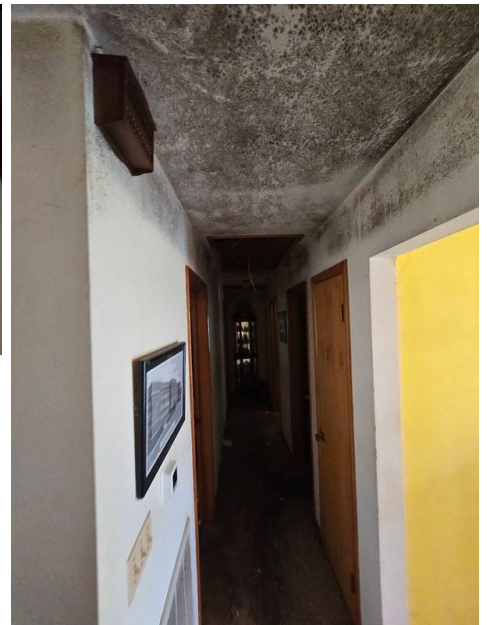
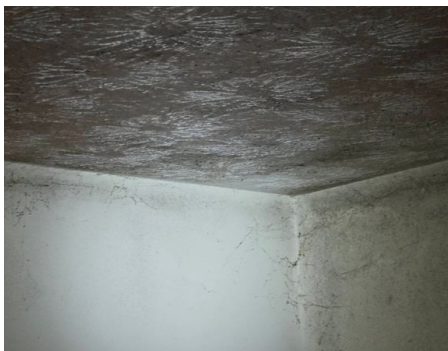
Mold at Ceiling

There was heavy mold at the ceiling throughout the interiors at living room, hallway, bathroom, etc. The humidity was over 60% which is enough for mold to grow. There was moisture in the crawlspace and roof/attic leaks.

In my opinion, this mold is likely caused by a combination of elevated humidity/mold from the crawlspace working up into the home (commonly called the stack effect, or heat rises), but attic moisture and possibly lack of regular airflow are also contributing factors.

Attic was not accessible except the entrance. It's possible further moisture/mold concerns could exist. Heavy belongings may also have concealed mold.

Drywall is considered porous and typically requires removal over cleaning attempts.

I recommend contacting a qualified mold remediation professional to remediate and correct all underlying moisture conditions.

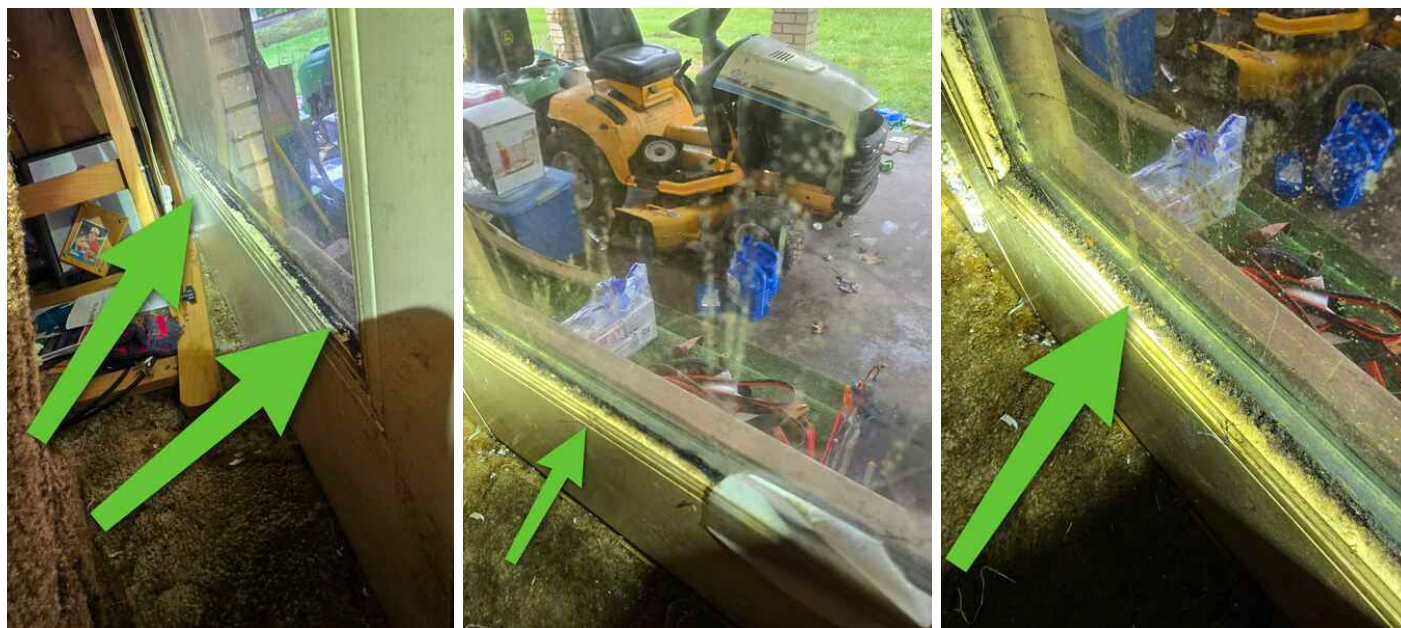
Mold Door

There was mold around the window frame of the right exterior door caused by past condensation. The humidity/moisture in the home needs to be corrected and this mold cleaned/remediated. Once conditions are improved monitoring for further condensation is recommended.

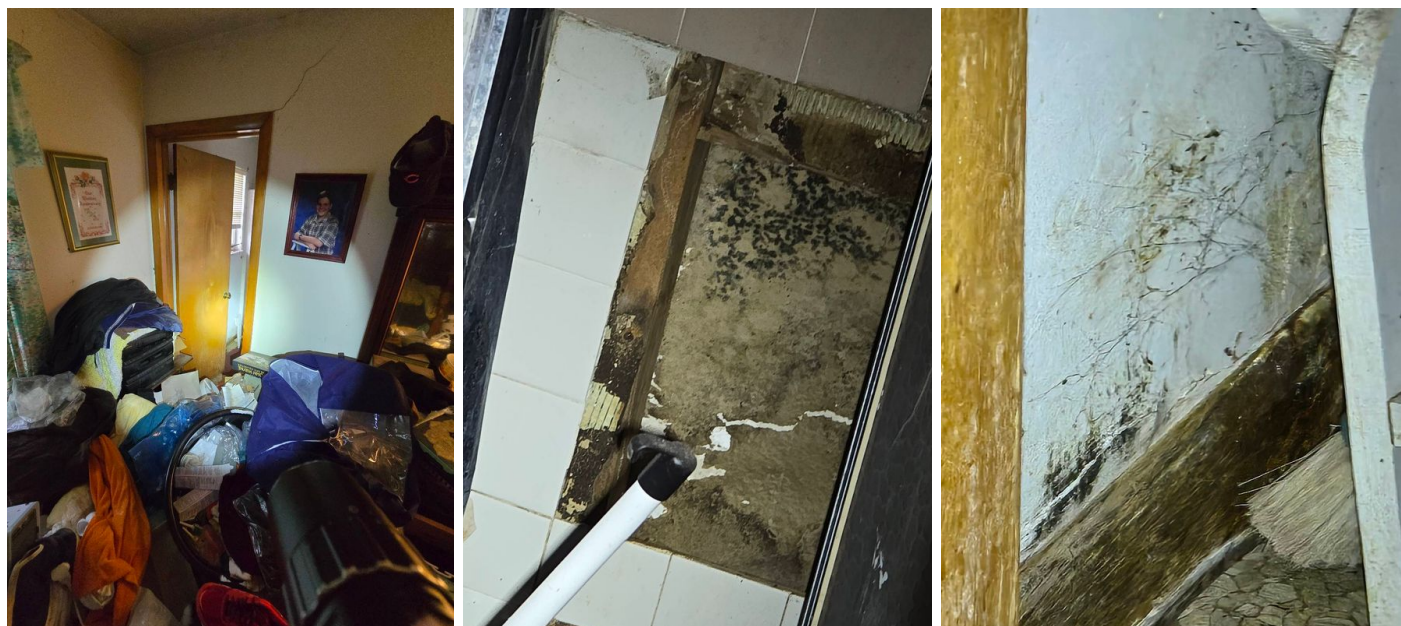
Mold at Master Bathroom

There was mold at the master bathroom. Due to obstructions it could not be accessed inspection. Further evaluation and remediation is recommended by a qualified professional.

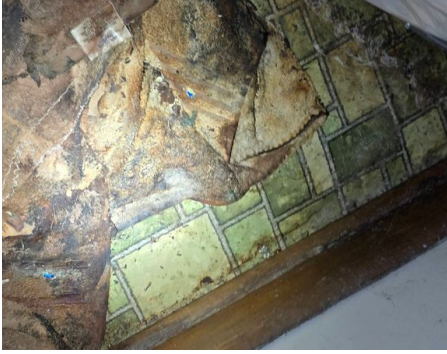
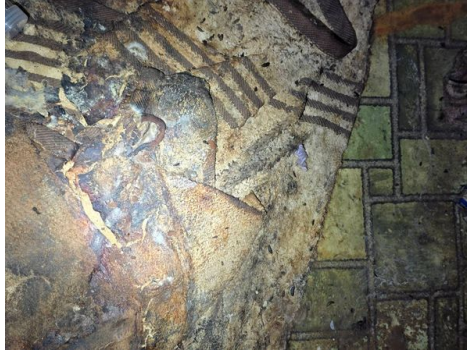
Moldy Debris

There was moldy debris near water heater, possibly from leaks. It should be discarded.

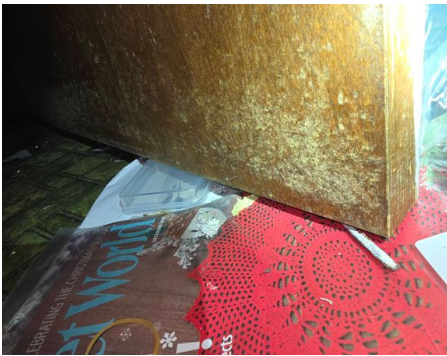
Possible Mold Laundry Door

There was possible mold at laundry room door. A mold test or cleaning is recommended.

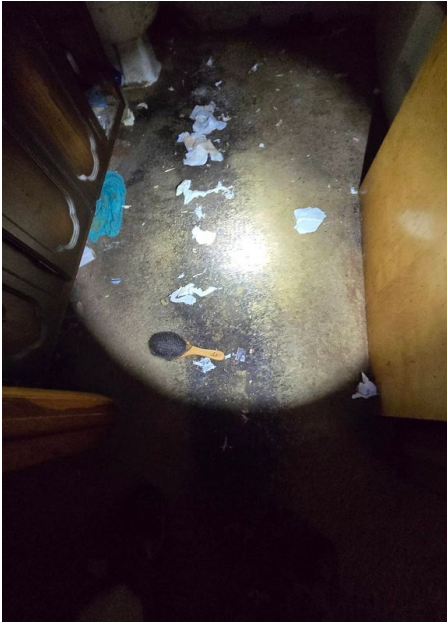
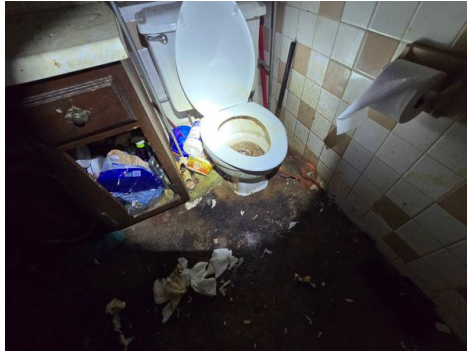
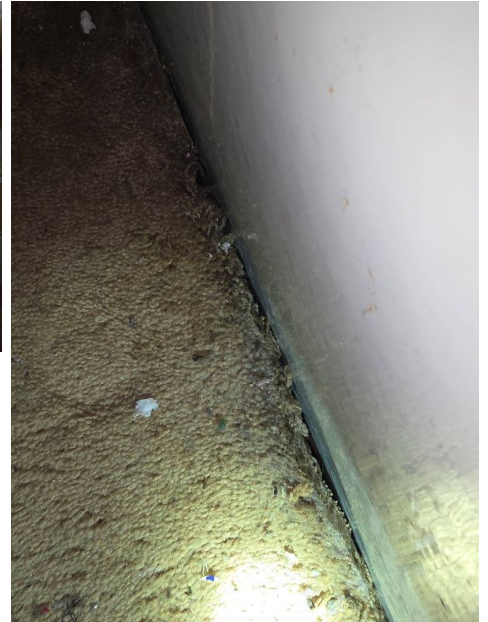
Possible Mold at Carpet

There was discoloration/possible mold at carpet. Due to the carpet being in poor condition in general, removal is recommended. The underside should then be checked for mold. I do not recommend putting carpet back in bathroom areas.

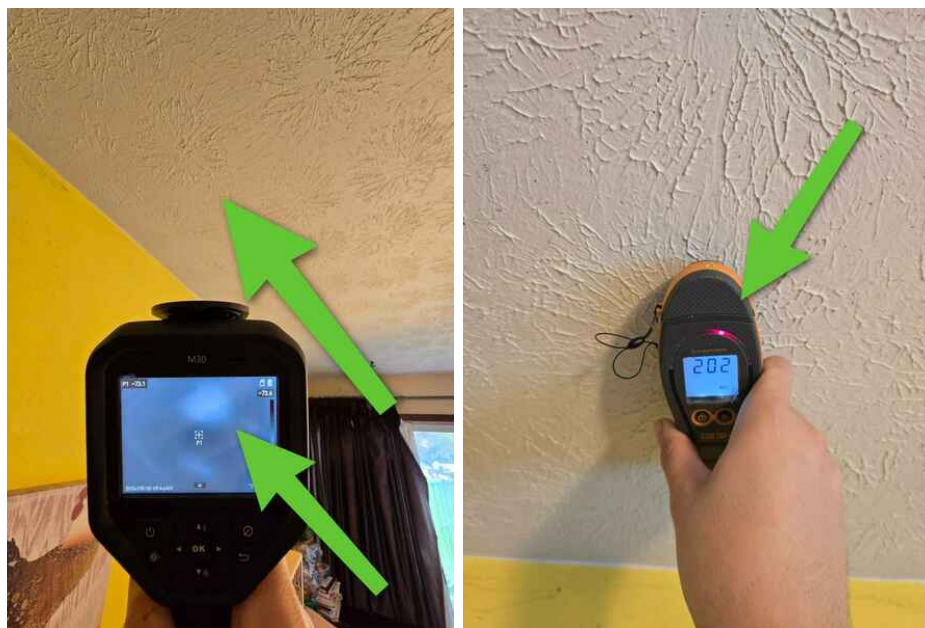
Moisture at Kitchen Ceiling

There was moisture at the ceiling right past the hallway/living room door. The moisture meter confirmed and the thermal camera identified it. The area above was not accessible due to attic belongings. Most common causes of moisture at attics are roof leaks and animal urine. Further evaluation is needed to confirm which and check for mold.

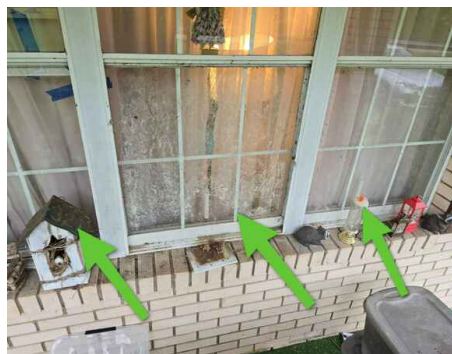
Failed Seal

Front windows had a failed seal. This can cause mold between the window panes. This is normal wear and tear as homes age but generally requires replacement to stop.

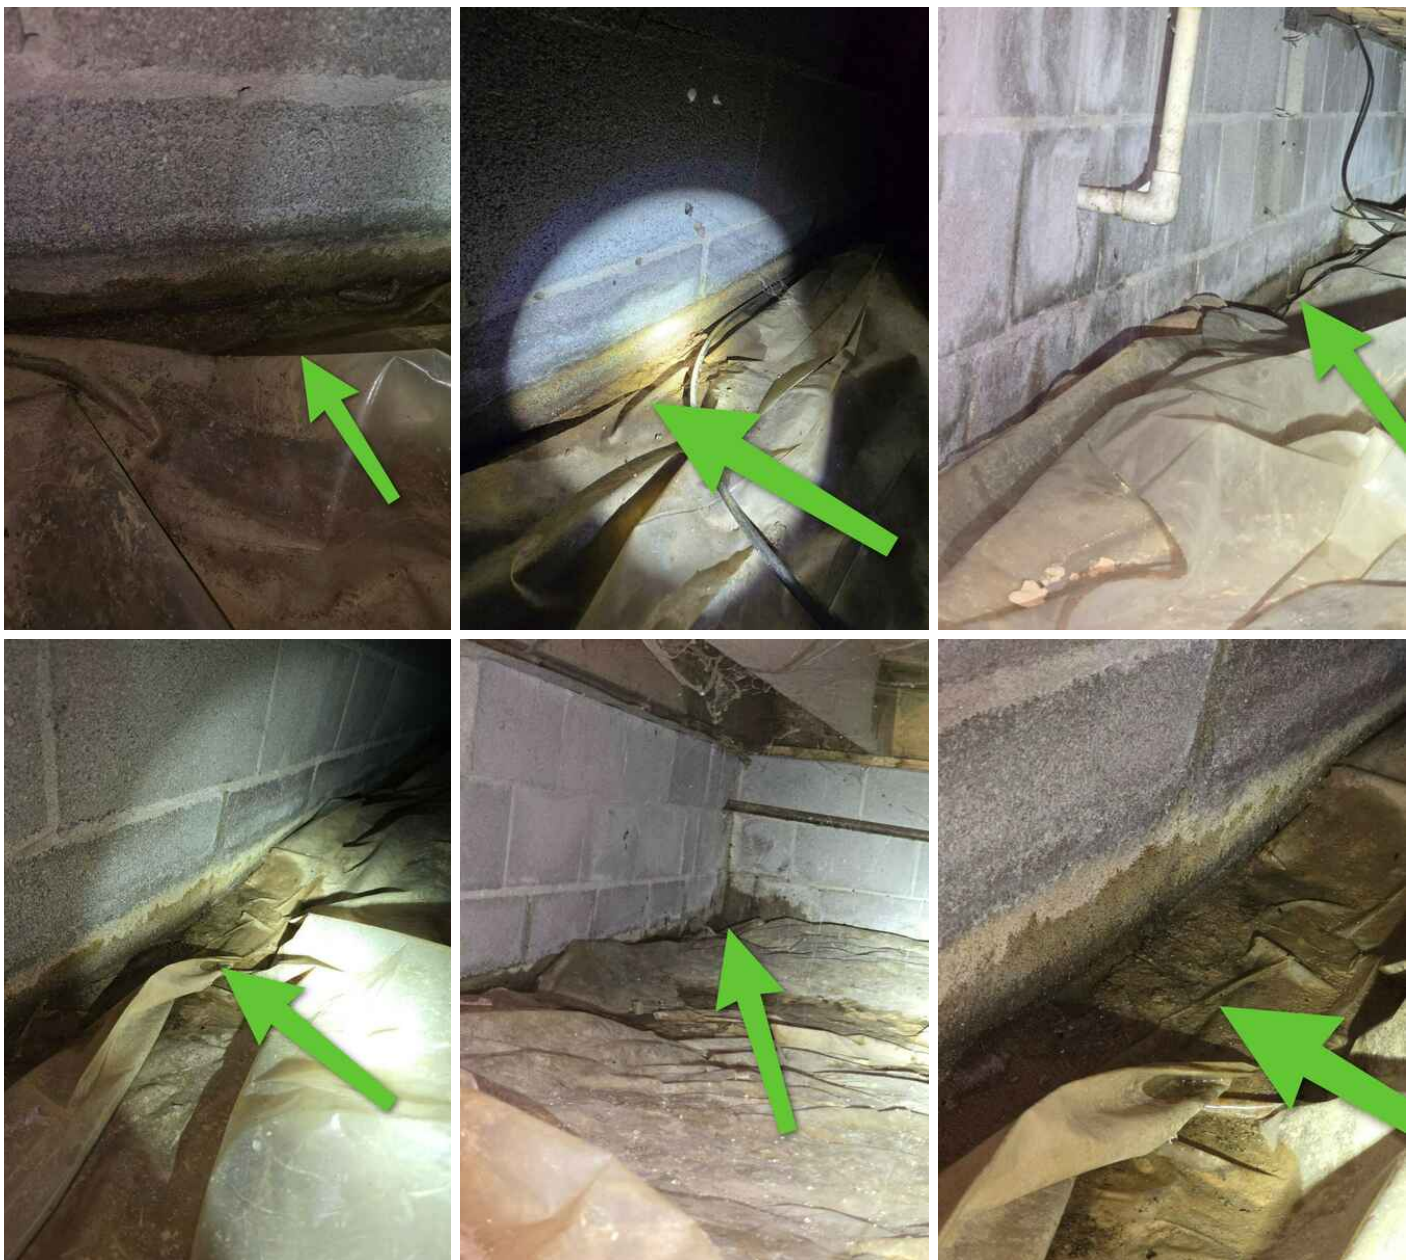
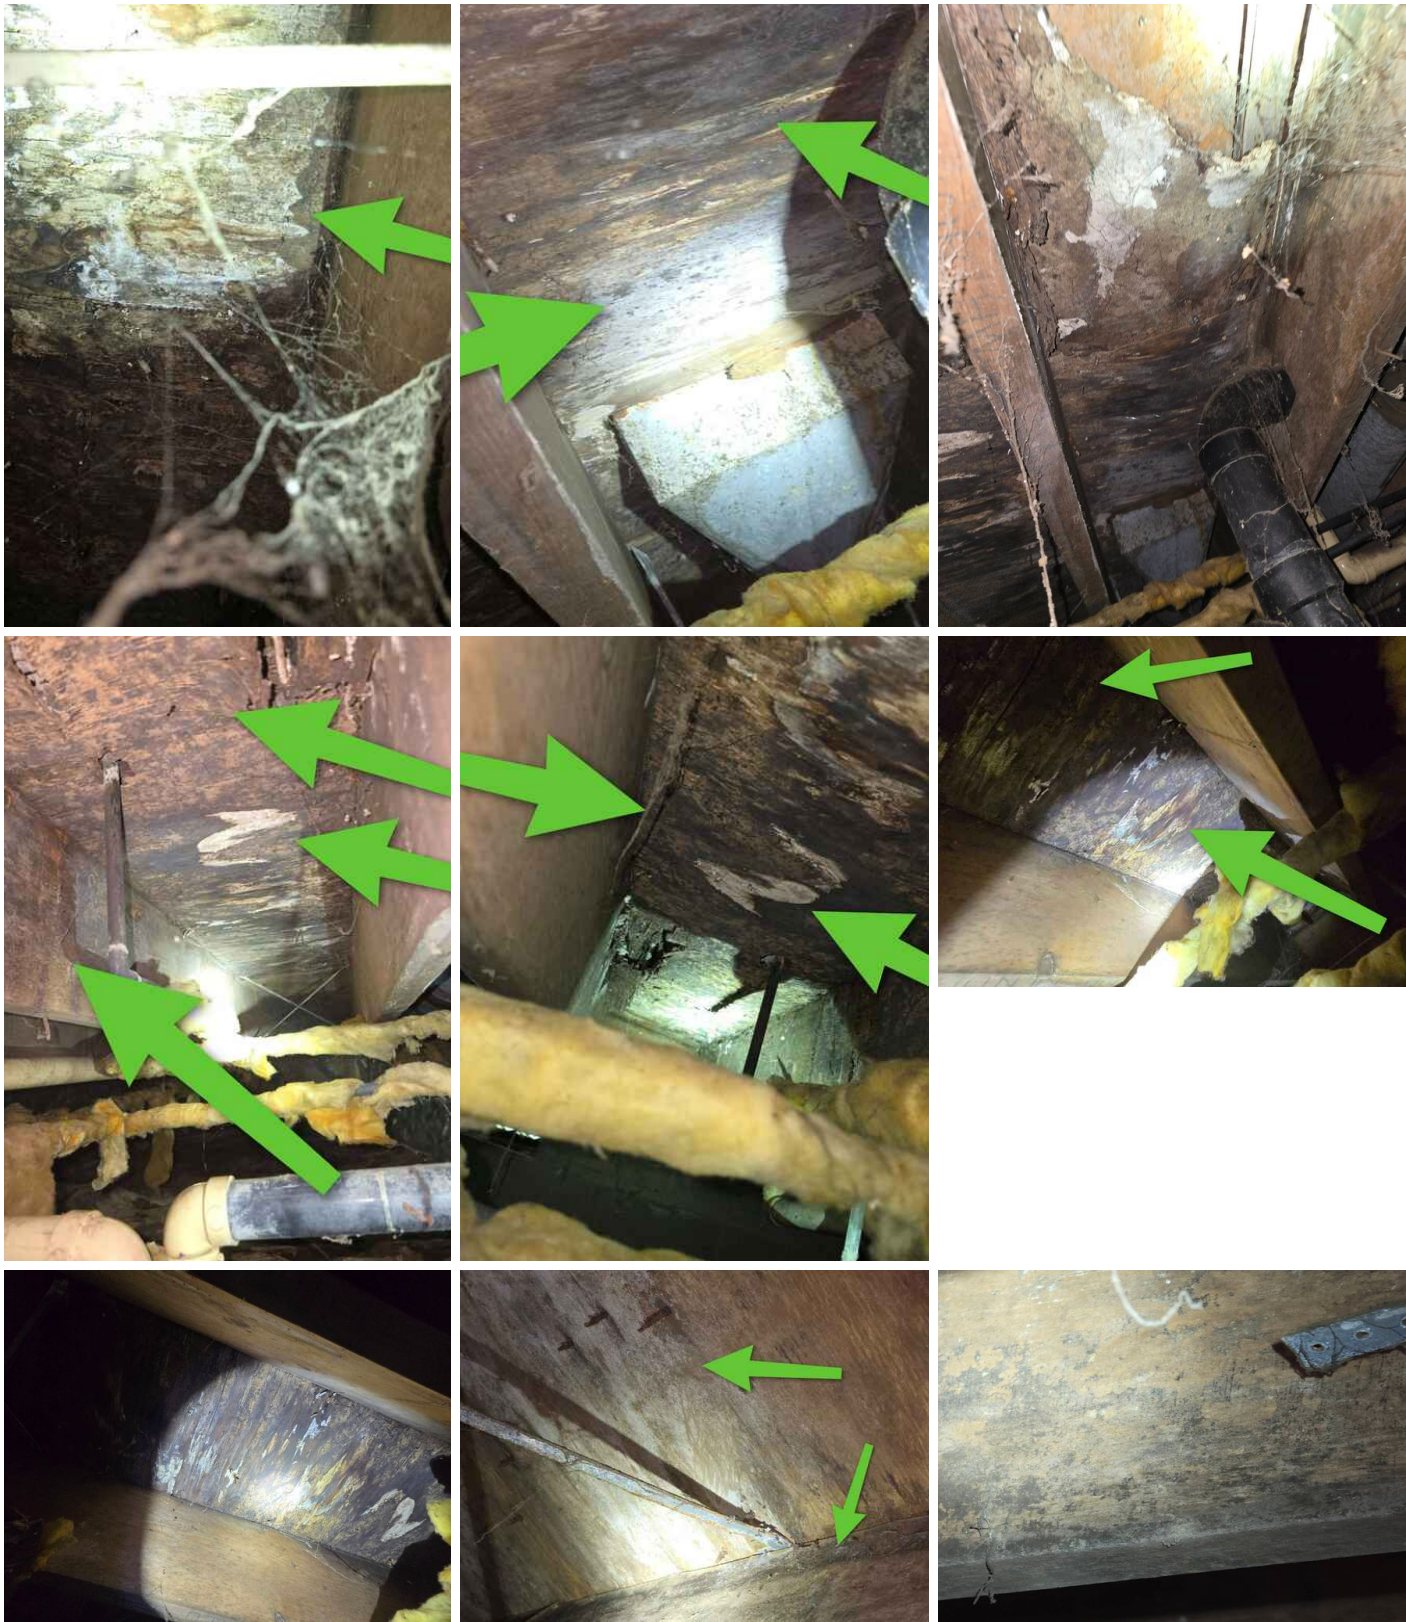
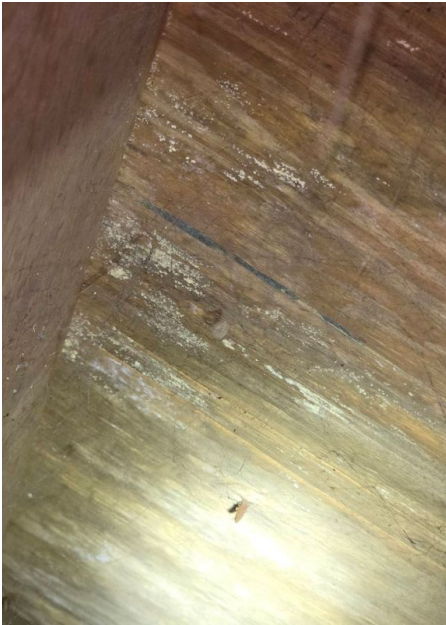
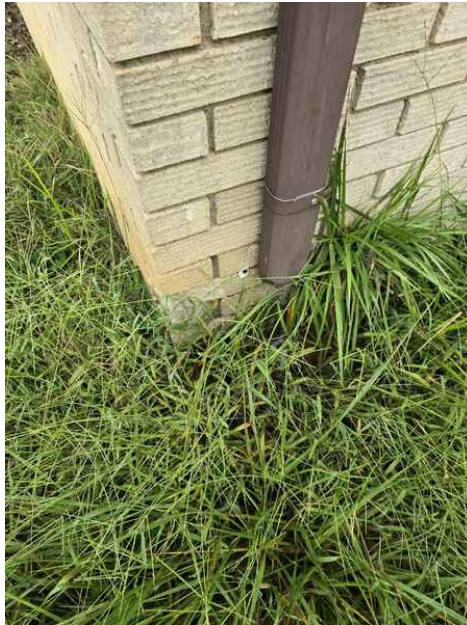
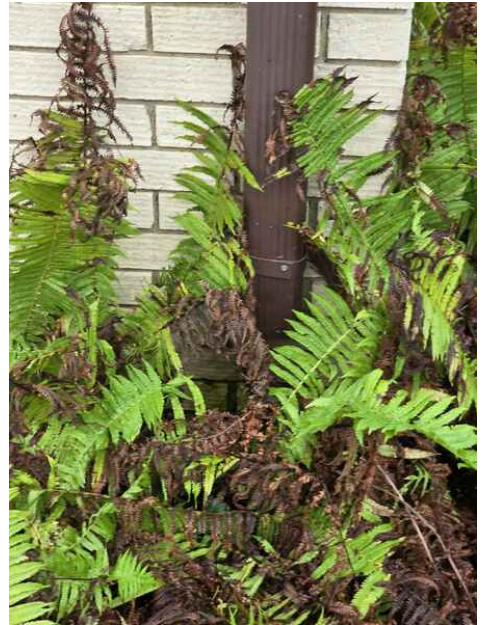
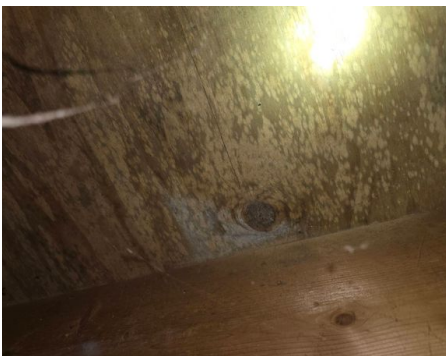
Mold at Crawlspace

There was heavy mold throughout the crawlspace but most common at the left areas.

Some mold was under plumbing areas and there were indications that leaks have occurred. Because water was off this could not be tested.

Signs of active and recurring water intrusion were present at the front, left, and back left perimeter areas. This is primarily the cause in my opinion, however traditional vented crawlspaces almost always have enough elevated humidity to allow mold to grow even when visible water is not present.

The downspouts discharging into the foundation are contributing to the water intrusion. Extending them and improving the grading may reduce or improve water, but in many cases a drainage system is needed to stop water intrusion completely.

Possible mold at ducts. A lab test may be needed to confirm.

Crawlspace encapsulation involves sealing the crawlspace from the outside/ground to keep humidity out. A dehumidifier or air supply system is then used to dry out any potential moisture. Building science has shown that encapsulation is the best, and oftentimes, only way to reduce/prevent mold in a crawlspace. Many professionals agree with this.

I recommend contacting a qualified mold remediation contractor to remediate any growth, evaluate further, and correct any underlying moisture intrusion/humidity concerns.

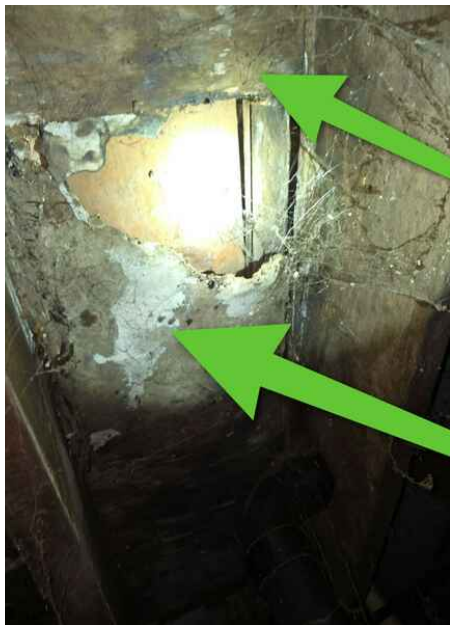
Courtesy Call Out Damaged Wood

Under the bathroom(s) areas of the crawlspace there was heavily rotten/damaged wood alongside mold. At one area there appeared to be a repair of plywood overtop of this damaged wood, but this could not be confirmed at all areas.

There was light/early rot at a few joists front left area of the crawlspace.

A carpenter/qualified builder should evaluate for any necessary repairs.

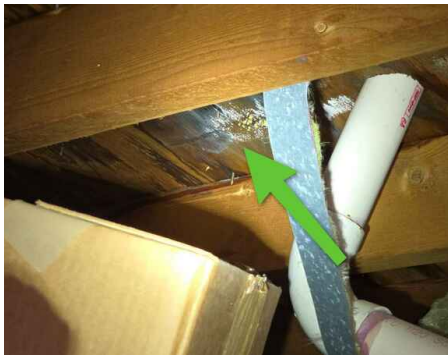
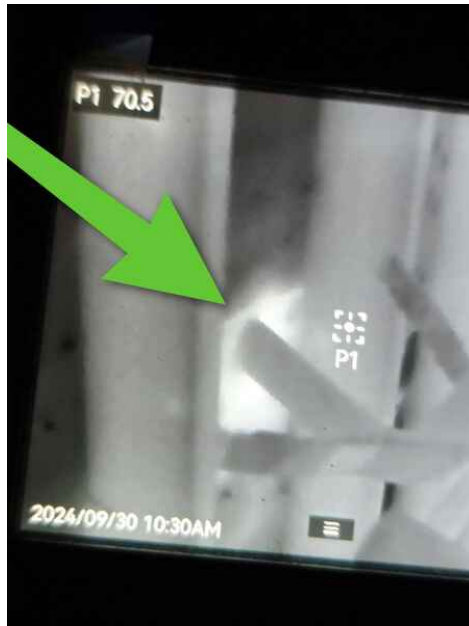
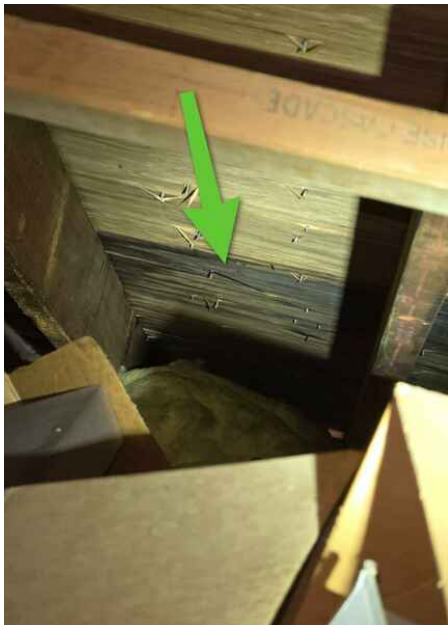
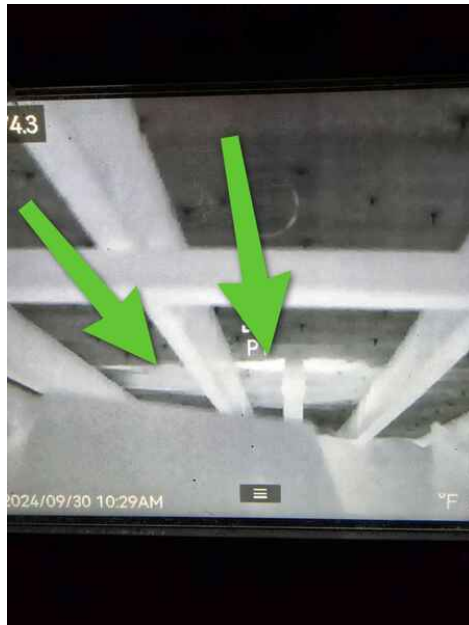
Mold From Roof Leaks

There were 2 roof leaks visible from entrance. They were visibly wet and showed cold spots at thermal camera along stain areas. Mold was present at one of them.

Because the attic was not able to be accessed, I recommend further inspection for leaks/mold, as well as having a qualified roofer evaluate and repair as necessary. Exposed nails were present at flashings which is a very common cause of leaks. All nails should be properly driven and sealed.

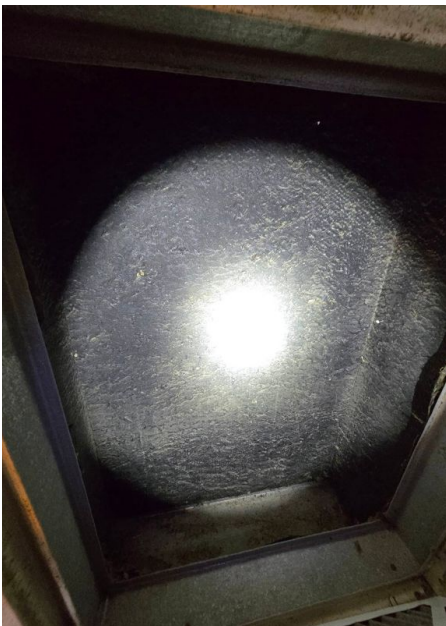
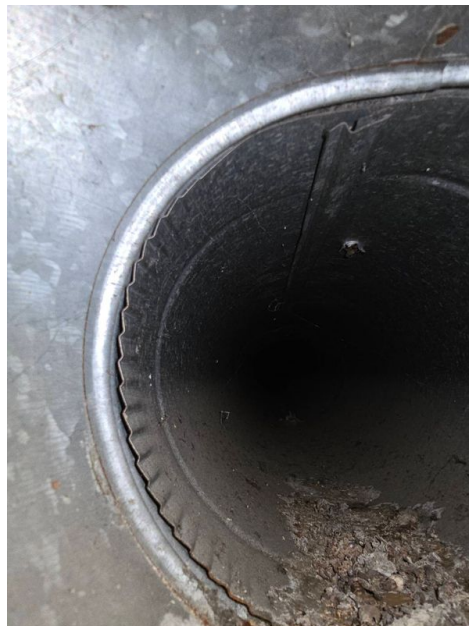
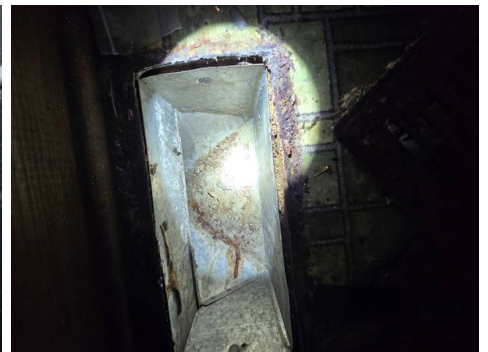
Mold at Air Ducts

There was mold and heavy discoloration/debris at air ducts. Some debris was present at air ducts elsewhere. I recommend a qualified professional remediate/clean the ducts as necessary. This type of material typically requires replacement as it is porous and may not be able to be cleaned properly.

After remediation, it is often advised to have a HEPA filter and UV or other air cleaning devices installed. UV light is best placed at the coil but is not 100% effective due to the speed at which air flows by.

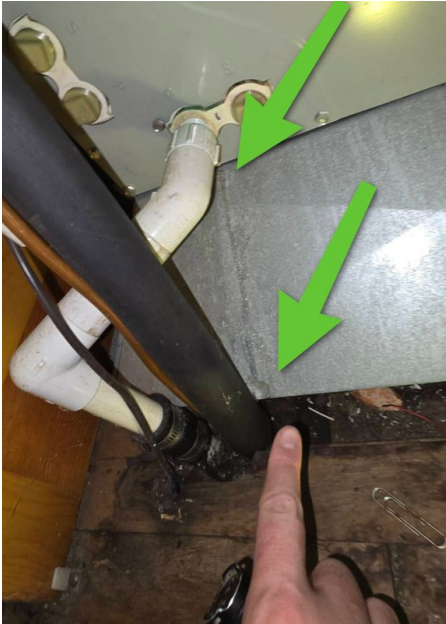
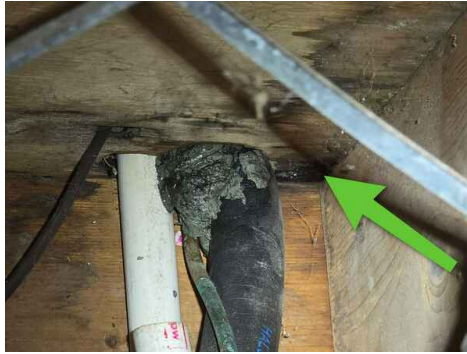
Leak at Air Handler

There was a condensate leak at the air handler. This should be repaired.

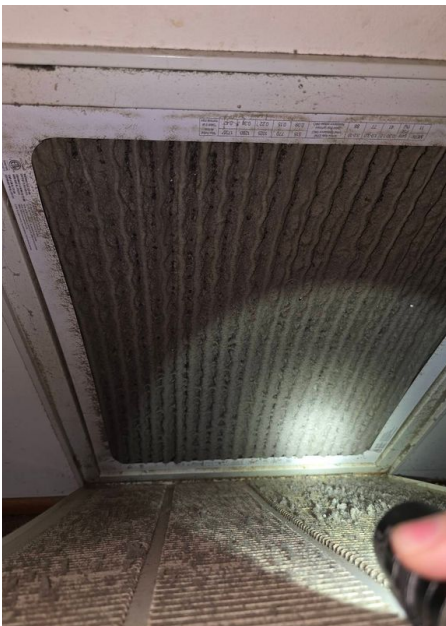
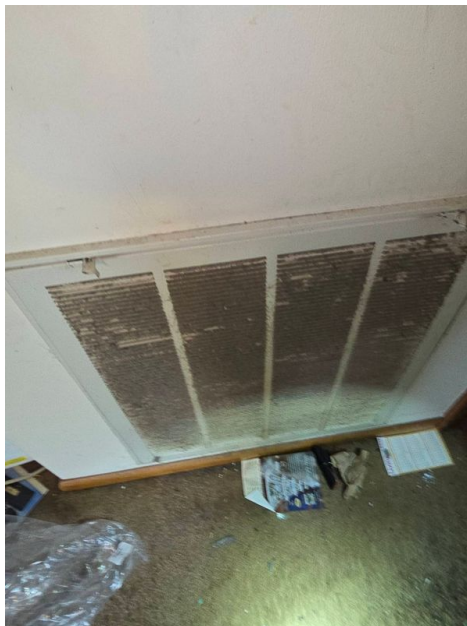
Filter Dirty

Filter was dirty and needs replaced. This increases dust and potential for mold in the system.

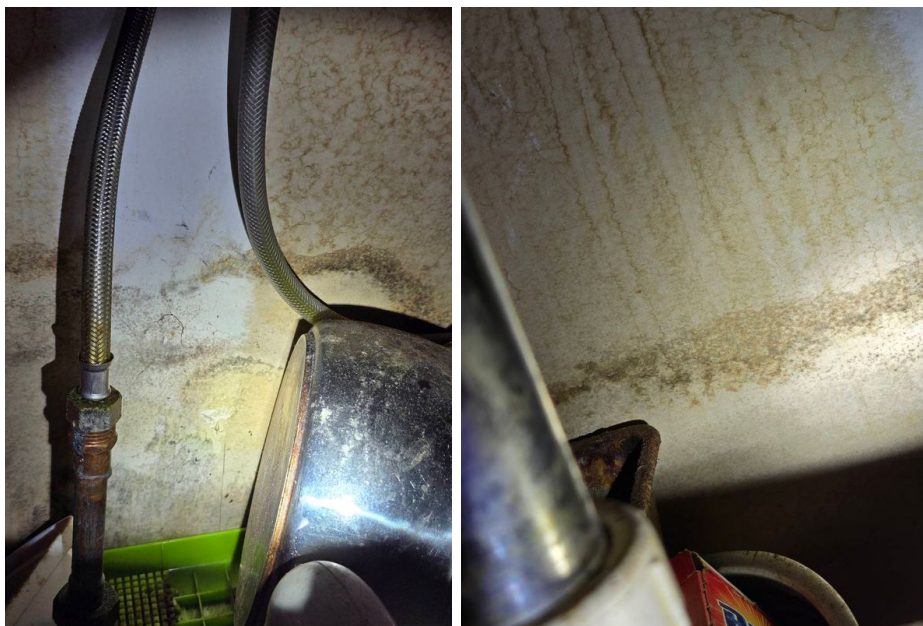
Mold Under Kitchen Sink

There was mold under kitchen sink which is typically due to water leaks. Since water was off this couldn't be confirmed. Further evaluation and remediation is recommended by a qualified mold professional.

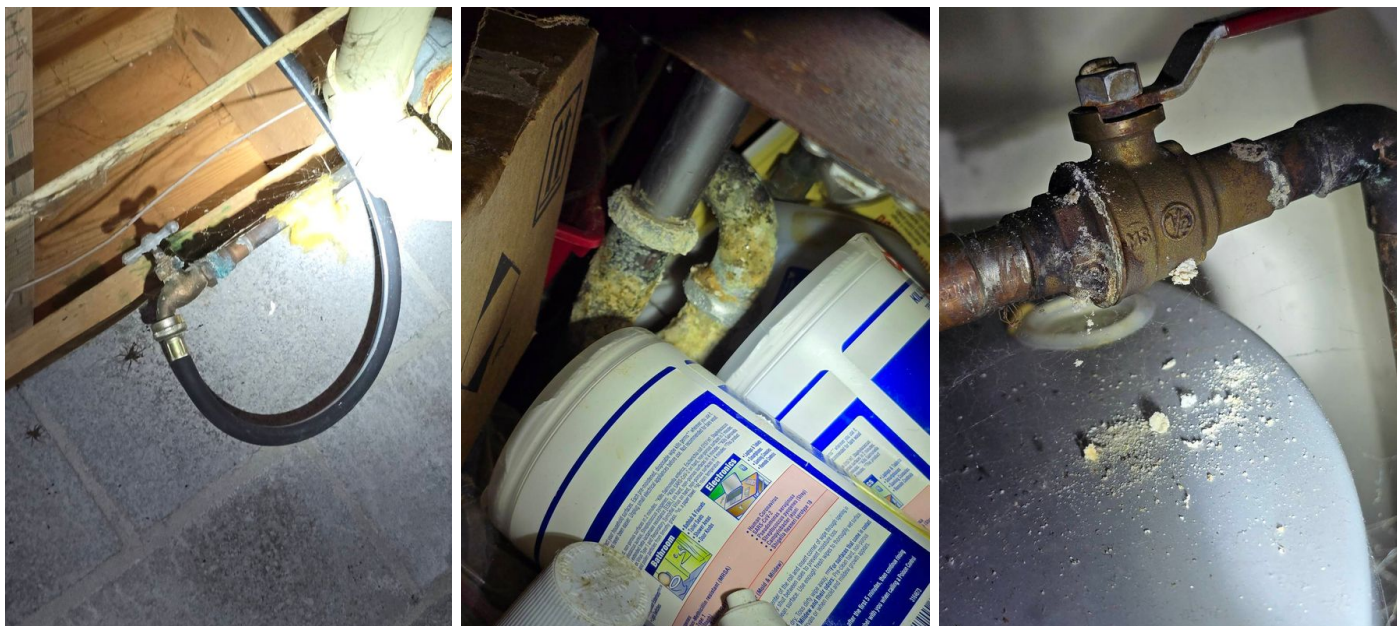
There was plumbing corrosion at crawlspace, under sinks, and water heater. Corrosion can lead to leaks. Monitor or have a plumber replace.

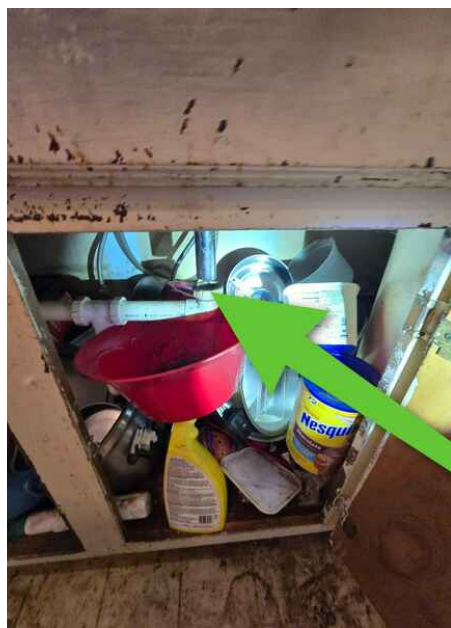
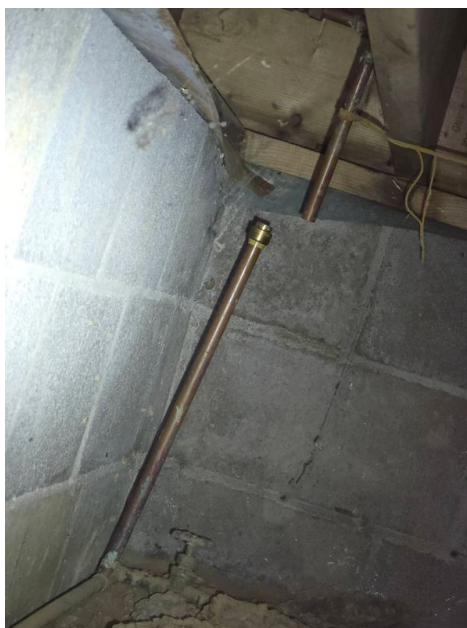
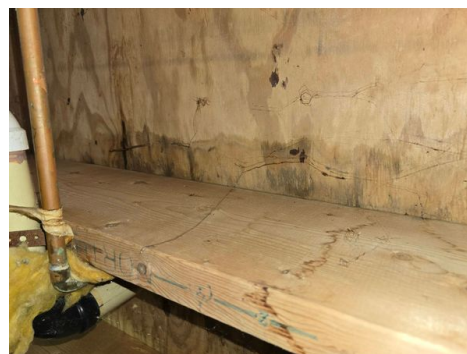
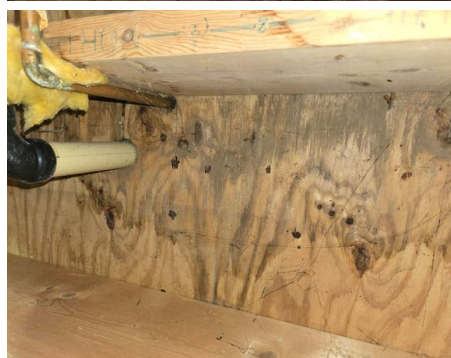
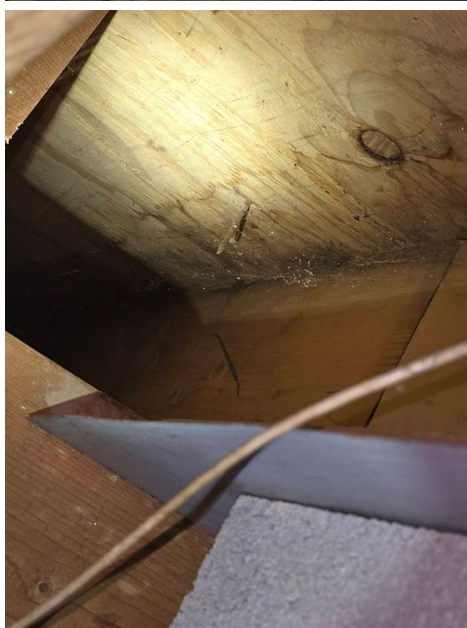
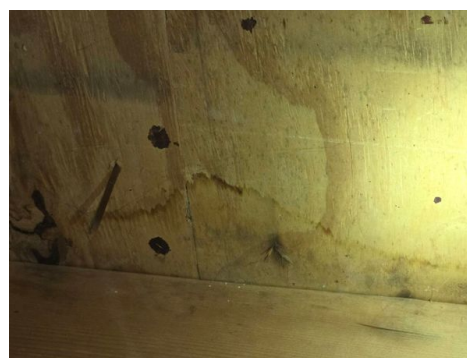
Signs of Leaking-Water Off

Water was off at the whole home and therefore water could not ran/checked for leaks at fixtures. There were signs that leaks have occurred at multiple areas, and plumbing pipes were disconnected at kitchen sink and a crawlspace area. I recommend a qualified plumber connect and test plumbing for leaks.
