# BLUEPRINT PROPERTY INSPECTIONS

## RESIDENTIAL INSPECTION REPORT

1234 Main Street  
Melbourne, FL 32940

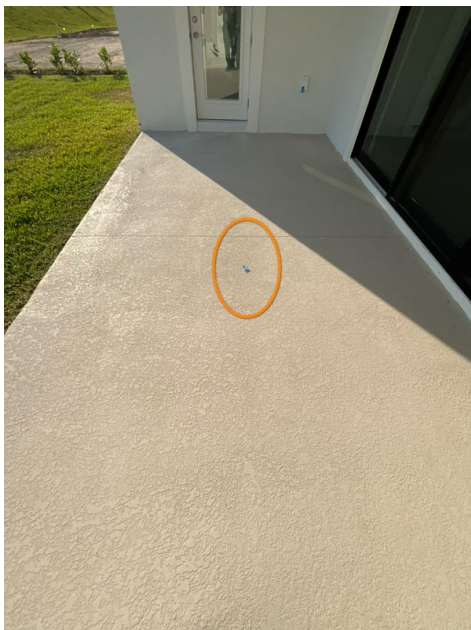
Lanai Slab

If a chip in the lanai's cement topcoat is not addressed several future issues can arise:

**Expansion of Damage** – Over time, foot traffic, weather exposure, and general wear can cause the chipped area to worsen, leading to larger cracks and further deterioration.

**Water Penetration** – A chipped topcoat exposes the underlying concrete to moisture. This can lead to water absorption, which weakens the material and may result in further cracking, spalling, or even structural damage, especially in areas prone to heavy rain or humidity.

**Potential Safety Hazard** – If the chip worsens, it can create an uneven surface, posing a tripping hazard, especially in high-traffic areas.

**Accelerated Wear & Maintenance Costs** – If left untreated, the exposed area can deteriorate faster than the rest of the surface, leading to the need for more extensive repairs or even resurfacing sooner than expected.

To prevent further damage, it's recommended to repair the chipped area promptly using an appropriate patching compound or resurfacing method.

Contact a qualified professional.

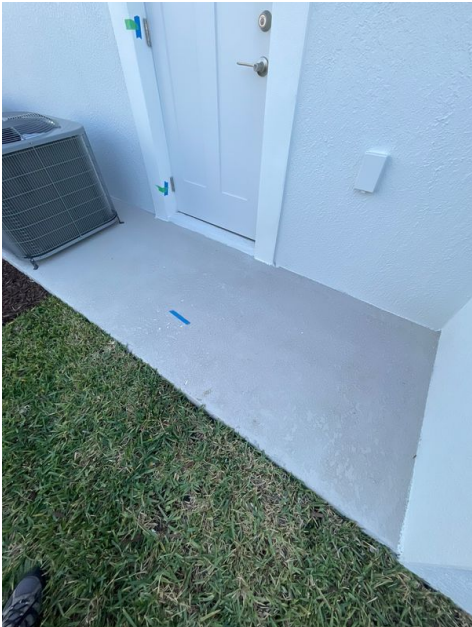
Garage Entry Slab

The dried paint drips on the side of the garage and HVAC slab are purely a cosmetic defect and do not affect the structural integrity or functionality of the home.

Fortunately, this is an easy fix. The affected area can be lightly sanded to smooth out the drips and then repainted for a clean, uniform finish. This is a minor touch-up that the builder or homeowner can easily address to improve the overall appearance of the area.

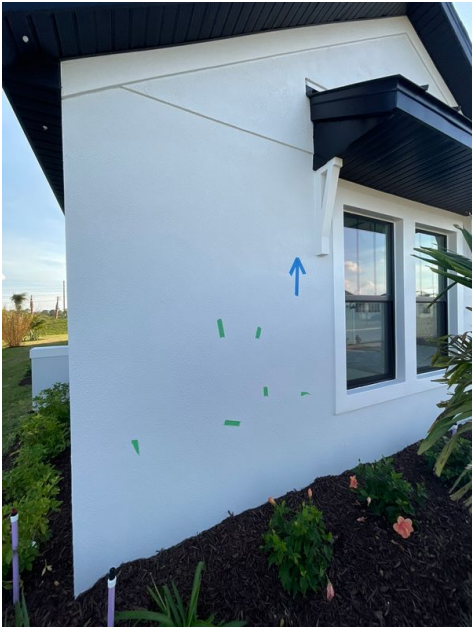
Front of Home

Touch up paint throughout exterior walls.

Recommendation  
Contact your builder.

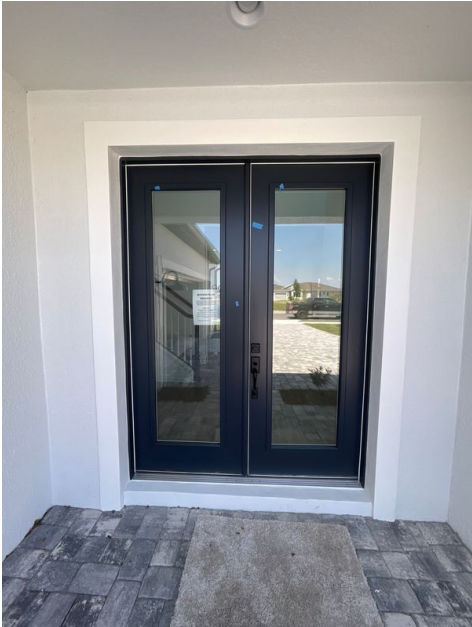
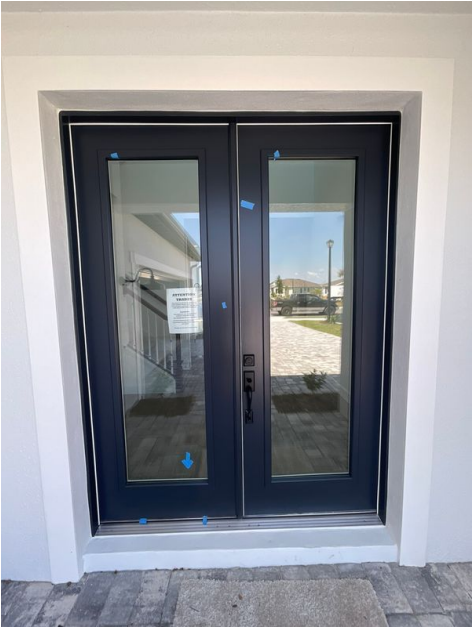
At the time of Inspection, Front Entry door in need of surface paint correction, door also has dings, missing caulking and paint above door molding.

Contact a qualified door repair/installation contractor.

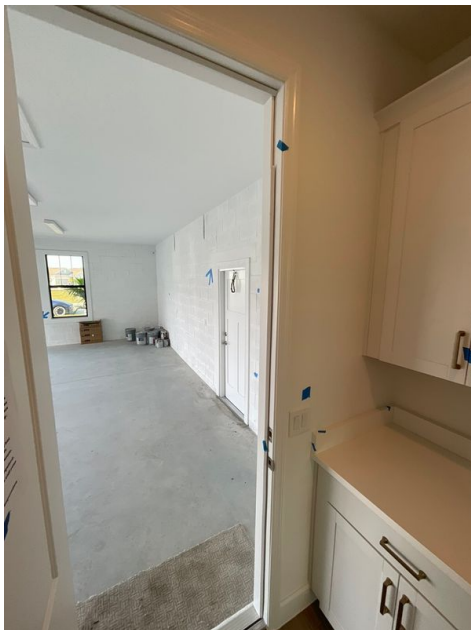
Garage Entry Door

Missing grout near the entry door can lead to several potential issues if not addressed:

**Water Intrusion** – Gaps in the grout allow water to seep into the subfloor, potentially leading to water damage, mold growth, and weakening of the structure over time.

**Tile Movement & Cracking** – Without grout to hold tiles in place, they can shift, leading to cracking, chipping, or even detachment, resulting in costly repairs.

It's recommended to reapply grout as soon as possible to prevent these issues and maintain the integrity of the flooring near the entryway.

Contact a qualified tile contractor

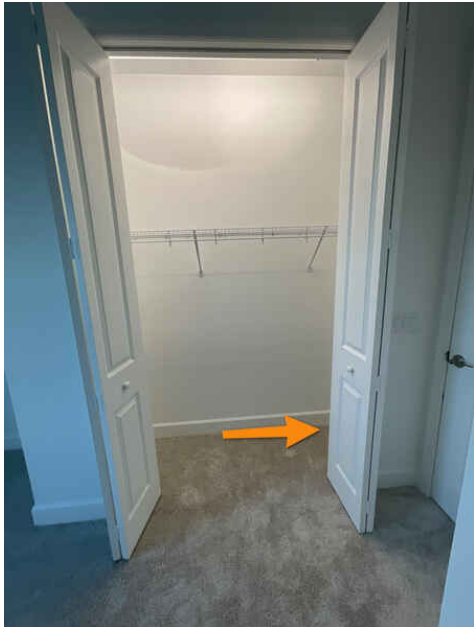
Bedroom 1 Closet Doors

The affected area can be lightly sanded to smooth out the nicks and then repainted for a clean, uniform finish. This is a minor touch-up that the builder or homeowner can easily address to improve the overall appearance of the closet door

Contact your builder.

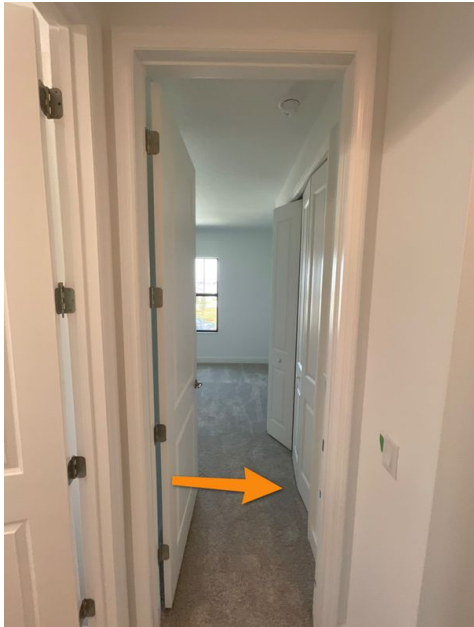
Bedroom 1 Second Floor

Door trim for bedroom 1 and laundry trimming missing caulking and paint

Recommendation  
Contact your builder.

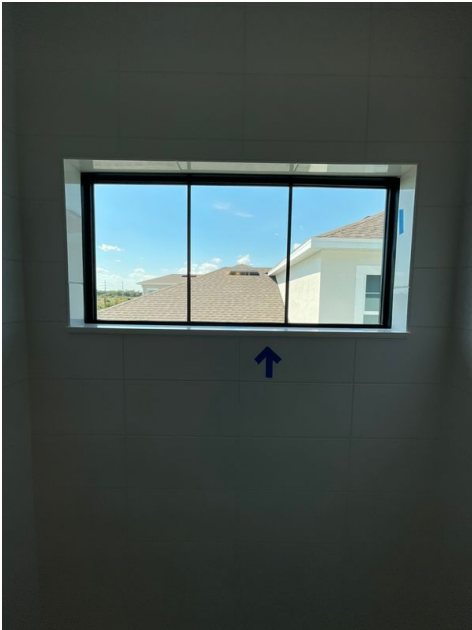
2nd Floor Bathroom Window

Window sill missing cap filler

Contact a qualified professional.

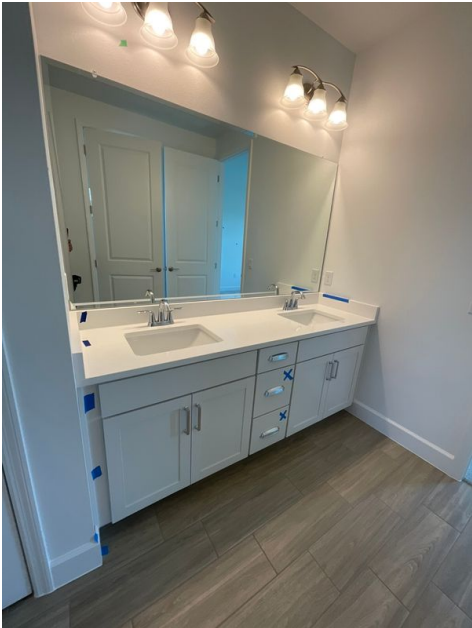
Bathroom 2nd Floor

Re-caulking and or re-grout needed. Properly add caulking/grout to shower, sink and toilet edges to prevent any water or moisture from entering walls.

Recommendation  
Contact a qualified professional.

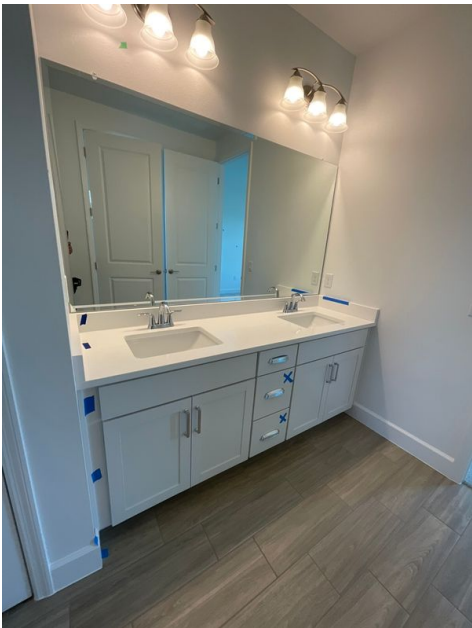
Bathroom 2nd Floor

Over spray of texture or paint shown on the cabinets

Recommendation  
Contact a qualified professional.

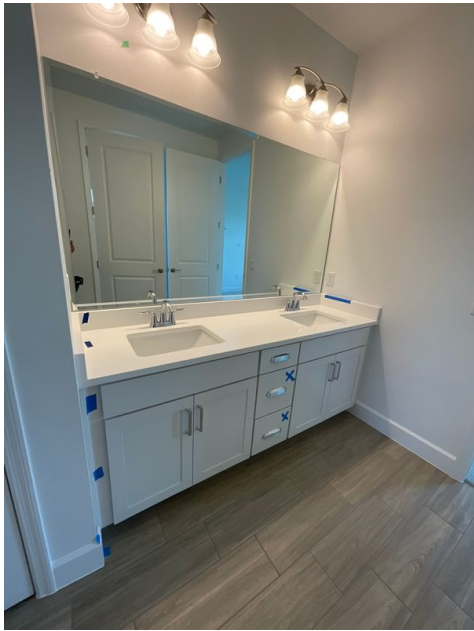
Bathroom 2nd Floor

2nd Floor Bathroom draws damaged

Recommendation  
Contact a qualified professional.

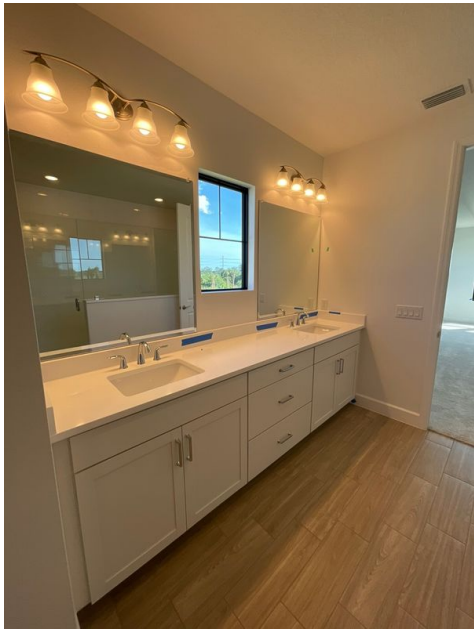
Master Bathroom

Re-caulking and or re-grout needed. Properly add caulking/grout to shower, sink and toilet edges to prevent any water or moisture from entering walls.

Recommendation  
Contact a qualified professional.

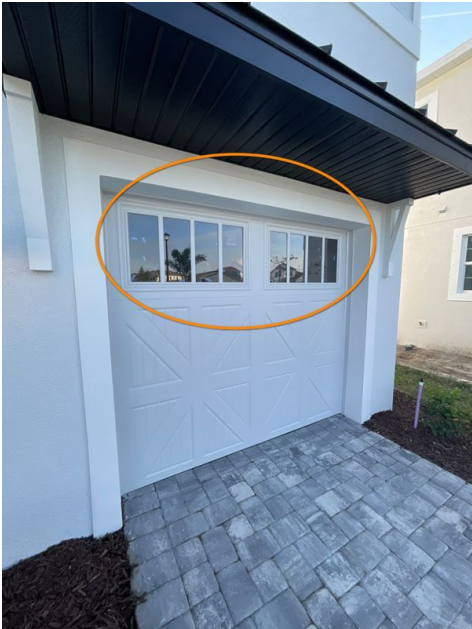
Single Car Garage

At the time of inspection, garage door glass section scratched in need of evaluation for possible replacement

Contact a qualified professional.
