## INSPECTION REPORT

1234 Main Street  
Ruskin, FL 33575

Buyer Name  
07/01/2025 9:00AM

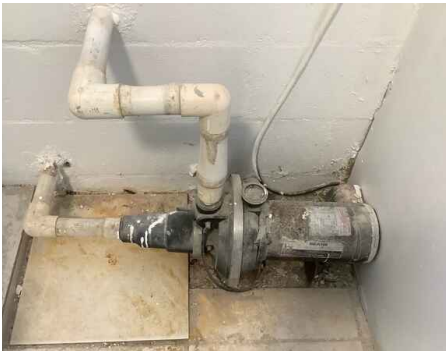
This may be old well equipment as property is on public water - consult with seller

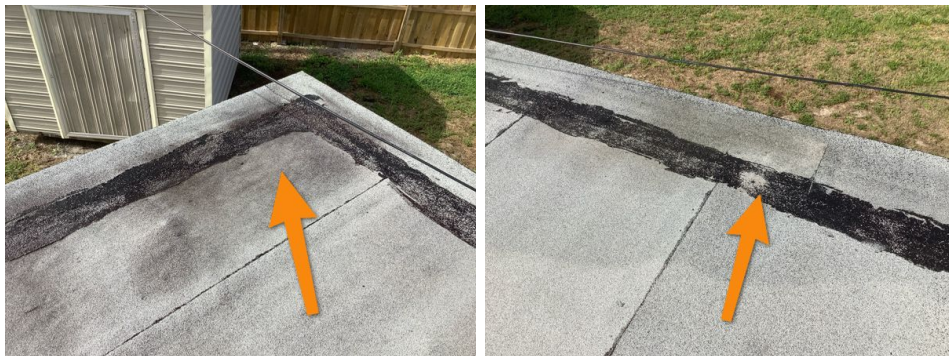
Ponding (pools of standing water) was found at one or more locations on the flat or low-slope roof surface. Water should be removed by a drainage system so that any remaining water evaporates within 48 hours after it rains. It may have been less than 48 hours with the recent rainfall. Recommend monitoring going forward of how long standing water lasts after it rains. Prolonged standing water can result in roof leaks. Recommend that a qualified contractor evaluate and repair as necessary to prevent ponding if less than 48 hours.

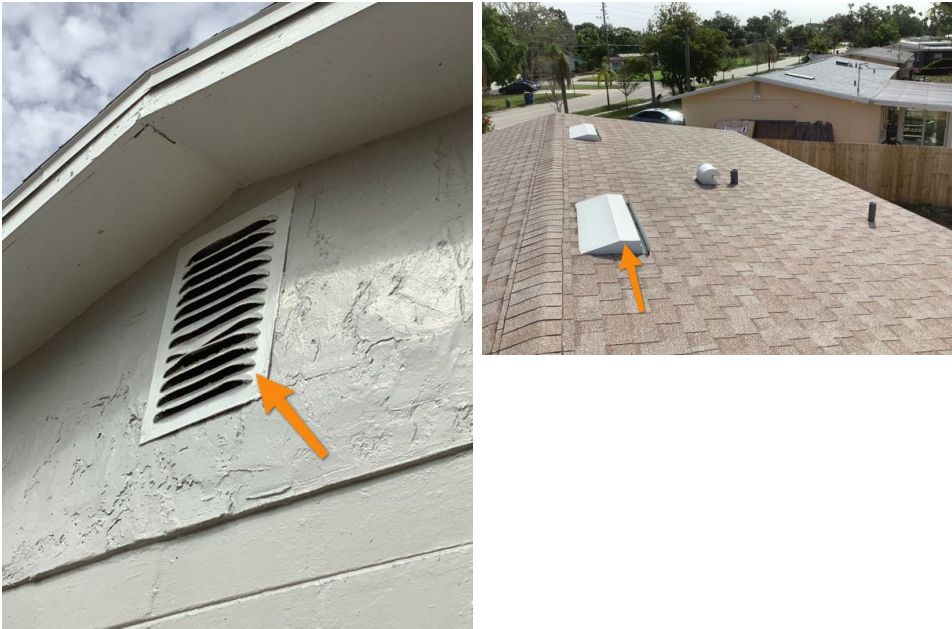
Please note the property has the improper use of mixed exhaust vents. Attic exhaust ventilation can consist of ridge vents, wind turbines, gable louvers, box/static vents and power fans; though only ONE should be used! Though it's a common practice today to have more than one, it is not recommended. Airflow dynamics dictates avoiding it. The manufacturers' Installation Instructions caution against it. Building Codes may cite it as a violation. And yet it remains one of the most questioned, challenged and, unfortunately, ignored best practices in residential attic ventilation. Lack of information, misunderstanding the science, and resistance to breaking old habits all contribute to the persistence of mixed exhaust vents on today's roofs. The main reason combining different types of exhaust vents is problematic is that it disturbs the proper flow of the attic air. To best help fight heat buildup and moisture buildup, attic ventilation must be a balanced system of intake vents (placed low on the roof in the soffit or at the roof's edge) and exhaust vents (placed at or near the roof's peak). This allows the incoming cooler, drier air to enter the attic at the lowest possible location, flush out any built-up heat and moisture from inside the attic all along the entire underside of the roof deck, and push it out through the exhaust vents high on the roof. But, if two or more different types of exhaust vents are in place, it short-circuits the system. Premature aging of roofing materials, buckled sheathing and signs of rotten wood can all be due to moisture and heat being trapped. An exhaust vent mixed with another type of exhaust vent that suddenly is pulled into intake airflow duties as a result of short-circuiting is not only pulling in air, but whatever the air is carrying that very moment: rain, snow, debris. Exhaust vents are not designed to ingest anything. If improved airflow is the goal, double-check if the correct type of exhaust vent is being used to match the size and design of the roof/attic and if it's being supplied with a balanced amount of intake ventilation. Mixing exhaust is not the solution.

Contact a qualified roofing professional.

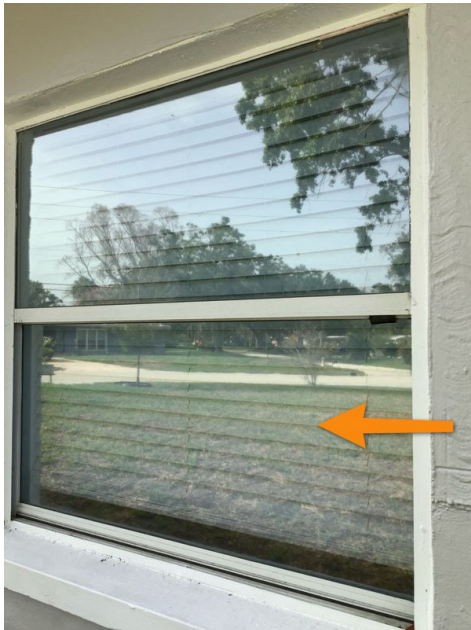
Front

**SCREEN MISSING**

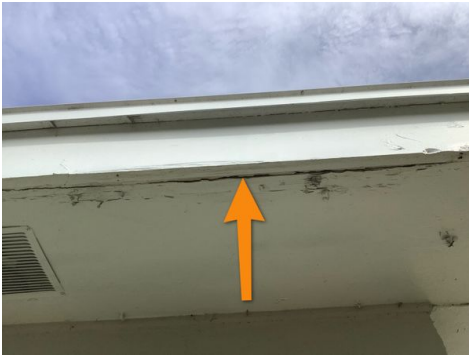
Rear

Fascia and/or soffit are damaged, deteriorated or substandard in one or more areas. A certified contractor should evaluate and repair as necessary.

Recommendation  
Contact a qualified professional.

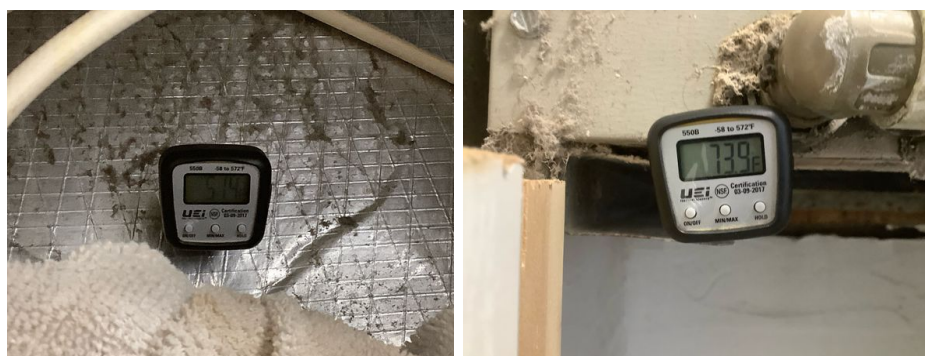
#### 22 Degrees

This is the number of degrees the system is cooling (or heating) the house air. While there isn't any perfect temperature you should set your HVAC system to, there is an ideal temperature difference between the supply and return air. The general range for this number is 14-24 degrees when operating the system during hot weather, lower when ambient temperatures are lower. There are many variables that can affect this # and depending on who you ask, you may get different ranges of what is acceptable among HVAC technicians. If you are concerned about the difference in temperatures, you should contact a certified HVAC professional for a full evaluation of the HVAC system. The test results were measured using a digital thermometer. The system appeared to function as expected when tested and appeared to be serviceable at the time of the inspection. As with all mechanical equipment, the unit may fail at any time without warning. The inspector cannot determine future failures.

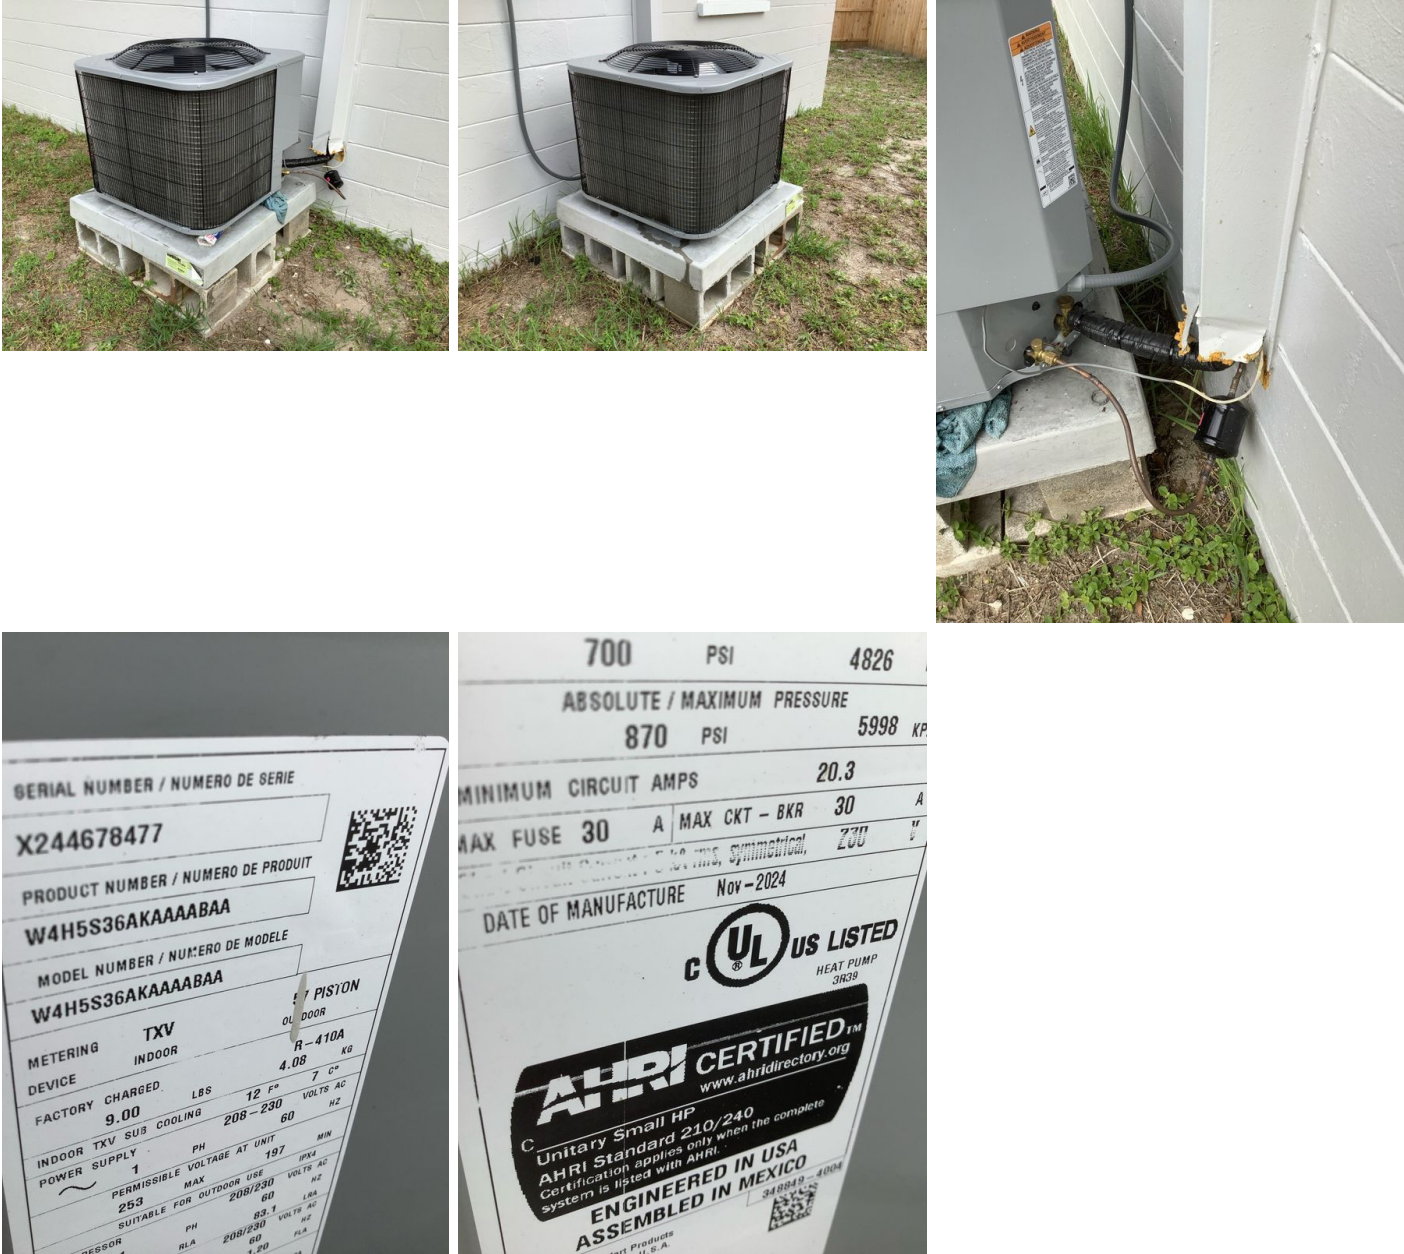
Condensing Unit(s): Split System - Working properly

The HVAC system was a split system with the condenser located outside. The thermostat and blower were checked and were working as designed. Determining correct size for an air conditioning system is beyond the scope of a home inspection.

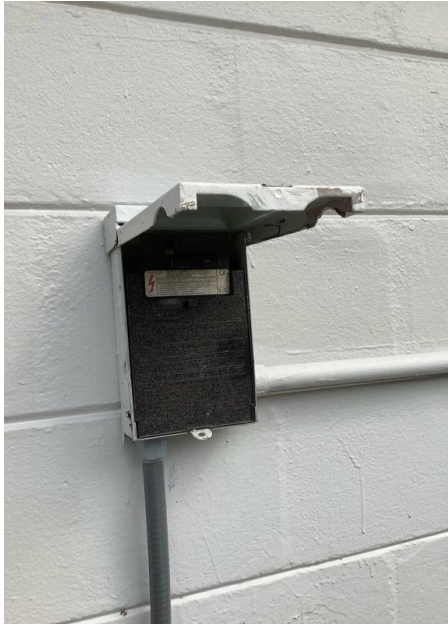
Exterior

The equipment local disconnect was in sight and accessible and acts as a shut off switch for use in an emergency or while servicing.

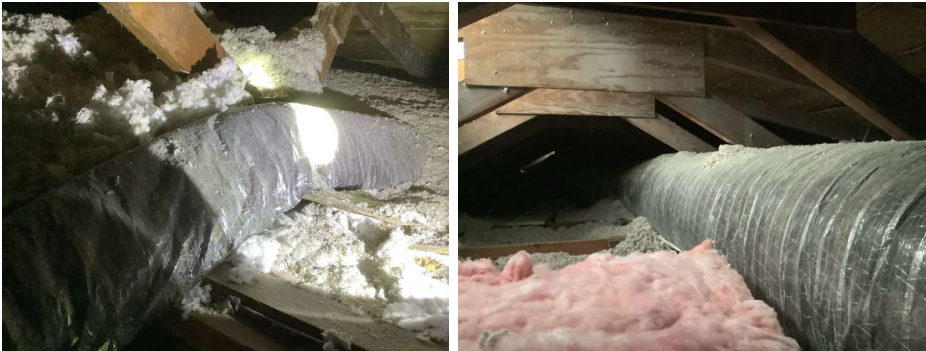
Duct Work: Ductwork  
Interior

Both the heating system and central air conditioning system share the same ductwork and appear to be properly installed and acceptable. We are not HVAC professionals. This inspection is not a Ductwork Efficiency Inspection (i.e., layout of ductwork, CFM flow to registers, etc.) which is beyond the scope of a home inspection. If you are concerned about the duct efficiency or design you should have an expert in that field evaluate the duct system.

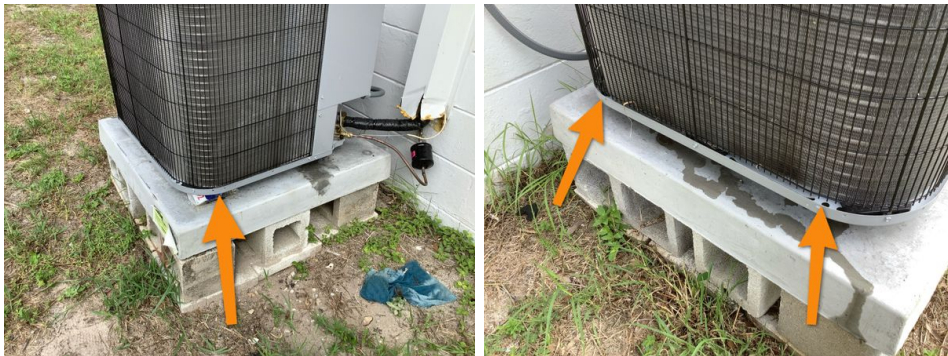
The outside condensing unit is not anchored to the concrete pad. Inspector was able to lift it up. It is recommended to have a certified contractor anchor the unit to the concrete pad to keep it from moving and causing damage and perhaps theft.

Contact a qualified heating and cooling contractor

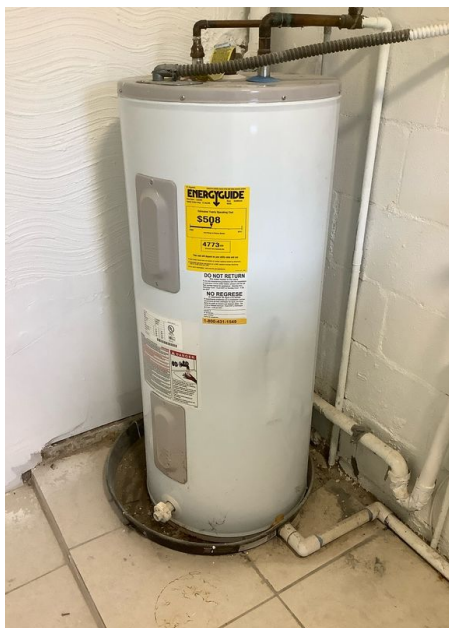
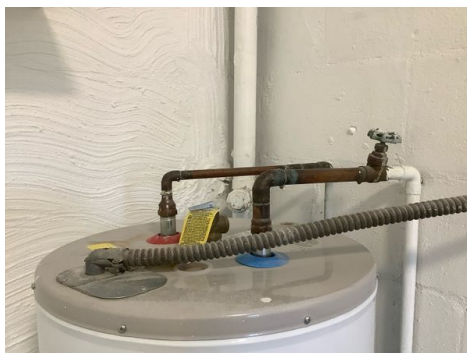
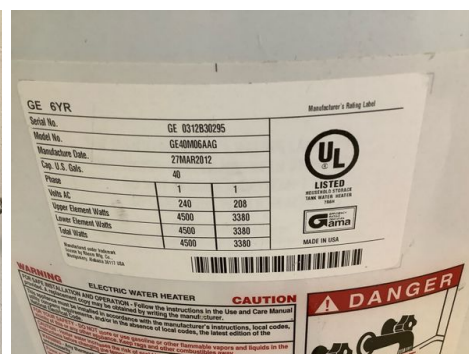
## Water Heater: Pictures of Unit

The water heater(s) was visually inspected in order to ensure proper installation and that no leaks, rust, or corrosion were present. The temperature of the water was also checked to ensure the water heater was functioning properly.

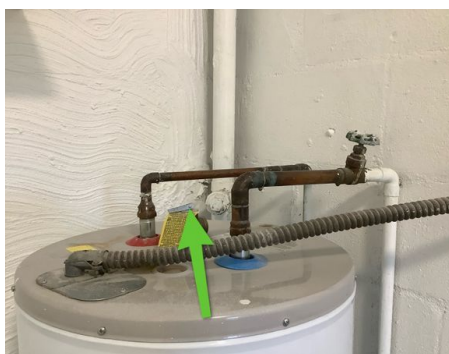
## Water Heater: T/P Release Valve

The water heater is equipped with a proper temperature and pressure relief valve and extension pipe. This device is an important safety device and should not be altered or tampered with. No adverse conditions were observed. Please note if you test the valve there's a risk that the valve won't close properly and will keep leaking, and then it will need to be replaced.

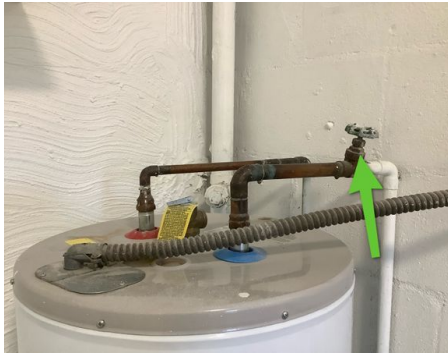
## Water Heater: Inlet Valve

The cold water inlet and hot water outlet connections appear properly installed and in serviceable condition. The water heater is equipped with a cold water inlet shut-off valve. It is functioning as designed and intended. Home inspectors do not operate any valves according to the standards of practice and valves may leak when operated after a period of inactivity. For this reason, they are not tested during the inspection.

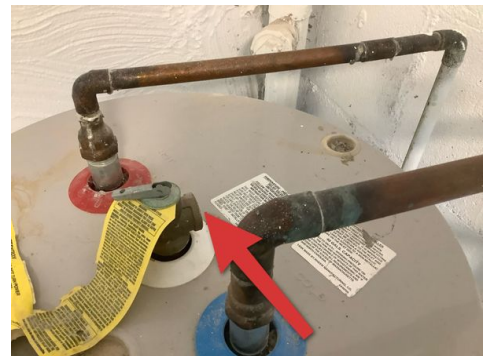
No drain line is installed for the temperature-pressure relief valve. This is a potential safety hazard due to the risk of scalding if someone is standing next to the water heater when the valve opens. A qualified plumber should install a drain line as per standard building practices (discharge pipe has to be 3/4" in diameter and suitable material such as copper or CPVC. It should also extend to 6 inches from the floor, or routed so as to drain outside).

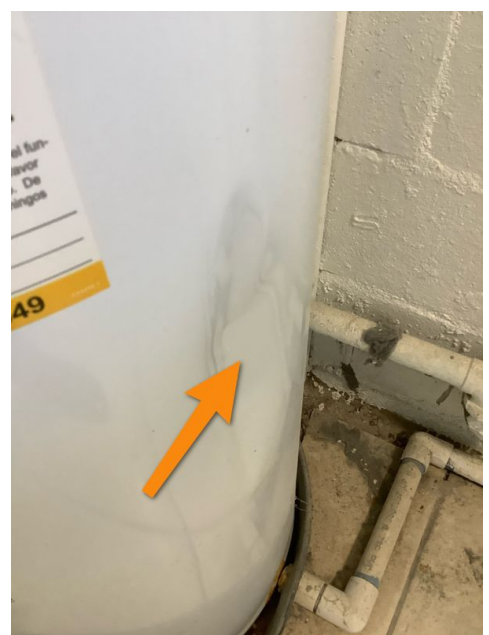
### 6.1.2 Water Heater

#### DAMAGE

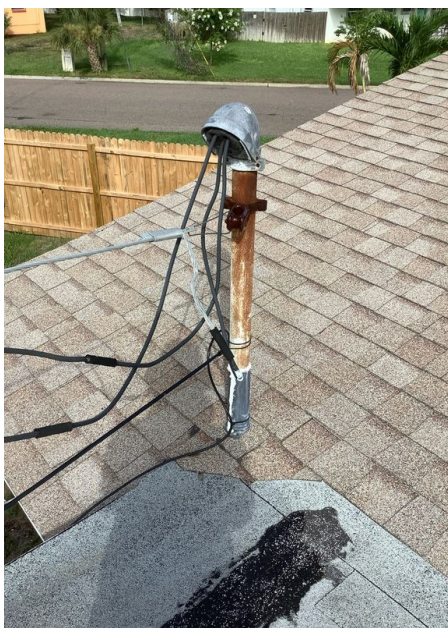
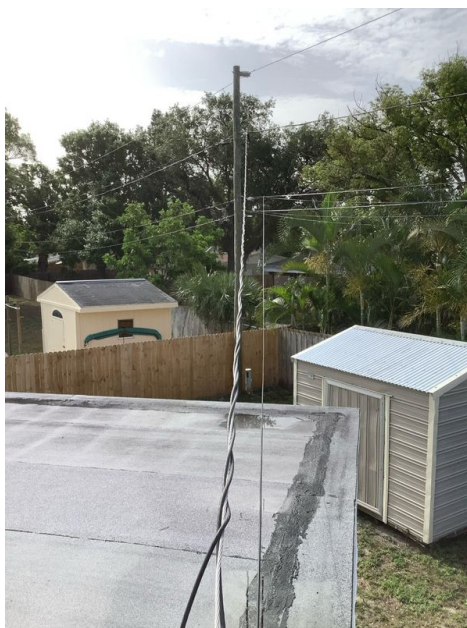
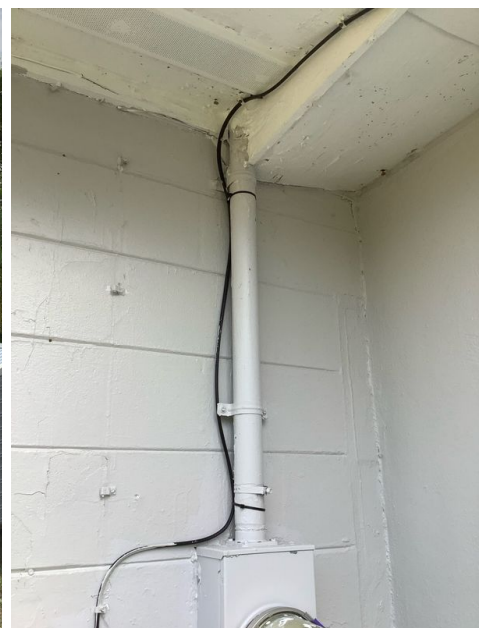
## Service Wires: Service entrance wires

Electricity goes through the meter to the main panel then onto the outlets.

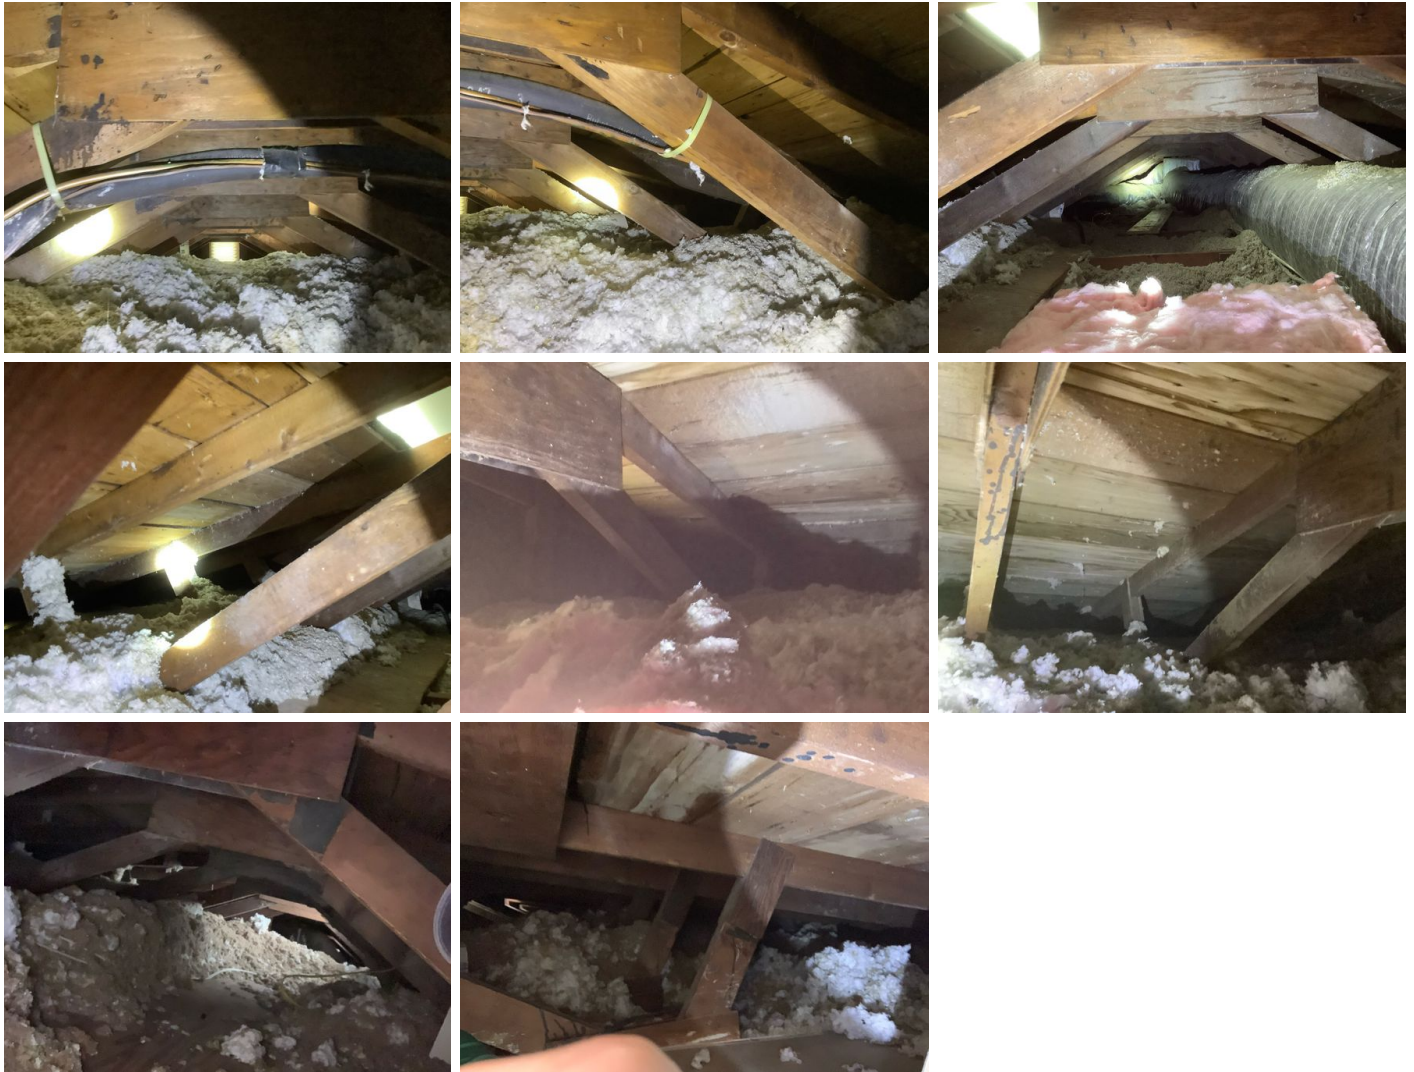
Attic

**Attic structure:** constructed to distribute the weight of the roof onto the exterior walls of the house.

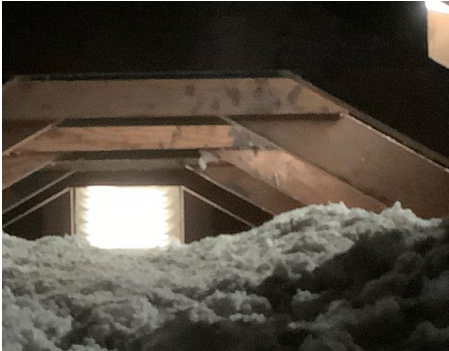
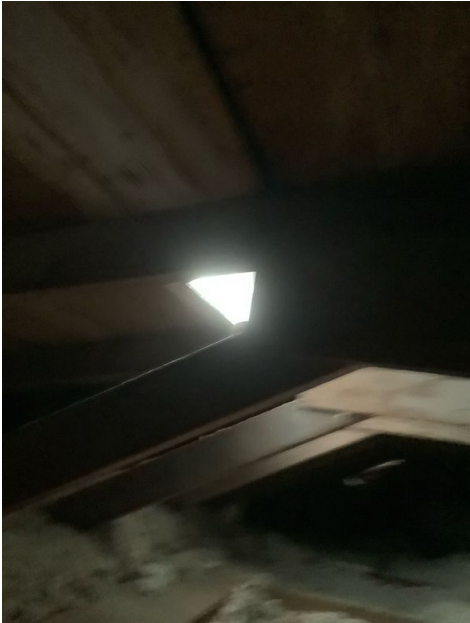
Attic

Current standards require 1 foot of ventilation for every 150 SF of attic space. Existing ventilation consists of static, gable, and perimeter soffit. It is outside the scope of a home inspection and outside the Standards of Practice for inspectors to determine the adequacy of ventilation.

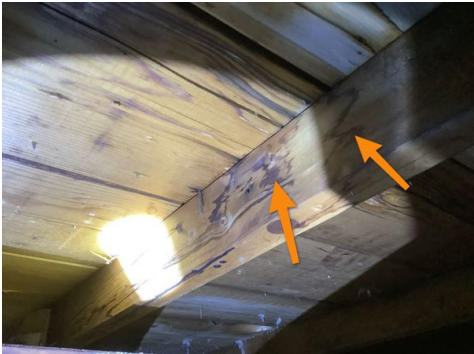
Stains were visible in one or more areas. The stains may be caused by a past leak/current leaks. They may have been prior to the 5 year old roof. Recommend asking the property owner(s) about roof leaks. The client(s) should monitor these areas in the future, especially after heavy rains, to determine if active leaks exist. If leaks are found, a qualified roofing contractor should evaluate and repair as necessary.

Recommendation  
Contact a qualified roofing professional.

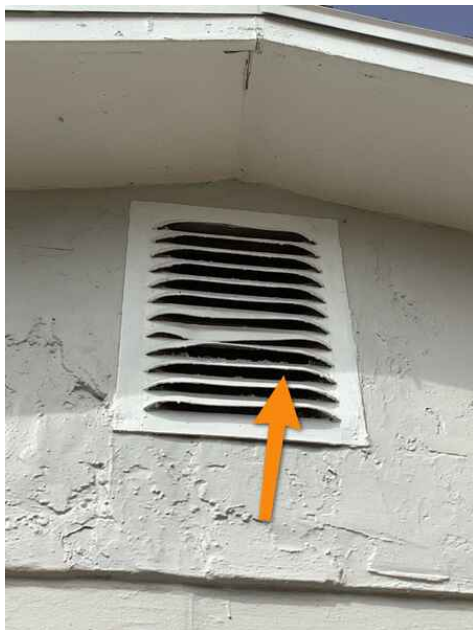
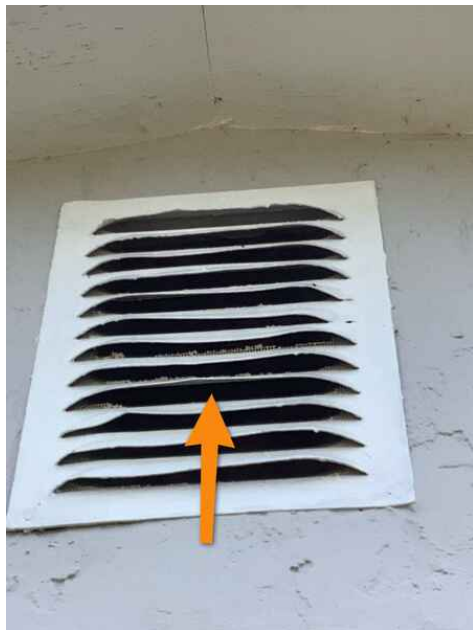
## 8.5.1 Ventilation

**GABLE VENT DAMAGE**

Contact a qualified professional.

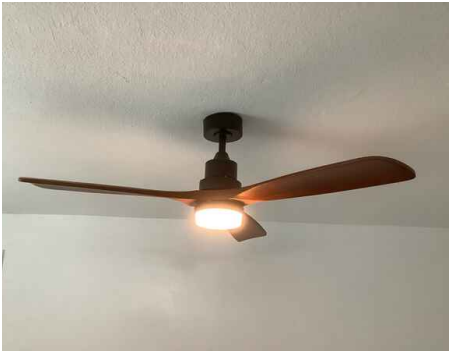
Couldn't find remote to operate fan

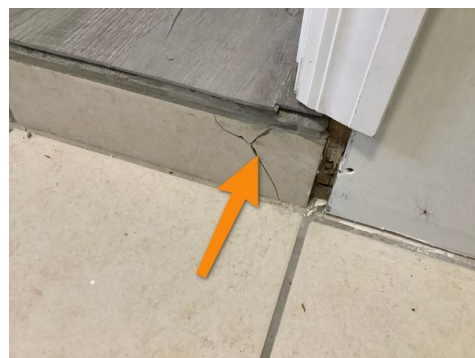
Laundry Room

Tile flooring is damaged, deteriorated, and/or substandard in one or more areas. A qualified contractor should evaluate and make repairs as necessary.

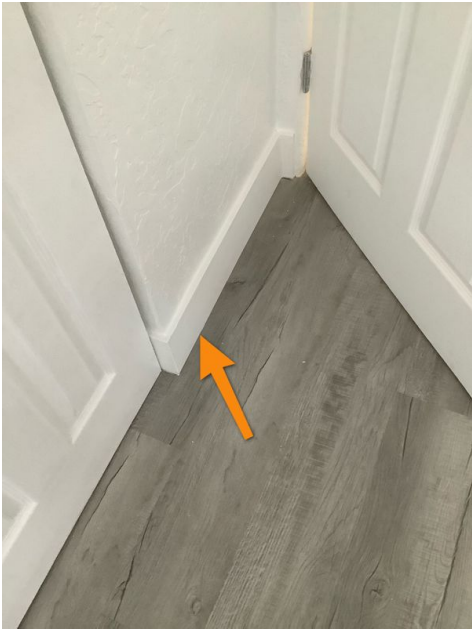
Bedroom

Fixtures such as door stops, hinge stops or wall stops are missing at one or more doors. It is recommend having a qualified contractor install stops, wall stops or hinge stops where missing. When wall/door stops are missing there is a possibility the door will create unnecessary damage.

Contact a qualified door repair/installation contractor.

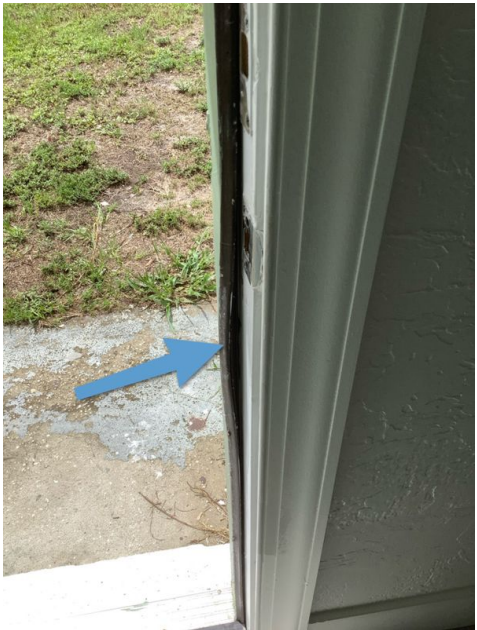
Rear

The weatherstrip around exterior entry door is deteriorated. Weatherstrip may simply need to be adjusted or replaced if needed.

Recommended DIY Project

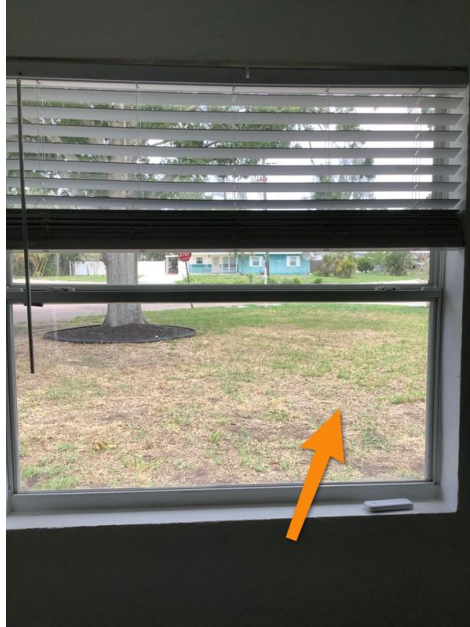
Bedroom

One or more windows are difficult to open and/or close. The windows should be adjusted so that they will open and close freely and all necessary repairs should be made.

Contact a qualified window repair/installation contractor.

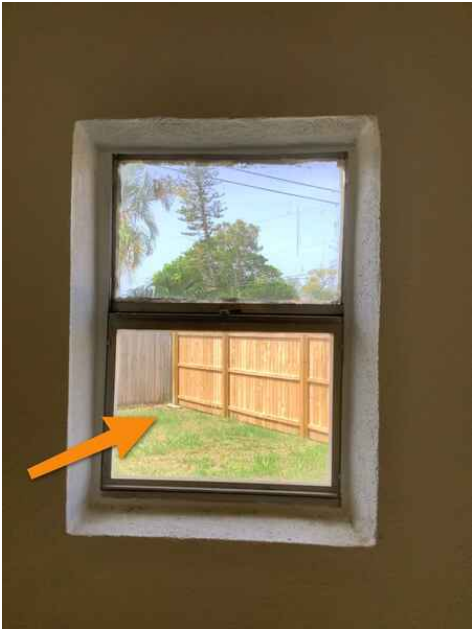
Laundry Room

One or more windows that were built to open, will not open, or open only minimally due to their being damaged and/or deteriorated in some way. Repairs should be made as necessary, and by a qualified contractor if necessary so windows open fully, and open and close easily.

Contact a qualified window repair/installation contractor.

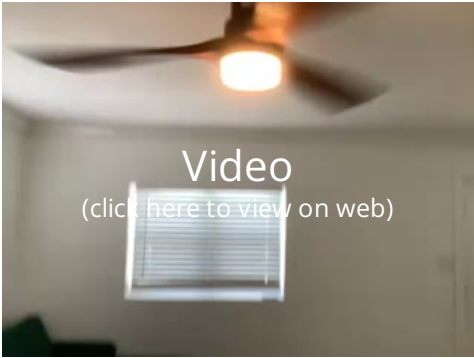
Ceiling fan is noisy at times and wobbles a bit during operation. Recommend having a qualified contractor evaluate and repair as necessary.

Contact a qualified professional.

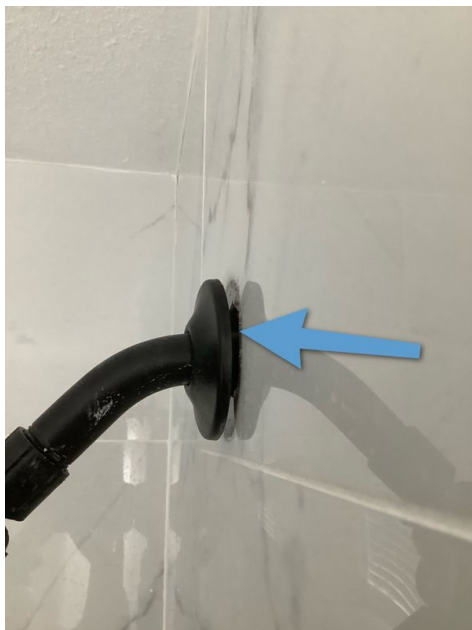
10.3.1 Shower

SHOWER HEAD NEEDS CAULKING

## Recommended DIY Project

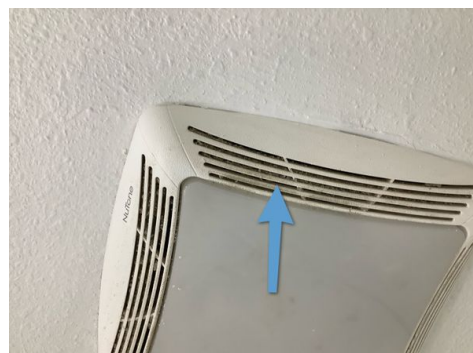
## 10.5.2 Exhaust Fan

**NONE WITH SHOWER**

One or more bathrooms with a shower do not have an exhaust fan installed. Moisture accumulation will occur and may damage the structure. Even if a bathroom has a window that opens, it likely does not provide adequate ventilation, especially during cold weather when the window is closed. A qualified contractor should install exhaust fans as per standard building practices where missing in bathrooms with showers. Even if a small toilet room in the bathroom has an exhaust fan if applicable, it's still a good idea to have one in the main bathroom as well near the shower. An exhaust fan may not have been required when the home was built, but its always recommended to add an exhaust fan where missing.

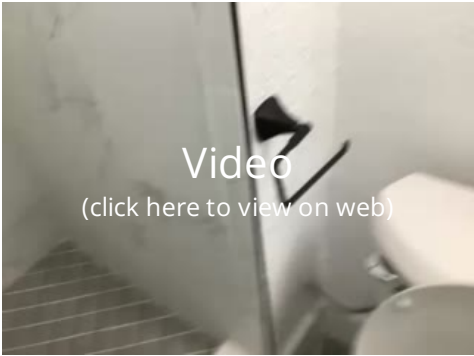
**LOOSE TOILET PAPER HOLDER**

The toilet paper holder is loose at the wall and damage may occur. The holder should be secured to the wall with the correct fasteners to help prevent damage.

Contact a qualified professional.

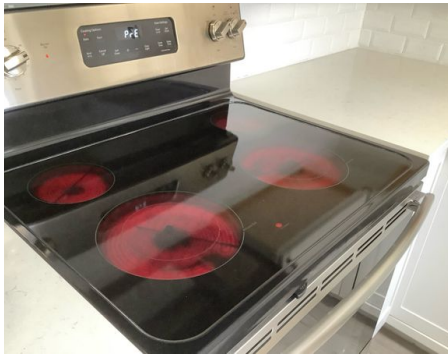
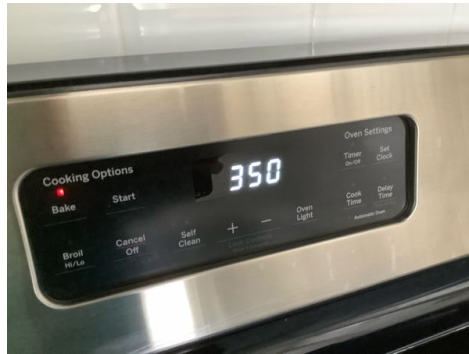
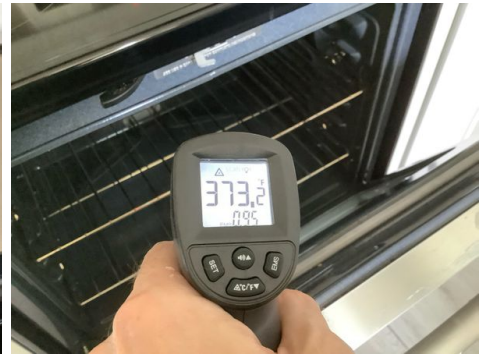
The heating elements for the oven and stove top functioned as expected. Oven calibration is beyond the scope of a building inspection.

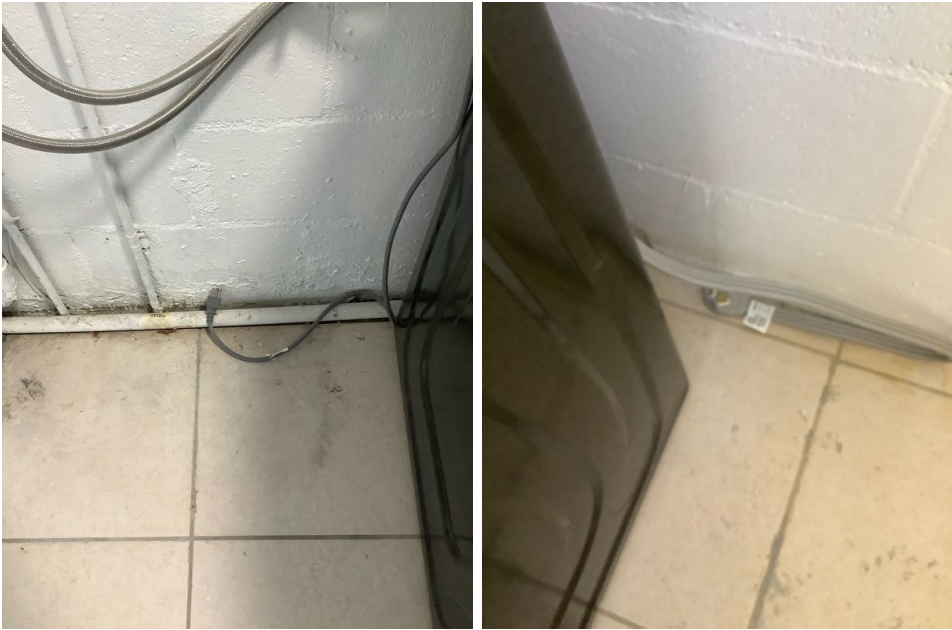
General  
**UNPLUGGED**  
LAUNDRY ROOM

Both unplugged. Inspectors don't plug in appliances. They may be unplugged for a reason. Inquire with seller.
