## HOME INSPECTION REPORT

1234 Main St.  
Bastrop TX 78602

# PROPERTY INSPECTION REPORT

**Concerning:** 1234 Main St. Bastrop TX 78602  
(Address or Other Identification of Inspected Property)

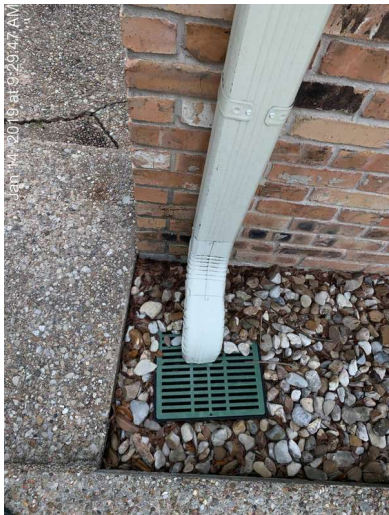
**1: Soil Elevations:**

**Deficient:** Soil elevations are too high on right side of garage . Industry standards call for a minimum of 4-6' inches of the foundation be visible on all elevations.

Should be 4-6' inches of foundation visible.

Recommendation: Contact a qualified landscaping contractor

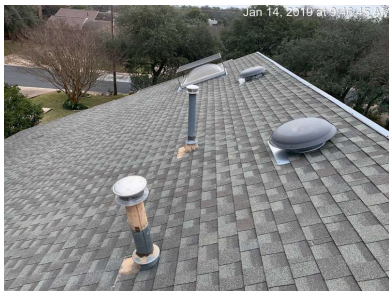
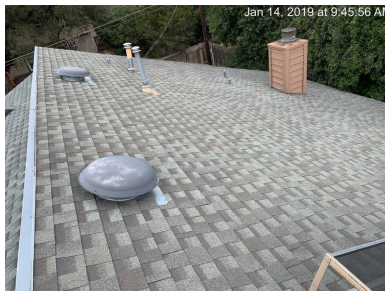
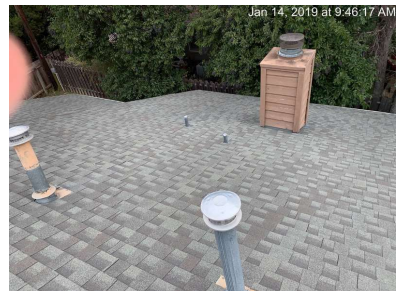
**1: Tree Limbs:**

**Deficient:** All tree limbs should be cut back away from roof covering a minimum of three feet to prevent damage from occurring during storm events.

Recommendation: Contact a qualified tree service company.

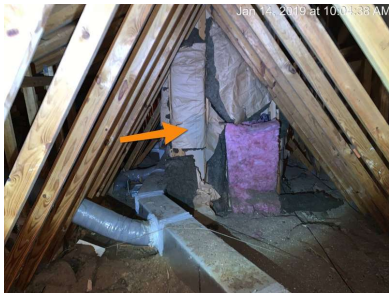
Vertical insulation attached to skylight.

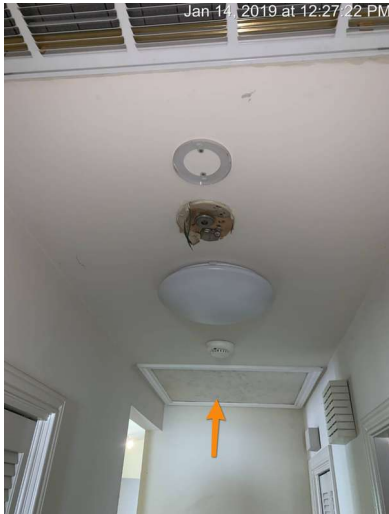
**Attic access is a sheet-rock hatch installed in the hallway. There is no ladder installed.**

**Opening is 31" x 32' inches.**

Attic access.

**Recommend installing a pull-down ladder for better access so that area can be used for storage.**

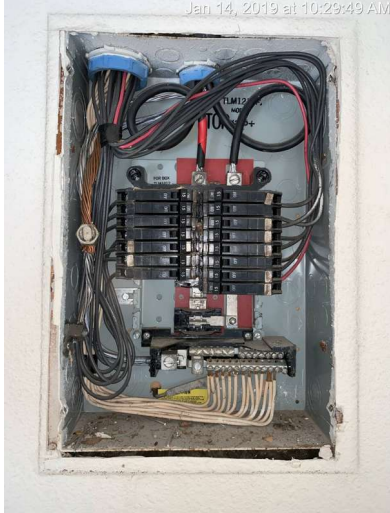
Sub-panel without cover.

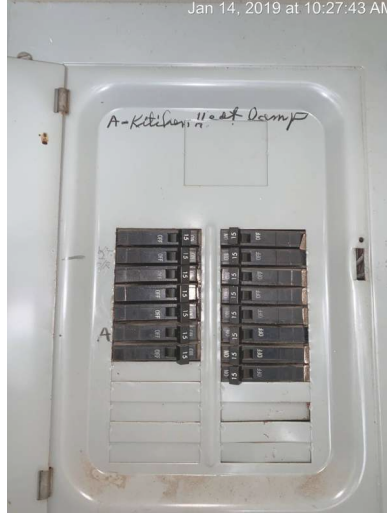
Sub-panel with cover.

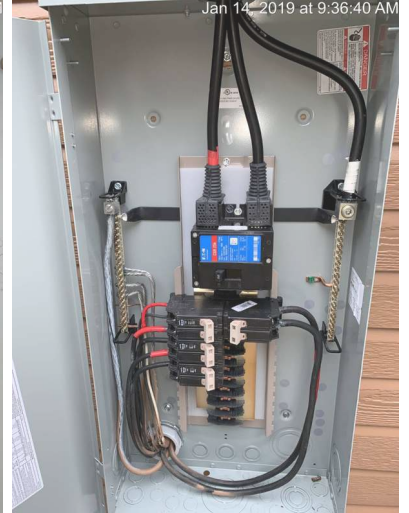
Main panel without cover.

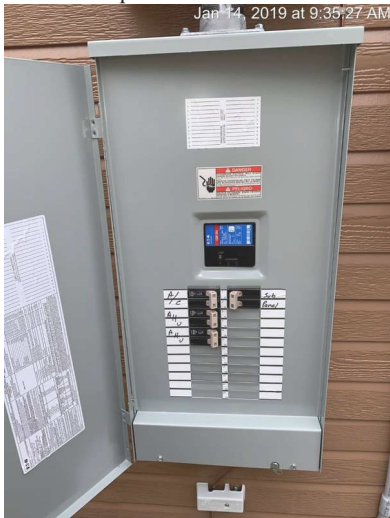
Main panel with cover.

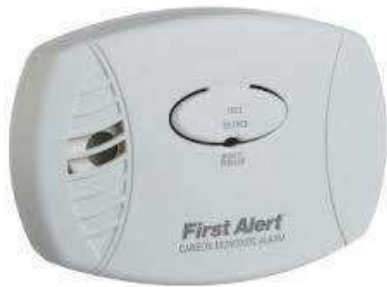
**Deficient:** Carbon monoxide detector is not present at time of inspection. Recommend installation one near kitchen before closing.

Recommendation: Contact a qualified electrical contractor.

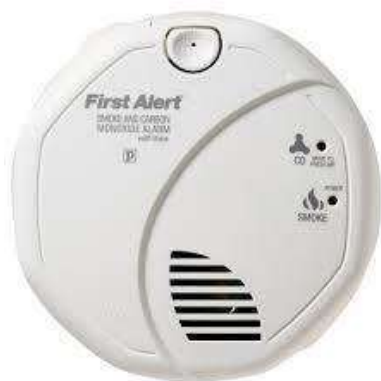
**2: Carbon Monoxide Detectors Required**

**Deficient:** All smoke detectors must now be a combination smoke/carbon monoxide detector. Please have an electrical specialist replace all existing units to meet current requirements.

Recommendation: Contact a qualified electrical contractor.

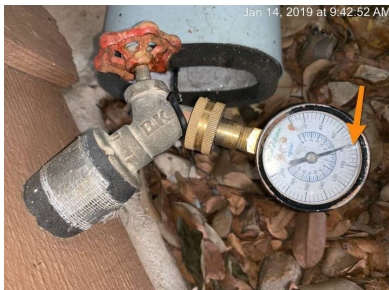
*Static Water Pressure Reading:* 80 - psi -  
**Water pressure reading is a cursory test, the pressure of the system can vary throughout the day.**

**Incoming water pressure that exceeds 80 psi can possible damage interior pipes and valves and should be further evaluated by a plumbing specialist.**

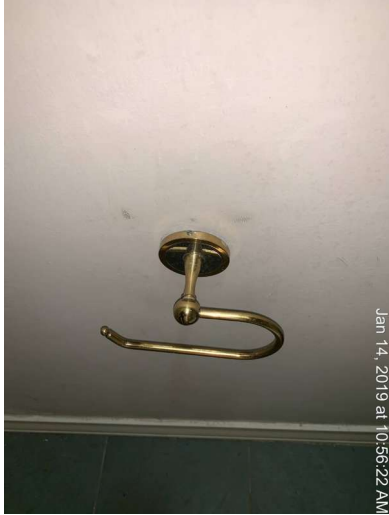
**1: Bathroom Fixtures Loose**

**Deficient:** Several towel bars, toilet paper holders, and towel bars are not properly secured . Have a handyman provide needed repairs.

Recommendation: Contact a qualified handyman.

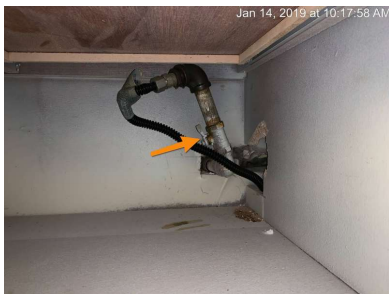
Gas cut-off
