PGR HOME INSPECTIONS

RESIDENTIAL HOME INSPECTION REPORT

1234 Main St.
Charleston SC 29414

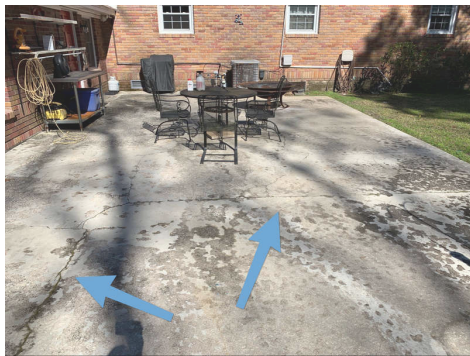
DRIVEWAY, SIDEWALK, PATIO CRACKING

One or more cracks observed, which may indicate movement in the soil (settlement) or expansion/ contraction of the material. Recommend monitoring and/or have concrete contractor patch and seal.

Recommendation

Contact a qualified concrete contractor.

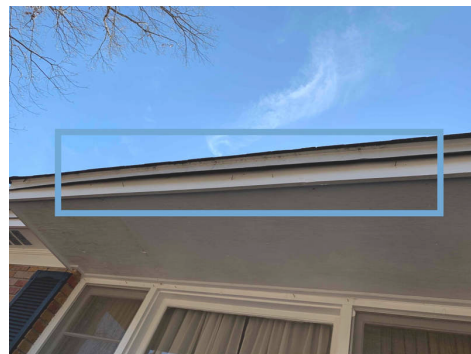
Front side of home

Drip edge on the front of the house is significantly bent up. Recommend resealing properly to help prevent possible unwanted pest from entering or loosing the drip edge to high winds.

Recommendation
Contact a qualified professional.

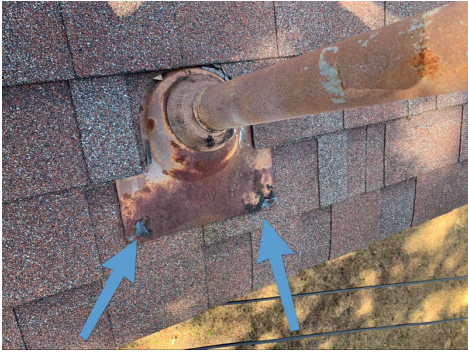
Possible water intrusion point where nail heads are exposed. Recommend sealing properly to prevent possible water intrusion and evaluate the other visible sealant and repair as needed.

Recommendation
Contact a qualified professional.

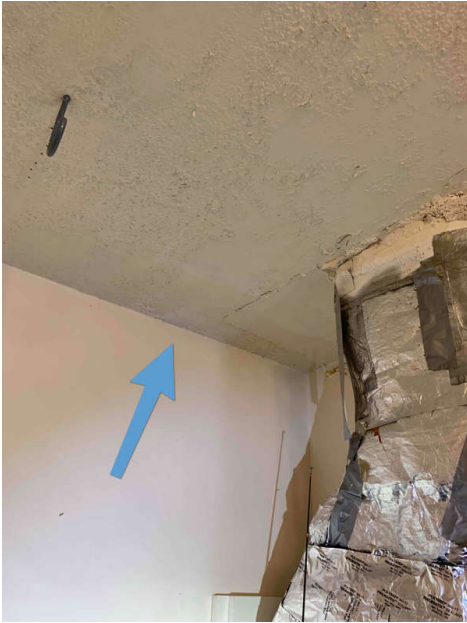
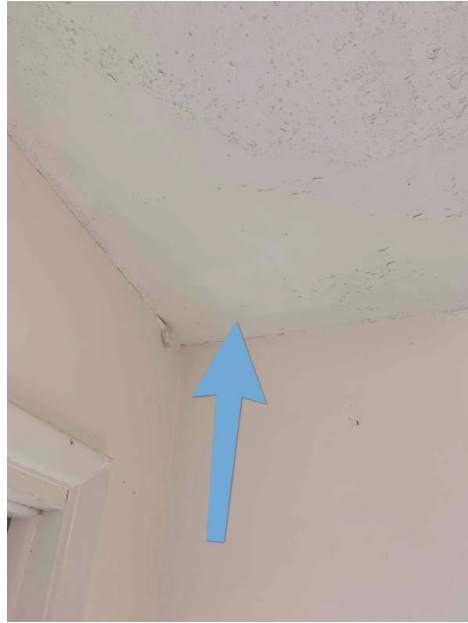
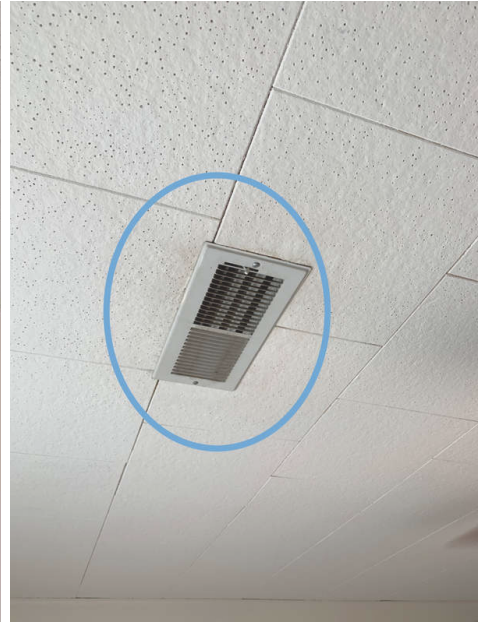
Back storage room

First bed on right front of house

Recommendation

Contact a qualified professional.

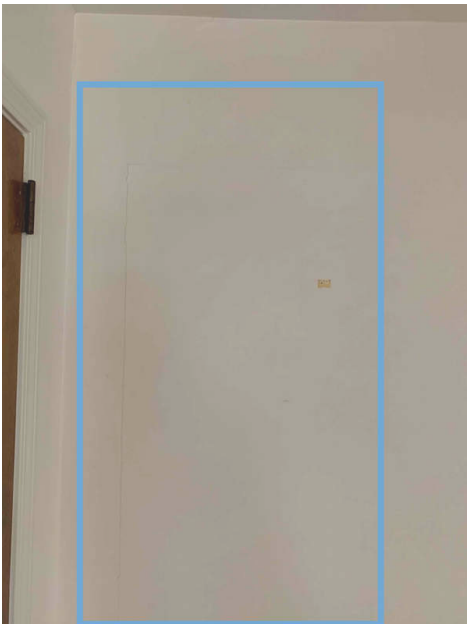
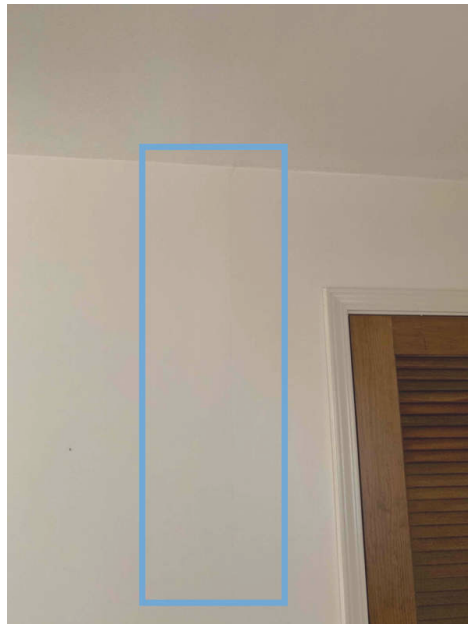
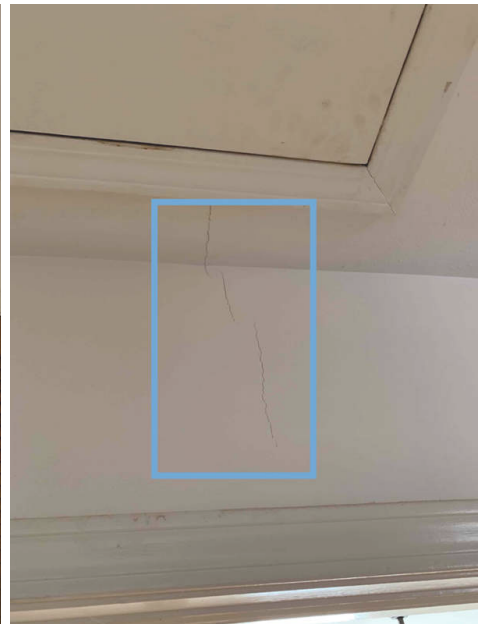
Where old front door used to be

Living Room

Front hallway by attic access

Recommendation

Contact a qualified drywall contractor.

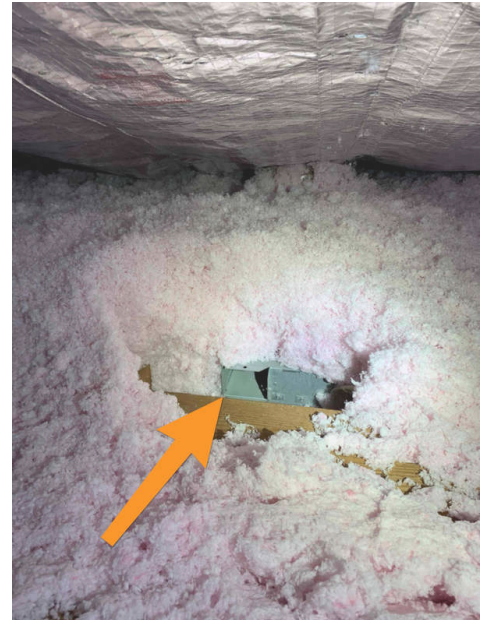
Guest Bathroom Front part of home

Bathroom fan vents into the attic, which can cause moisture, increased humidity and possible mold growth. Recommend a qualified professional properly terminate the exhaust to the exterior.

Contact a qualified professional.

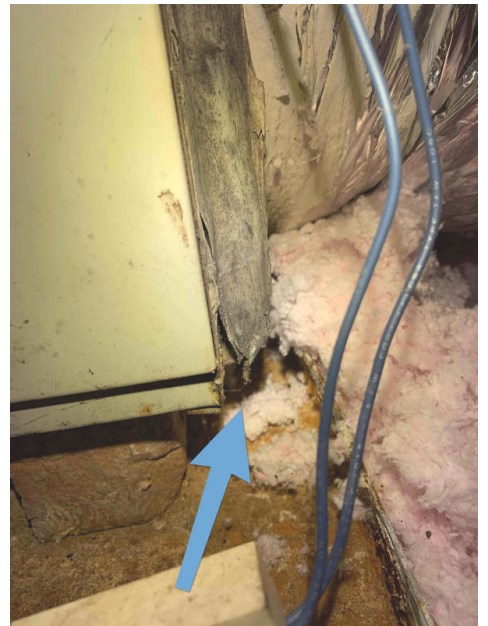
HEIL unit front right corner

Tape and mastic coming undone resulting in possible air leakage. Recommend a licensed HVAC contractor evaluate and reseal.

Contact a qualified HVAC professional.

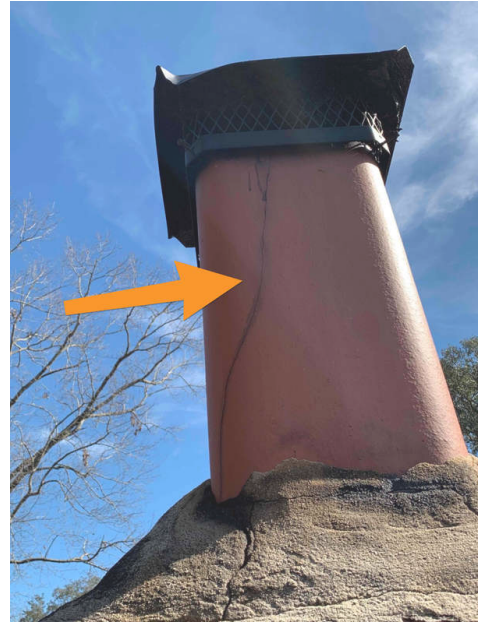
CHIMNEY FLUE CRACKED

The chimney flue had one or more cracks, which can lead to further damage to the chimney structure. Recommend a qualified contractor repair.

Contact a qualified roofing professional.

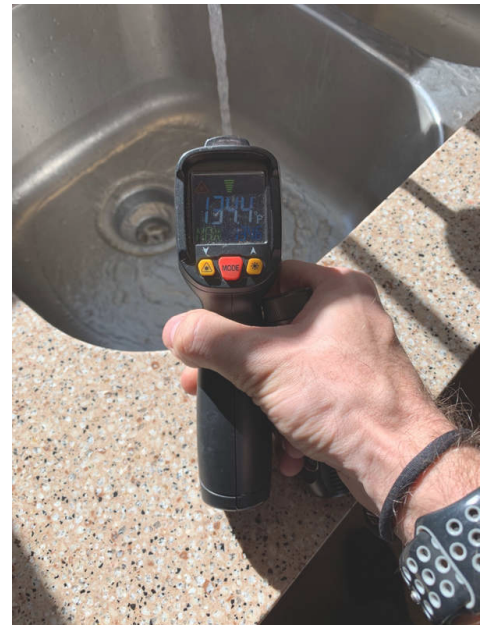
RECOMMEND REDUCING TEMP SETTING

Registered 134 degree water temperature coming from the kitchen sink. It is recommended the water heater temperature be set to 120 degrees F to reduce the risk of scalding.

Contact a handyman or DIY project

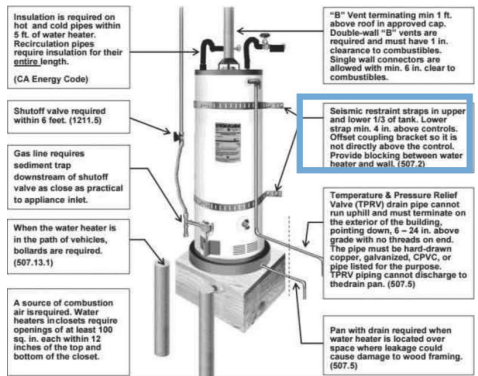
SEISMIC STRAPS MISSING

Water heater is missing seismic straps which are recommended for the area. Recommend a qualified professional install on the top and bottom third of the tank.

Contact a qualified professional.

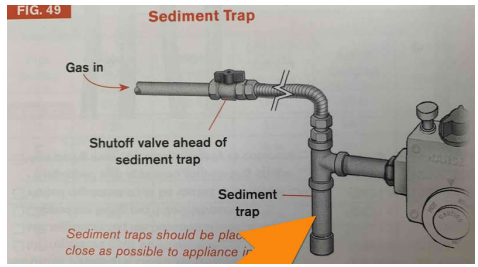
There is not a proper sediment trap located behind the shut off valve. They should be placed as close as possible to the unit. These help catch and prevent sediment in the gas from entering the unit potentially causing damage. Recommend a licensed plumbing professional repair.

Contact a qualified plumbing contractor.

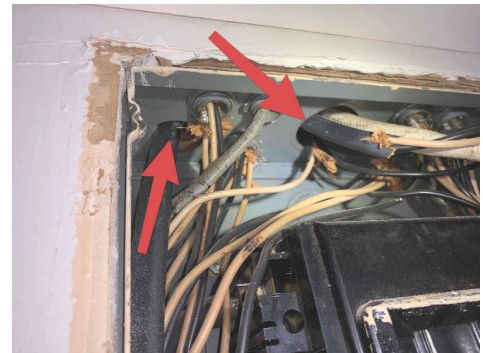
MISSING BUSHINGS

Wire bushings help protect the wire at the point where it enters the panel box. The edges around this area over time can cut into the wiring potentially causing a short or arc creating a potential fire hazard. Recommend a licensed electrician install.

Contact a qualified electrical contractor.

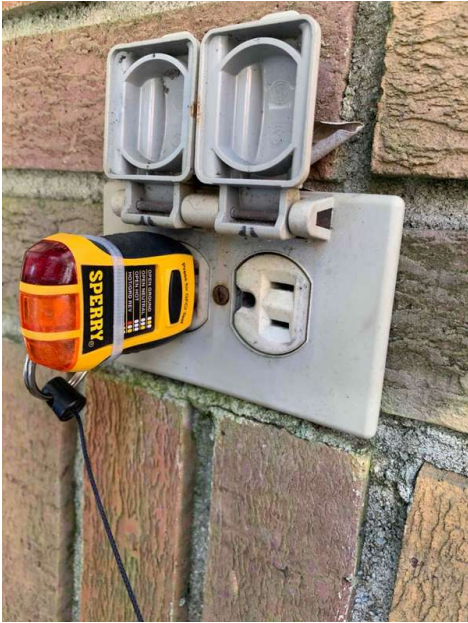
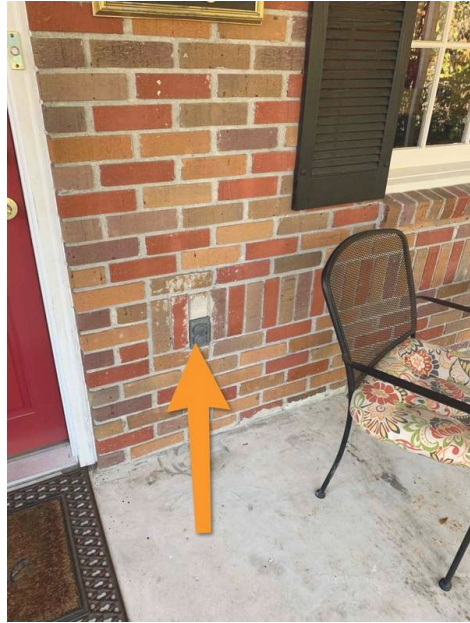
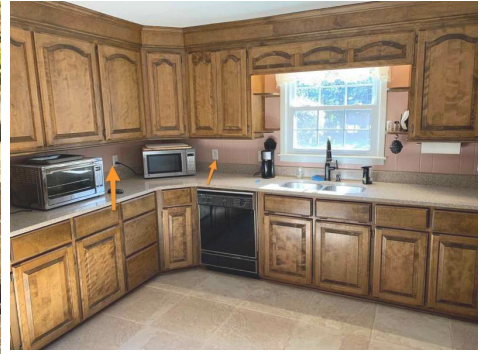
Back patio left of right door

No GFCI protection present in all locations where the receptacle could come in contact with water or other liquid. Potential safety hazard.

Recommend licensed electrician upgrade by installing ground fault receptacles or breakers for locations specified: **OUTSIDE, BATHROOM, KITCHEN receptacles.**

Contact a qualified electrical contractor.

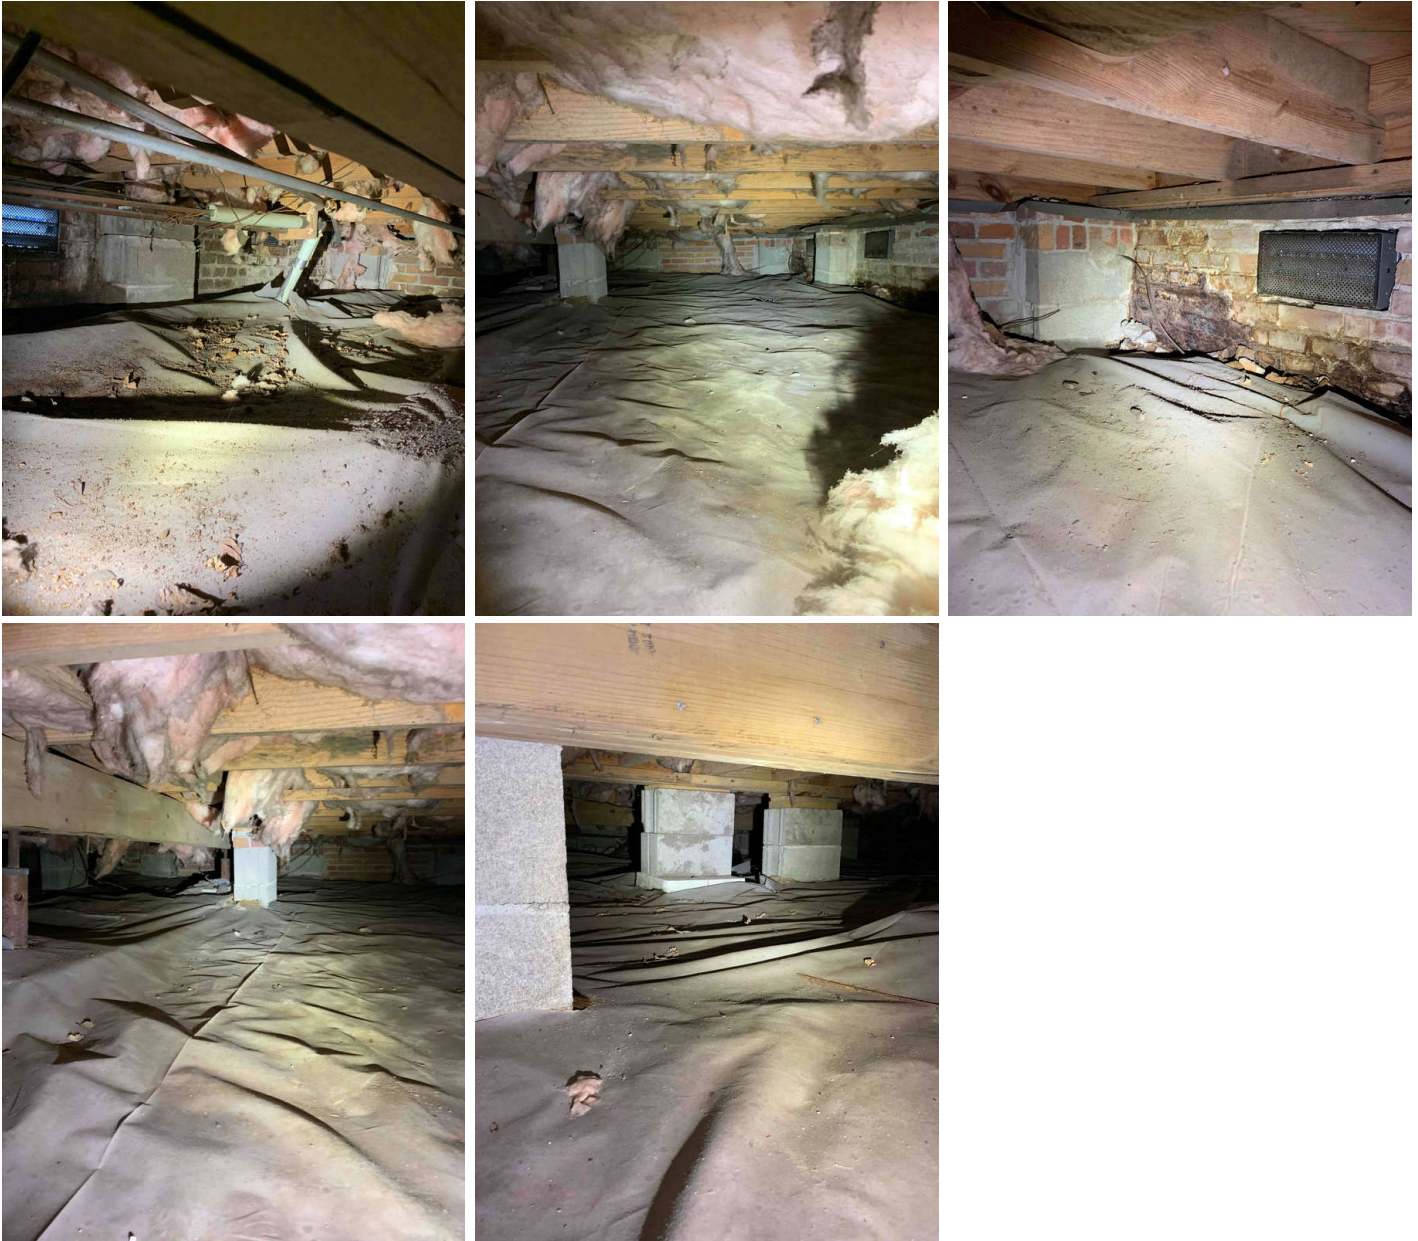
12.2.1 Crawlspace

EFFLORESCENCE/ MOISTURE INTRUSION

Moderate Deficiency

Efflorescence noted on the crawlspace surface in one or more locations. This a white, powdery deposit that is consistent with long term moisture intrusion. This can compromise the soil's ability to support the home structure and/or lead to mold growth. No other signs of inadequate drainage or grading issues present on the day of inspection. Recommend a qualified foundation contractor evaluate and provide a solution to reduce the moisture entering the crawlspace.

Contact a qualified professional.

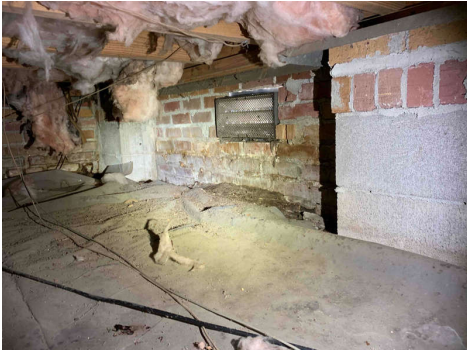
12.3.1 Floor Structure

MOISTURE INTRUSION/ WOOD ROT

Significant Deficiency/ Safety Hazard

Observed one or more areas where there were signs of moisture intrusion and rotting on the subfloor and neighboring joists. Did not see any signs of active leaking at time of inspection. Moisture readings were moderately high, around 15-17%. Recommend a qualified contractor evaluate further and identifying the moisture intrusion point, repairing and replace the damaged/ rotted subfloor and joist.
