## YOUR HOME INSPECTION

1234 Main St.  
Garland Texas 75043

# PROPERTY INSPECTION REPORT

**Concerning:** 1234 Main St. Garland Texas 75043  
(Address or Other Identification of Inspected Property)

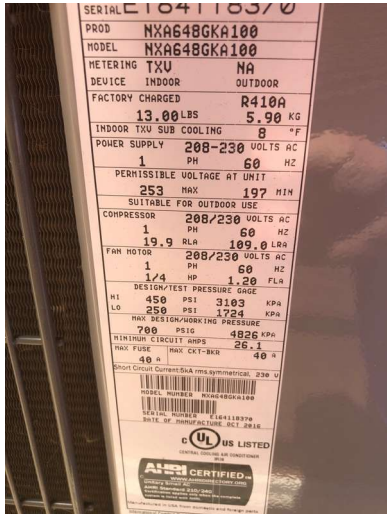
*AC Unit Information:* Main House unit, 2016, 4 Ton, Max 40 amp breaker, Arcoaire, Filter located at unit in attic, Media Filter, 410, Temp differential 21

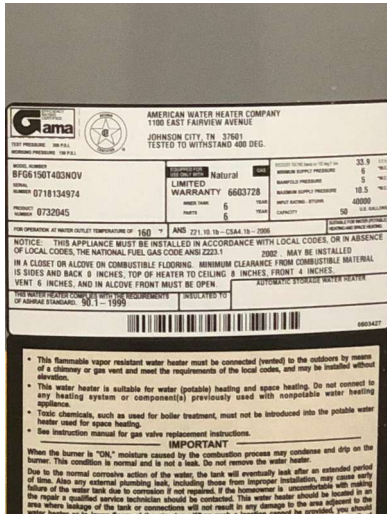
*Water Heater:* Energy Type: Gas, Capacity: 50 Gallon, Craftmaster

The T & P Valve (Temperature & Pressure Release Valve) should be tested annually for reasons of safety. Follow the manufacturers instructions for testing procedures.

We highly recommend the use of a water alarm at the water heater. This alarm will sound at the presence of any water leaks and could help prevent major water intrusion events due to failure of the water heater. These units are available online or at major home improvement centers for about \$10 each.
