YOUR HOME INSPECTION COMPANY

ERIC JONES HOME INSPECTION

1234 Main St.
Upper Darby PA 19082

Buyer Name
10/16/2018 9:00AM

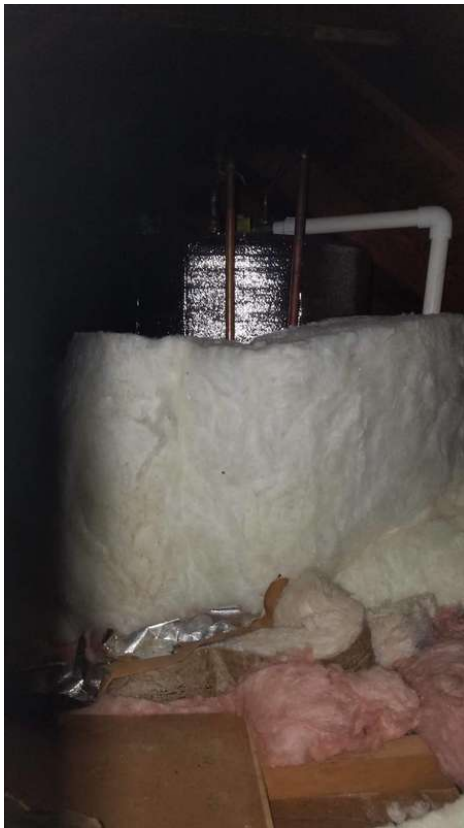
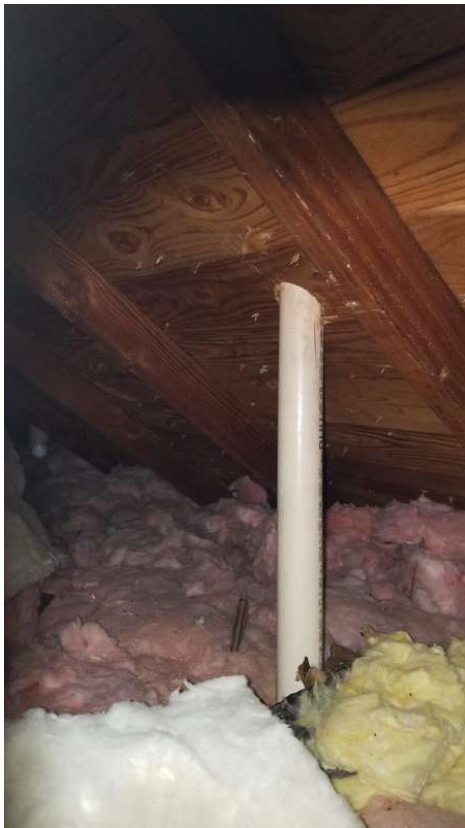
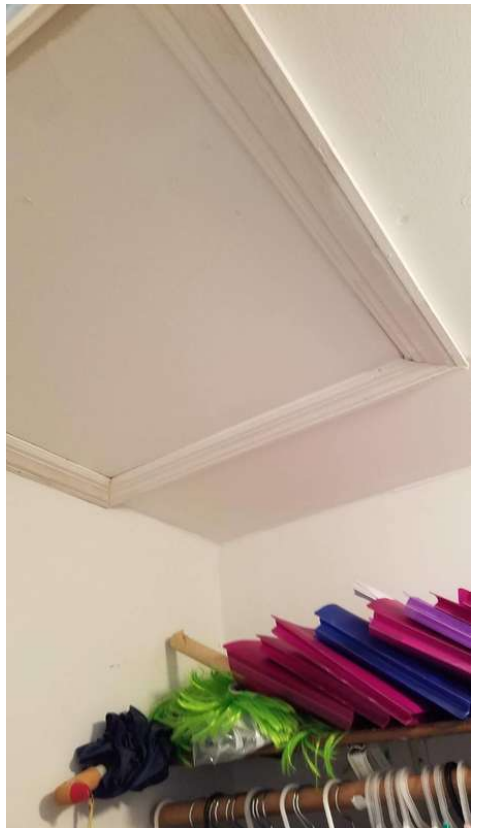
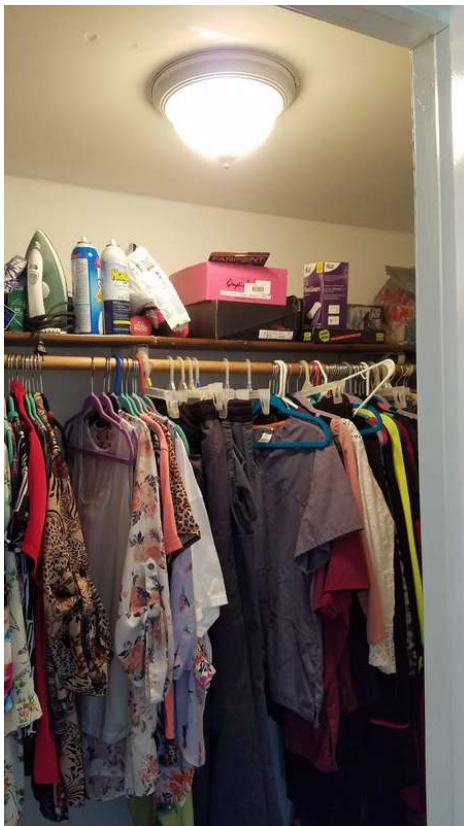
Unit B

Note: There was minimal attic space, viewed from closet scuttle opening in the bedroom closet.

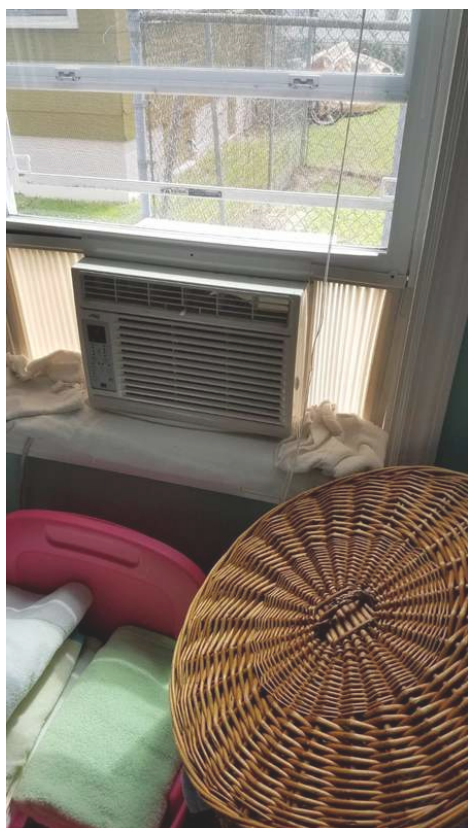
Unit A & B

Unit B had several window units for cooling. Unit A did not have any central cooling or window units installed.

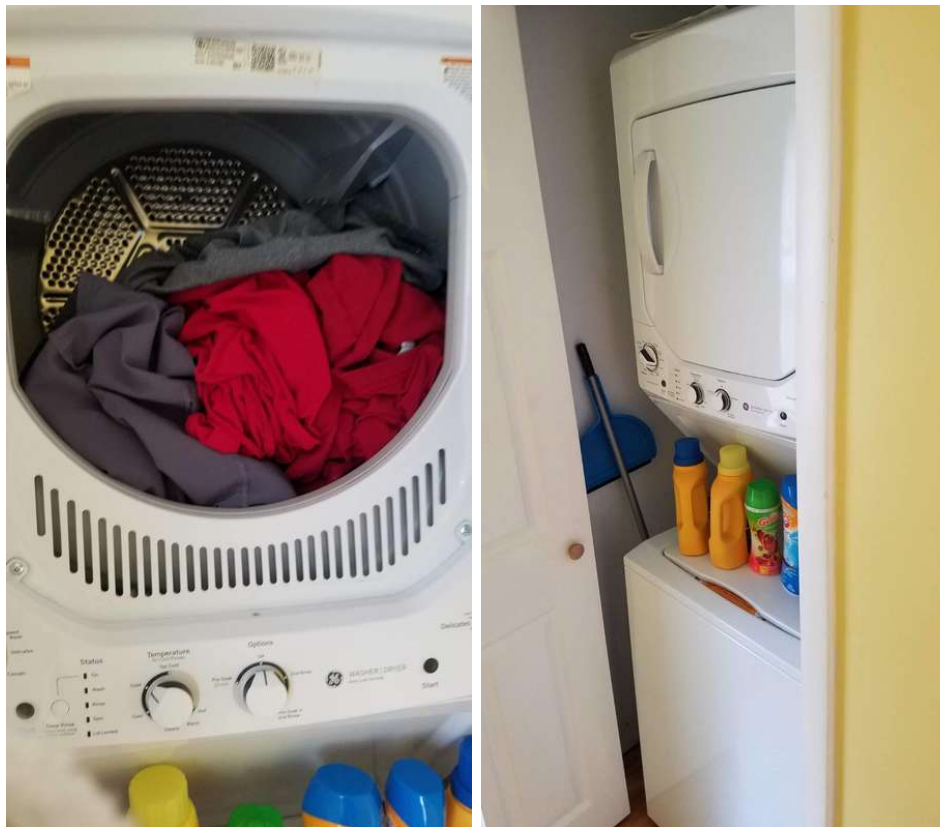
UNIT B

The clothes washing machine was full of clothing at time of inspection and was not operated. Unit was a newer GE Unit.
