## RESIDENTIAL HOME INSPECTION

1234 Main St.  
Wellington 6022

Buyer Name  
10/27/2018 9:00AM

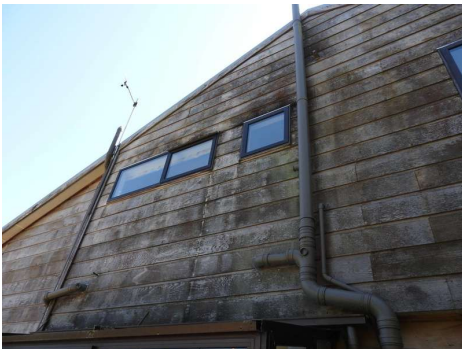
The retrofitted double glazed windows - with the added weight of the double glazing this may cause the window joinery to sag where these are installed as new. modern windows would have WANZ bars installed into the framework to account for the extra weight. This is showing on the bay window in the kitchen, you can see the weight of the roof and the window has dropped and it's putting stress on the joins.

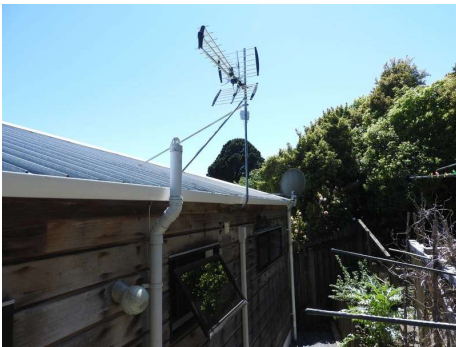
**Inspected presence of : Aerials and antennae**

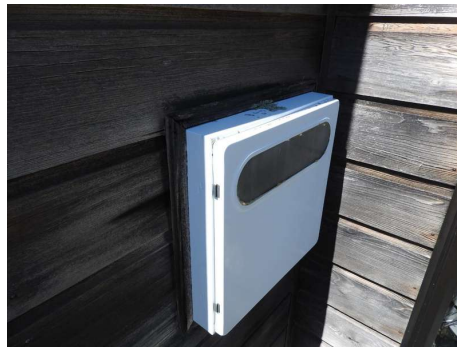
**Inspected presence of : Electricity services**

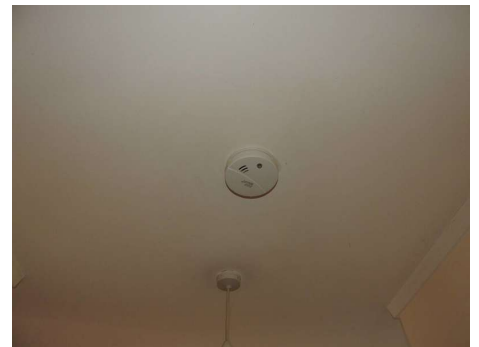
**Inspected presence of : Fire warning and control systems (including smoke detectors)**

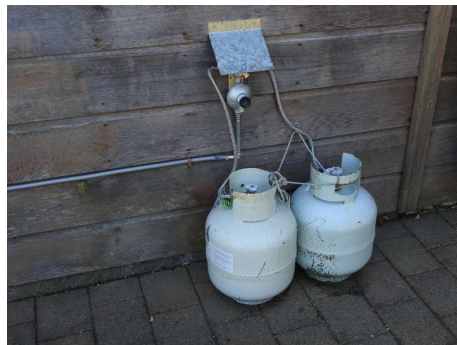
**Inspected presence of : Gas services**
